# Keeyask Generation Project Environmental Protection Plan

EnvPP-2017-01

## **ENVIRONMENTAL PROTECTION PLAN ANNUAL REPORT**

**April 2016 – March 2017**

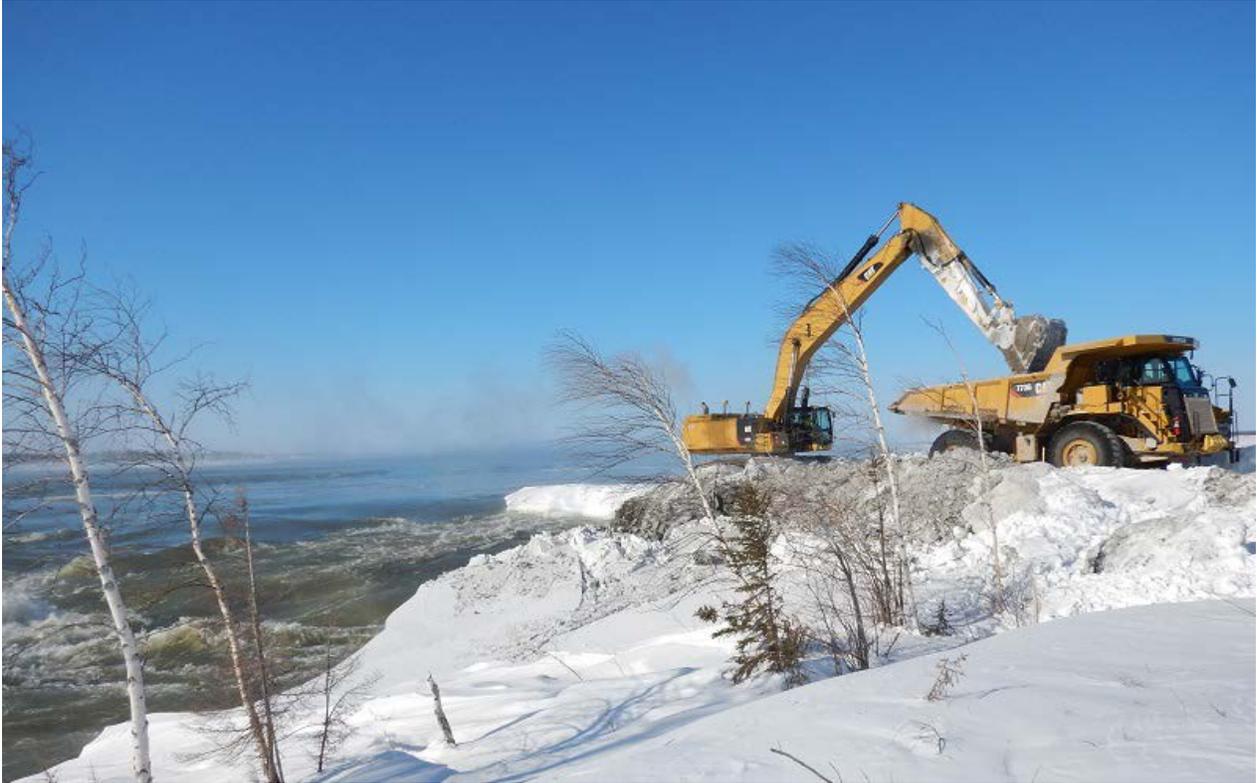
Three unanticipated alterations to existing structures were required during the reporting period. In the spring of 2016, an extension of the Central Dam Cofferdam and re-alignment of the Tailrace summer level cofferdam was required due to leakage from a geological feature (i.e., fissures in the bedrock). In the fall of 2016, a re-installation of the North Channel Rock Groin was required to prevent ice jamming in Gull Rapids. In anticipation of forecasted high water levels, a Stage II North Channel Rock Groin top-up began in the spring of 2017 (Photo 5).

**Photo 5: Stage II North Channel Rock Groin top-up in preparation for high spring 2017 water levels**

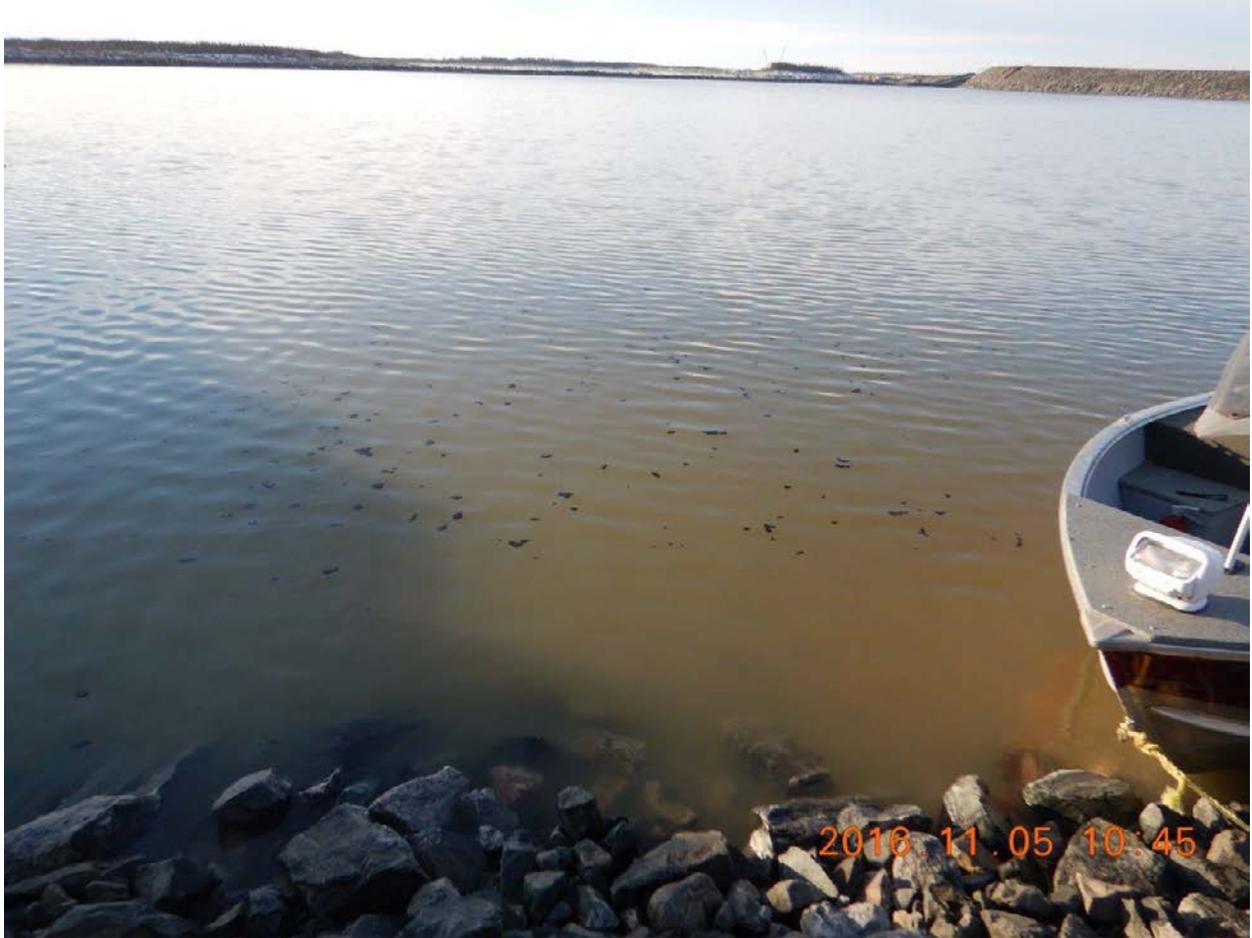
On November 5, 2016, a black, grainy substance was observed on the surface of the water inside the inner groin of the Stage II Summer Level Tailrace Cofferdam while conducting visual inspections of the in-stream work (Photo 10 and Map 4). That same day samples of the water and the substance were collected for analysis by an accredited laboratory and a marine boom was installed between the inner and outer groins to prevent the substance from entering the Nelson River. In-stream work was temporarily suspended between November 7 and 11, 2016, until the sample results provided evidence that the substance was non-hazardous. The analysis results indicated that the substance was mainly comprised of silicon, aluminum, and iron – the main elements that comprise feldspars and pyrite, which are common rocks in the geology around Keeyask. This suggests that the substance was likely rock dust and did not pose a substantial environmental risk in the small volume that had been observed.

**Photo 10: The grainy, black substance observed floating on the water inside the inner groin of the Stage II Summer Level Tailrace Cofferdam on November 5, 2016**

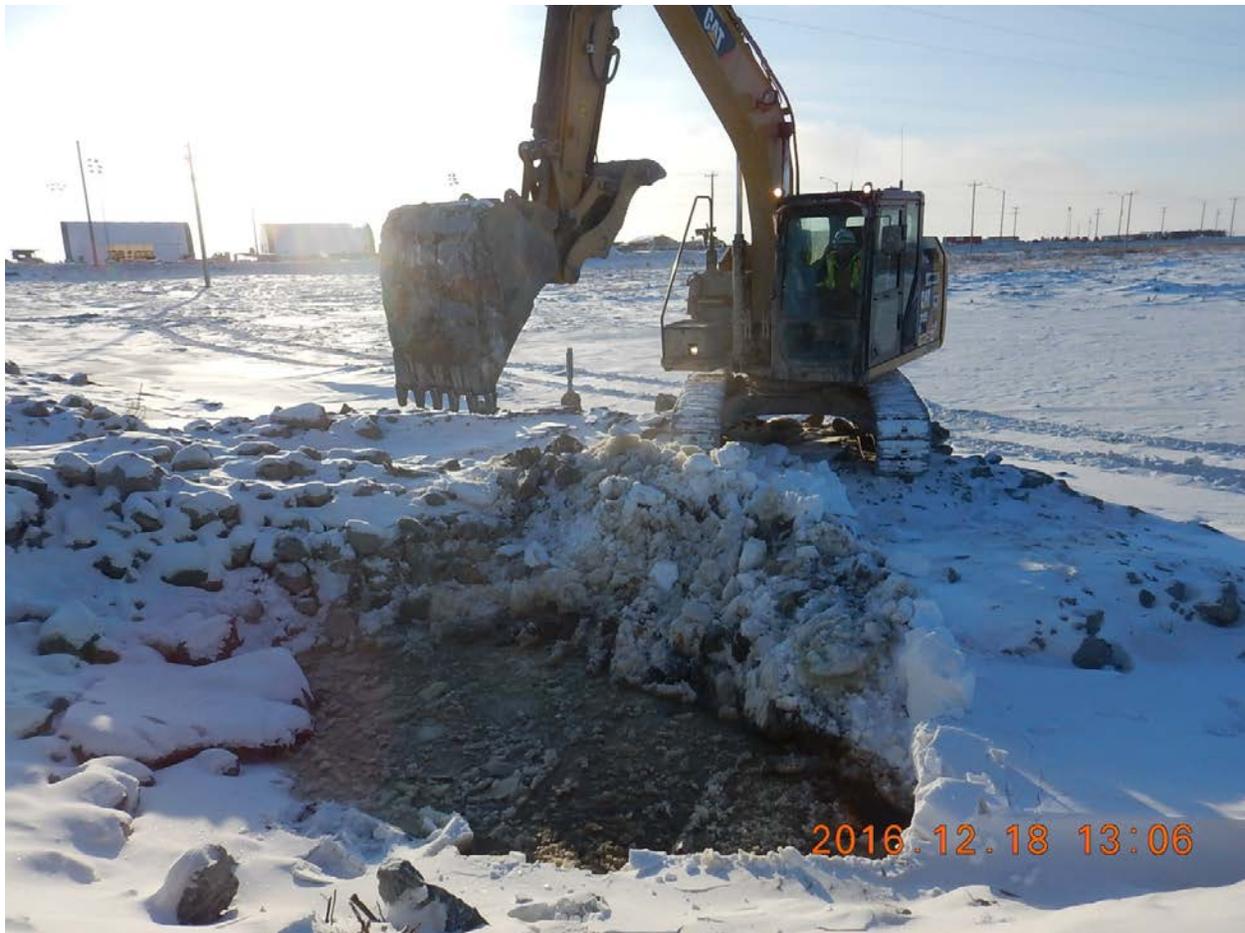
In December 2016, an investigation began near Work Area A when water was observed to be seeping through a vegetated area. The water had a sewage-like odour, leading to an investigation into whether the nearby lift station had sprung a leak. After the area was excavated and the pipes were inspected, it was concluded that there was no leakage and the odour was attributed to the saturated peat present at the site. Although the regulators were notified, there were no follow-up actions required (Photo 11).

**Photo 11: Excavation of lift station for pipe inspection near Work Area A**

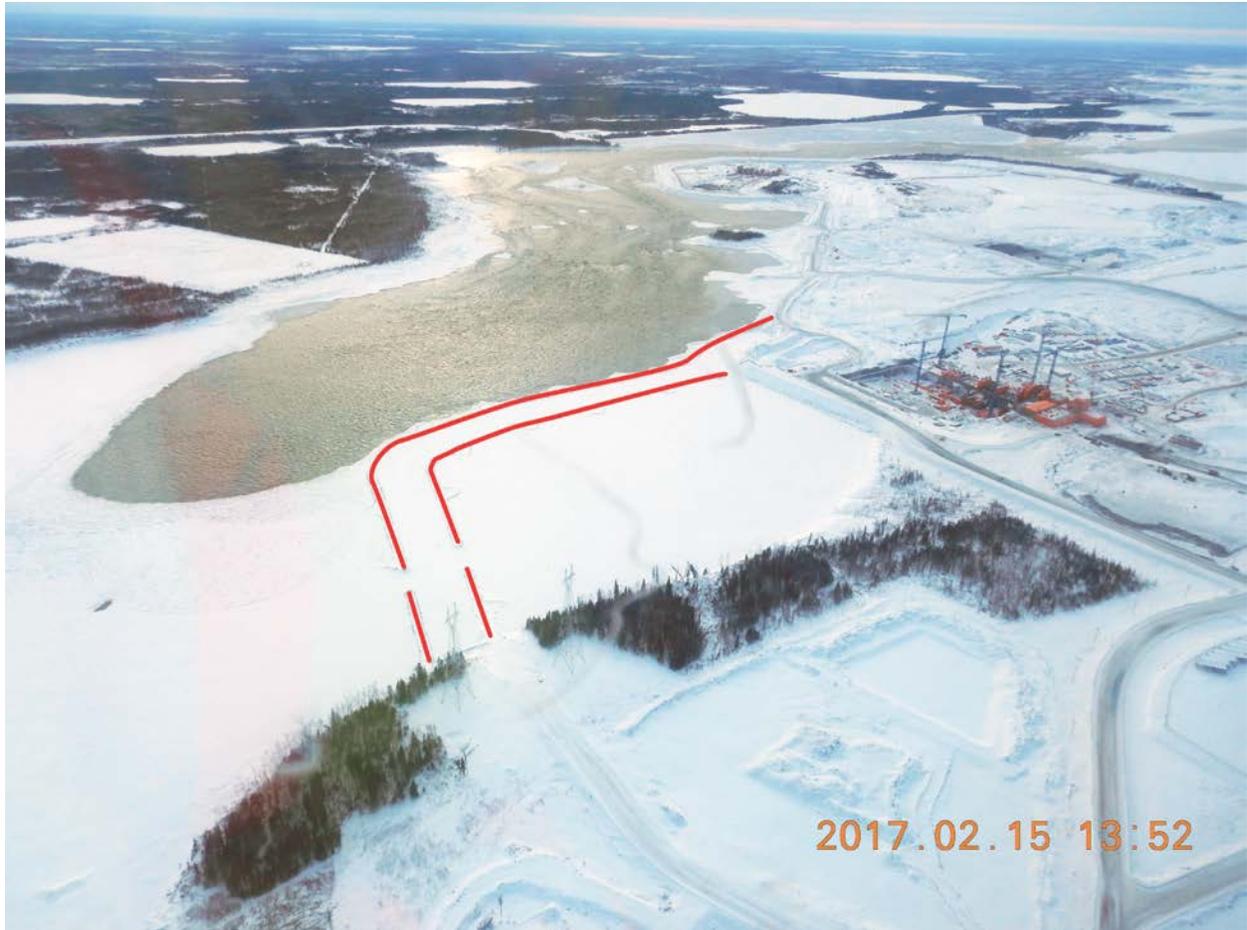
A fish salvage could not be conducted prior to winter within the impoundment area of the Tailrace Summer Level Cofferdam, once the work stopped on November 30, 2016. Because of this, the inner and outer rock groins were left open to allow fish to move freely in and out of the area during the winter (visible in Photo 15).

**Photo 15:** Aerial view of the Tailrace Summer Level Cofferdam in the winter, showing the location of the inner and outer rock groins (red lines) and gap left for fish movement

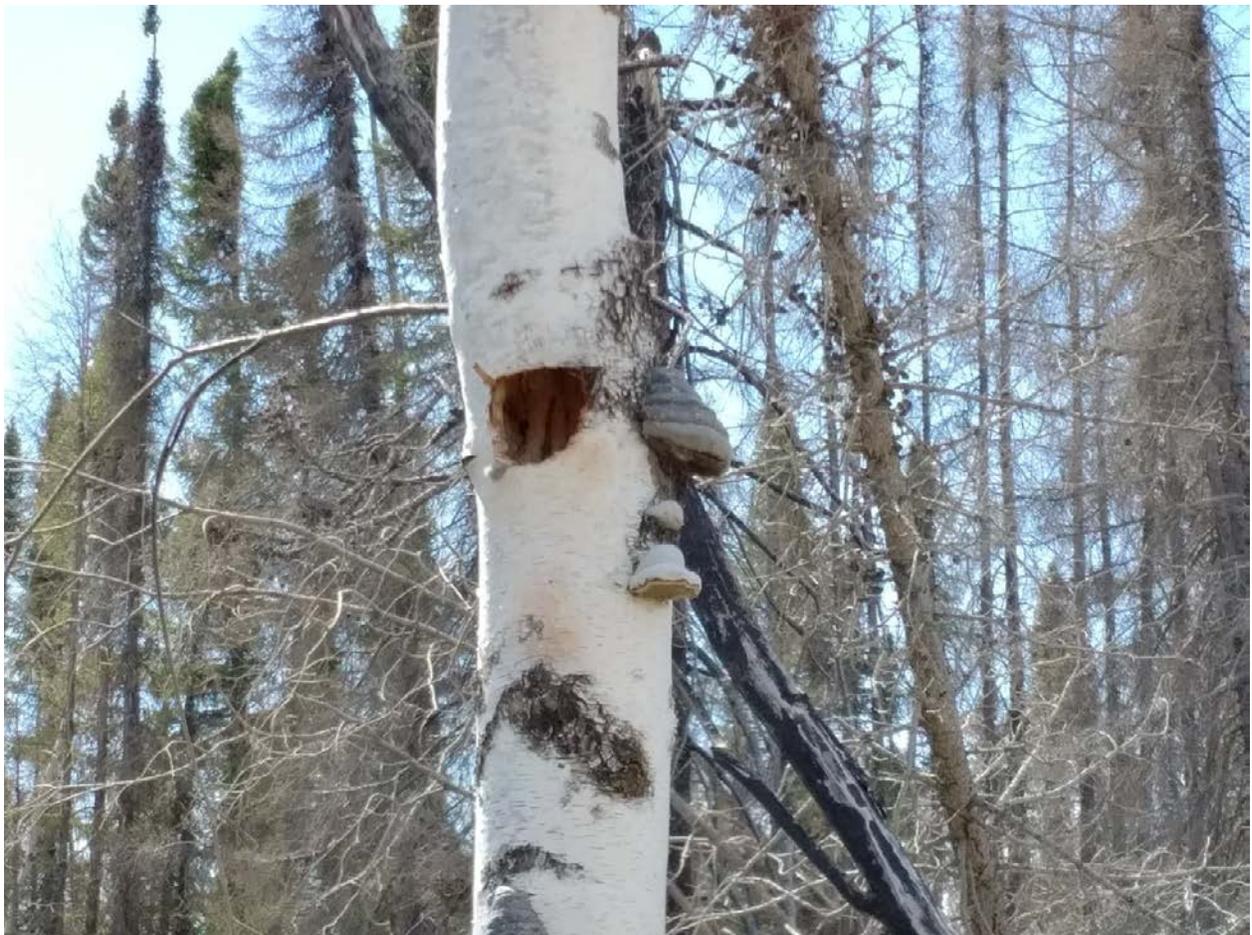
One active northern flicker nest was found (Photo 32) during the pre-clearing nest search and at least one white-throated sparrow was alarm calling (an indication that it had a nest nearby). Although a nest was not located during the pre-clearing survey, calls from a black-backed woodpecker indicated it also may have had a nest in the proposed area to be cleared.

**Photo 32: Active northern flicker nest observed during a pre-clearing nest search**

Due to the widespread nesting activity recorded in the area surveyed, clearing did not proceed at this location within the breeding bird nesting period.

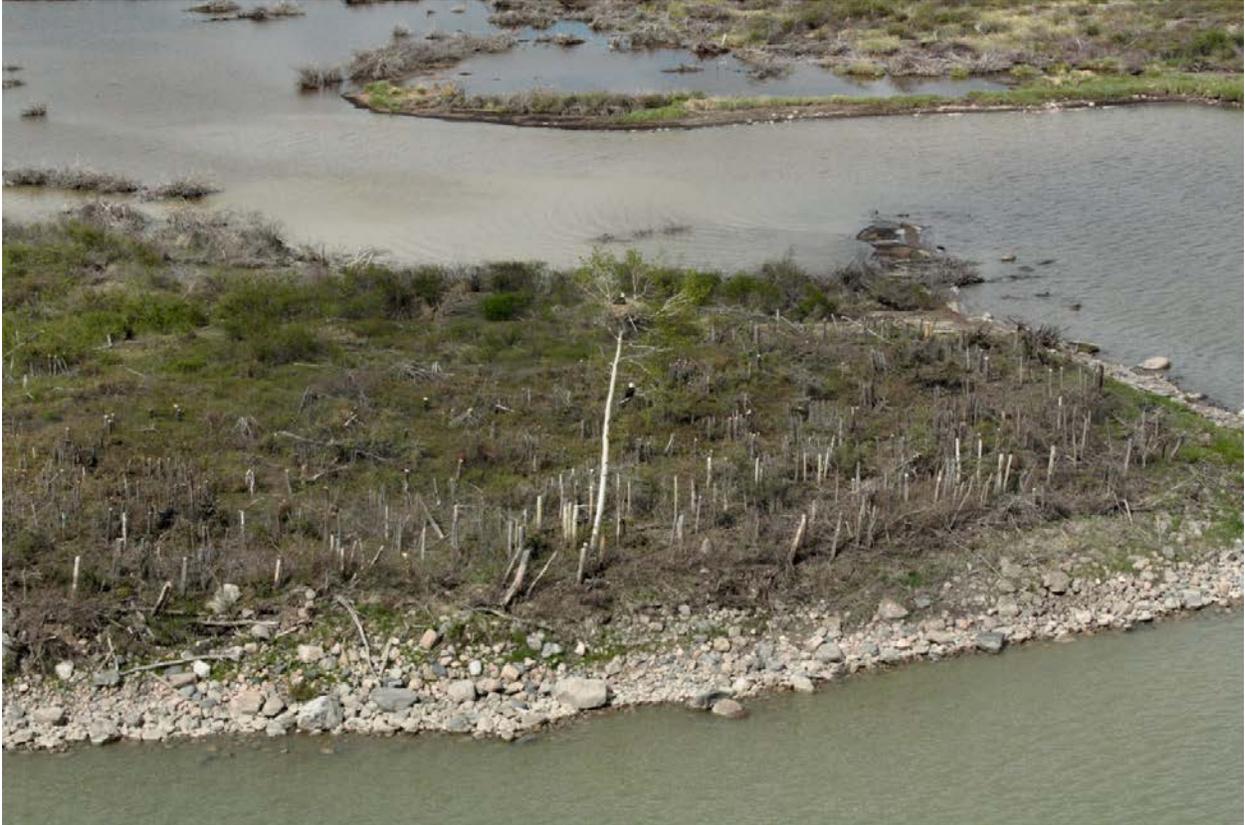
During reservoir clearing in 2016, two single trees were left standing in the future reservoir area. Photo 34 shows one of these trees with an occupied bald eagle nest in 2016, which shows the value of not removing the nest prior to impoundment. In February 2017, while clearing on the south side of the future reservoir area, an unoccupied eagle nest was discovered. A decision was made to leave the tree with the nest standing, so it is available for use by bald eagles in future nesting seasons. The nest will be monitored in the summer of 2017 to determine if it is active. These trees will remain in place, but will eventually fall over after impoundment of the reservoir. The tree will then likely be removed by a Keeyask boat patrol crew.

**Photo 34: Single tree left standing in the future reservoir area and used by bald eagles for nesting in 2016**

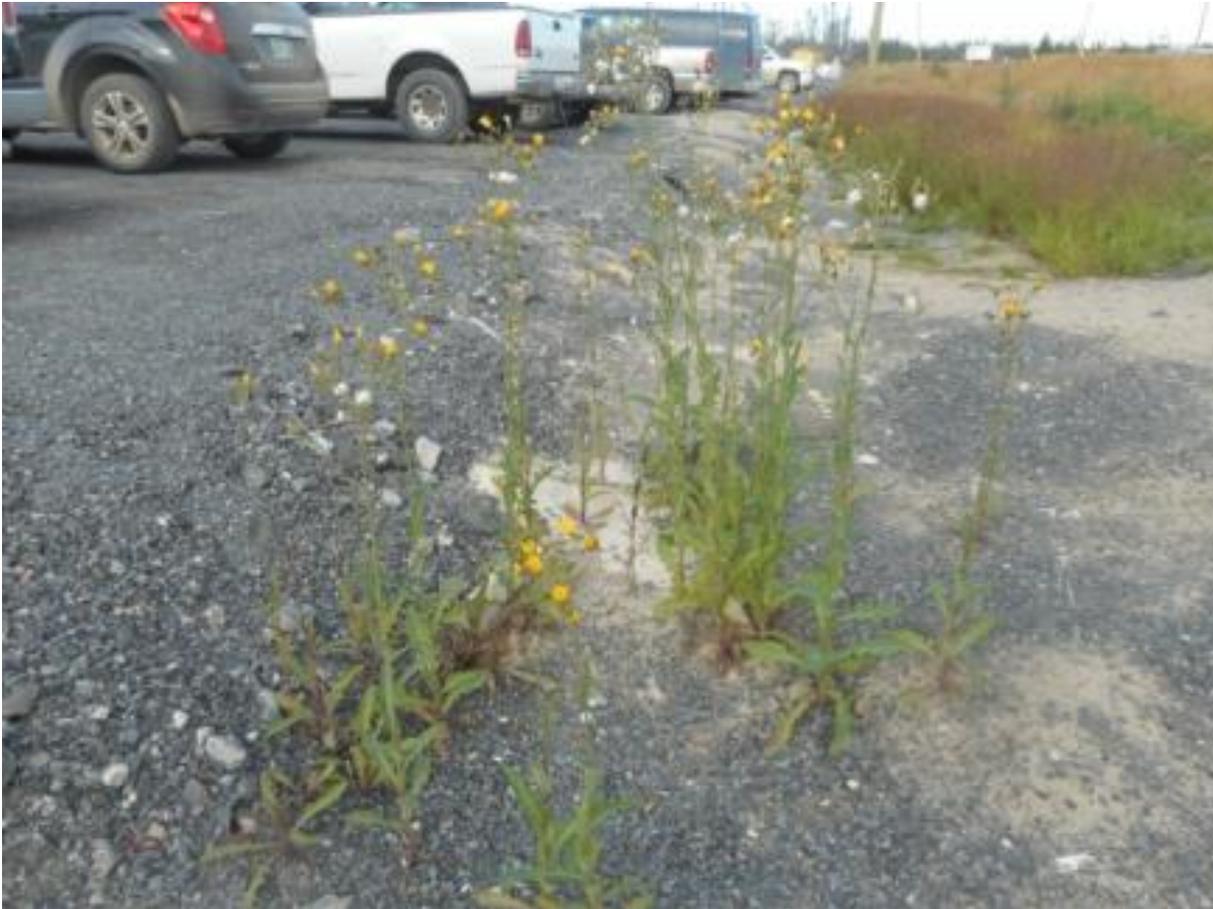
As described in the Project Environmental Protection Plans, means to mitigate impacts of invasive species on site include the requirement for vehicles coming to site to arrive clean, sourcing materials locally, and using native seed mixes for planting in disturbed areas. Despite these measures, several species of invasive or non-native plants were observed during monitoring surveys at the Project site, largely within the areas first developed under the Keeyask Infrastructure Project that are now part of the larger Project footprint. A total of 16 invasive species were previously observed during the fall 2015 surveys. An example of one is shown in Photo 36.

**Photo 36: Perennial Sow thistle found near the Start-Up Camp parking lot**

Based on recommendations from invasive plant monitoring, herbicide was applied on August 24 and 25, 2016 in portions of four key areas, including the Start-up Camp, Borrow Area G-1, Main Camp, and Work Area B, where the highest concentrations of invasive plants occurred (Map 9). Monitoring of these areas will be ongoing. Ultimately, revegetation of native plant species through the Project's Vegetation Rehabilitation Plan is intended to dramatically reduce the distribution and abundance of the invasive species observed to date on the Project site.
