Keeyask Generation Project
Terrestrial Effects Monitoring Plan

Habitat Loss and Disturbance Monitoring Report

TEMP-2018-01

June 2018

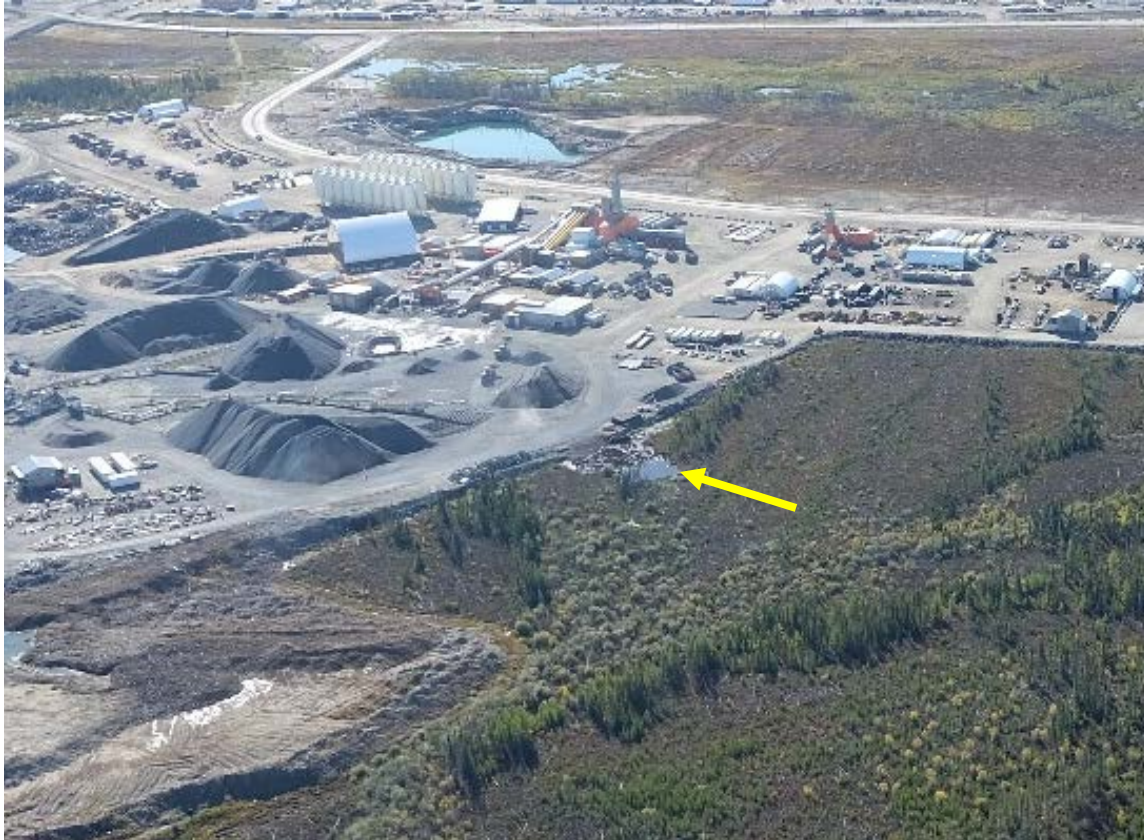
Figure 3–6: Work Area A (looking south) on September 19, 2017. Yellow arrow identifies remediated sediment area

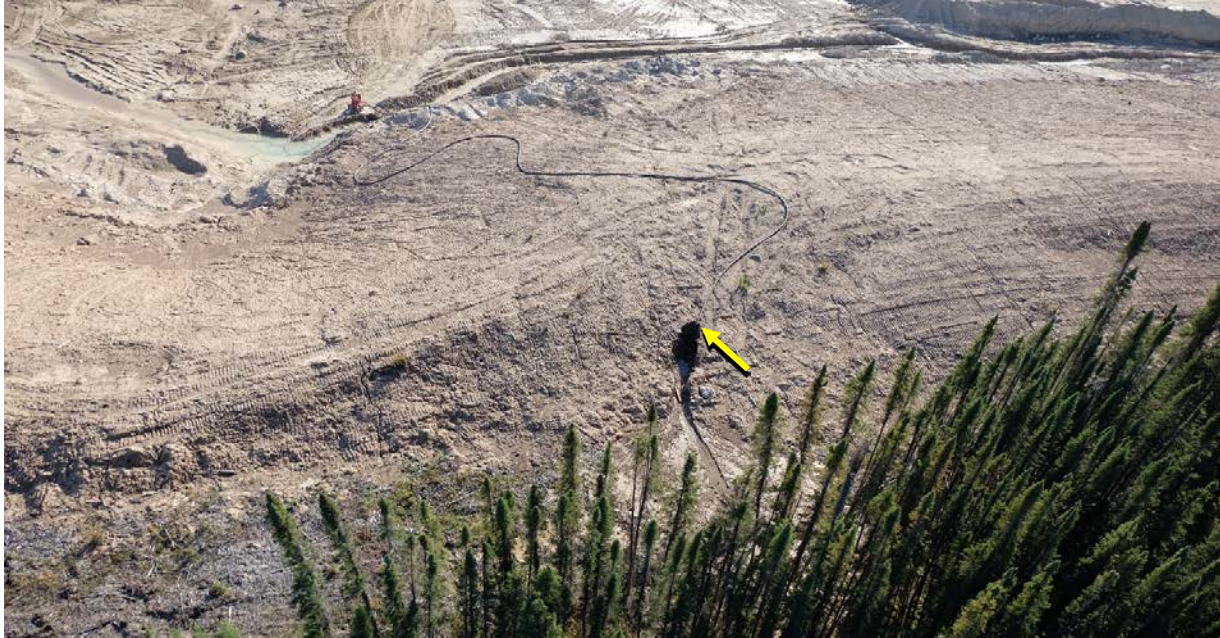
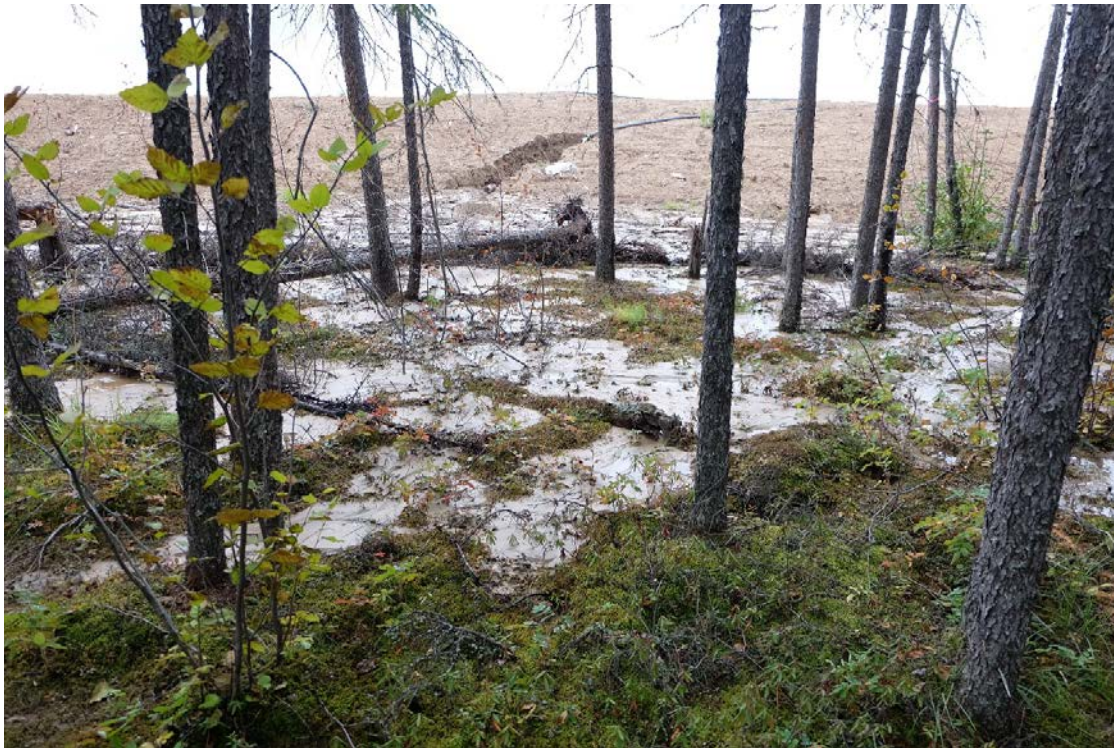
Figure 3–9: Sedimentation into adjacent undisturbed habitat at two locations in borrow area N-5

Borrow Area N-5 (looking south) on September 19, 2017. Yellow arrow identifies drainage hose and gully at location A

Borrow Area N-5 (looking south) on September 18, 2017, sedimentation in uncleared forest at location A

During the 2017 surveys, it was observed that erosion gullies at two locations along the north slope of Borrow Area N-5 had deposited sediment into the adjacent uncleared forest (Figure 3–9; Map 3-3). At one of the locations (Location A), the gully was formed by an active drainage hose. This gully was continuing to expand, and sediment was being deposited several meters into the forest. At the other location (Location B), a gully had formed and deposited sediment into the adjacent cleared area, and slightly into the uncleared forest. The cause of the gully at this location was unclear. It was recommended in the field reports that erosion barriers be

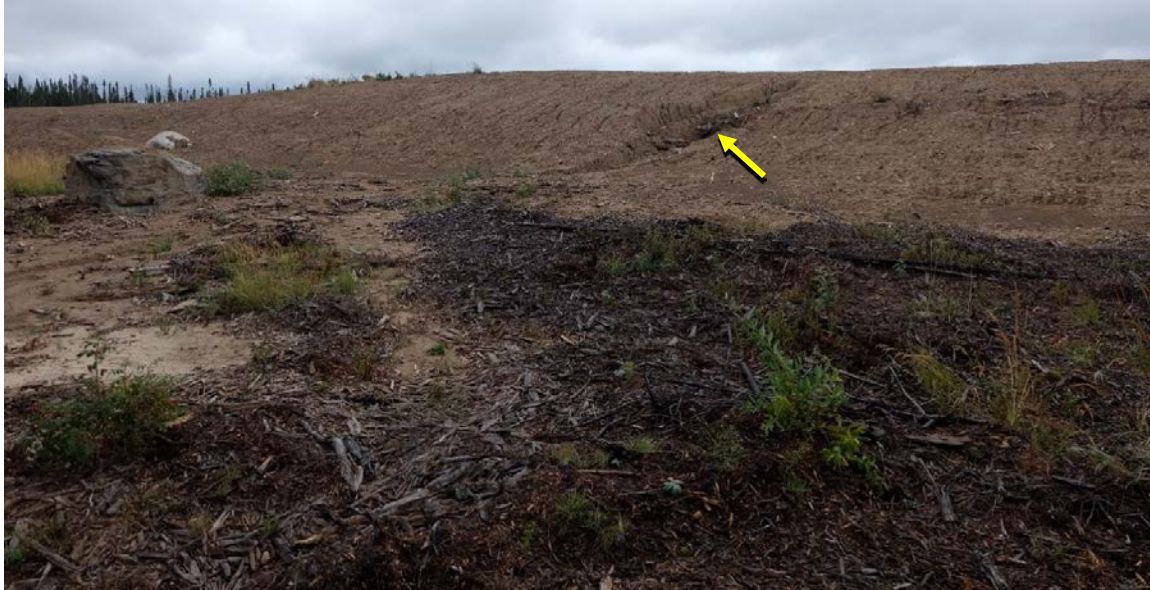
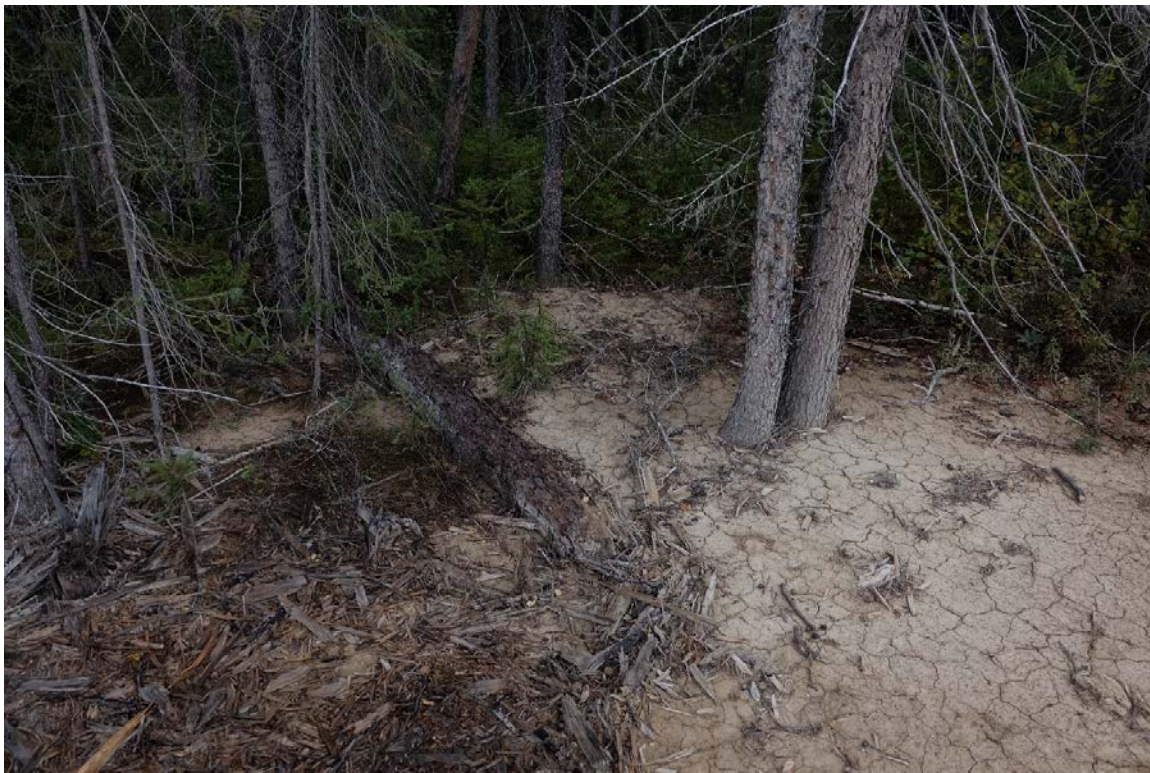
Figure 3–9: Continued...

Borrow Area N-5 (looking southeast) on September 18, 2017. Yellow arrow identifies gully at location B

Borrow Area N-5 (looking north) on September 18, 2017, with sedimentation in uncleared forest at location B

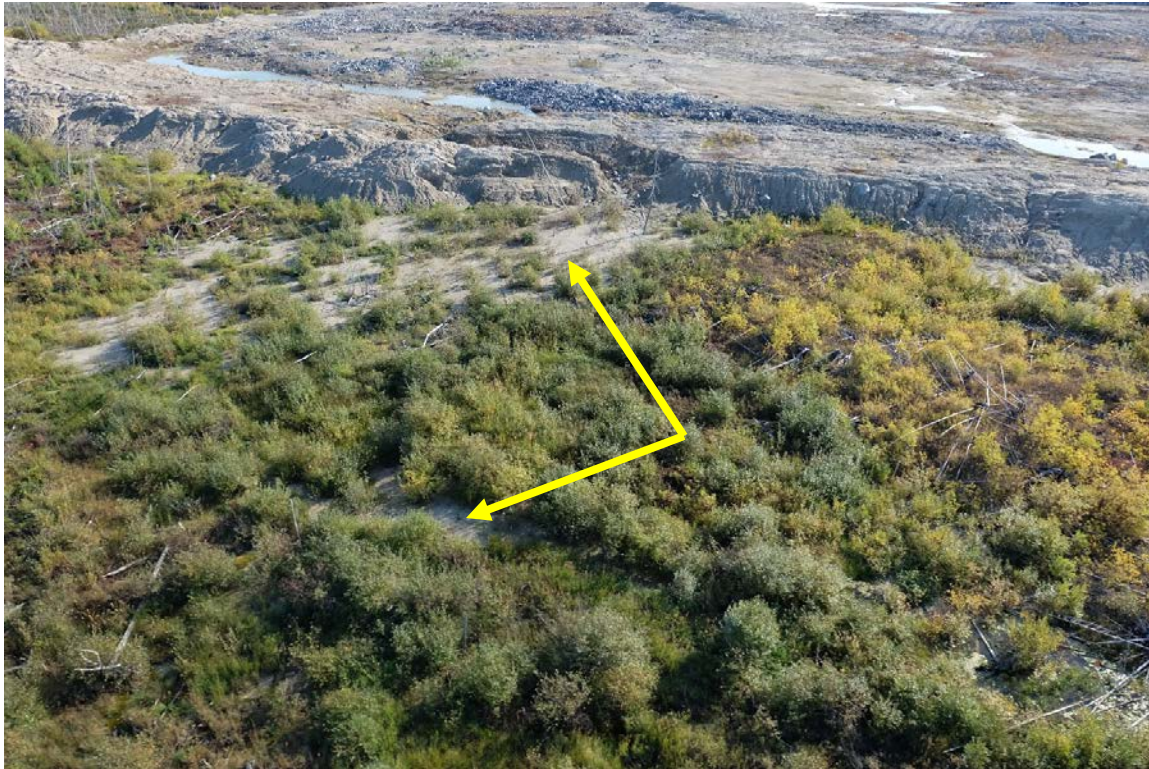
Figure 3–13: Sediment deposition into uncleared areas from EMPA slopes

EMPA D16 (looking south) on September 19, 2017. Yellow arrows identify sediment entering wetland

The largest such disturbance was near the northeast corner of EMPA D16, where a large gully deposited sediment approximately 50 m into a wetland adjacent to Stephens Lake, disturbing approximately 0.13 ha (Map 3-3). At the time of the 2017 surveys, the sediment appeared to have reached the lake. It was recommended in the field reports that a barrier be erected to stop sediment entering the wetland north of EMPA D16, and that the silt fences along the east side of EMPA D16 be repaired and reinforced.

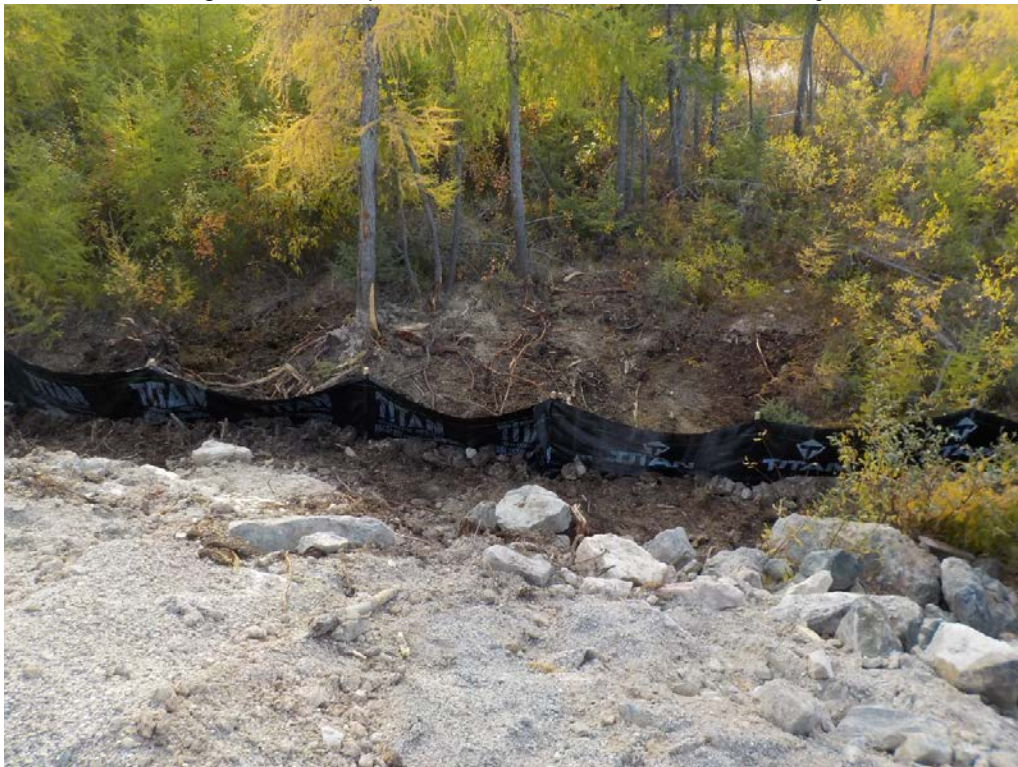
Remediated sediment deposition area in EMPA D17 (looking west) on September 19, 2017

One disturbed area on the west side of EMPA D17 covered approximately 0.02 ha. The sediment was subsequently removed from the uncleared area using an excavator, and a silt fence was installed around the perimeter of the EMPA in fall, 2017. Removal of the sediment resulted in mechanical damage to the trees, their roots, and the surface organic substrate (Figure 3–13). Bark was stripped from some of the lower tree trunks, and roots were exposed

and/or torn from the organic substrate, and damaged by the excavator. Low vegetation and peat moss was removed along with the sediment.

Sedimentation from eroding slopes on the west side of EMPA D17 and on the northeast side of EMPA D16 caused disturbance to areas outside the approved Project footprint. Additional damage to some trees, their roots and the organic substrate in at the former location occurred when much of this sediment was subsequently removed by an excavator. In this case, sediment removal may have done more damage to the vegetation than if nothing had been done. In the absence of removal, future rains could wash some of the sediment into the same areas, providing a larger area of habitat alteration for non-native plant colonization. Some options for similar situations in the future include limiting the spatial extent of remedial excavation, leaving more or all of the sediment in place and/or strengthening silt fences to limit the risk of failure.

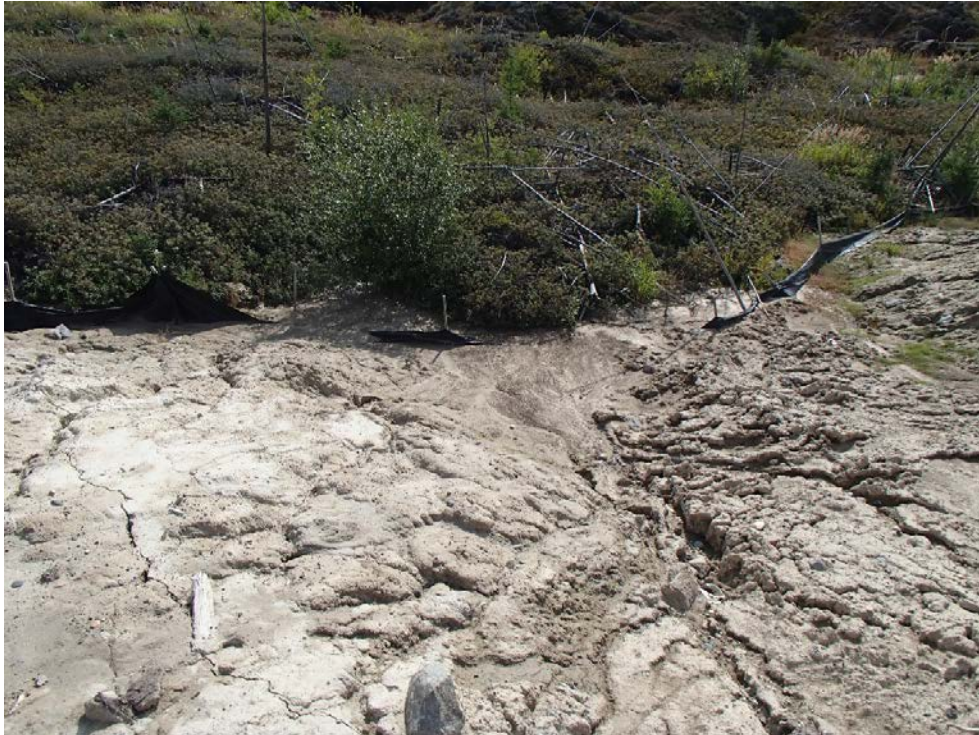
Figure 3–13: Continued...

Failed silt fence on east side of EMPA D16 (looking east) on August 25, 2017

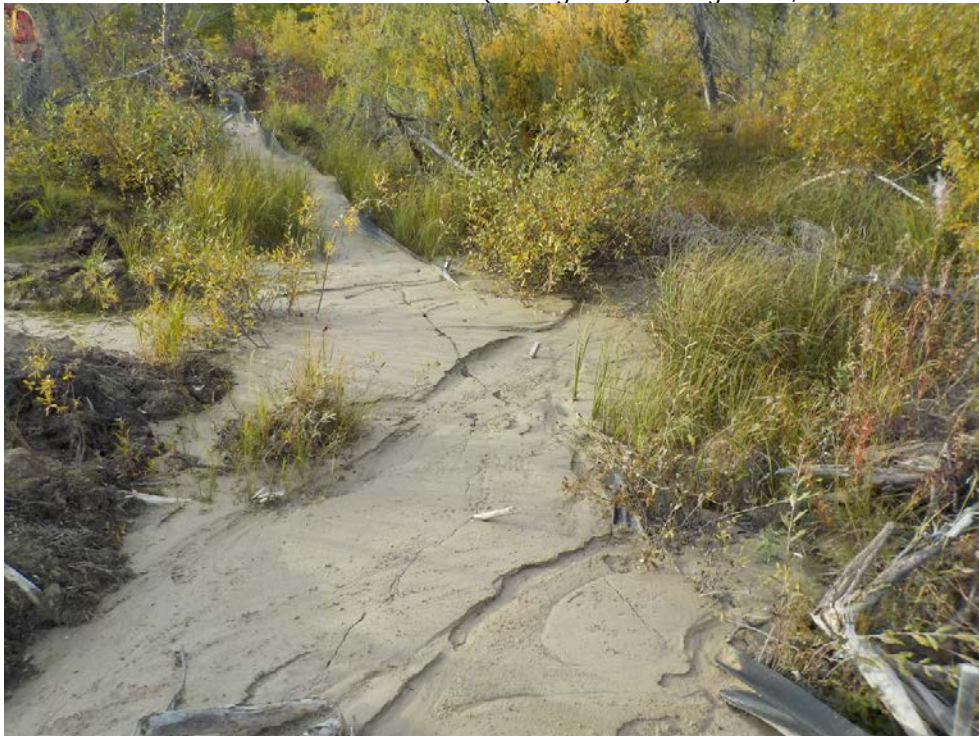
Failed silt fence on northeast side of EMPA D17 (looking northwest) on September 19, 2017

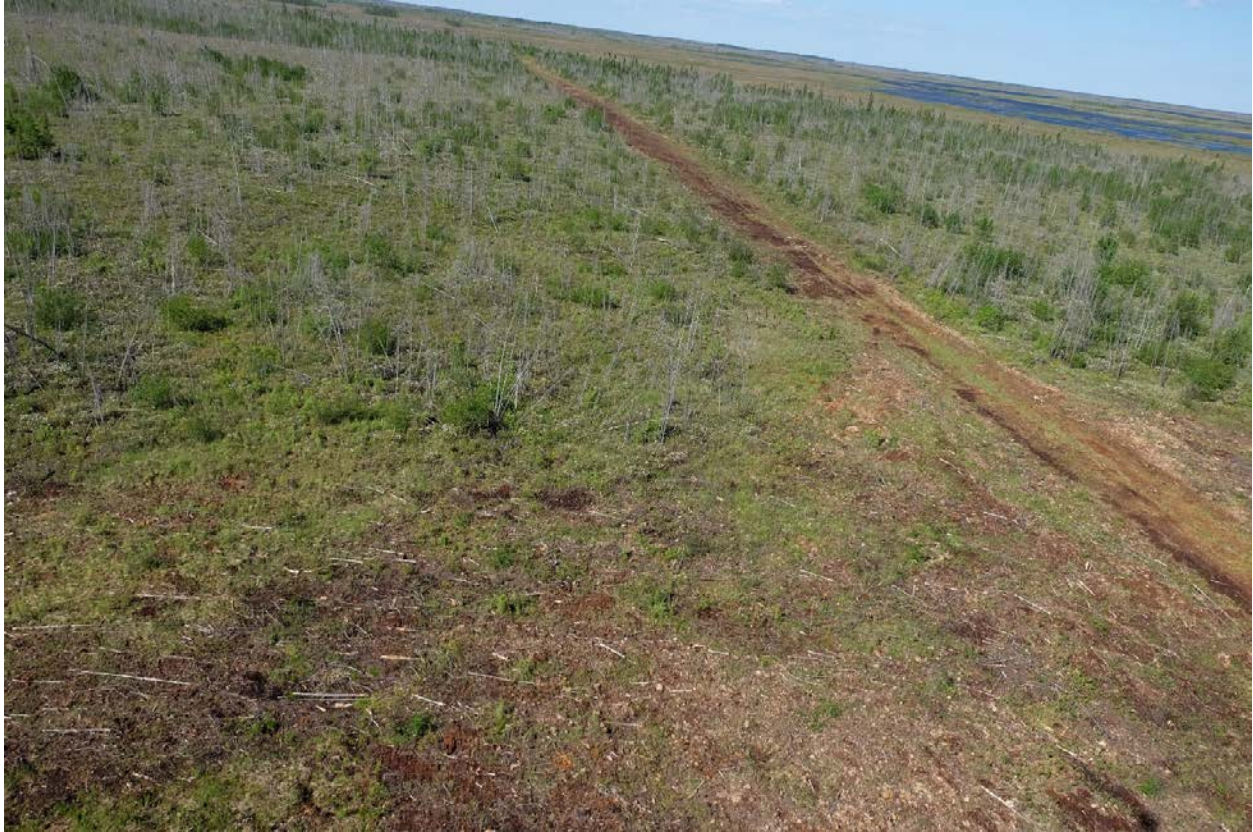
Figure 3–16: Pre-existing cutline used for access to reservoir clearing (looking southwest) on July 5, 2017

Several access trails were used for reservoir clearing or to conduct geotechnical investigations near Little Gull Lake (Figure 3–16; Map 3-2). Some were created along existing cutlines, while others were newly cleared. By September 2017, the total impacted area in trails was 41 ha. Of this total, 10 hectares were newly cleared.

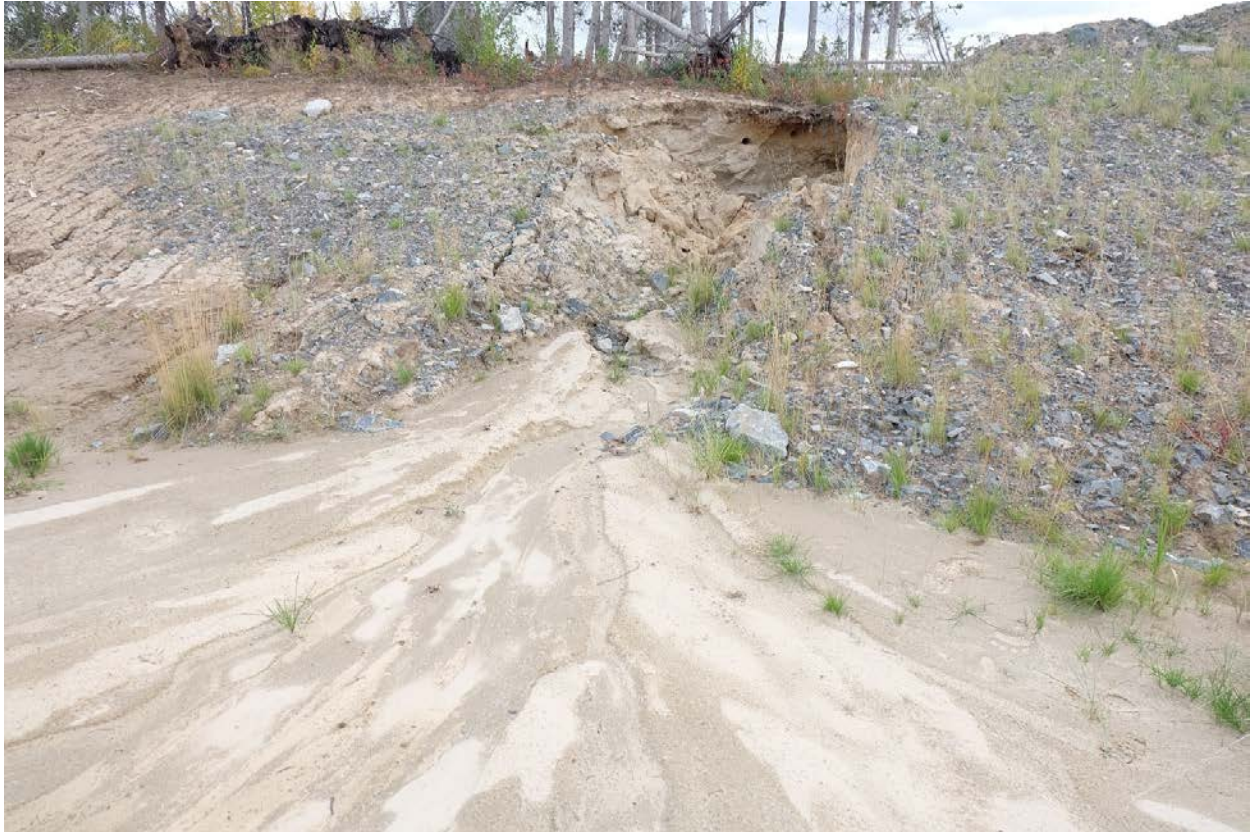
Figure 3–17: Erosion gully in NAR ditch along treed bank, September 2017
