Keeyask Generation Project Terrestrial Effects Monitoring Plan

Habitat Loss and Disturbance Monitoring Report

TEMP-2019-01

By
ECOSTEM Ltd.

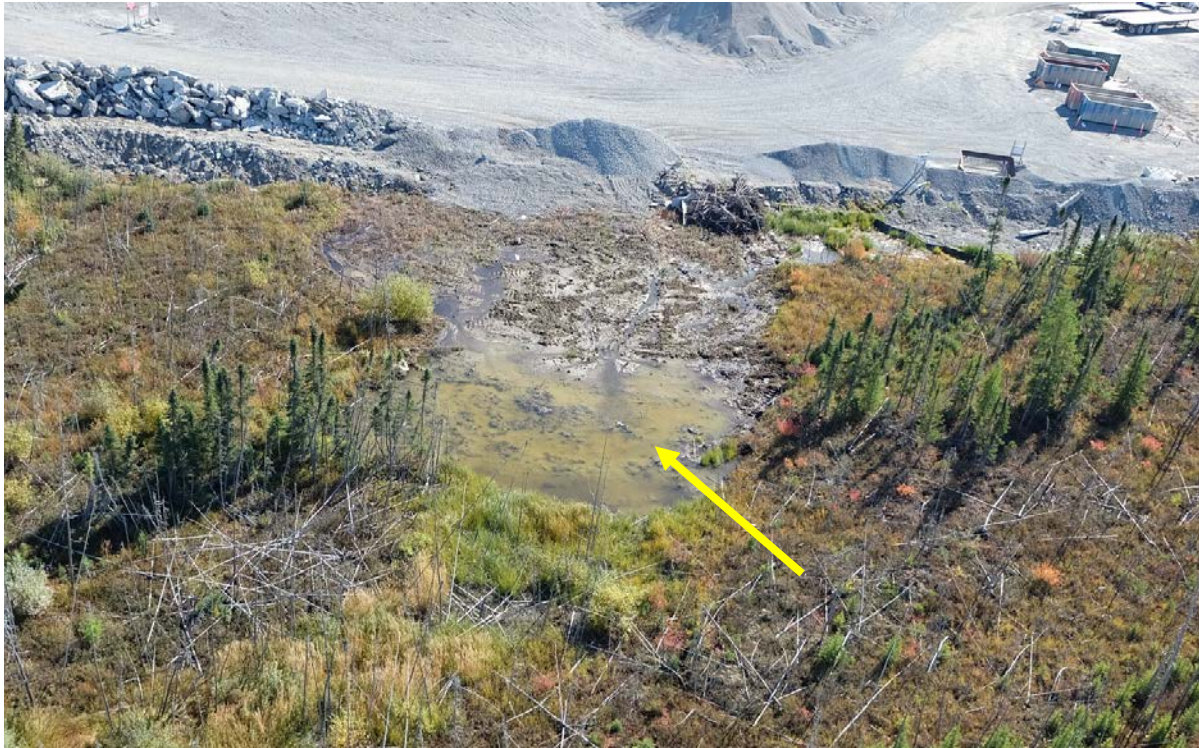
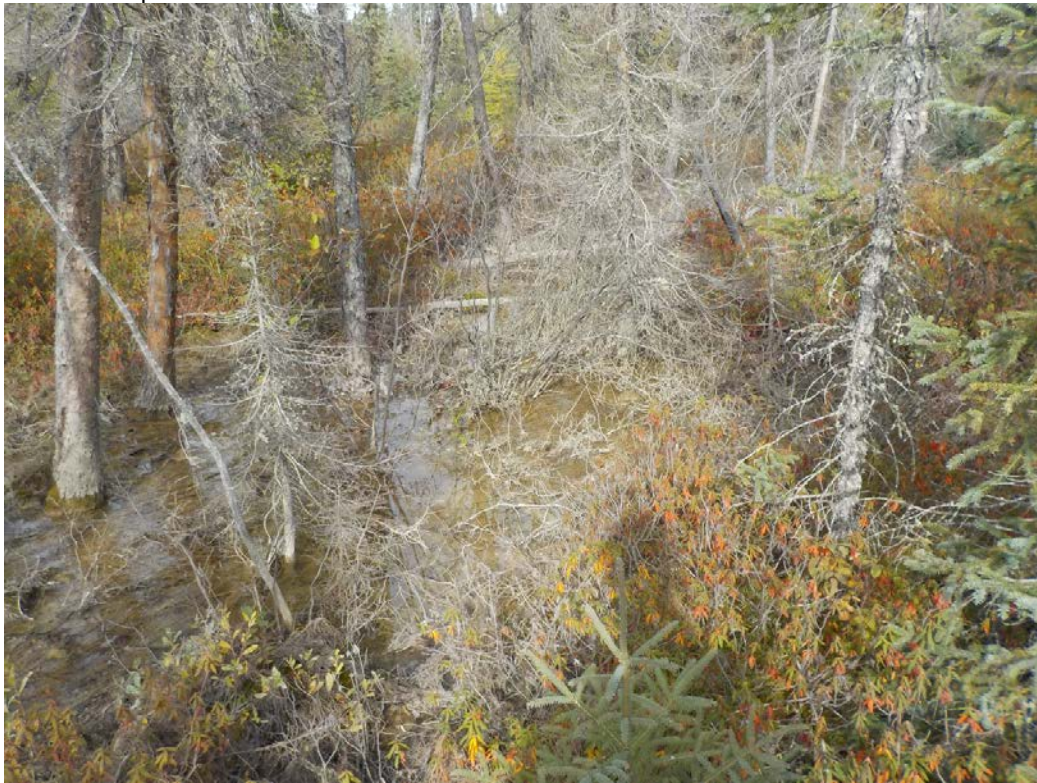
Figure 3-6: Disturbances outside of cleared areas in Work Area A and the Main Camp

Work Area A (looking east) on September 15, 2018. Yellow arrow identifies disturbance in remediated sediment deposition area

Understorey disturbance from drainage outflow at northeast corner of Main Camp on September 16, 2018

On the west side of the batch plant in Work Area A, sediment had been deposited over approximately 0.16 ha of uncleared vegetation (Map 3-3) at the time of the 2017 surveys. When this sediment was subsequently excavated from the area, the underlying vegetation and substrate was disturbed. The 2018 surveys found that sediment excavation expanded the disturbed area by approximately 448 m², or 0.04 ha (Figure 3-6).

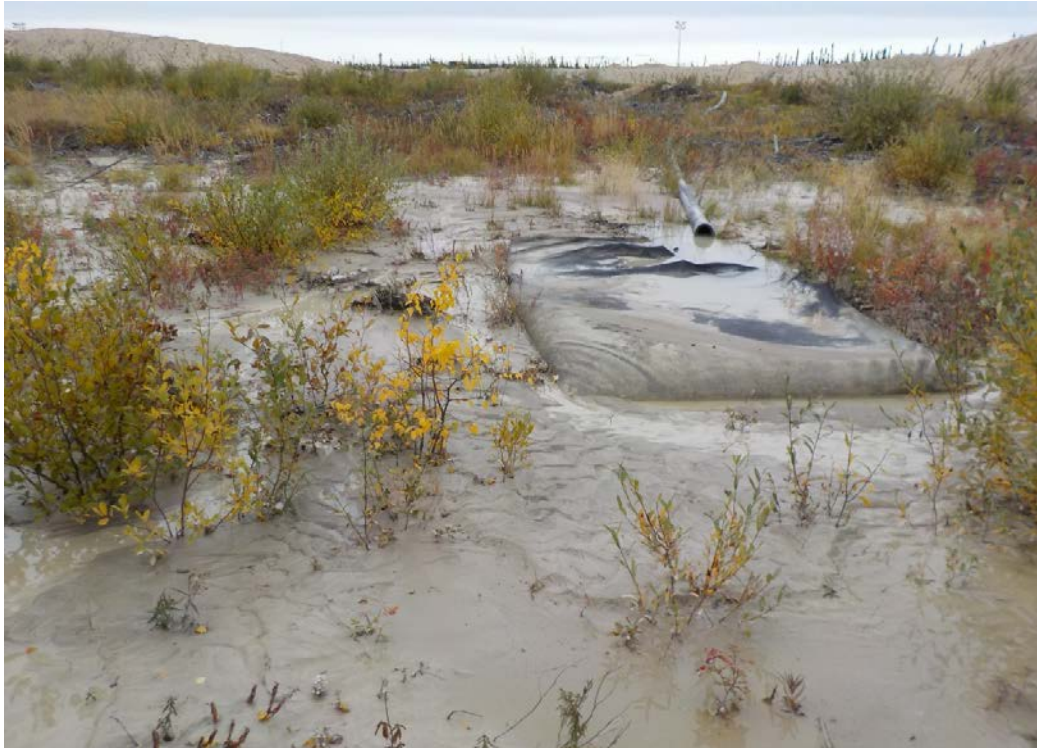
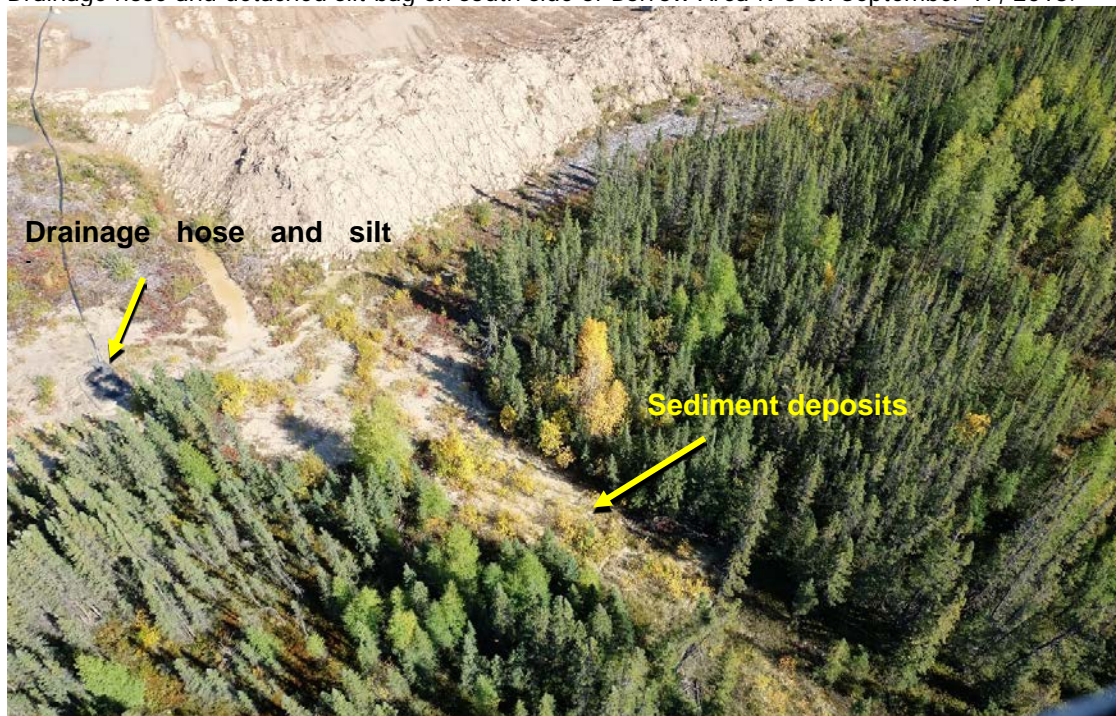
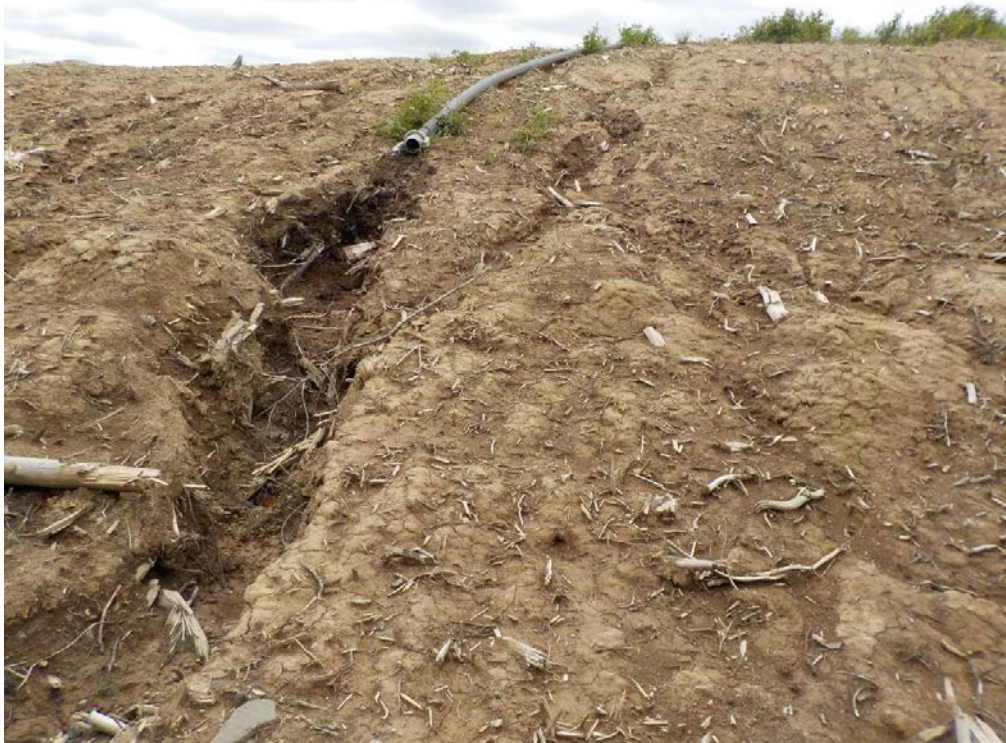
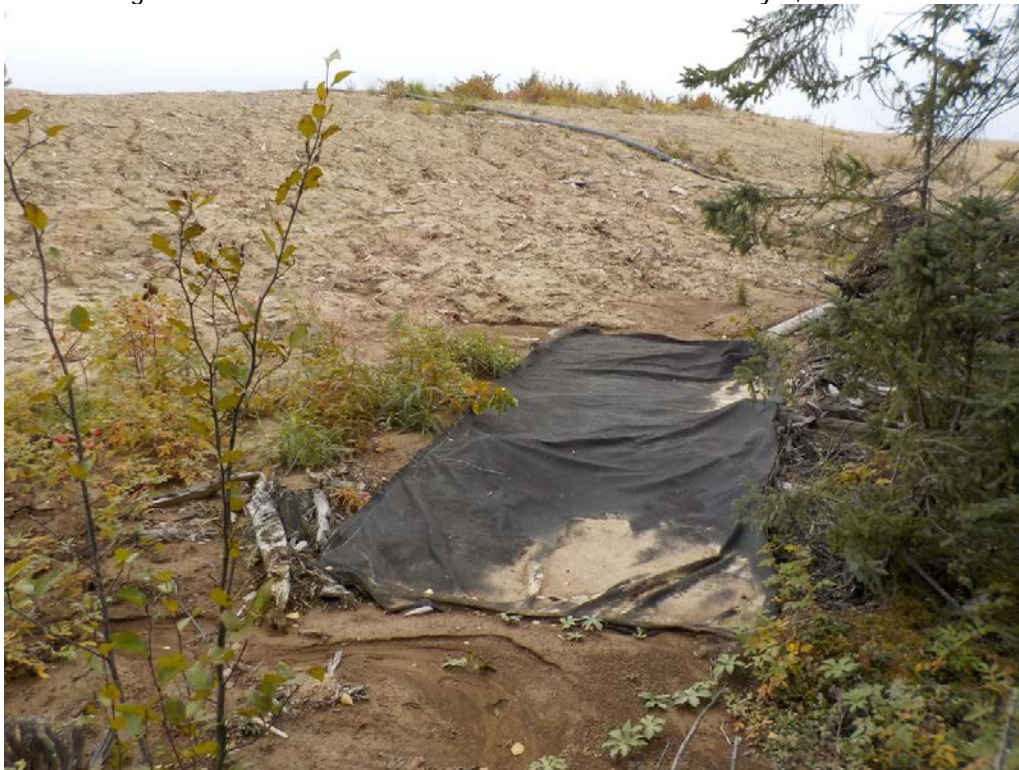
Figure 3-9: Sediment deposition into adjacent undisturbed habitat in borrow areas N-5 and G-3

Drainage hose and detached silt bag on south side of Borrow Area N-5 on September 17, 2018.

Sediment deposition into uncleared forest and cutline at south side of Borrow Area N-5 (looking northeast) on September 15, 2018

New drainage hose location at north side of Borrow Area N-5 on July 3, 2018

Extended drainage hose and silt bag at north side of Borrow Area N-5 on September 17, 2018

The 2017 surveys had observed a drainage hose along the north side of Borrow Area N-5 eroding a mineral slope and depositing sediment into the uncleared forest. The field report recommended that erosion barriers be constructed where needed, and that the drainage hose be extended to the base of the slope and secured. Surveys in early July, 2018 found that the hose had been moved to a new location on the slope, a new erosion gully was forming (Figure 3-9) and sediment was being deposited into the adjacent uncleared forest. Manitoba Hydro staff were notified while staff were conducting the July surveys. By the time of the September 2018 surveys, the hose had been extended to the base of the slope, and a sediment bag was attached. However, it was noted that a hole had formed in the sediment bag, and a small amount of sediment was escaping into the uncleared area (Map 3-3).

In 2017, a drainage hose on the north side of Borrow Area N-5 was eroding the bank and depositing sediment into undisturbed terrestrial habitat. The location of the drainage hose was moved between September 2017 and July 2018. Monitoring in 2018 found that erosion and sediment deposition was now occurring at the new hose location. The 2018 recommendation following the field survey was to take steps to eliminate bank erosion at this new location. Site staff have since moved this hose to a new location and installed a silt bag. Surveys in 2019 will evaluate if the most recent measures are successfully containing the sediment.

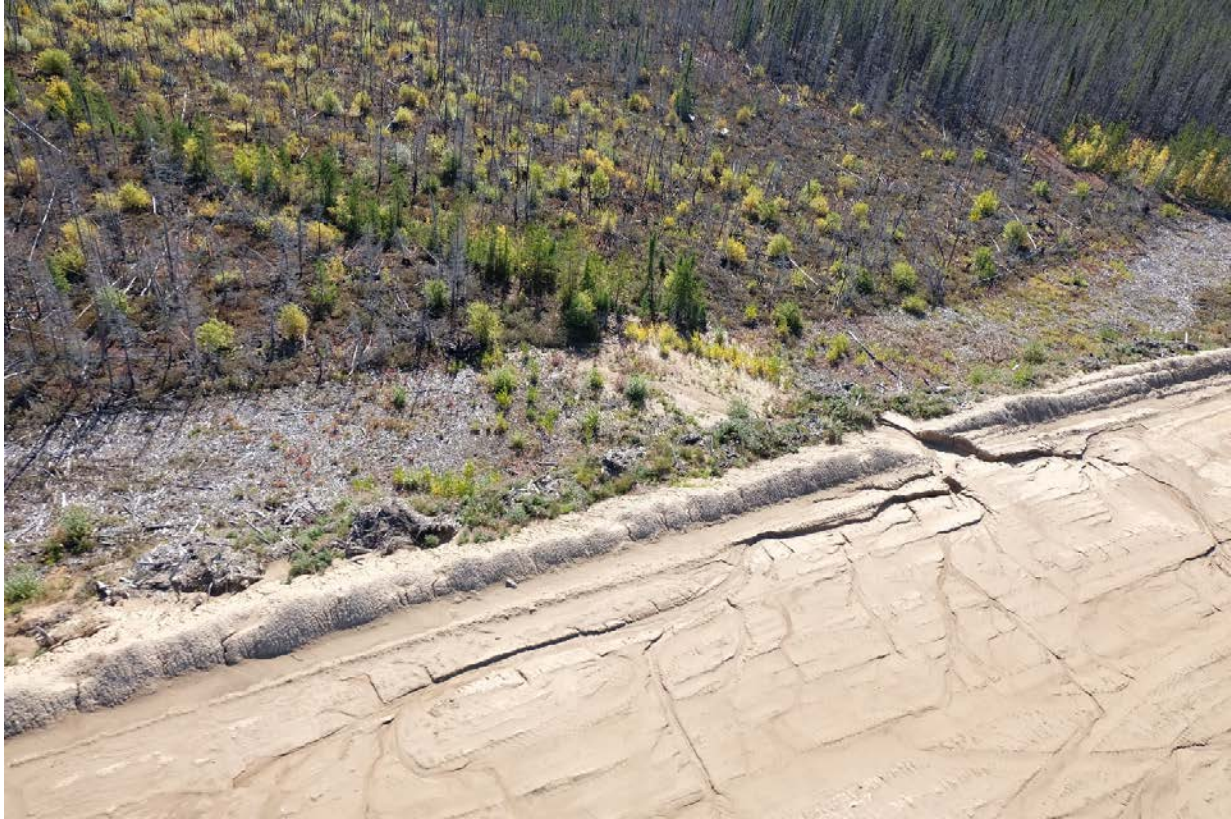
Figure 3–9: Continued...

Sediment deposition into uncleared area near southeast end of Borrow Area G-3 on September 15, 2018

In Borrow Area G-3, erosion on the mineral slopes around the perimeter was depositing sediment into the uncleared forest at several locations (Map 3-3; Figure 3-9). It was recommended that site staff inspect the locations and evaluate if additional erosion control measures would be needed to prevent sediment from entering undisturbed terrestrial habitat. As of March 2019, sediment fence had been installed along a portion of the south side of the borrow area.

Localized sediment deposition into undisturbed areas was occurring at two borrow areas. At Borrow Area G-3, sediment from eroding banks was bypassing silt fences along its southeast perimeter. Sediment was also being deposited at several other locations around the borrow area perimeter. On the south side of Borrow Area N-5, a new drainage hose was depositing silt approximately 60 m along a cutline and into uncleared vegetation. The 2018 field survey recommendation was for site staff to inspect these areas, install or reinforce silt fences where needed, and evaluate and implement additional erosion control measures as needed. As of March, 2019, no new erosion control measures had been implemented. Surveys in 2019 will document any newly installed measures.

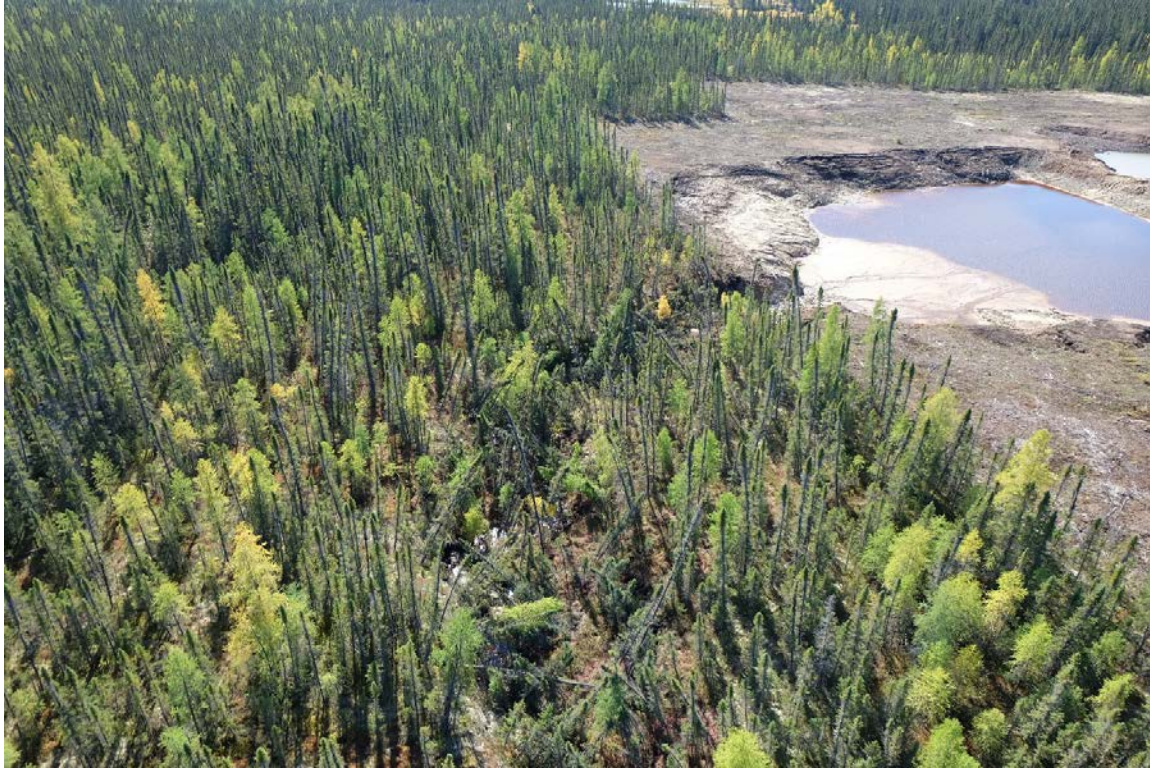
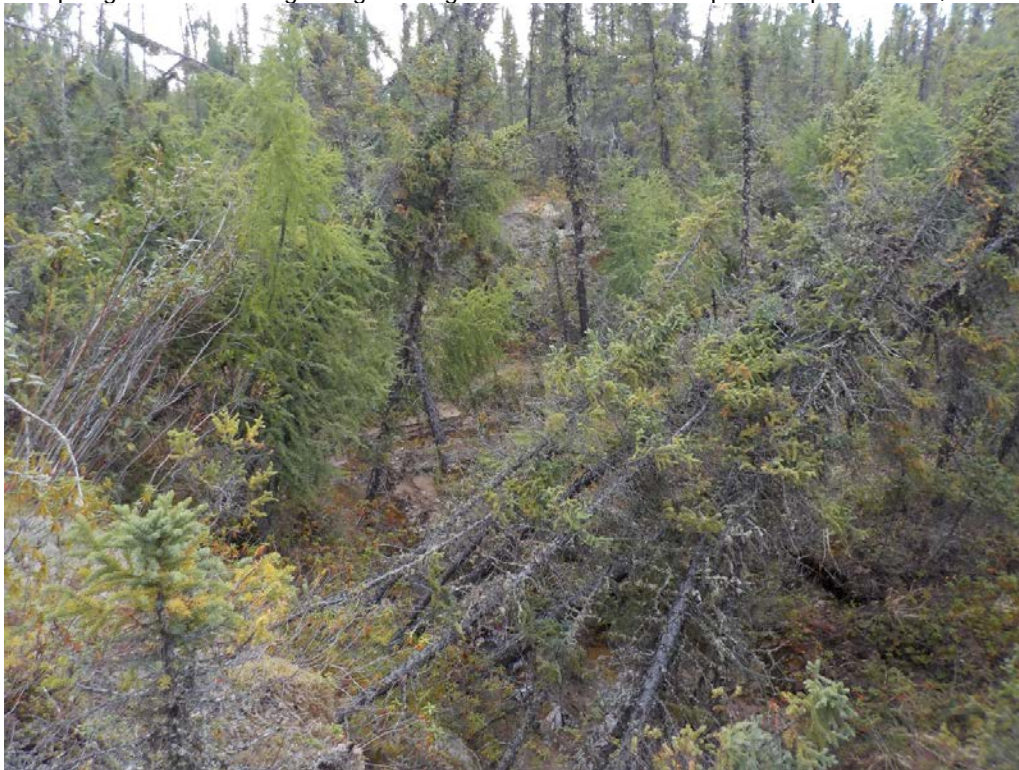
Figure 3-10: Mass wasting between the SAR and Borrow Area B-6

Collapsing trees extending along drainage channel into borrow pit on September 15, 2018

Ground view of disturbance between SAR and borrow pit on August 30, 2018

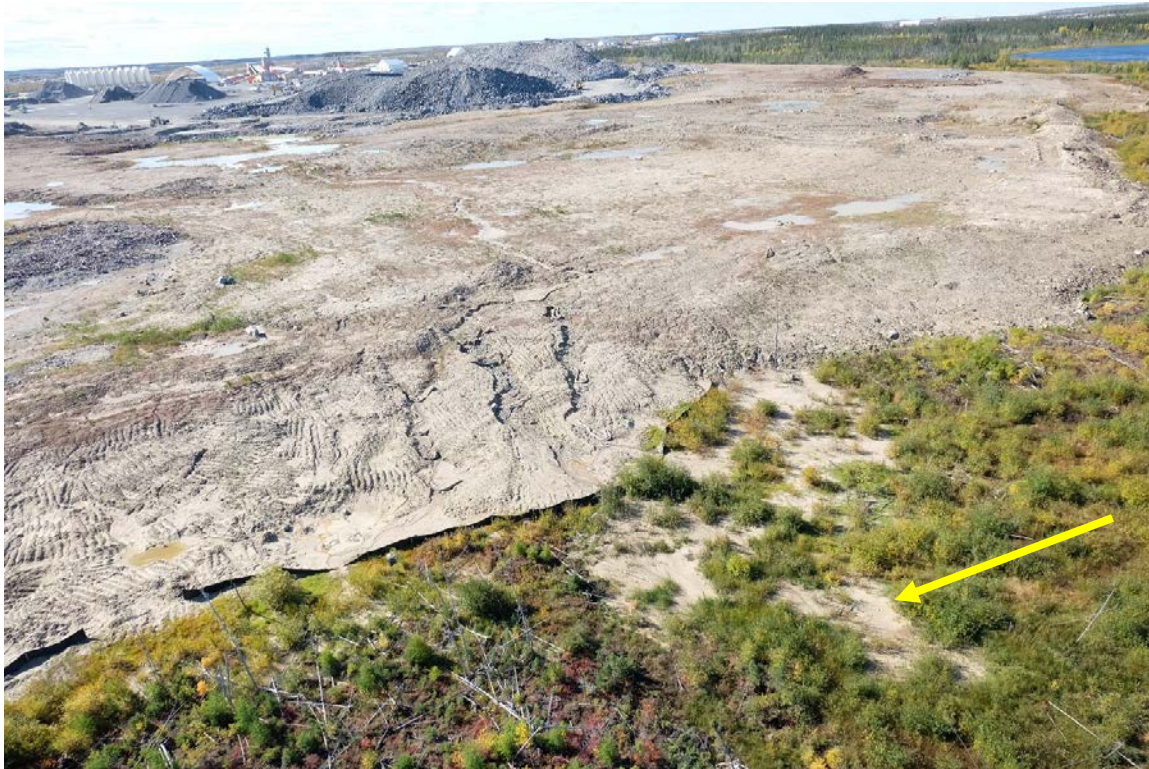
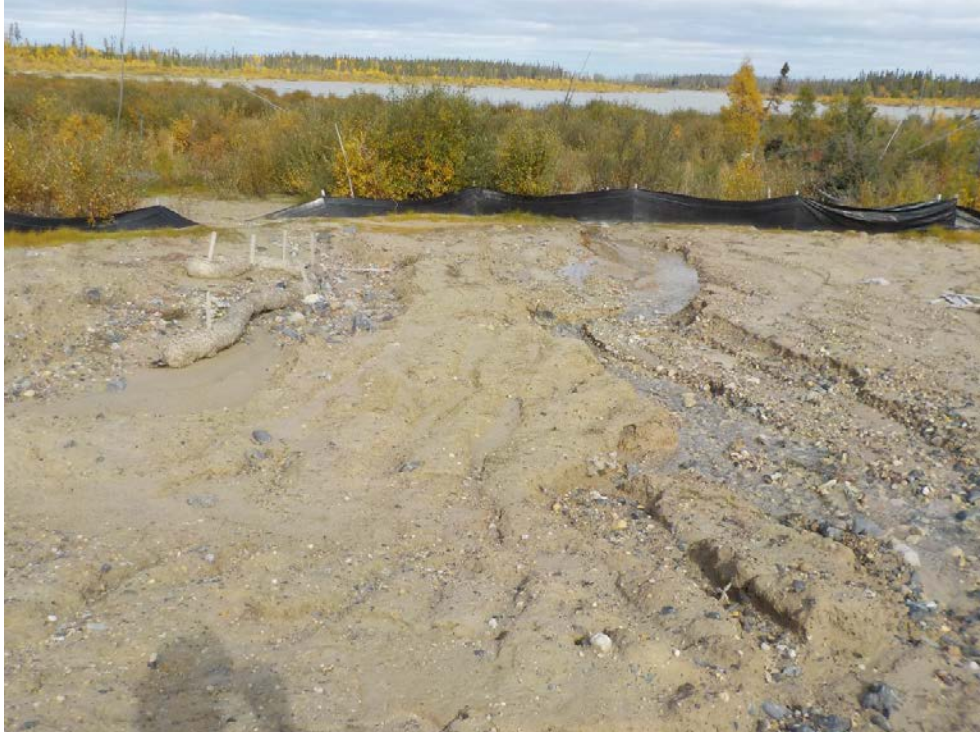
Figure 3-14: Disturbance outside of approved Project footprint associated with EMPA D16

EMPA D16 (looking southwest) on September 15, 2018. Yellow arrow identifies sediment.

Failed silt fence near northeast corner of EMPA D16 (looking north) on September 17, 2018

For EMPA D16, surveys in 2017 found that sediment from slope erosion had overwhelmed the silt fences, and sediment was being deposited into uncleared vegetation adjacent to the northern and eastern slopes of EMPA D16. The silt fences were subsequently reinforced in those locations. However, surveys in 2018 found that they had been overwhelmed again (Figure 3-14; Map 3-3).

Similar to what was found in 2017, the largest such disturbance at EMPA D16 was near its northeast corner. Erosion had created a channel, which drained a pond in the EMPA adjacent to the rock crusher. Water drainage from the pond carried sediment through the wetland north of the EMPA into the water of Stephens Lake. In combination, these disturbances affected approximately 0.17 ha (Map 3-3).

At EMPAs D16 and D17, sediment has been overwhelming silt fences since 2017. Surface water runoff is depositing this sediment into a water channel that is connected to Stephens Lake and into a wetland that is adjacent to Stephens Lake. At both EMPAs, the sediment transport occurred in the presence of erosion control measures, including slope grading and the installation of silt fences. For both of these situations, the 2018 recommendation from the field survey was to inspect the entire relevant bank, repair existing silt fences, and add new erosion containment measures as needed to prevent sediment from entering Stephens Lake. Silt fencing was repaired and/or reinforced around the perimeters of both EMPAs in fall 2018. Implementation of more mitigation at the north side of EMPA D16, including re-sloping and installation of check dams and armouring, was completed in March 2019. Surveys in 2019 will evaluate if these measures have successfully contained the sediment.

It was recommended that site staff inspect the entire northeast side of EMPA D16 and repair existing and/or add new erosion containment measures to prevent sediment from entering Stephens Lake. Silt fences were repaired or reinforced in the fall of 2018. Implementation of additional mitigation measures at the north side of EMPA D16 began in March, 2019. As of March 31, 2019, a rock berm had been installed along the base of the northeast slopes of EMPA D16, and organic material had been spread over the mineral materials downslope from the berm.

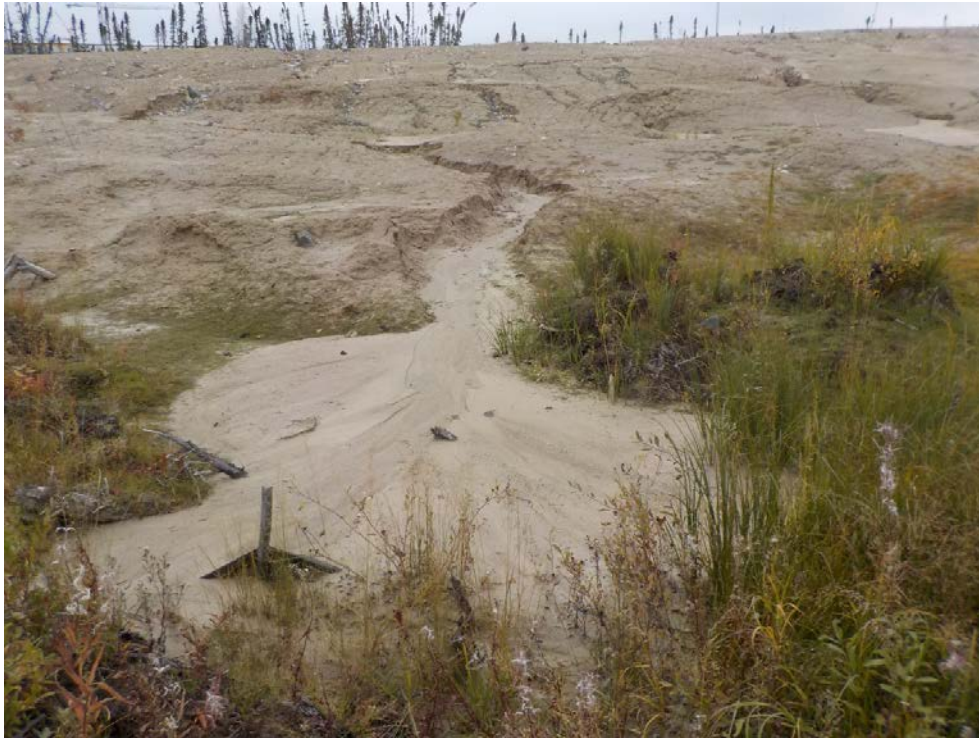
Figure 3-14: Continued

Failed silt fence on northeast side of EMPA D17 (looking south) on September 17, 2018

At EMPA D17, surveys in 2017 found that sediment from slope erosion had overwhelmed the silt fences and was being deposited into uncleared vegetation adjacent to the northern slopes. The silt fences were subsequently reinforced in those locations. However, surveys in 2018 found that they had been overwhelmed again (Figure 3-14; Map 3-3). These silt fences were repaired or reinforced in the fall of 2018.

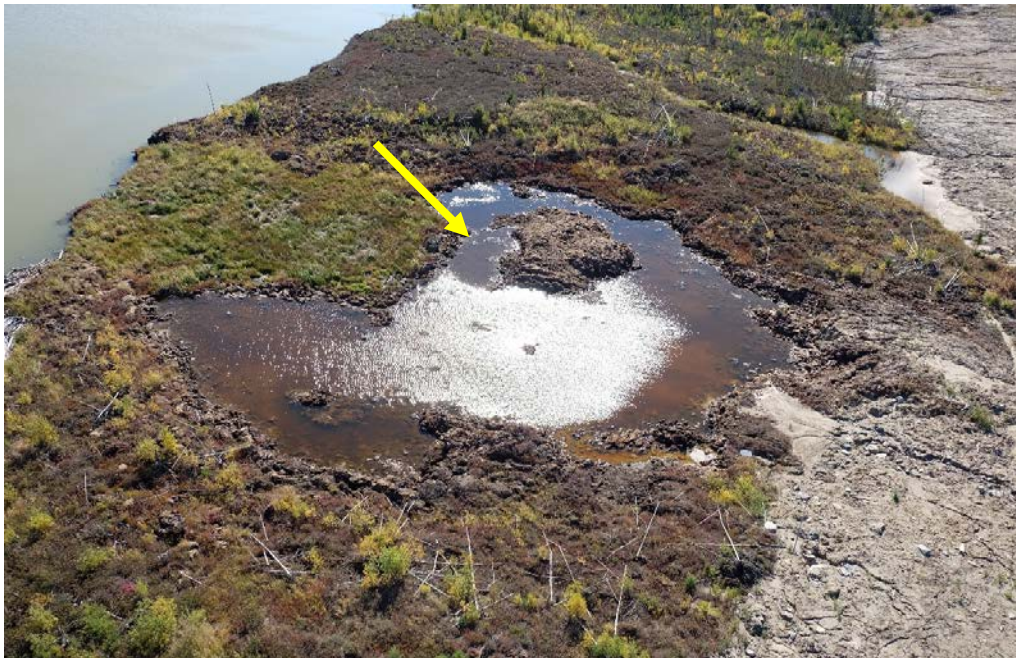
Figure 3-15: Disturbed area adjacent to the east side of EMPA D16 on September 15, 2018.

Most of the new area cleared or disturbed outside of the approved Project footprint was associated with Borrow Area E-1. Most of the remaining clearing and disturbance to areas outside the approved Project footprint was caused by sediment deposition from eroding slopes on the north side of EMPA D16, and a peat plateau bog on the east side of the same EMPA that collapsed after it was disturbed by a bulldozer (Tanner Booth pers. comm.; Figure 3-15).

An additional approximately 0.16 ha disturbance was observed adjacent to the east side of the EMPA D16 (Figure 3-14). Site environmental staff indicated that a peat plateau bog there was disturbed by heavy equipment. The surface peat disturbance appears to have led to ground ice melting, which caused the bog to collapse and a small pond to form.

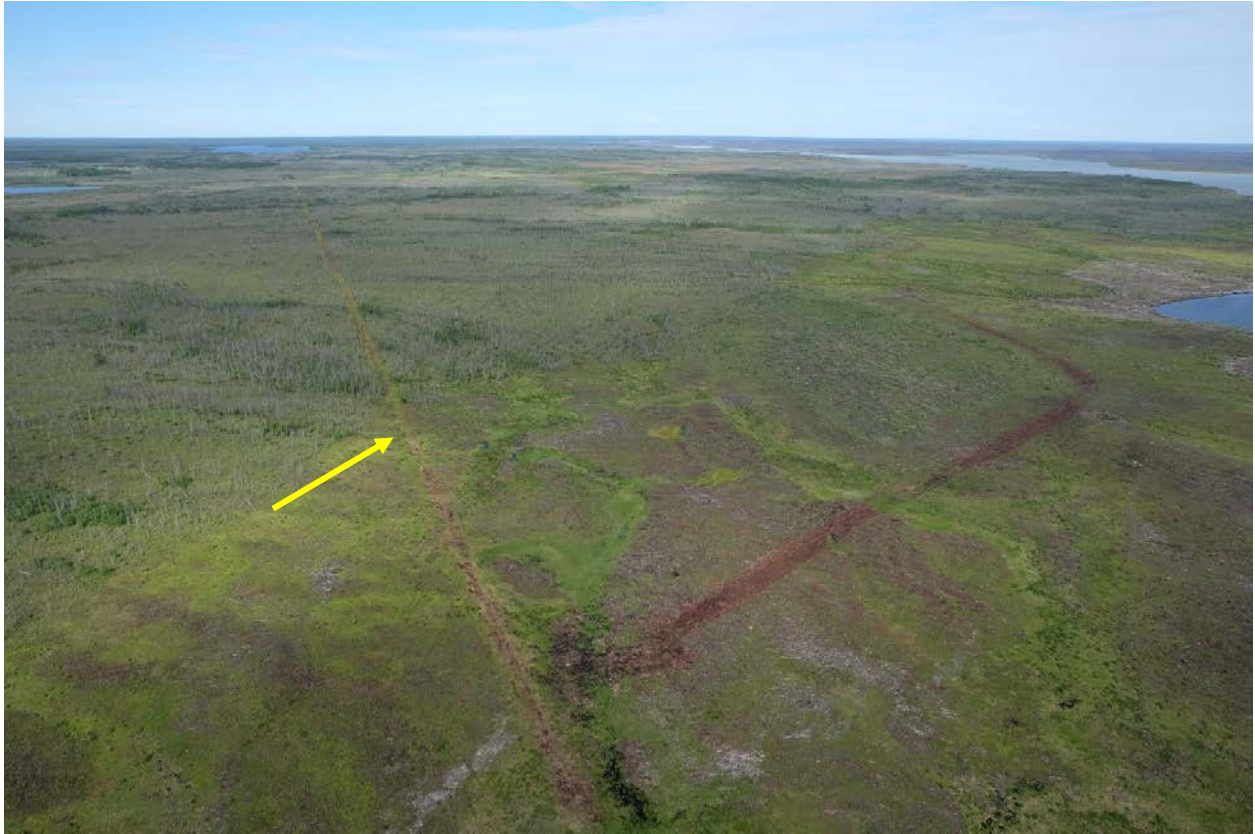
Figure 3-18: Pre-existing cutline used for access to reservoir clearing (looking west) on July 5, 2018

Pre-existing cutline (indicated by yellow arrow) used for access to reservoir clearing areas (looking west) on July 5, 2018. The darker track to the right in the photo is a trail created for reservoir clearing

Several access trails were used for reservoir clearing or to conduct geotechnical investigations near Little Gull Lake (Figure 3-18; Map 3-2). In some cases, new trails were cleared, but where possible pre-existing trails were utilized. The latter case was considered to be a Project disturbance, as opposed to Project clearing. By September 2018, the total area in trails was 41 ha, which is unchanged from 2017.

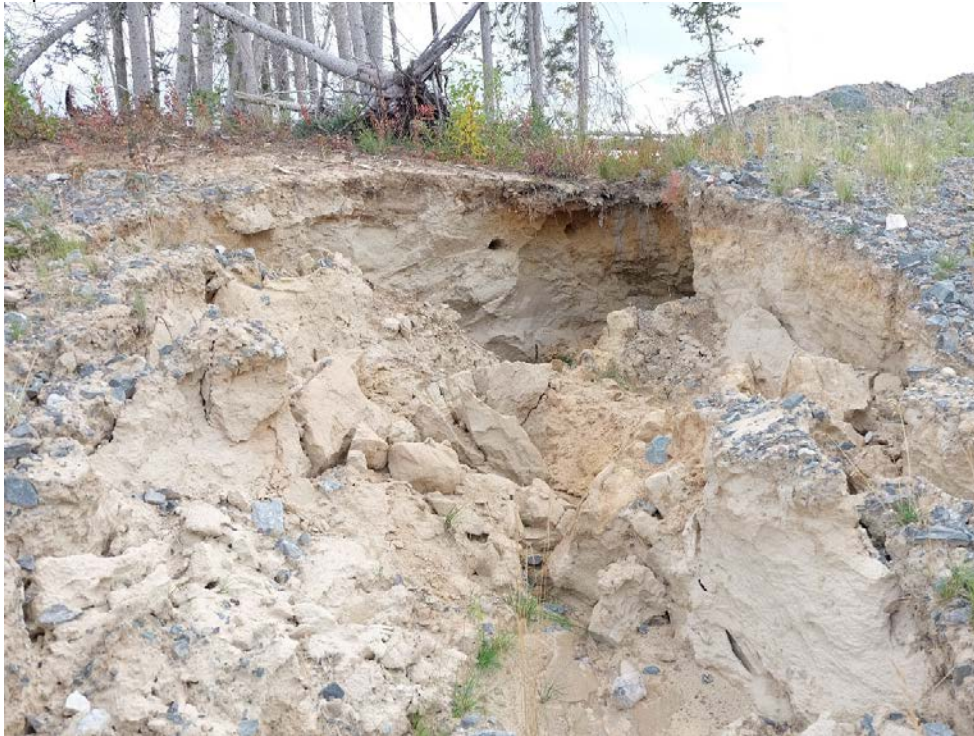
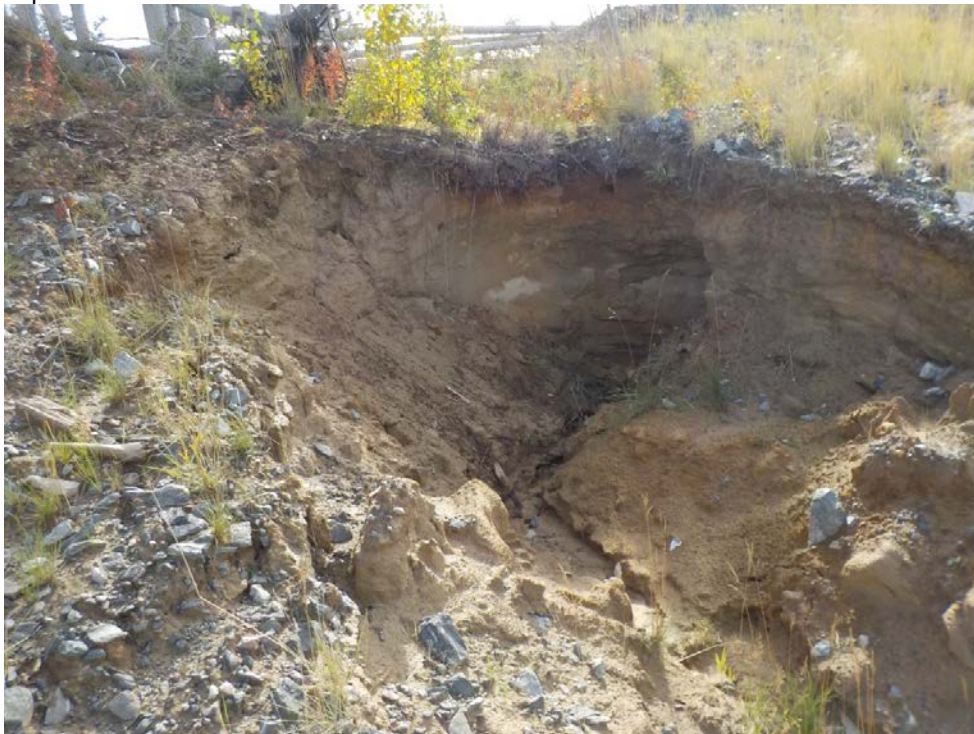
Figure 3-19: Majority of the erosion gully in NAR ditch along treed bank in September 2017 and September 2018

One instance of disturbance was observed within the NAR footprint. Erosion on the south ditch bank adjacent to Borrow Area KM-1 had created a gully. This gully was first identified during 2016 surveys. Since then, erosion has expanded the gully and removed the mineral material under a treed area between the ditch and the borrow area (Map 3-3; Figure 3-19). Gully expansion between the 2017 and 2018 surveys was about 3 m², which was less than that observed between 2016 and 2017.
