Keeyask Generation Project
Terrestrial Effects Monitoring Plan

Habitat Loss and Disturbance Monitoring Report

TEMP-2020-01

ECOSTEM Ltd.

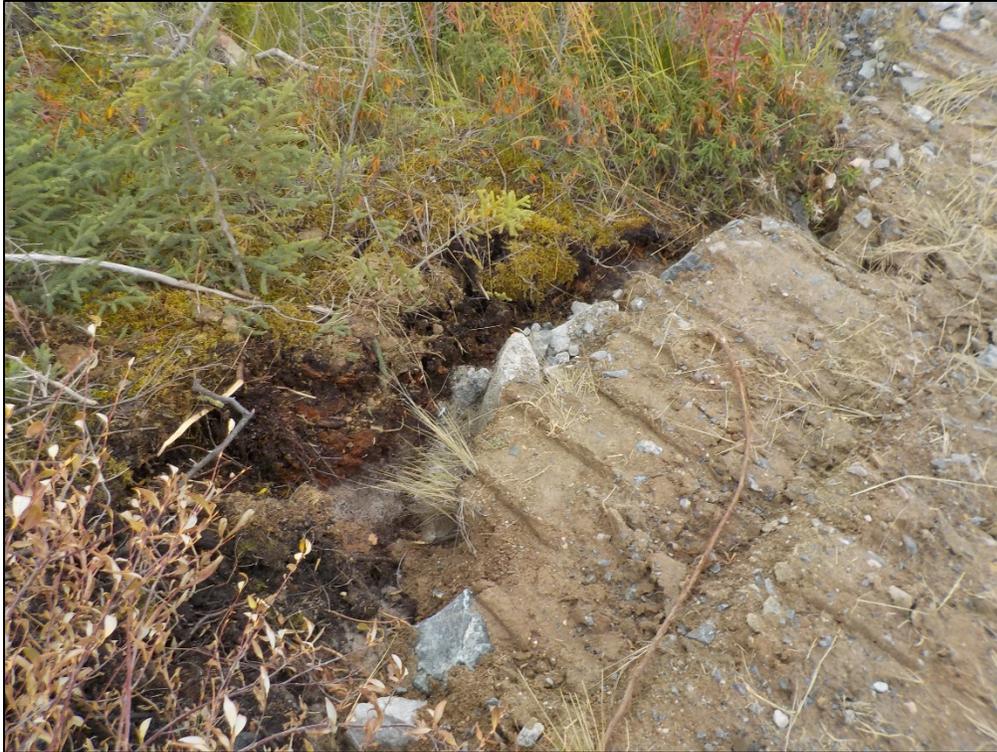
Erosion disturbance on the south ditch bank of the NAR adjacent to Borrow Area KM-1 had created a gully since it was first identified during 2016 surveys. Erosion had expanded the gully between the ditch and the borrow area between 2016 and 2018 (Map 3-2). Field surveys in 2019 found that the area had since been remediated by filling the eroded area. Some minor erosion and sediment deposition around the eastern fringes of the remediated area noted in 2019 (Photo 3-1), but the bank was subsequently covered with organic material. The site will be monitored for substantive changes in 2020.

Photo 3-1: Erosion around fringes of excavated area adjacent to Borrow Area KM1

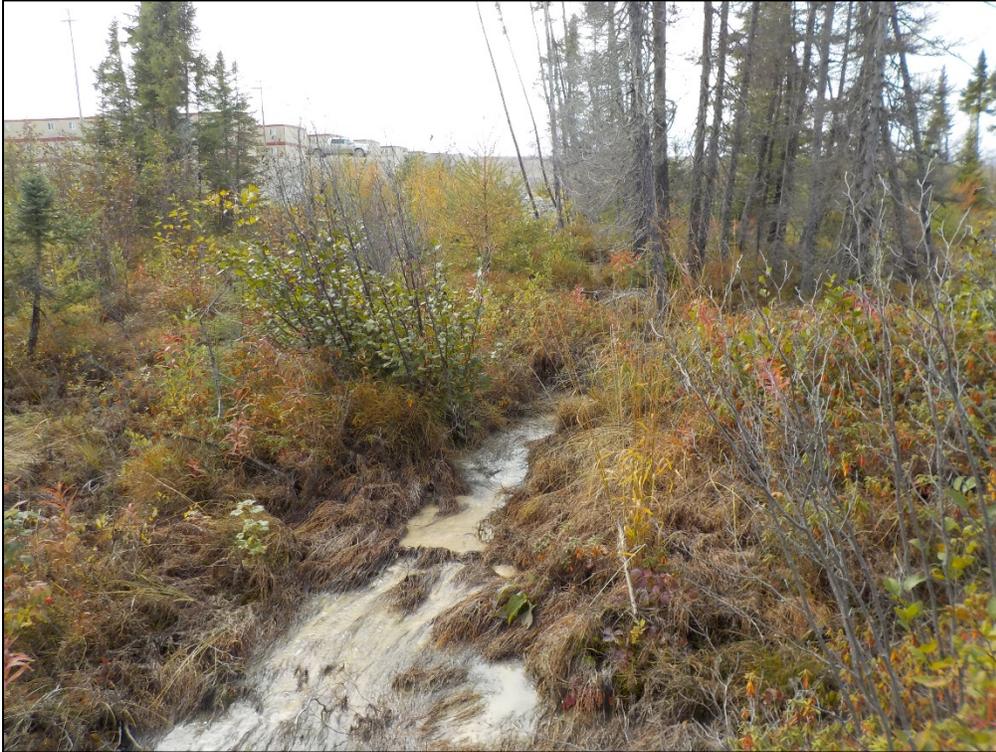
Photo 3-2: Channel created by running water from culvert northeast of Main Camp

At the northeast corner of the Main Camp, water outflow from the culvert continued to deteriorate the surrounding otherwise undisturbed vegetation. At the time of the 2019 surveys, this disturbance extended approximately 80 metres into the uncleared forest and was within 25 m of the approved Project footprint limit. The flowing water had undermined the substrate, toppled trees and appeared to be the cause of some additional tree mortality. If this disturbance expands, it would only affect a common habitat type (black spruce dominant vegetation on thin peatland) and would not threaten any sensitive sites identified in the EnvPPs. This disturbance will be

revisited in September, 2020 and an evaluation will be made as to whether any mitigation is recommended.

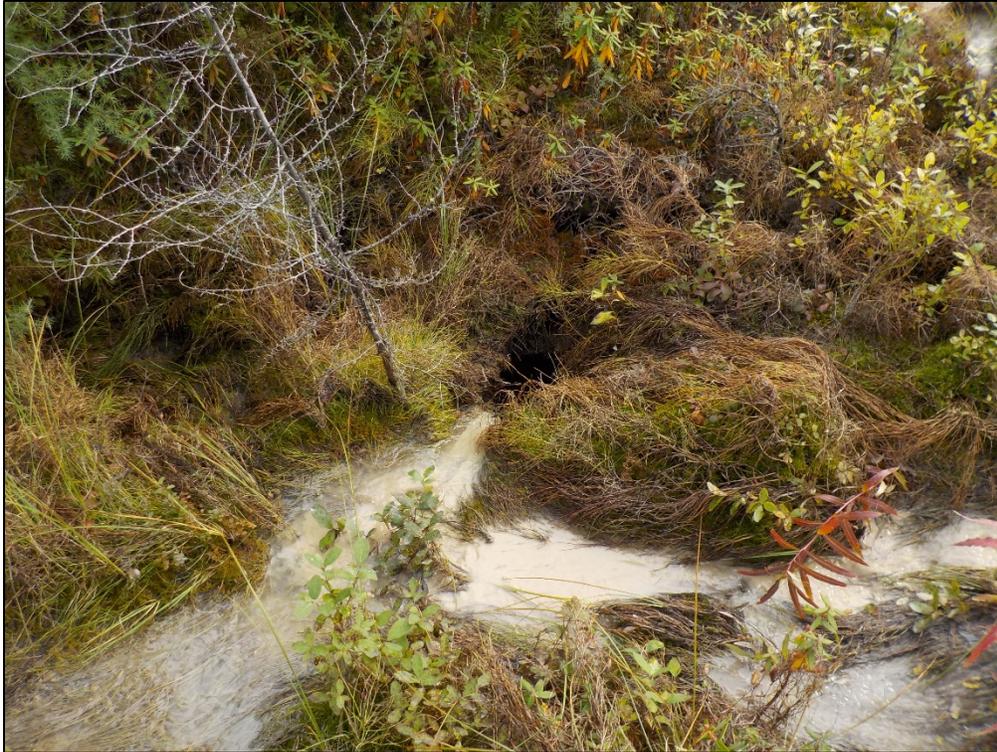
Photo 3-3: Hollow in substrate created by running water northeast of Main Camp

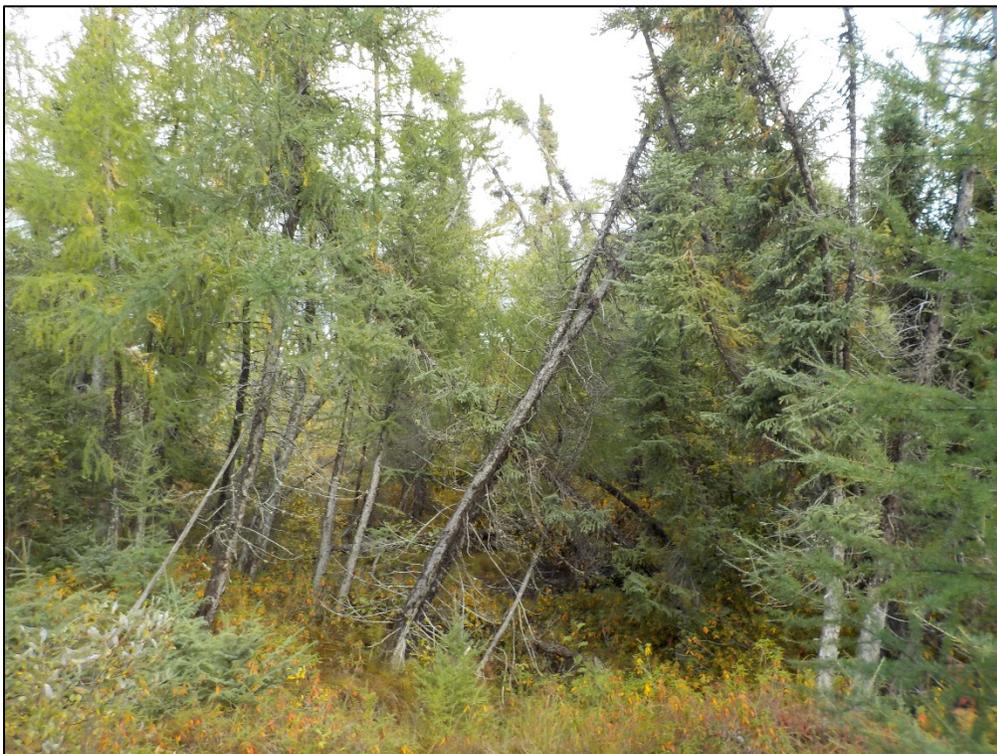
Photo 3-4: Trees toppling into hollered out area northeast of Main Camp

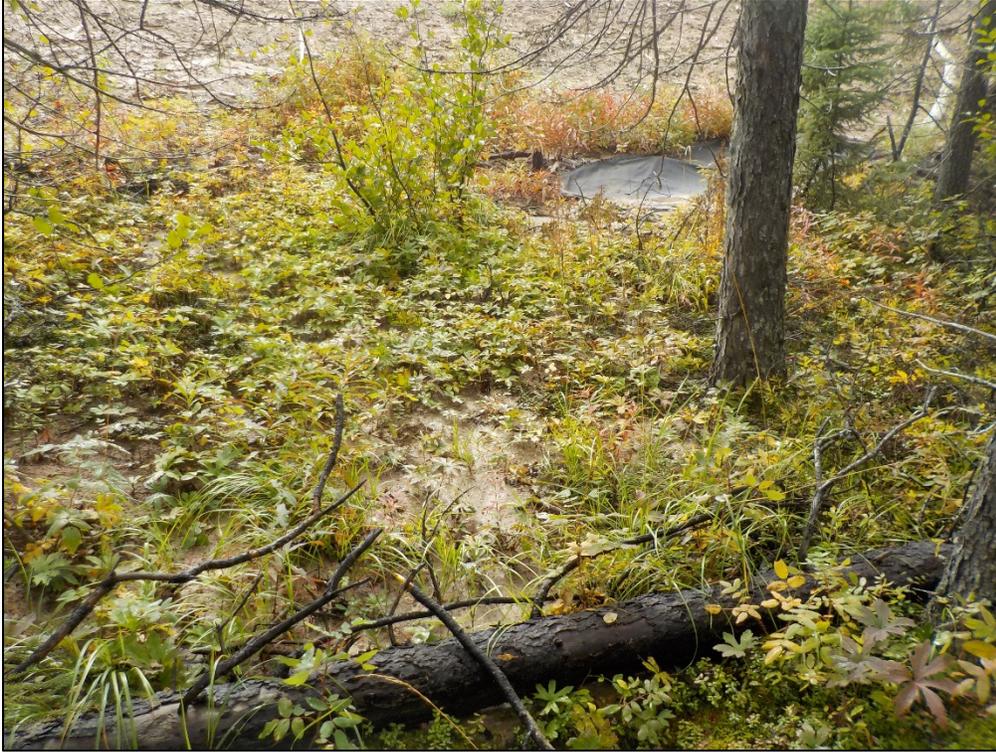
Along the north side of Borrow Area N-5, surveys up to September 2018 found that water from drainage hoses had eroded mineral slopes and deposited sediment into the uncleared forest. Subsequently, hoses had been moved or removed from the area. In 2019, sediment was being deposited from the most recent hose location into the surrounding uncleared forest (Map 3-2; Photo 3-5). Also, approximately 20 dead and dying black spruce trees were observed in the forest near the original hose location. The subsequent hose locations prior to 2019 showed signs of stabilization as evidenced by re-establishing vegetation.

Photo 3-5: Sediment deposition into adjacent forest on north edge of Borrow Area N-5

In 2017, water from a drainage hose on the north side of Borrow Area N-5 was eroding the bank and depositing sediment into otherwise undisturbed terrestrial habitat. The drainage hose was re-located three times. At the most recent location, a silt bag was added to the end of the hose. Surveys in 2019 found that although the silt bag was somewhat effective, sediment was still depositing into the adjacent uncleared forest at its most recent location. While erosion and sediment deposition had stopped or been reduced at two of the previous hose locations, tree mortality was observed at the original hose location. No additional mitigation measures were recommended after the 2019 field survey because moss hummocks appeared to be containing the deposition area, the total deposition area was small and the deposition area was well within the planned Project footprint. Surveys in 2020 will determine if further mitigation measures for these areas are required.

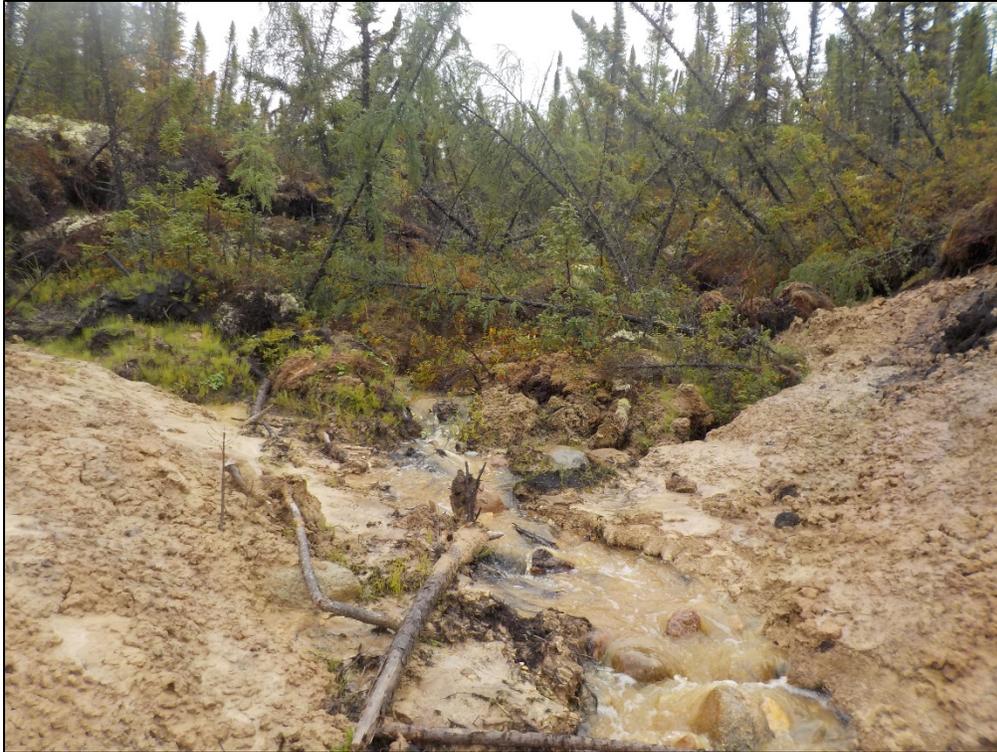
In Borrow Area B-6, mass wasting continued to create a disturbance along a natural drainage channel, affecting otherwise undisturbed habitat (Map 3-2). Significant water flow from the SAR to the east edge of the pit undermined the uncleared forest and created a deep, wide channel (Photo 3-6). Surveys in 2019 found that the impacted area did not expand substantially since 2018.

Photo 3-6: Undermined forest and channel in Borrow Area B-6

Significant water flow from the SAR into Borrow Area B-6 continued to erode the substrate in undisturbed adjacent forest. By 2018, a deep runnel had been created in a low-lying area. The associated erosion caused mass wasting along the runnel between the ditch and Borrow Area B-6, causing trees along the runnel to slump and collapse inward. The 2019 surveys found the size of the disturbed area had not increased substantially since 2018. At this time, no mitigation measures are recommended for this disturbance as it does not appear to be expanding significantly. This conclusion will be reevaluated following the 2020 field surveys.

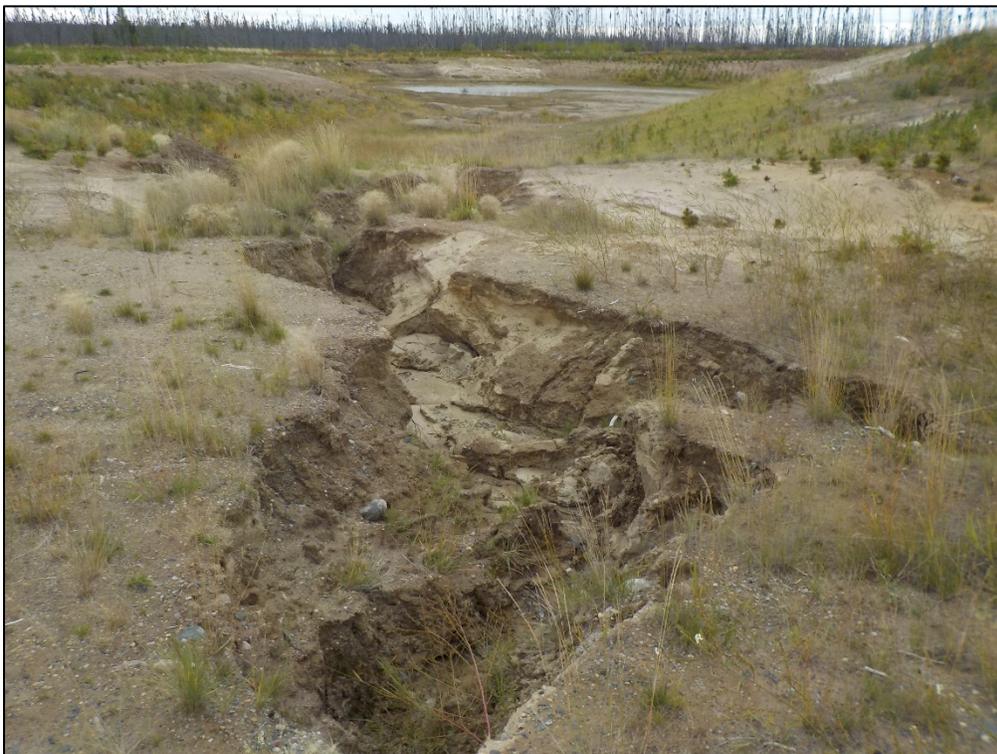
In Borrow Area KM1, the 2019 surveys found that erosion runnels were widening and deepening (Photo 3-7). These runnels were washing away vegetation and could eventually affect tree seedlings that had been planted nearby.

Photo 3-7: Erosion in Borrow Area KM1

Erosion runnels were widening and deepening in Borrow Area KM1, potentially affecting the surrounding planted seedlings. It is recommended that site staff inspect and evaluate these areas and implement erosion control measures as needed.

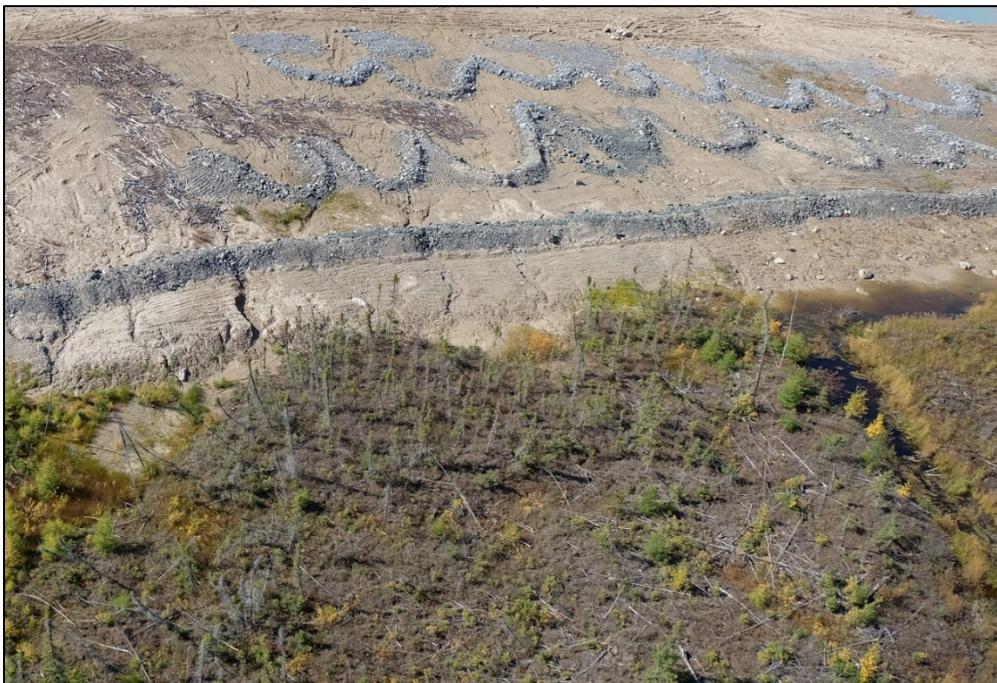
Along the northern and eastern slopes of EMPA D16, the 2019 surveys found that sediment deposition from bank erosion had reduced or stopped with the exception of a few small areas on the eastern edge (Photo 3-8; Map 3-2). Water and sediment were still flowing under the rock berm into the surrounding uncleared vegetation in a small stretch close to where a peat plateau bog was disturbed in 2018. Near the northeastern corner of this EMPA, sediment deposition had disturbed another 0.02 ha of uncleared vegetation.

Photo 3-8: Aerial view of sediment deposition into adjacent vegetation, along eastern edge of EMPA D16

As of 2019, the installation of check dams and armouring along the north and east edges of EMPA D16 appeared to reduce or stop the expansion of erosion and sediment deposition in most locations. While straw wattles placed in gullies on the western edge of EMPA D16 reduced the movement of sediment downhill, it did not completely stop sediment from reaching the adjacent wetland. Following the 2019 surveys, it was recommended that site staff enhance containment measures where needed and assess if further measures were feasible to prevent sediment from entering surrounding uncleared areas. Site staff is currently developing a plan to address these issues.

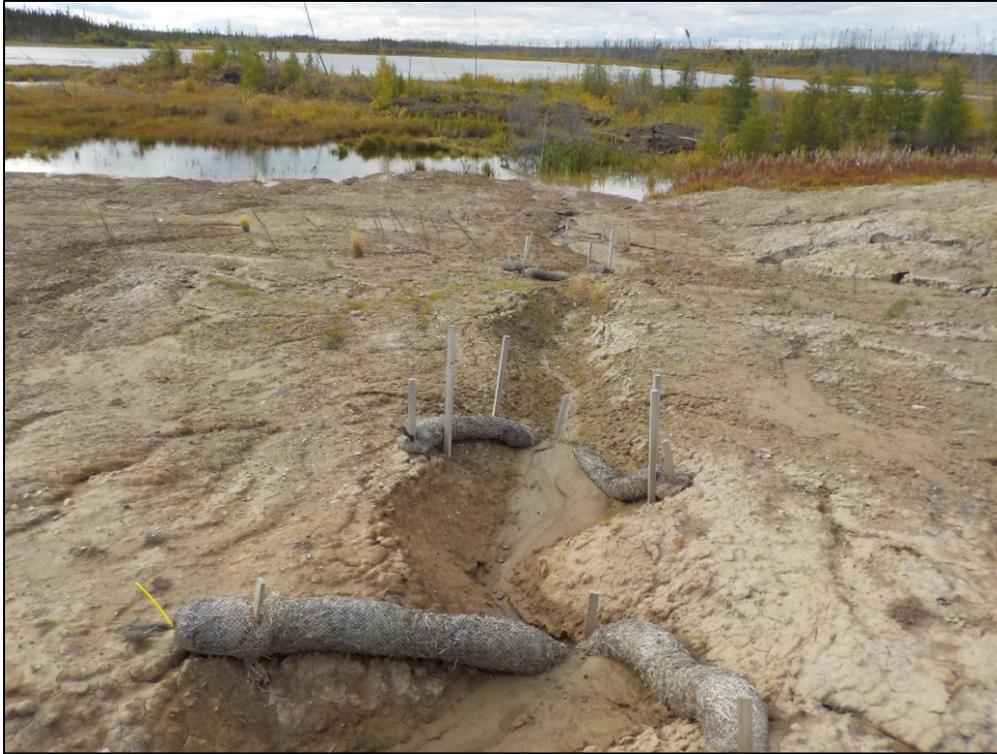
Silt fences along the western edge of EMPA D16 had been removed since September 2018. Straw wattles that were placed into gullies appeared to have reduced sediment flow beyond the EMPA, although the 2019 surveys found that sediment was still getting to the bottom of the hill and into the adjacent marsh area because it was bypassing, and/or flowing over and under the wattles (Photo 3-9; Map 3-2).

Photo 3-9: Straw wattles in gully along western edge of EMPA D16

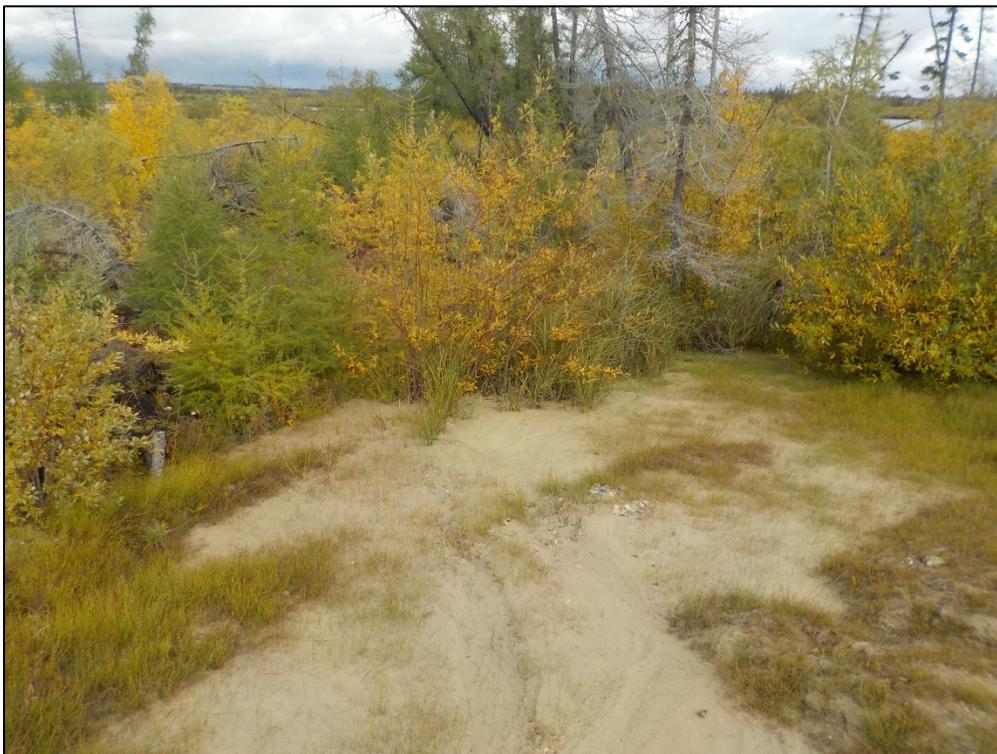
At EMPA D17, surveys in 2019 found that sediment from slope erosion had continued to overwhelm silt fences and was being deposited into uncleared vegetation adjacent to the northeastern slopes (Photo 3-10; Map 3-2). Runoff was found entering a pond approximately 30 metres northeast of the EMPA but no visible effects on the vegetation was observed at that time.

Photo 3-10: Sediment from EMPA D17 entering uncleared vegetation

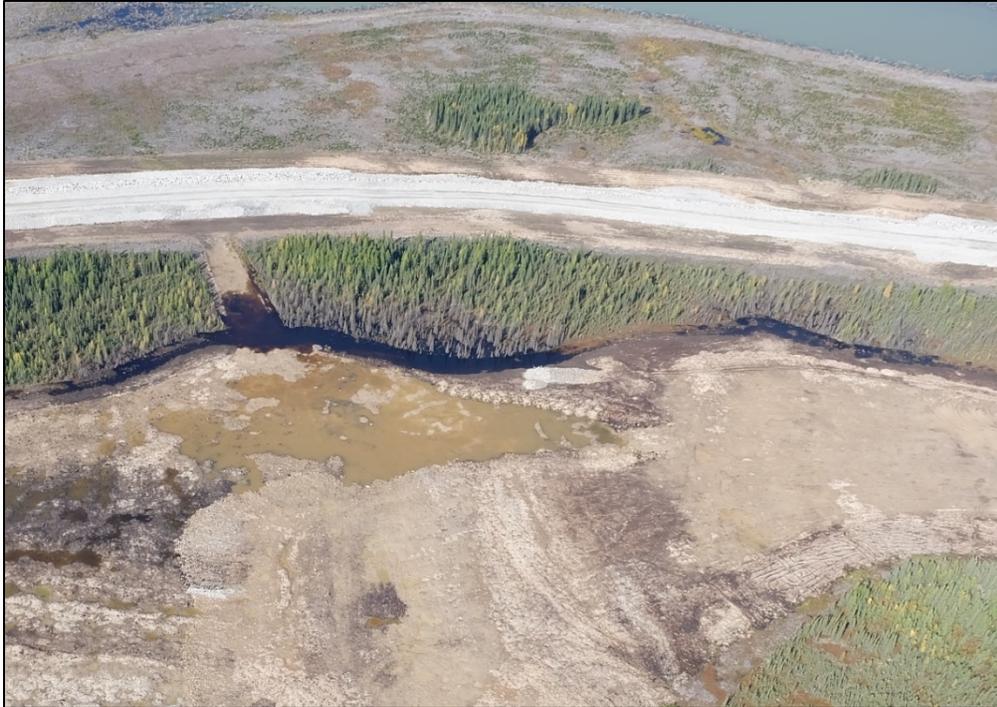
Approximately 0.4 ha of disturbance was found along the northern edge of EMPA D27(4). Here, localized water had collected at the base of the EMPA slope and formed several ponds by 2018. These ponds extended into the adjacent undisturbed forest causing vegetation mortality (Photo 3-11; Map 3-2). At the same time, emergent marsh plants (likely sedges) were colonizing some of the ponds in 2018 (Photo 3-12), however these plants appear to have mostly disappeared by September 2019. These ponds will be surveyed for marsh vegetation in 2020.

Photo 3-11: Aerial view of flooding and dying trees on northern edge of EMPA D27(4)

Water collecting along the northern edge of EMPA D27(4) created several ponds, causing vegetation mortality in approximately 0.4 ha of adjacent uncleared forest. The area of vegetation mortality could expand over time. At the same time, marsh plants have colonized some of the ponds. No mitigation is recommended at this time as the potentially affected area is small, the disturbance is within the planned and possibly disturbed footprint, and the development of off-system marsh is a positive effect even if only a temporary one. These ponds will be surveyed for marsh vegetation in 2020.

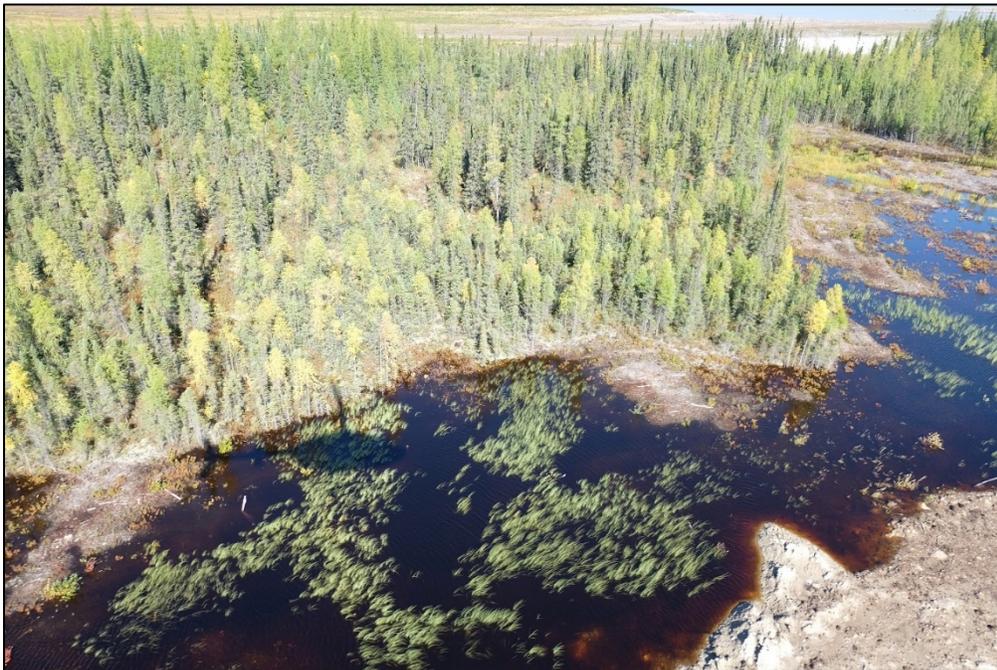
Photo 3-12: Aerial view of emergent vegetation in pond along the northern edge of EMPA D27(4) in September 2018

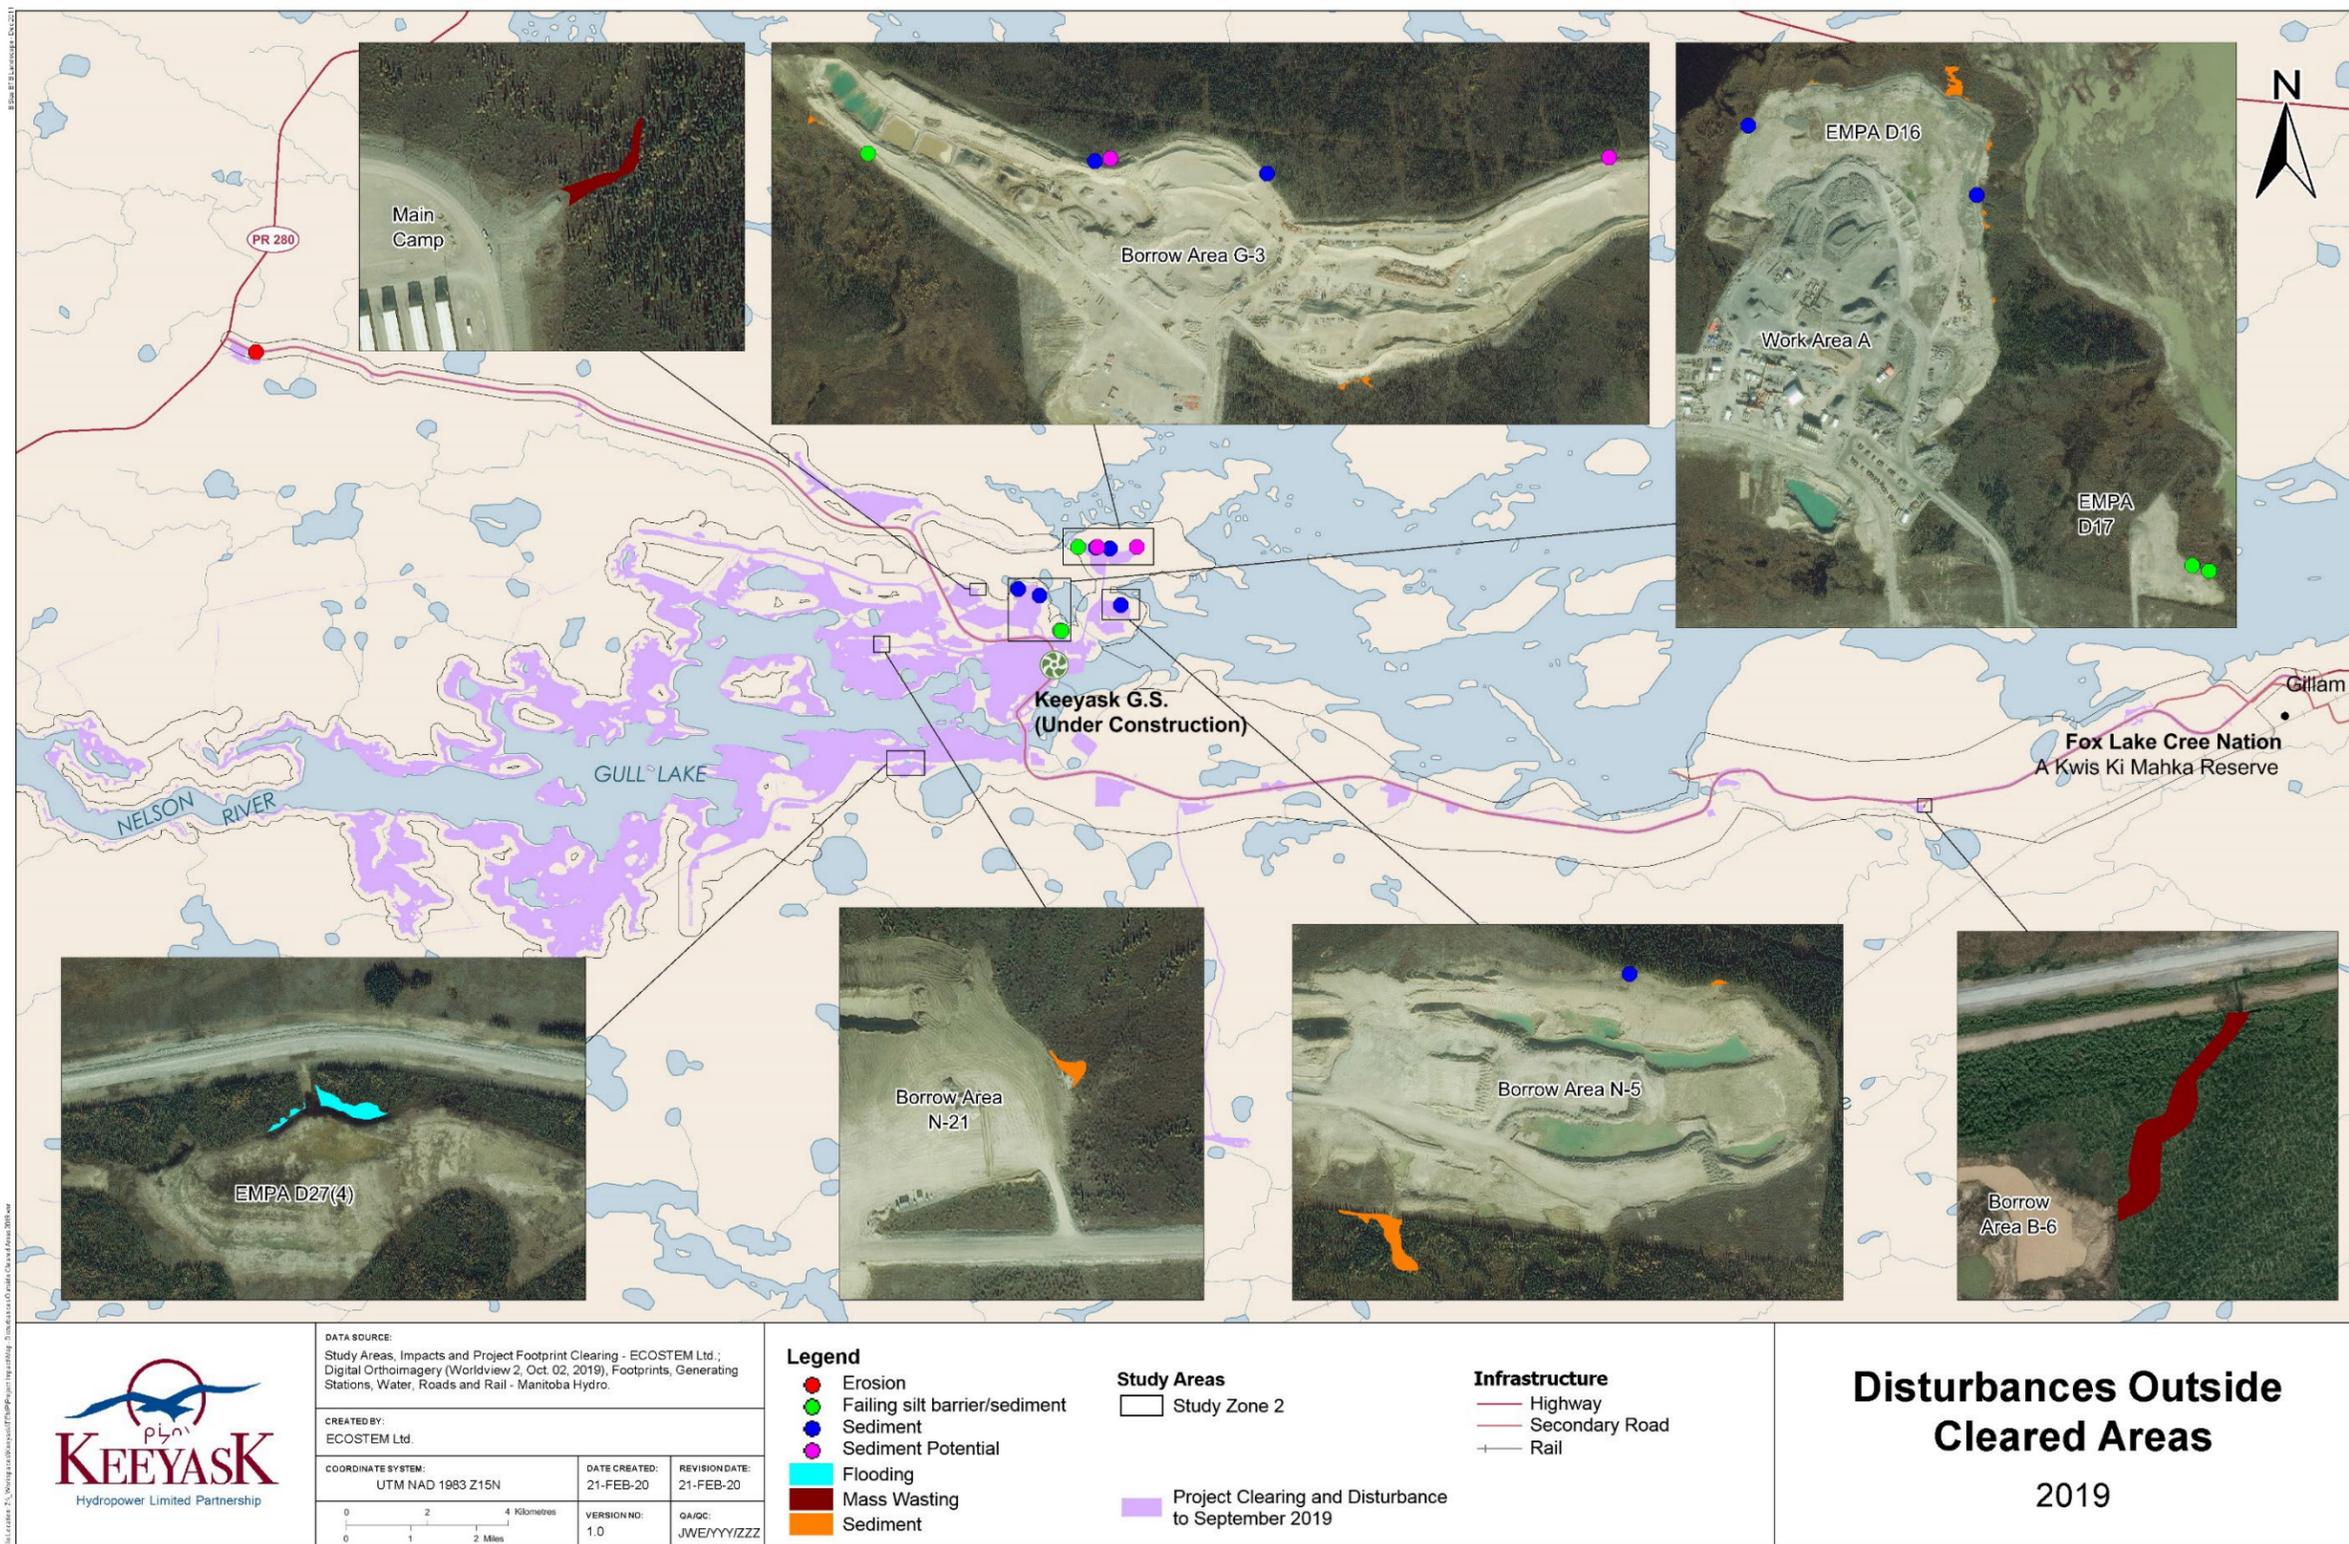
Map 3-2: Disturbances outside of cleared areas in 2019

Sediment was being deposited several metres into uncleared adjacent forest on the eastern edge of Borrow Area N-21 where new clearing was found in 2019 (Map 3-2).

At Borrow Area N-21, sediment was being deposited into the adjacent forest along the eastern edge where new clearing was located. It is recommended that Manitoba Hydro site staff inspect and evaluate these areas and implement erosion control measures as needed.
