Keeyask Generation Project
Terrestrial Effects Monitoring Plan

Habitat Loss and Disturbance Monitoring Report

TEMP-2021-01

By
ECOSTEM Ltd.

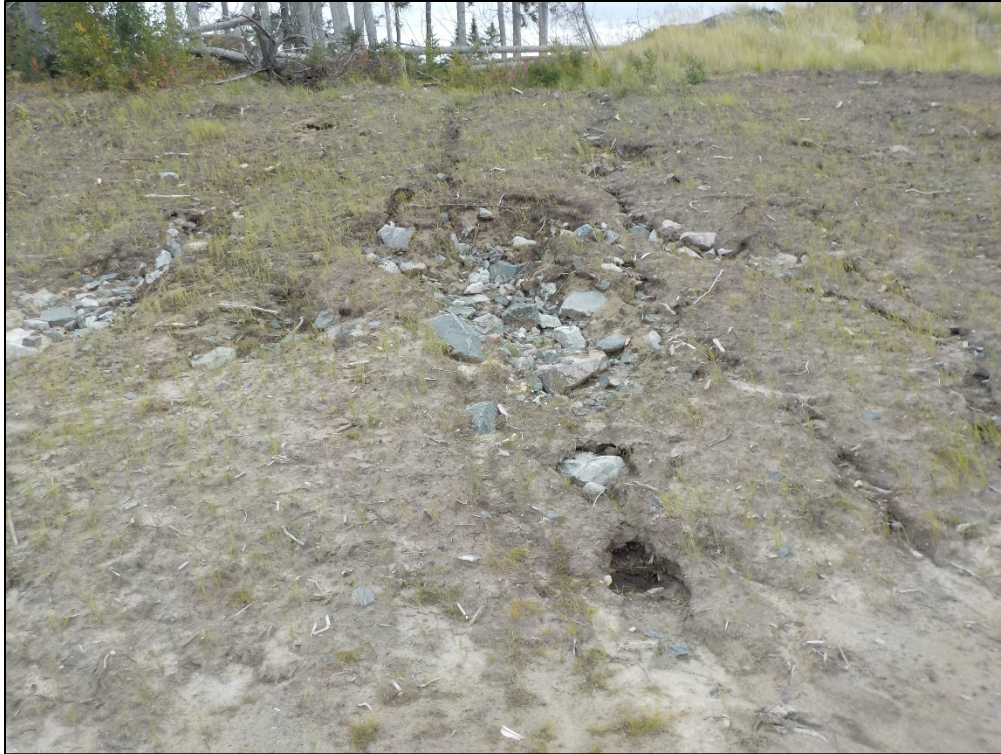
Erosion disturbance on the south ditch bank of the NAR adjacent to Borrow Area KM-1 had created a gully since it was first identified during 2016 surveys. Erosion had expanded the gully between the ditch and the borrow area between 2016 and 2018 (Map 3-2). Field surveys in 2019 found that the area had since been remediated by filling the eroded area. Some minor erosion and sediment deposition around the eastern fringes of the remediated area was noted in 2019. The bank was subsequently covered with organic material. The 2020 monitoring recorded new but minor erosion on the ditch slope (Photo 3-1). The site will be monitored for substantive changes in 2021.

Photo 3-1: Erosion on ditch bank adjacent to Borrow Area KM-1

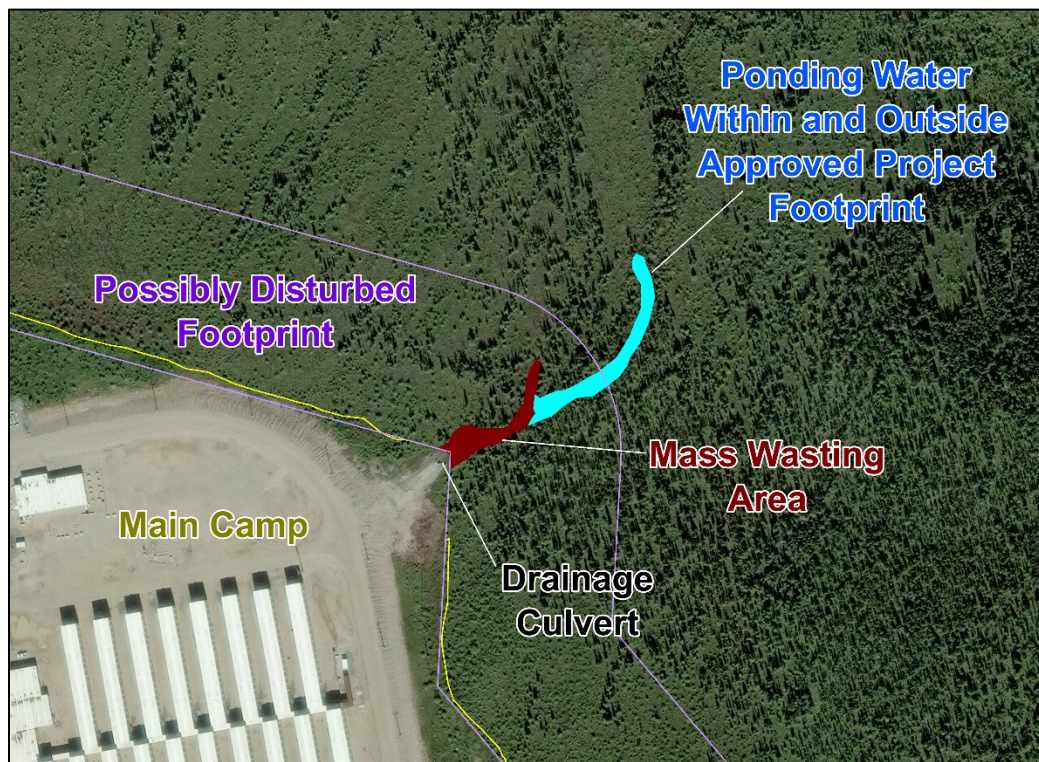
At the northeast corner of the Main Camp, a disturbance created by water outflow from a culvert extended approximately 160 m into the uncleared forest in 2020 (Map 3-2; Figure 3-1). This was an increase of 80 m since September 2019. The associated disturbed area expanded by 0.05 ha in the possibly disturbed Project area, and by 0.06 ha outside of the planned and possibly disturbed Project footprint area. At the time of the 2020 survey, this disturbance extended more than 75 metres past the approved Project footprint boundary.

Figure 3-1: Mass wasting (in brown) and ponded water (in blue) outside Main Camp in 2020

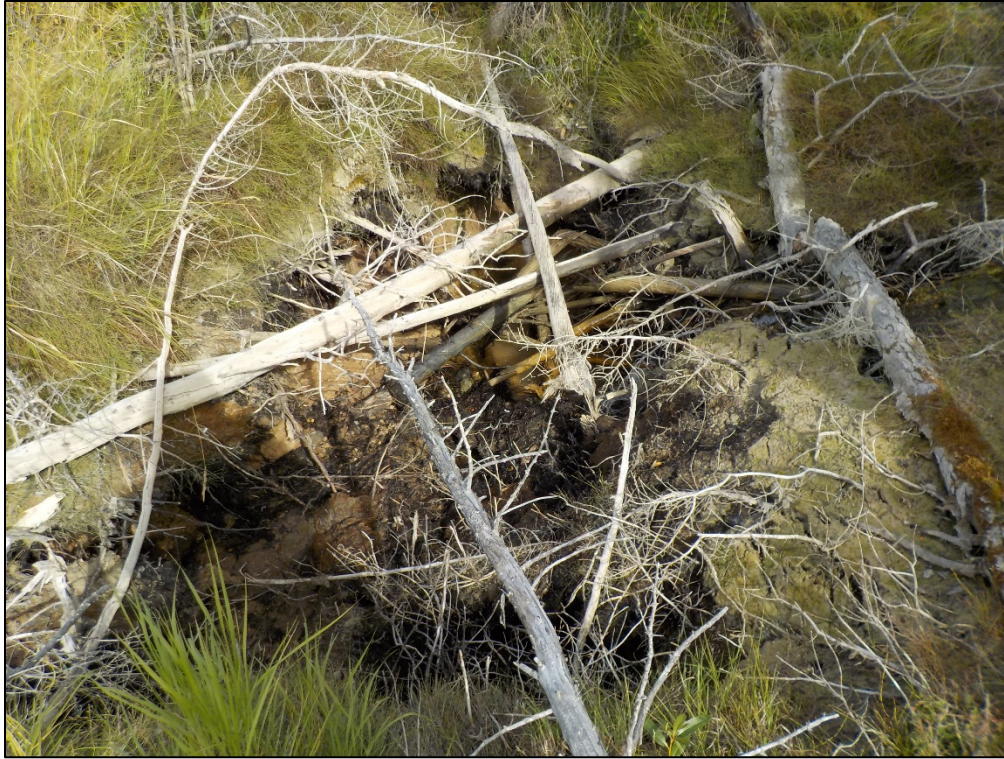
Within this disturbed area, rapidly flowing water had created a channel through the vegetation. This water started flowing underground in spots, which created mass wasting and hollow areas within the substrate, and then toppled trees in towards the hollowed areas (Photo 3-2 and Photo 3-3). Outside of the Project footprint, this disturbance was affecting a common habitat type (black spruce dominant vegetation on thin peatland). This disturbance also has the potential to affect an off-system marsh if it reaches the low area adjacent to the marsh.

Photo 3-2: Mass wasting northeast of Main Camp

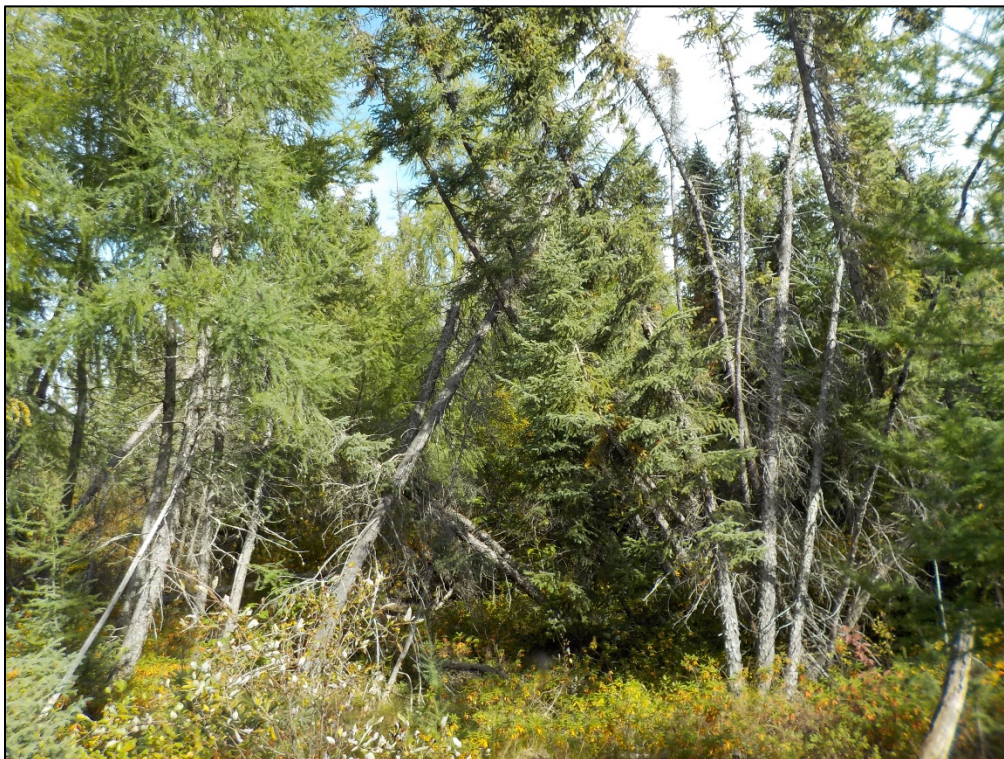
Photo 3-3: Trees toppling into hollowed out area northeast of Main Camp

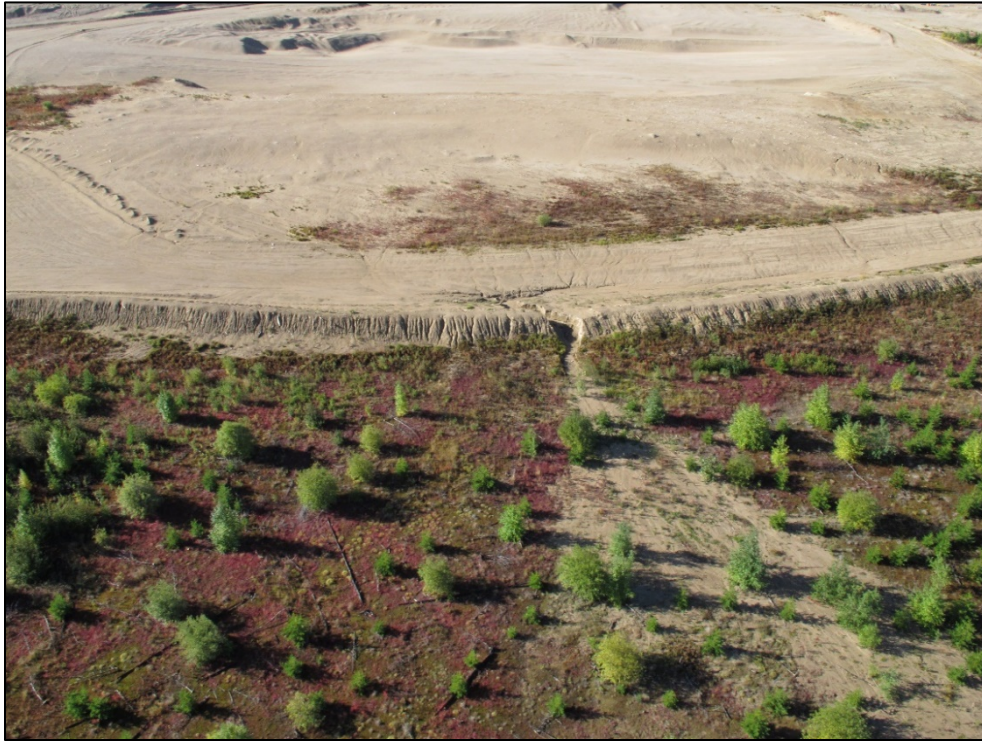
Extensive erosion and sediment deposition into uncleared forest totaling 0.1 ha along the northern edge of Borrow Area G-1 at KM 17 was observed in 2020 (Photo 3-4; Map 3-1). An additional 0.06 ha of sediment deposition was found on the southeastern edge and at the access road

Photo 3-4: Erosion and sediment deposition at northern edge of Borrow Area G-1 at KM 17

At Borrow Area G-1, erosion is depositing sediment into adjacent uncleared vegetation at a number of locations (see Section 3.3.4.1 for details). To prevent an expansion of the sediment deposition area, it is recommended that sediment barriers be installed and/or slopes be regraded as needed at these locations.

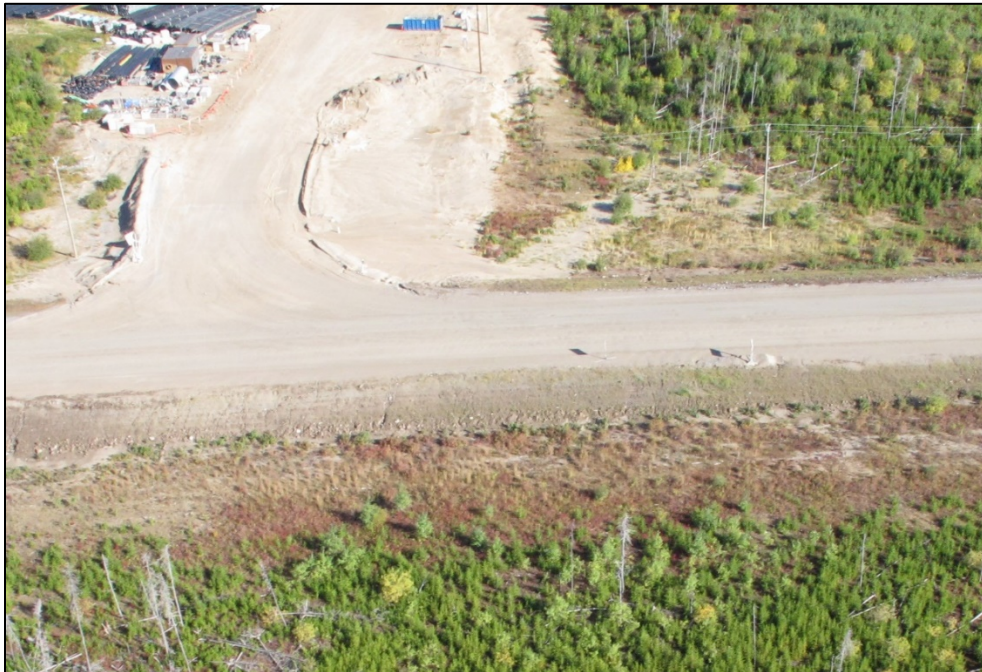
entrance of KM 17 (Photo 3-5). Of the total new disturbance in KM 17, 78% was outside of the approved Project footprint (Appendix 1: Table 7-1). Erosion and sediment deposition was also observed at the eastern corner of G-1 at KM 15 (Map 3-2).

Photo 3-5: Sediment deposition at entrance of Borrow Area G-1 at KM 17

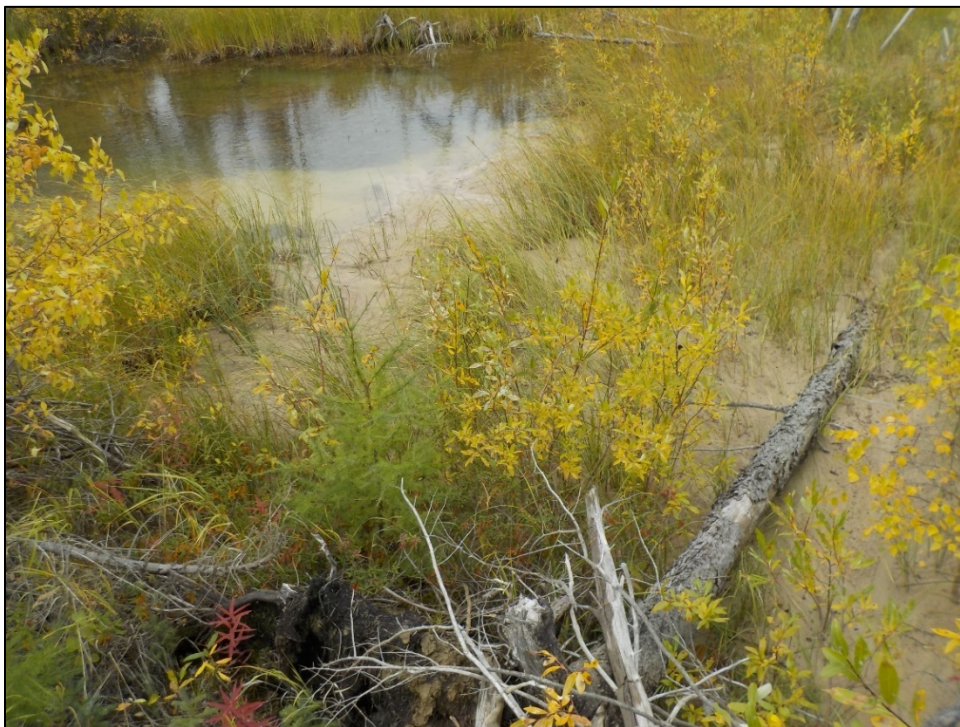
In past years at Borrow Area G-3, erosion on mineral slopes around the perimeter had been depositing sediment into the uncleared forest at several locations. Sediment fences had been installed along portions of the south side of the borrow area in spring of 2019, but September surveys found that sediment was bypassing them. Surveys in 2020 found that sediment deposition was ongoing in several spots around the perimeter despite all slopes being graded and sediment fences removed in the borrow area (Map 3-1; Map 3-2). Two locations on the northern edge where sediment deposition into uncleared vegetation were taking place had the potential to affect a much greater area due to the natural topography. Sediment deposition into an adjacent marsh on the western edge of the borrow area was also occurring as of September 2020 (Photo 3-6).

Photo 3-6: Sediment deposits in marsh adjacent to Borrow Area G-3

At Borrow Area G-3, ongoing erosion and runoff is impacting otherwise undisturbed terrestrial habitat as well as planted tree seedlings (see Section 3.3.4.2 for details). For the locations where sediment deposition is impacting otherwise undisturbed terrestrial habitat, it is recommended that sediment barriers be installed or extended.

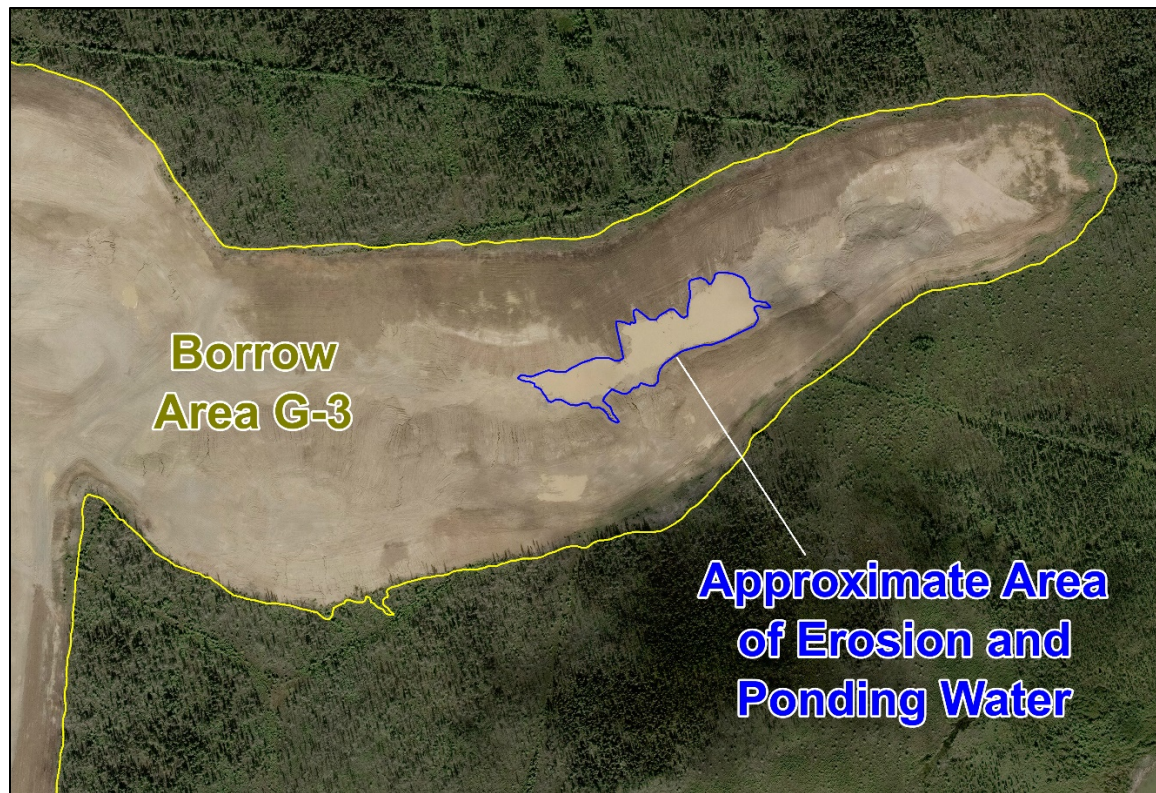
In the eastern half of Borrow Area G-3, erosion on excavated slopes was washing away planted seedlings and also flooding planted seedlings in the basin of the excavated area (Figure 3-2; Photo 3-7). Seedling mortality and dieback of a large number of planted seedlings in the basin were also observed during surveys in 2020.

Figure 3-2: Approximate area where erosion and ponded water were affecting planted seedlings in the eastern portion of Borrow Area G-3

Planted tree seedlings in G-3 are being affected by upslope water runoff or erosion. In the area where planted tree seedlings are being inundated by upslope water runoff, it is not feasible to prevent further seedling mortality from occurring as the surrounding area is at a higher elevation. Additionally, it is possible that the ground surface of this area is at or below the top of the groundwater table. On this basis, it is recommended that trees not be planted at the bottom of low areas where periodic ponding of water may occur.

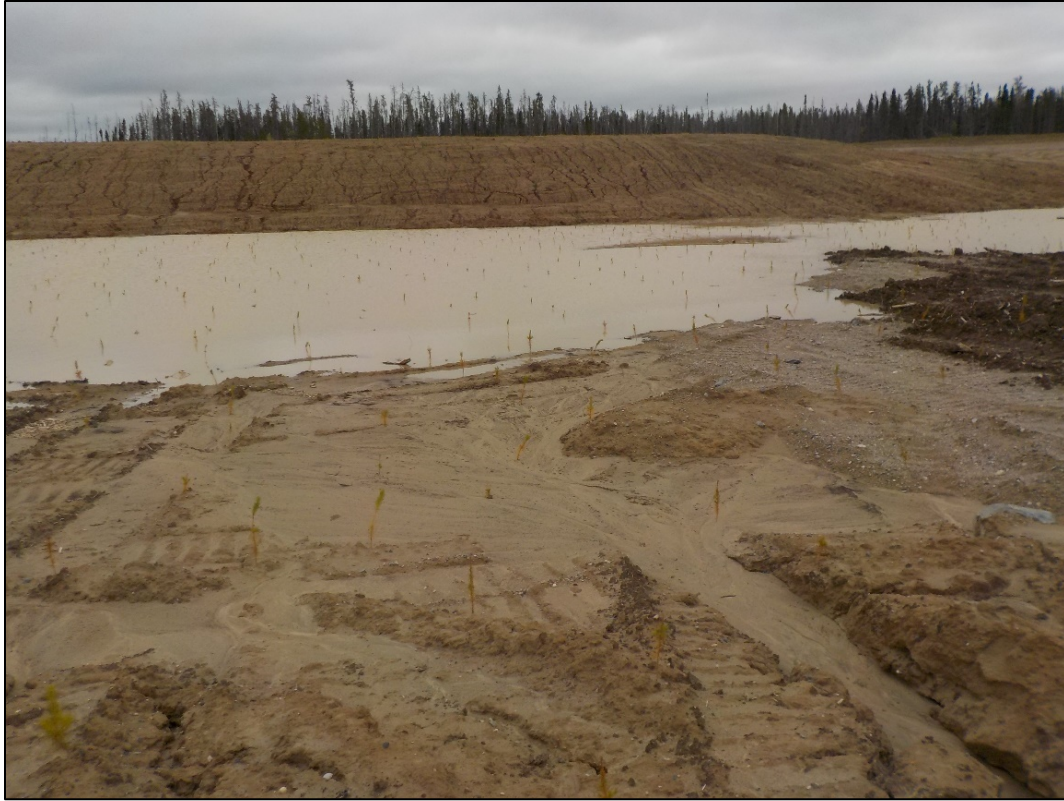
Photo 3-7: Erosion and ponded water affecting planted seedlings in Borrow Area G-3

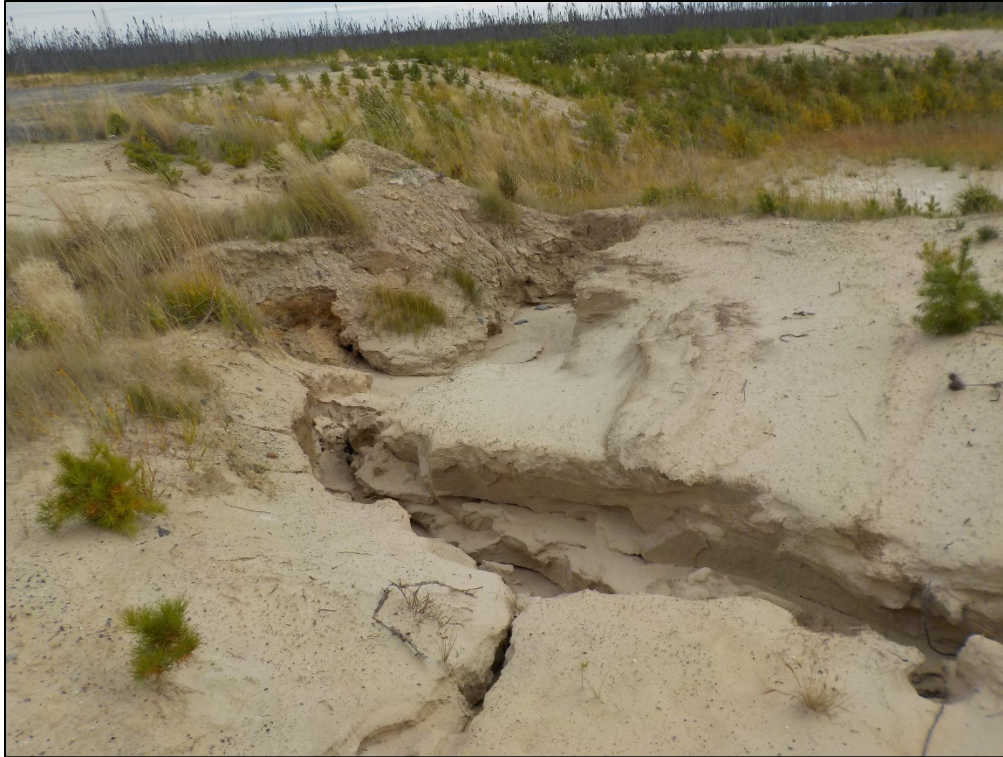
In Borrow Area KM-1, 2020 surveys found that erosion runnels continued to widen and deepen (Photo 3-8). The erosion was washing away vegetation and could eventually affect nearby planted tree seedlings.

Photo 3-8: Erosion in Borrow Area KM-1

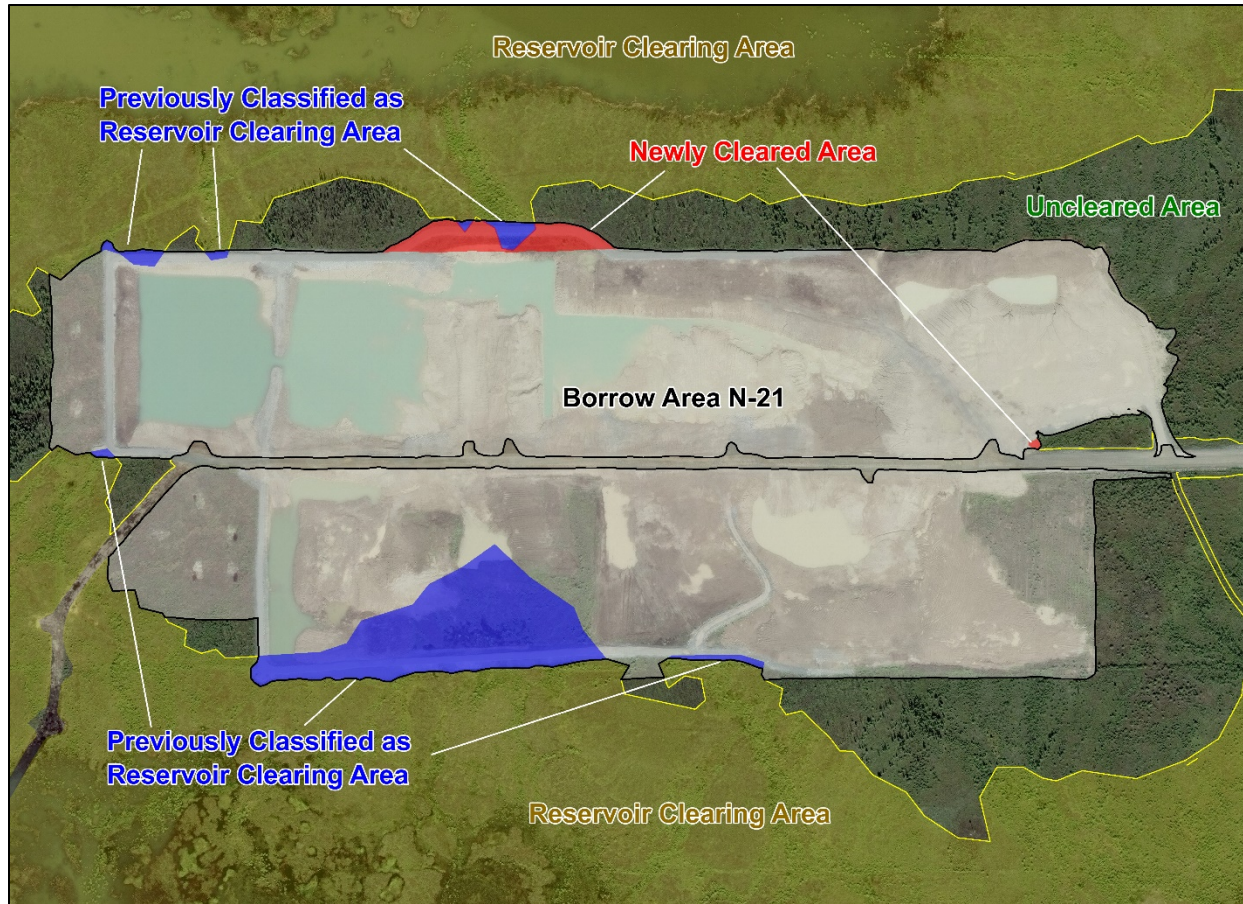
The construction of a rock berm around the western half of Borrow Area N-21 in 2020 occupied 2.4 ha of previously classified reservoir clearing area (Figure 3-3). Construction of the rock berm created approximately 0.4 ha of new clearing (Figure 3-3). This berm was constructed to keep fish out of the excavated area following reservoir impoundment.

Figure 3-3: Locations of rock berms constructed within previously uncleared areas (red) and within area previously classified as reservoir clearing (blue) in Borrow Area N-21

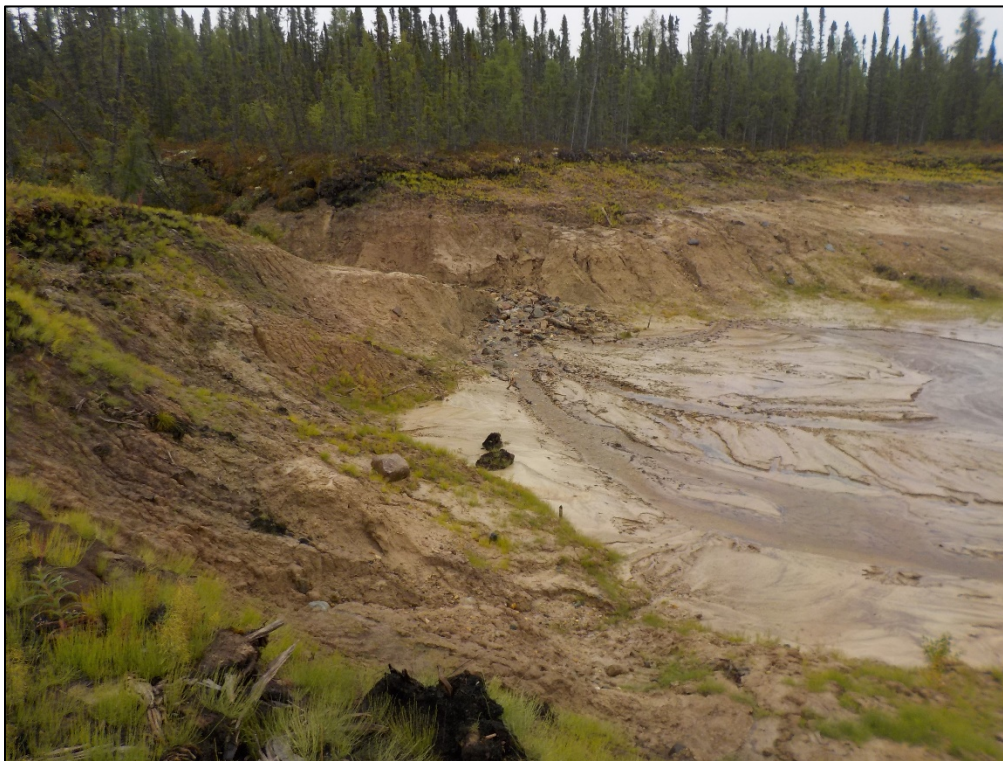
In Borrow Area B-6, mass wasting continued to create a disturbance along a natural drainage channel, affecting otherwise undisturbed habitat (Map 3-1). Significant water flow from the SAR to the east edge of the pit undermined the uncleared forest and created a deep, wide channel (Photo 3-9). The 2020 surveys found that the impacted area had not expanded substantially since 2019.

Photo 3-9: Erosion and ponded water at eastern edge of Borrow Area B-6

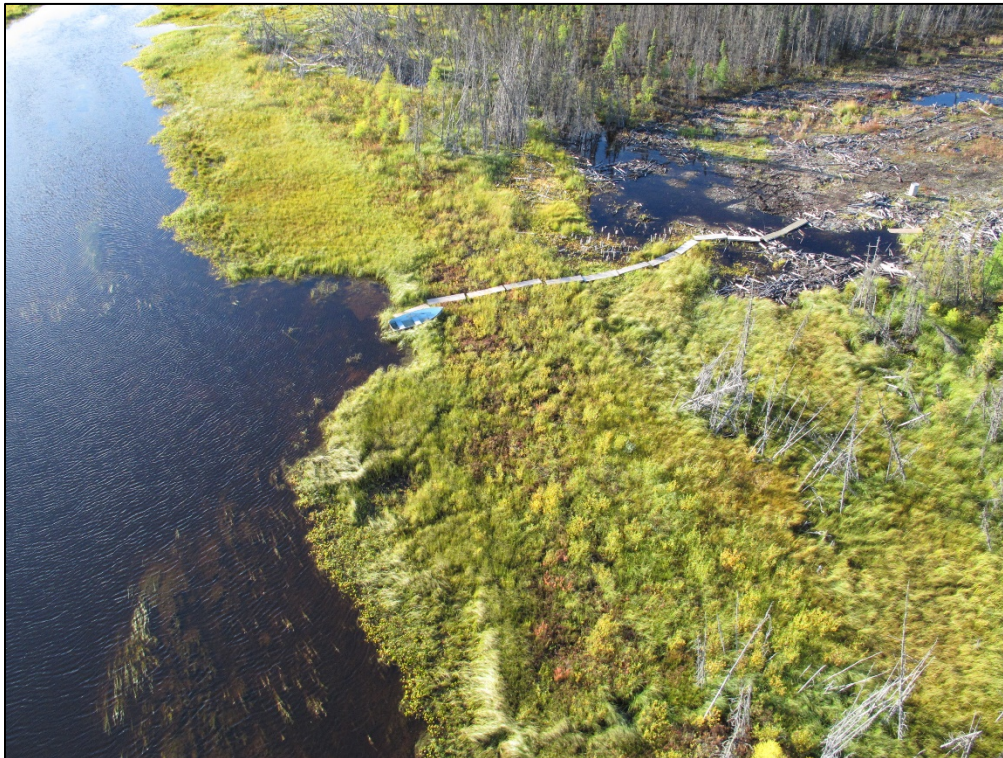
Additional disturbance along the Ellis Esker (E-1) access corridor was observed in 2020 outside previously cleared areas (Map 3-1). These additional disturbances, which were ATV trails, totaled 0.03 ha within the possibly disturbed Project footprint (Appendix 1: Table 7-1). Other disturbances in the corridor observed in 2020 included a broken-down ATV, two boats and several plywood planks located where the corridor intersected the stream flowing from Joslin Lake (Photo 3-10; Map 3-2).

Photo 3-10: Boat and plywood planks in Borrow Area E-1 access corridor

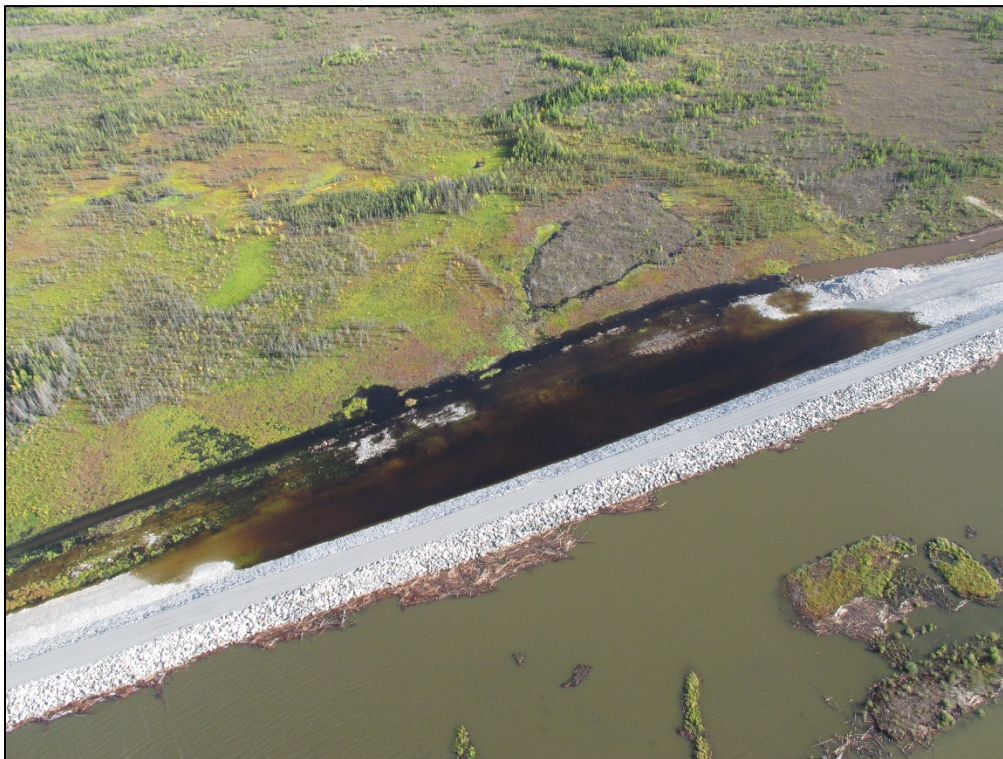
Ponded water disturbance was observed inside the South Dyke bounds. This ponding was entirely within planned Project footprint bounds at the time of the 2020 survey (Photo 3-11).

Photo 3-11: Ponding water inside South Dyke bounds

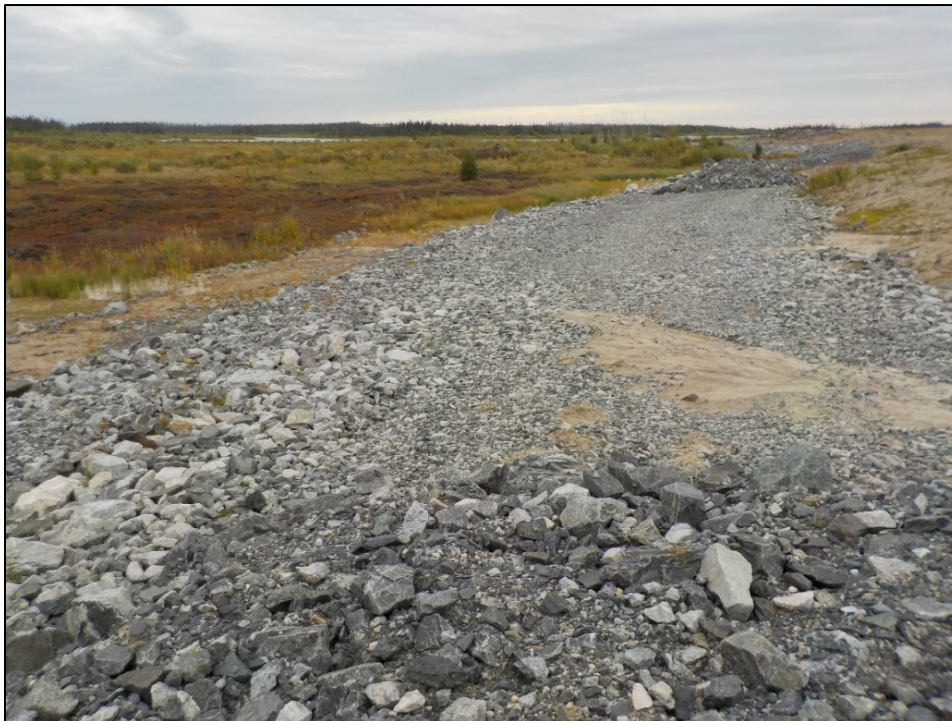
As of September 2020, sediment deposition from bank erosion was continuing around the perimeter of EMPA D16. Water and sediment were flowing through and sometimes over the rock berm into the surrounding uncleared vegetation in many locations (Photo 3-12; Map 3-1; Map 3-2). Sediment deposition had disturbed an additional 0.08 ha (93% of which was within the possibly disturbed Project footprint) of uncleared vegetation in four locations along the western, northern and eastern edges of the EMPA. This included a 0.06 ha area of sediment deposition on the western edge, bringing the disturbance closer to the adjacent marsh. This disturbance resulted from a gap left in the rock barrier, which allowed sediment to pass through into the adjacent marsh habitat (Photo 3-13).

Photo 3-12: Low spot in rock barrier with sediment flowing over top at the northern edge of EMPA D16

As the sediment deposition occurring on the western edge of this EMPA D16 was extending towards an off-system marsh, it is recommended that the rock berm be reinforced where it is collapsing or inadequately containing sediment. It is also recommended that site staff monitor the rock berm for other locations where this situation is occurring and implement reinforcement measures as appropriate.

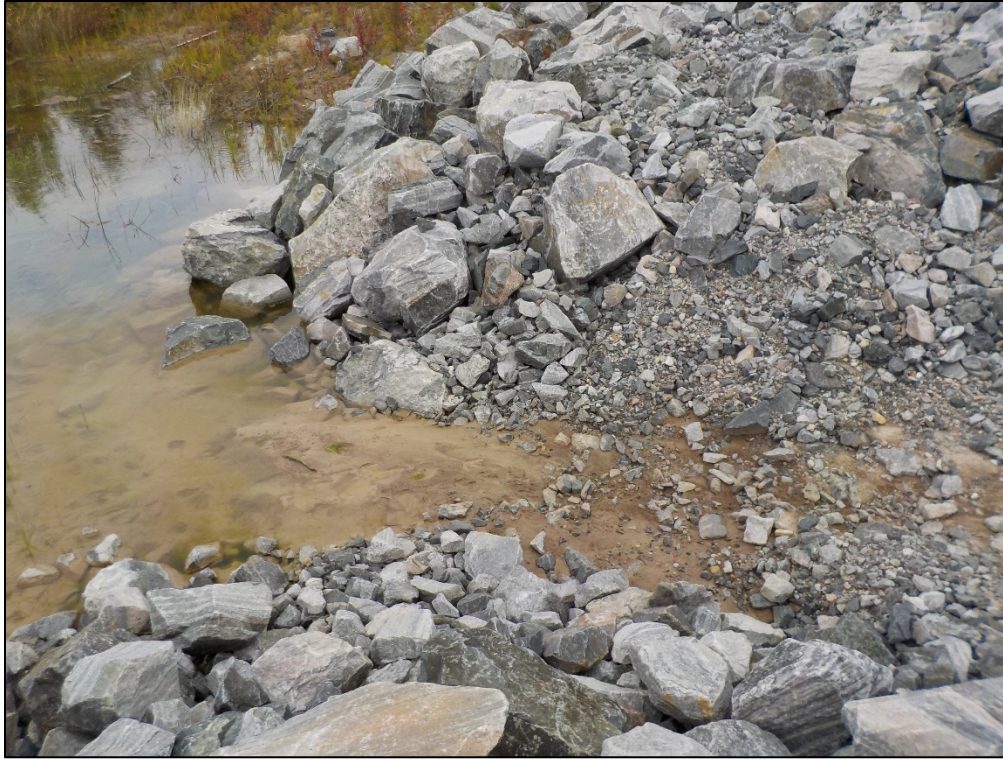
Photo 3-13: Gap in rock barrier in EMPA D16 that allowed sediment to pass through into adjacent marsh

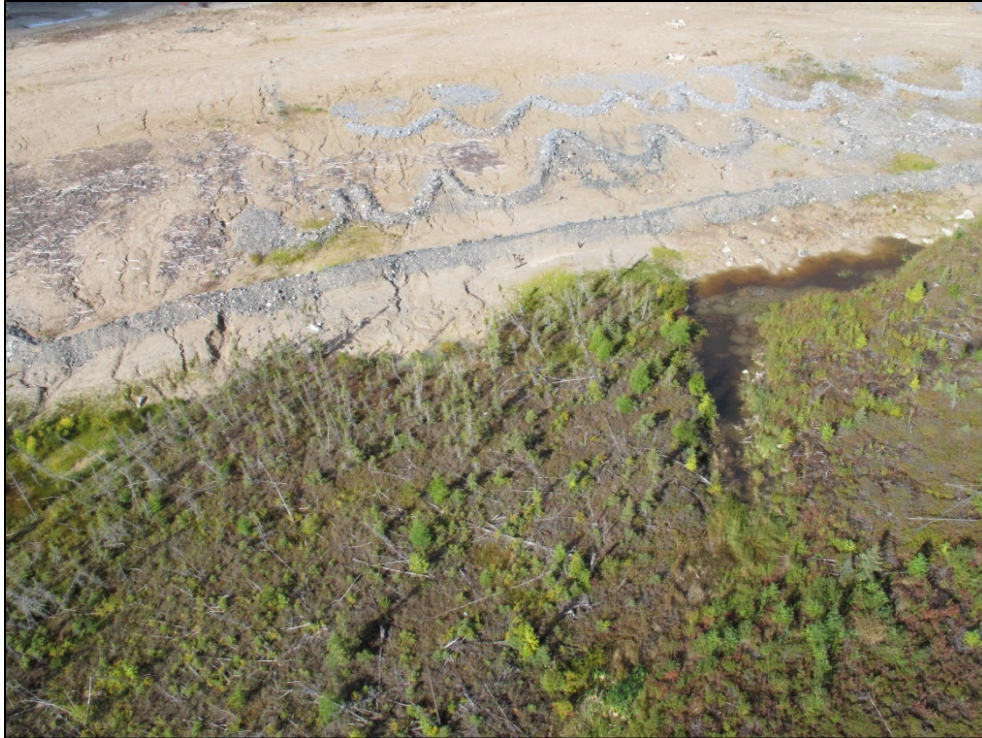
The rock barrier along the eastern edge of EMPA D16 was eroding and breaking down in some spots due to heavy upslope runoff (Photo 3-14). One portion of the rock barrier on the northern edge of the EMPA appeared to be at a lower elevation than the rest of the barrier to the east and west and sediment was observed to begin flowing over it, stopping short of the outer edge (Photo 3-12). Another stretch of the rock barrier along the northeastern edge of the EMPA where sediment deposition was occurring appeared to be composed mainly of large boulders as opposed to variable sized material as the rest of the barrier (Photo 3-15).

Photo 3-14: Rock barrier erosion at eastern edge of EMPA D16

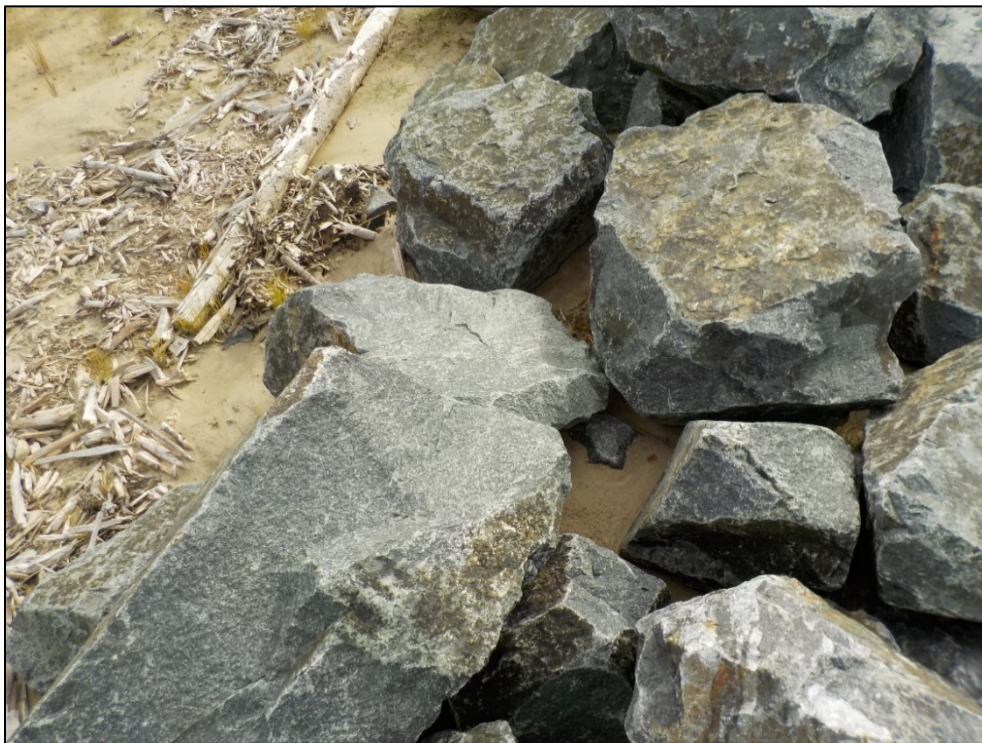
Photo 3-15: Rock barrier composed mainly of large boulders allowing sediment to pass through at the northern edge of EMPA D16

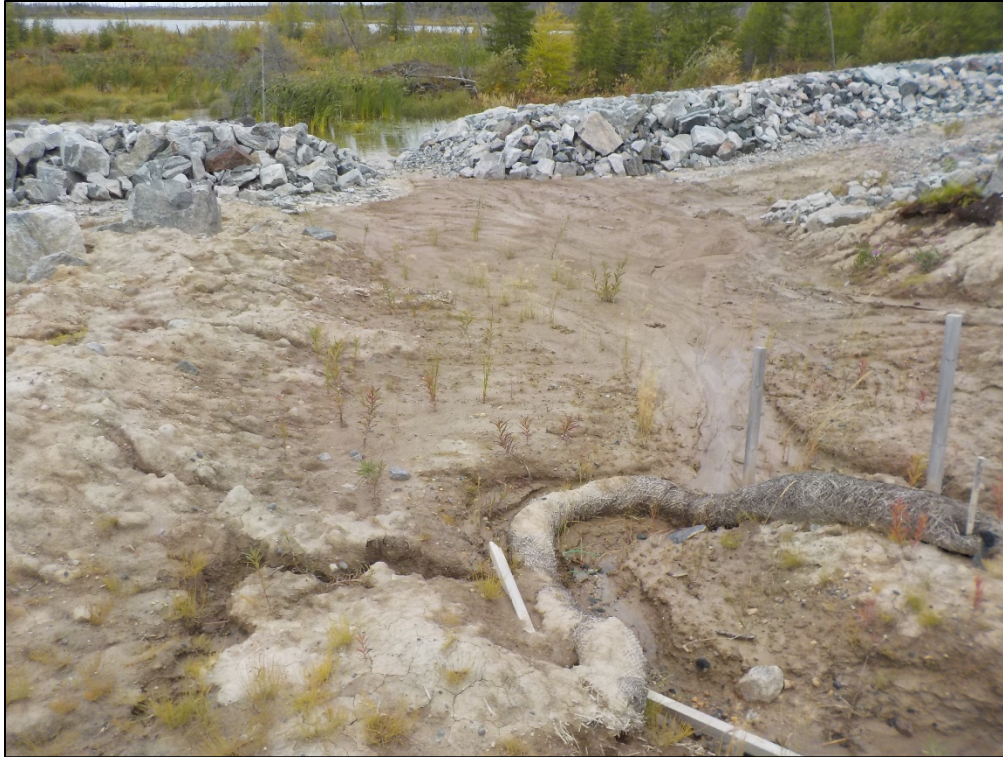
Photo 3-16: Sediment passing through straw wattles installed on western edge of EMPA D16

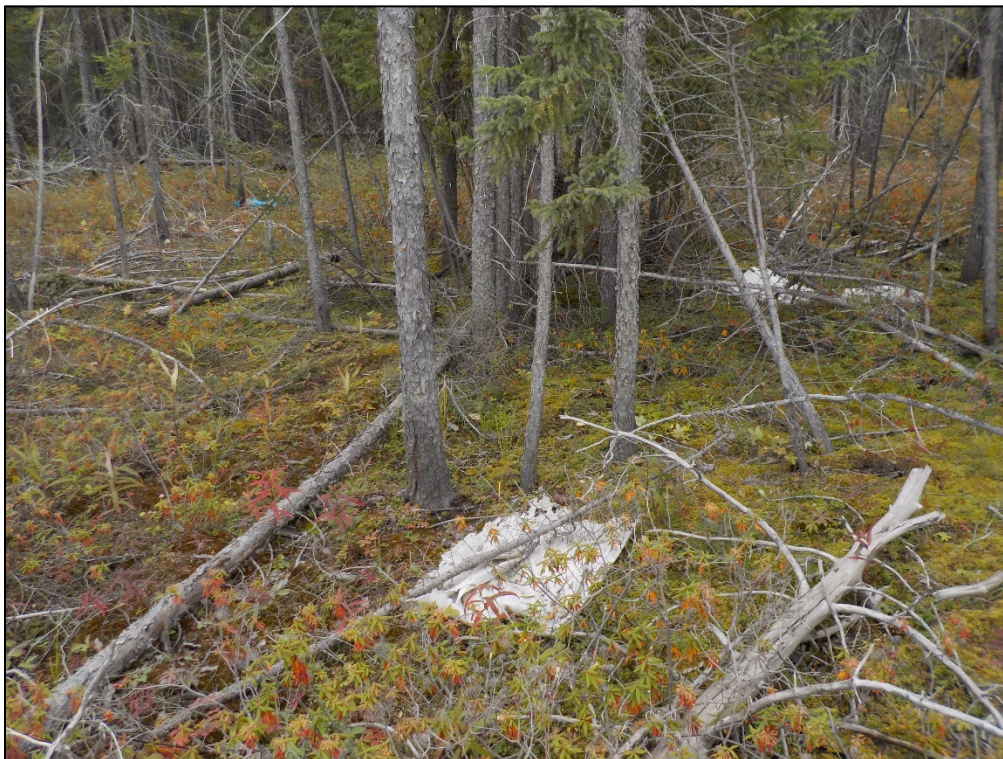
The 2020 surveys also found construction debris at several sites within and outside of EMPA D16 bounds (Photo 3-17; Map 3-2).

Photo 3-17: Construction debris in uncleared vegetation outside EMPA D16

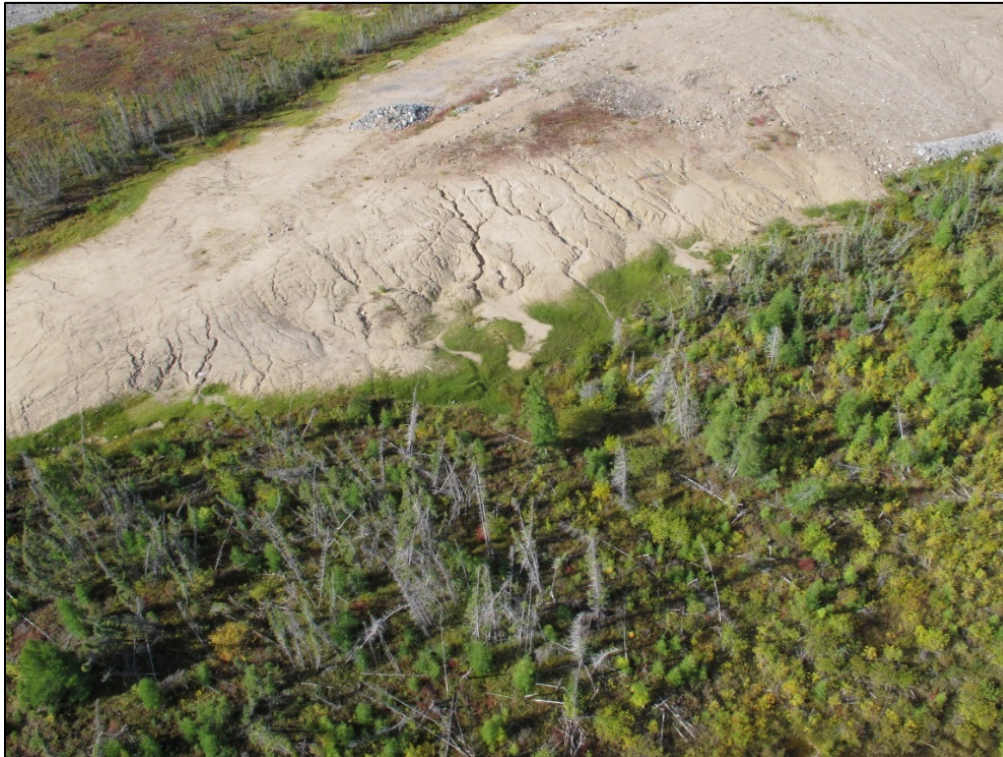
While some of these effects were ongoing at the time of the 2020 surveys, it was unlikely that the sediment deposition would expand further as much of the surrounding ground was higher in elevation. The remaining slopes had dense vegetation growing at their base (Photo 3-18), indicating that those slopes were being naturally stabilized. This site will continue to be monitored for adverse effects in 2021.

Photo 3-18: Vegetation growing at base of EMPA D17 slopes

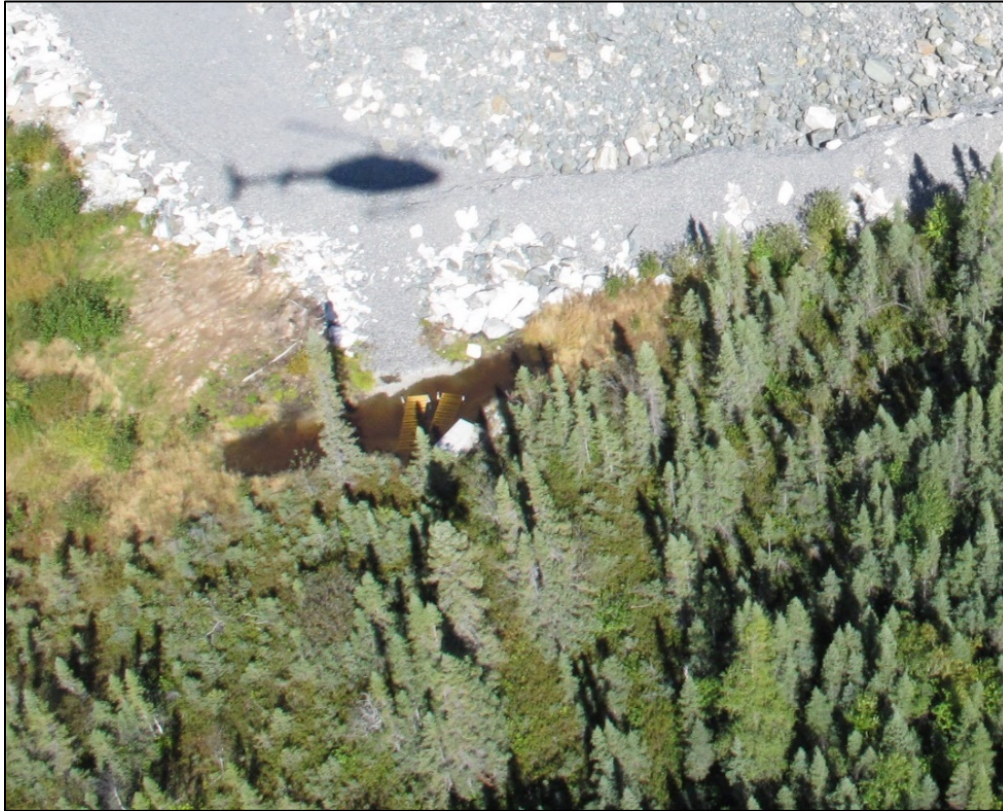
At the time of the 2020 survey, the eastern half of EMPA D23(1) was being used as a granular material storage area. Construction material and debris in the adjacent uncleared forest was also noted during surveys at the southern edge of the EMPA (Photo 3-19).

Photo 3-19: Aerial view of construction debris on southern edge of EMPA D23(1)

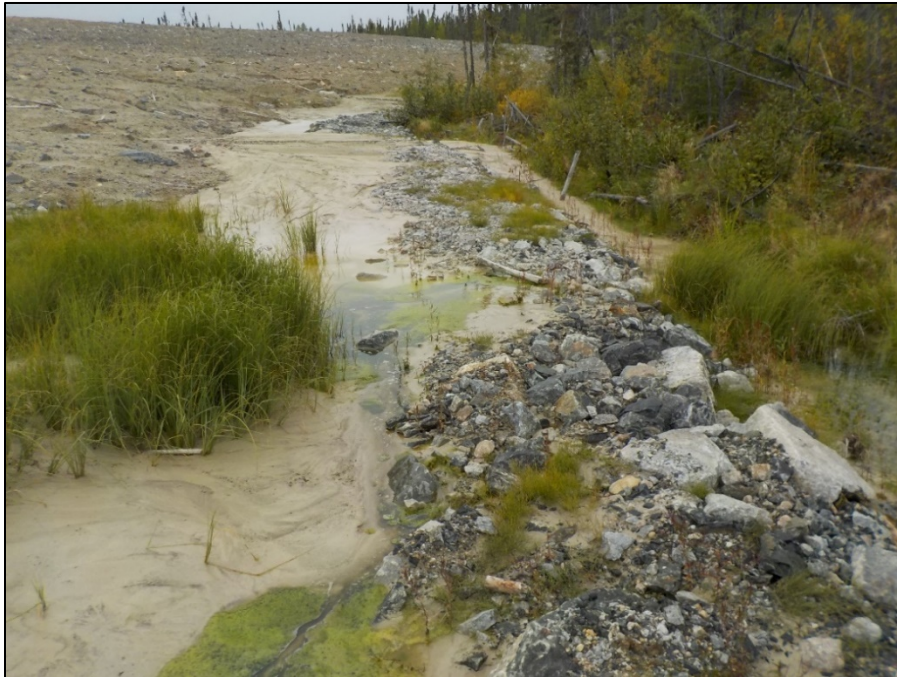
Erosion and sediment deposition within the planned Project footprint area was found overtopping previously installed rock berms at the northeastern edge of EMPA D23(2)-E (Photo 3-20). These impacts were at a location that could potentially affect the dewatered portion of Stephens Lake to the northeast if the disturbance should expand (Map 3-1; Figure 3-4).

Photo 3-20: Sediment overtopping rock berms in EMPA D23(2)-E

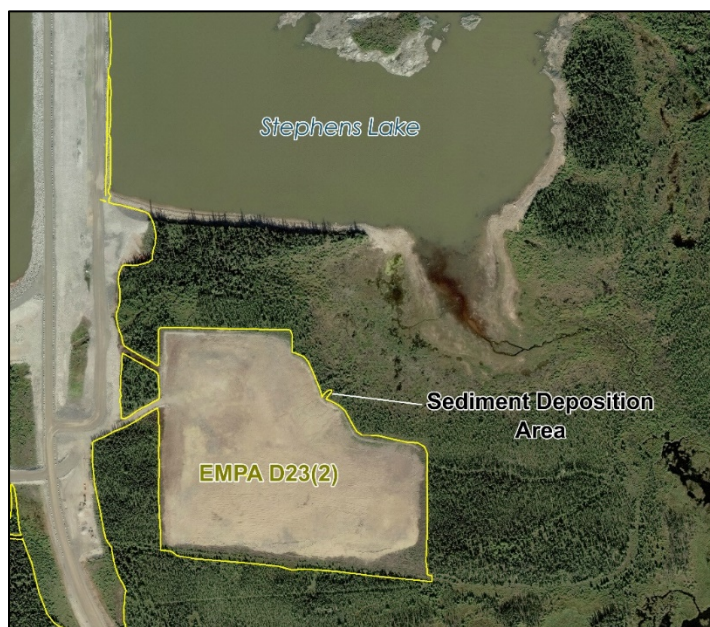
Figure 3-4: Erosion and sediment deposition from EMPA D23(2)-E

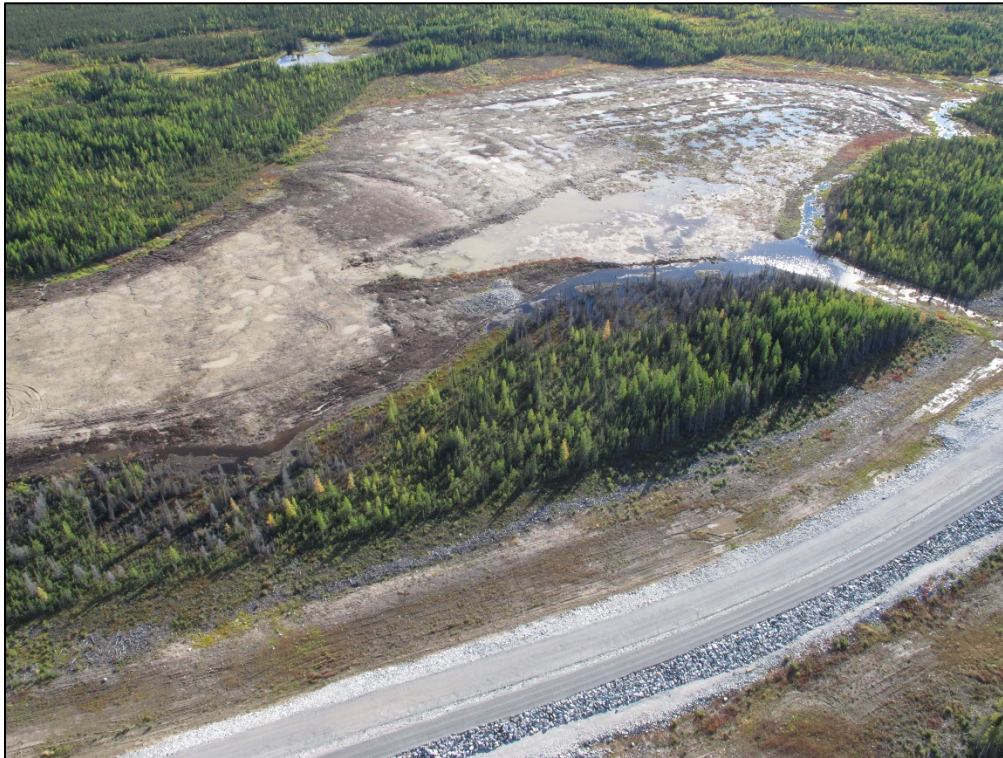
Approximately 0.3 ha of additional disturbance was found along the northern edge of EMPA D27(4) in 2020, bringing the total amount of disturbance outside previously cleared areas to 0.7 ha (Map 3-1). Over half (56%) of the additional disturbance was located in the possibly disturbed Project footprint (Appendix 1: Table 7-1).

In previous years, water had collected in localized sites at the base of the EMPA slope and formed ponds which extended into the adjacent undisturbed forest, causing vegetation mortality. While emergent marsh plants (likely sedges) had initially been colonizing the ponds, these plants had mostly disappeared by September 2019. At the time of the 2020 surveys, no vegetation was observed in the ponds and the amount of tree and vegetation dieback had increased (Photo 3-21). A strong stagnant odour was also noted in the general area around the pools at the time of the 2020 surveys.

Photo 3-21: Aerial view of ponded water and dying trees on northern edge of EMPA D27(4)
