Keeyask Generation Project
Terrestrial Effects Monitoring Plan

Habitat Loss and Disturbance Monitoring Report

TEMP-2021-01

By
ECOSTEM Ltd.

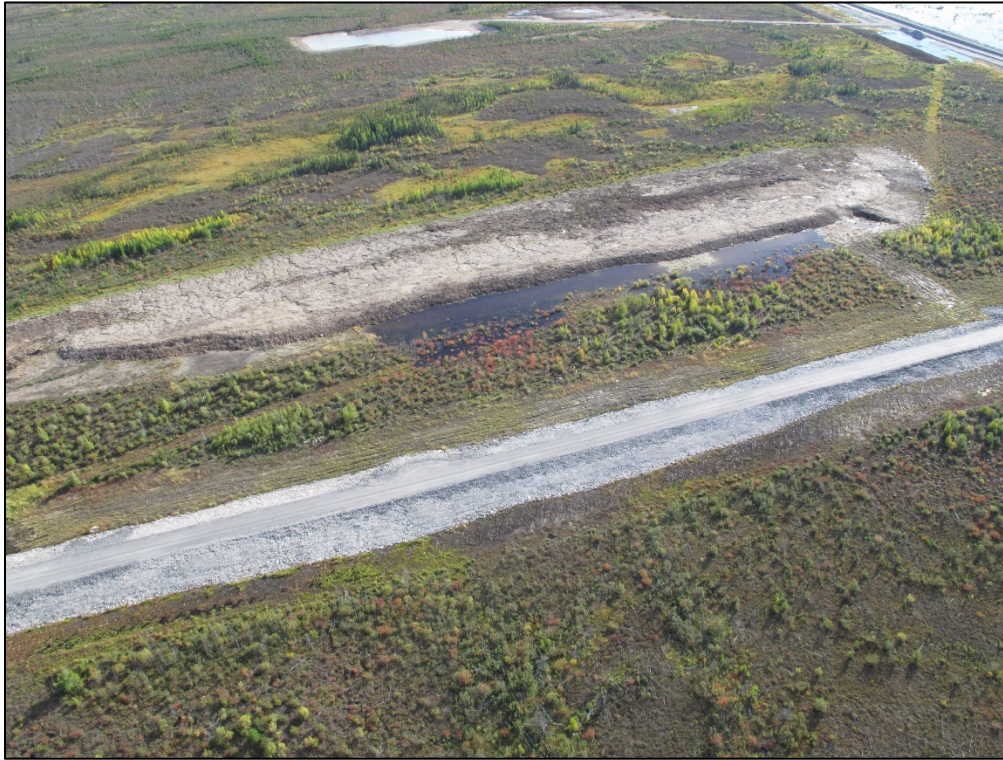
Newly ponded water was observed along the northern edge of EMPA D28(1)-E in 2020, inundating about 0.2 ha of adjacent undisturbed vegetation (Photo 3-22; Map 3-1). Some vegetation dieback was also observed at the time of the survey.

The bulk of this new disturbance (84%) was located within the possibly disturbed Project footprint (Appendix 1: Table 7-1).

Photo 3-22: Aerial view of ponded water and dying vegetation on northern edge of EMPA D28(1)-E

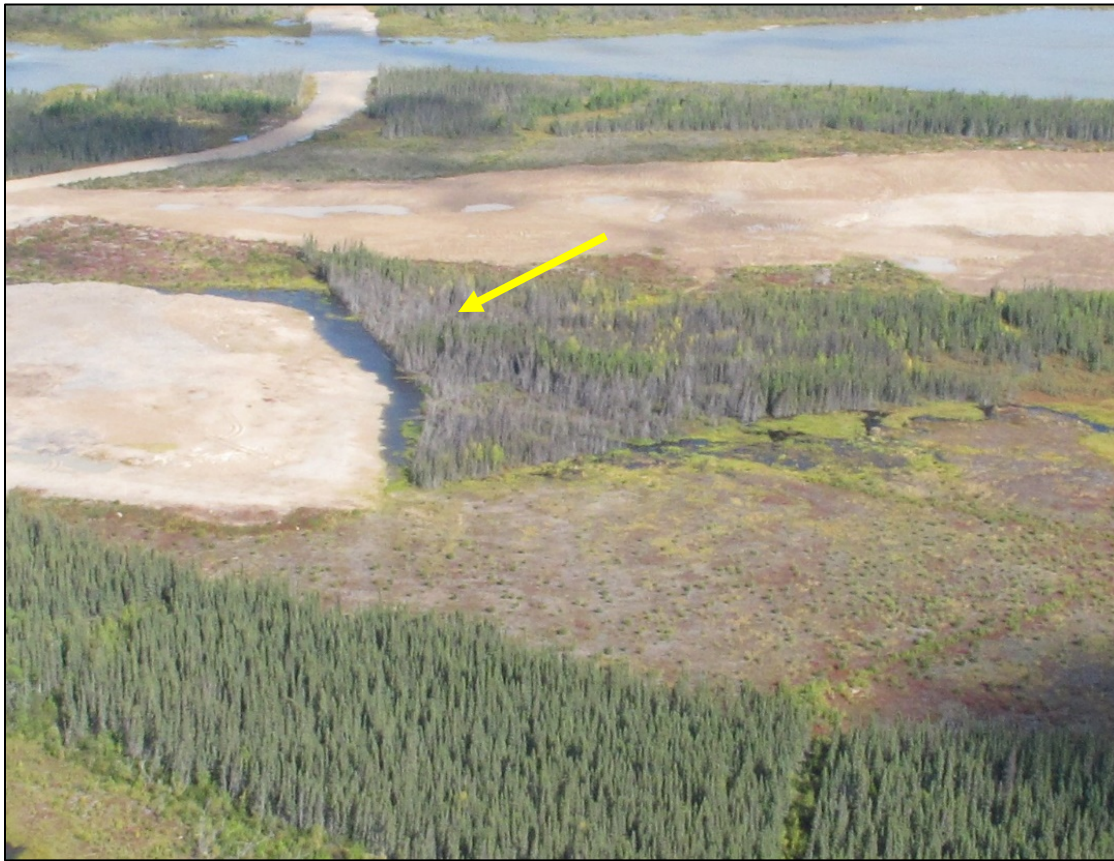
At the eastern edge of EMPA D35(1)-E in 2020, ponded water as well as significant tree dieback was observed in the adjacent uncleared forest (Photo 3-23; Map 3-2). This resulted in the disturbance of approximately 1.6 ha of planned Project area.

Photo 3-23: Ponded water and tree dieback at the eastern edge of EMPA D35(1)-E

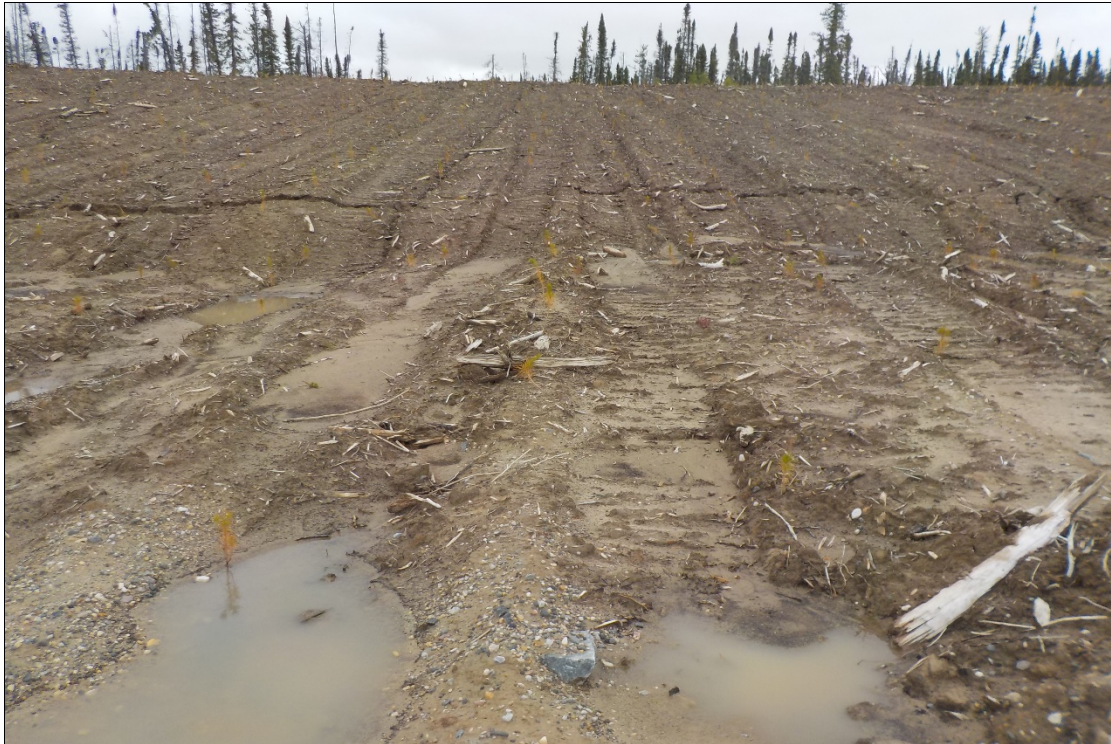
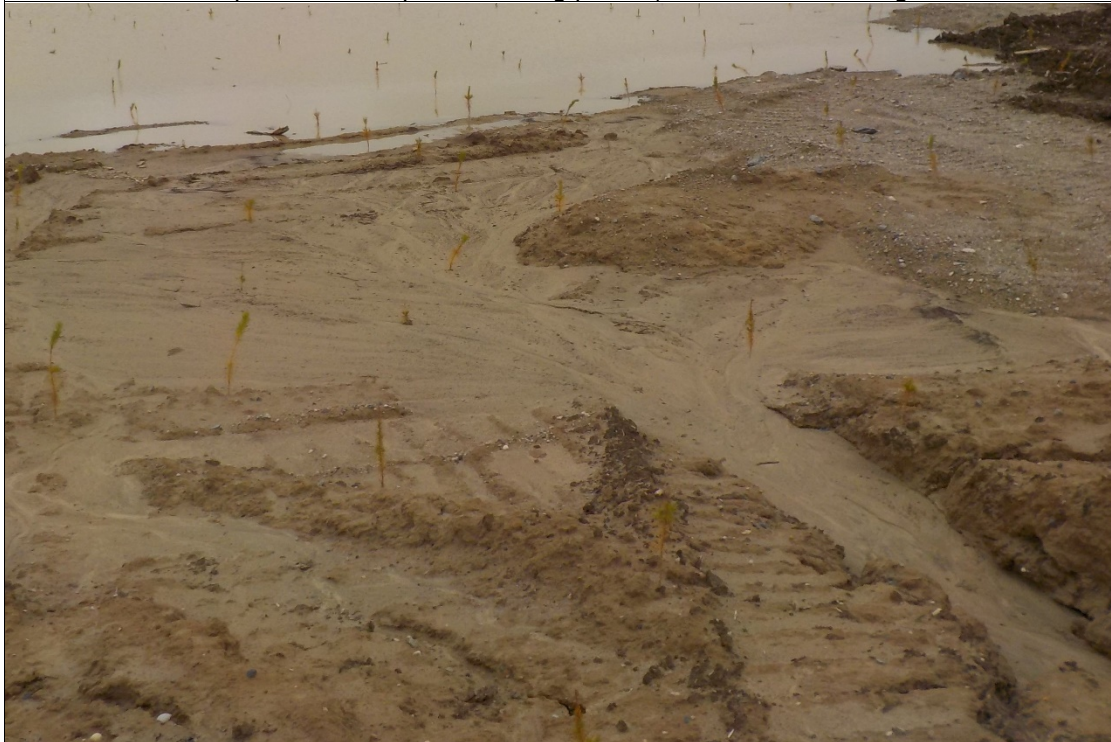
Figure 4-1: Grading and site preparation parallel to slope direction in G-3, and associated erosion and tree impacts

Mitigation is not recommended for the slopes in G-3 where planted tree seedlings are being washed away as it is unlikely that further impacts can be prevented or reduced. These slopes are long and have been planted with seedlings. It is noted that a factor contributing to the amount of erosion and tree seedling loss is that in some areas the grading and site preparation were implemented parallel to the slope (Figure 4-1), which increases the amount of downslope water flow and its velocity. A recommendation for future grading and site preparation is to complete the machine work in a direction that is perpendicular to the slope direction where this is safe to do.

Area on northern slope of G-3 with parallel discing pattern, with flooded seedlings at base

Example of erosion and water ponding in low areas, with seedlings washing away in same area

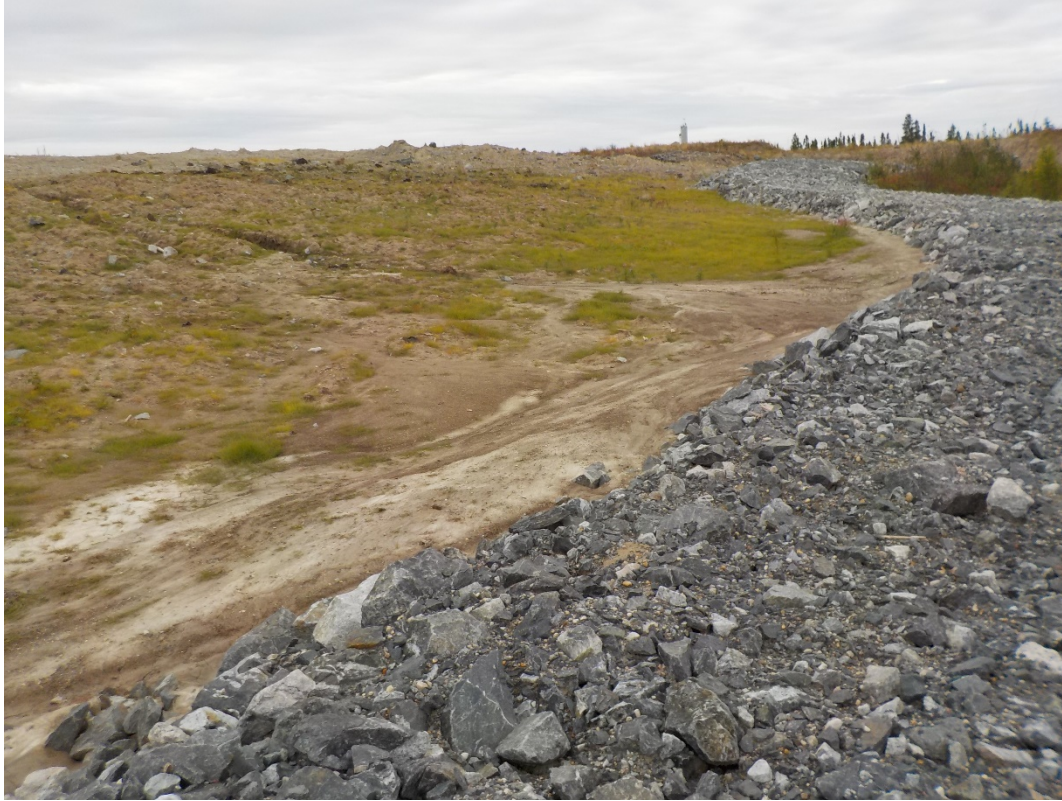
Photo 4-1: Well-performing portion of a rock berm at western end of EMPA D16

As the sediment deposition occurring on the western edge of this EMPA D16 was extending towards an off-system marsh, it is recommended that the rock berm be reinforced where it is collapsing or inadequately containing sediment. It is also recommended that site staff monitor the rock berm for other locations where this situation is occurring and implement reinforcement measures as appropriate.
