# Keeyask Generation Project Environmental Protection Plan

## Environmental Protection Plan Annual Report

ENVPP-2022-01

**APRIL 2021 - MARCH 2022**

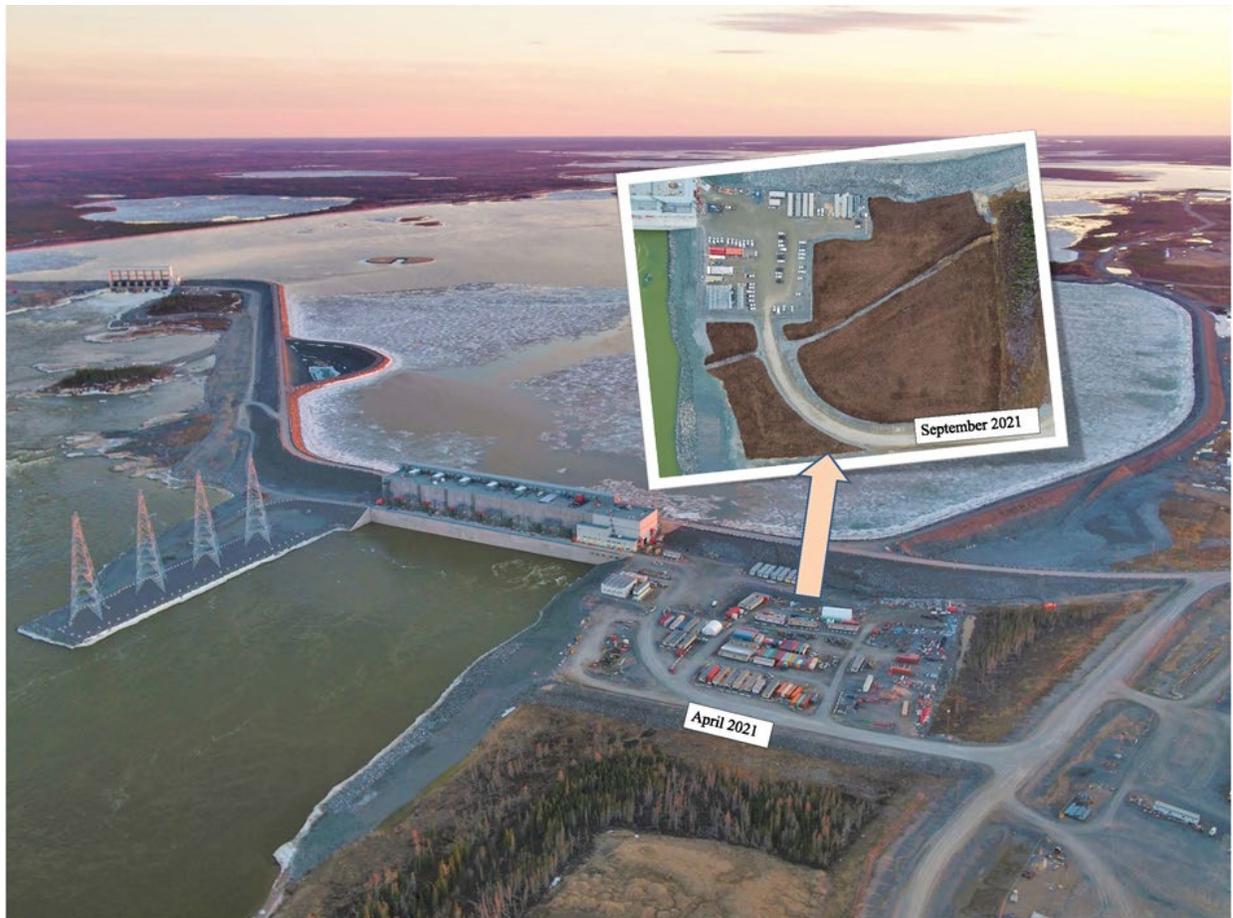
**Photo 2. Remediation of Work Area C (Area 51, Service Bay Laydown)**

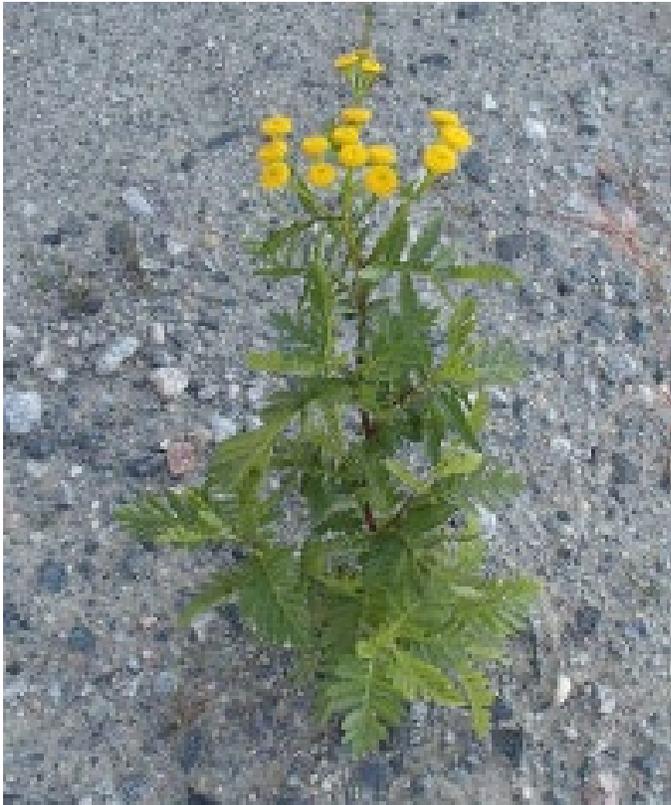
**Photo 3. Common tansy, one of the invasive plants found at the Project site during construction.**

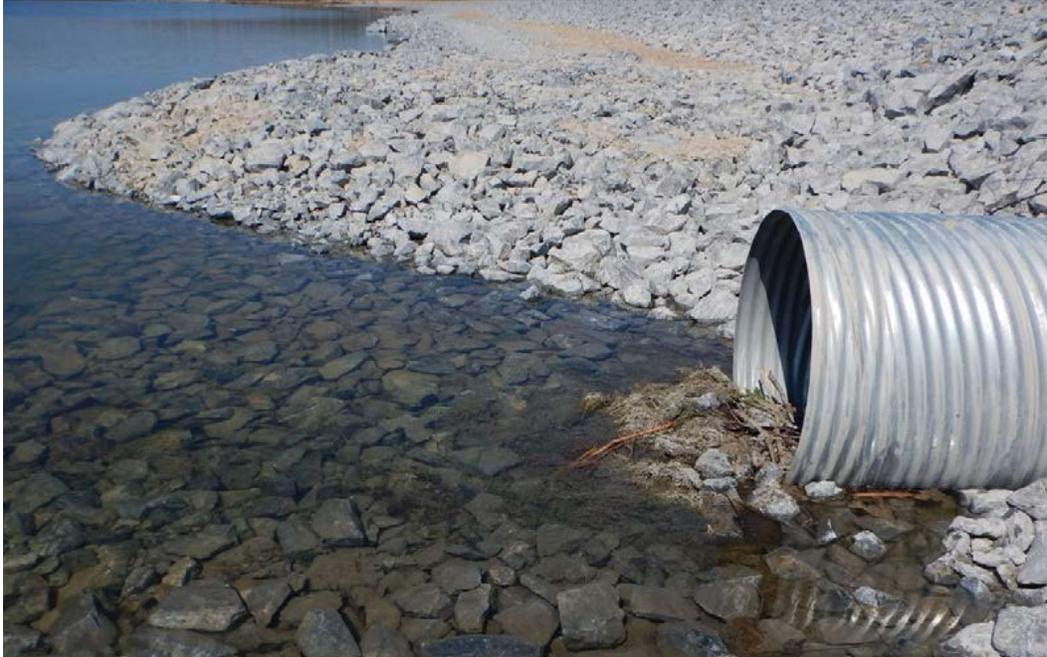
**Photo 12.** Culvert at the Butnau Wier stream crossing (SC-8) along the South Access Road, in late May, 2016. At this time, beavers were placing woody debris in the culvert opening.

In November 2018, a 1200 mm diameter beaver cone (see Photo 13) was installed on the culvert at SC-8 by Manitoba Hydro Kettle GS maintenance staff. First, all debris blocking water flow through the culvert was removed, and the area around the inlet of the culvert was cleaned. The metal cone, designed with a port allowing for fish passage at the bottom end, was installed by drilling two holes through the culvert inlet to secure the two plates on the beaver cone. These plates are used to hold the cone securely in place and prevent it from moving or drifting from the culvert inlet.

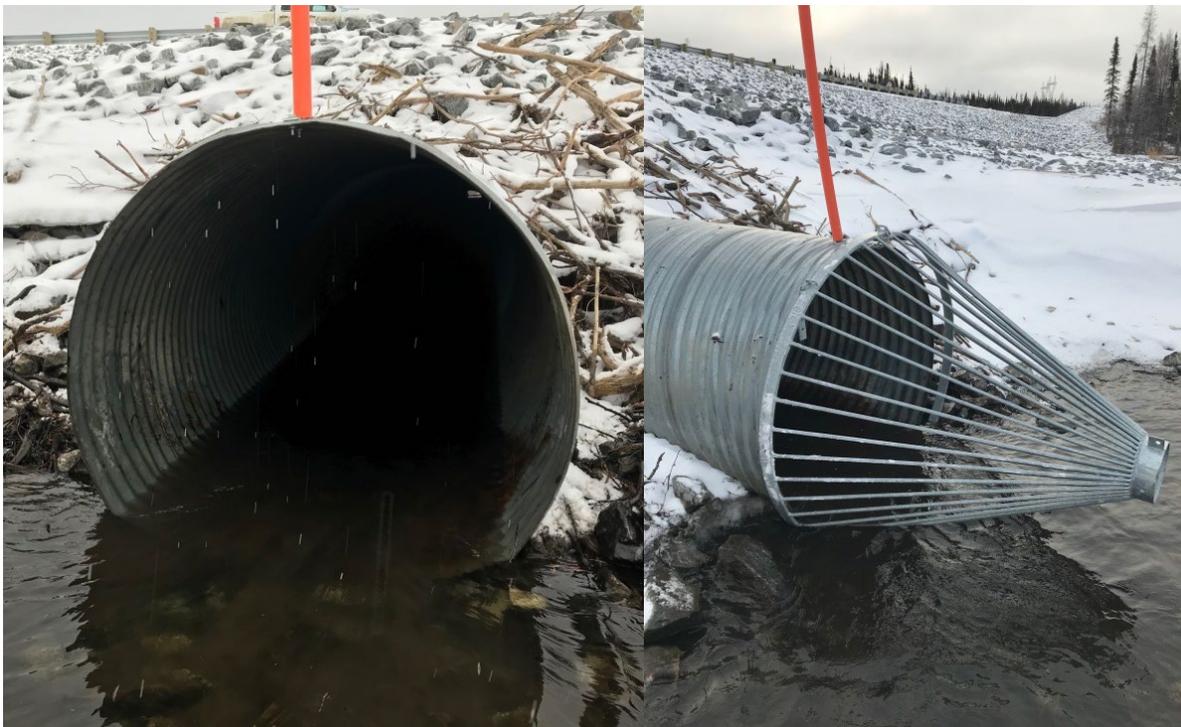
**Photo 13.** Culvert at the Butnau Wier stream crossing (SC-8) along the South Access Road, before (left) and after (right) the installation of a beaver cone in November 2018.

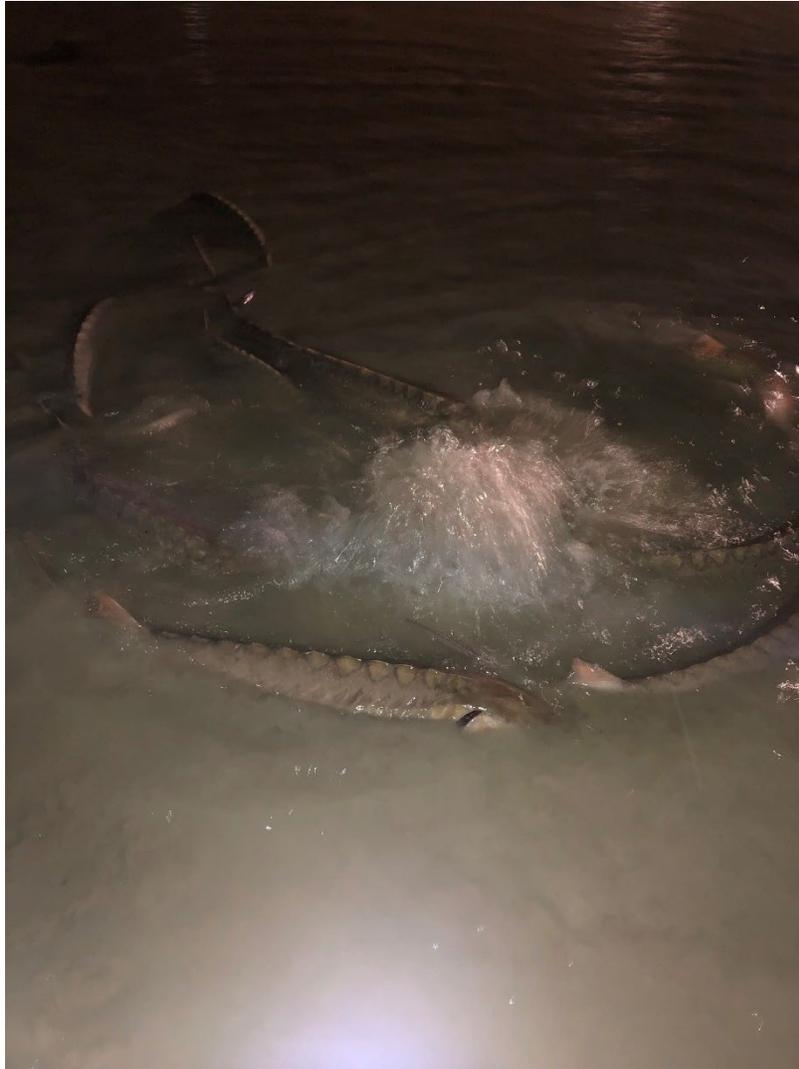
Downstream stop logs were installed in Unit 6 of the powerhouse on September 23, 2021 to de-water the unit and allow further construction. During the de-watering process, fish were seen. A fish salvage of the draft tube was carried out, rescuing 162 fish. The catch had a total of 176 fish, consisting of 140 Longnose Sucker, 26 Lake Sturgeon, seven Lake Whitefish, two Burbot, and one Walleye. The two Burbot, all Lake Sturgeon, and the majority of Longnose Sucker (96%) were released alive into Stephens Lake. The Lake Whitefish and Walleye did not survive.

**Photo 21. Fish observed within the lower draft tube of the Keyyask GS Unit 6 prior to fish salvage on September 24, 2021 (left). The salvage crew shut off the pump emptying the draft tube to allow fresh water to enter.**

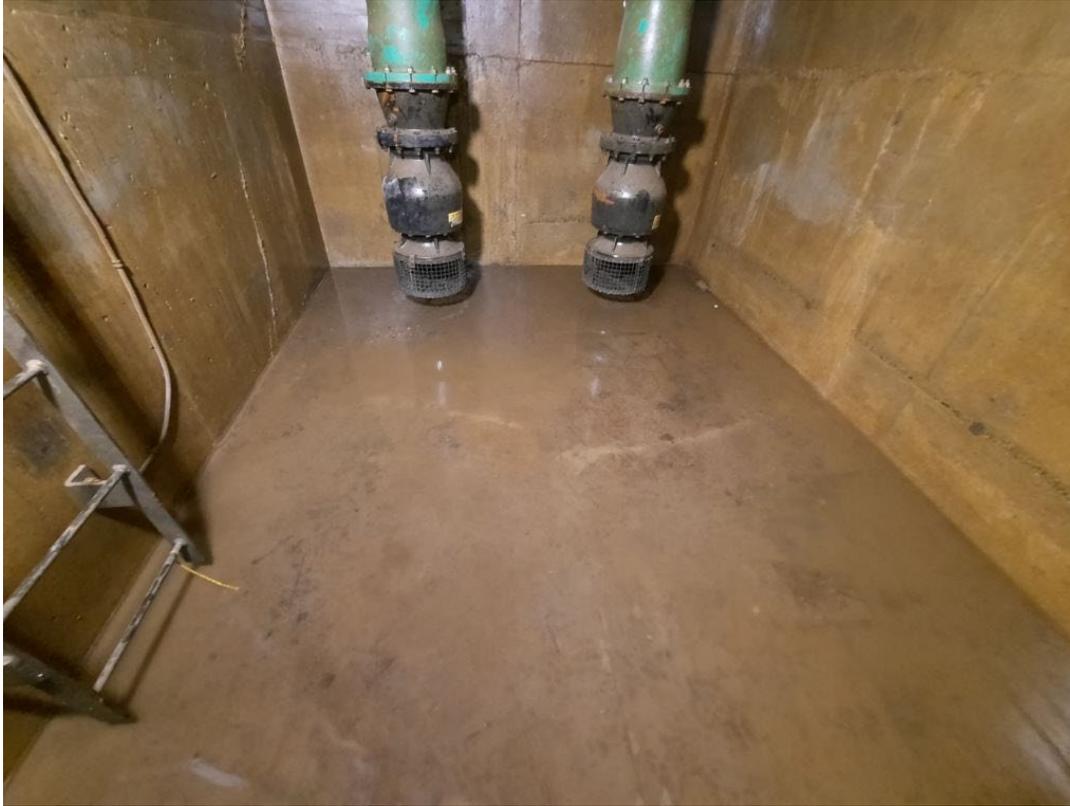
When sump pit 2/3 was dewatered on March 16, 2022, 15 fish were found in the pit by construction staff. Eight Burbot were rescued, seven of which were approximately 12 to 13 inches long, and another that was 26 inches long. Six suckers were found, four were alive and two were dead. They were approximately 11 to 12 inches long. One juvenile Lake Sturgeon that was 15 inches long was also found alive. All live fish were released to the tailrace via the viewing gallery.

**Photo 26. Dewatering sump.**

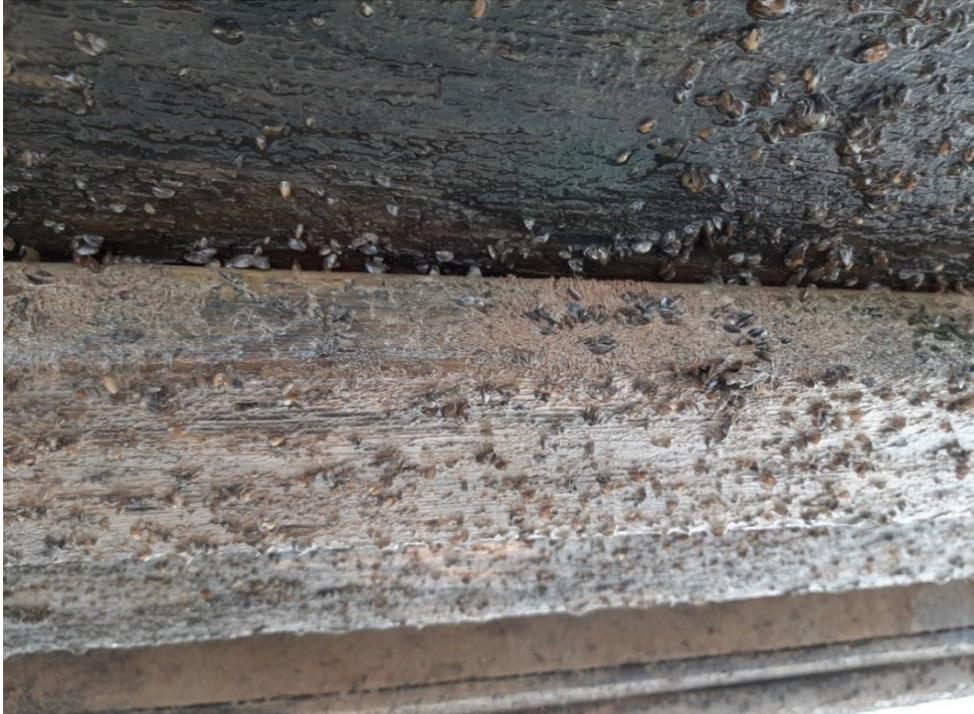
Gull Lake, annually, to monitor for the presence of adult mussels (Photo 35). The first, adult zebra mussels were found at Keeyask in 2020 on both the substrates and on in-water infrastructure, (booms, docks, buoys, etc.), which were inspected annually (Photo 36).

**Photo 36. Zebra mussel colony found on the underside of a downstream dock following removal of the dock for the winter (October 2020).**

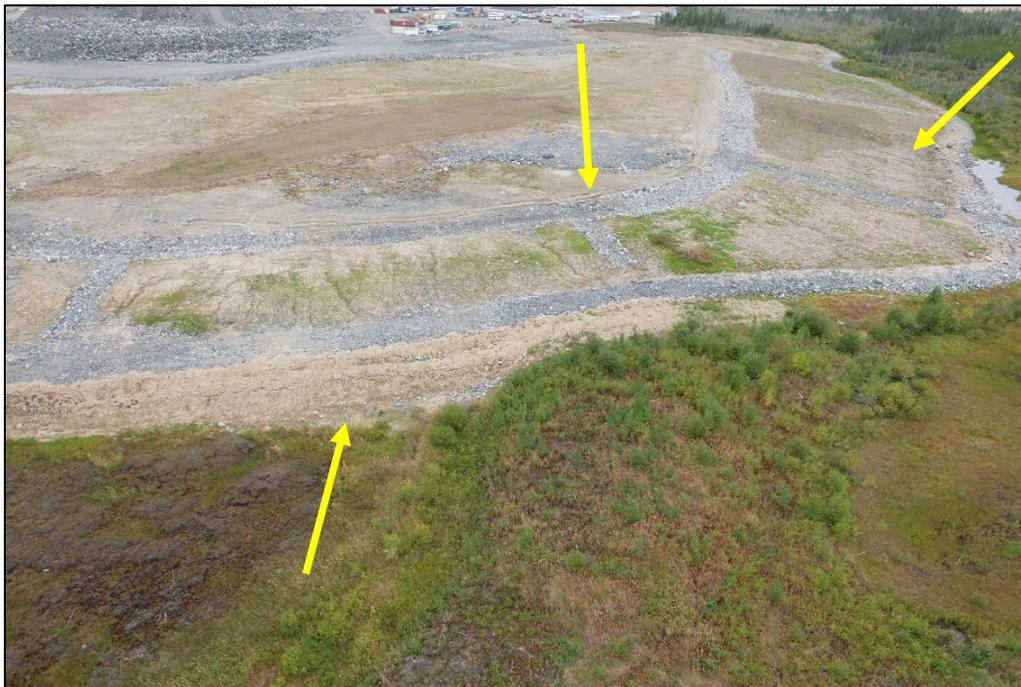
**Photo 42. Mounded soil berm (left), rock-lined drainage channel with turnouts (center) and regraded slopes (right) at northern and western edges of EMPA D-16.**

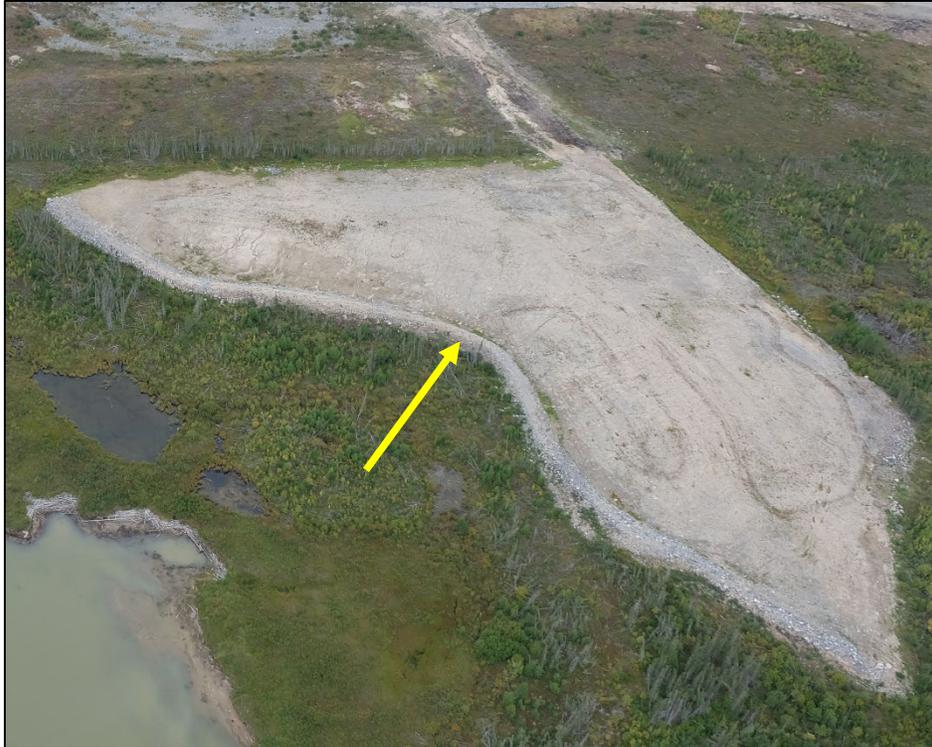
**Photo 43. Rock berm along northwestern edges of EMPA D-17.**

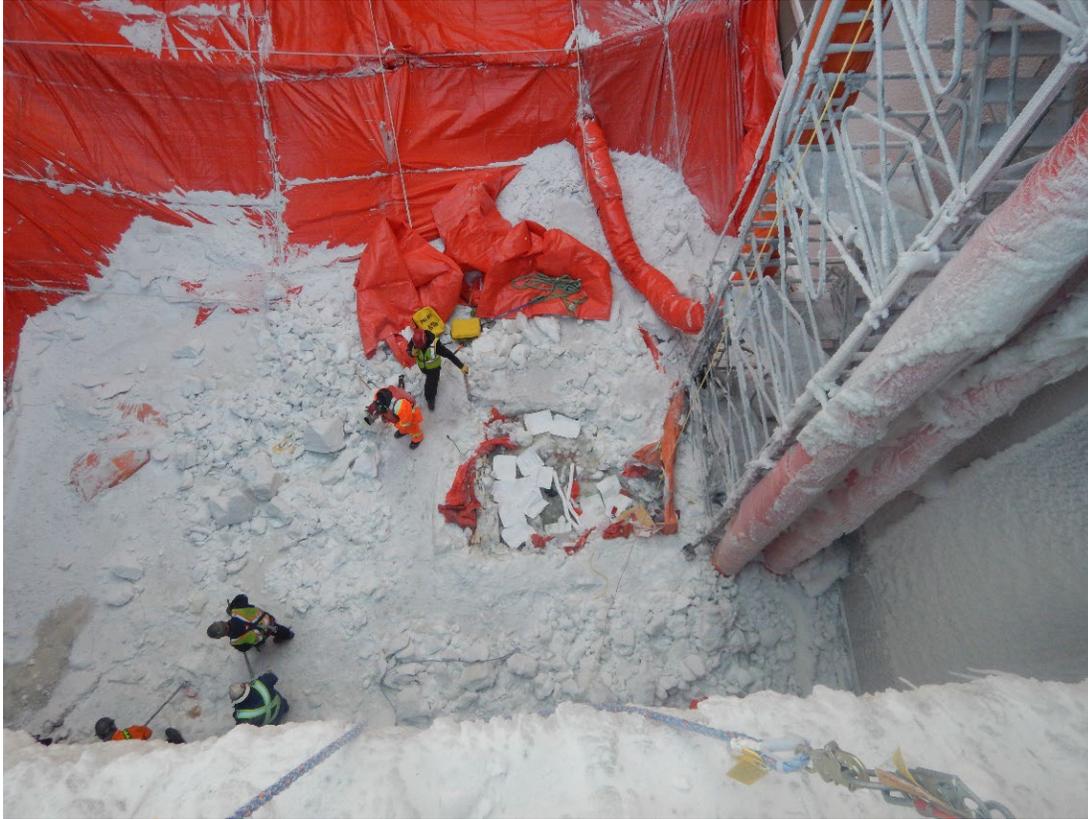
**Photo 45. Release remediation efforts within spillway water passage 4.**

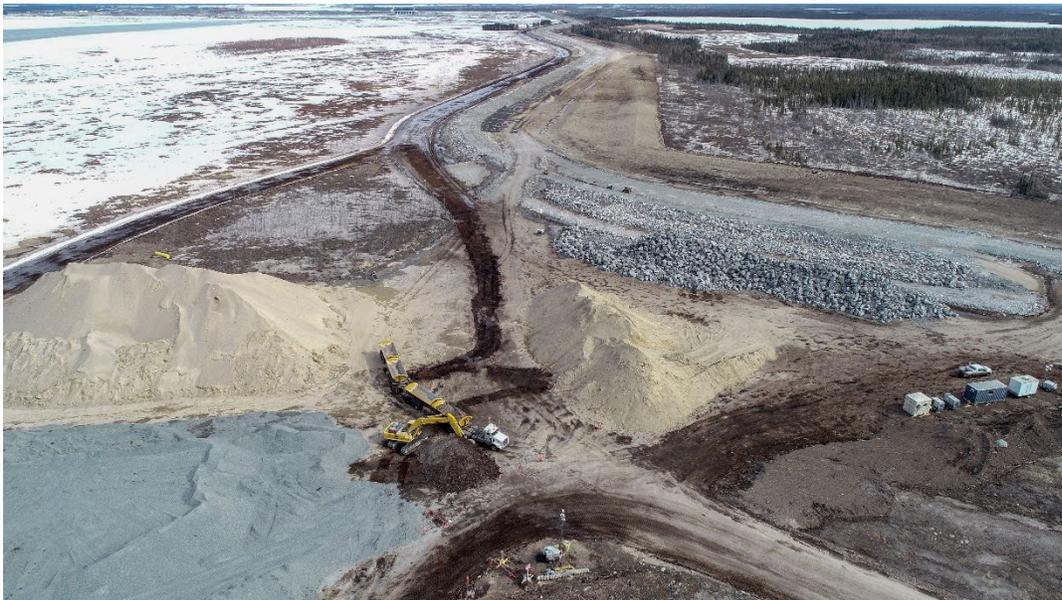
**Photo 46. Release remediation efforts along South Dike.**
