Keeyask Generation Project Terrestrial Effects Monitoring Plan

Habitat Loss and Disturbance Monitoring Report

TEMP-2022-01

By
ECOSTEM Ltd.
June 2022

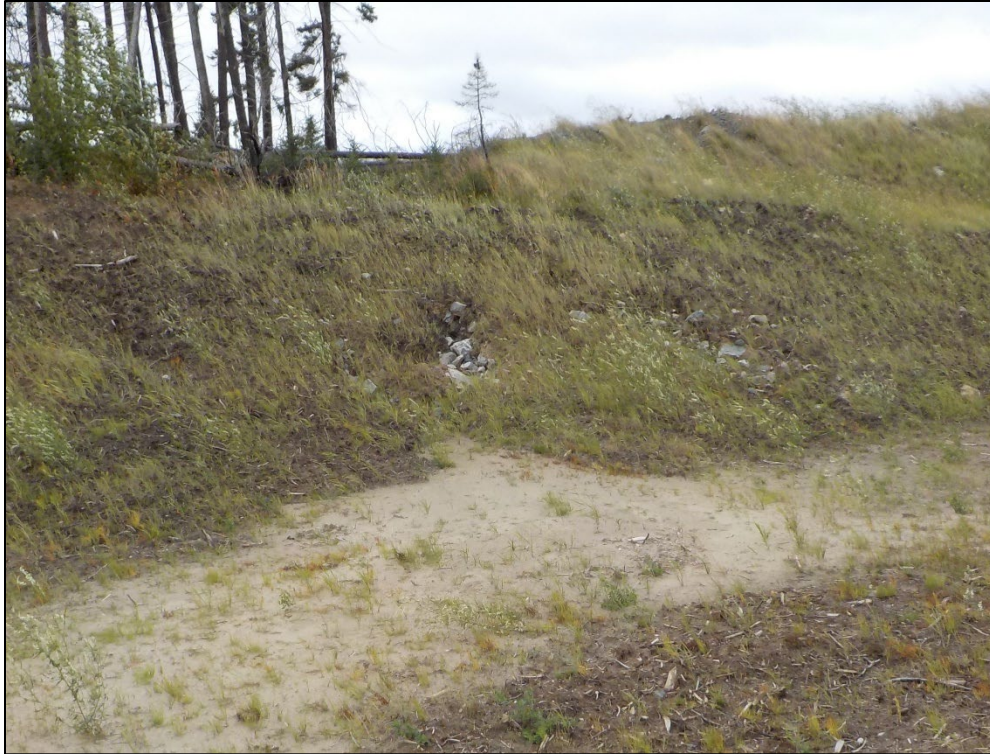
Erosion disturbance on the south ditch bank of the NAR adjacent to Borrow Area KM-1 had created a gully since it was first identified during 2016 surveys. Erosion had expanded the gully between the ditch and the borrow area between 2016 and 2018 (Map 3-2). Field surveys in 2019 found that the area had since been remediated by filling the eroded area. Some minor erosion and sediment deposition around the eastern fringes of the remediated area was noted in 2019. The bank was subsequently covered with organic material, however minor erosion on the ditch slope was found during surveys in 2020. The 2021 monitoring recorded a slight expansion of erosion on the ditch slope and an increase in vegetation cover (Photo 3-1). The site will be monitored for substantive changes in 2022.

Photo 3-1: Erosion on ditch bank adjacent to Borrow Area KM-1

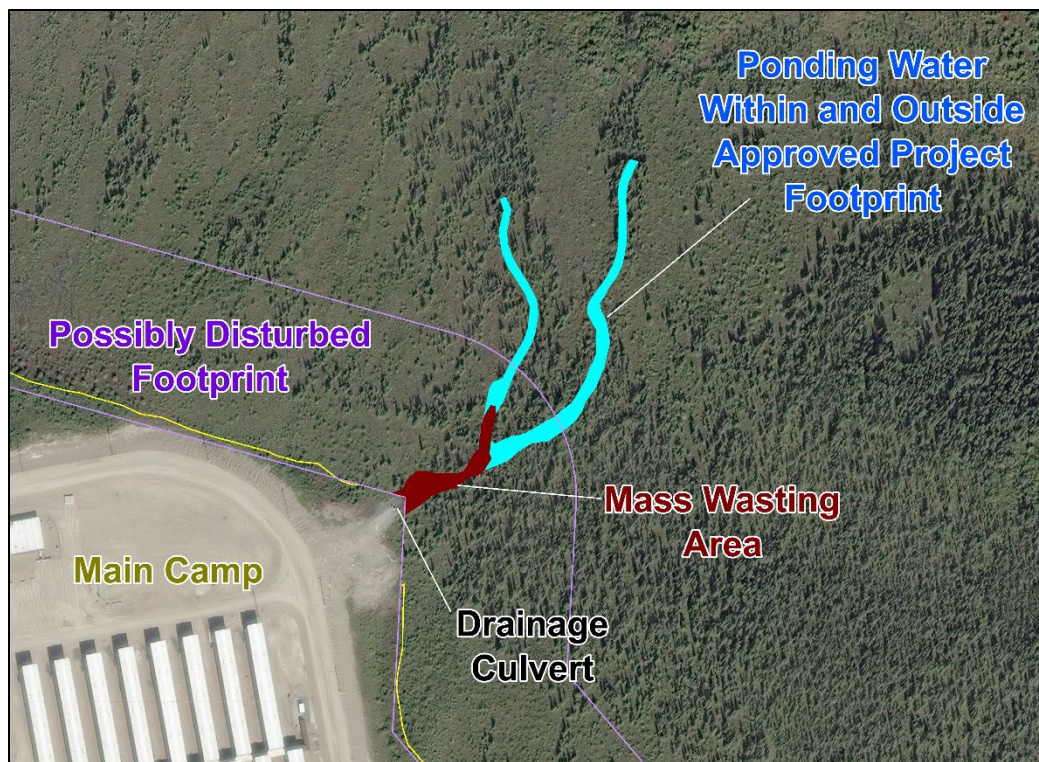
At the northeast corner of the Main Camp, a disturbance in the form of outflow from a drainage culvert, produced a channel of water that flowed through previously undisturbed vegetation. By September 2021, the flowing water extended approximately 250 m into the undisturbed forest (Map 3-2; Figure 3-1). This was an increase of 90 m since September 2020 and an increase of 170 m since September 2019. Water percolating up from the ground, depositing sediment and forming an additional channel of flowing water, was identified during surveys in 2021 (Photo 3-2 and Photo 3-3). This new channel extended 130 m into the previously undisturbed forest. The total associated disturbed area expanded by 0.02 ha in the possibly disturbed Project area, and by 0.08 ha outside of the planned and possibly disturbed Project footprint area. At the time of the 2021 survey, this disturbance extended more than 160 metres past the approved Project footprint boundary, which was an increase of 85 m since September 2020.

Figure 3-1: Mass wasting (in brown) and ponded water (in blue) outside Main Camp in 2021

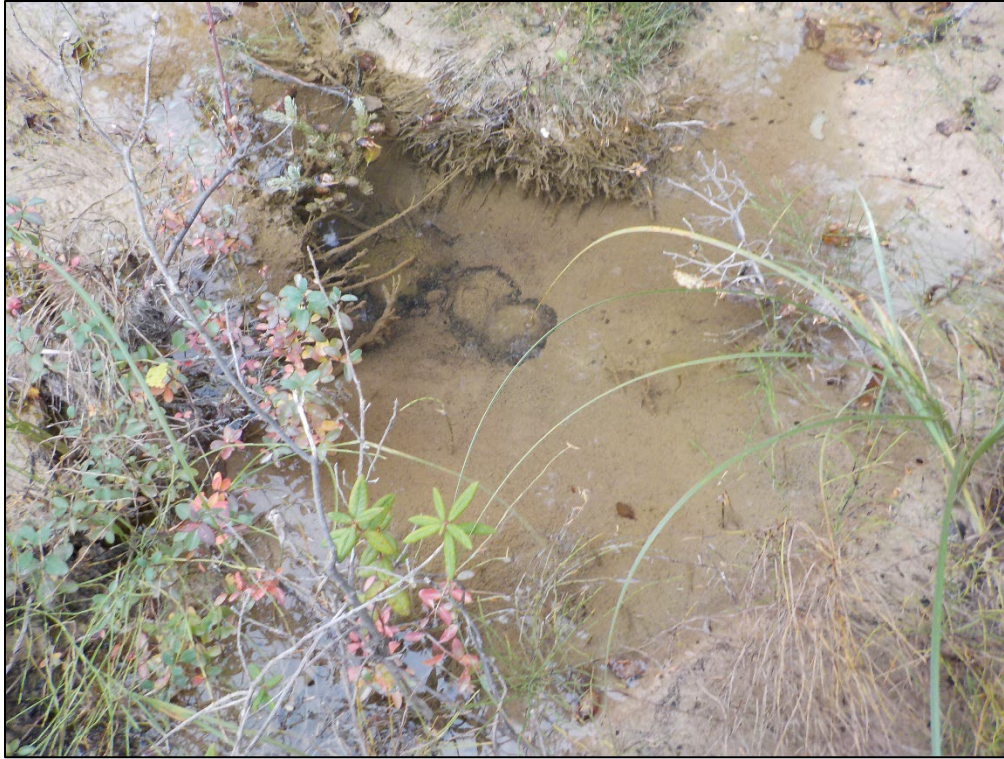
Photo 3-2: Water percolating up from the ground northeast of Main Camp

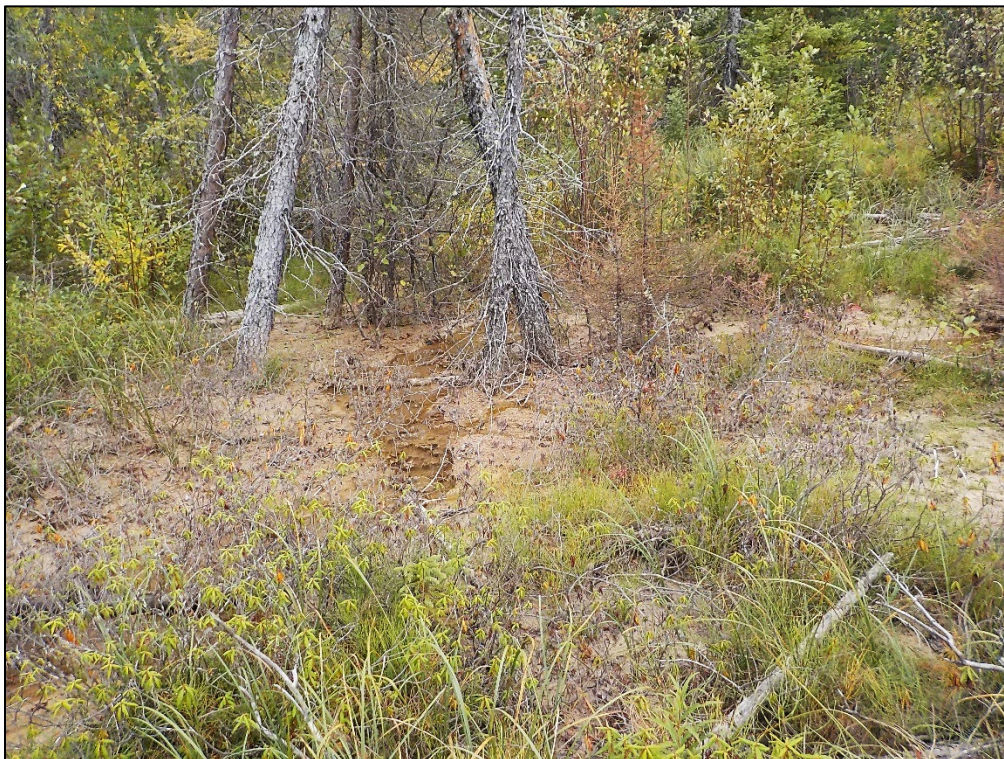
Photo 3-3: Sediment deposition and new water channel northeast of Main Camp

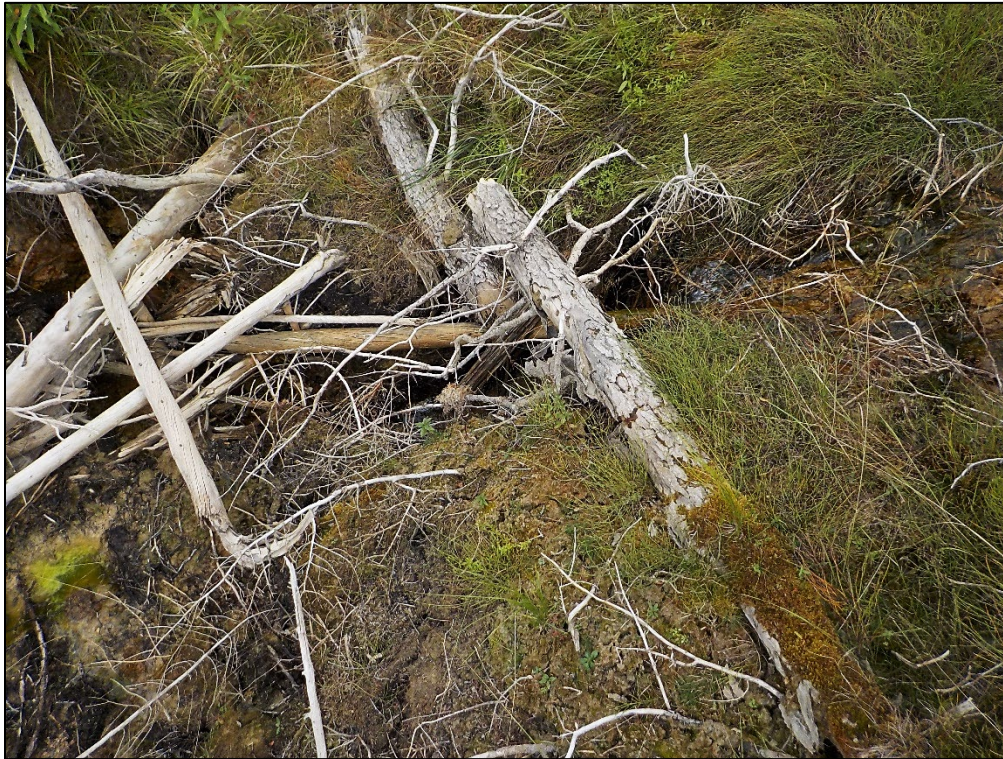
Within this disturbed area, rapidly flowing water started flowing underground in spots, which created mass wasting and hollow areas within the substrate (Photo 3-4). Trees were also toppling in towards the hollowed areas. Outside of the Project footprint, this disturbance was affecting a common habitat type (black spruce (*Picea mariana*) dominant vegetation on thin peatland). This disturbance also has the potential to affect an off-system marsh if it reaches the low area adjacent to the marsh.

Photo 3-4: Water flowing into hollow area and then underground northeast of Main Camp

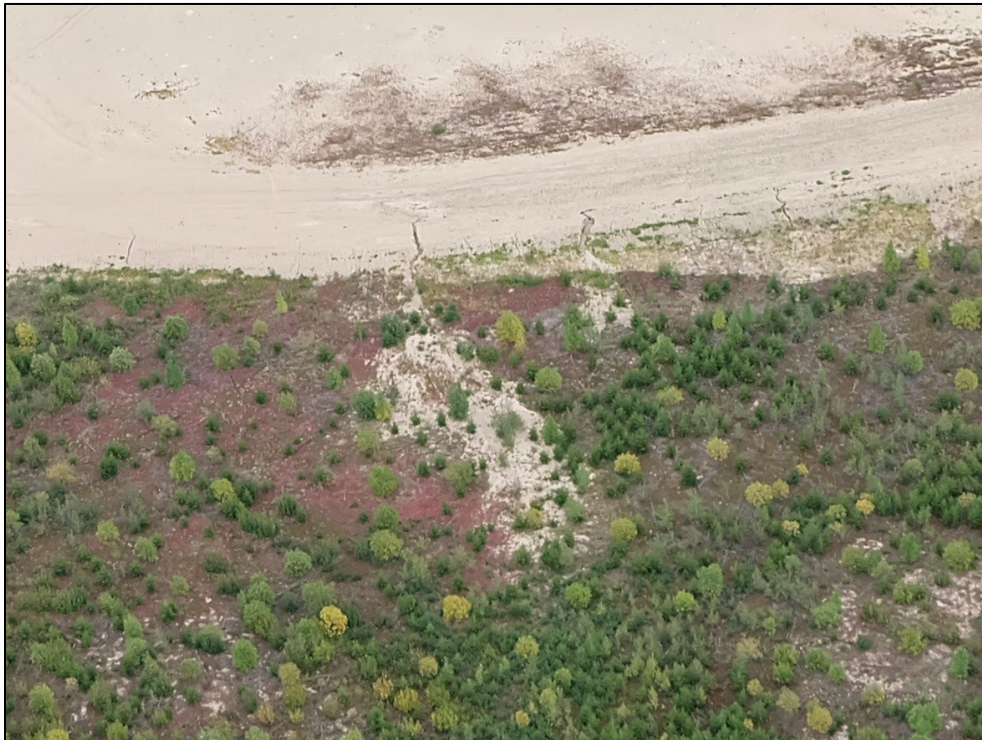
Erosion and sediment deposition into undisturbed forest was observed in 2020 at one location on the northern edge of Borrow Area G-1 at KM 17. Although sediment deposition continued to occur at this location in 2021, the area affected had not increased (Photo 3-5; Map 3-1). An additional area of sediment deposition was found adjacent to this location in 2021, however only a small area had been affected at the time of the survey and only a small portion of that was found to be outside of the planned and possibly disturbed Project footprint area. Sediment deposition on the southeastern edge of G-1 at KM 17 identified during 2020 surveys had not increased in size at the time of the 2021 survey. Erosion and sediment deposition was also observed at the eastern

Photo 3-5: Erosion and sediment deposition at northern edge of Borrow Area G-1 at KM 17

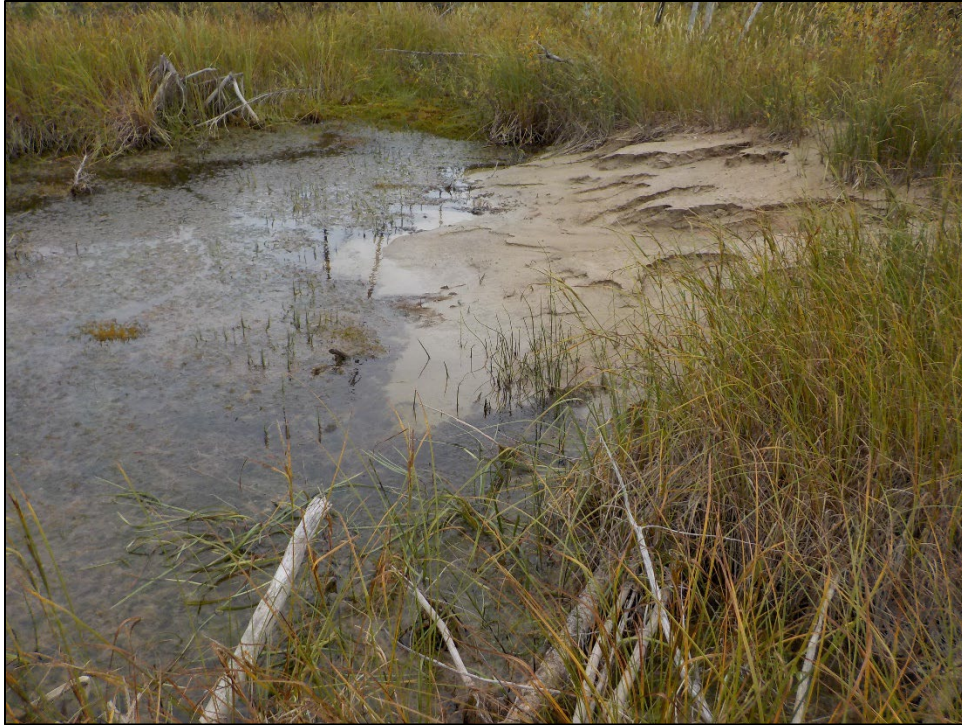
In past years at Borrow Area G-3, erosion on mineral slopes around the perimeter had been depositing sediment into the undisturbed forest at several locations. Sediment fences had been installed along portions of the south side of the borrow area in spring of 2019, but September surveys found that sediment was bypassing them. Surveys in 2020 and 2021 found that sediment deposition was ongoing in several spots around the perimeter despite all slopes being graded and sediment fences removed in the borrow area (Map 3-1; Map 3-2). Two adjacent locations on the northern edge where sediment deposition into undisturbed vegetation were taking place had the potential to affect a much greater area due to the natural topography. Sediment deposition into an adjacent marsh on the southwestern edge of the borrow area was also ongoing and increased slightly as of September 2021 (Photo 3-6).

Photo 3-6: Sediment deposits in marsh adjacent to Borrow Area G-3

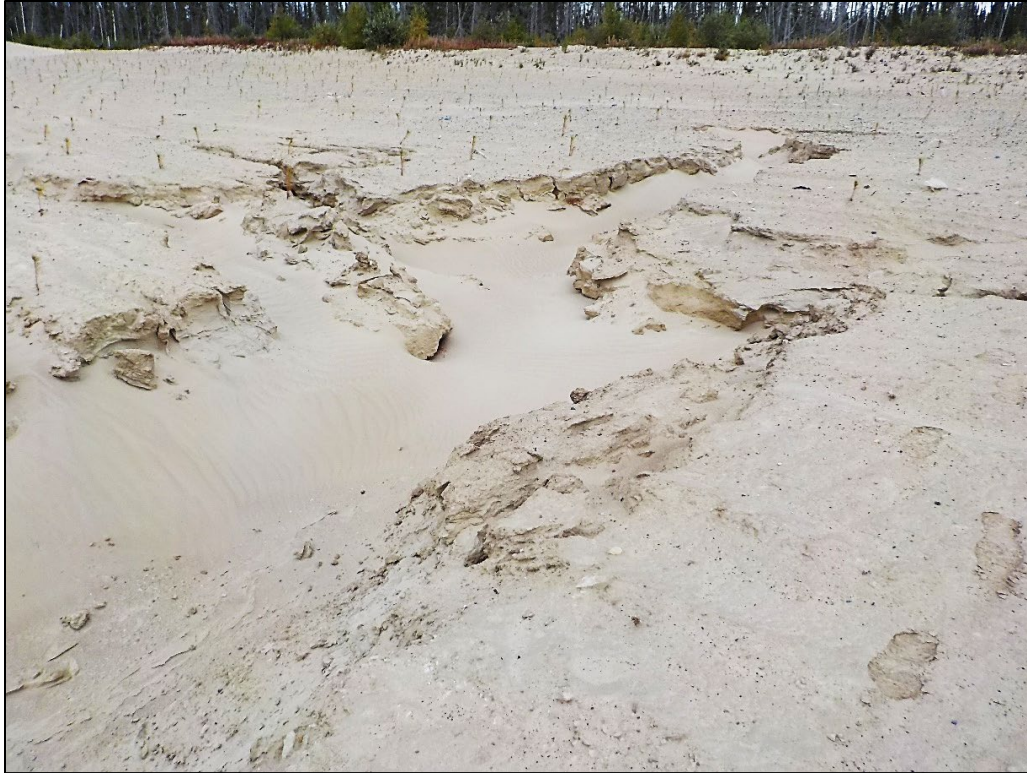
Erosion on excavated slopes in the eastern half of Borrow Area G-3 was observed to be washing away planted seedlings in 2020 (Photo 3-7). Surveys in 2021 found that erosion continued not only in this area but all throughout the excavated slopes of the borrow area (Photo 3-8). Seedling mortality and dieback of a large number of planted seedlings as a result of ponding water in the basin were also observed during surveys in 2020. By September 2021, all of the flooded seedlings at the bottom of the excavated crater had died (Figure 3-2; Photo 3-8).

Photo 3-7: Erosion affecting planted seedlings in Borrow Area G-3

Mitigation is not recommended for the slopes in G-3 where planted tree seedlings are being washed away as it is unlikely that further impacts can be prevented or reduced. These slopes are long and have been planted with seedlings. It is noted that a factor contributing to the amount of erosion and tree seedling loss is that in some areas the grading and site preparation were implemented parallel to the slope (Figure 4-1), which increases the amount of downslope water flow and its velocity. A recommendation for future grading and site preparation is to complete the machine work in a direction that is perpendicular to the slope direction where this is safe to do.

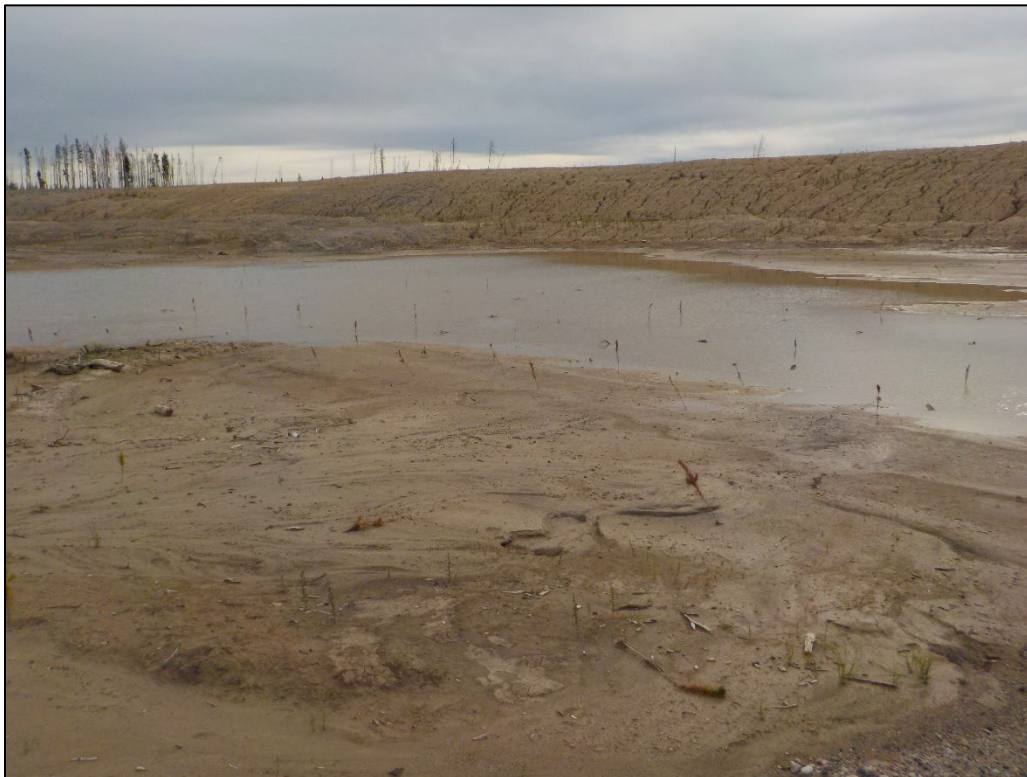
Photo 3-8: Planted seedling mortality in Borrow Area G-3

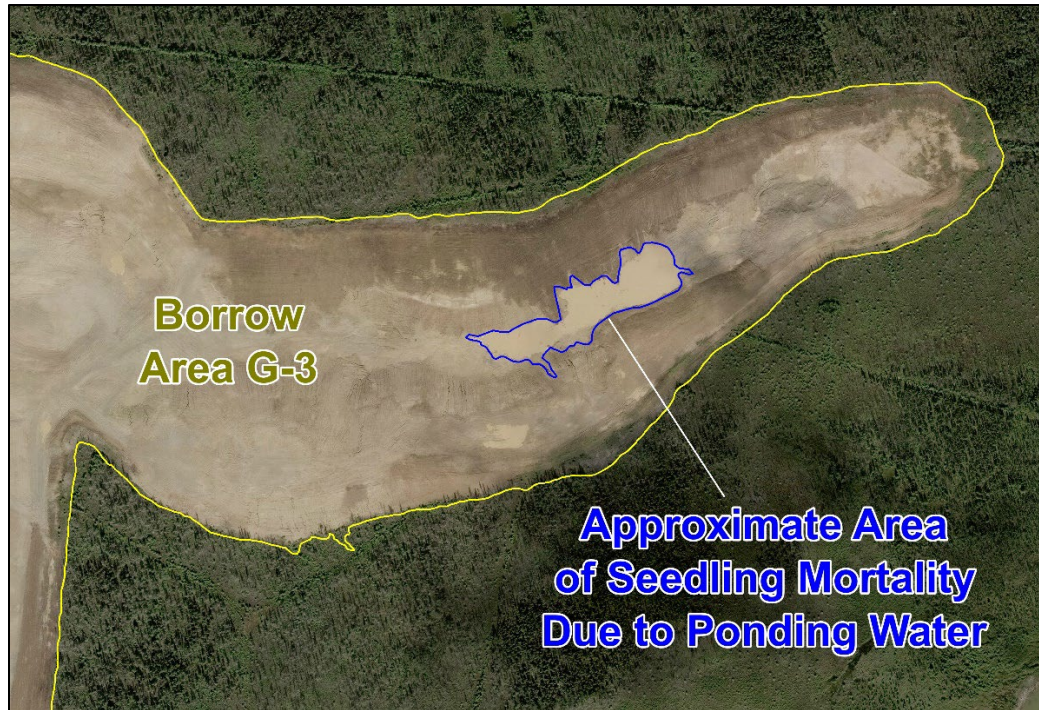
Figure 3-2: Approximate area where erosion and ponded water affected planted seedlings in the eastern portion of Borrow Area G-3

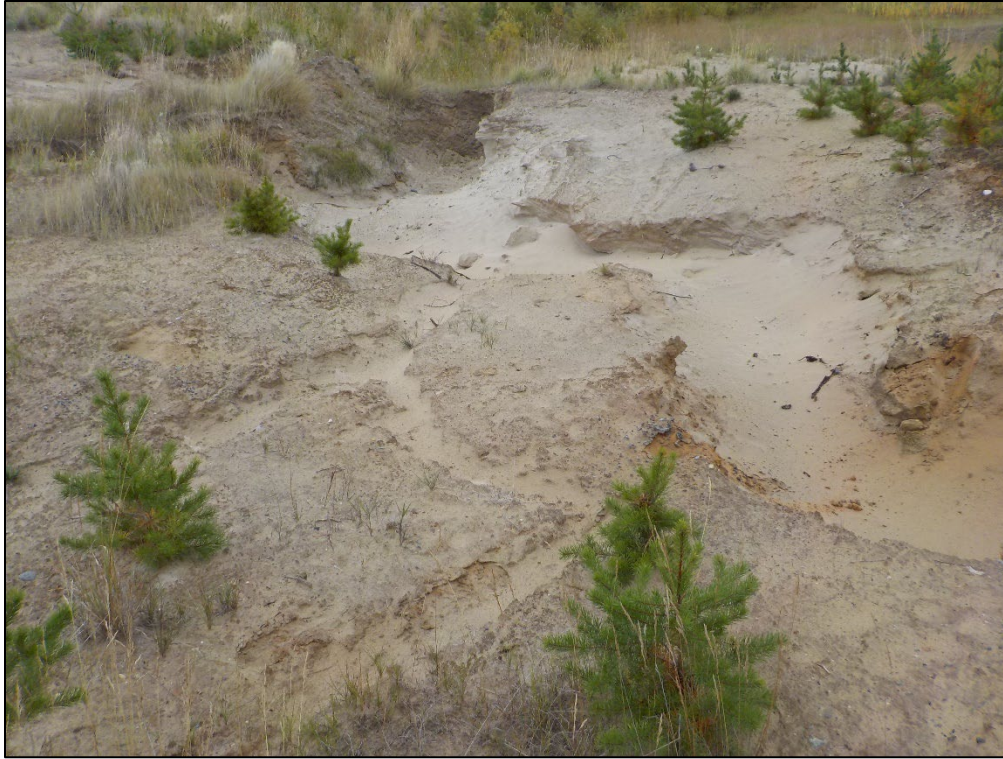
In Borrow Area KM-1, 2021 surveys found that erosion runnels continued to widen and deepen (Photo 3-9). The erosion was beginning to wash away planted seedlings and saplings.

Photo 3-9: Erosion in Borrow Area KM-1

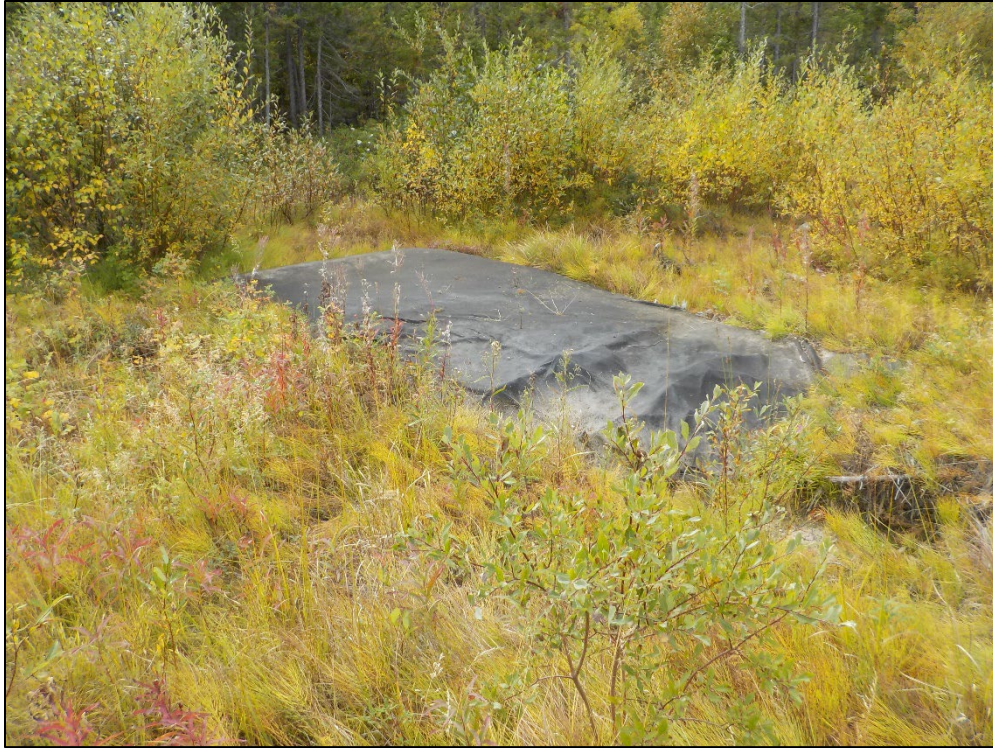
On the south side of Borrow Area N-5, a sediment bag left after a drainage hose was removed was still in place as of September 2021 (Photo 3-10).

Photo 3-10: Sediment bag on south side of Borrow Area N-5 on September 13, 2021

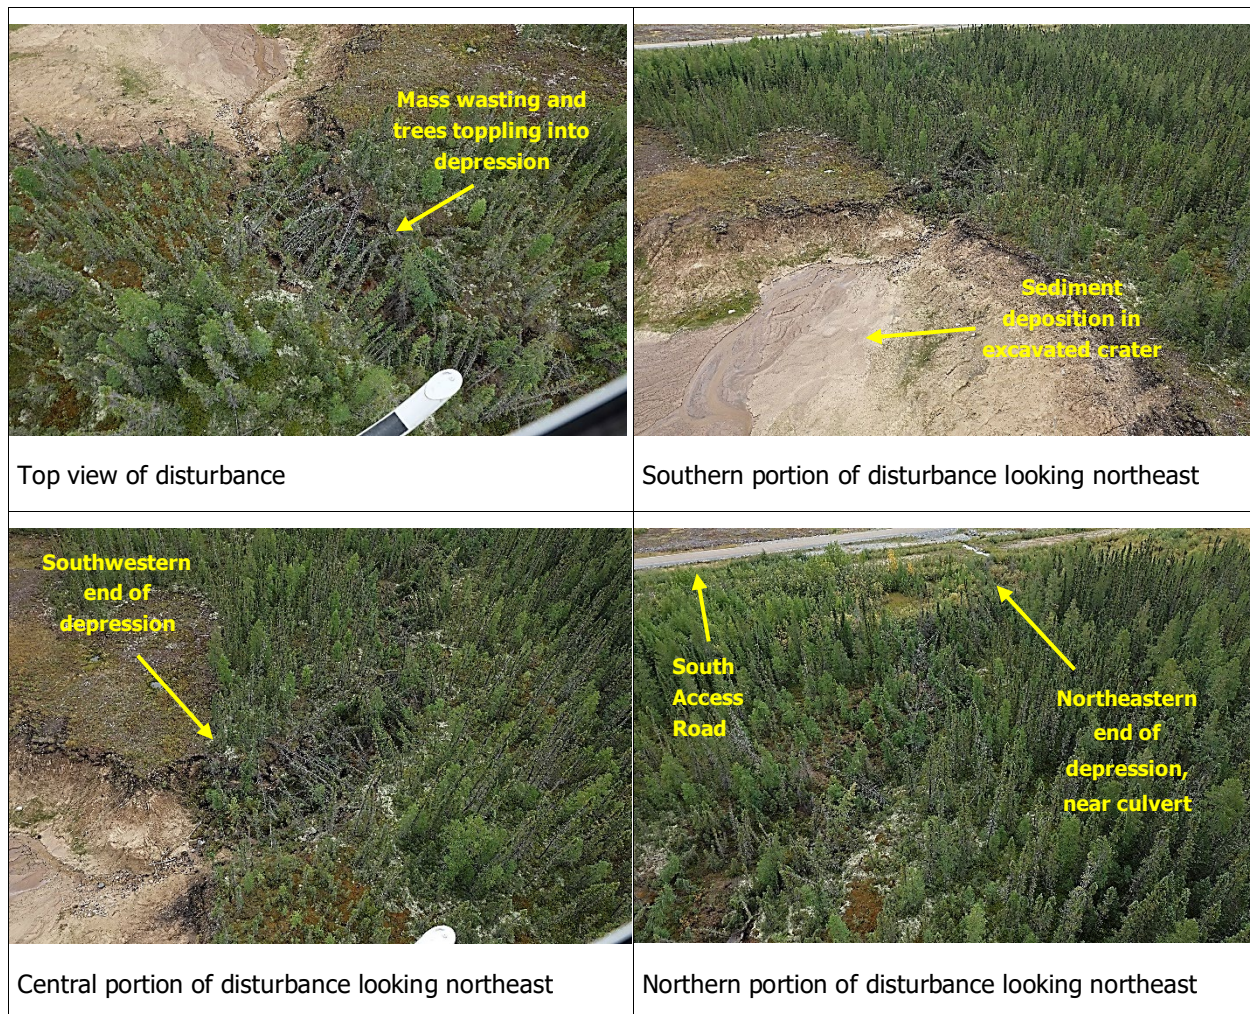
In Borrow Area B-6, mass wasting continued to create a disturbance along a natural drainage channel, affecting otherwise undisturbed habitat (Map 3-1). Significant water flow from the SAR to the east edge of the pit undermined the previously undisturbed forest and created a deep, wide depression (Figure 3-3). The 2021 surveys found that although the impacted area had not expanded substantially since 2019, mass wasting along the disturbances edges was still occurring (Photo 3-11). Erosion and mass wasting was also identified on the northern edge of the excavated crater in Borrow Area B-6 (Photo 3-12).

Figure 3-3: Aerial view of disturbance at Borrow Area B-6 showing extent of effects

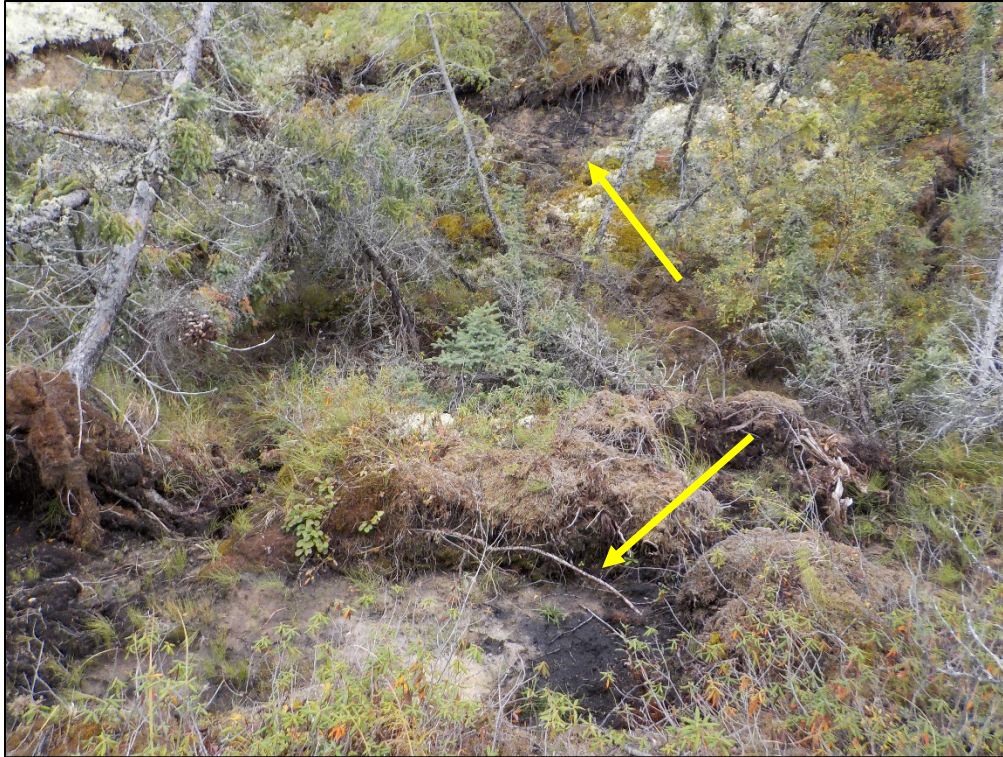
Photo 3-11: New mass wasting along depression edges northeast of Borrow Area B-6

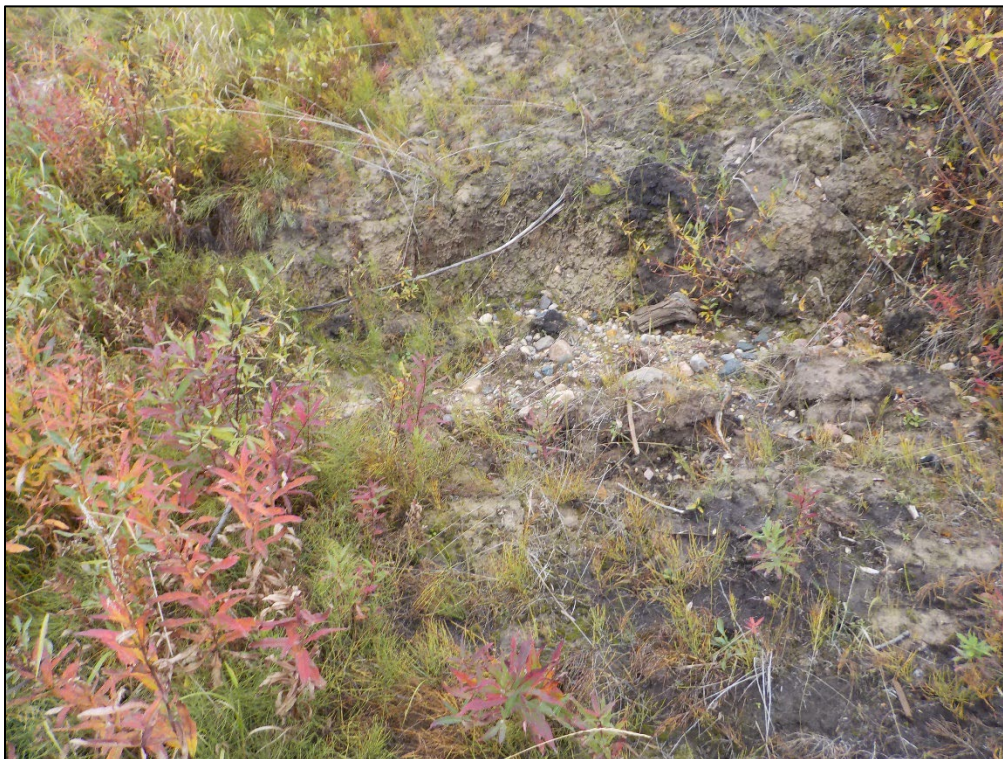
Photo 3-12: Erosion on the northern edge of the excavated crater in Borrow Area B-6

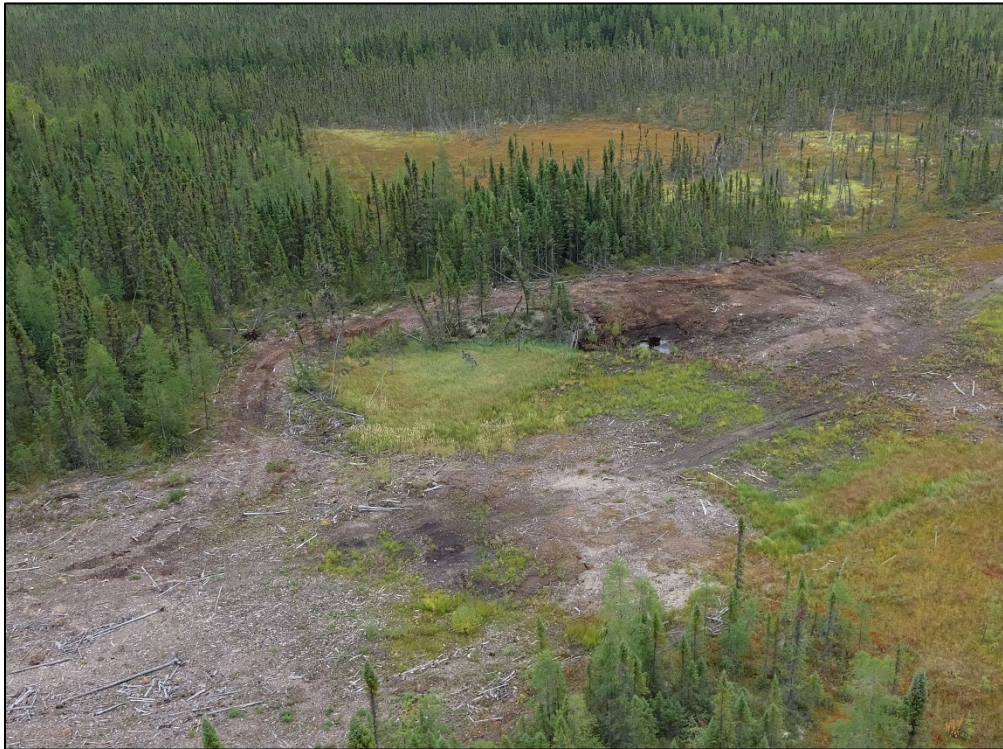
Additional disturbance along the Ellis Esker (E-1) access corridor was observed in 2021 outside previously cleared areas (Map 3-1). These additional disturbances, which were ATV trails, totaled 0.02 ha within the possibly disturbed Project footprint (Appendix 1: Table 7-1; Photo 3-13). Other disturbances in the corridor observed in 2021 included two boats and several plywood planks located where the corridor intersected the stream flowing from Joslin Lake (Photo 3-14; Map 3-2).

Photo 3-13: ATV trails in Borrow Area E-1 access corridor

Several disturbances were found along the access corridor to the Ellis Esker borrow area (see Section 3.3.4.8 for details). These disturbances did not appear to be caused by the Project. Ongoing consultations with the partner First Nations will determine if access to this corridor should be blocked.

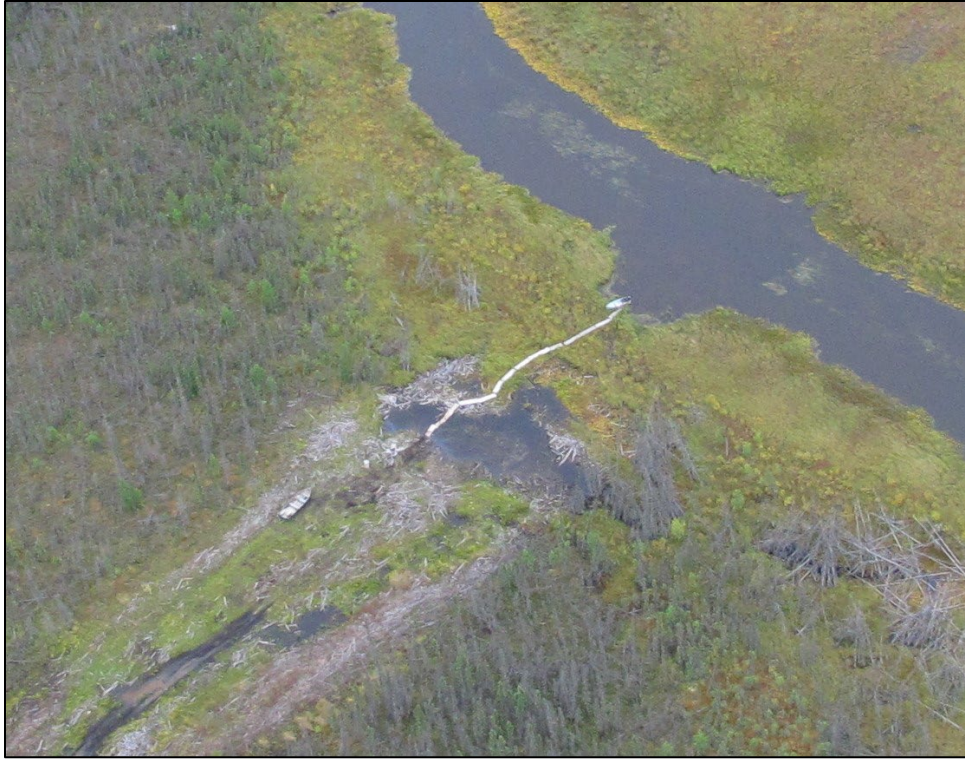
Photo 3-14: Boats and plywood planks in Borrow Area E-1 access corridor

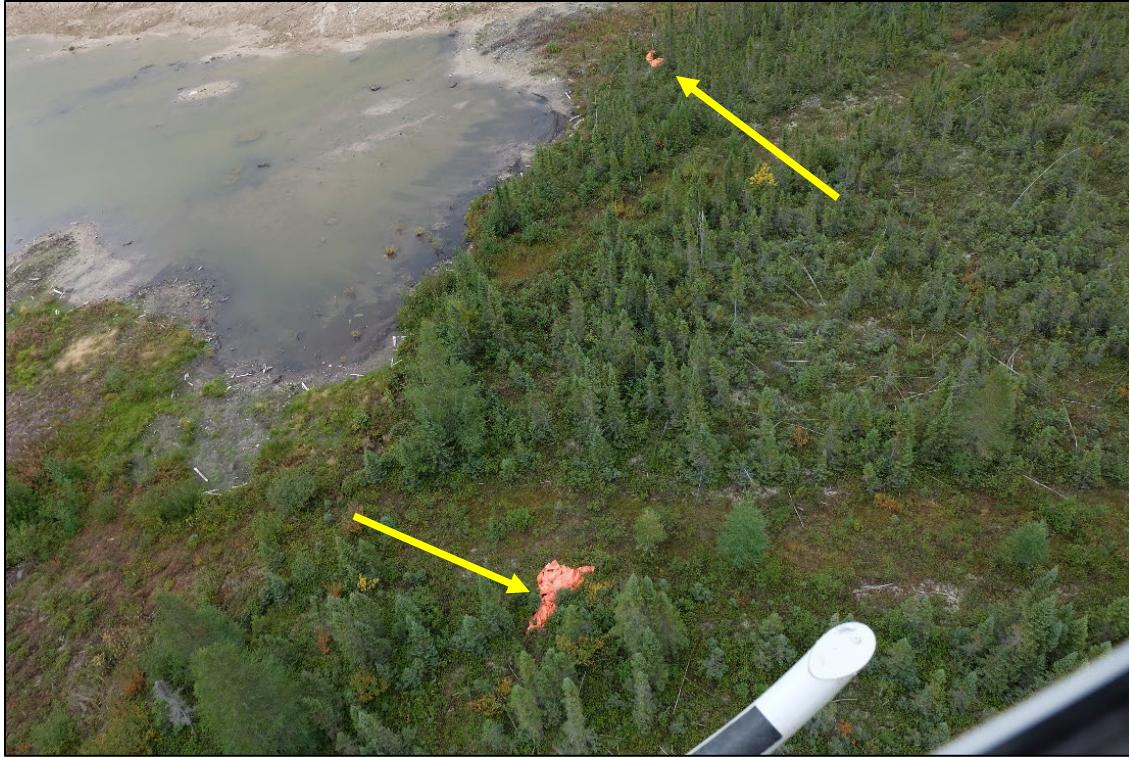
Ponding water in Borrow Areas S-2a and S-2b found during 2020 surveys did not increase in size at the time of the 2021 surveys and no vegetation mortality was observed in adjacent undisturbed vegetation (Map 3-2). These locations will be monitored for adverse effects in 2022. No new clearing or disturbance was found outside of the planned Project footprint, however construction debris was found along the southern and eastern edges of Borrow Area S-2a (Photo 3-15).

Photo 3-15: Construction debris along the eastern edge of Borrow Area S-2a

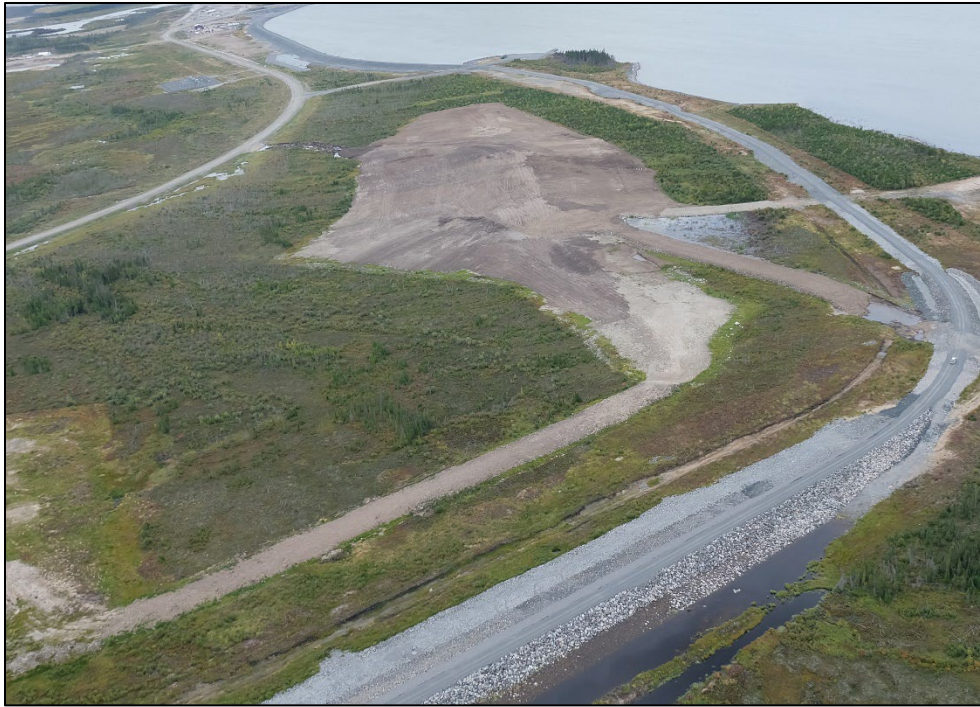
Approximately 0.17 ha of disturbed area was identified in various locations around the perimeter of EMPA D12(2)-E in 2021 (Map 3-2; Photo 3-16). Of which, 7% was within the possibly disturbed Project footprint (Appendix 1: Table 7-1). This disturbance can be attributed to the regrading of slopes in the area.

Photo 3-16: Regraded slopes and associated disturbance around perimeter of EMPA D12(2)-E

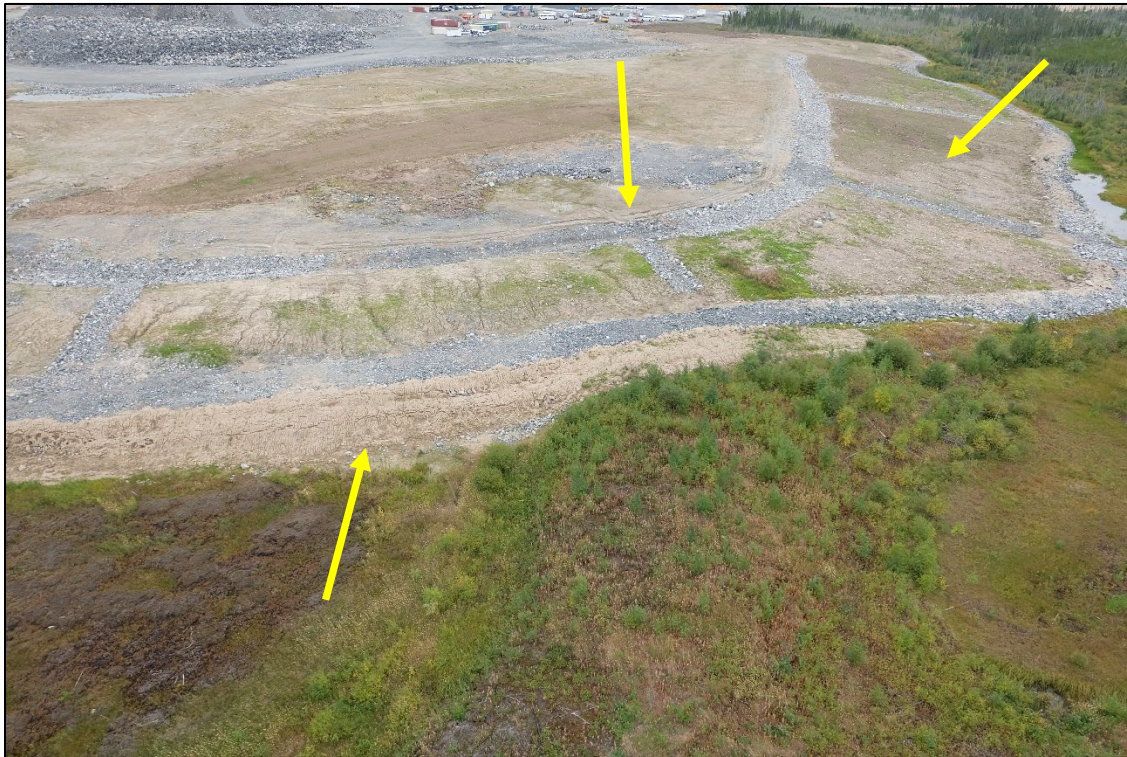
Photo 3-17: Mounded clay material (left), rock-lined drainage channel with turnouts (center) and regraded slopes (right) at northern and western edges of EMPA D16(1)-E

Surveys in 2021 found that an additional 105 m of rock berm was constructed along the western edge of the EMPA and other portions of the rock berm were reinforced with additional material. Additional clay material was placed outside of the rock berm at the northern fringes of the EMPA (Photo 3-17). Straw wattles placed in gullies were removed along the western edges of the EMPA

and slopes here were regraded. A rock-lined drainage channel with turnouts that ran parallel to the rock berm further upslope was constructed in late 2020.

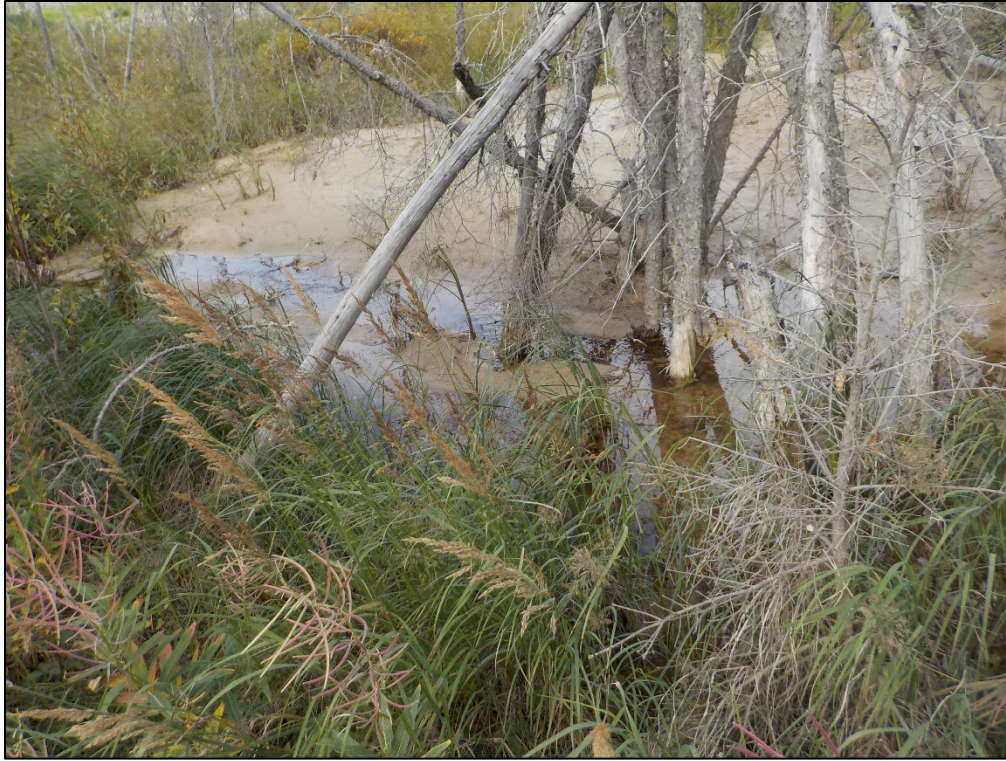
As of September 2021, disturbance totaling 0.03 ha (8% of which was within the possibly disturbed Project footprint) was identified at four locations around the perimeter of EMPA D16(1)-E (Map 3-2; Appendix 1: Table 7-1). More than half (59%) of the new disturbance was located at the southwestern corner where erosion deposited sediment and created a flowing channel of water into previously undisturbed vegetation (Photo 3-18). The habitat affected was split evenly between tall shrub on thin peatland and black spruce dominant on thin peatland. The remaining disturbed area was the result of earthwork and grading efforts prior to the 2021 survey.

Photo 3-18: Sediment deposition and flowing water at the southwestern corner of EMPA D16(1)-E

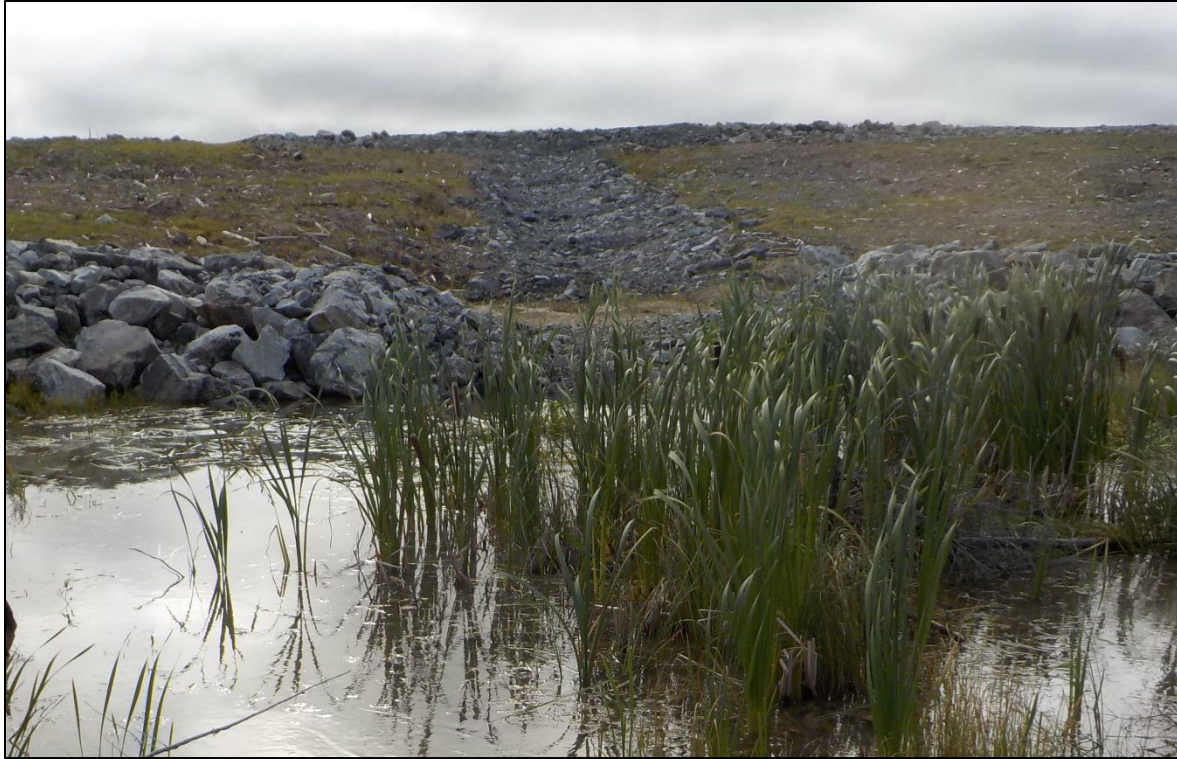
A gap left in the rock berm on the western edge of EMPA D16(1)-E, which allowed sediment to pass through into the adjacent marsh habitat in 2020, was still present at the time of the 2021 survey. The runnel created by erosion leading to the gap in the rock berm was excavated, lined with rock and converted into a turnout for the drainage channel further upslope (Photo 3-19). Sediment deposition at this location had decreased from previous years as of September 2021, however it was unclear if this was a result of the recent earthworks in the area or due to decreased rainfall from previous years. This area will be monitored for additional adverse effects in 2022.

Photo 3-19: Gap in rock berm (center) and rock-lined turnout (top-center) adjacent to marsh (foreground) on western edge of EMPA D16(1)-E

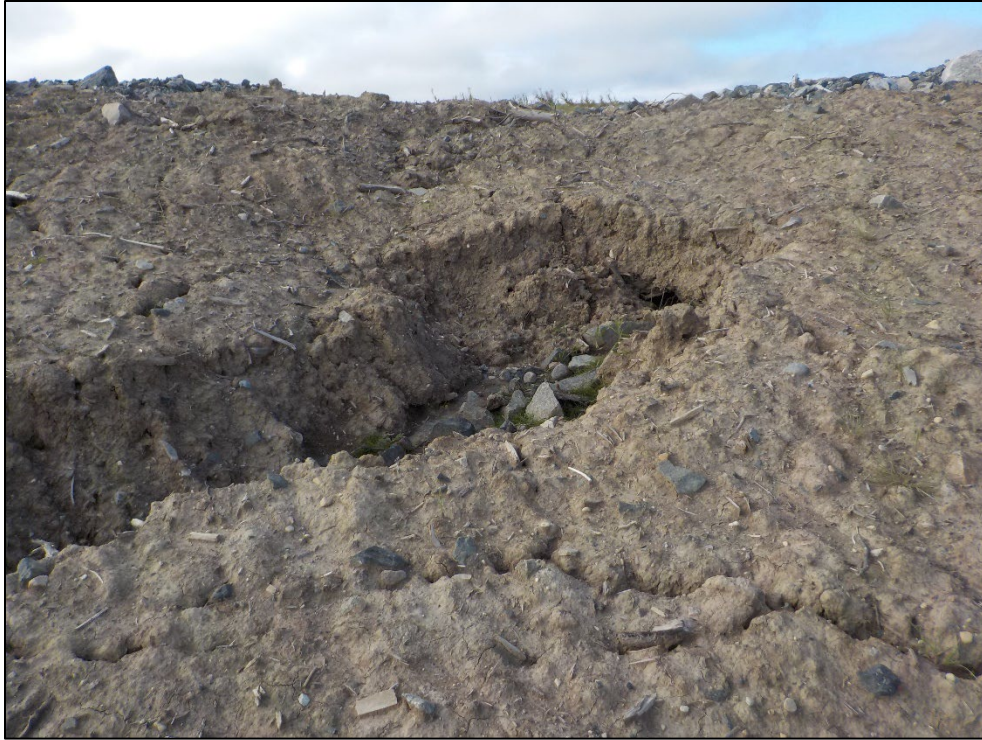
Surveys in 2021 identified some locations on the northern edge of EMPA D16(1)-E where erosion of the newly mounded clay outside of the recently reinforced rock berm was starting to occur (Photo 3-20). These locations had potential to deposit sediment into the adjacent undisturbed forest in the event of further erosion however it was not observed at the time of the survey in 2021.

Photo 3-20: Erosion of mounded clay outside rock berm at northern edge of EMPA D16(1)-E

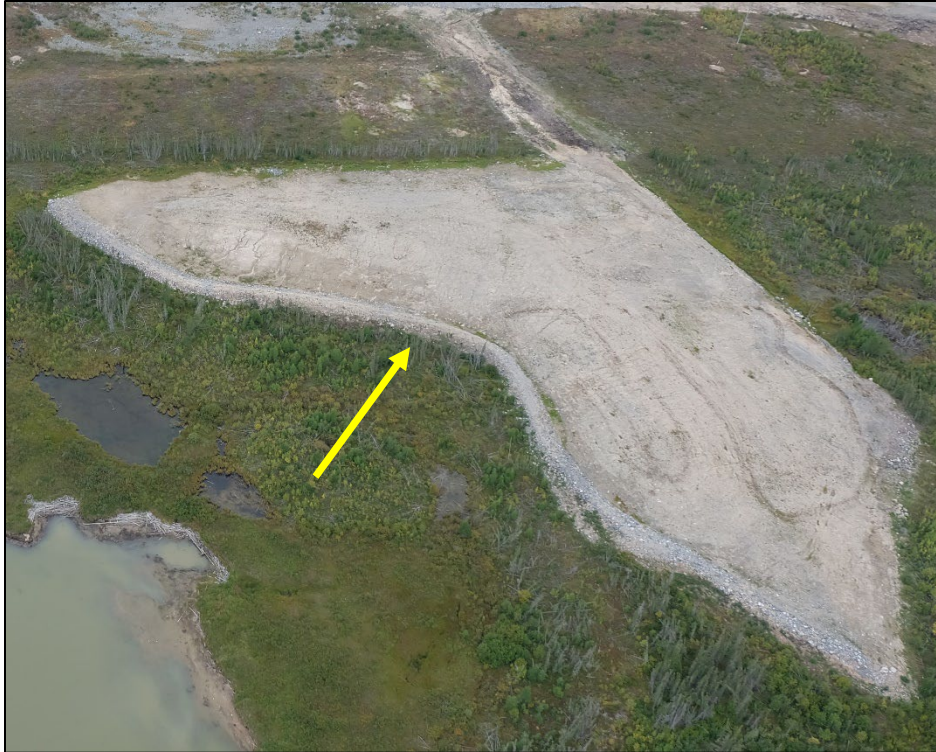
Previous surveys at EMPA D17-E found that sediment from slope erosion was overwhelming sediment fences and being deposited into undisturbed vegetation. Additionally, runoff was entering an adjacent pond to the northeast. As of September 2021, a rock berm had been constructed along the northwestern edges (Photo 3-21). This area will continue to be monitored for adverse effects in 2022.

Photo 3-21: Rock berm constructed along northwestern edges of EMPA D17-E
