Keeyask Generation Project Terrestrial Effects Monitoring Plan

Habitat Loss and Disturbance Monitoring Report

TEMP-2022-01

By
ECOSTEM Ltd.
June 2022

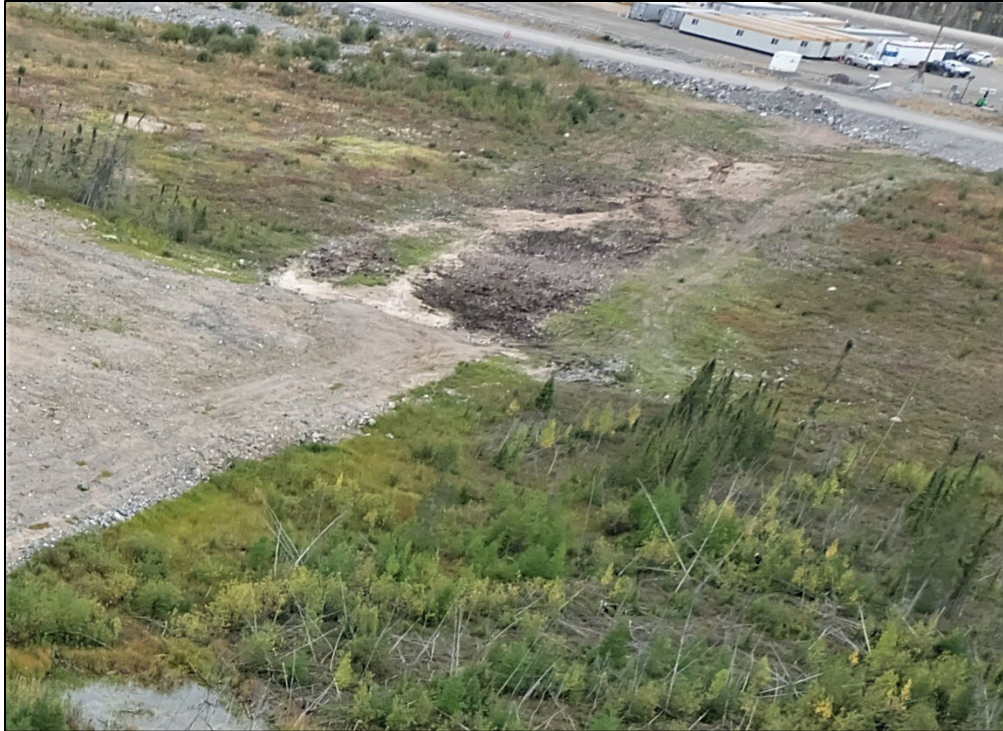
Approximately 0.15 ha of new disturbance in previously undisturbed vegetation was identified at the entrance of EMPA D17-E at the time of the 2021 surveys (Map 3-2; Photo 3-22). About 31% of the new disturbance was within the possibly disturbed Project footprint (Appendix 1: Table 7-1). This disturbance can be attributed to road decommissioning efforts within the Construction Footprint.

Photo 3-22: Road decommissioning and associated adjacent disturbance at entrance of EMPA D17-E

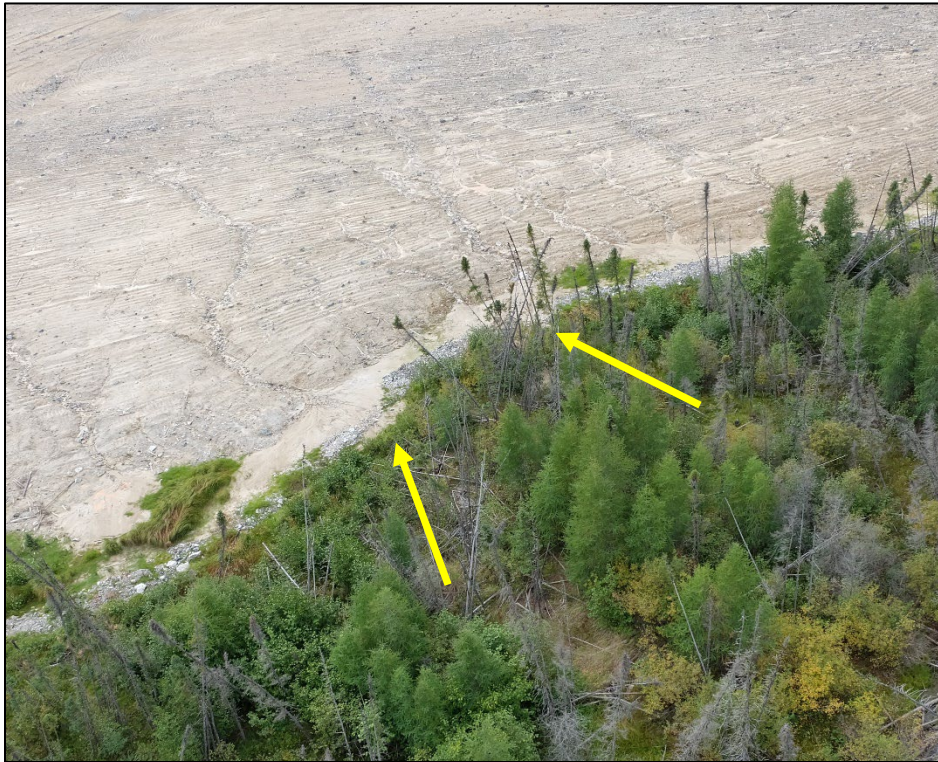
Erosion and sediment deposition within the planned Project footprint area was found overtopping previously installed rock berms at the northeastern edge of EMPA D23(2)-E in 2020 and conditions remained the same at the time of the 2021 surveys (Photo 3-23). These impacts were at a location that could potentially affect the dewatered portion of Stephens Lake to the northeast if the disturbance should expand (Map 3-1; Figure 3-4).

Photo 3-23: Sediment overtopping rock berm in EMPA D23(2)-E

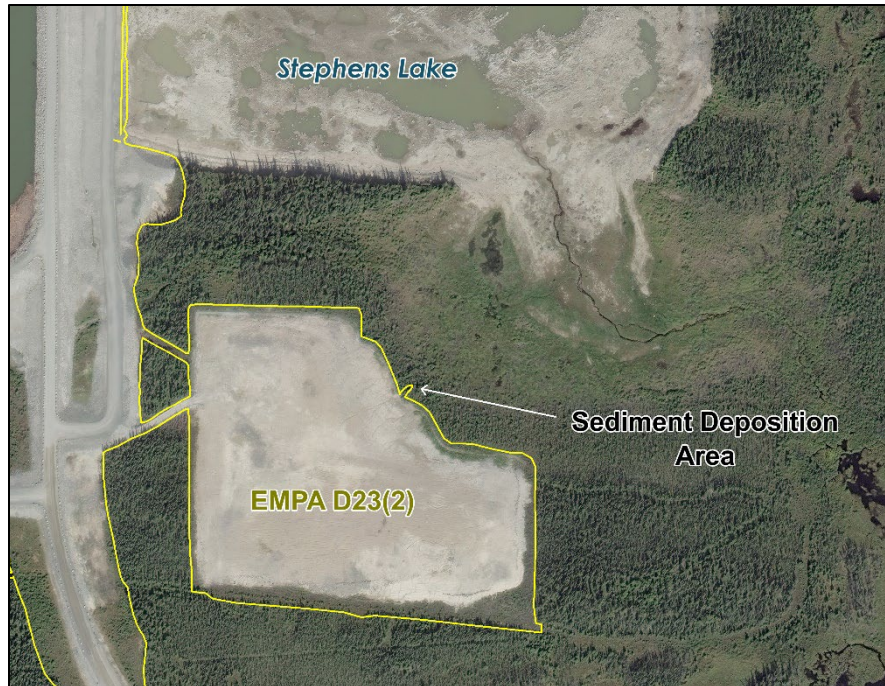
Figure 3-4: Erosion and sediment deposition from EMPA D23(2)-E

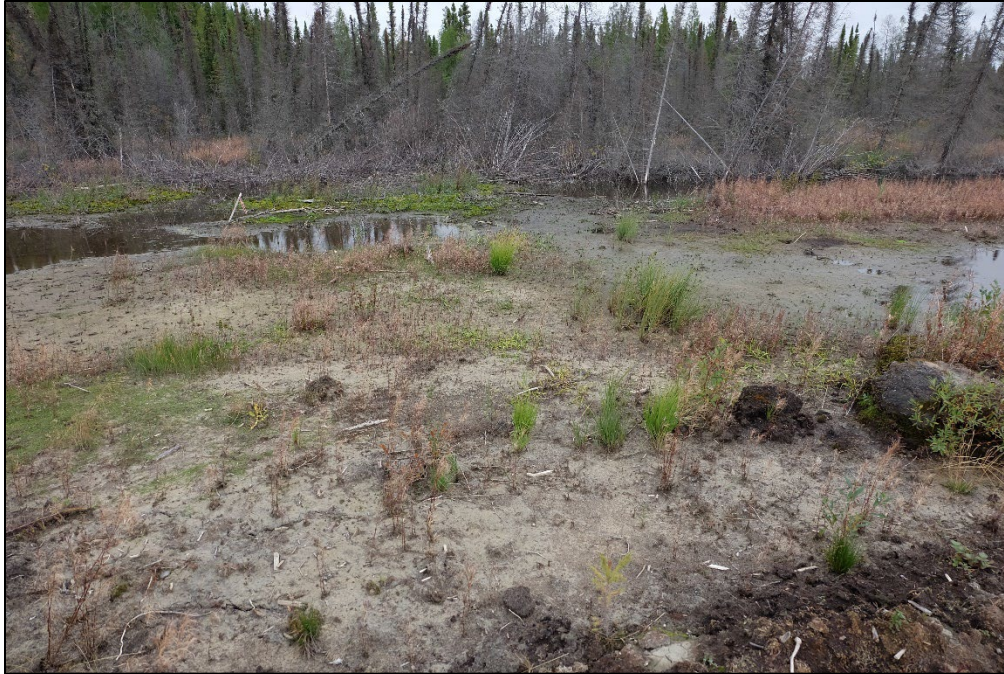
In previous years, water had collected in localized sites at the base of the EMPA slope and formed ponds which extended into the adjacent undisturbed forest, causing vegetation mortality. While emergent marsh plants (likely sedges) had initially been colonizing the ponds, these plants had mostly disappeared by September 2019. At the time of the 2021 surveys, water levels in the ponds were considerably lower and some vegetation was observed in the dried ponds (Photo 3-24). The amount of tree and vegetation dieback had not increased since September 2020. A strong stagnant odour noted in the general area around the pools in 2020 was not noticed at the time of the 2021 survey. Monitoring for adverse effects in this area will continue in 2022.

Photo 3-24: Dried ponds with some vegetation regeneration on the northern edge of EMPA D27(4)-E

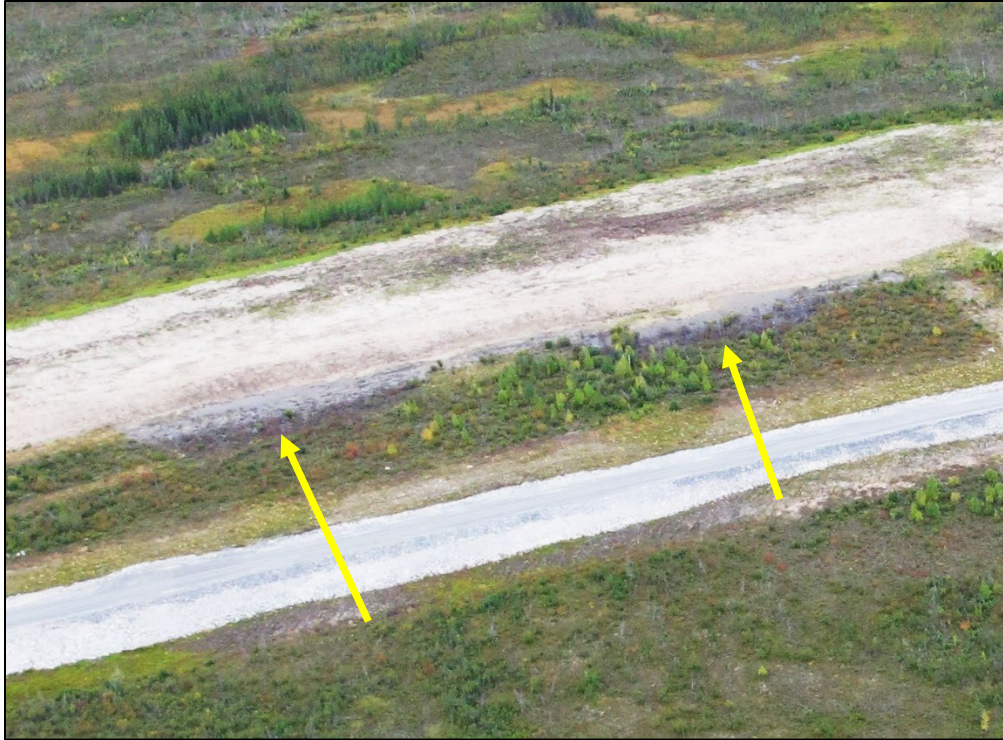
Vegetation dieback was observed along the northern edge of EMPA D28(1)-E in 2020 as a result of ponding water. By September 2021, water levels had gone down considerably and the amount of vegetation dieback had not increased (Photo 3-25). Monitoring for adverse effects in this area will continue in 2022.

Photo 3-25: Aerial view of ponded water and dying vegetation on northern edge of EMPA D28(1)-E

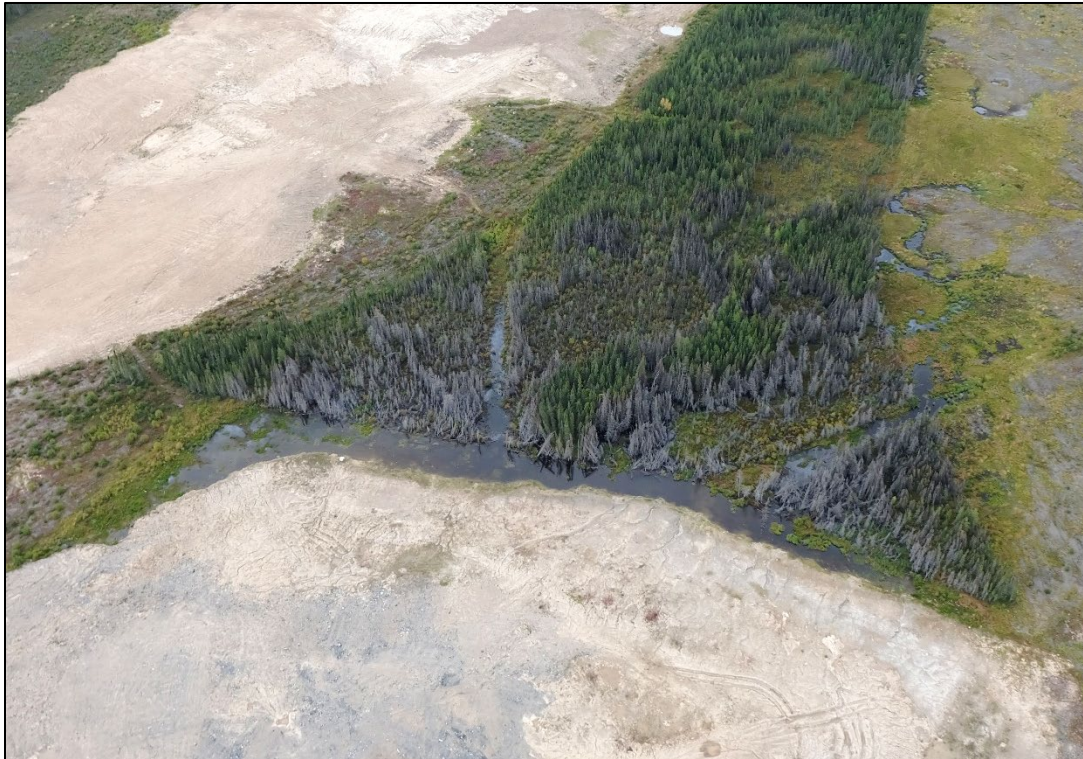
At the eastern edge of EMPA D35(1)-E in 2020, ponded water as well as significant tree dieback was observed in the adjacent undisturbed forest. Water levels had gone down considerably by September 2021 and the area of dieback had not increased (Photo 3-26). Monitoring for adverse effects in this area will continue in 2022.

Photo 3-26: Ponded water and tree dieback at the eastern edge of EMPA D35(1)-E

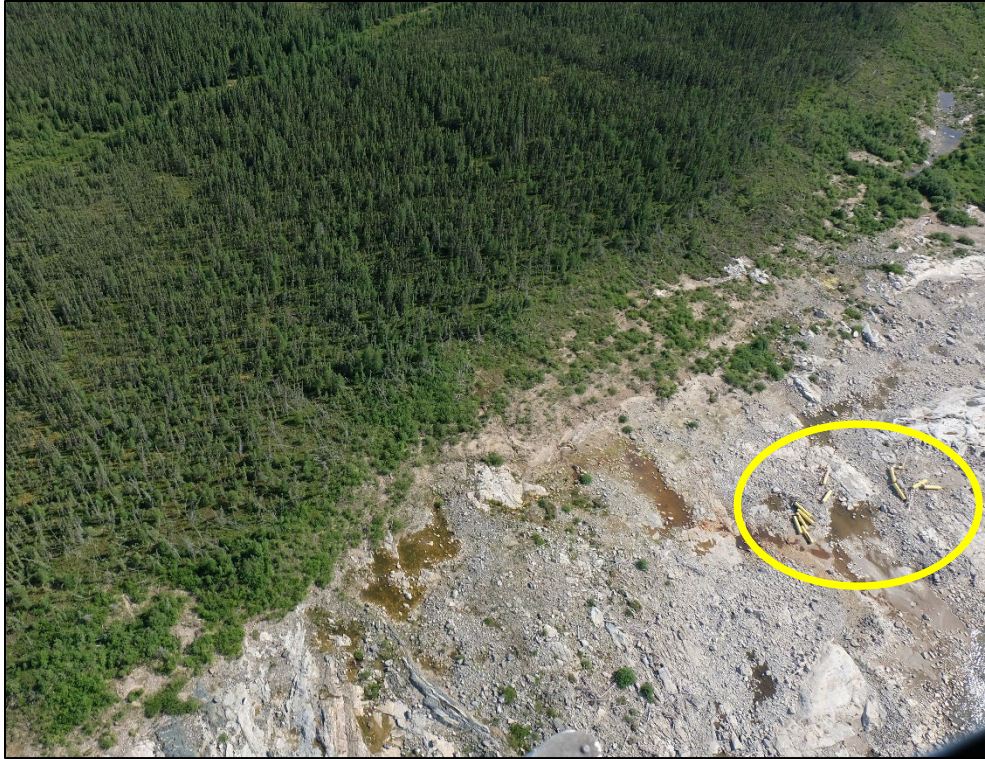
Surveys in 2021 found three areas along the southern shore of the Nelson River downstream of the dam where portions of ice booms had washed up onto the shore (Photo 3-27; Map 3-2).

Photo 3-27: Portions of ice boom (yellow area) washed up on the south shore of the Nelson River, downstream of the dam (dewatered area)

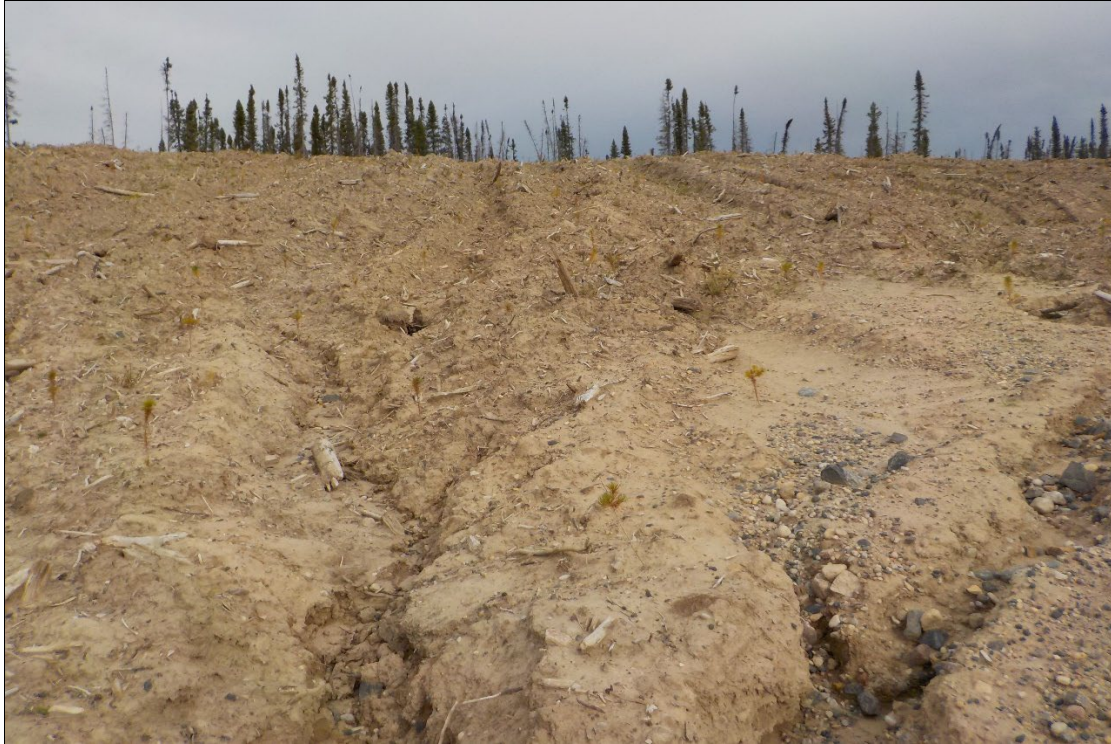
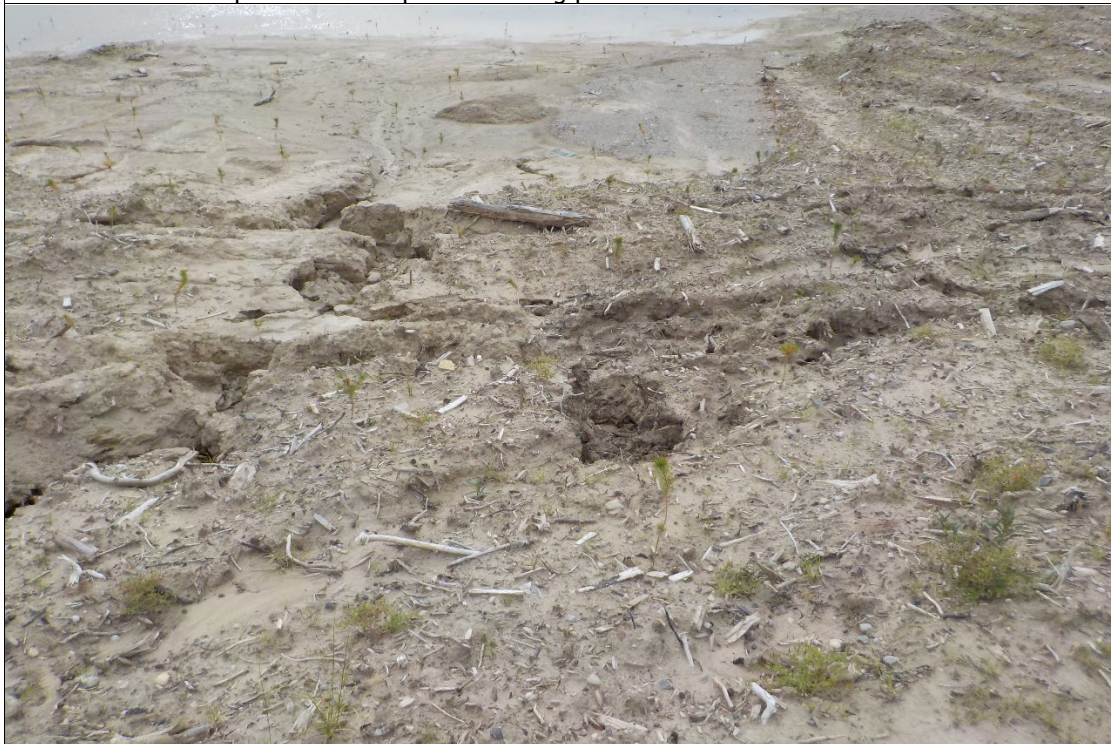
Figure 4-1: Grading and site preparation parallel to slope direction in G-3, and associated erosion and tree impacts

Area on northern slope of G-3 with parallel discing pattern

Example of erosion and water ponding in low areas, with seedlings washing away in same area

Mitigation is not recommended for the slopes in G-3 where planted tree seedlings are being washed away as it is unlikely that further impacts can be prevented or reduced. These slopes are long and have been planted with seedlings. It is noted that a factor contributing to the amount of erosion and tree seedling loss is that in some areas the grading and site preparation were implemented parallel to the slope (Figure 4-1), which increases the amount of downslope water flow and its velocity. A recommendation for future grading and site preparation is to complete the machine work in a direction that is perpendicular to the slope direction where this is safe to do.
