Keeyask Generation Project Terrestrial Effects Monitoring Plan

Habitat Rehabilitation Implementation and Success Monitoring Report

TEMP-2022-06

June 2022

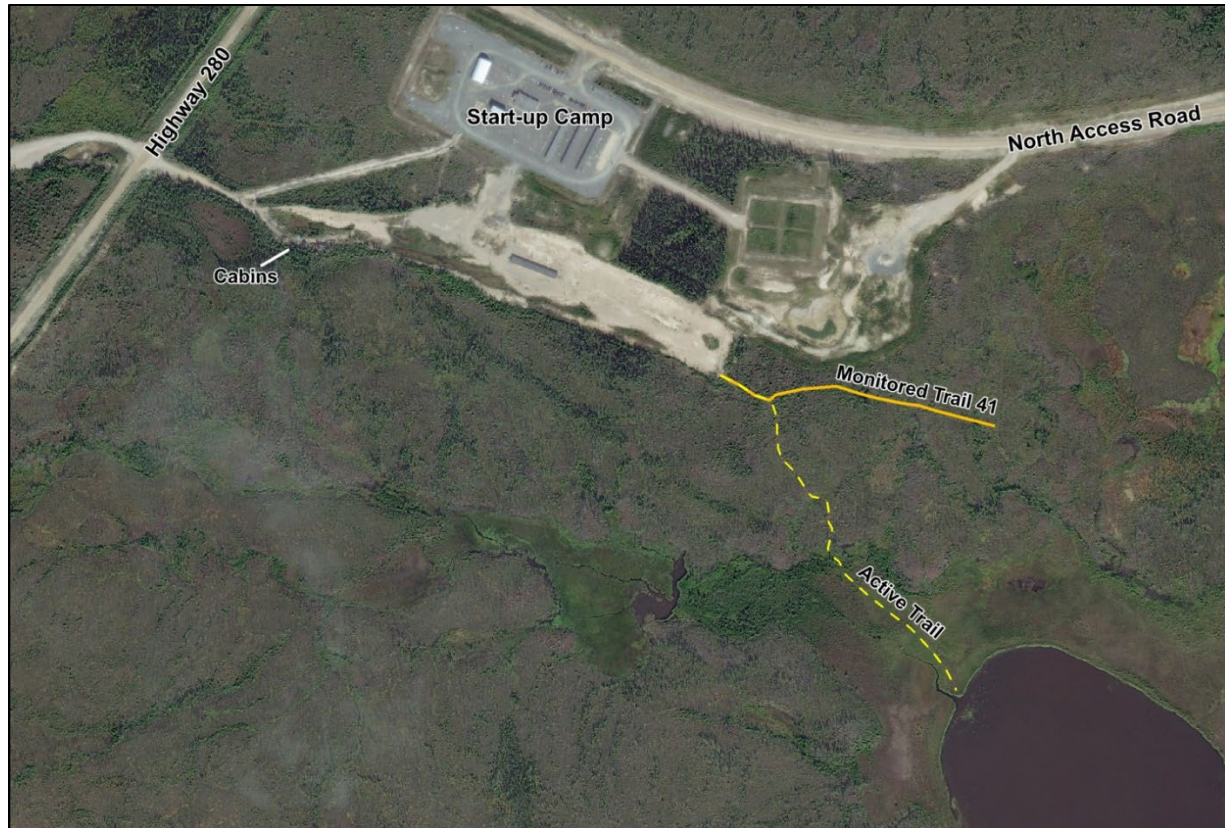
Figure 4-1: Recent activity along Trail 41 attached to the Start-up Camp

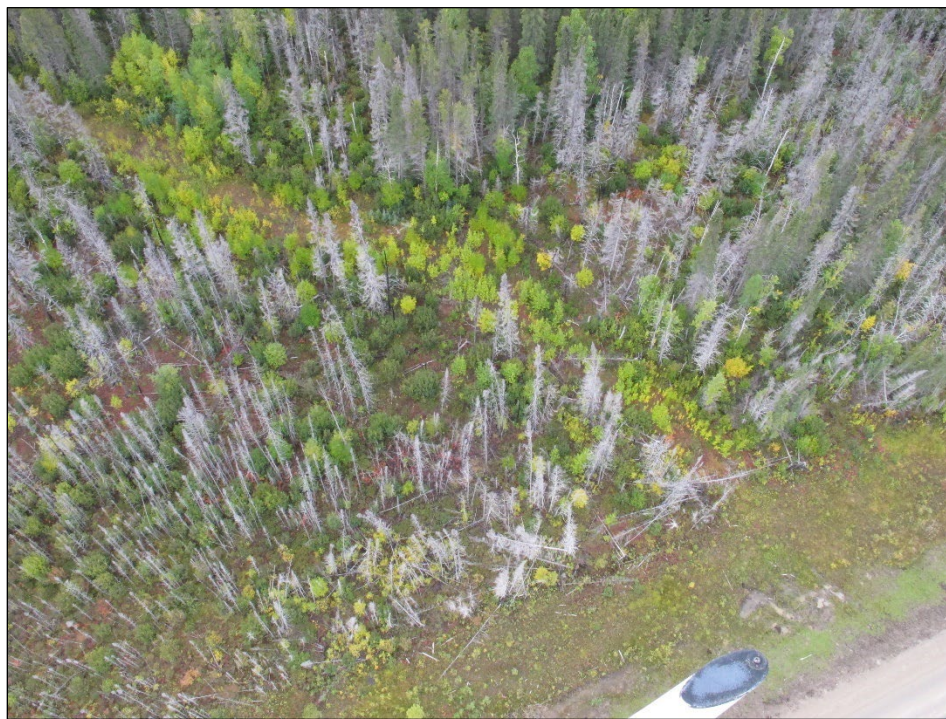
For the 47 trails included, monitoring data found no change in vegetation regeneration status or trail blocking measures since 2017. Also, there was no additional Project-related disturbance or clearing in any of the monitored trails (see Photo 4-1).

Photo 4-1: Trail with advanced regeneration leading off the NAR.

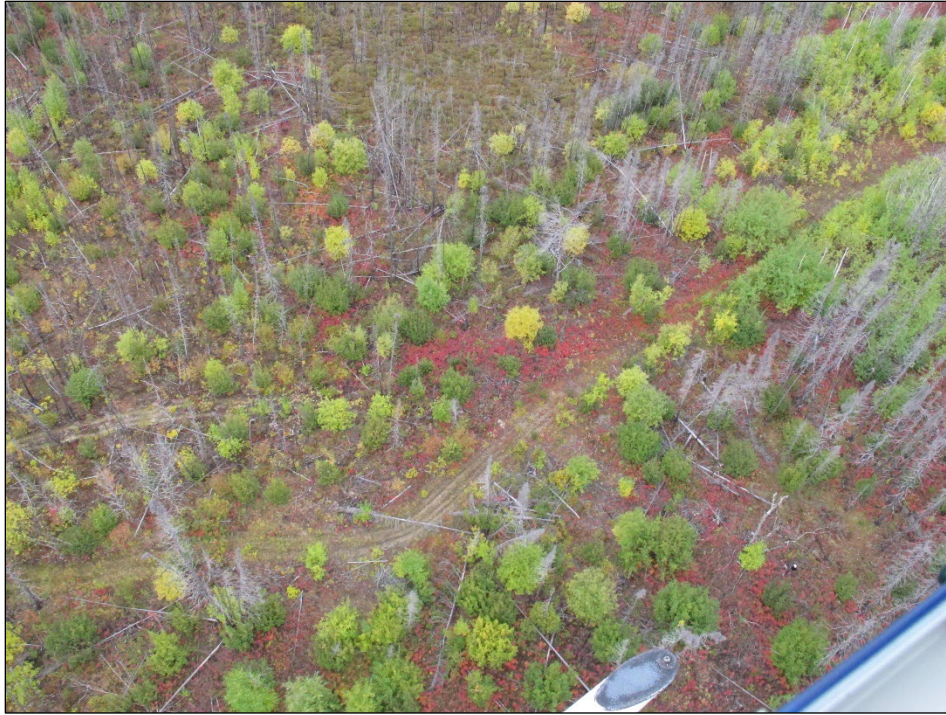
Photo 4-2: Trail off of the Start-up Camp with evidence of recent activity on the south fork (towards the left of the photo).

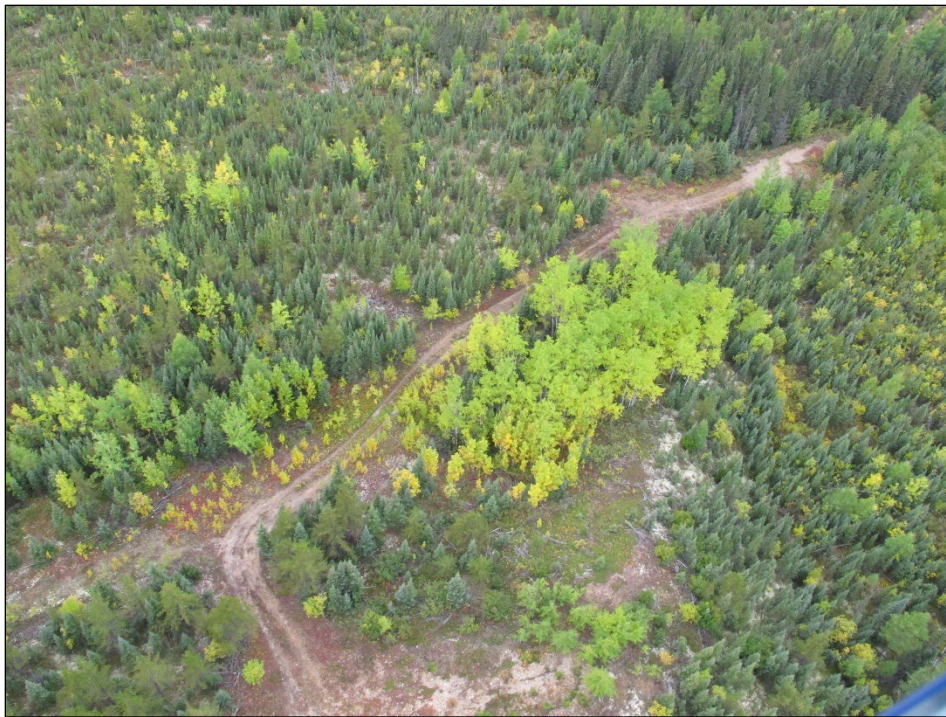
Photo 4-3: Trail north of Borrow Area G-5 with signs of use.

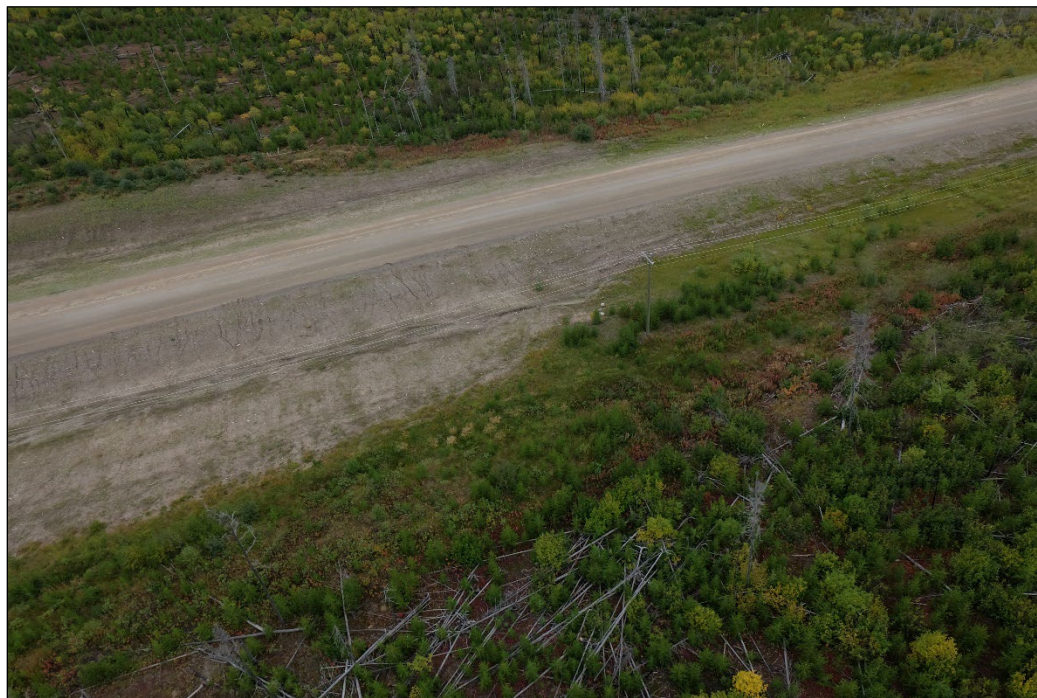
Photo 4-4: Wide area barren of vegetation (left hand side), surrounded with moderate to high cover, along the NAR near the road to the Cemetery site.

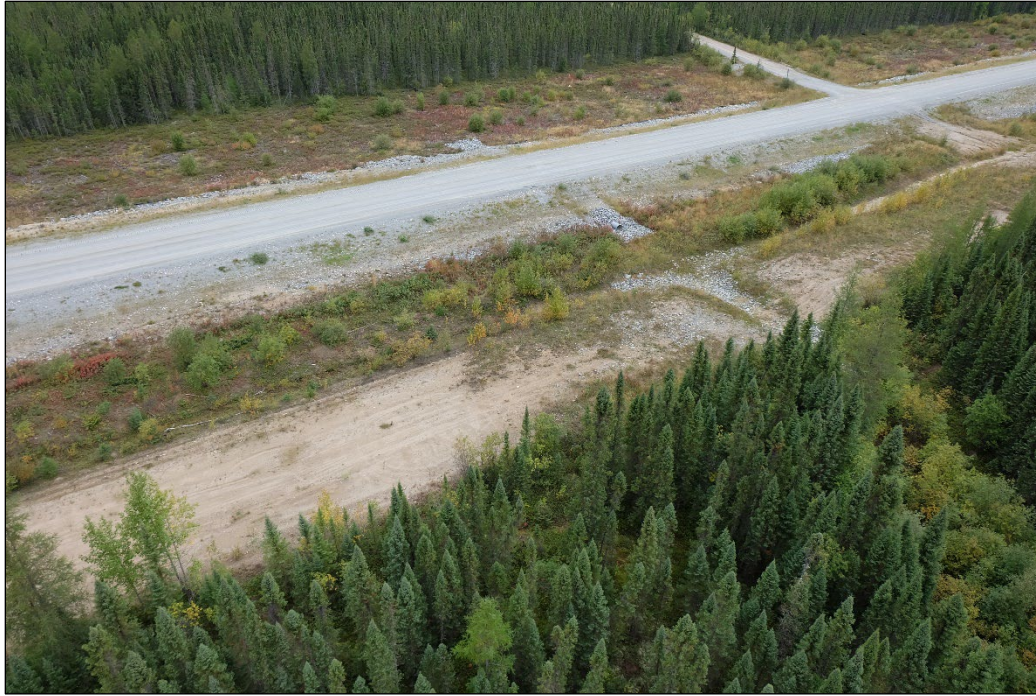
associated with older infrastructure, such as the decommissioned Butnau Road (Photo 4-5). The remaining sparse or barren areas were generally found to cover large portions of the entire ditch intermittently along the road, rather than occurring continuously along the side of the roadway.

Photo 4-5: Areas of barren, sparse, moderate and high vegetation cover on the old Butnau road along the SAR.

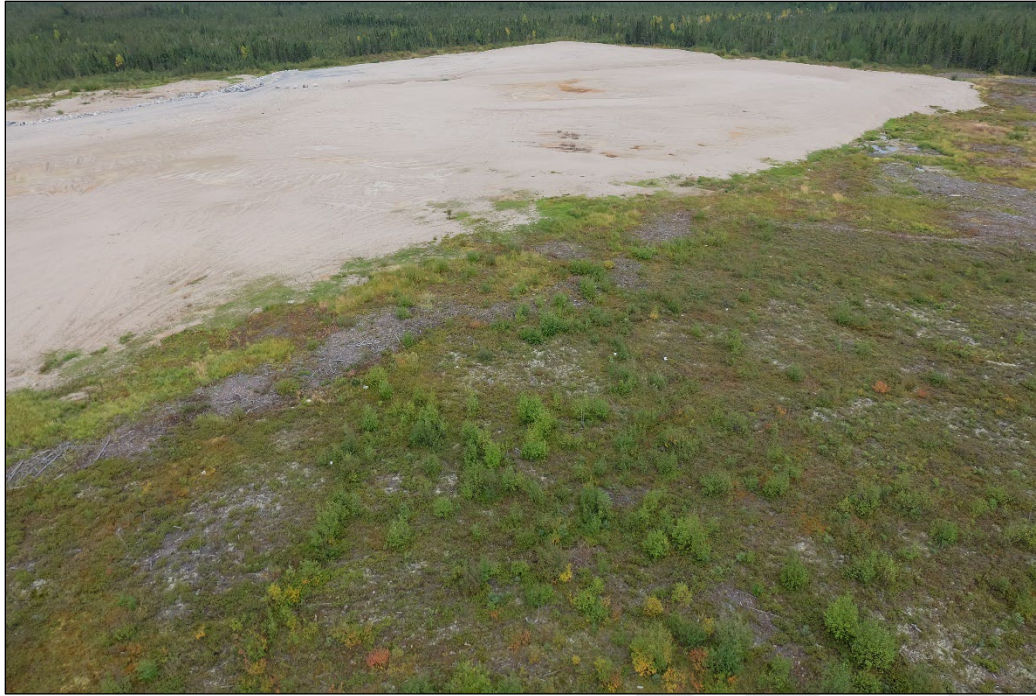
Photo 4-6: Cleared, but vegetated (foreground) and barren portions of Borrow Area S-2a.

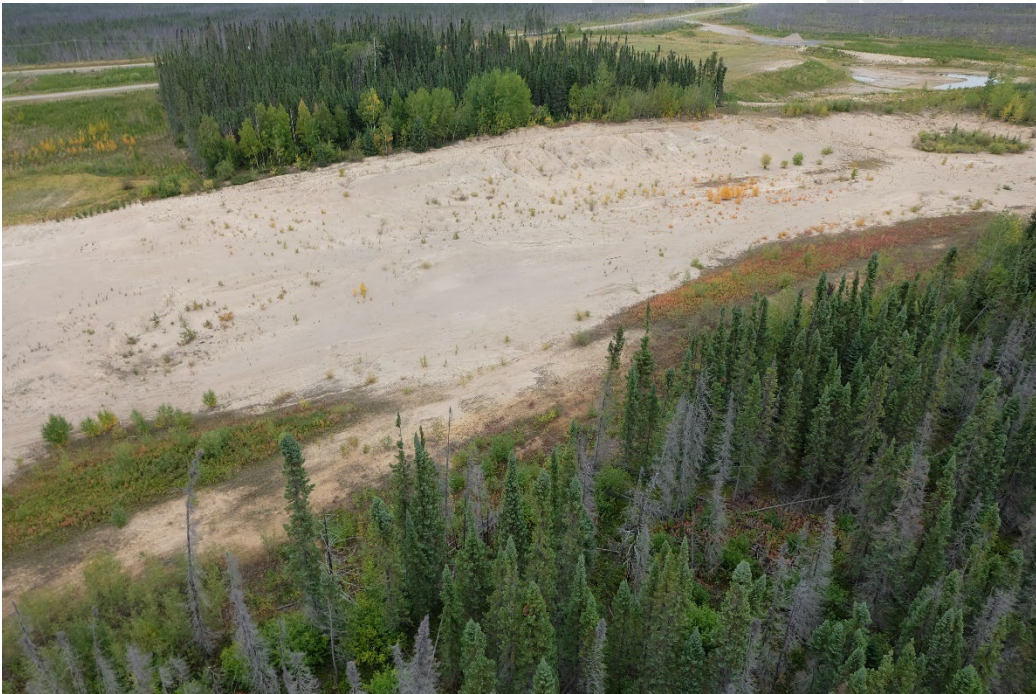
The camp areas, which included the Start-up Camp (SUC) and the Main Camp (MAC), encompassed a total of 18.3 ha. Low shrub/graminoid/bryoid was the most common vegetation type, at 40.3% of the camp area, followed by None at 27.4%. Sparsely treed/tall shrub, Woodland, Tall shrub and Sparsely treed represented 16.2%, 9.7%, 4.0% and 2.0%, respectively. Emergent was the only other type encountered, at less than 1%. The sparse and barren areas within the camps were mainly found in the large excavated area south of the SUC (Photo 4-7), and along the edges of the permanent roadways and infrastructure.

Photo 4-7: Barren areas in the excavated area of the SUC.

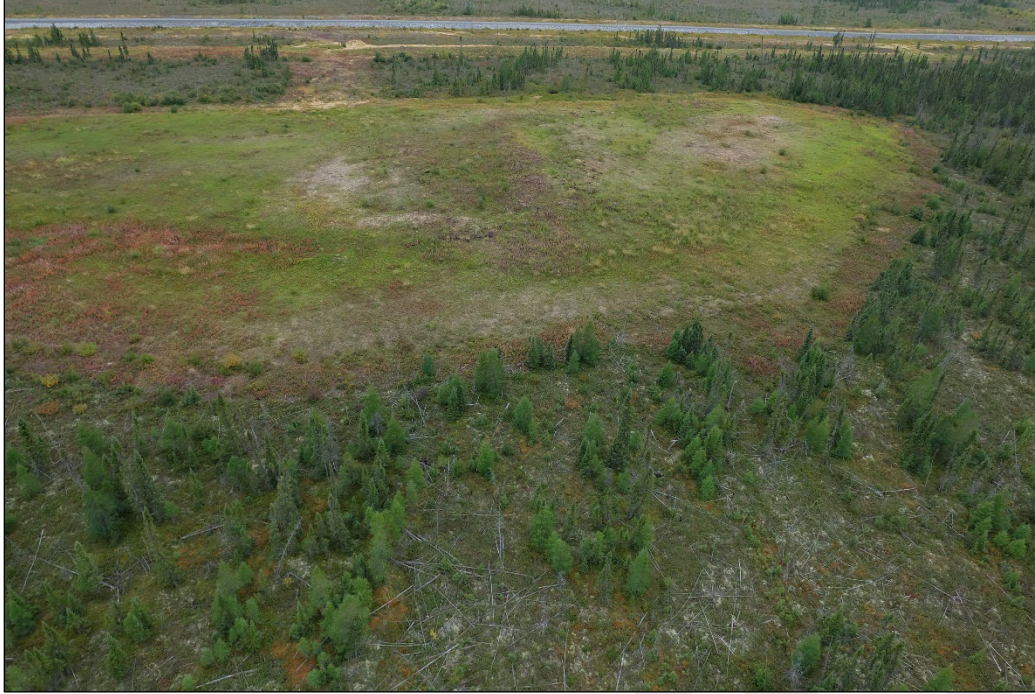
Photo 4-8: Vegetated EMPA D3-E along the North Dike.

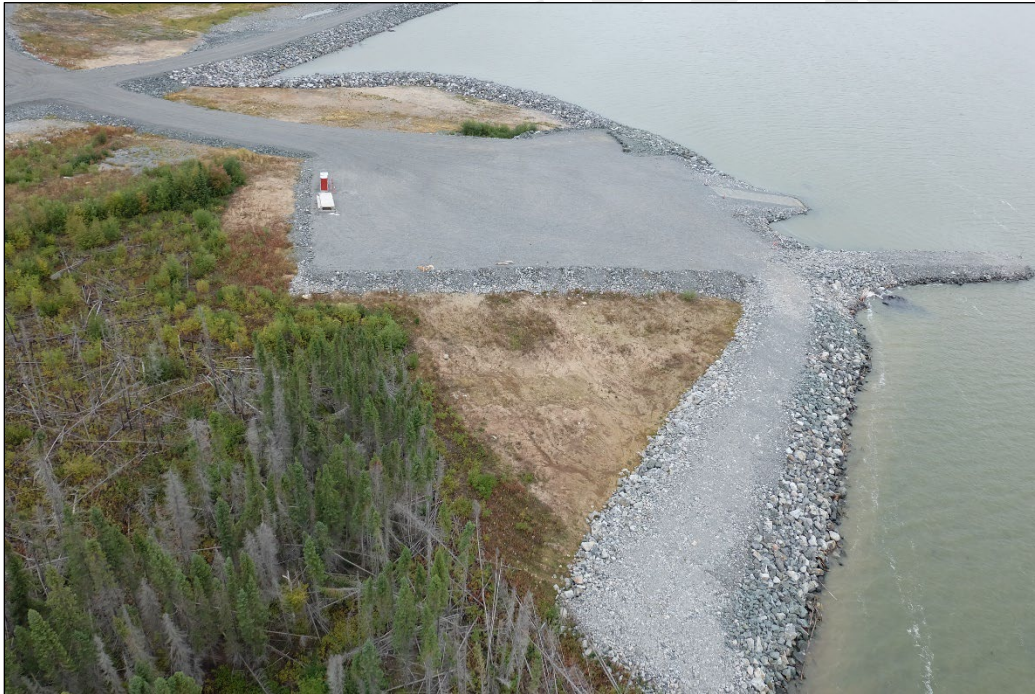
Photo 4-9: Portage route area on the North Dike, showing surrounding areas with barren and sparse vegetation.

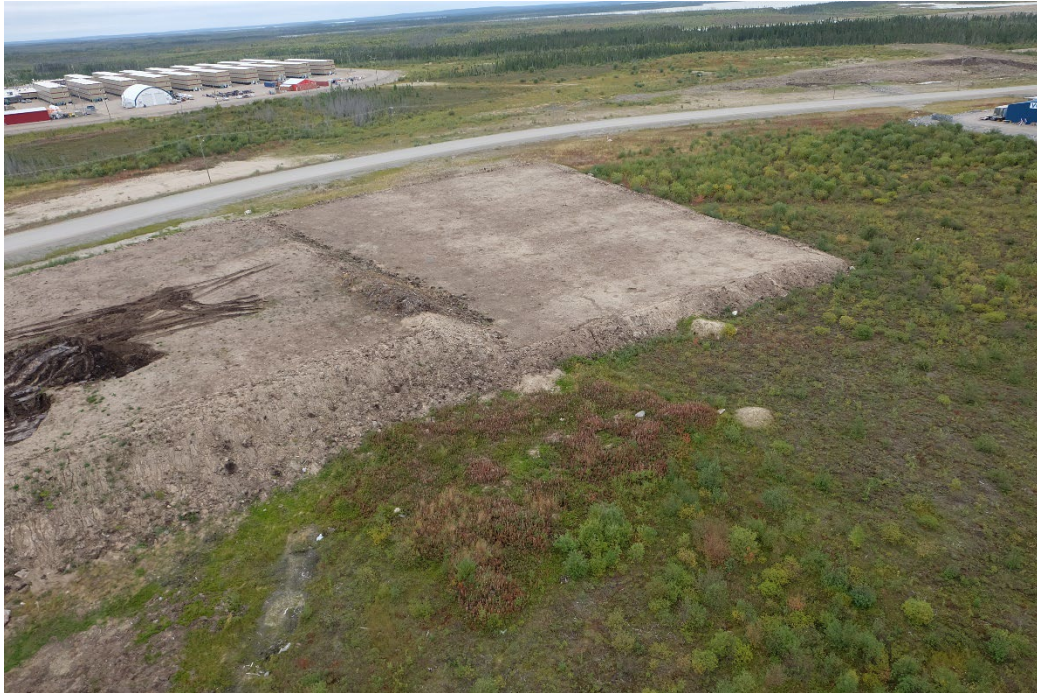
Photo 4-10: Work area A, showing barren and moderately to highly vegetated areas.

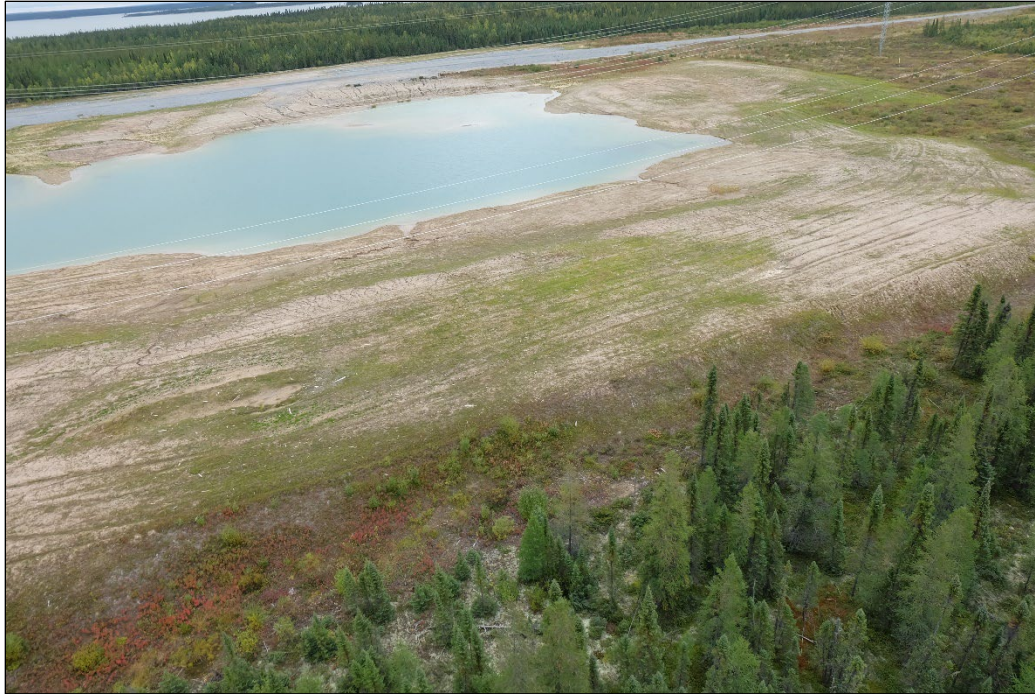
Photo 4-11: Seeded area regeneration in B-3.
