Keeyask Generation Project
Terrestrial Effects Monitoring Plan

Habitat Rehabilitation Implementation and
Success Monitoring Report

TEMP-2018-07

Manitoba Hydro

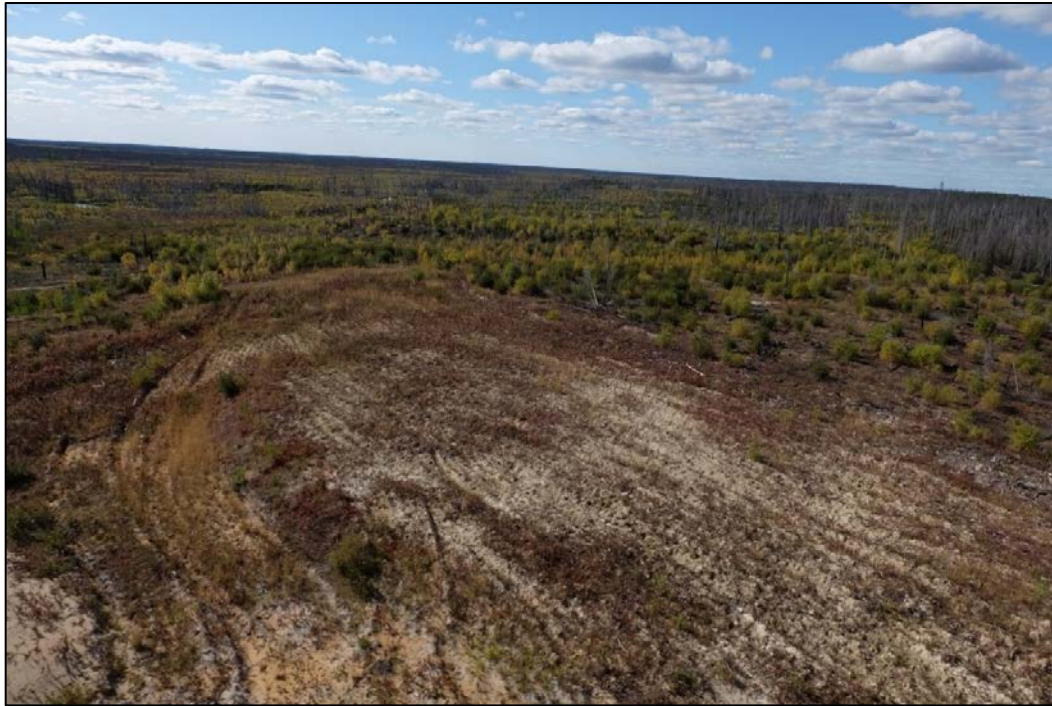
The planned site preparation was observed to have been implemented in each applicable treatment area.

Photo 3-1: Treatment area 09 in Borrow Area KM-9 that was prepared with a discer

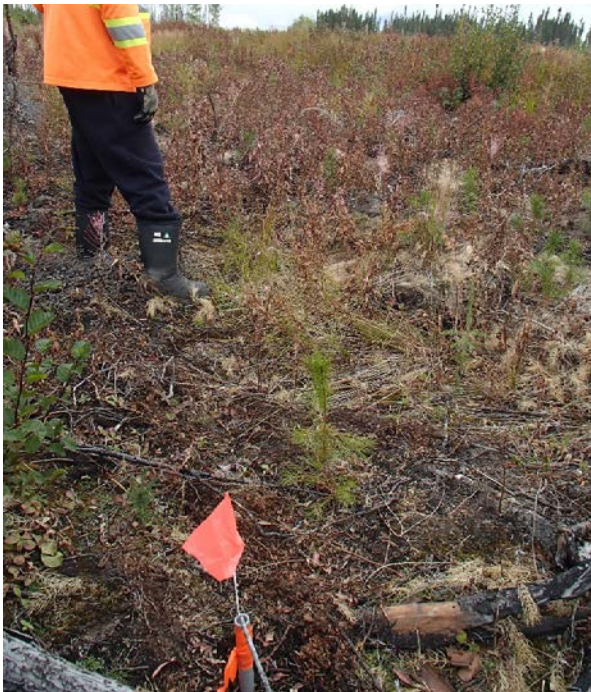
Surface organic material between 1 and 5 cm thick

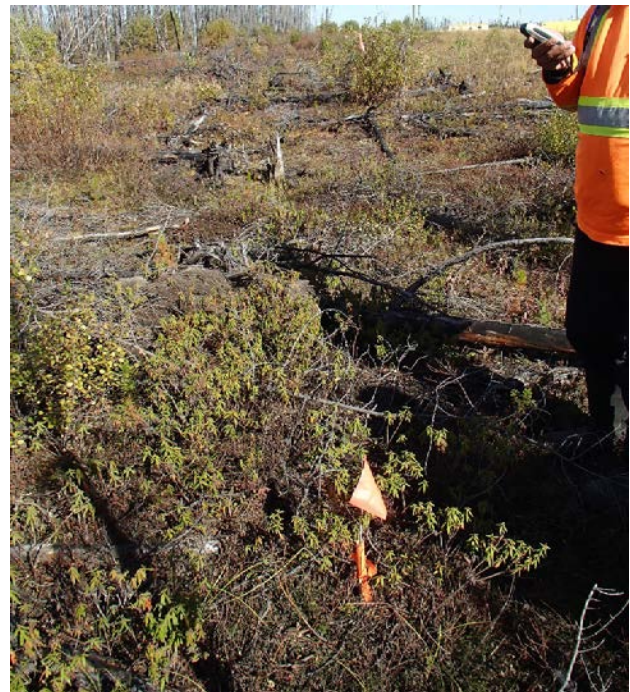
Surface organic material between 10 and 15 cm thick

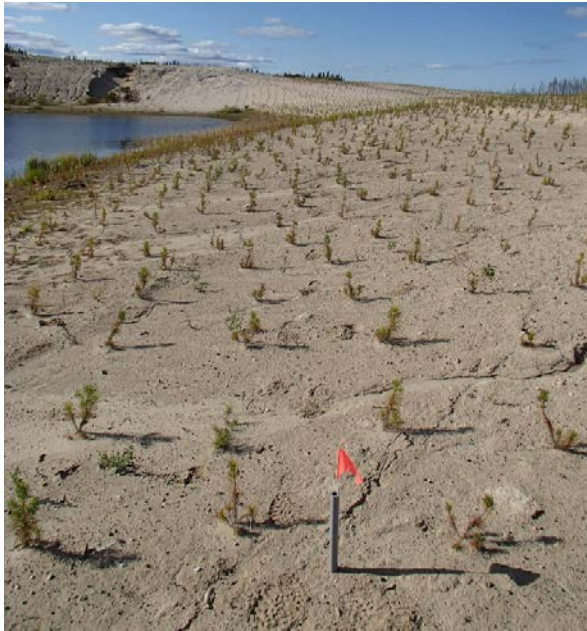
Planted jack pine in Borrow Area KM-4

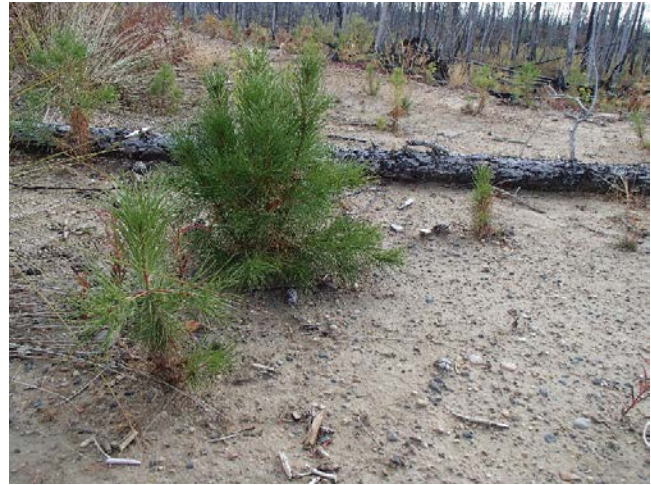
Mixture of naturally regenerating (foreground) and planted (background) jack pine in Borrow Area KM-4

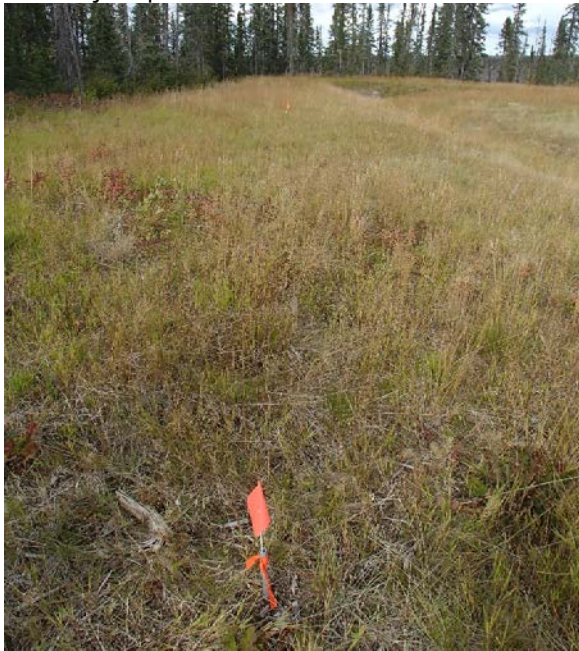
Black spruce planting area in Borrow Area KM-1

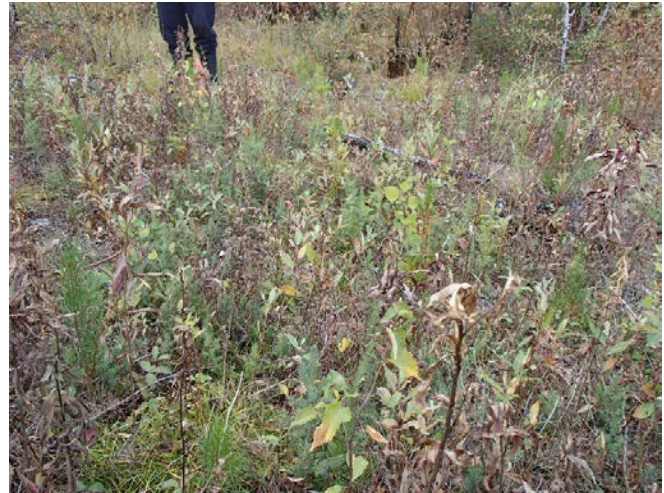
Naturally regenerating black spruce with planted jack pine in Borrow Area KM-4

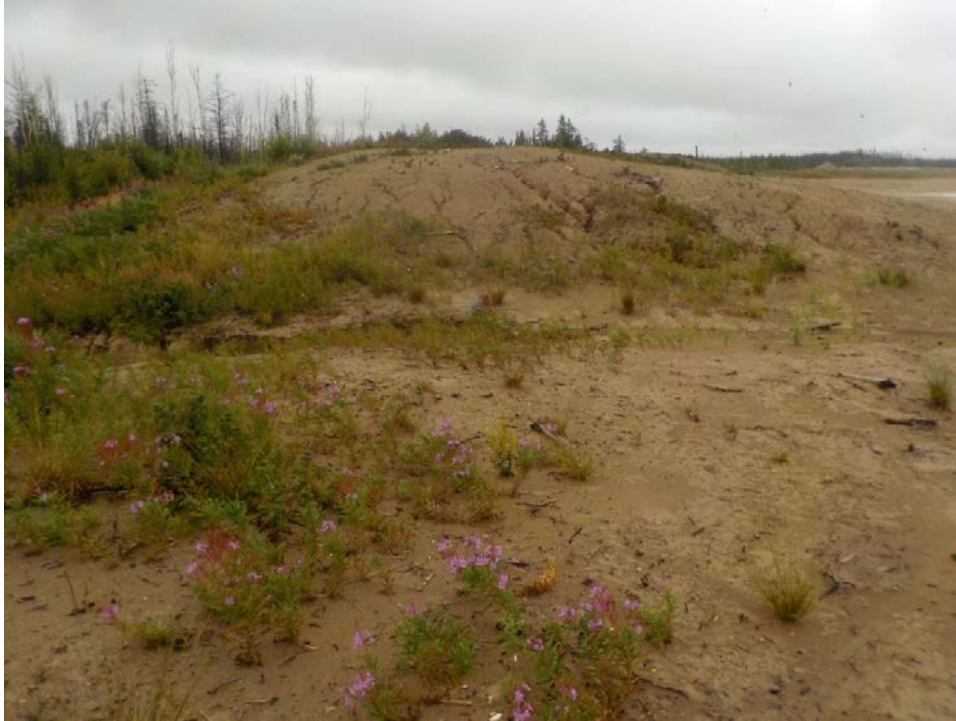
Trail 45

Figure 3-4: Piled materials from Borrow Area G-5 blocking entrance to trails in August 2017

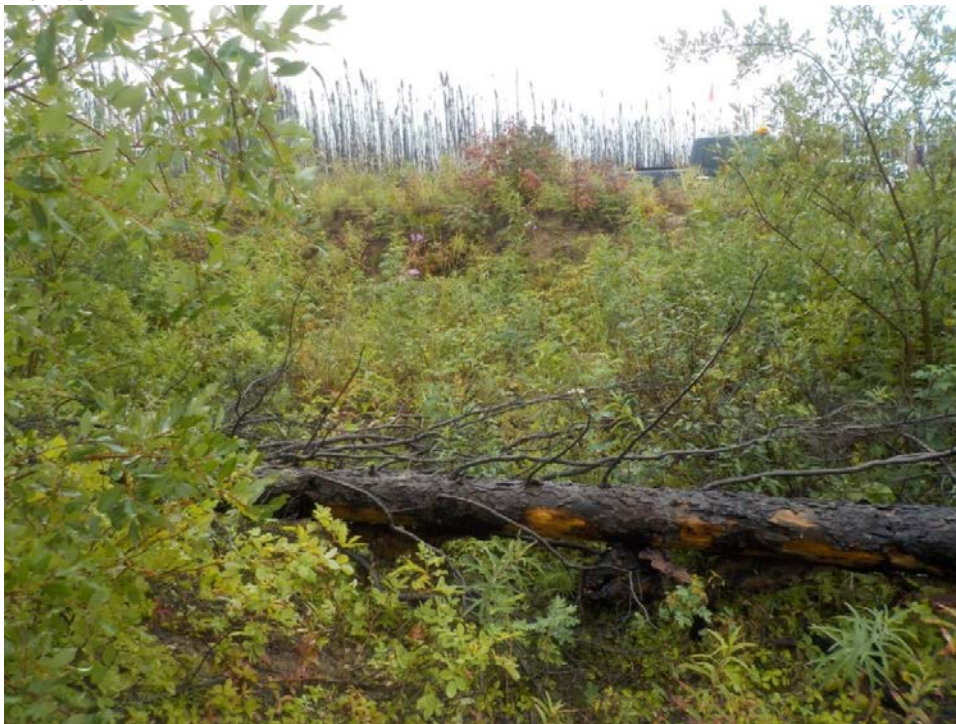
Trail 44 (Truck is in borrow area on opposite side of berm)

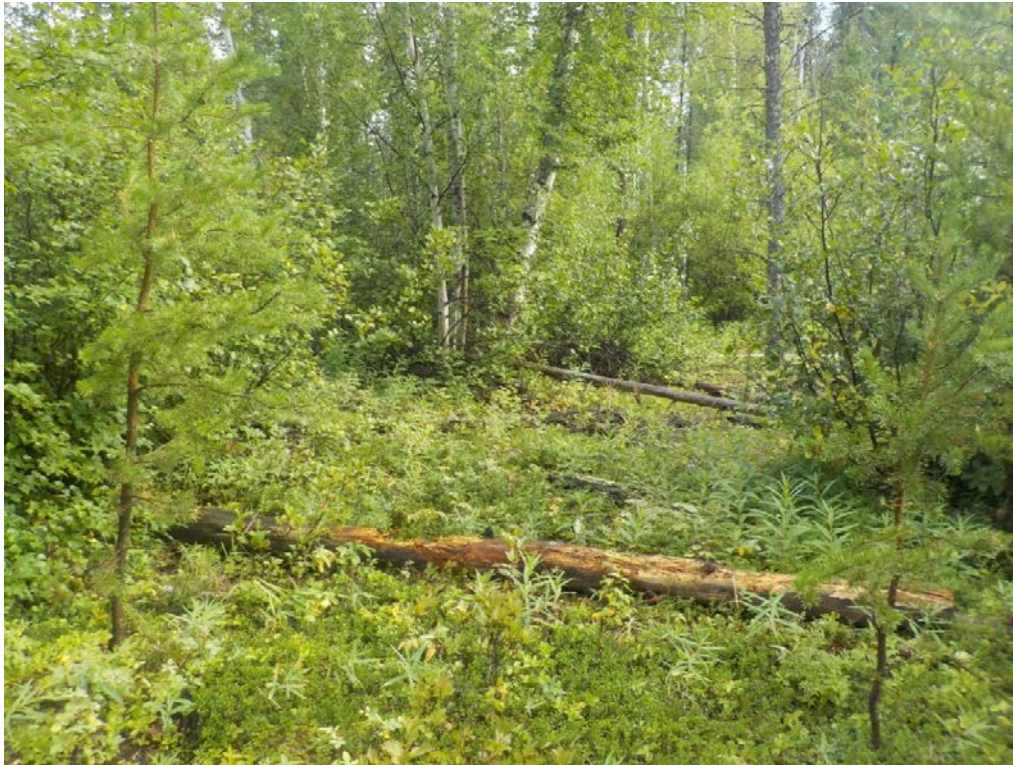
Trail 35

At four of the trails, natural vegetation regeneration had advanced to the point that the trails were no longer distinct from the surrounding area (Table 3-6; Figure 3-5). At an additional seven locations, trails could not easily be located because the general area had burned in 2013 (Figure 3-6). These situations tended to occur on mineral substrates.

Figure 3-5: Trails no longer distinct due to advanced regeneration in August 2017

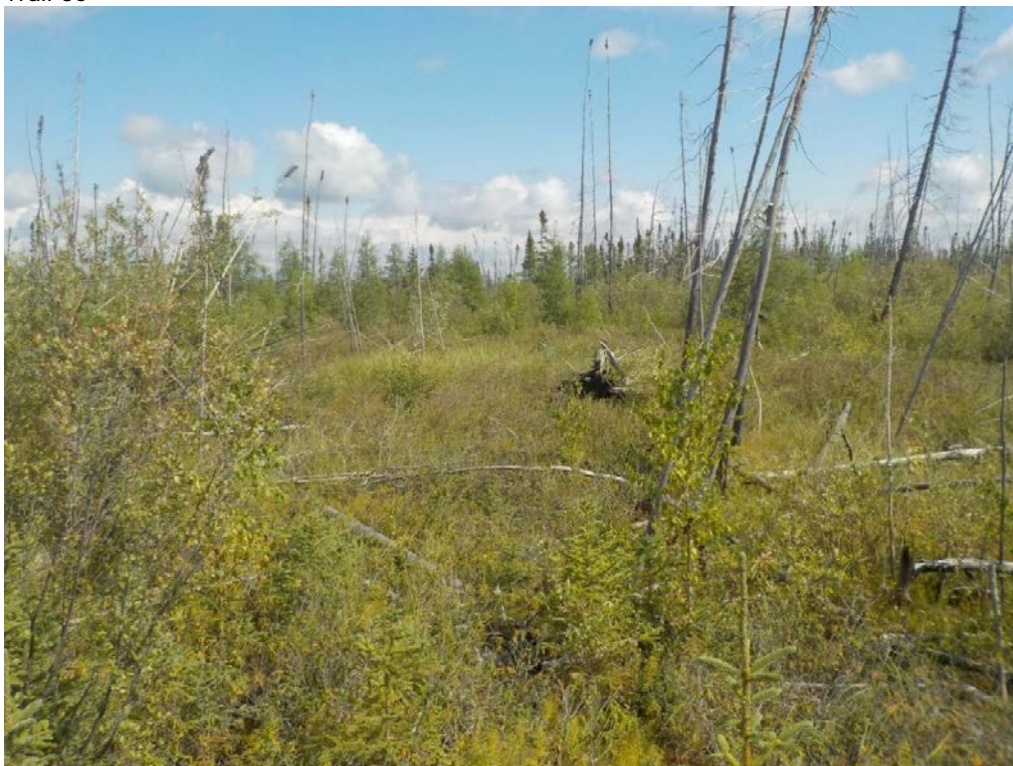
Trail 29 (Regenerating from 1999 burn)

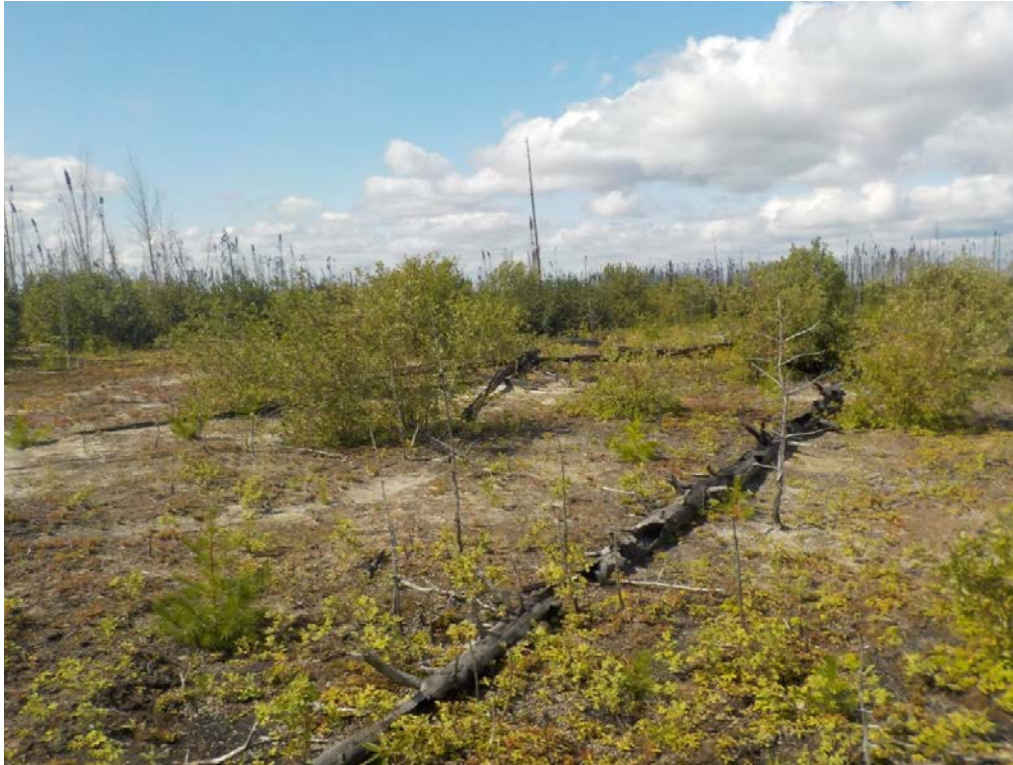
Trail 25

Figure 3-6: Trails no longer distinct in August 2017 following 2013 burn
