Keeyask Generation Project  
Terrestrial Effects Monitoring Plan

Wetland Loss and Disturbance Monitoring Report  
TEMP-2020-03

Prepared for  
Manitoba Hydro

By  
ECOSTEM Ltd.

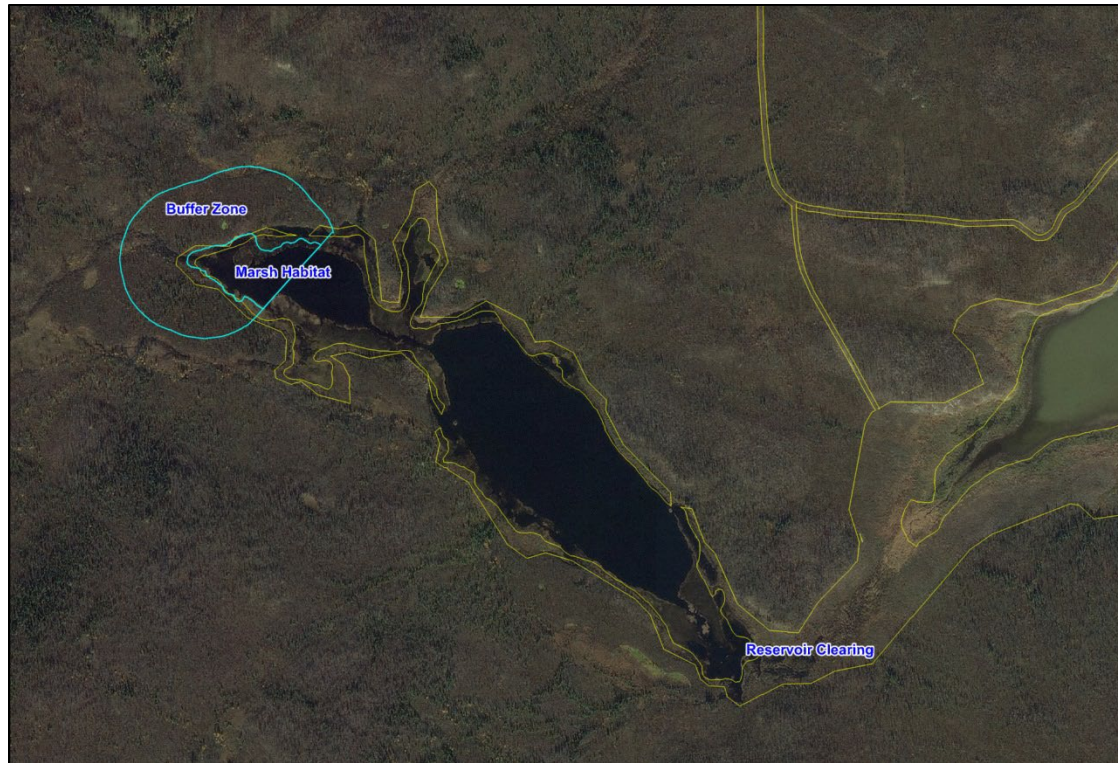
**Figure 3-1: Satellite imagery showing reservoir clearing (all within the approved Project footprint) at Wetland 3 in 2019**

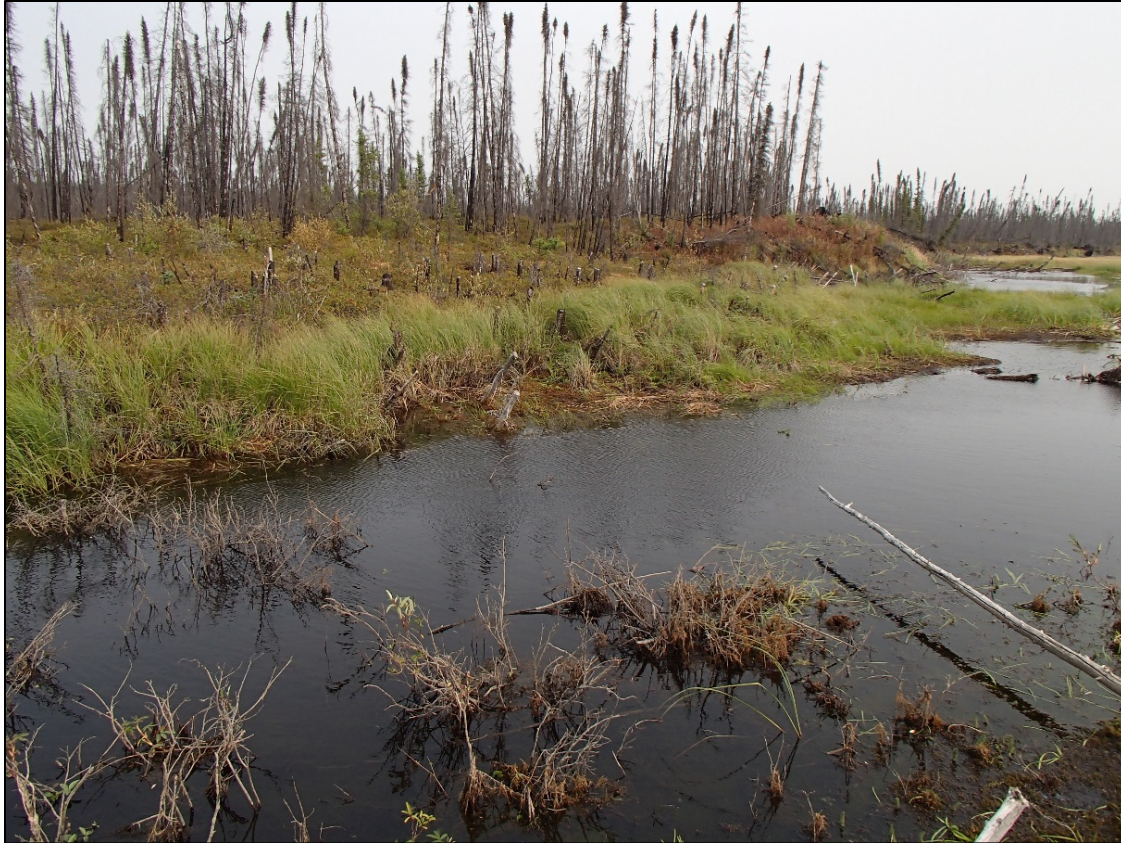
Approximately 0.26 ha of the cleared area was in the marsh habitat buffer and 0.10 ha was in the marsh habitat (Table 3-1). Cleared trees were visible where collapsed or collapsing peatlands outside of the planned Project footprint had become part of the marsh habitat (Photo 3-2).

**Photo 3-2: Cleared trees in Wetland 3 on August 31, 2017**

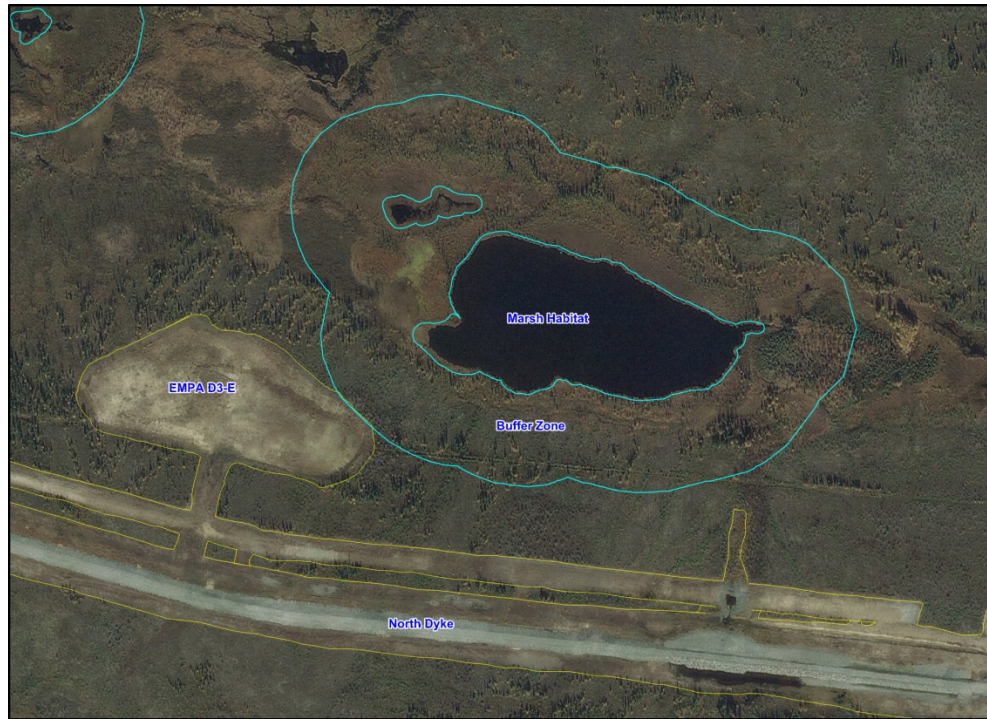
The 2016 ground survey found that a very small amount of EMPA clearing in the possibly disturbed Project footprint (< 0.01 ha; Table 3-1; Figure 3-3) extended into the buffer portion of the wetland. Ground surveys from 2017 to 2019 found no further changes to the EMPA and no new impacts on the wetland were observed.

The potential for sediment runoff from the EMPA into the wetland buffer is likely decreasing because the EMPA is becoming increasingly vegetated, which will help stabilize the soil (Photo 3-6). Evidence of runoff has not been recorded for past few years.

**Figure 3-3: Satellite image showing EMPA D3-E adjacent to the Wetland 37 buffer**

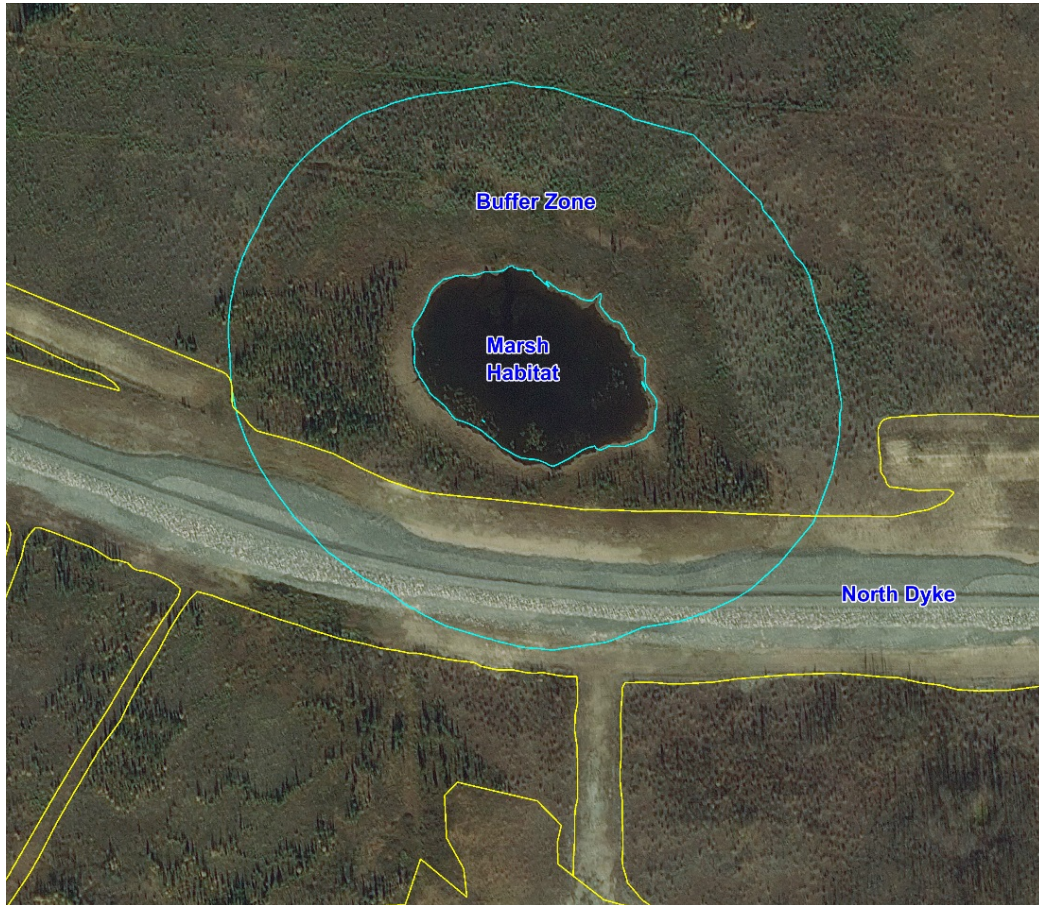
By the time of the 2016 survey, planned Project clearing for the dyke (Map 3-1) had extended through the buffer to approximately 3 m away from the southern portion of the marsh habitat (Figure 3-4). All of this 1.75 ha of clearing was within the planned Project footprint (Table 3-2). It was noted in 2017 that water levels in the marsh habitat at the time of the survey appeared to be lower than the median level based on exposed underwater portions of marsh vegetation. Surveys in 2018 and 2019 found that water levels appeared to be approximately at the median level in Wetland 40 (Figure 3-5).

**Figure 3-4: Satellite imagery showing dyke clearing (all within the planned Project footprint) at Wetland 40 in 2019**

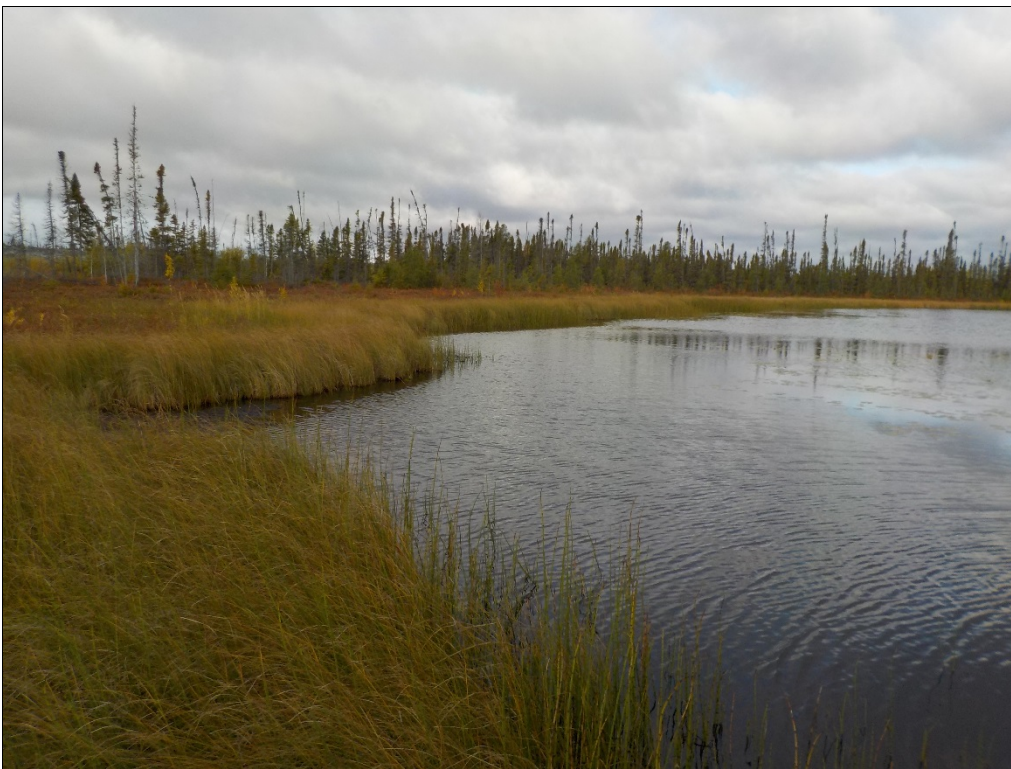
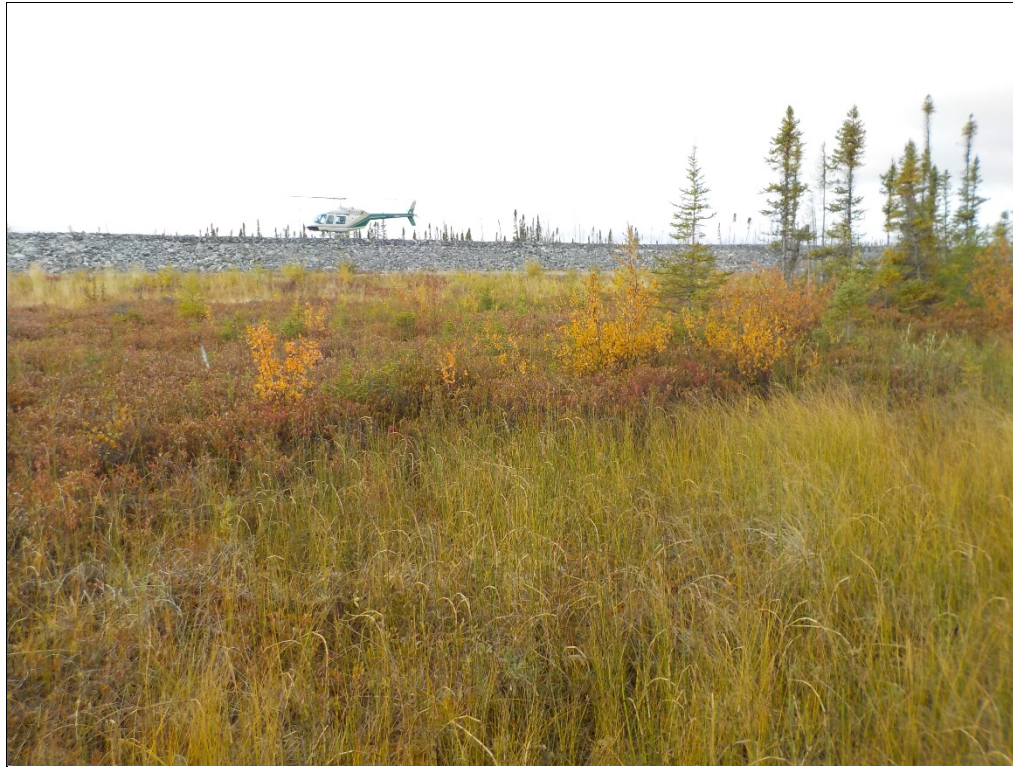
It was also noted in 2016 that a shallow slope leading from the dyke clearing to the water's edge should be monitored for the potential to transport sediment from the exposed mineral of the dyke into the marsh. In 2017, it was recommended that a silt fence be installed between the dyke clearing and the wetland at the base of the slope. As of September 2019, no sedimentation or runoff from the dyke was observed, and there had been no recent construction activity in the vicinity. The mineral slope facing the marsh remained shallow, and it appeared that risk of

sedimentation due to runoff was low under current conditions. A peatland with black spruce seedlings and saplings was continuing to regenerate between the dyke clearing and the marsh (Figure 3-5). As regeneration progresses, this peatland is expected to become an increasing barrier to potential runoff. Given the stable condition of the area, no mitigation is recommended at this location. These areas will be monitored for any future runoff effects.

View along the shores of Wetland 40

Regenerating peatland between marsh and dyke clearing

**Figure 3-5: Ground photos of Wetland 40 on September 9, 2019**

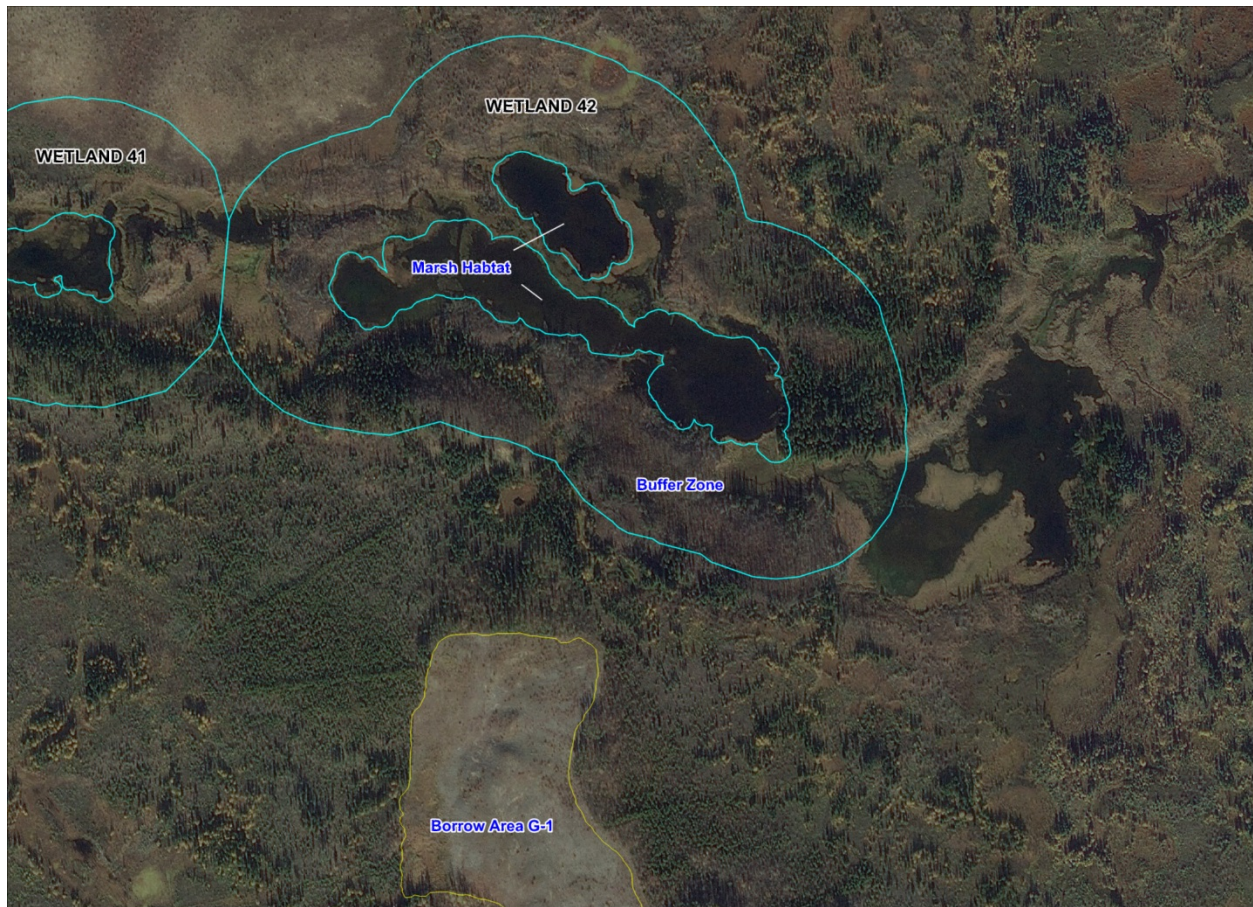
During the 2016 aerial survey, it was noted that there was a significant slope extending downwards from Borrow Area G-1 clearing to the southern edge of the wetland. A sediment control recommendation was not made given that the band of undisturbed vegetation between the exposed mineral area and the marsh buffer was approximately 90 m wide.

Up to the time of the 2019 surveys, there were no signs of erosion along the slope to the wetland. Also, there were no apparent changes in the undisturbed vegetation between the wetland and the cleared area in Borrow Area G-1 (Photo 3-9), and no new clearing or excavation in the nearby portion of Borrow Area G-1. Ground surveys in 2018 found that the peat bank at the base of the slope adjacent to the wetland was beginning to slump and break apart (Photo 3-10). This was likely due to melting permafrost in the recently burned peat plateau bog. The band of intact vegetation will continue to be monitored in order to determine if there is any erosion or surface runoff from the slope into the marsh, but the risk for this is declining due to the advanced state of regeneration in Borrow Area G-1.

**Figure 3-6: Satellite imagery showing proximity of Borrow Area G-1 clearing to Wetland 42**

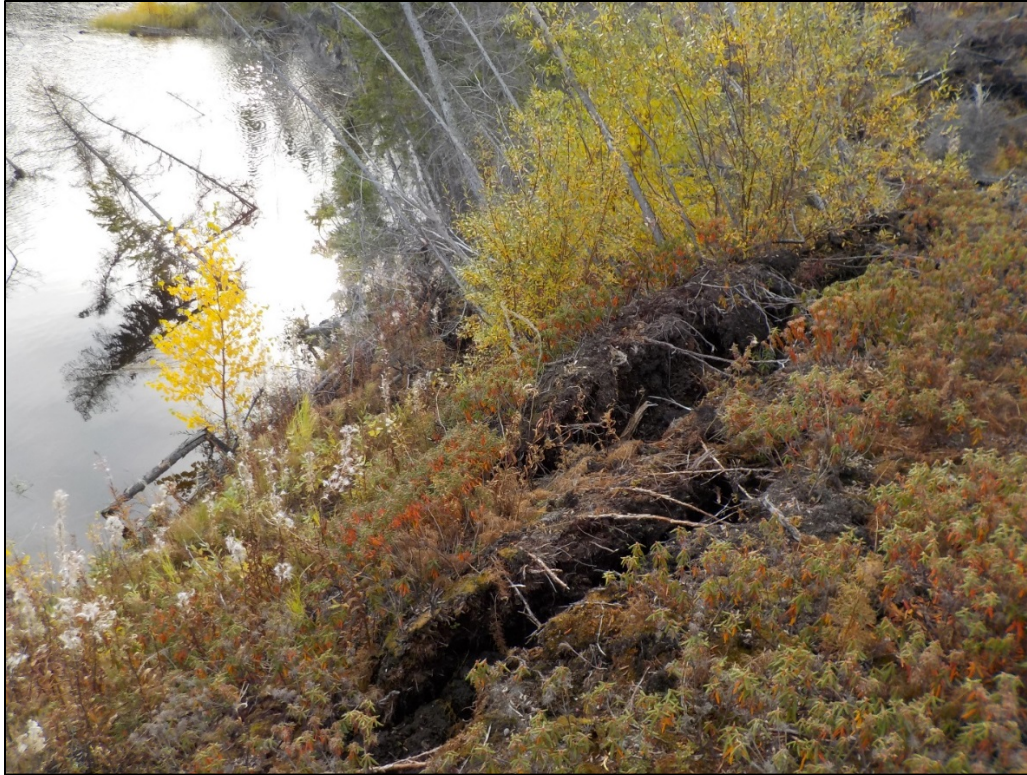
**Photo 3-10: Slumping peat bank adjacent to Wetland 42 on September 16, 2018**

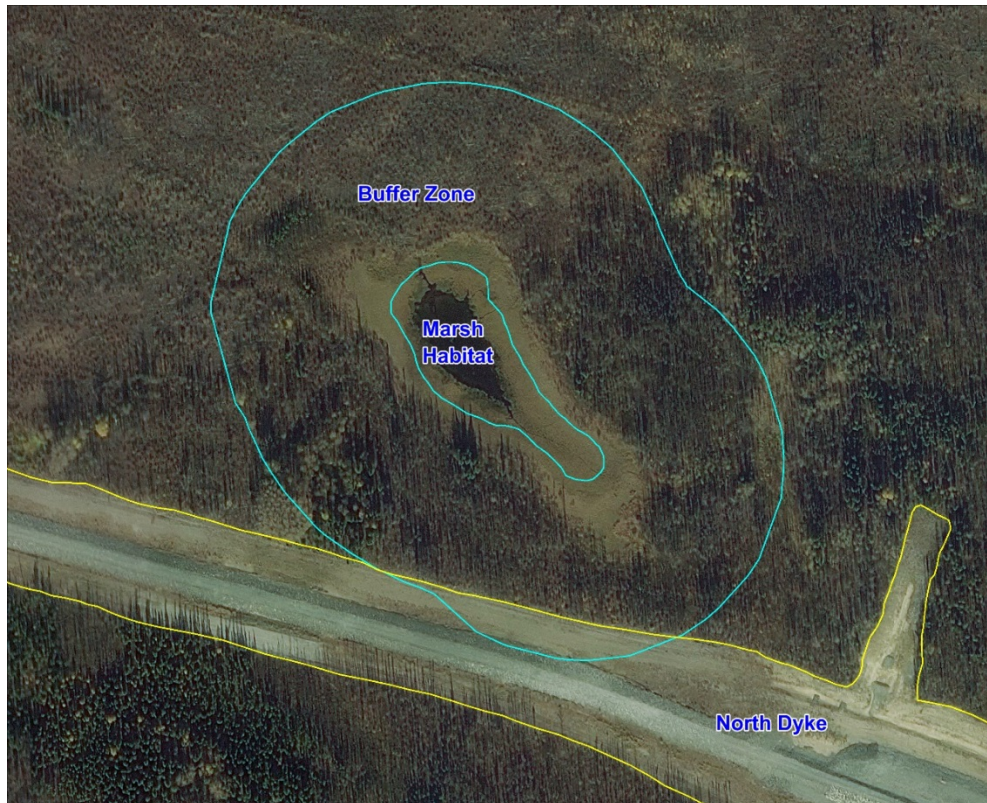
By the time of the 2016 ground survey, north dyke clearing had extended approximately 25 m into the marsh habitat buffer (Figure 3-7; Map 3-1). All of this 0.24 ha of clearing was within the planned Project footprint (Table 3-2) and no other Project impacts were noted at that time. All of the dyke clearing within Wetland 45 was also within the above noted burned area.

**Figure 3-7: Satellite imagery showing North Dyke clearing (all within the planned Project footprint) at Wetland 45 in 2019**

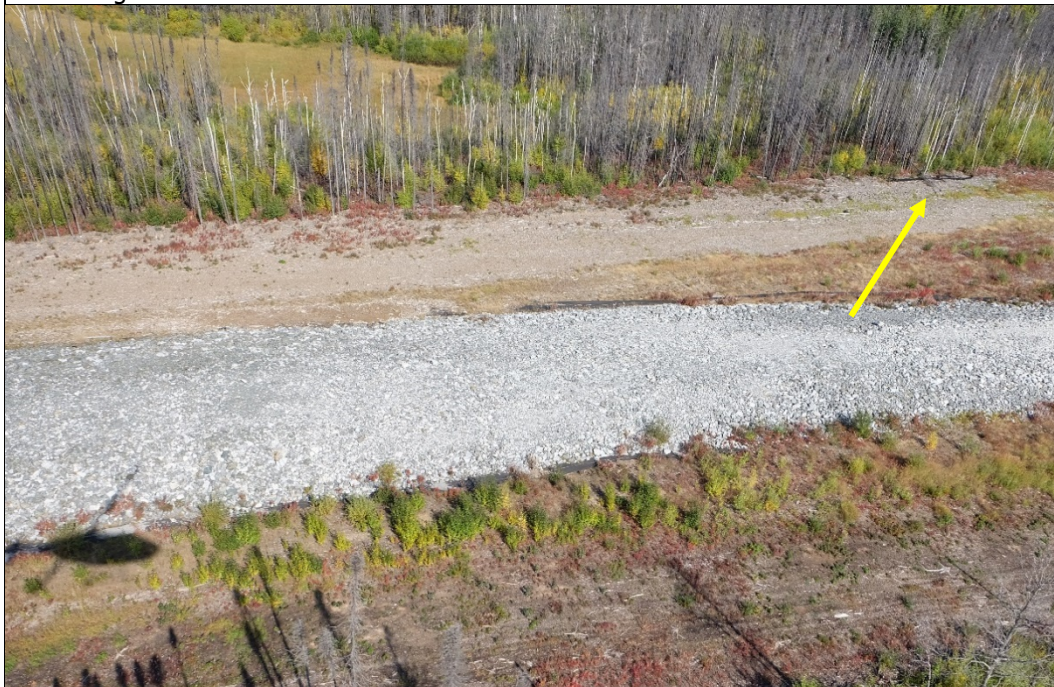
A slope of approximately 15% through the dyke clearing area to the marsh habitat creates the potential for future surface runoff to carry material into the marsh habitat. In addition to the slope

containing exposed mineral material in the cleared area (Figure 3-8), the entire slope had been burned with some areas having virtually all vegetation removed. At the time of the 2019 surveys, no runoff or sedimentation was seen entering the marsh habitat. It was noted that there was a small hill between the wetland and the dyke, which may serve as a natural barrier to potential future runoff. In 2017, it was recommended that staff evaluate and implement sediment control measures such as silt fence where needed as a preventative measure (e.g., a silt fence at the base of the dyke). A short silt fence was installed at one location (Figure 3-8). Given the subsequent stability, additional silt fences no longer appear to be necessary at this location. These areas will be monitored for any future runoff effects.

Silt fence installed at bottom of North Dyke slope near Wetland 45

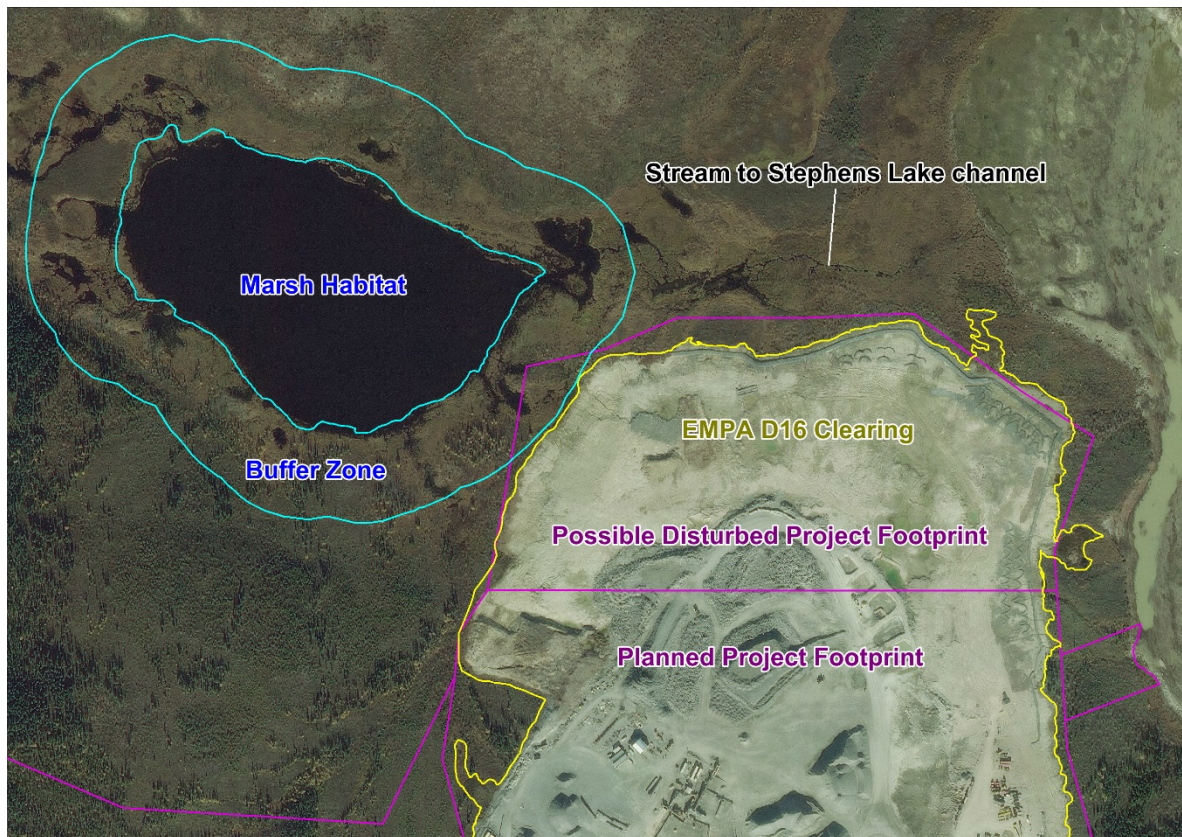
**Figure 3-11: Wetland 51 in 2019 satellite imagery showing adjacent EMPA, stream to Stephens Lake channel, 2019 Project clearing (yellow line), and the boundaries of licensed Project footprint (purple line)**

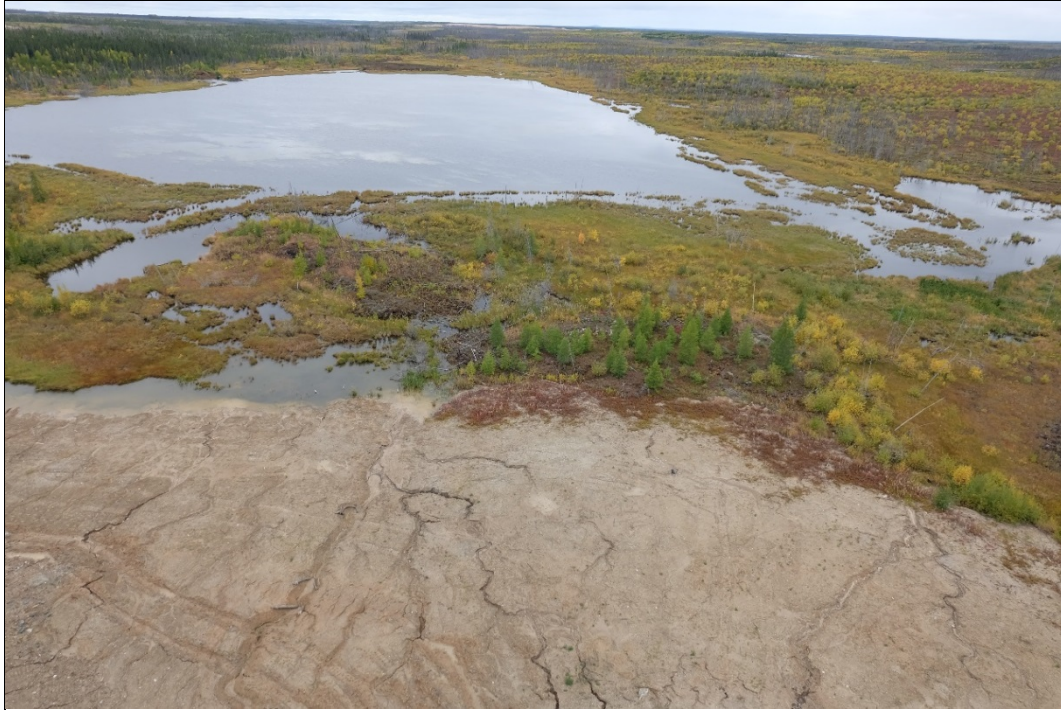
Aerial view of EMPA D16 slope near the east shore of Wetland 51, showing erosion channels and sediment entering marsh habitat buffer

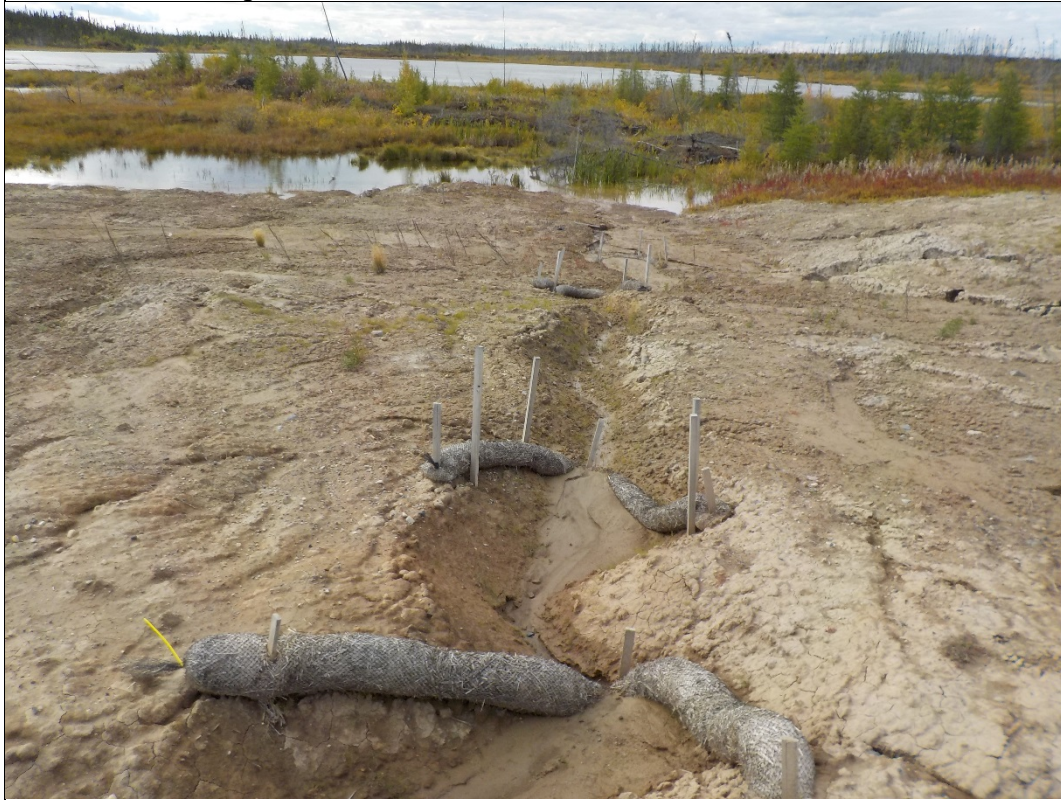
Sediment overtopping straw wattles placed within channels along western edge of Wetland 51

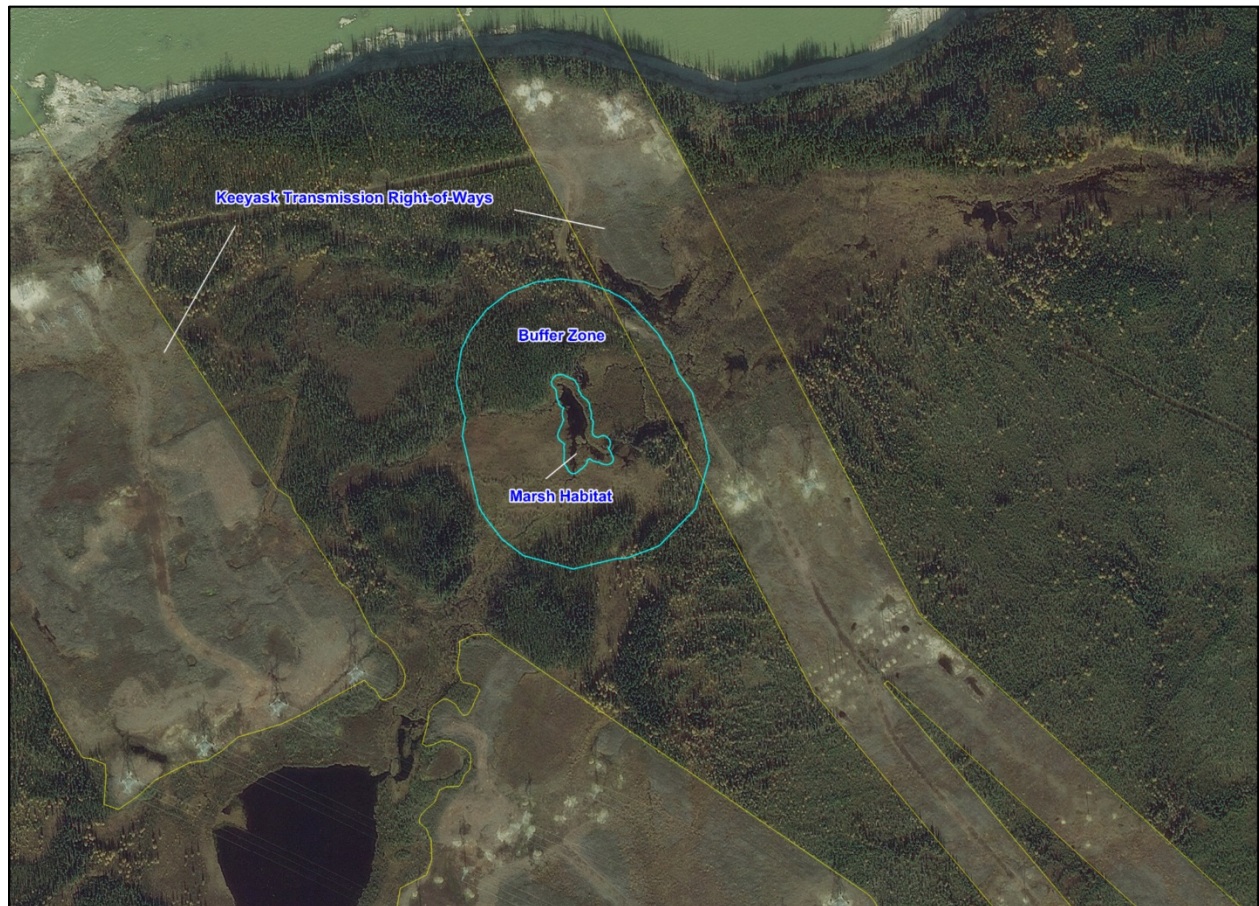
Clearing in the marsh habitat buffer was observed during the 2015 aerial surveys. This clearing was for the Keeyask Transmission Project right-of-way (RoW), which is a separate project (Figure 3-14; Photo 3-13). See ECOSTEM (2018) for details.

**Figure 3-14: Satellite imagery showing Keeyask Transmission Project clearing in the Wetland 53 buffer zone**

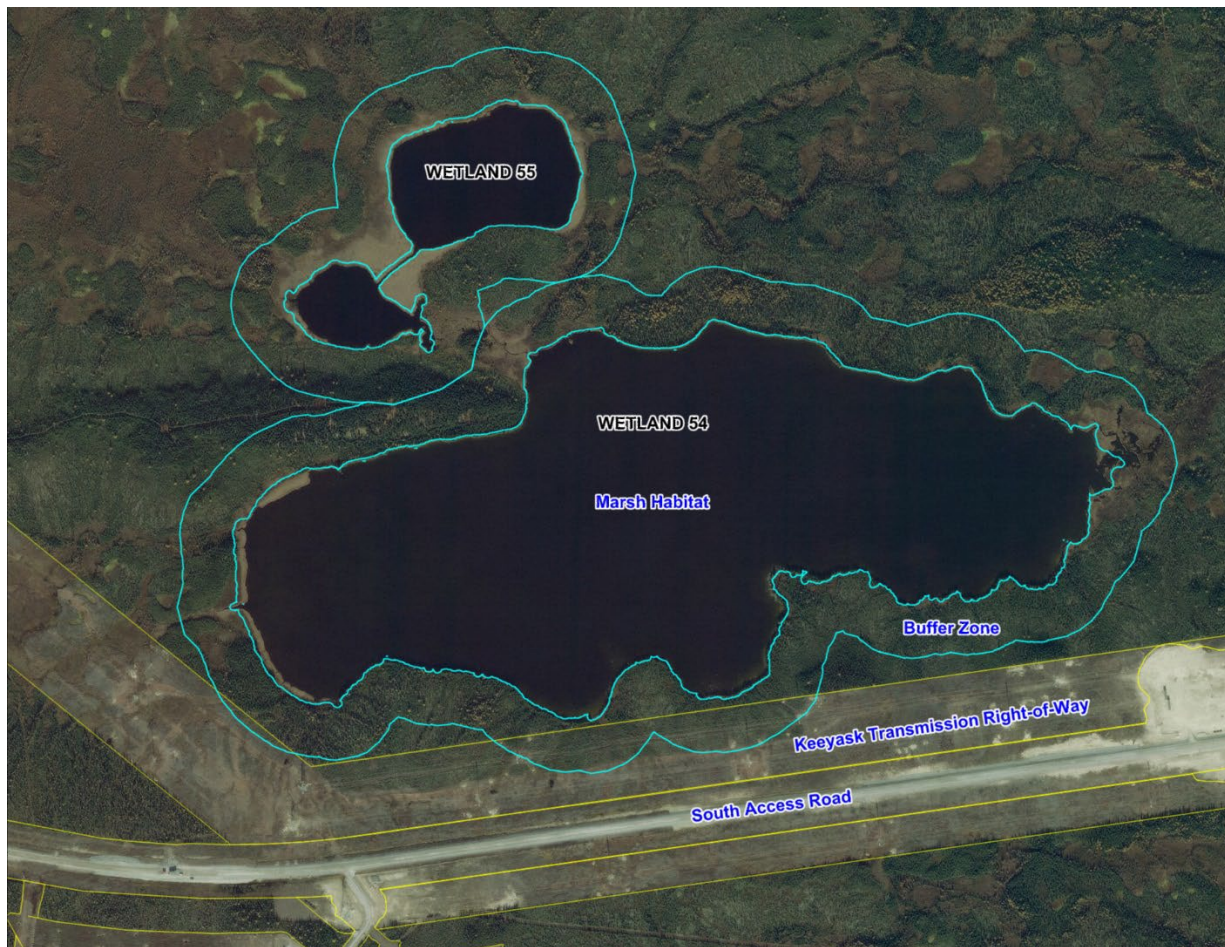
Surveys in 2015 and 2016 found clearing and disturbance in the marsh habitat buffer, but this was for the Keeyask Transmission Project RoW (Figure 3-15). Ground surveys in 2016 and 2017, and aerial surveys in 2018 and 2019 found no expansion of the impacts recorded in 2015 and 2016. The relatively dense existing low vegetation in the cleared areas within 100 m of the marsh should be adequate to stabilize soils and facilitate revegetation. Specific observations regarding the impacts observed in 2015 and 2016 are provided in ECOSTEM (2018).

**Figure 3-15: Satellite imagery showing Keeyask Transmission Project clearing in the Wetland 54 buffer zone**

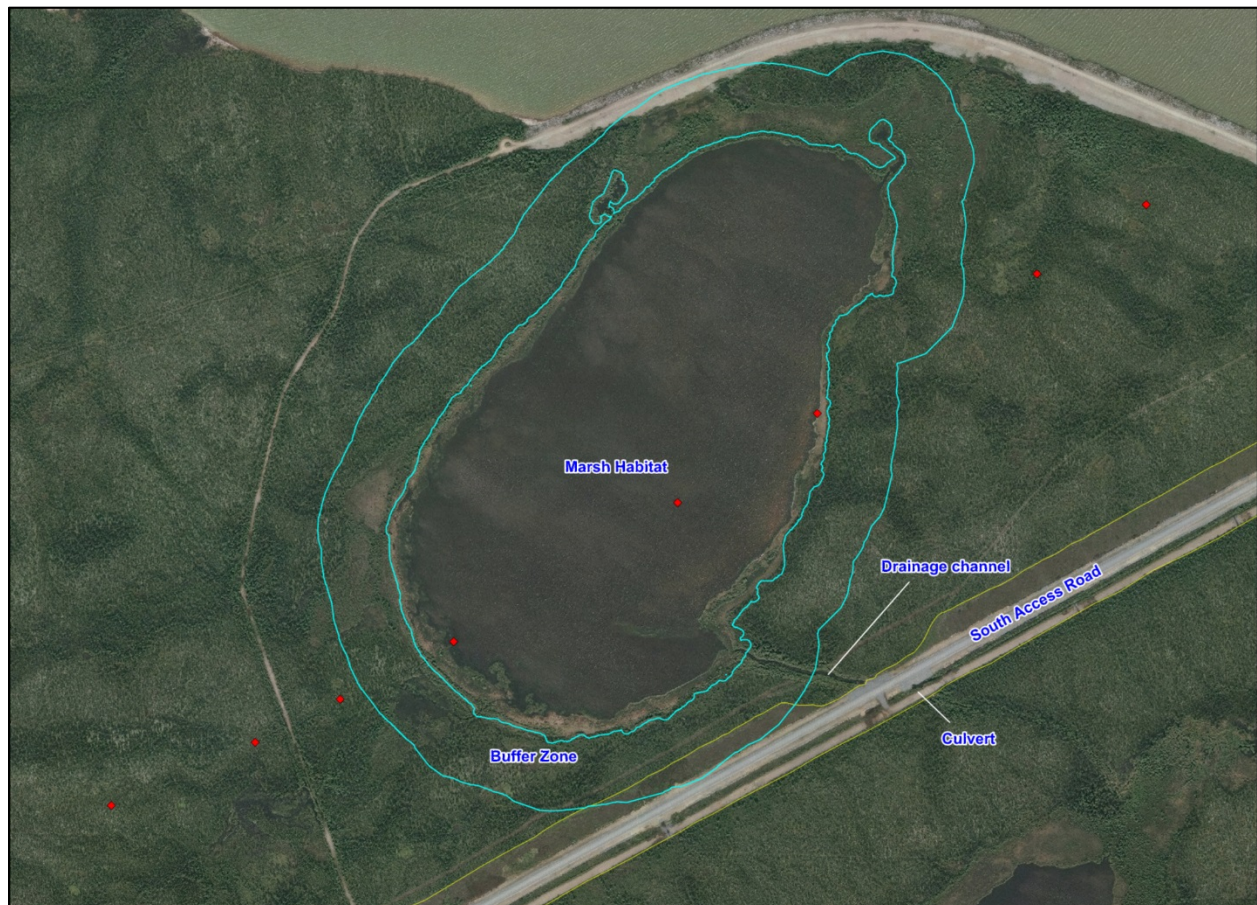
**Figure 3-16: Satellite imagery showing South Access Road clearing in the Wetland 57 buffer zone (all within the planned Project footprint)**

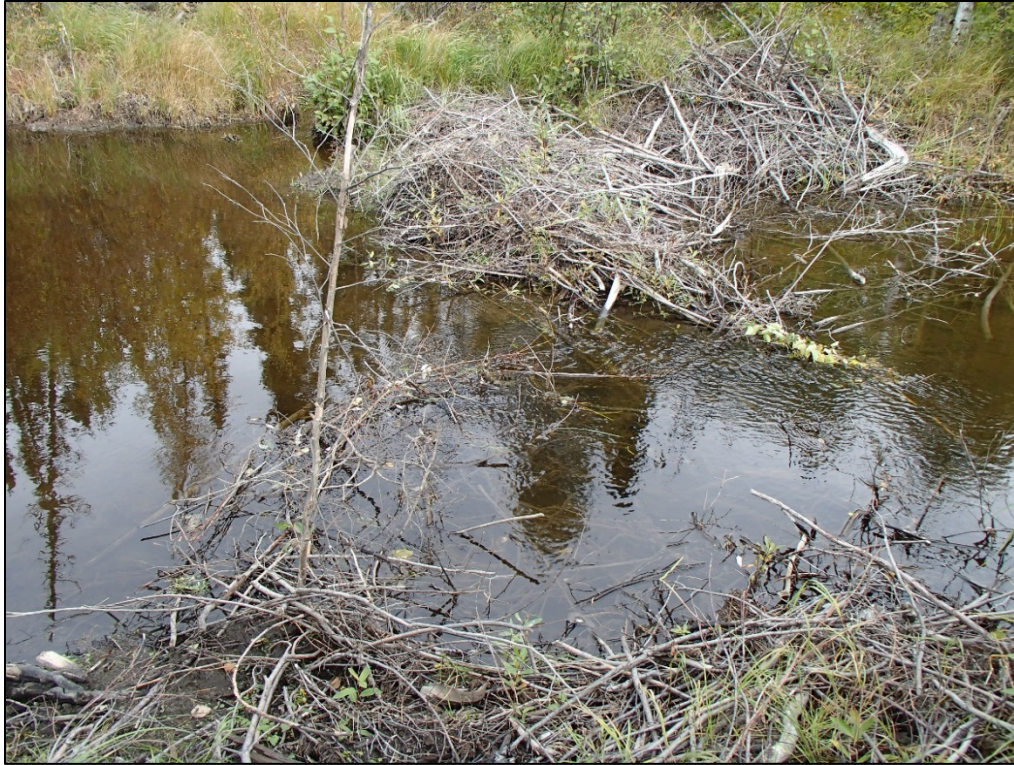
**Photo 3-15: Breached beaver dam in drainage channel of Wetland 57 on September 9, 2019**

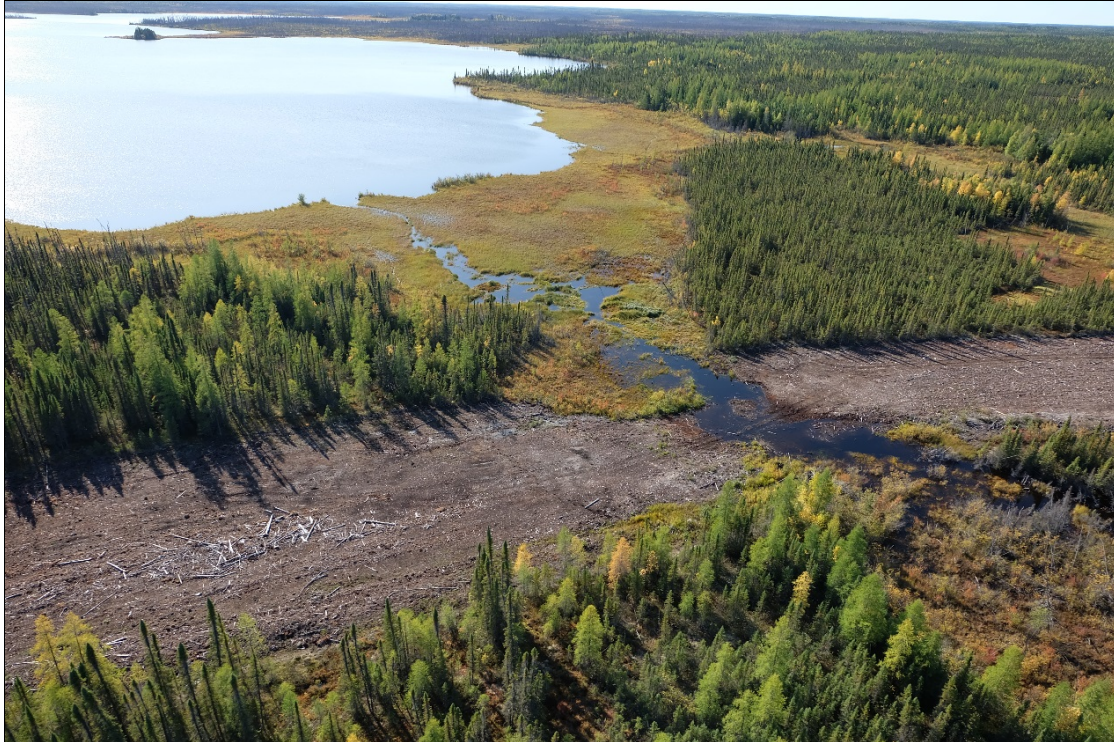
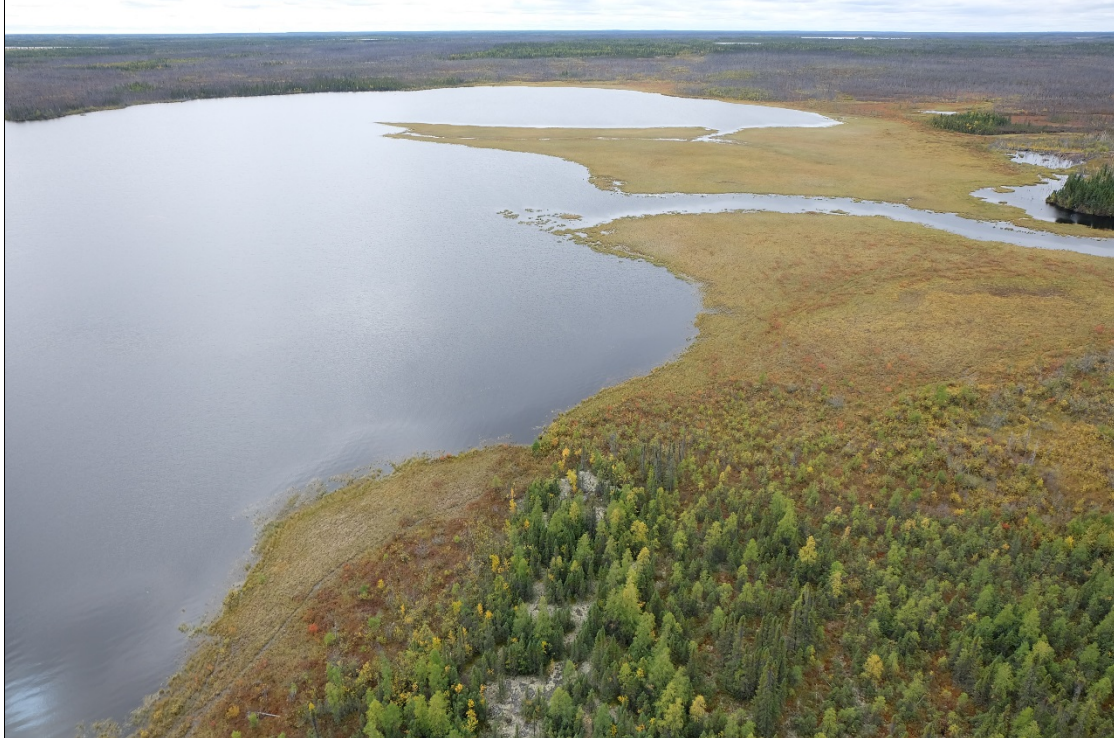
In terms of other potential Project impacts, a natural drainage channel into the wetland ran through the clearing (Figure 3-19). There is a possibility that the vegetation clearing, past construction activity or future revegetation activity could alter water flow into the wetland through localized changes to the moisture regime or soil compaction.

Ellis Esker access road adjacent to wetland buffer

**Figure 3-19: Aerial views of Wetland 60 on September 9, 2019**
