Keeyask Generation Project Aquatic Effects Monitoring Plan

Fish Winterkill Survey in Little Gull Lake Report

REPORT #AEMP-2022-08

FISH WINTERKILL SURVEY IN LITTLE GULL LAKE: YEAR 1 MONITORING

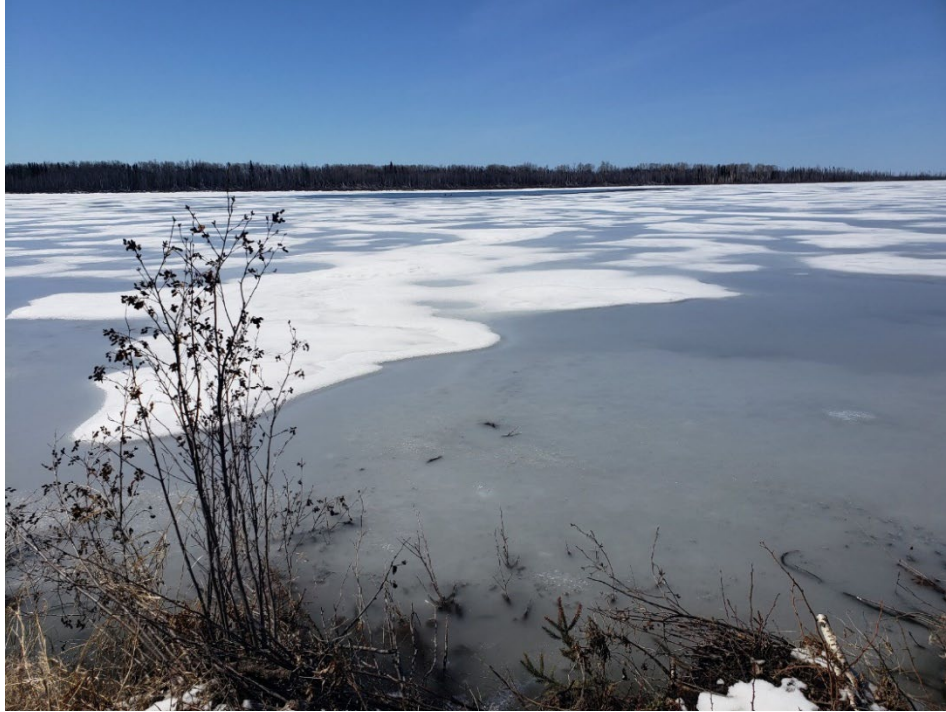
On May 27, 2021, Little Gull Lake was frozen, except for an area surrounding the aerator. Photos were taken from the north shore (Photos 1-3).

Photo 1: Little Gull Lake on May 27, 2021, from the North shore facing South. Open water surrounding the aerator is shown.

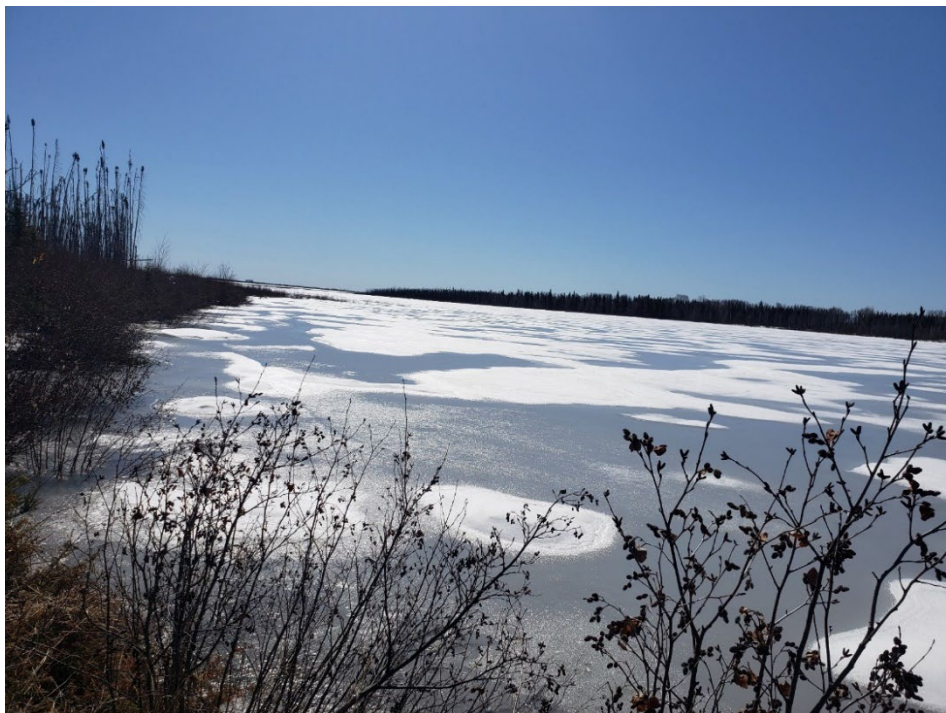
Photo 2: Little Gull Lake on May 27, 2021, on the North shore facing East towards the connection to the Nelson River.

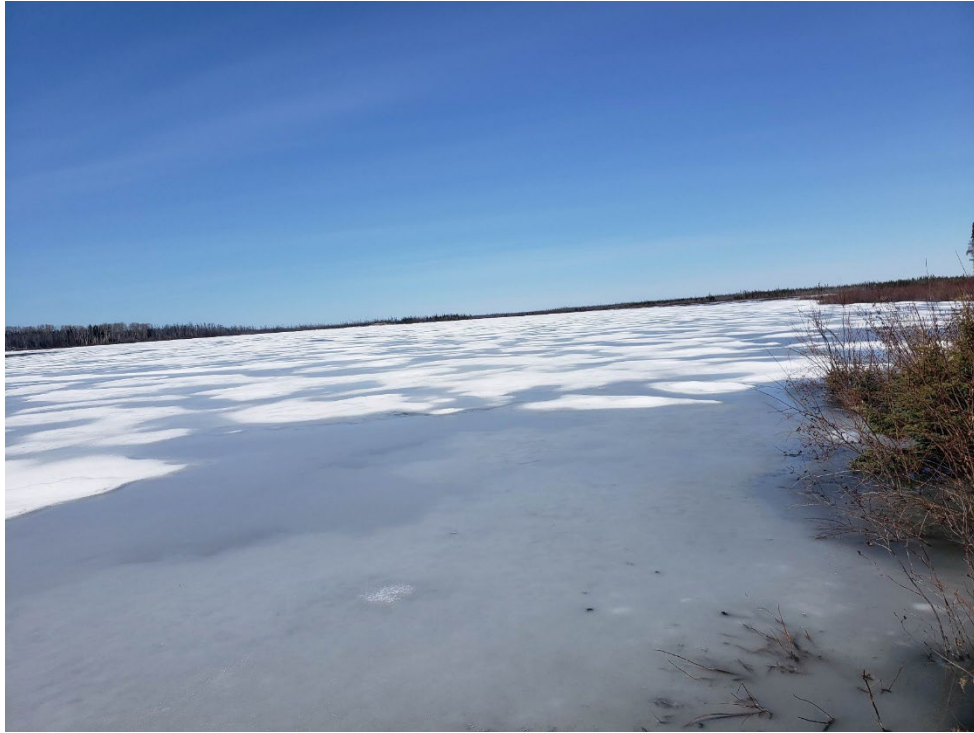
Photo 3: Little Gull Lake on May 27, 2021, on the North shore facing West.

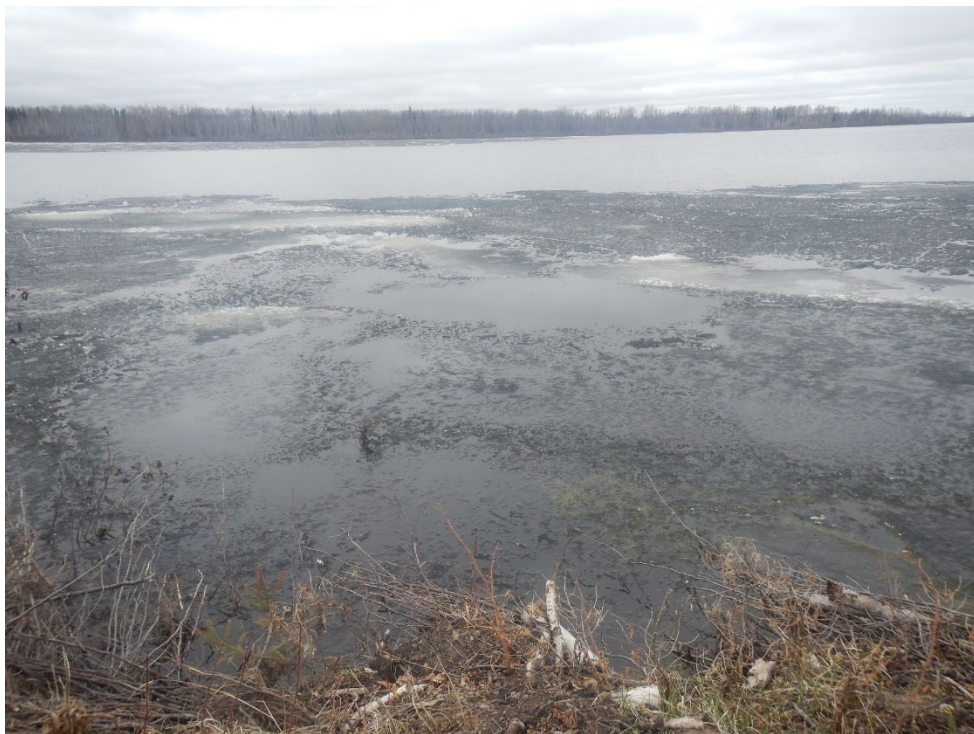
On May 30, 2021, Little Gull Lake was largely ice-free in the eastern extent. The connection to the Nelson River mainstem was still blocked by ice. A survey was conducted by walking the north shore, no dead fish were observed (Photos 4-6).

Photo 4: Little Gull Lake on May 30, 2021, on the North shore facing South.

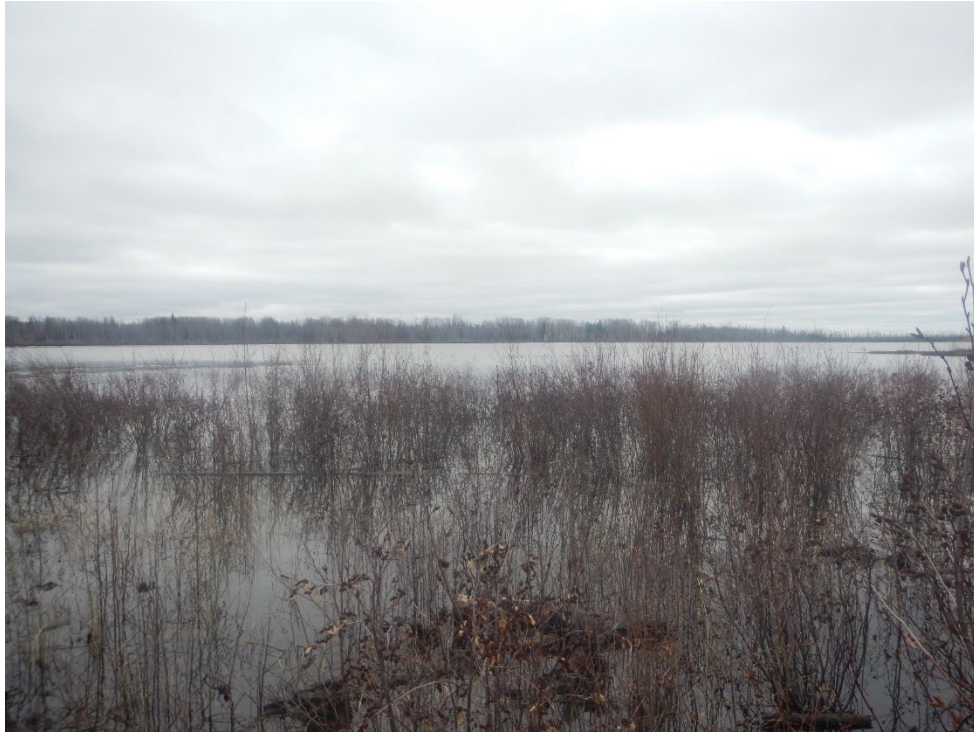
Photo 5: Flooded shoreline along North shore of Little Gull Lake, May 30, 2021.

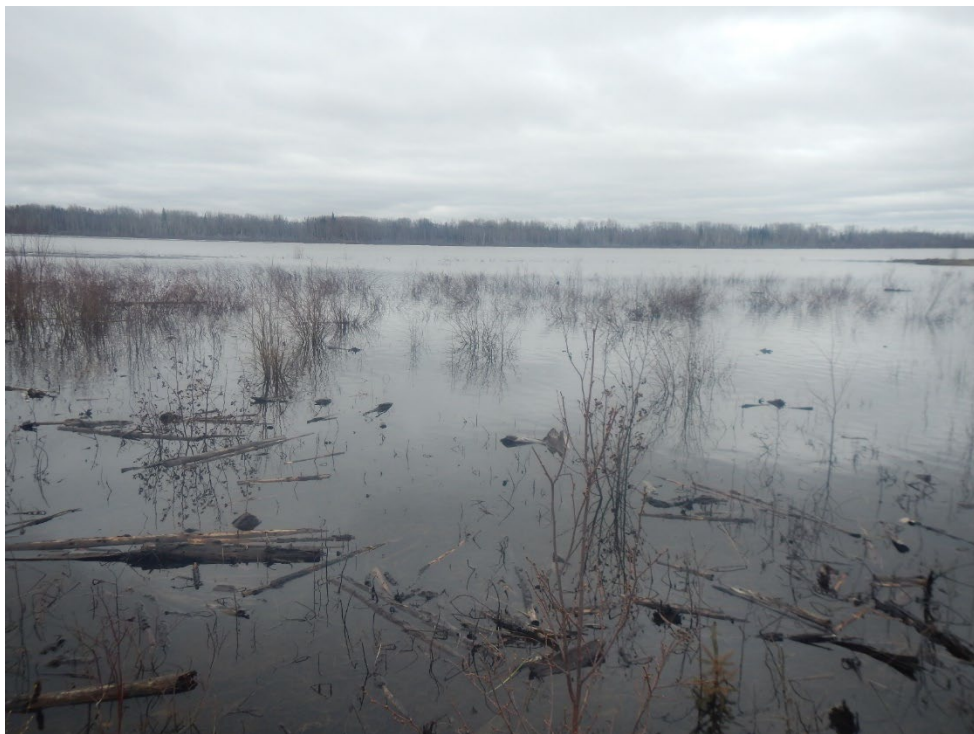
Photo 6: Flooded shoreline along North shore of Little Gull Lake, May 30, 2021.

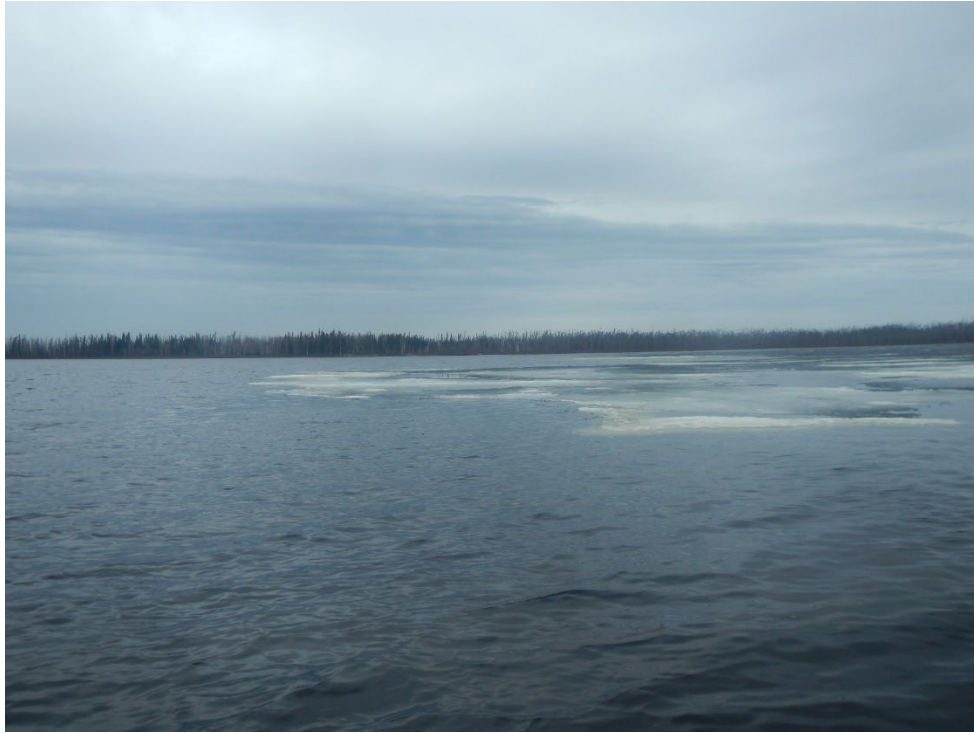
On May 31, 2021, Little Gull Lake was largely ice-free over its entire extent, however, the eastern extent and the connection to the Nelson River remained blocked by ice. An aluminum Jon boat was paddled around the perimeter of open water (Map 2; Photos 7-8).

Photo 7: Little Gull Lake from South shore facing North, May 31, 2021.

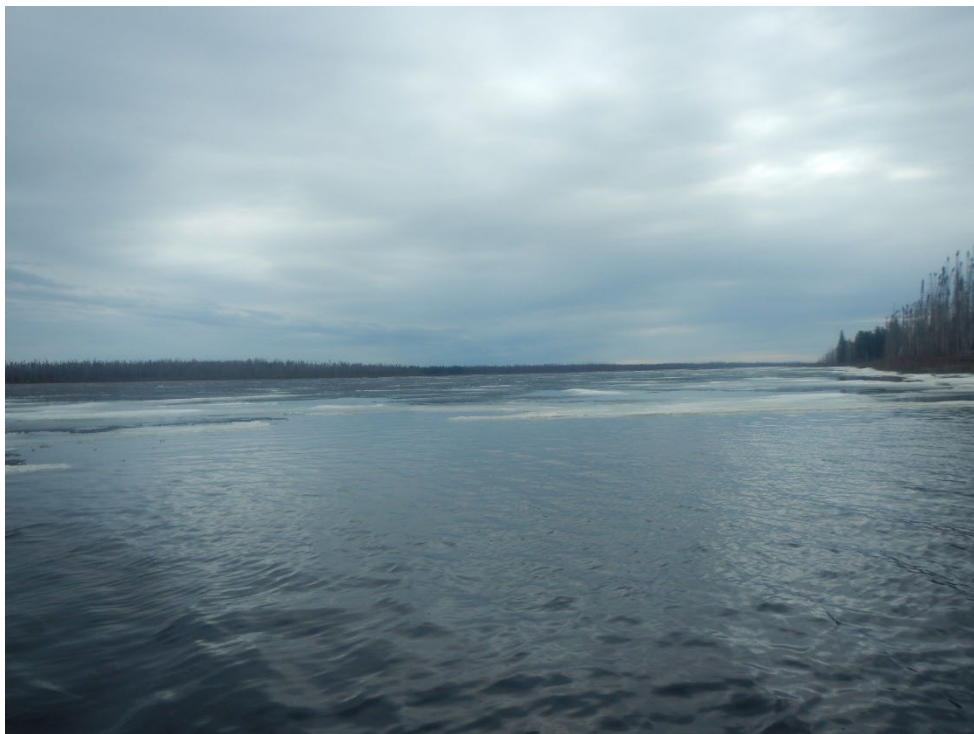
Photo 8: Little Gull Lake from South edge facing east towards connection to the Nelson River mainstem.
