Keeyask Generation Project Terrestrial Effects Monitoring Plan

Habitat Loss and Disturbance Monitoring Report

TEMP-2023-01

HABITAT LOSS AND DISTURBANCE MONITORING YEAR 1 OPERATION 2022

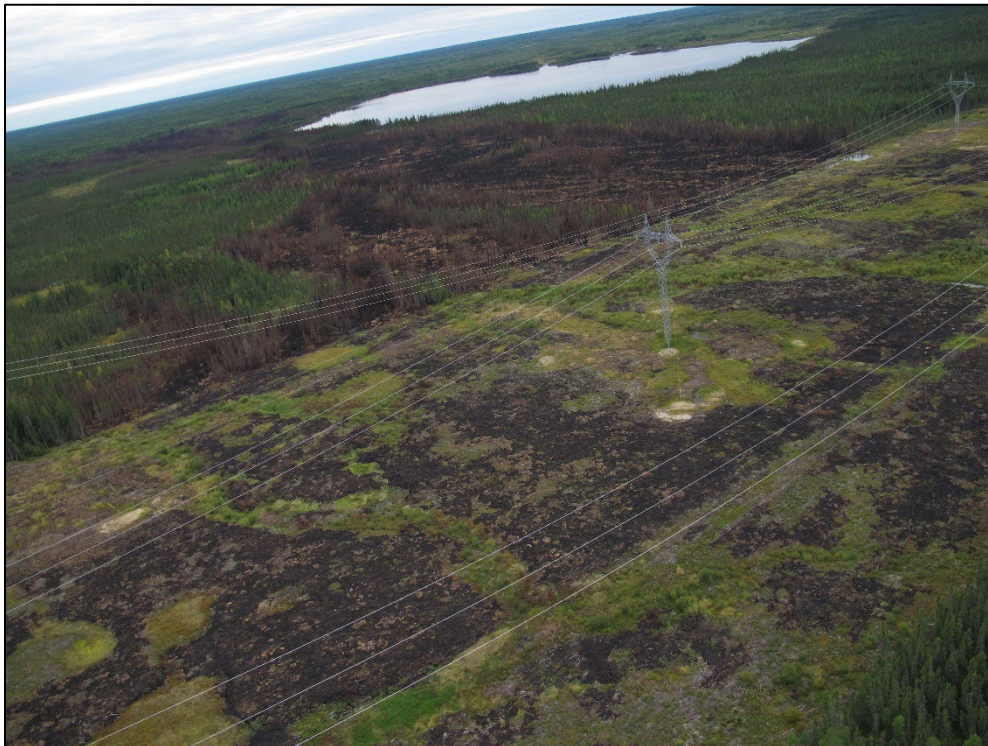
A wildfire in 2022 burned approximately 125 ha of forest area south of the SAR about halfway between the Butnau dam and the town of Gillam (Photo 3-1). The fire overlapped approximately 25 ha of the approved project Footprint.

Photo 3-1: Forest fire south of SAR in 2022

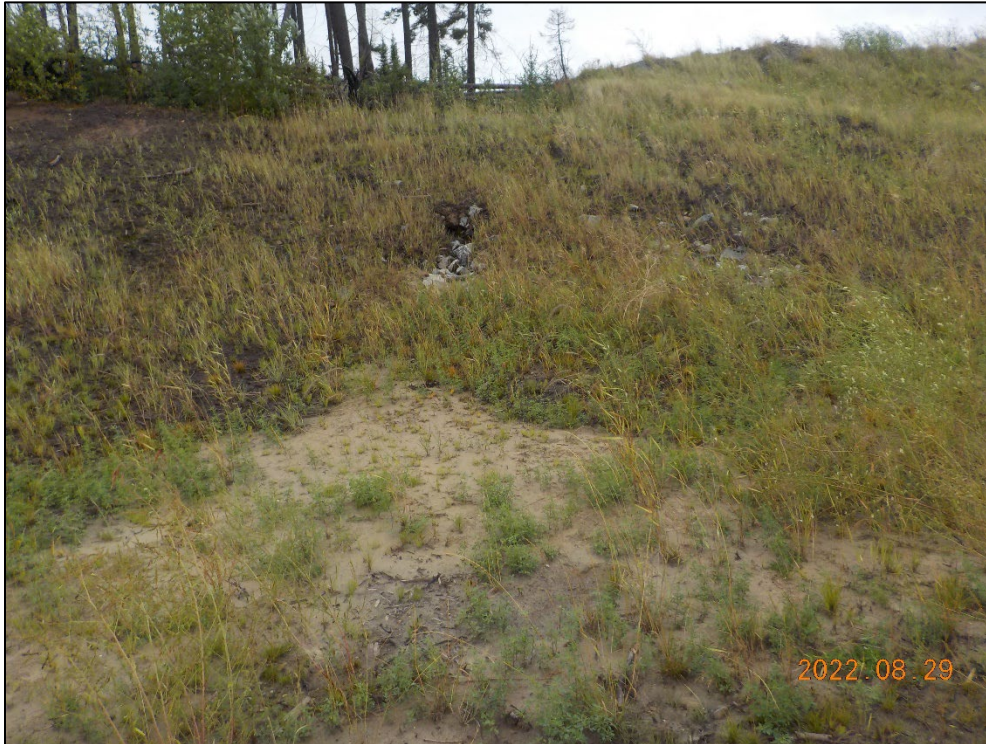
Erosion disturbance of the NAR bank adjacent to Borrow Area KM-1 first identified during 2016 surveys continued in 2022, however the effects were minor and not likely to increase in extent (Photo 3-2). Monitoring of this site will continue.

Photo 3-2: Erosion on NAR side bank adjacent to Borrow Area KM-1 in 2022

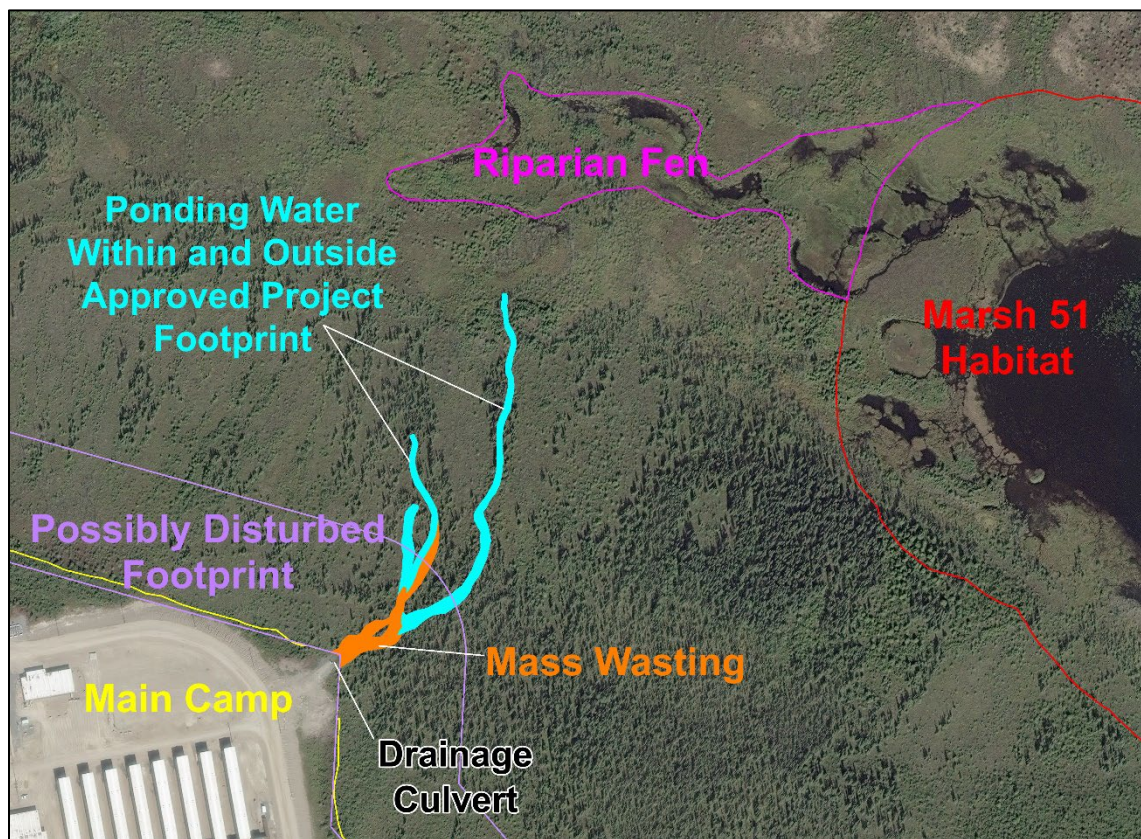
By September 2022, the flowing water from the culvert at the northeast corner of the Main Camp extended approximately 350 m into the undisturbed forest (Map 3-2; Figure 3-1). This was an increase of 90 m since September 2021. The total associated disturbed area expanded by 0.06 ha in the possibly disturbed Project area, and by 0.08 ha outside of the planned and possibly disturbed Project Footprint areas. At the time of the 2022 survey, this disturbance extended more than 250 metres past the approved Project Footprint boundary.

Figure 3-1: Mass wasting (in orange) and ponded water (in blue) outside Main Camp

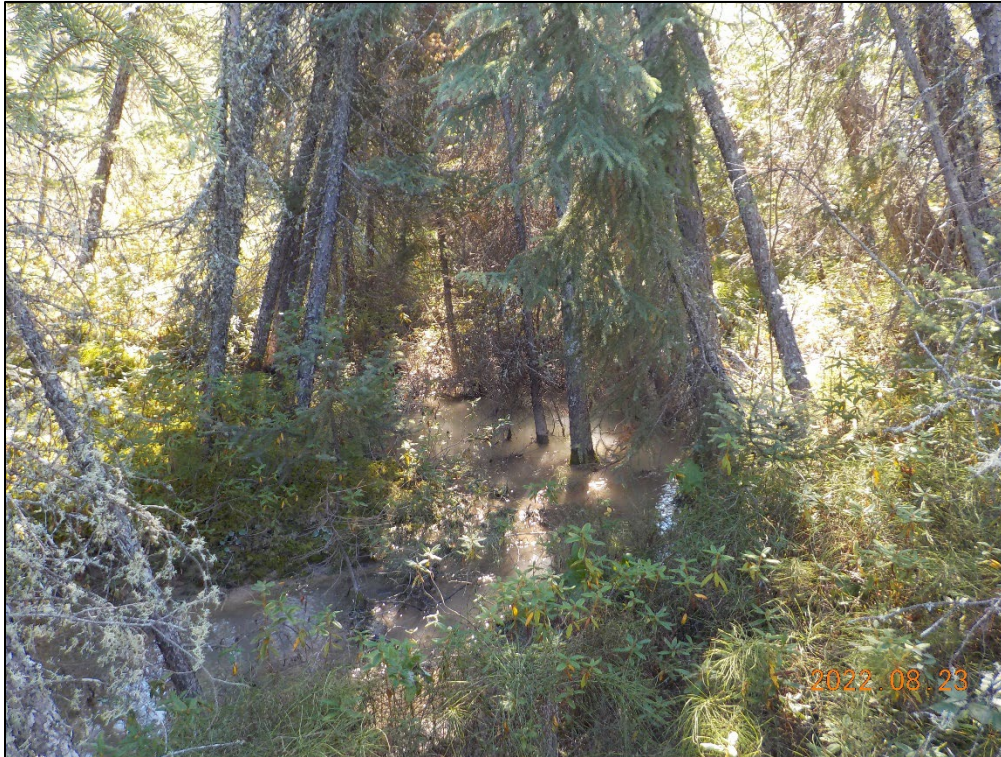
In 2022, the flowing water continued to run underground in spots, topple trees and deposit sediment (Photo 3-3). The flowing water continued causing the substrate to subside, and by up to a metre or more in some areas (Photo 3-3). Outside of the Project Footprint, this disturbance was affecting a common habitat type (black spruce (*Picea mariana*) dominant vegetation on thin peatland). At the time of the 2022 survey, this disturbance had also reached the low area adjacent

Photo 3-3: Flowing water, subsidence and toppled trees outside Main Camp in 2022

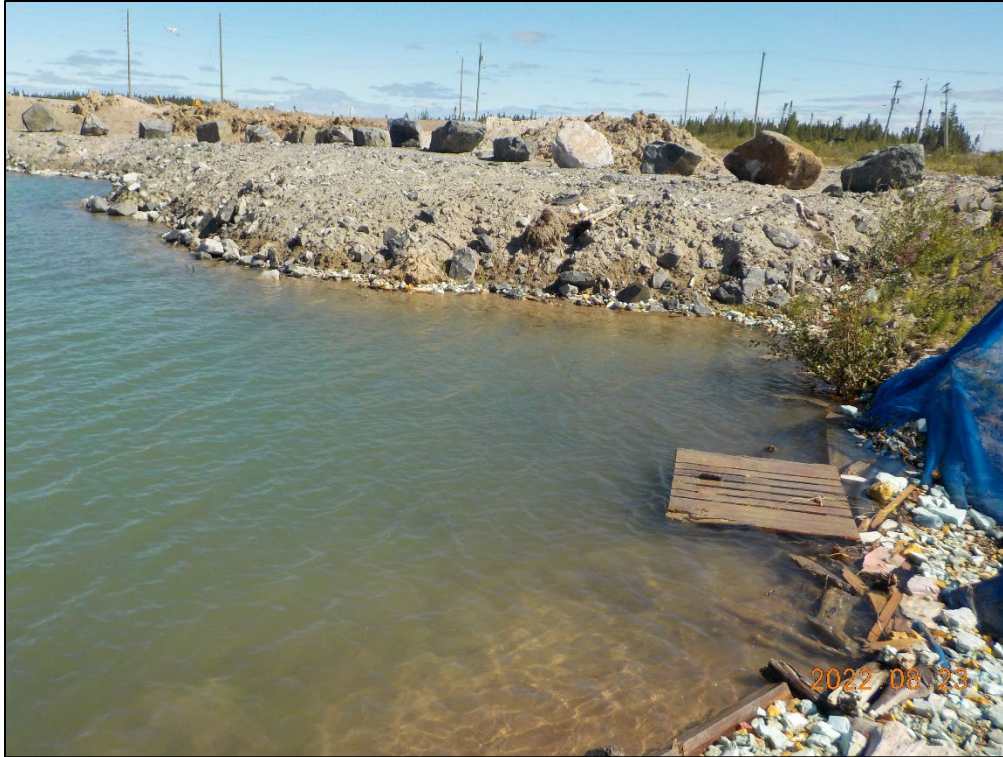
A large amount of construction debris was observed along the edges of the excavated crater in Quarry A (in the southeast corner of Work Area A; Map 3-2; Photo 3-4). Small, broken up pieces of Styrofoam and other debris were observed to be floating in the water, encircling the crater walls. This quarry was still active in 2022 and was being used in support of site decommissioning.

Photo 3-4: Construction debris along the excavated crater walls in Quarry A in 2022

In Quarry A, in the southeastern corner of Work Area A, construction debris encircling the excavated crater walls was composed mostly of small broken pieces of Styrofoam (see Section 3.3.2 for details). Wind could carry the small pieces of Styrofoam a substantial distance. It is recommended that the debris and small pieces of Styrofoam be removed as soon as feasible.

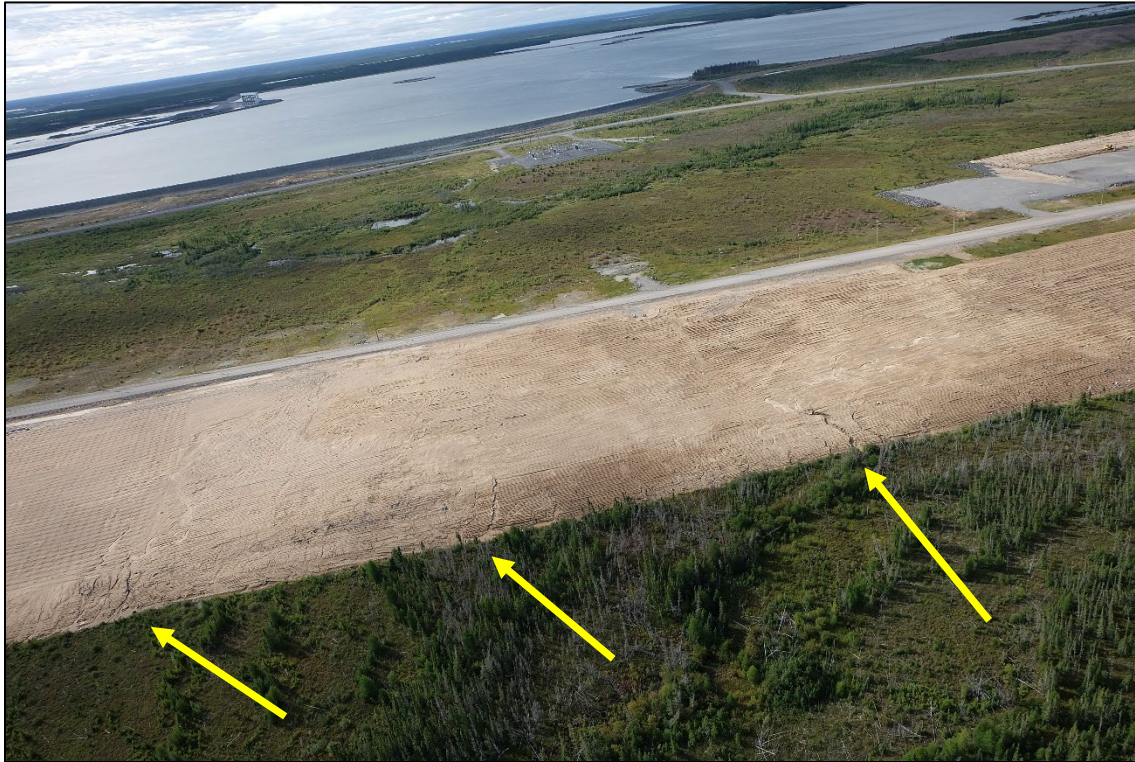
New locations of erosion at the northern edge of Work Area A were observed during the 2022 survey (Map 3-2; Photo 3-5). These locations had the potential to deposit sediment into the adjacent undisturbed vegetation.

Photo 3-5: New locations where erosion may potentially cause sediment deposition into undisturbed vegetation (yellow arrows) along northern edge of Work Area A

New locations where erosion could potentially deposit sediment into the adjacent undisturbed vegetation along the northern edge of Work Area A were identified in 2022 (see Section 3.3.2 for details). It is recommended that measures such as sediment barriers or slope grading be implemented to prevent any possible deposition from extending into the adjacent possibly disturbed Project Footprint.

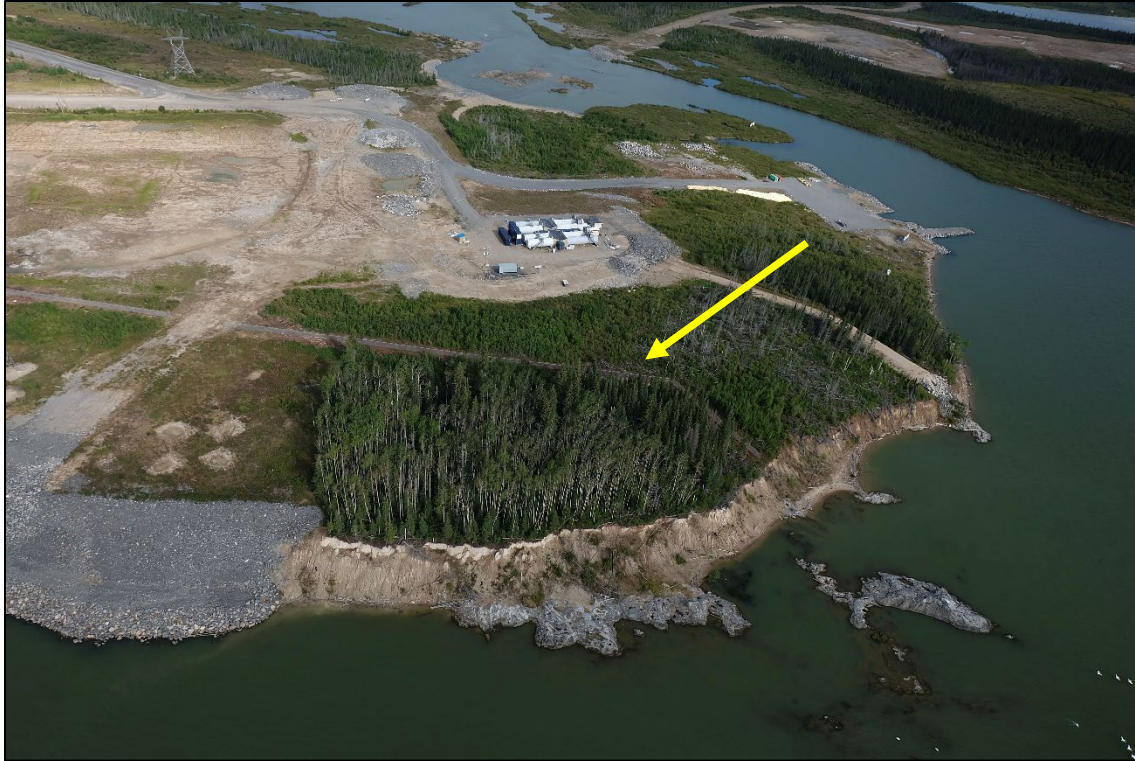
Approximately 0.2 ha of new clearing was identified during 2022 surveys in Work Area C (Map 3-2; Photo 3-6). About 64% of the additional clearing was within the planned Project Footprint and the remainder was outside of the planned and possibly affected portions of the Project Footprint. This clearing was the result of new safety fencing installed on the southern edge of the work area.

Photo 3-6: New clearing for safety fencing (yellow arrow) along the southern edge of Work Area C in 2022

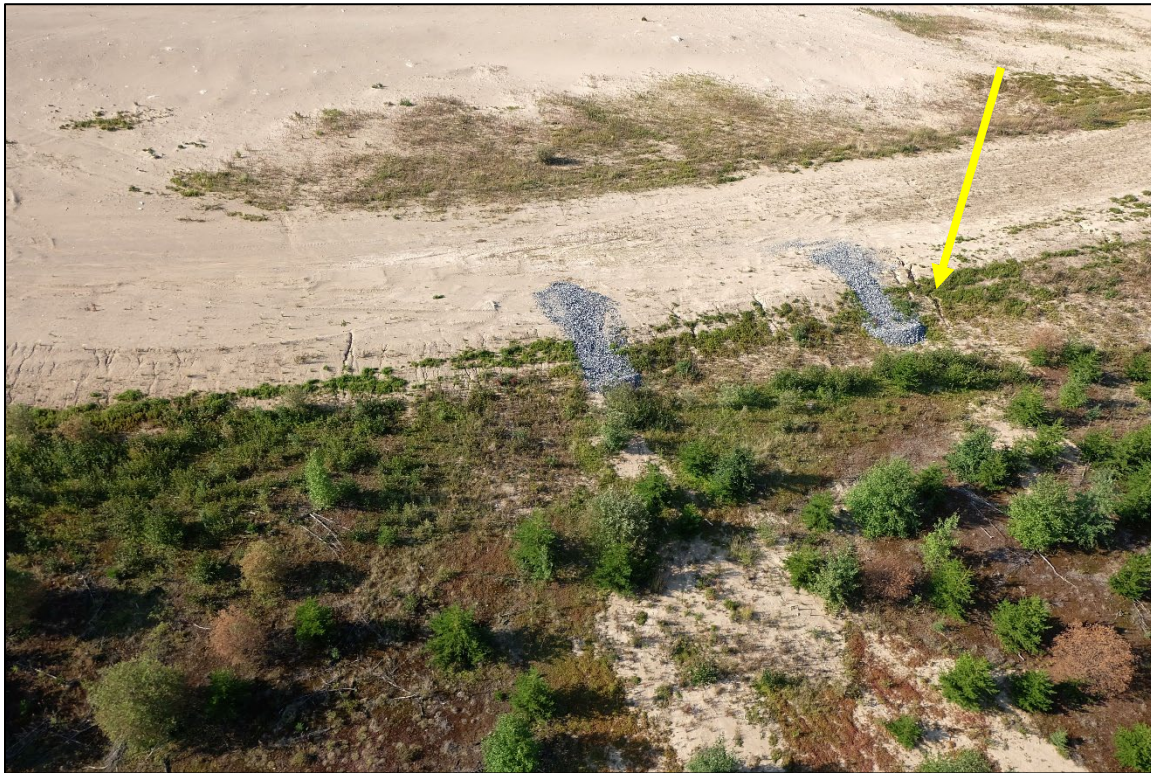
Previously identified erosion and sediment deposition on the northern edge of Borrow Area G-1 at KM 17 were addressed in 2022 with the placement of rock within the erosion channels (Photo 3-7). Sediment deposition from this area had stopped. However, a new erosion channel had formed adjacent to the old ones. This new erosion area may continue depositing sediment into the undisturbed vegetation.

Photo 3-7: Rock placed in old erosion channels and new erosion channel (yellow arrow) at the northern edge of Borrow Area G-1 at KM 17 in 2022

Erosion along the northern edge of Borrow Area G-1 was depositing sediment into the adjacent undisturbed terrestrial habitat (see Section 3.3.3.1 for details). The disturbances are only a few metres from the approved Project Footprint bounds. It is recommended that measures such as sediment barriers or slope grading be implemented to prevent the deposition from extending outside of the approved Project Footprint.

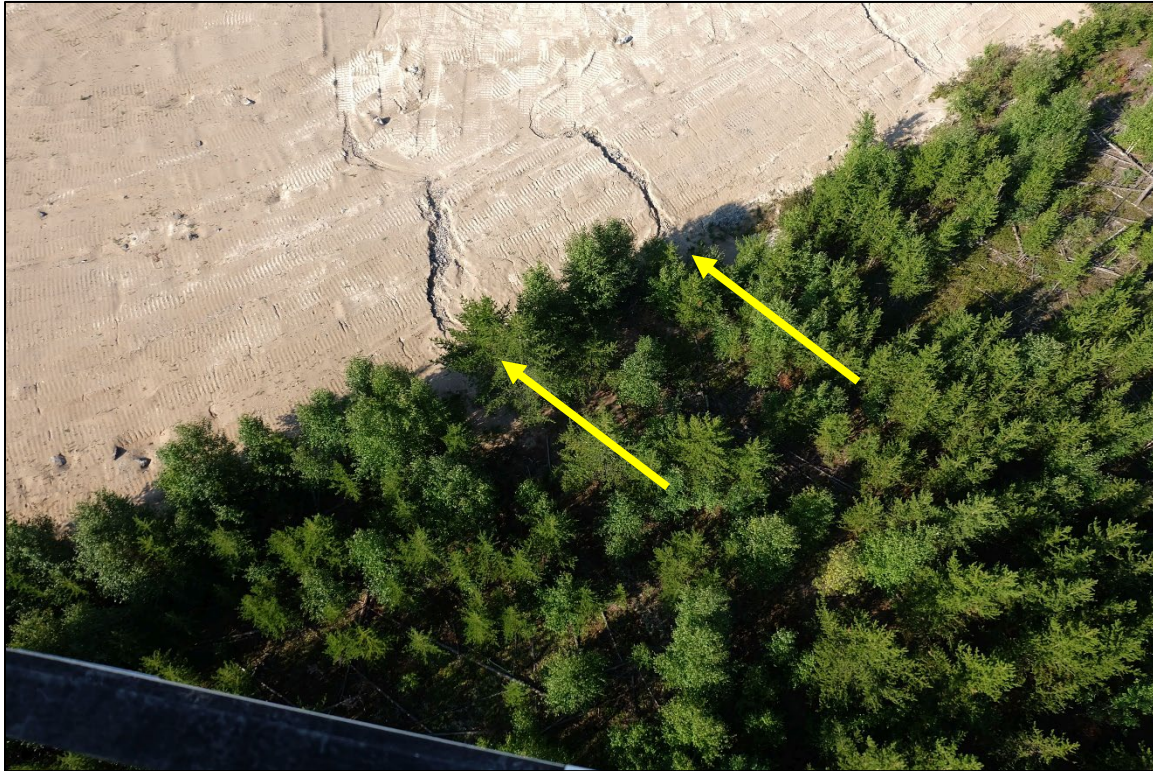
Previously identified erosion and sediment deposition on the northern edge of Borrow Area G-1 at KM 15 were also ongoing at the time of the 2022 survey (Photo 3-8).

Photo 3-8: Erosion and sediment deposition (yellow arrows) on the northern edge of Borrow Area G-1 at KM 15 in 2022

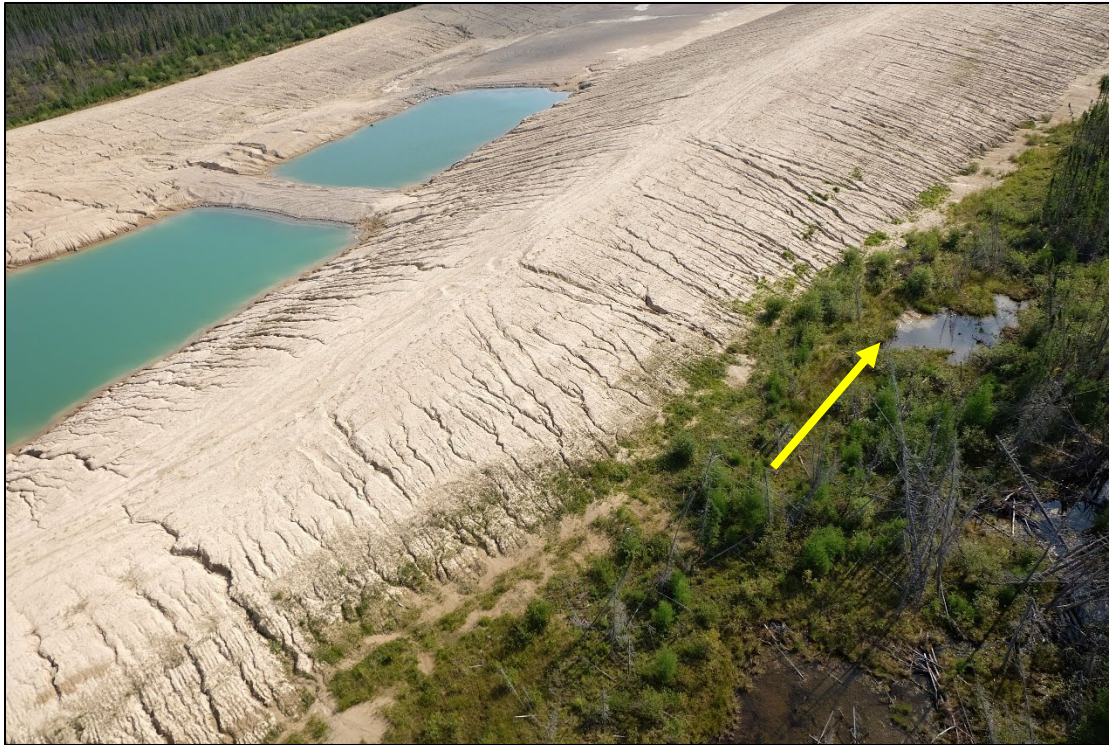
Surveys in 2022 found that sediment deposition on mineral slopes around the perimeter was ongoing in several spots (Map 3-1; Map 3-2). Sediment deposition into an adjacent marsh on the southwestern edge of the borrow area was also ongoing but had not increased since September 2021 (Photo 3-9).

Photo 3-9: Sediment deposits in marsh (yellow arrow) adjacent to Borrow Area G-3 in 2022

At Borrow Area G-3, ongoing erosion and runoff was impacting otherwise undisturbed terrestrial habitat as well as planted tree seedlings (see Section 3.3.3.2 for details). The area potentially affected is relatively large. It is recommended that measures such as sediment barriers be installed or extended at the locations where sediment deposition is impacting otherwise undisturbed terrestrial habitat.

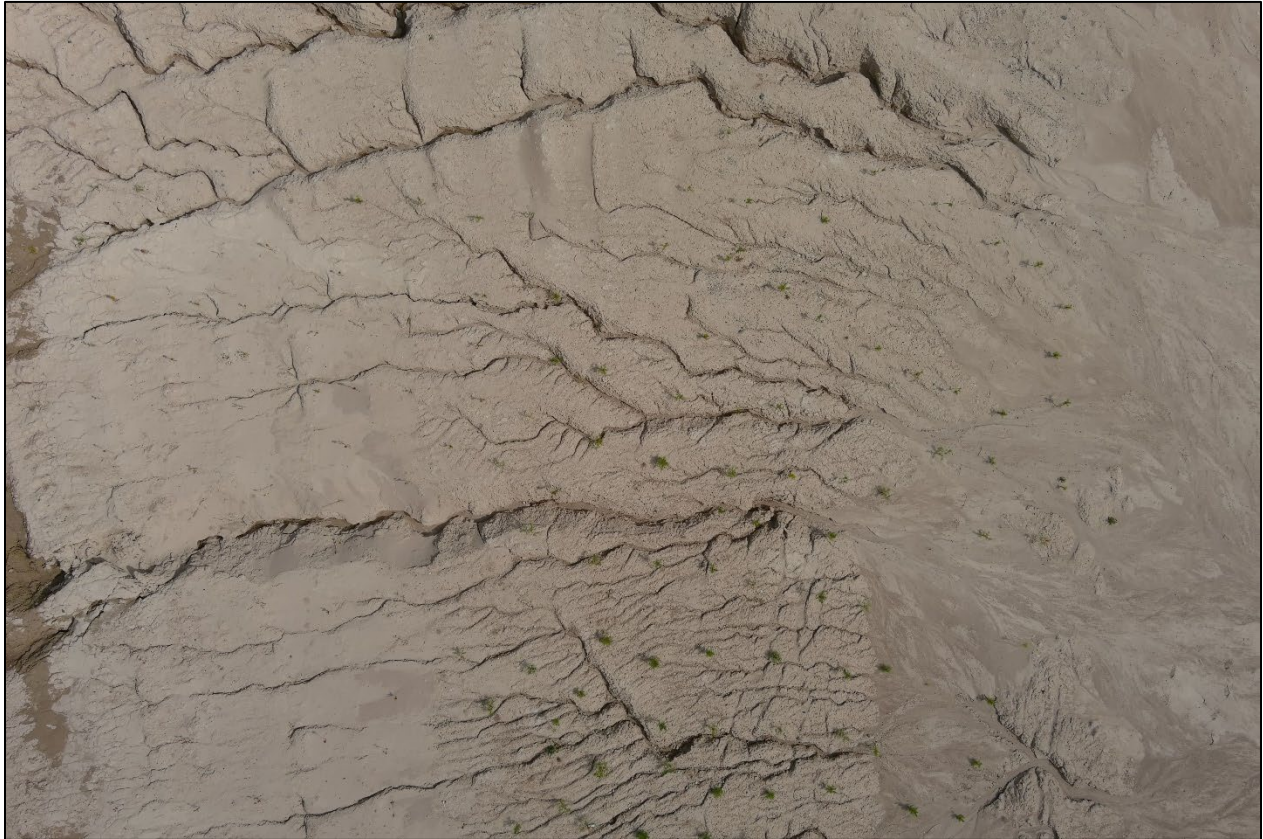
Surveys in 2020 found that erosion on excavated slopes in the eastern half of Borrow Area G-3 had been washing away planted tree seedlings. Monitoring in 2022 found that erosion continued to wash away planted tree seedlings throughout the exposed slopes of the borrow area (Photo 3-10).

Photo 3-10: Erosion affecting planted seedlings in Borrow Area G-3 in 2022

In Borrow Area G-3, erosion on the bank slopes is washing away planted tree seedlings. Mitigation is not recommended as it is unlikely that further impacts can be prevented or reduced. These slopes are long and have been planted with seedlings. It is noted that a factor contributing to the amount of erosion and tree seedling loss is that in some areas the grading and site preparation were implemented in the same direction as the bank slope (Figure 4-1), which increases the amount of downslope water flow and its velocity. Where this is safe to do, a recommendation for future grading and site preparation is to complete the machine work in a direction that is perpendicular to the bank slope direction.

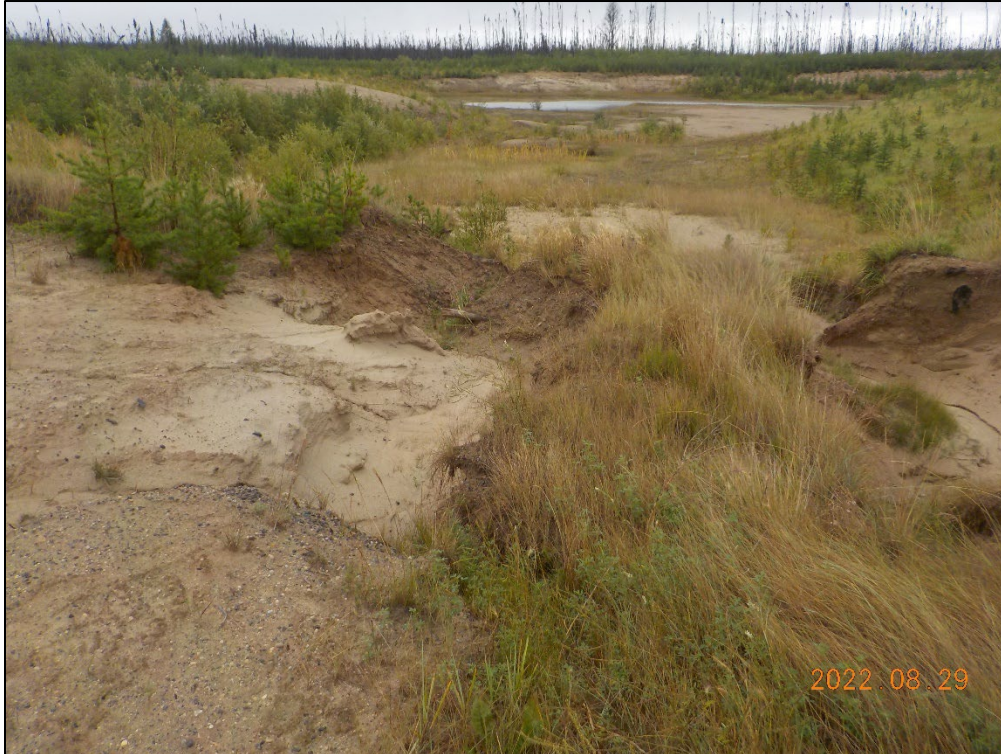
In Borrow Area KM-1, 2022 surveys found that erosion runnels continued to widen and deepen (Photo 3-11). The erosion had washed away planted tree seedlings and saplings.

Photo 3-11: Erosion and affected planted seedlings in Borrow Area KM-1 in 2022

Within Borrow Area KM-1, there is potential for planted tree seedlings to be impacted by erosion, water runoff and the associated sediment deposition (see Section 3.3.3.3 for details). It is recommended that site staff inspect and evaluate these areas to determine if tree seedlings are likely to be lost or damaged and, if so, to implement erosion control measures as needed.

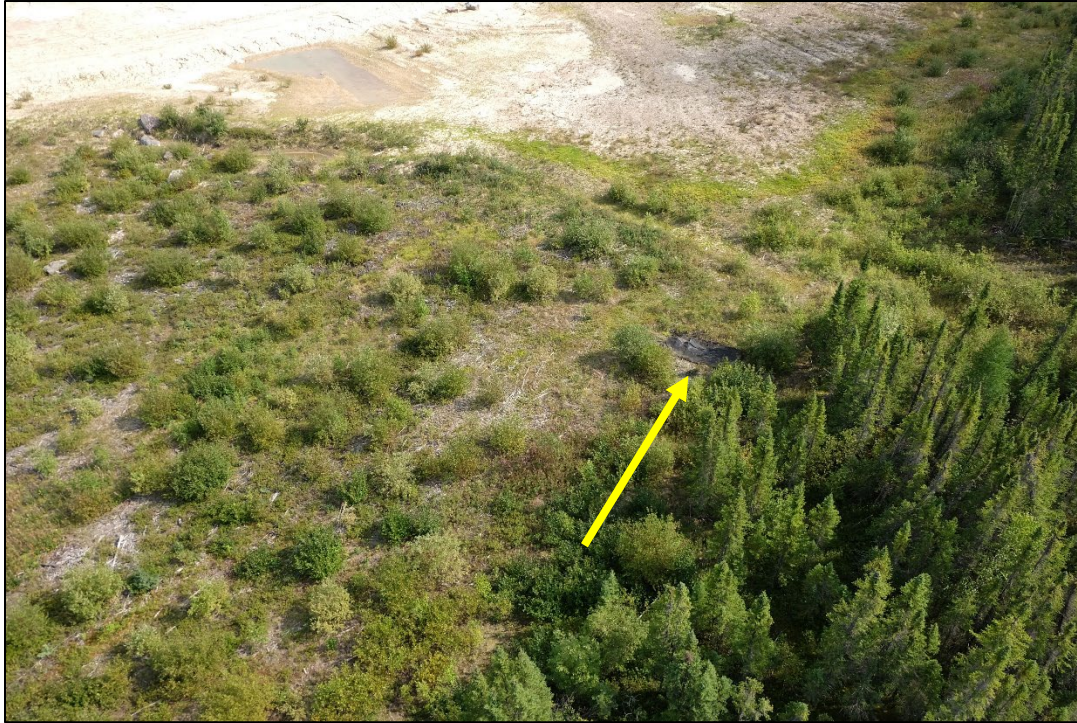
On the south side of Borrow Area N-5, a sediment bag left after a drainage hose was removed was still in place as of September 2022 (Photo 3-12).

Photo 3-12: Sediment bag (yellow arrow) on south side of Borrow Area N-5 in 2022

dewatered area. Additionally, a relict sediment bag remained at the southern edge of Borrow Area N-5. It is recommended that the debris and relict sediment bag be removed.

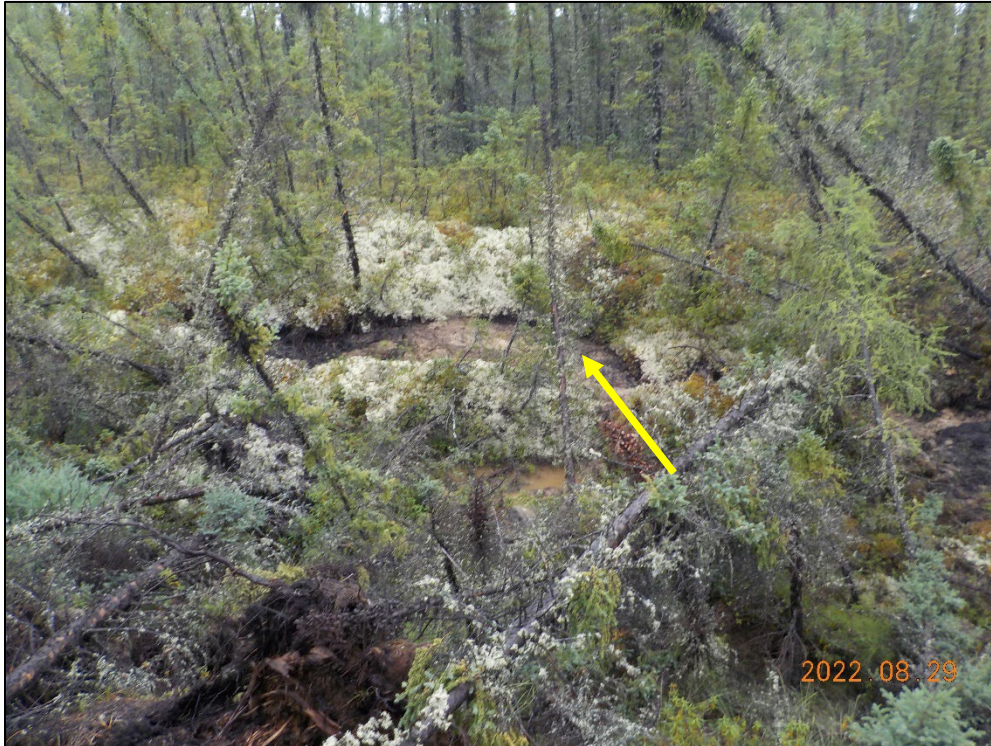
In Borrow Area B-6, mass wasting continued to create a disturbance along a natural drainage channel, affecting otherwise undisturbed habitat (Map 3-2). The 2022 surveys found that although the impacted area had not expanded substantially since 2019, mass wasting along the disturbances edges was still occurring (Photo 3-13). Erosion and mass wasting also continued on the northern edge of the excavated crater in Borrow Area B-6 (Photo 3-14).

Photo 3-13: New mass wasting (yellow arrow) along depression edges northeast of Borrow Area B-6 in 2022

Mass wasting and erosion had continued along the excavated crater banks and the depression edges northeast of Borrow Area B-6 (See Section 3.3.3.5). No mitigation is recommended for this site at this time given that it is small in area, substantial expansion of the deposition area is not anticipated, it is affecting common habitat types, and it is well within the approved Project Footprint.

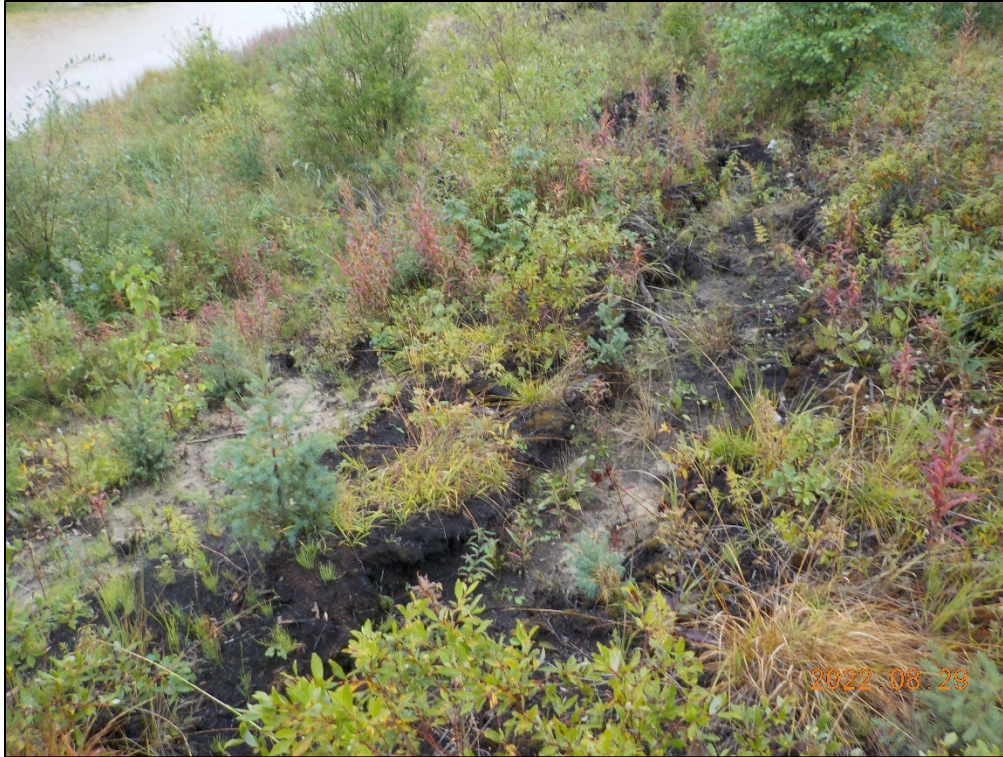
Photo 3-14: Erosion on the northern edge of the excavated crater in Borrow Area B-6 in 2022

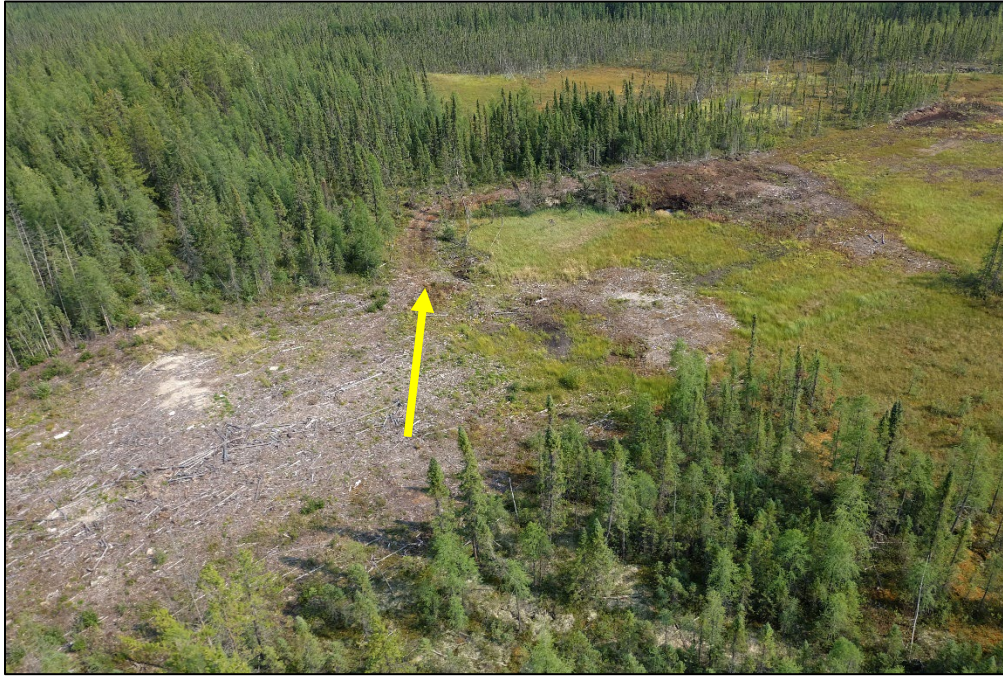
Disturbance along the Ellis Esker (E-1) access corridor in the form of ATV trails and plywood planks near to Joslin Lake continued to be used at the time of the September 2022 survey (Photo 3-15; Photo 3-16; Map 3-2).

Photo 3-15: ATV trails in Borrow Area E-1 access corridor in 2022

Disturbances were found along the access corridor to the Ellis Esker borrow area (see Section 3.3.3.6 for details). These disturbances did not appear to be caused by the Project. Ongoing consultations with local resource users are recommended to determine if access to this corridor should be blocked.

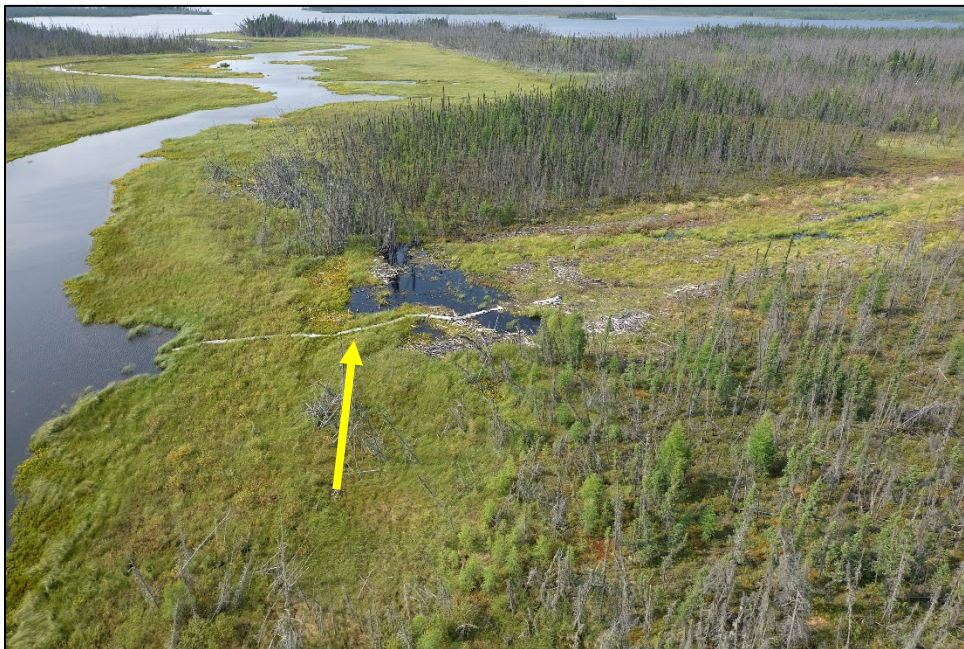
Photo 3-16: Plywood planks in Borrow Area E-1 access corridor in 2022

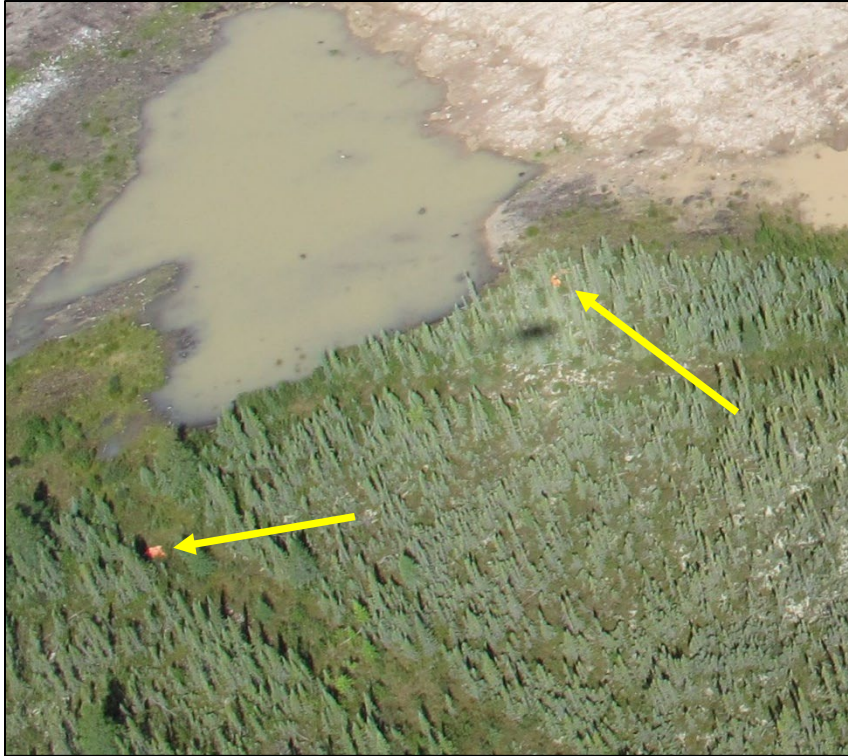
Construction debris found along the eastern edges of Borrow Area S-2a in 2021 remained in place as of September 2022 (Photo 3-17).

Photo 3-17: Construction debris (yellow arrows) along the eastern edge of Borrow Area S-2a in 2022

Construction debris observed in previous surveys remained in several areas during site surveys in 2022. These included the southern and western edges of Borrow Area S-2a (an active borrow area in 2022) and along the southern shore of the Nelson River, downstream of the dam, in the

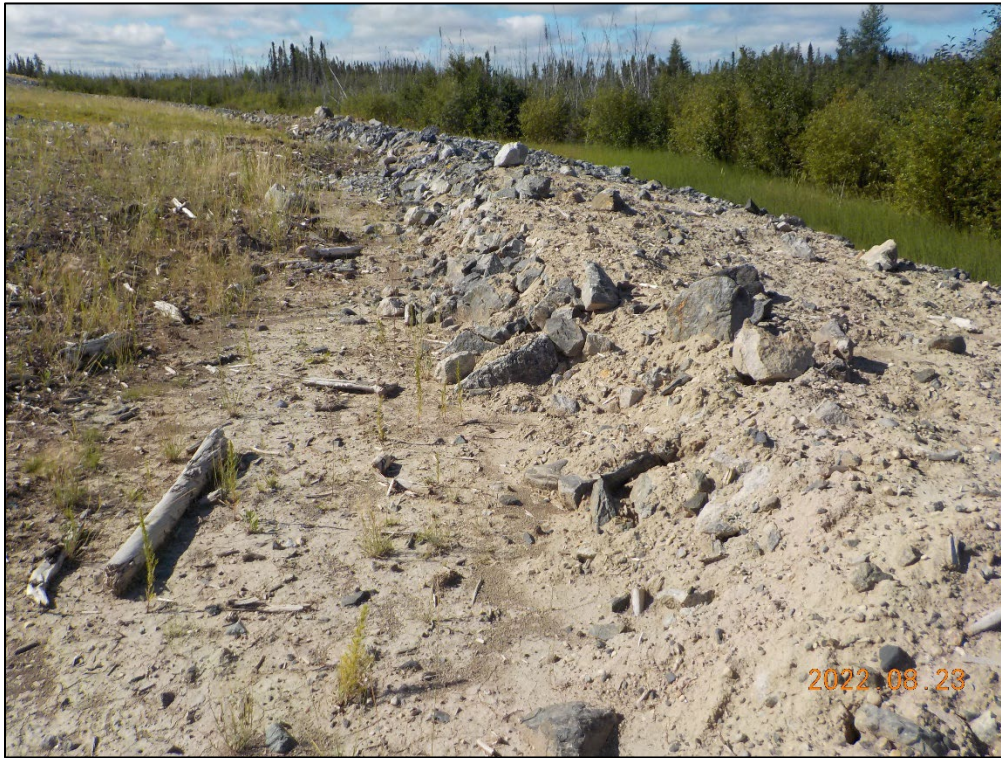
Surveys in 2022 found that the rock berms along the edges of the EMPA were reinforced with additional material. The various inconsistencies identified in previous surveys such as coarse rock composition and low elevation had been addressed by filling in sparse areas and raising elevations (Photo 3-18). No new disturbances were observed at the time of the 2022 survey, however some erosion issues still exist, as described in the following paragraphs.

Photo 3-18: Reinforced rock berm in EMPA D16(1)-E in 2022

At EMPA D16(1)-E, erosion and sediment deposition was being well contained within the rock berm, (see Section 3.3.5.1 for details). Sediment deposition on the northern edge of the EMPA had slowed as a result of rock berm reinforcement. It is recommended that site staff monitor the rock berm for any breakdown and reinforce where necessary.

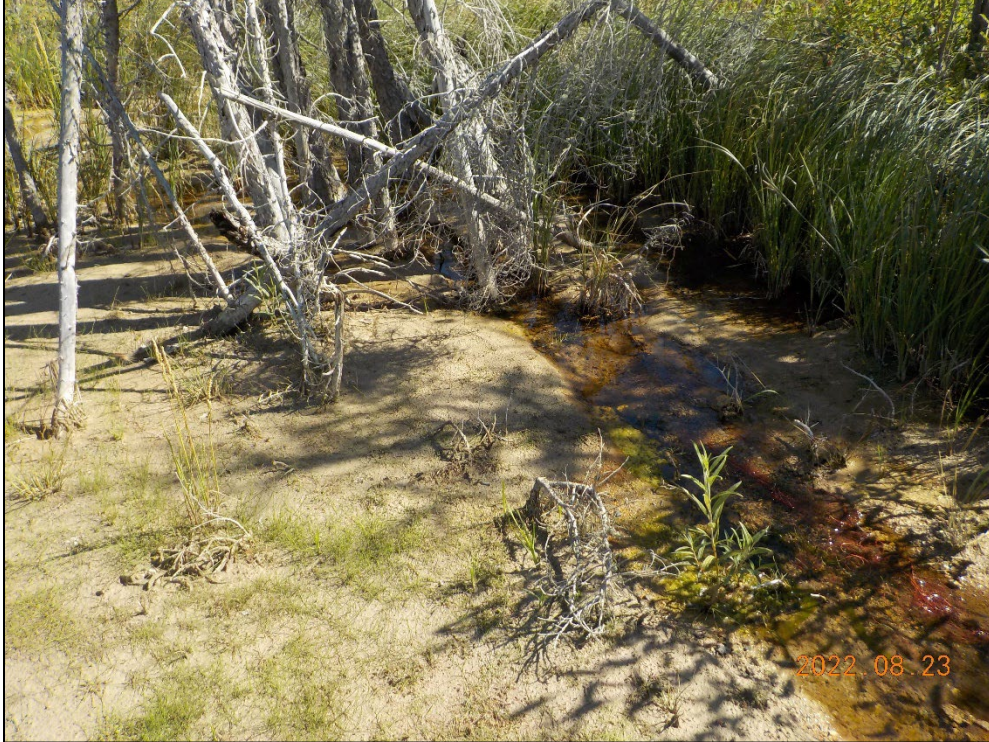
Erosion at the southwestern corner that had deposited sediment and created a flowing channel of water into previously undisturbed vegetation was ongoing at the time of the 2022 survey (Map 3-2; Photo 3-19). While the erosion effects had not expanded compared to previous surveys, water still flowed through the area into the adjacent vegetation. The source of the water appeared to have come from 30 metres south of the disturbance, where water was observed to flow from underneath a large pile of boulders (Photo 3-20). The source of the water coming from underneath the boulder pile could not be determined at the time of the survey, however a culvert was observed approximately 70 metres west of the boulder pile and was assumed to be the main source of water runoff (Photo 3-21).

Photo 3-19: Sediment deposition and flowing water at the southwestern corner of EMPA D16(1)-E in 2022

At the southeastern corner of EMPA D16(1)-E, water runoff created a channel that was transporting water and sediment into the adjacent undisturbed forest (see Section 3.3.5.1 for details). No mitigation is recommended for this site at this time given that it is small in area, substantial expansion of the deposition area is not anticipated, and it is within the approved Project Footprint.

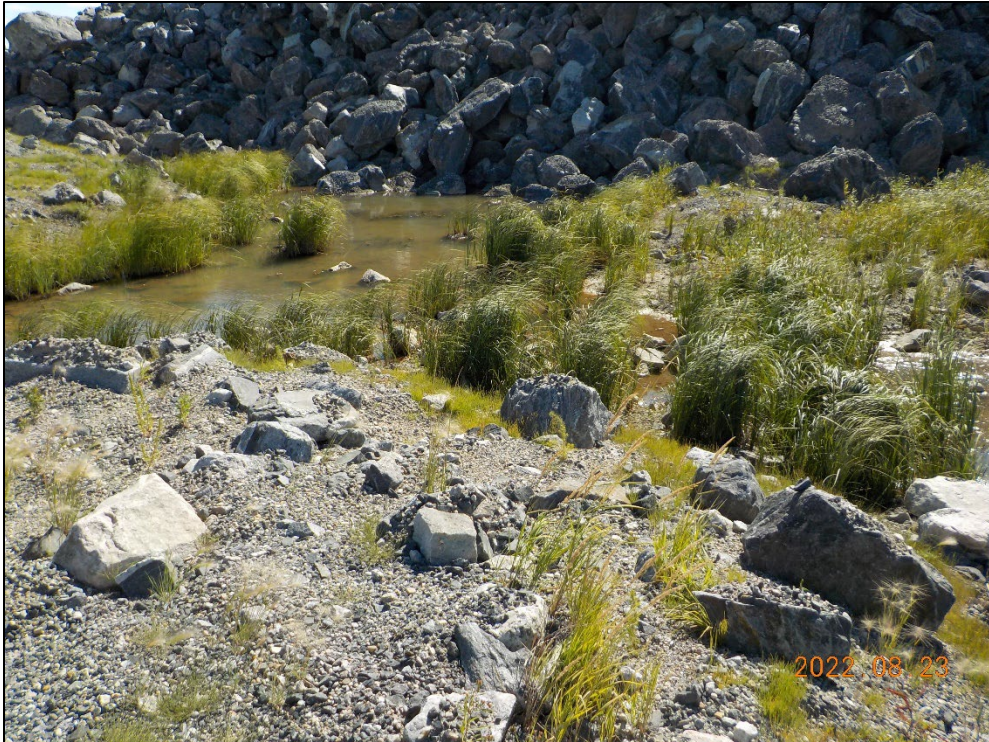
Photo 3-20: Flowing water from boulder pile in EMPA D16(1)-E in 2022

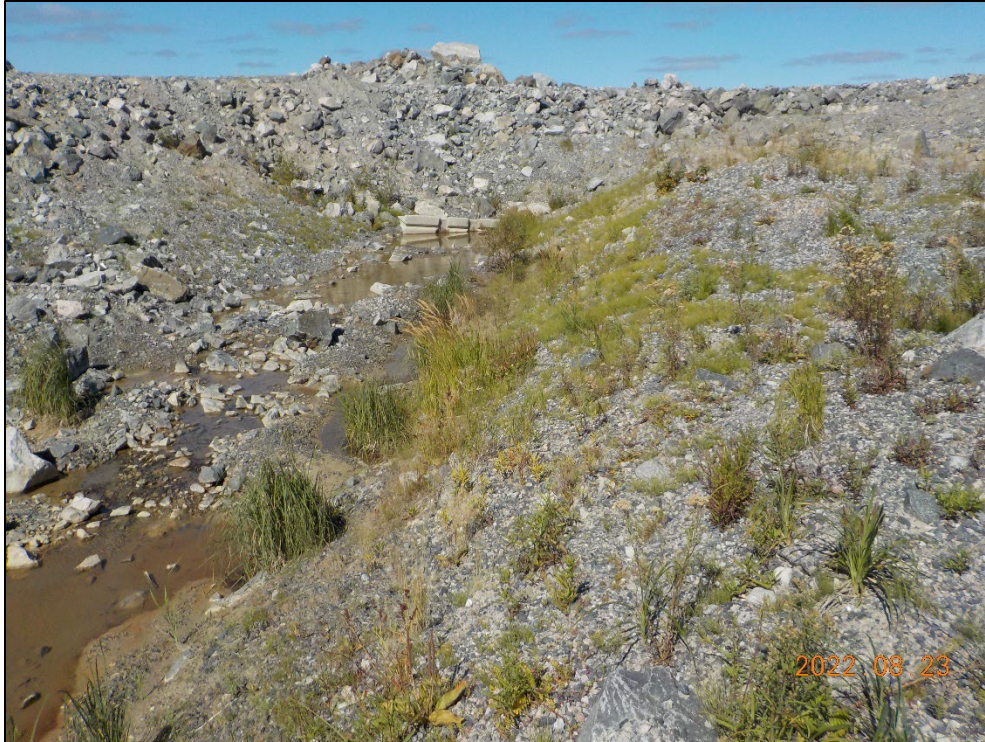
Photo 3-21: Water from culvert in EMPA D16(1)-E in 2022

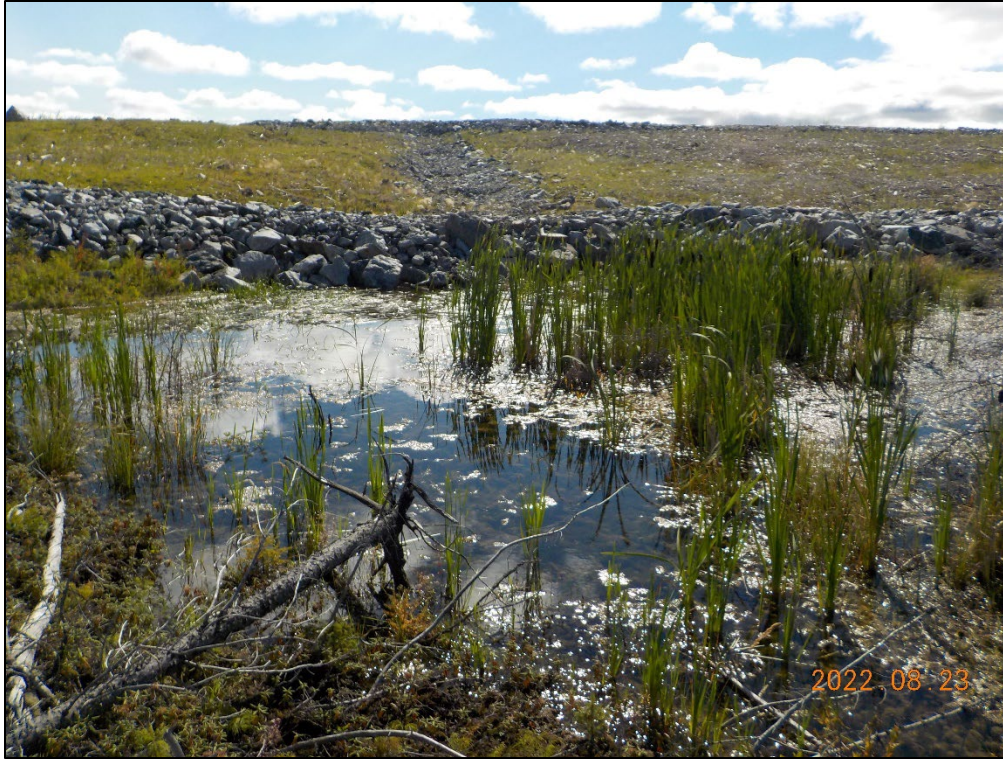
A gap left in the rock berm on the western edge of EMPA D16(1)-E, observed in 2020, had allowed sediment to pass through into the adjacent marsh habitat. This gap was filled in at the time of the 2022 survey (Photo 3-22). Erosion and sediment deposition had stopped at the location, and the water that had pooled adjacent to the marsh appeared clearer than in previous surveys. Monitoring of this site will continue.

Photo 3-22: Filled-in gap in rock berm (center-top) adjacent to marsh (foreground) on western edge of EMPA D16(1)-E in 2022

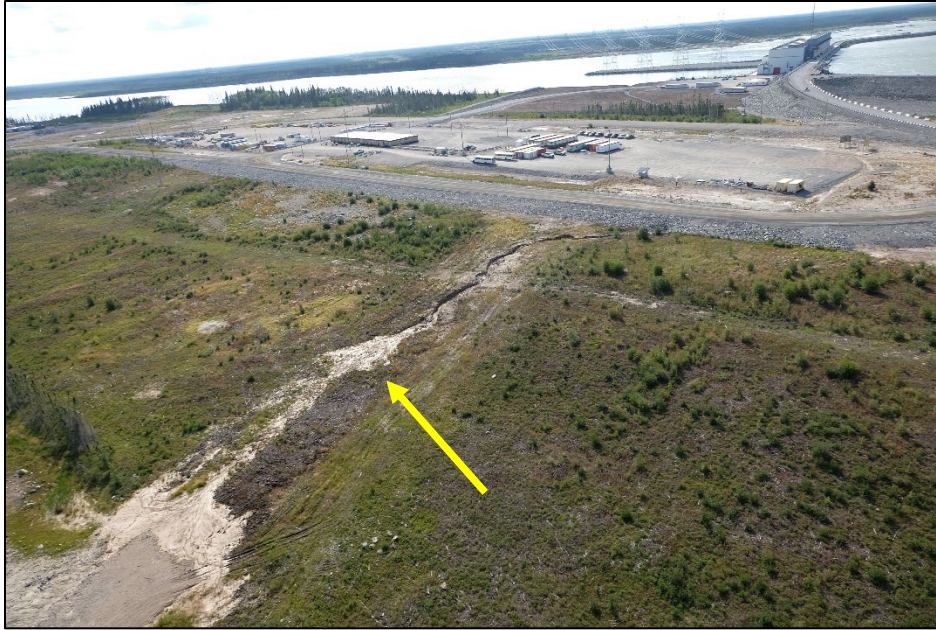
As of September 2022, the removal of the temporary road to EMPA D17-E in 2021 appeared to have created conditions where runoff from the adjoining access road flowed north towards the EMPA, depositing sediment adjacent to it (Photo 3-23). If sediment deposition continues, there is potential to extend past previously cleared bounds and outside of the planned and possibly disturbed Project Footprint areas (Figure 3-2).

Photo 3-23: Runoff and sediment deposition (yellow arrow) along decommissioned road to EMPA D17-E in 2022

At EMPA D17-E, runoff and sediment deposition along the decommissioned road has the potential to extend past the approved Project Footprint. The disturbance is only a few metres from the approved Project Footprint bounds. It is recommended that measures such as sediment barriers or slope grading be implemented to prevent increase outside of the approved Project Footprint.
