Keeyask Generation Project Terrestrial Effects Monitoring Plan

Habitat Loss and Disturbance Monitoring Report

TEMP-2023-01

HABITAT LOSS AND DISTURBANCE MONITORING YEAR 1 OPERATION 2022

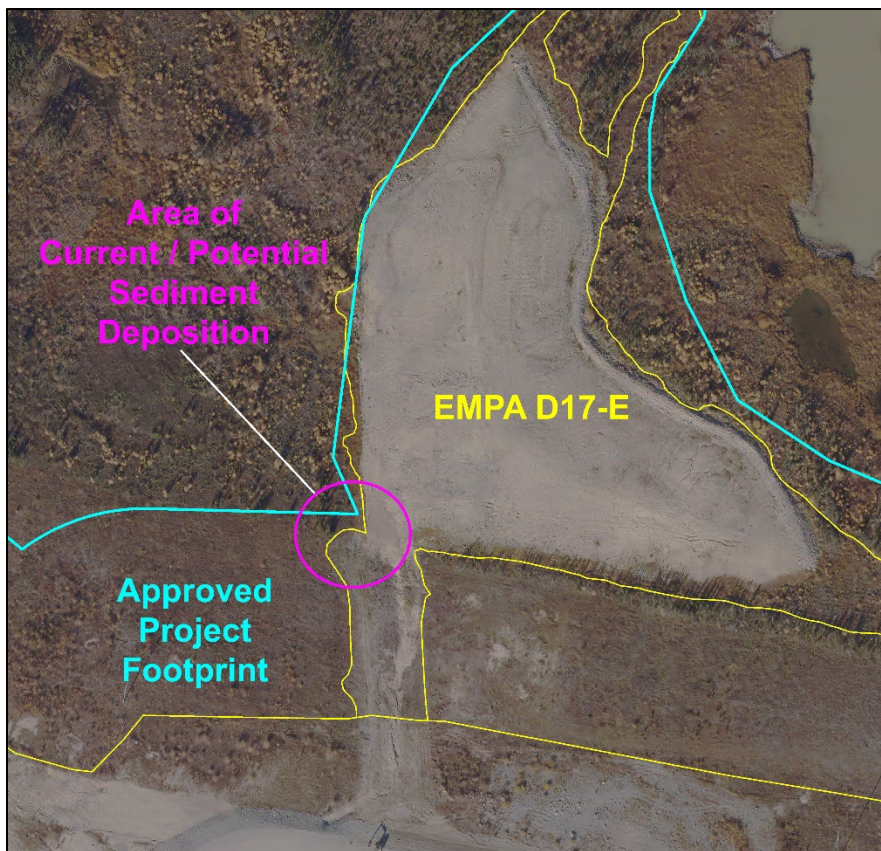
Figure 3-2: Sediment deposition near approved Project Footprint bounds at EMPA D17-E in 2022

At EMPA D17-E, runoff and sediment deposition along the decommissioned road has the potential to extend past the approved Project Footprint. The disturbance is only a few metres from the approved Project Footprint bounds. It is recommended that measures such as sediment barriers or slope grading be implemented to prevent increase outside of the approved Project Footprint.

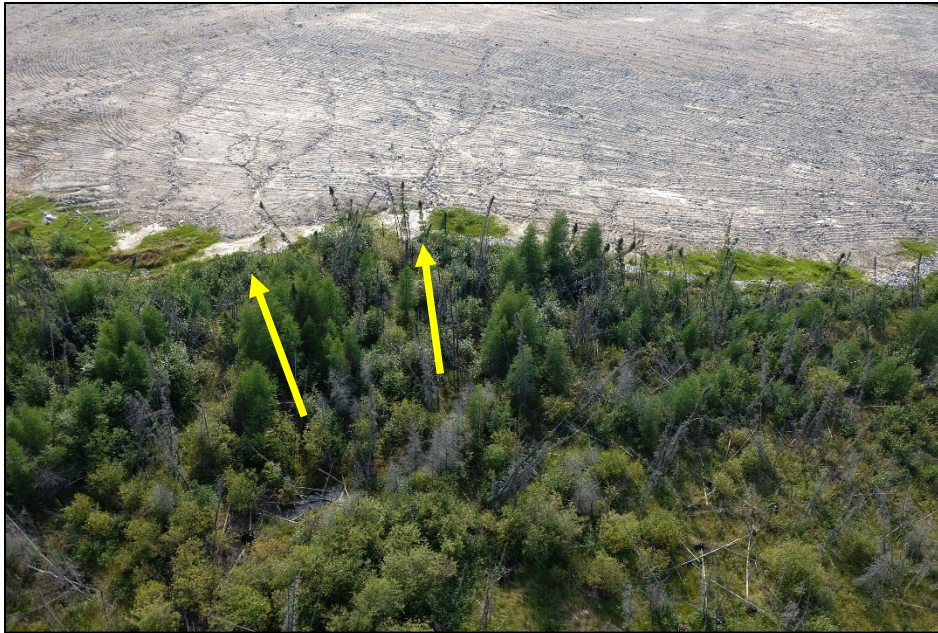
Erosion and sediment deposition within the planned Project Footprint area was overtopping previously installed rock berms at the northeastern edge of EMPA D23(2)-E in 2022 (Photo 3-24). These impacts were at a location that could potentially affect the dewatered portion of Stephens Lake to the northeast if the disturbance should expand (Map 3-1; Figure 3-3).

Photo 3-24: Sediment (yellow arrows) overtopping rock berm in EMPA D23(2)-E in 2022

At the northeastern edge of EMPA D23(2)-E, erosion-related sediment deposition is approaching the dewatered portion of Stephens Lake (see Section 3.3.5.3 for details). It is recommended that measures be implemented to eliminate or reduce sediment movement beyond the existing rock berm.

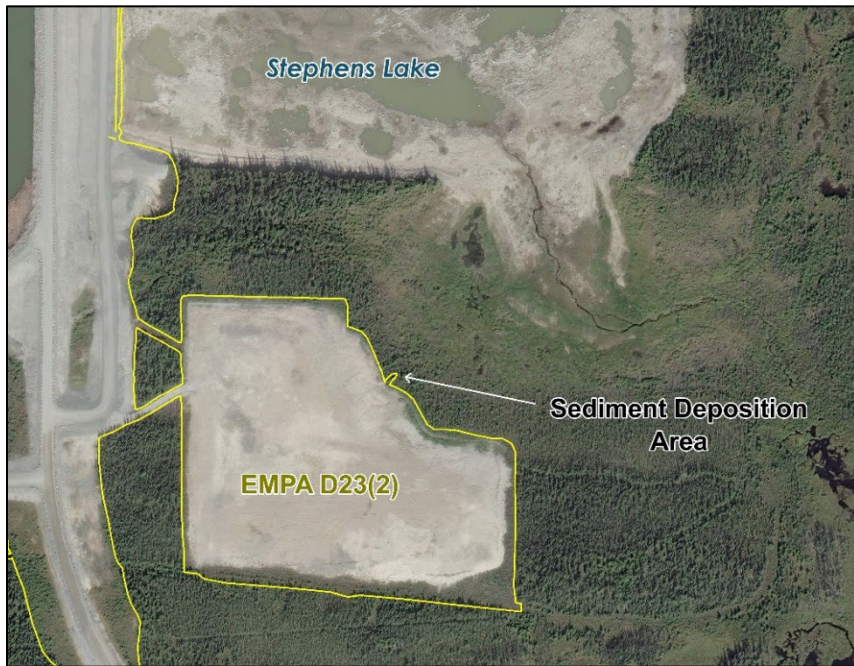
Figure 3-3: Erosion and sediment deposition from EMPA D23(2)-E in 2022

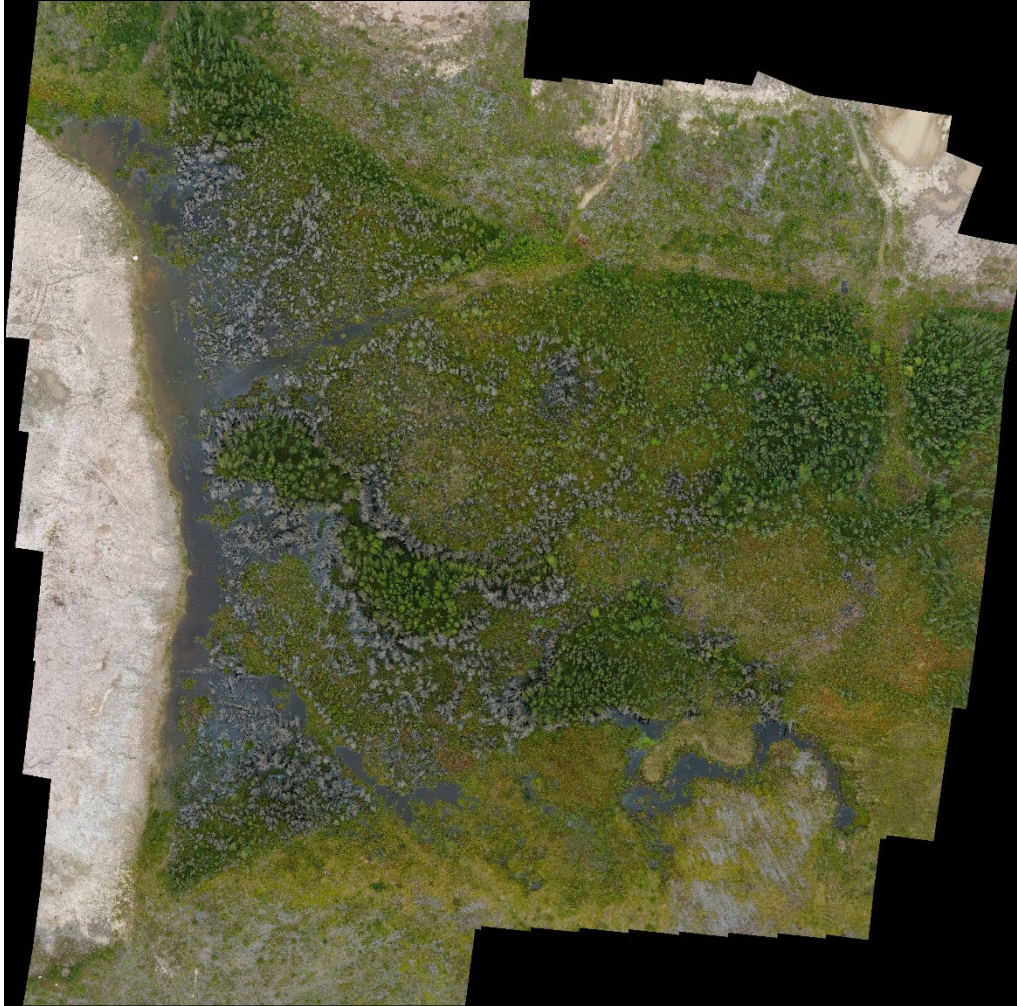
At the eastern edge of EMPA D35(1)-E, ponded water and tree dieback in the adjacent undisturbed forest continued to be an issue in 2022, where the area of dieback had increased by 0.02 ha within the planned Project Footprint (Table 3-2; Photo 3-25). This was despite water levels remaining lower than in previous surveys. Monitoring of this site will continue.

Photo 3-25: Ponded water and tree dieback at the eastern edge of EMPA D35(1)-E in 2022

Project-related water ponding in EMPA D35(1)-E did not increase in size at the time of the 2022 survey, however tree dieback had increased since 2021. No mitigation is recommended for this location at this time as the impacted area is relatively small, affecting a common habitat type and within the approved Project Footprint.

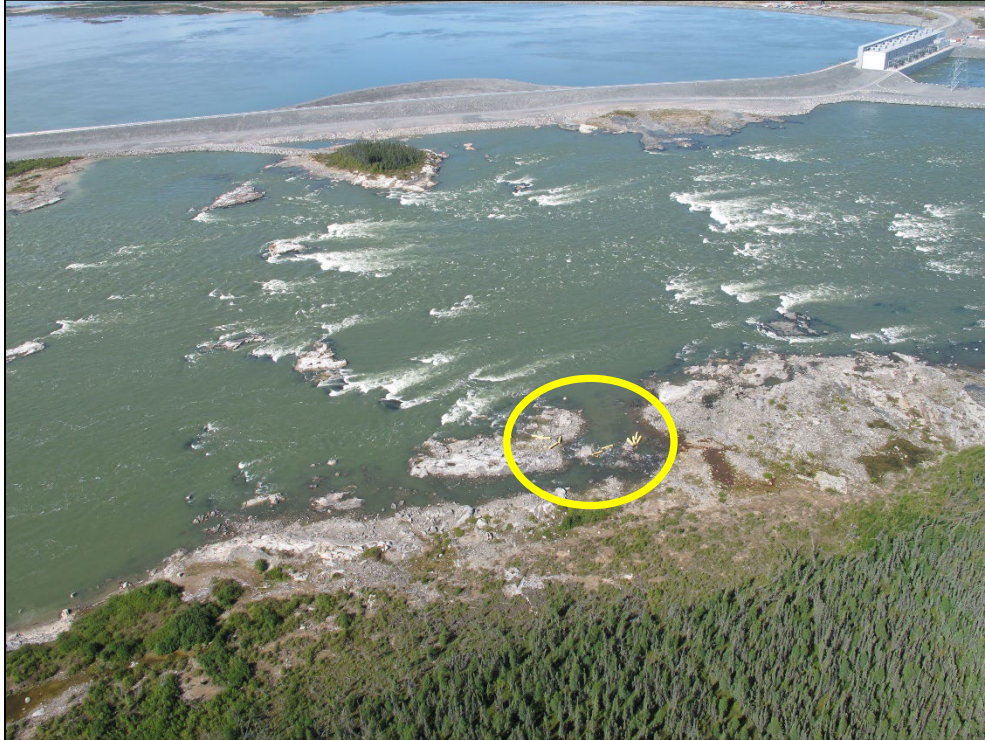
As of September 2022, the portions of ice boom identified in 2021 surveys remained at each of the three previously identified locations (Photo 3-26; Map 3-2).

Photo 3-26: Portions of ice boom (yellow circle) washed up on the south shore of the Nelson River, downstream of the dam (dewatered area) in 2022

Construction debris observed in previous surveys remained in several areas during site surveys in 2022. These included the southern and western edges of Borrow Area S-2a (an active borrow area in 2022) and along the southern shore of the Nelson River, downstream of the dam, in the

dewatered area. Additionally, a relict sediment bag remained at the southern edge of Borrow Area N-5. It is recommended that the debris and relict sediment bag be removed.

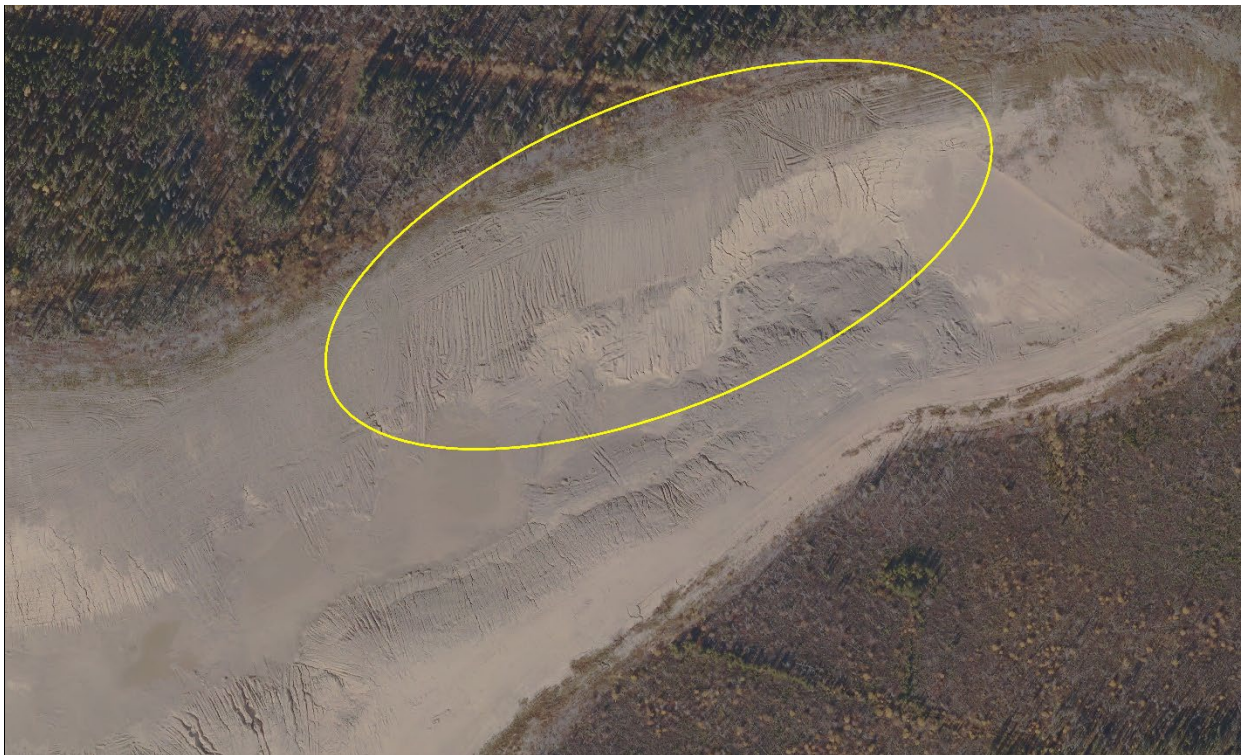
In Borrow Area G-3, erosion on the bank slopes is washing away planted tree seedlings. Mitigation is not recommended as it is unlikely that further impacts can be prevented or reduced. These slopes are long and have been planted with seedlings. It is noted that a factor contributing to the amount of erosion and tree seedling loss is that in some areas the grading and site preparation were implemented in the same direction as the bank slope (Figure 4-1), which increases the amount of downslope water flow and its velocity. Where this is safe to do, a recommendation for future grading and site preparation is to complete the machine work in a direction that is perpendicular to the bank slope direction.

Area on northern slope of G-3 with parallel grading pattern

Figure 4-1: Grading and site preparation parallel to slope direction in G-3 (2022 imagery)
