Keeyask Generation Project  
Terrestrial Effects Monitoring Plan

**Habitat Rehabilitation Implementation and Success  
Monitoring Report**

TEMP-2023-07

#### **YEAR 1 OPERATION**

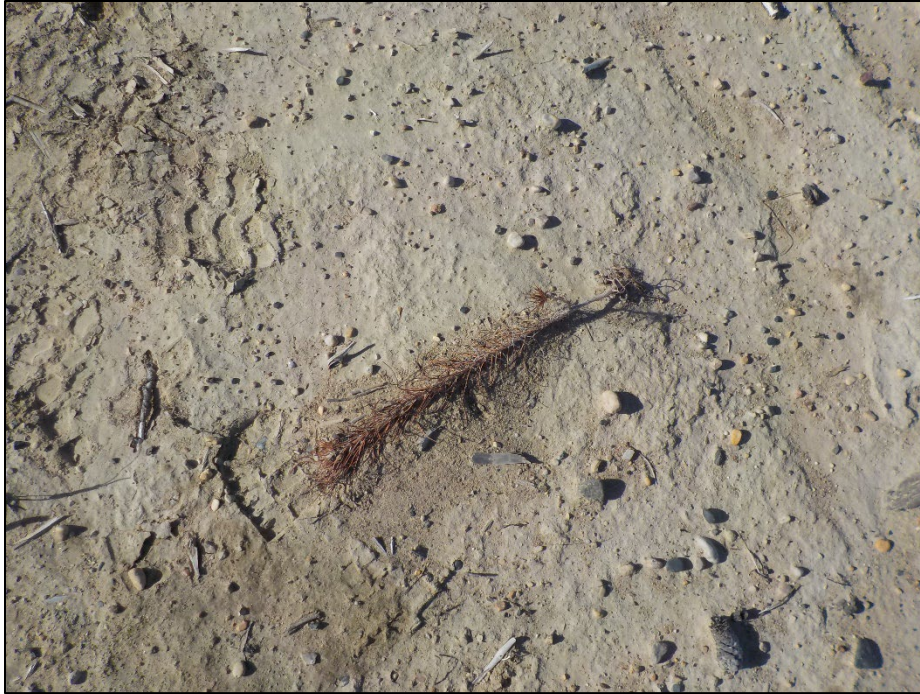
**Photo 3-1: Recently dead jack pine with erosion damage**

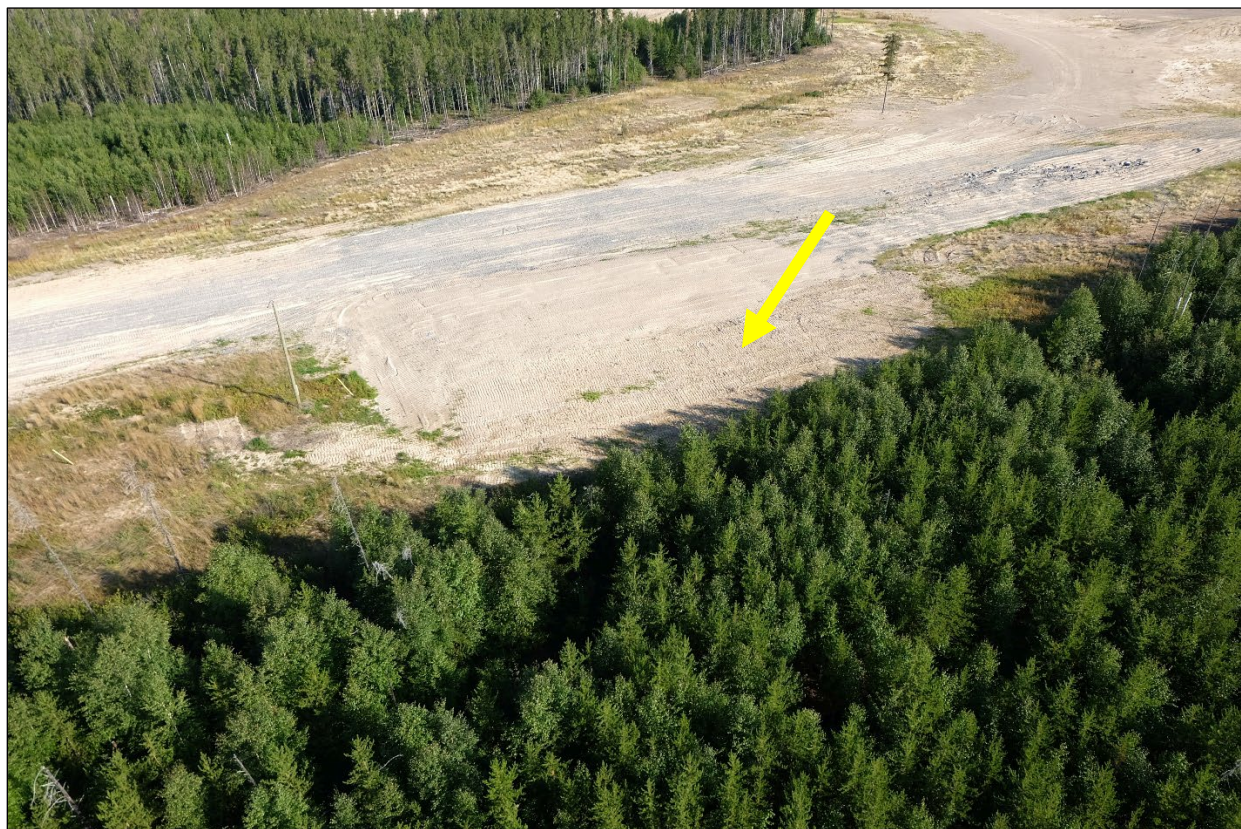
**Photo 4-1: Area in Borrow Area G-1 at KM-15 where rehabilitation activities changed vegetation cover and structure**

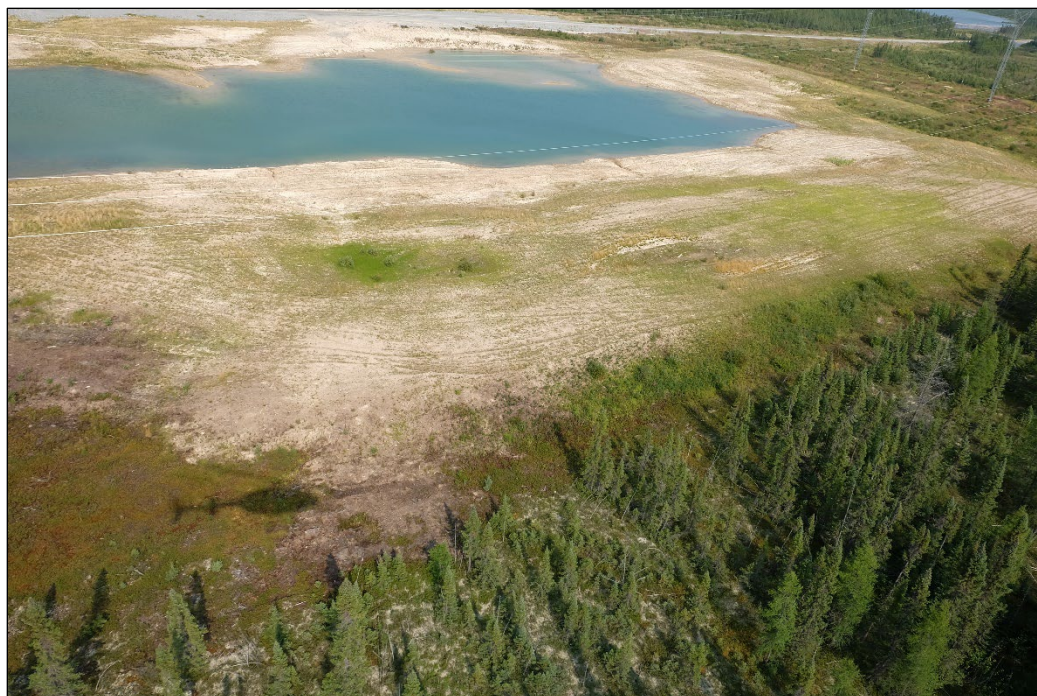
**Photo 4-2: Seeded area regeneration in B-3 in September 2022**

From 36% to 59% of each of the seeding areas was still barren (i.e., cover<10%) in 2022. Substrate conditions were thought to be a contributor to the degree of revegetation to date. Monitoring for the Wuskwatim Generation Project (ECOSTEM 2017) found that grass revegetation was slow on dry, compact substrates, or coarse, rapidly drained soils. Portions of the two locations seeded in 2020 had similar substrates to these, and as such are expected to establish over several years.

Further assessment of the seeded areas and other portions of the temporary Project Footprint, including substrate conditions for the Vegetation Rehabilitation Plan, will help to understand reasons for varying revegetation success. Monitoring of seeded locations will continue in 2023.

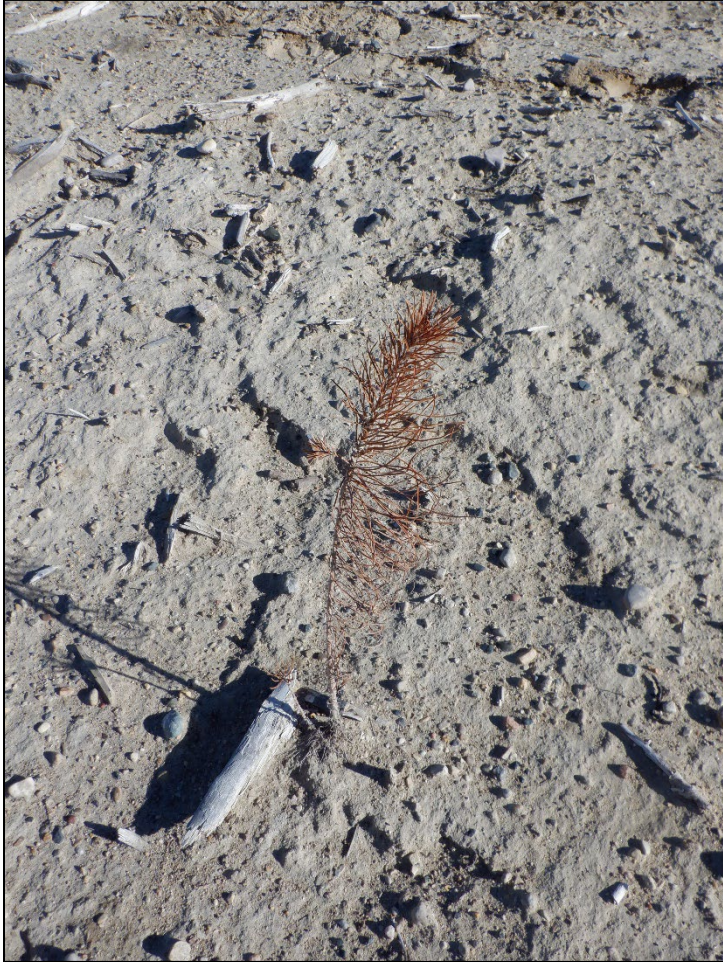
Pooling all planted stems tallied in 2022 for each rehabilitation location, overall mortality (Photo 4-5) was highest in Borrow Area G-3, with 30.0% of tallied stems dead (Figure 4-3). This was followed by Haul Roads 3-4 (25.2%) and EMPA 27(4)-E (23.2%). Mortality was lowest overall in EMPA D23(2)-E (14.9%).

**Photo 4-5: Recently dead jack pine (vigour 1) in Borrow Area G-3 in 2022**

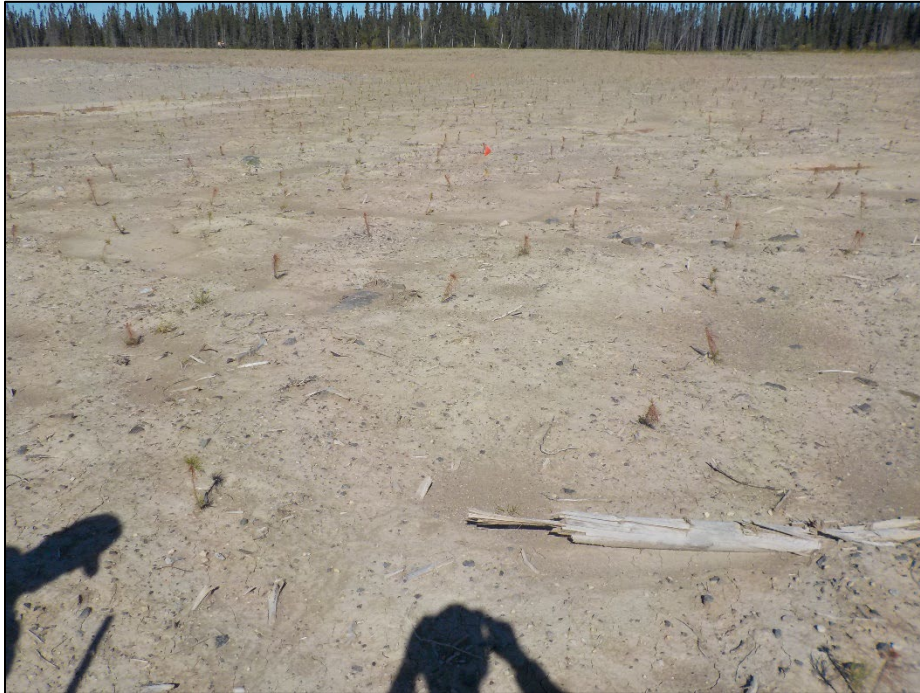
Vigour class was variable for live jack pine stems in the planting areas (Map 4-5). In general, planting areas where average vigour was less than 4 was dominated by stems with poorer condition and health (Photo 4-6), more often having a dead leader (Photo 4-7), or only a few living

**Photo 4-6: Area with poor jack pine condition (red leaves, vigour 0-4) in Borrow Area N-5 (PA-1) in 2022**

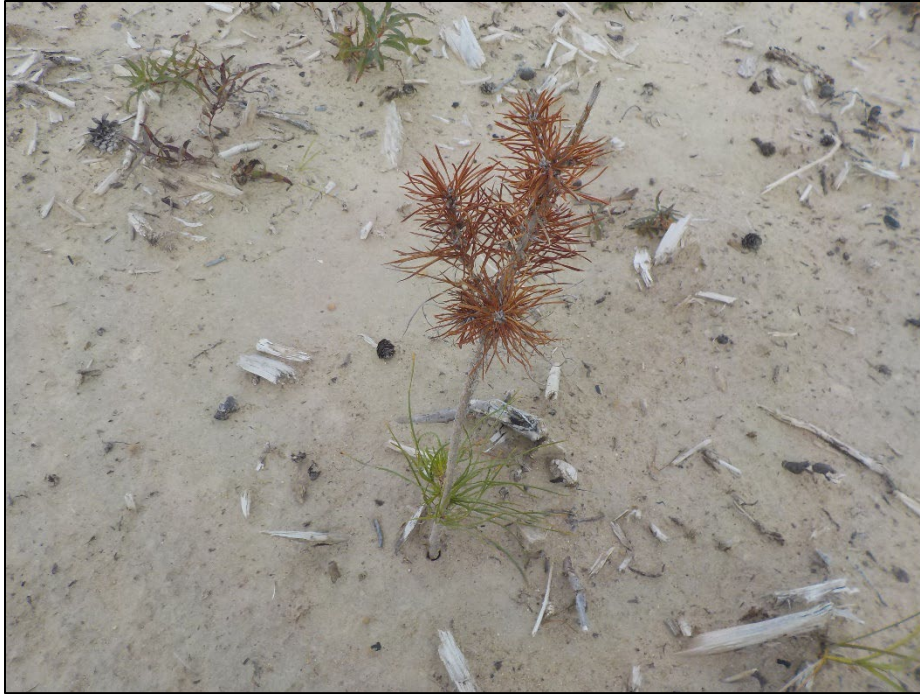
**Photo 4-7: Jack pine with dead leader and few living leaves (vigour 3, close to 2) in Borrow Area G-3 in 2022**

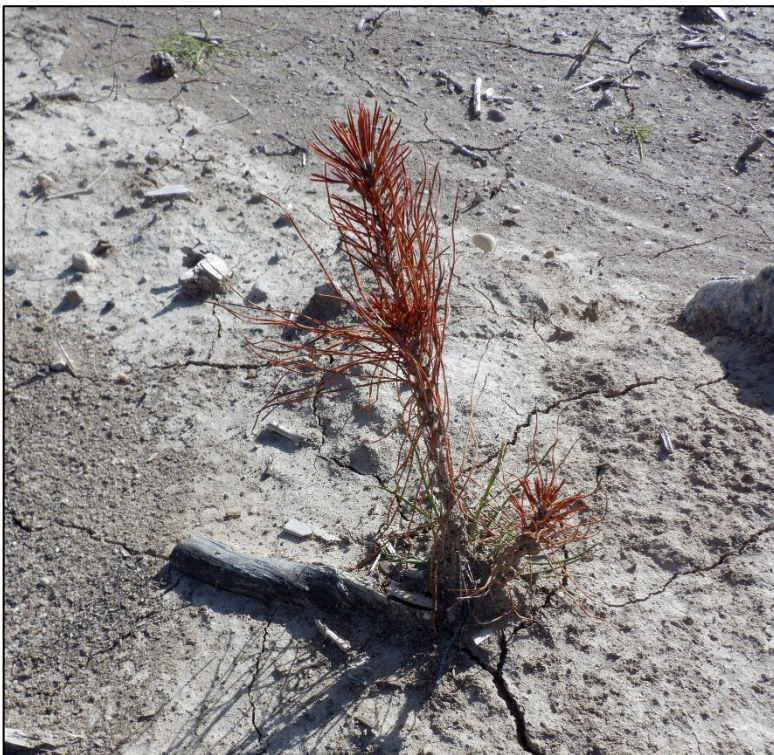
**Photo 4-8: Jack pine, vigour 2, only 2 or 3 leaves still green in Borrow Area G-3 in 2022**

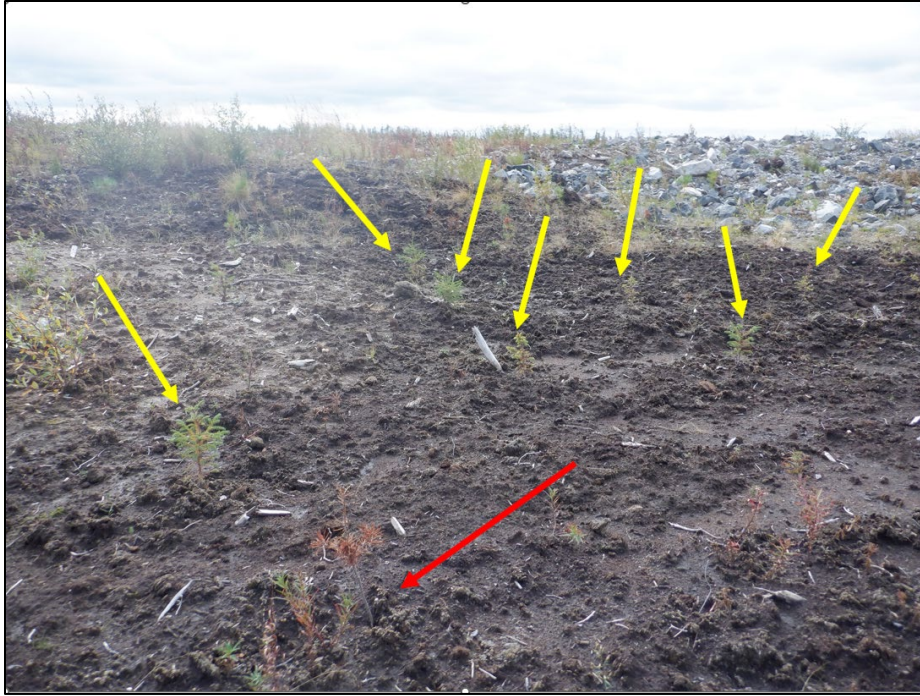
Average vigour class for live black spruce stems was at least 4 in all planting areas, except for the one planting area in EMPA D23(1)-E (Table 4-11). For black spruce, average vigour was above 5 (mostly healthy) in 15 of the 21 planting areas where live stems were present (Photo 4-9).

**Photo 4-9: Black spruce vigour 5 or 6 (yellow arrow) and dead jack pine (vigour 1) in 2022**

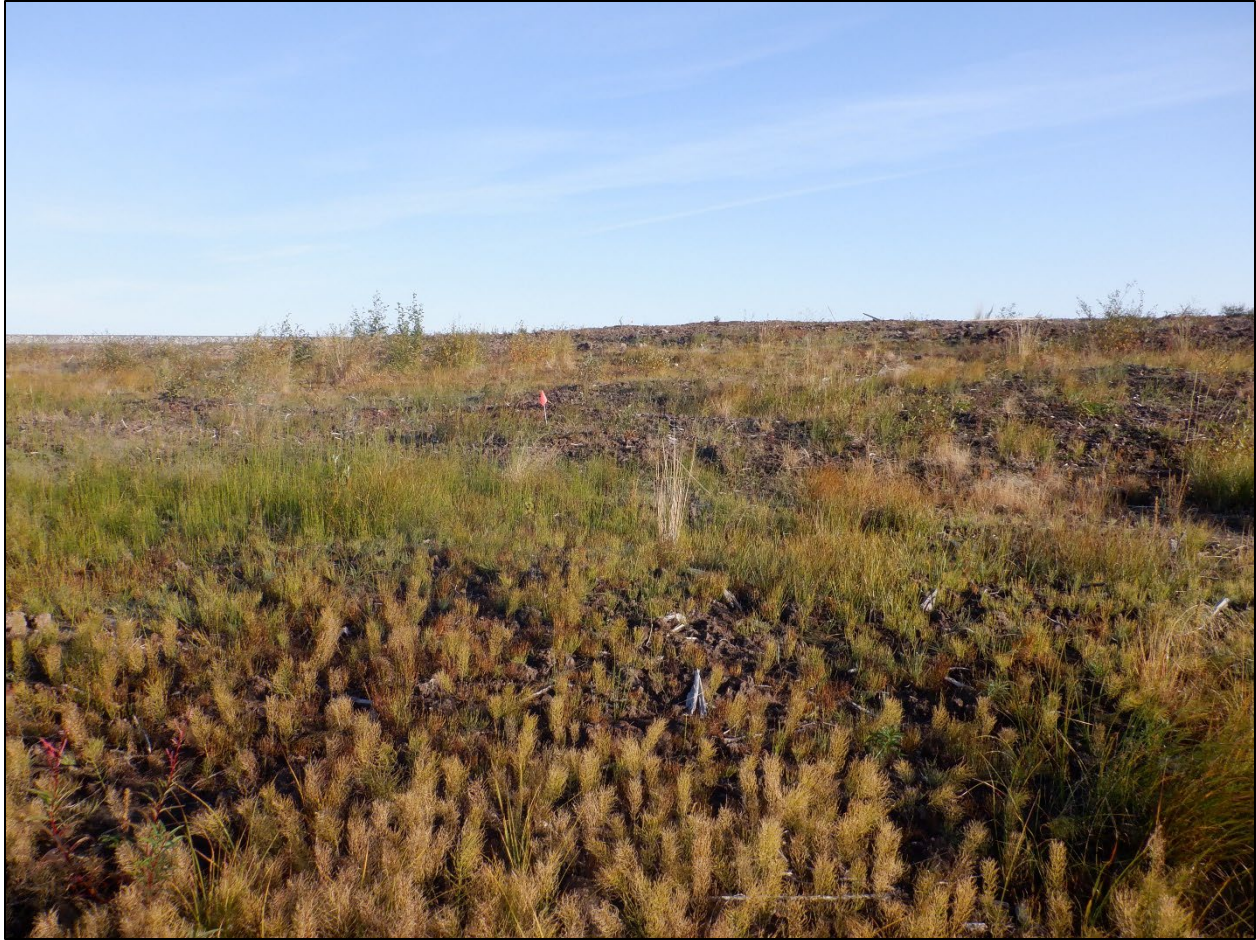
The reasons why the estimated planted stem density in EMPA D23(1)-E (1,117 stems/ha) was far below the target density of 2,500 stems/ha are uncertain. It is possible that the planted stem density was underestimated to some degree due to some stems being overlooked during the surveys. This rehabilitation area had higher cover of naturally regenerating herbaceous vegetation (Photo 5-1). If some trees died soon after planting, then their remnants may not have been visible during the following year's survey.

**Photo 5-1: Naturally regenerating vegetation on EMPA D23(1)-E**

The exception was the planting area in EMPA D23(1)-E. While this area had organic material spread on the surface, the seedlings were generally in poor condition. However, it appeared that the organic material was spread on the surface but not mixed with the underlying mineral. Surveys for developing the target habitat types for the Vegetation Rehabilitation Plan will confirm substrate conditions in the areas planted.

It appears that some of the areas planted in 2020 and 2021 may need additional planting. However, it is generally not feasible to determine which areas this applies to before the boundaries of the temporary Project areas are finalized, and after substrate conditions are mapped for the Vegetation Rehabilitation Plan. The exception is the EMPA D23(1)-E planting area, where supplemental planting is needed.
