Keeyask Generation Project
Terrestrial Effects Monitoring Plan

Habitat Rehabilitation Implementation and Success
Monitoring Report

TEMP-2024-05

YEAR 2 OPERATION

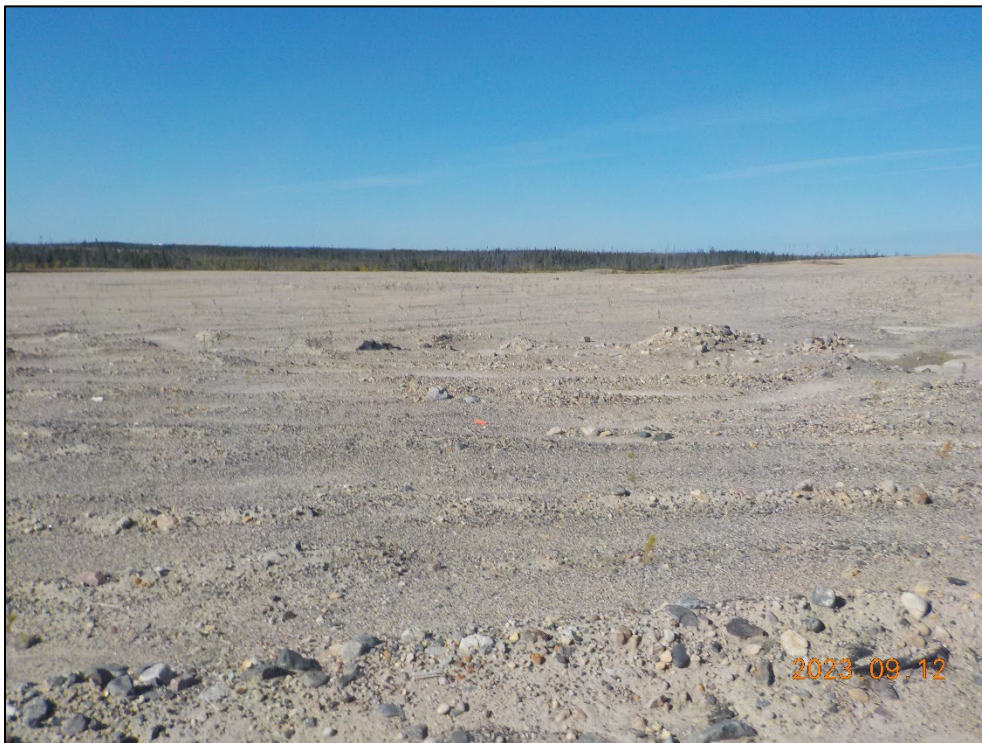
Photo 4-2: Barren vegetation cover and structure in Borrow Area G-3.

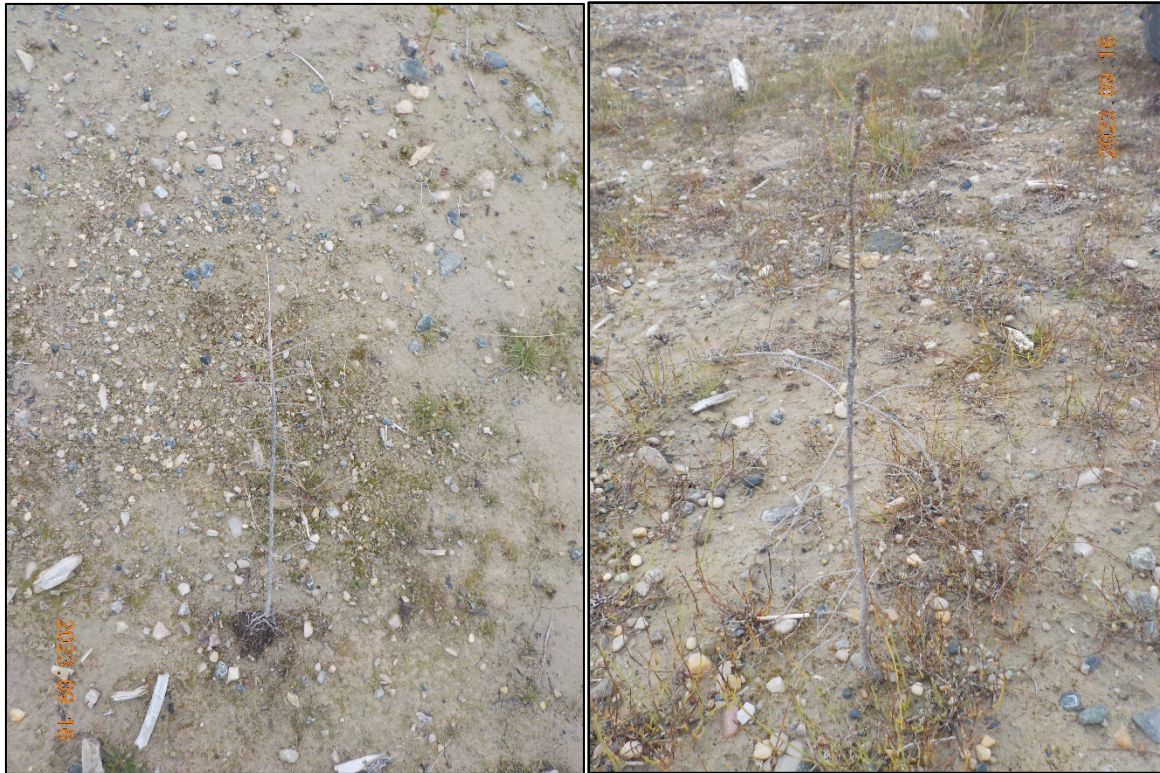
Photo 4-6: Dead jack pine (vigour 0) in EMPA D-27(4)-E in 2023

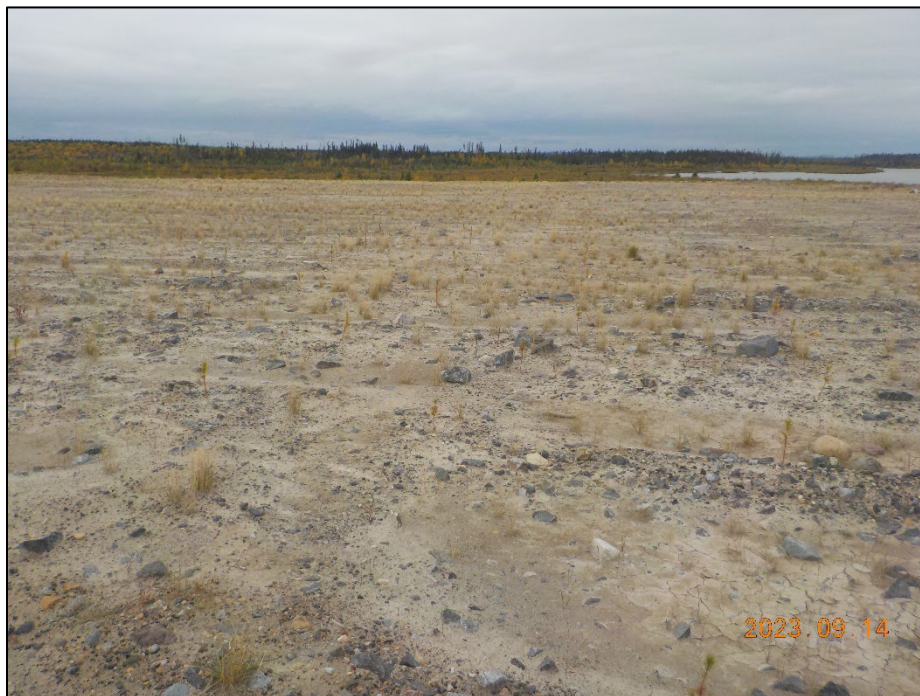
Photo 4-7: Area with poor jack pine condition (red leaves, vigour 0-4) in EMPA D-12(2)-E (PA-1) in 2023

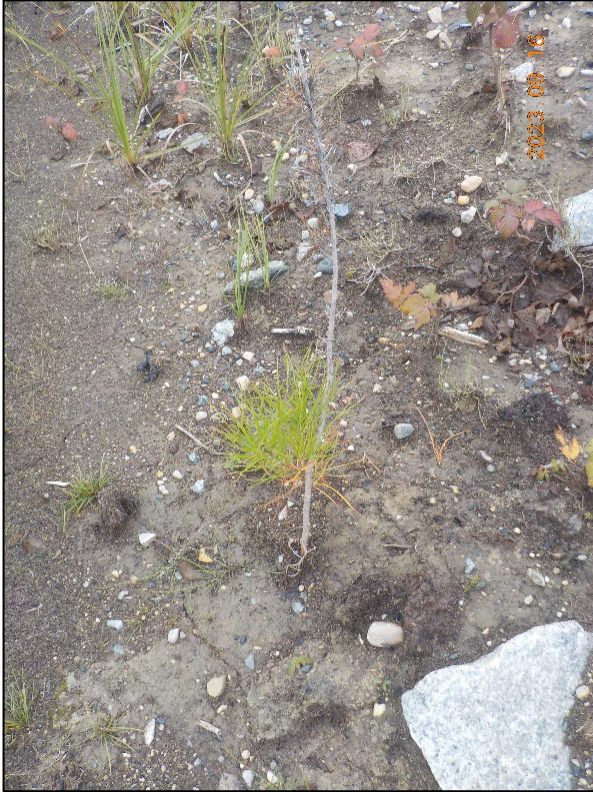
Photo 4-8: Jack pine with dead leader and some living leaves (vigour 3) in EMPA D-27(4)-E in 2023

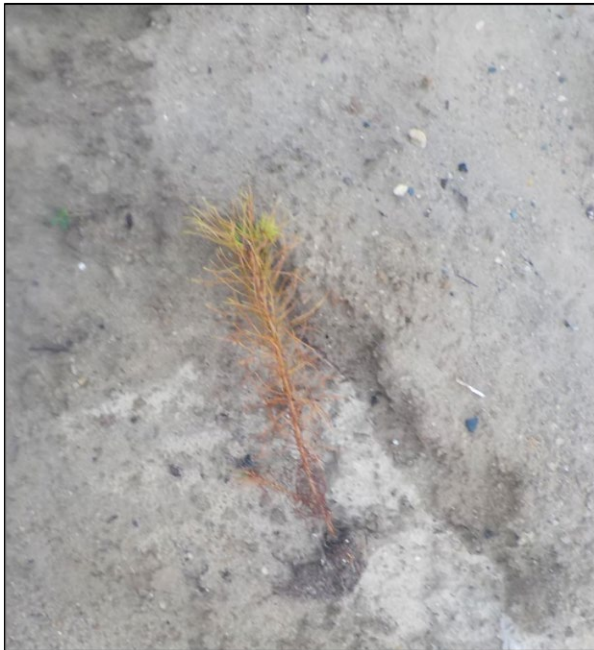
Photo 4-9: Jack pine, vigour 2, with a few leaves still green in Borrow Area KM-17 in 2023

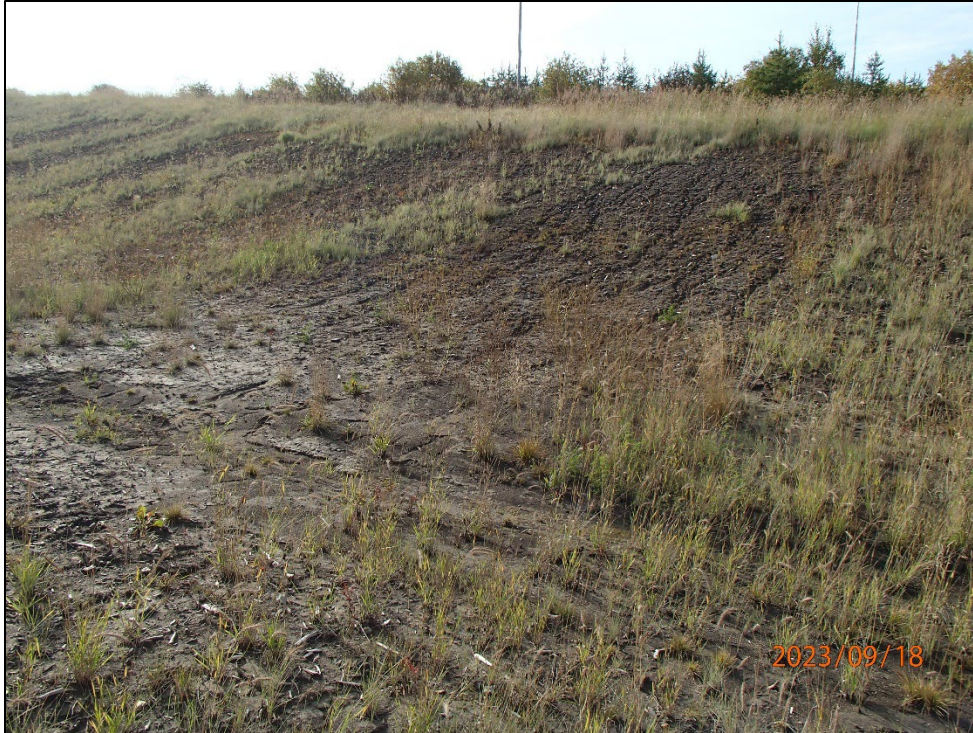
Photo 4-11: Regenerating seeded slope with vegetation gaps at an area surveyed for poor regeneration along the North Access Road in 2023

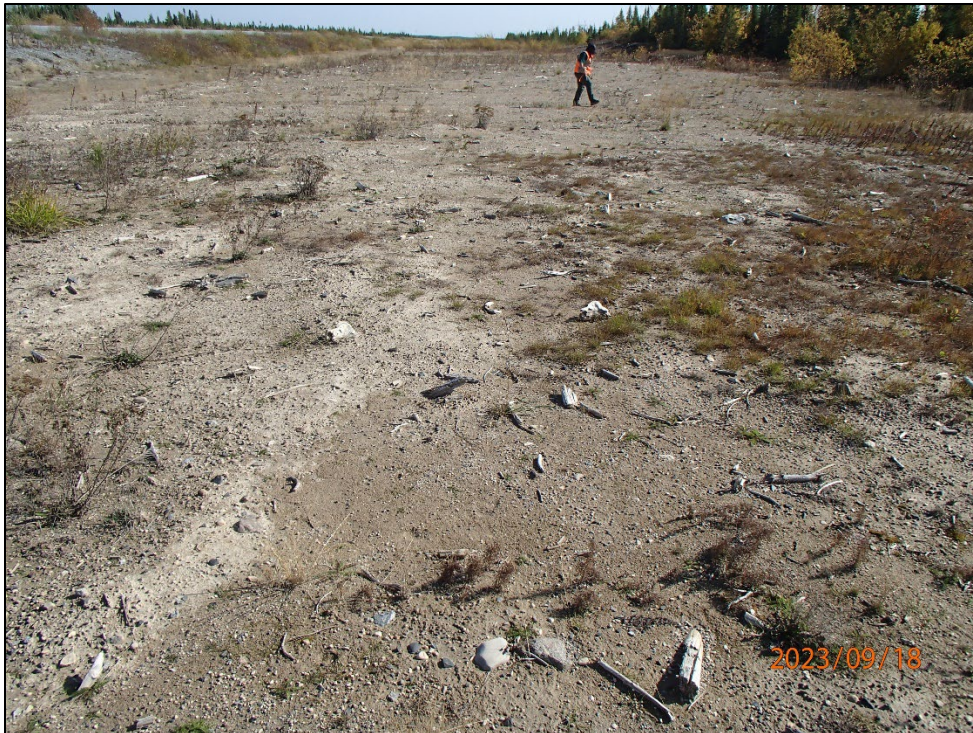
Patches of insufficient or borderline insufficient regeneration were small (Photo 4-12), all with areas less than 0.5 ha. The reasons for poor regeneration in the patches appeared to be generally due to substrate conditions, active erosion (Photo 4-13), and/or a gap in grass seeding.

Photo 4-12: Insufficient and borderline insufficient vegetation cover along the South Access Road in 2023

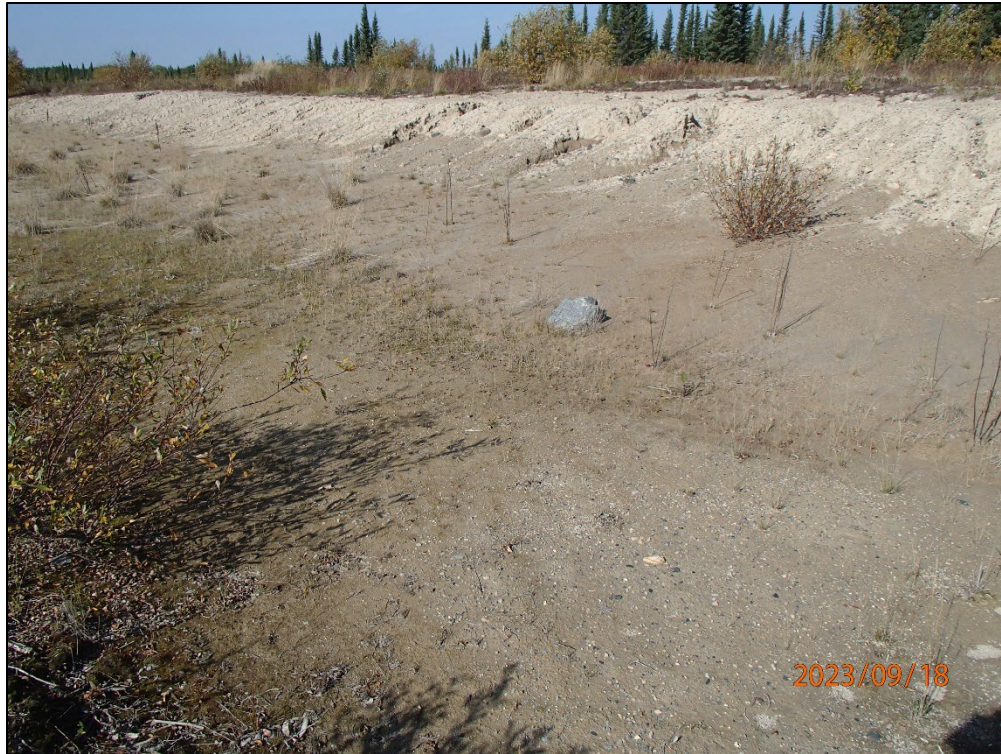
Photo 4-13: Barren, eroding slope along the South Access Road in 2023

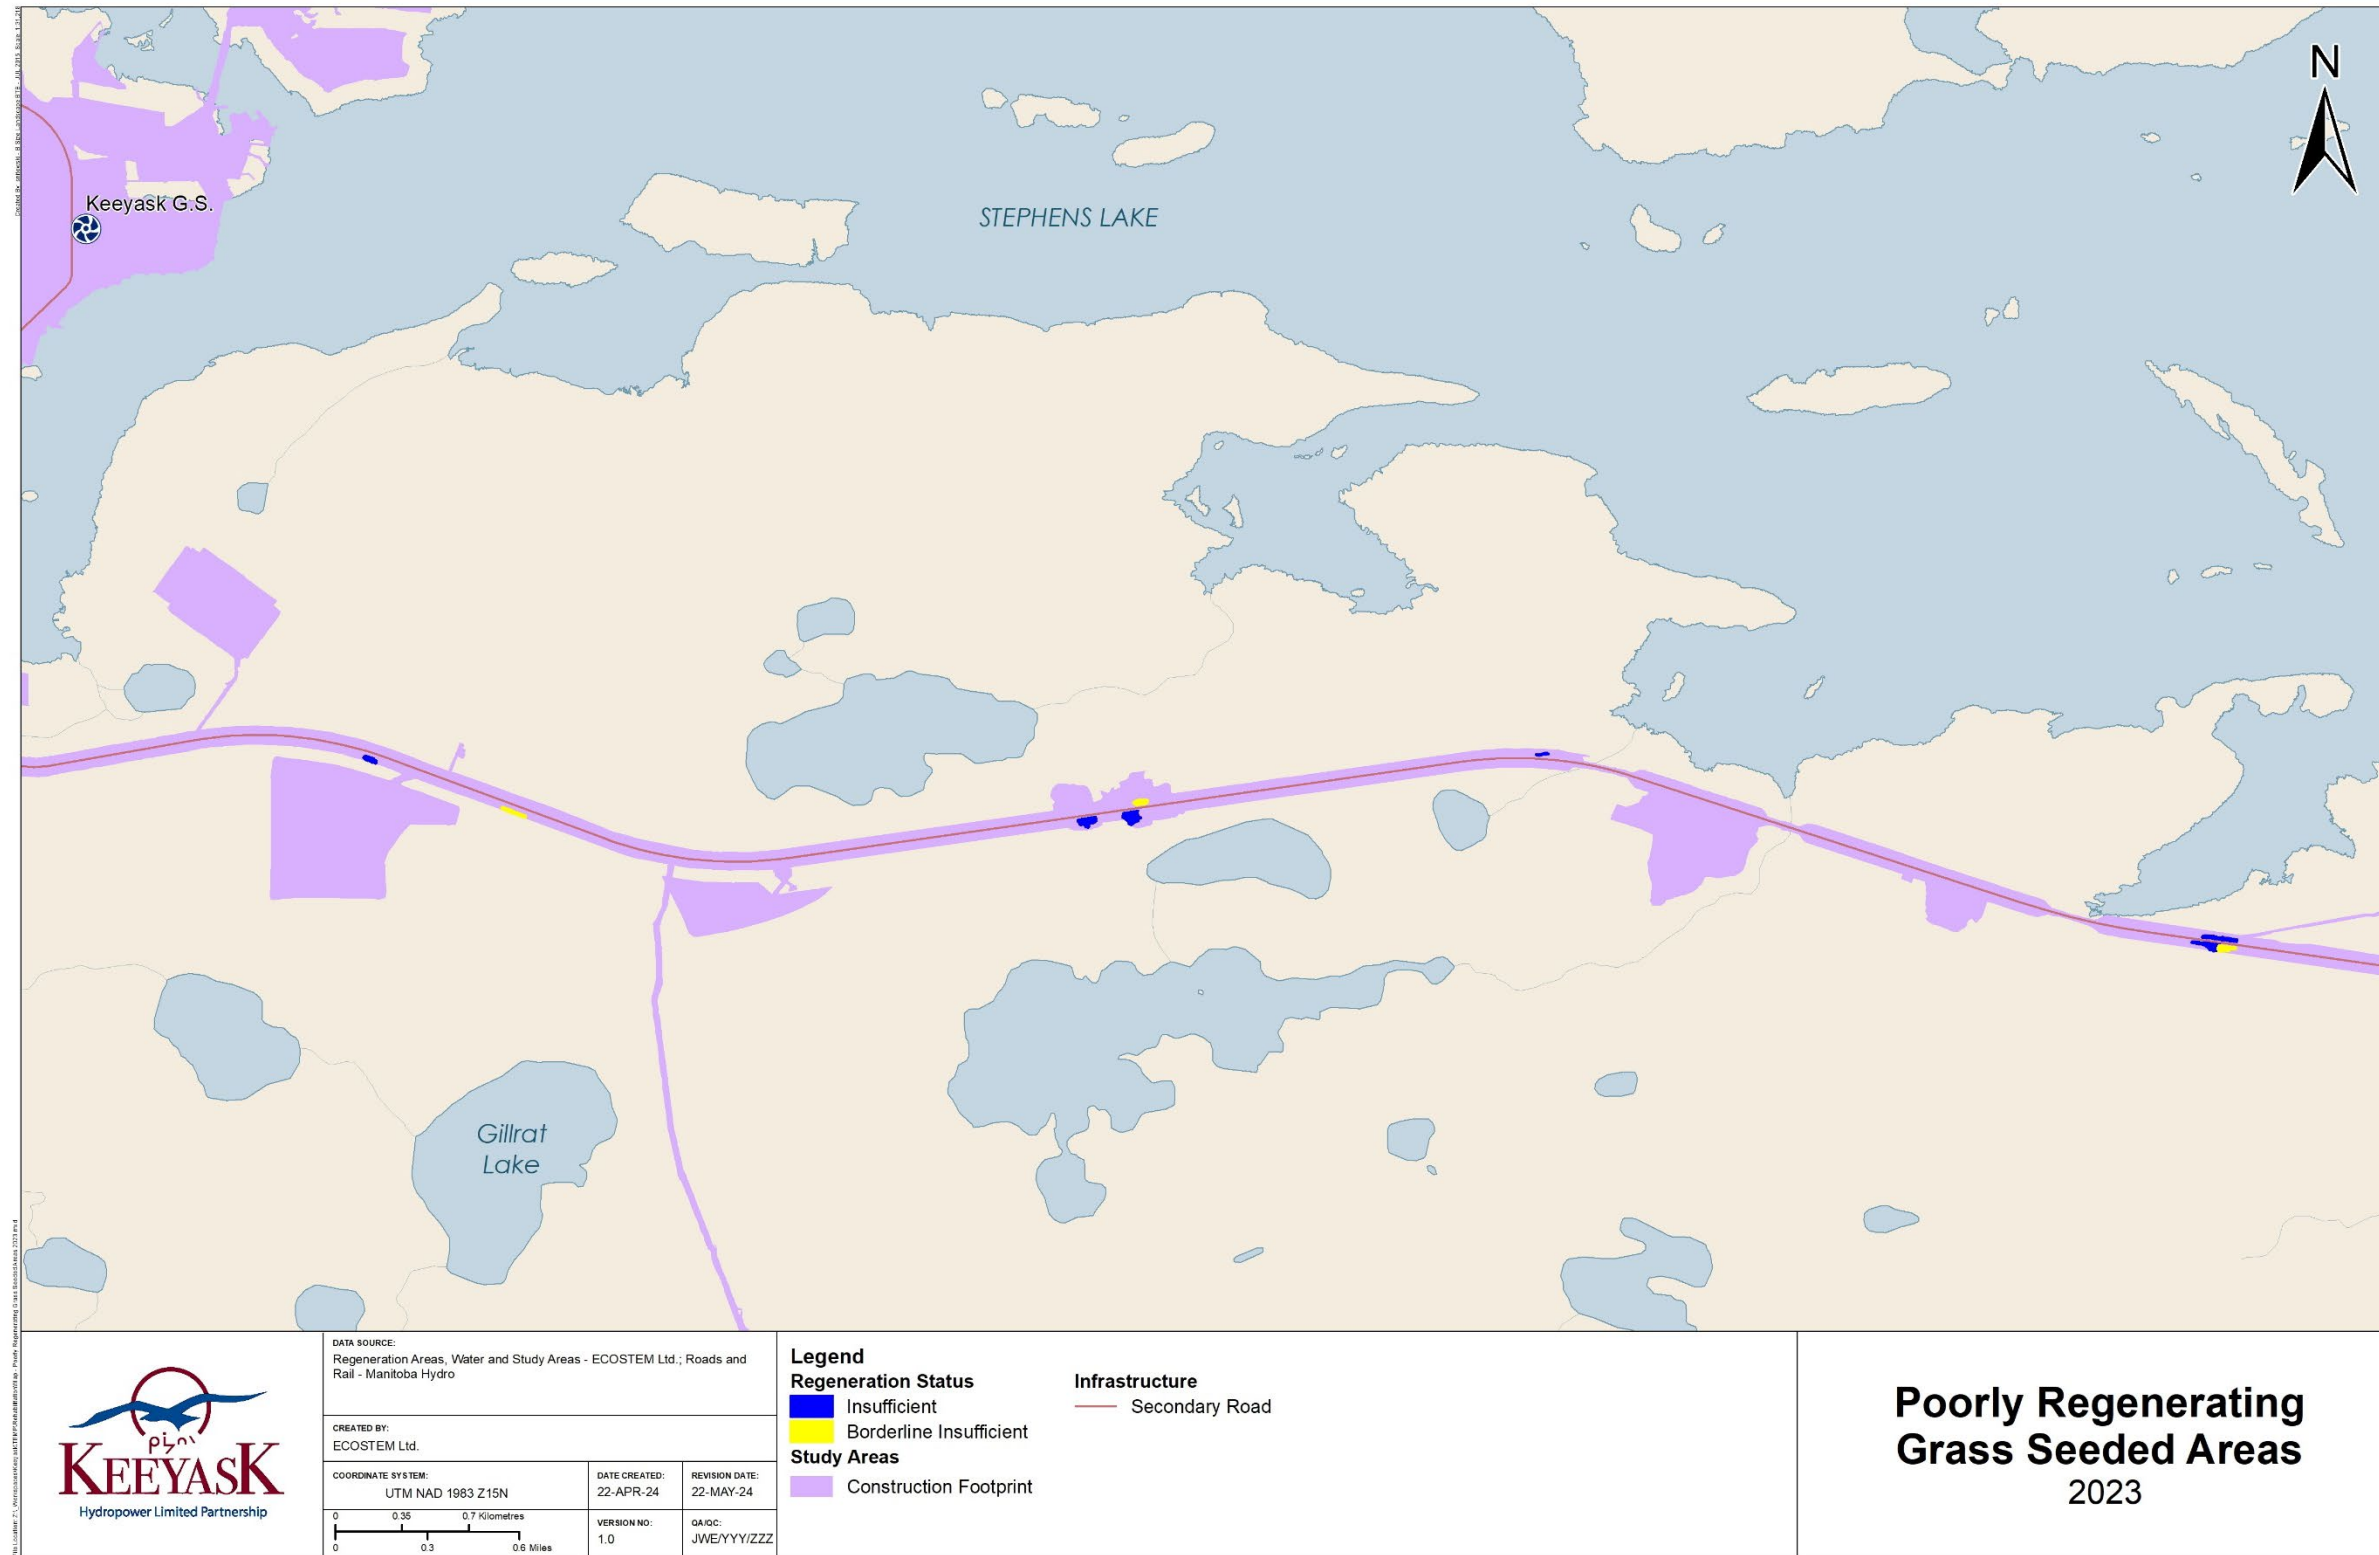
Map 4-11: Grass seeded areas that are poorly regenerating as of September 2023

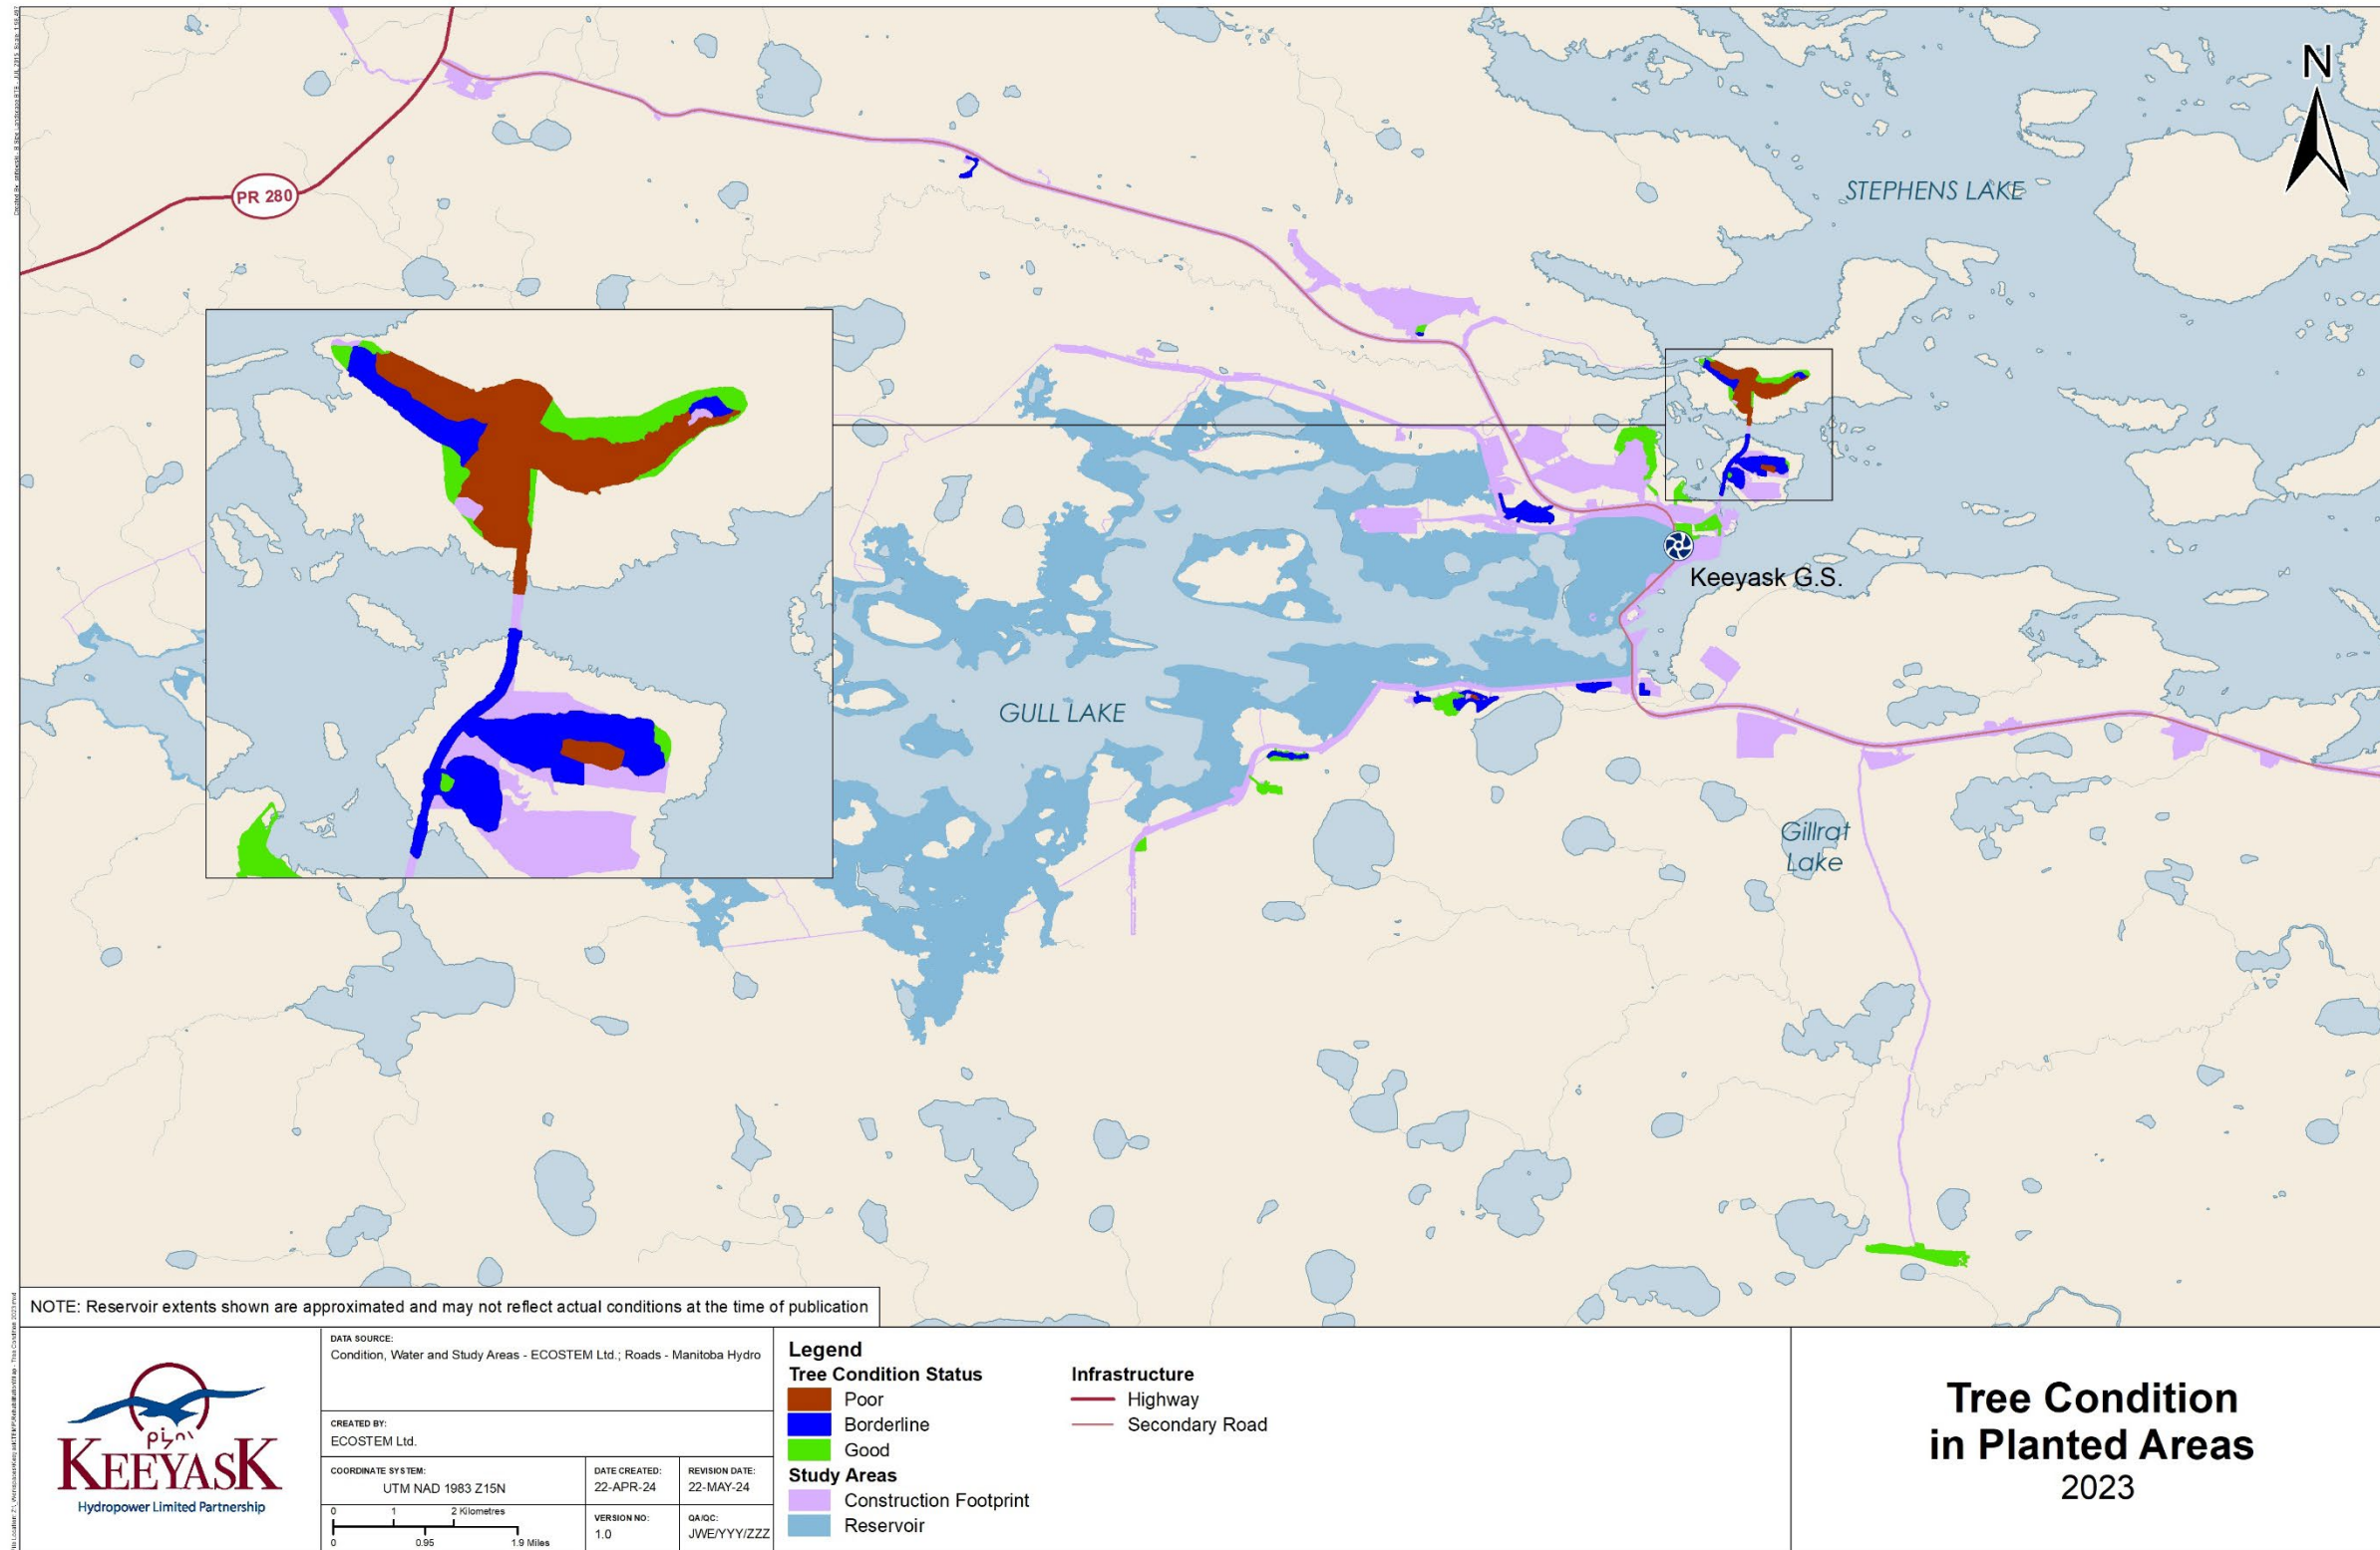
Map 4-12: Tree condition in planted areas as of September 2023

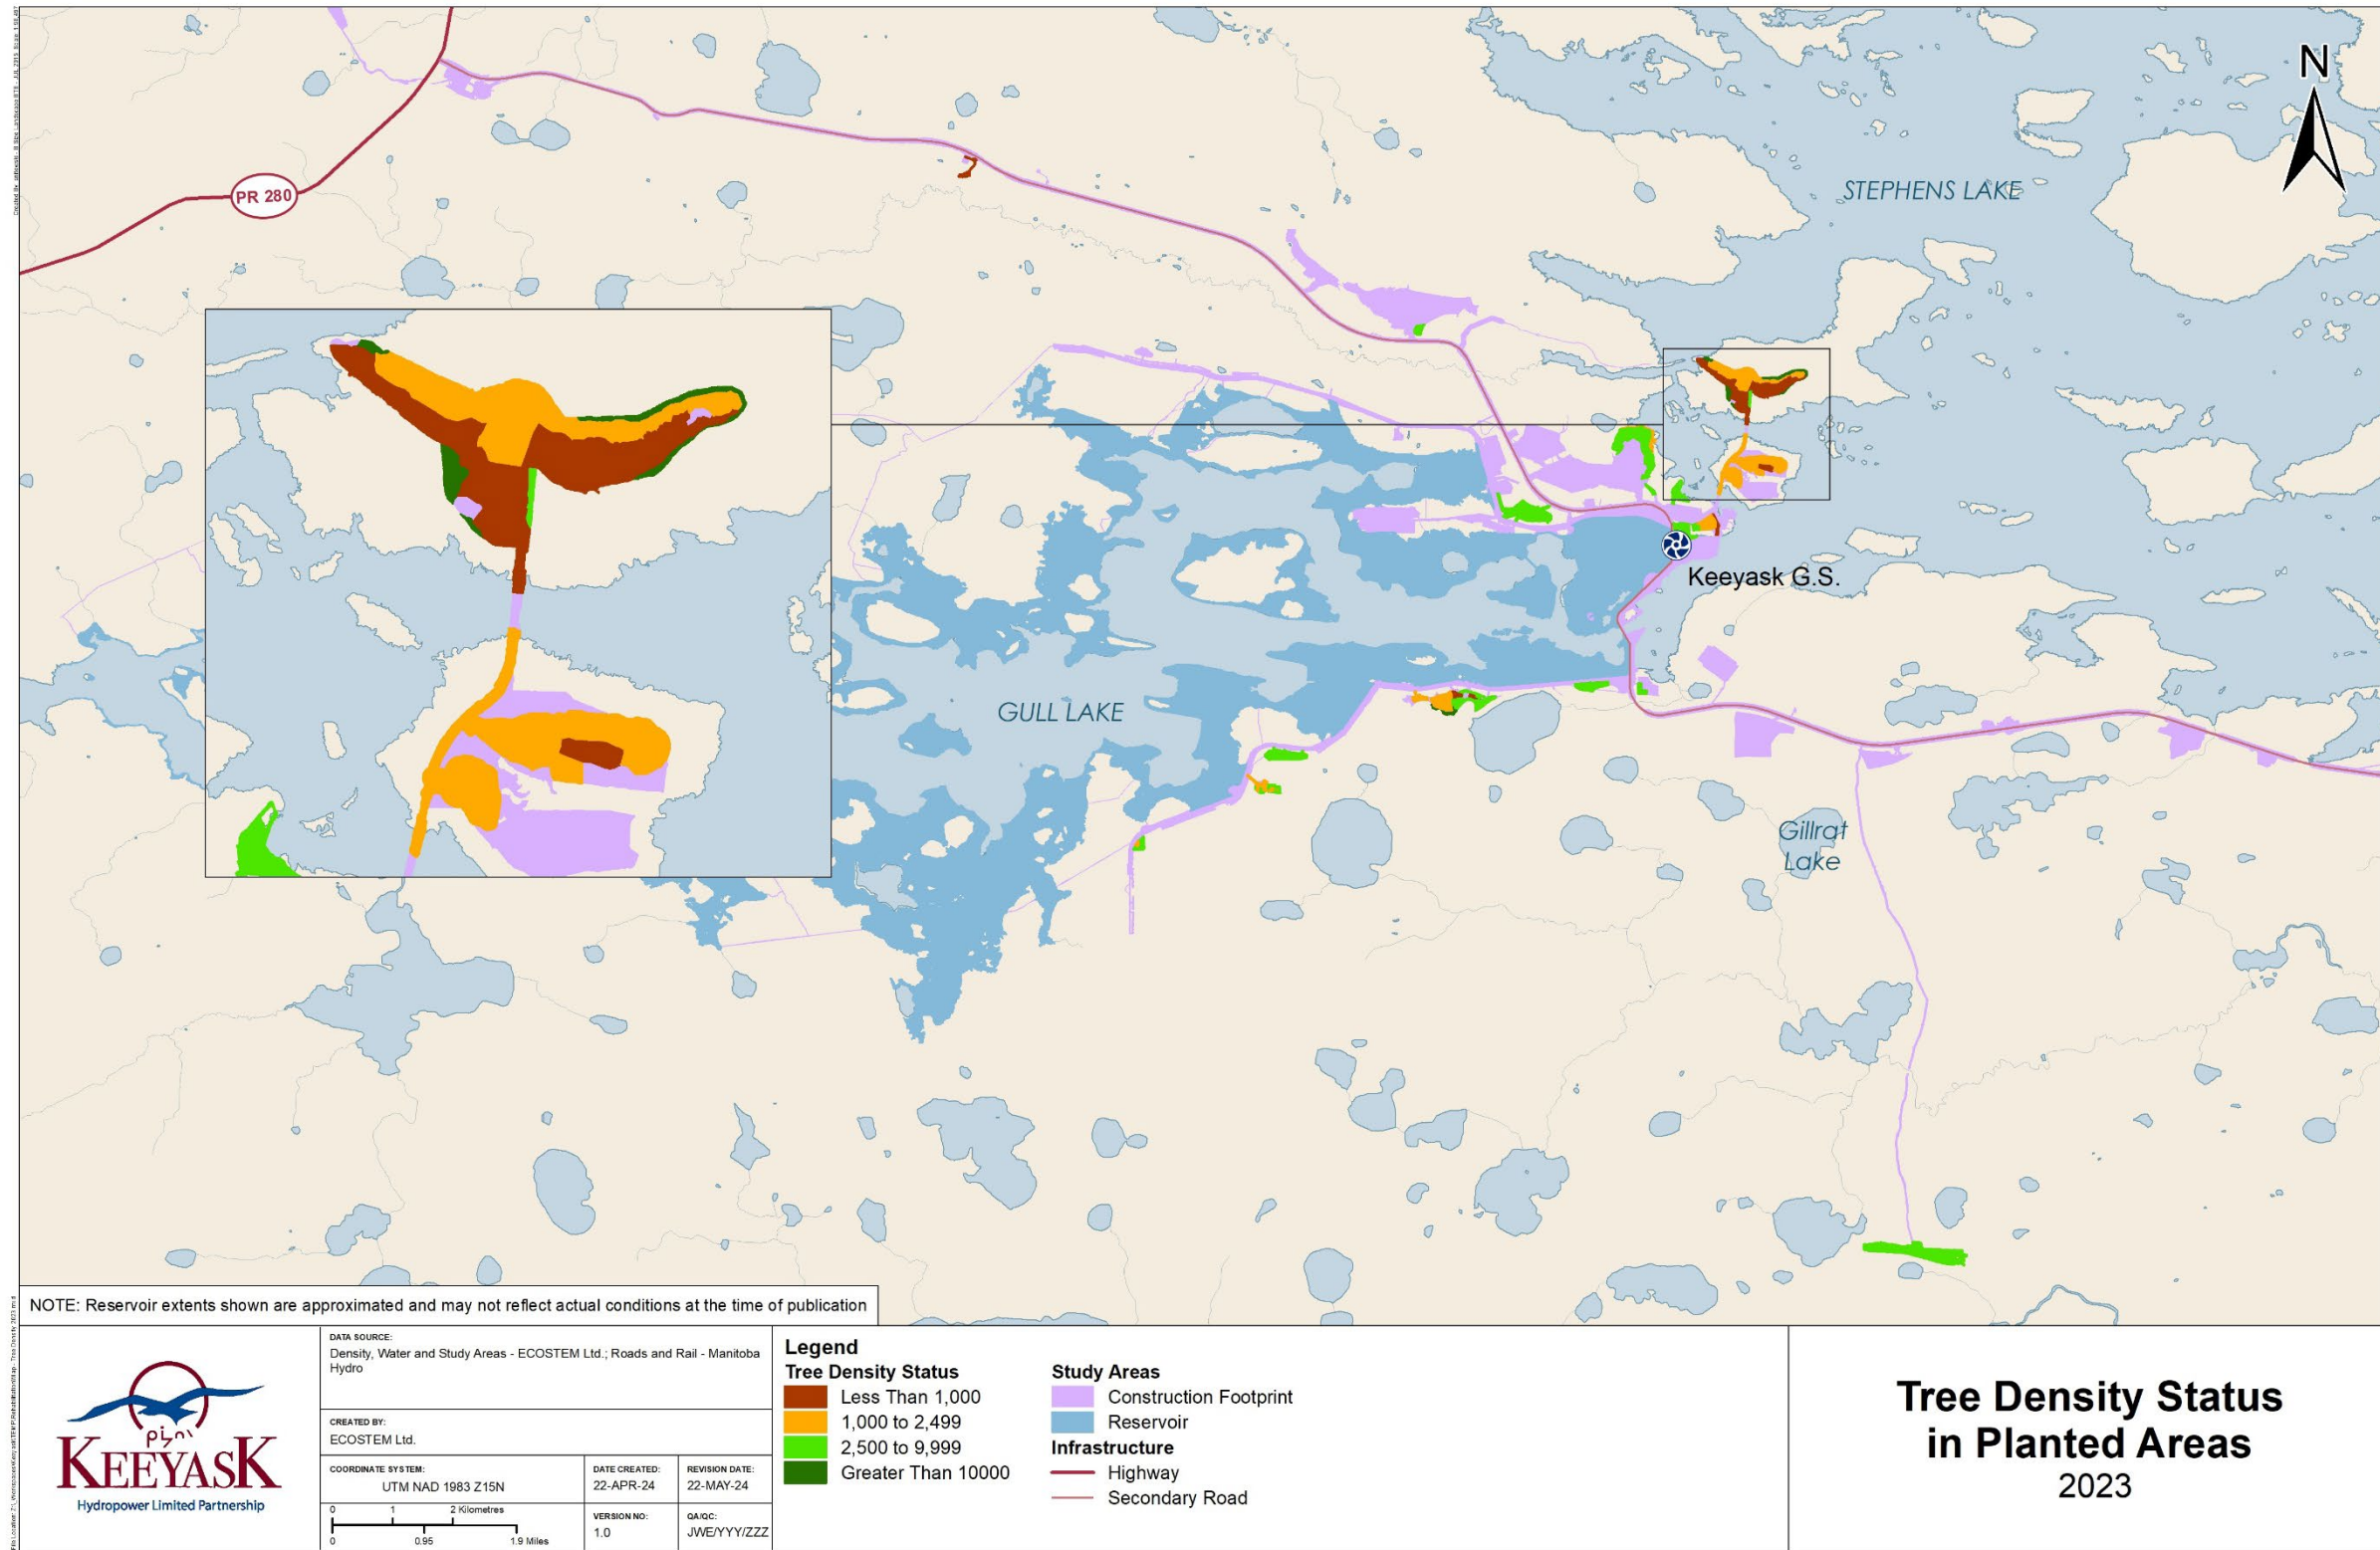
Map 4-13: Tree density status in planted areas as of September 2023

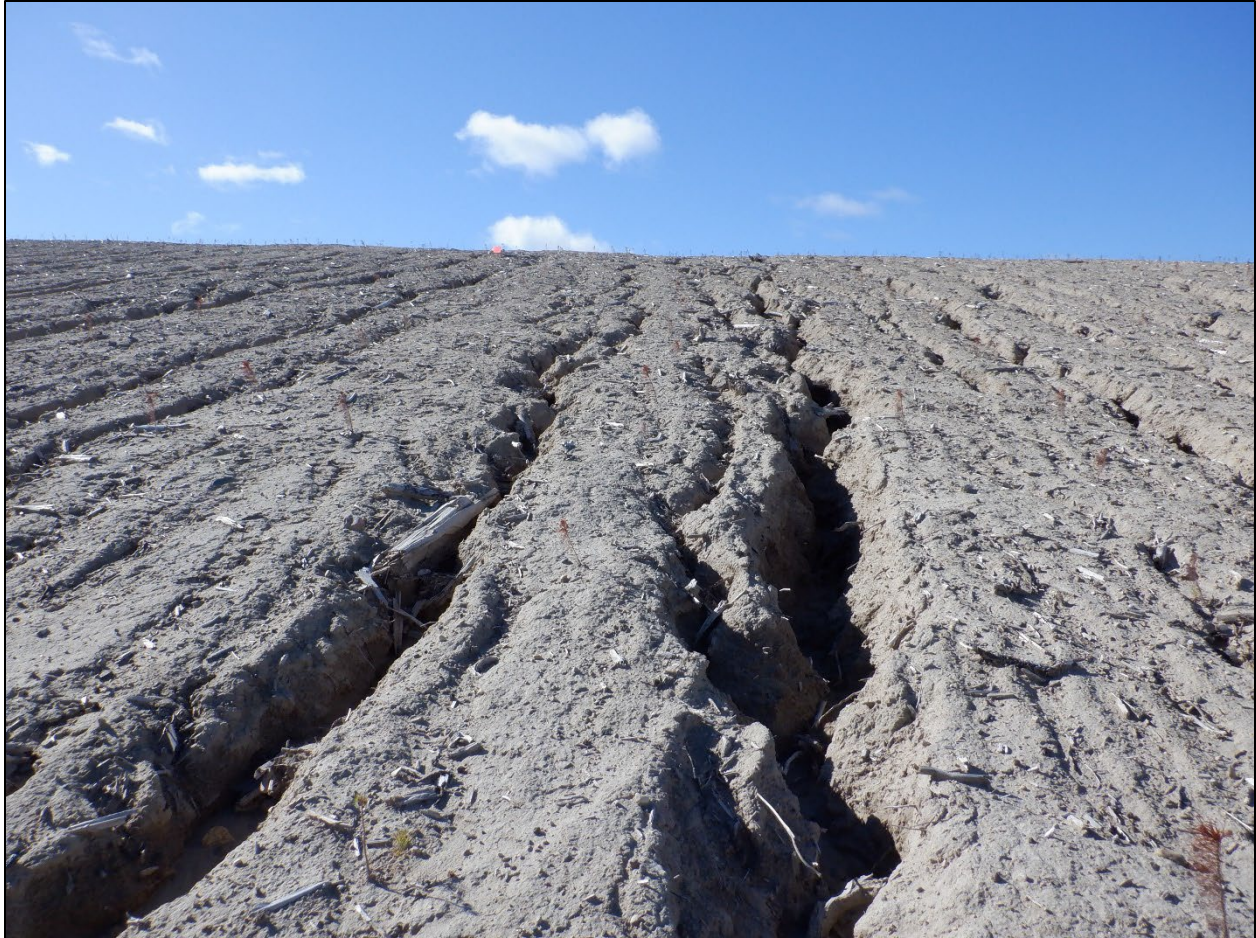
Photo 5-2: Jack pine seedlings growing near erosion channels in Borrow Area G-3 in 2023
