# Keeyask Generation Project Environmental Impact Statement

## Supporting Volume Aquatic Environment

June 2012

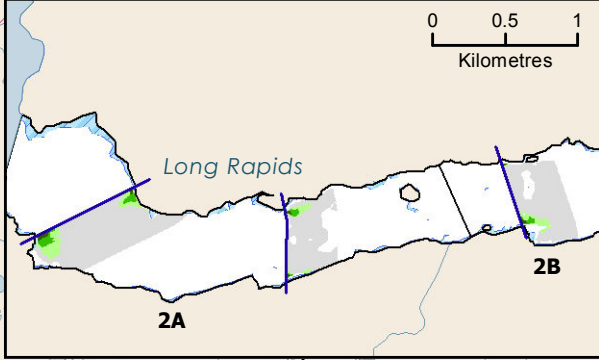
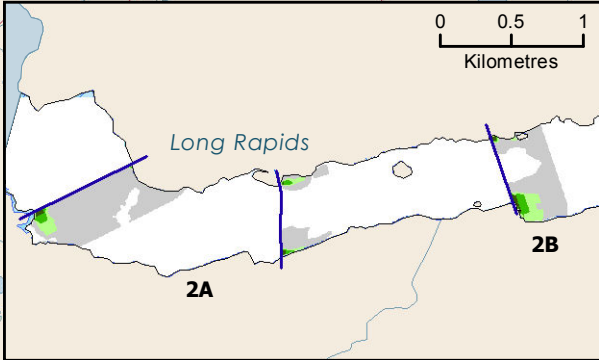
**Lake Sturgeon Spawning Habitat at 5<sup>th</sup> Percentile Inflow**  
 Five Variable Habitat Suitability Index Model

Note: Existing Environment frame shows 5<sup>th</sup> percentile inflow and Stephens Lake level of 141.1m. Post-Project frame shows Year 30 shoreline, reservoir at 159 metres and 5<sup>th</sup> percentile inflow with 4 unit full gate plant operation with spill and Stephens Lake level of 141.1m. Mitigation measures are not shown. Extents of dewatered area are estimated based on the existing environment 95<sup>th</sup> percentile flow.

Map illustrates the estimated extent of dewatered area when the spillway is not in operation. The true extent of this area is uncertain due to the limited bathymetric data.

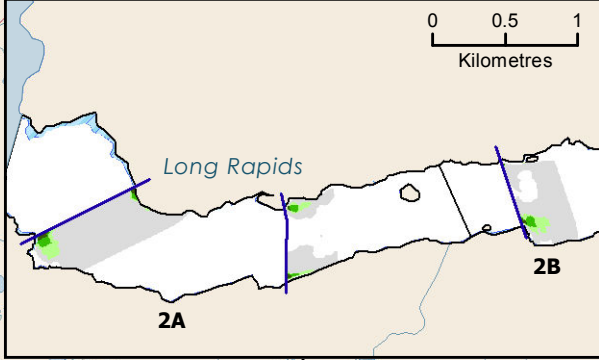
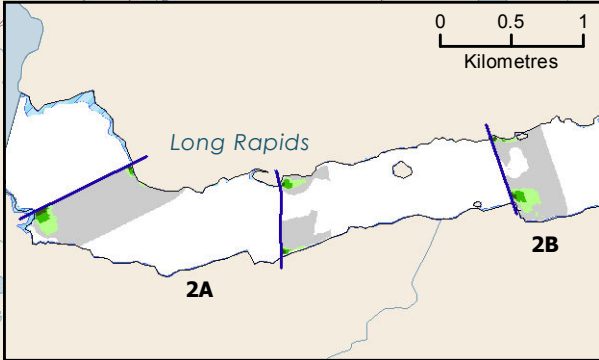
**Lake Sturgeon Spawning Habitat at 50<sup>th</sup> Percentile Inflow**  
**Five Variable Habitat Suitability Index Model**

Note: Existing Environment frame shows 50<sup>th</sup> percentile inflow and Stephens Lake level of 141.1m. Post-Project frame shows Year 30 shoreline, reservoir at 159 metres and 50<sup>th</sup> percentile inflow with 6 unit full gate plant operation with spill and Stephens Lake level of 141.1m. Mitigation measures are not shown. Extents of dewatered area are estimated based on the existing environment 95<sup>th</sup> percentile flow.

Map illustrates the estimated extent of dewatered area when the spillway is not in operation. The true extent of this area is uncertain due to the limited bathymetric data.

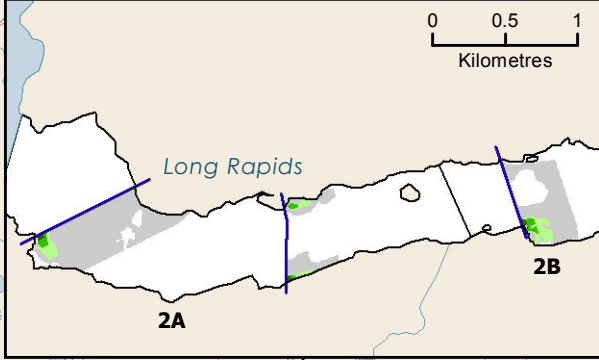
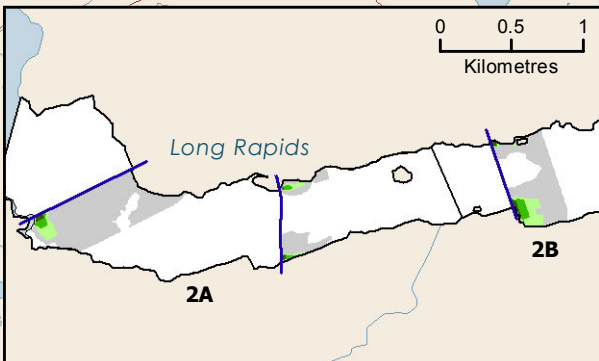
**Lake Sturgeon Spawning Habitat at 95<sup>th</sup> Percentile Inflow**  
**Five Variable Habitat Suitability Index Model**

Note: Existing Environment frame shows 95<sup>th</sup> percentile inflow and Stephens Lake level of 141.1m. Post-Project frame shows Year 30 shoreline, reservoir at 159 metres and 95<sup>th</sup> percentile inflow with 7 unit full gate plant operation with spill and Stephens Lake level of 141.1m. Mitigation measures are not shown. Extents of dewatered area are estimated based on the existing environment 95<sup>th</sup> percentile flow.

Map illustrates the estimated extent of dewatered area when the spillway is not in operation. The true extent of this area is uncertain due to the limited bathymetric data.
