Keeyask Generation Project Environmental Impact Statement

Supporting Volume Aquatic Environment

June 2012

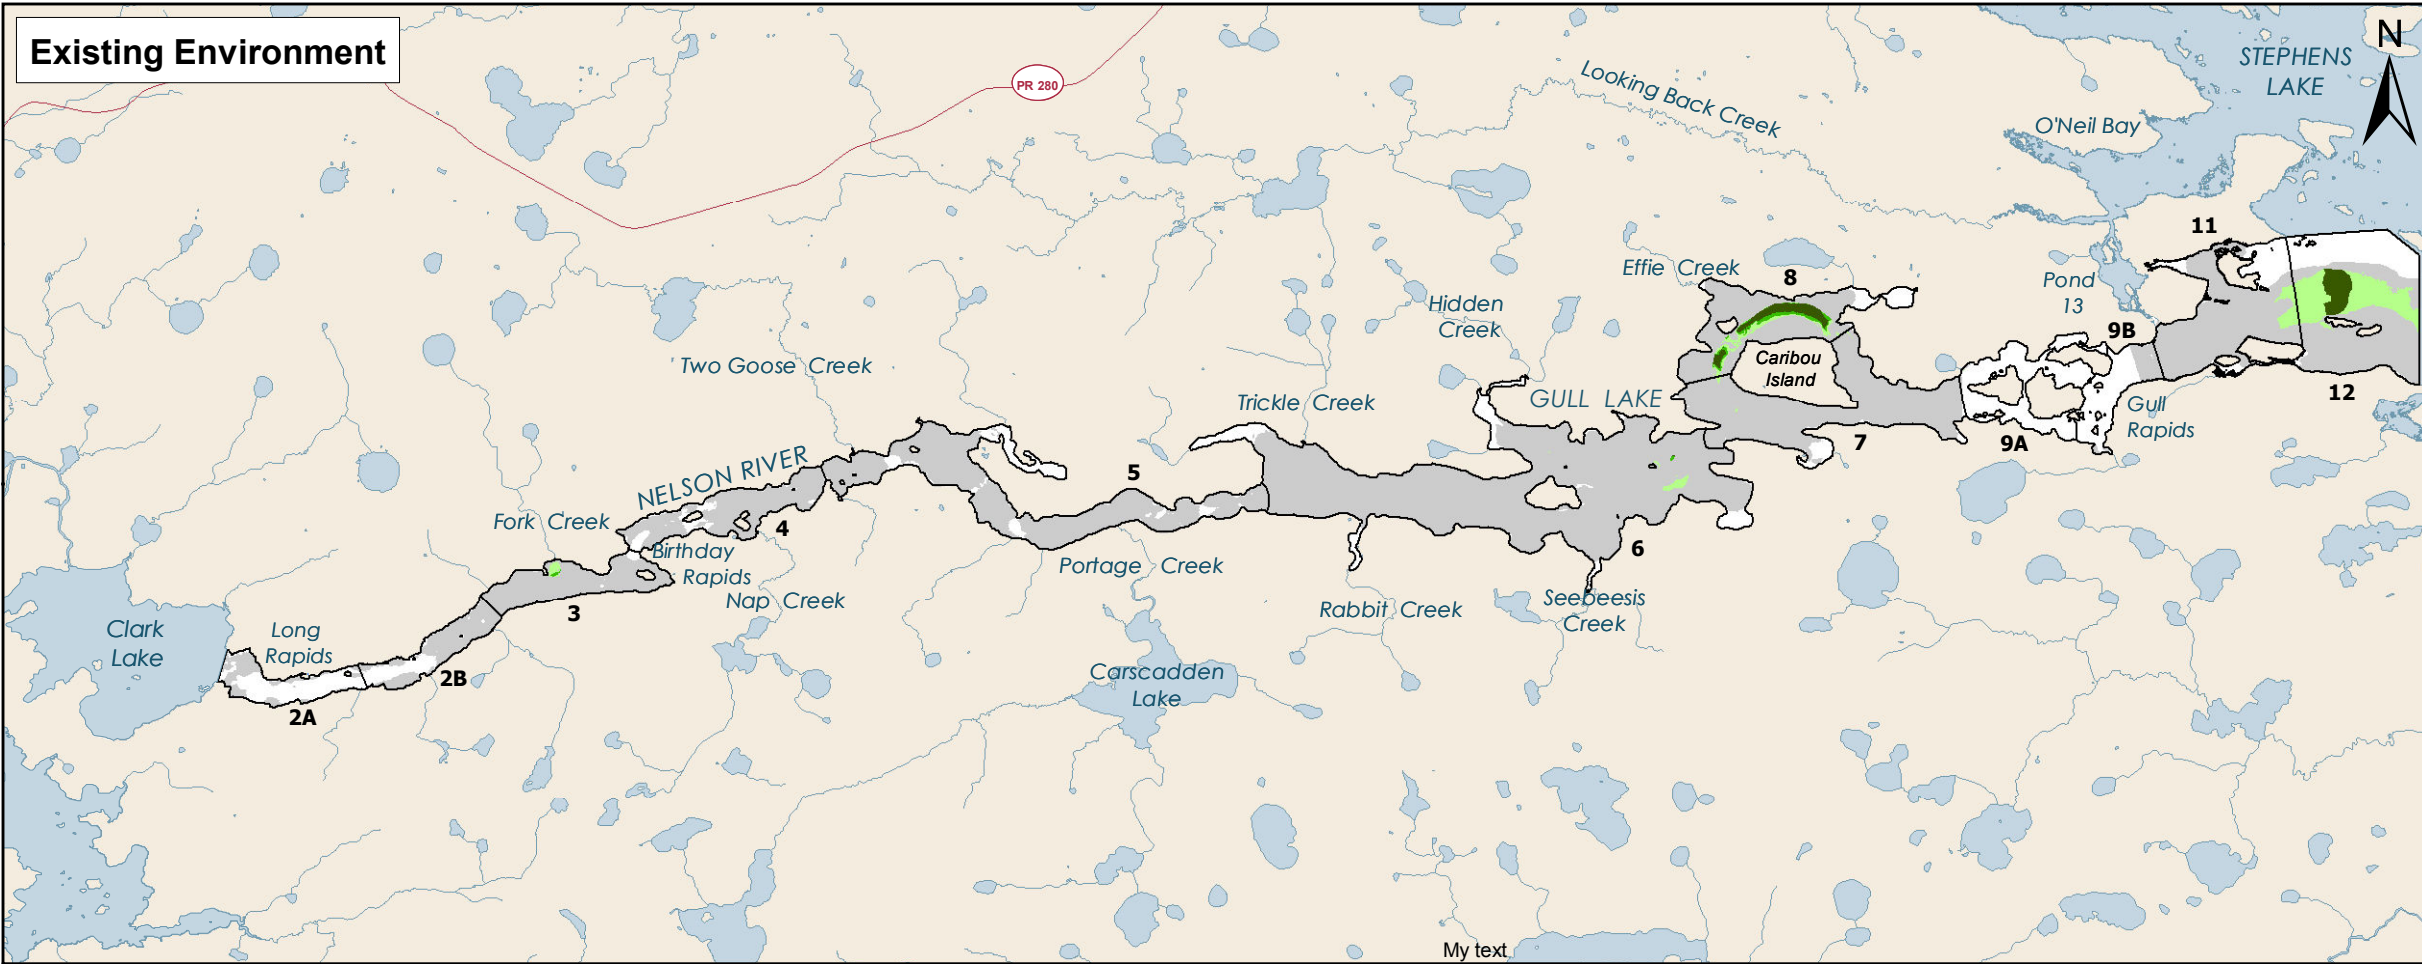
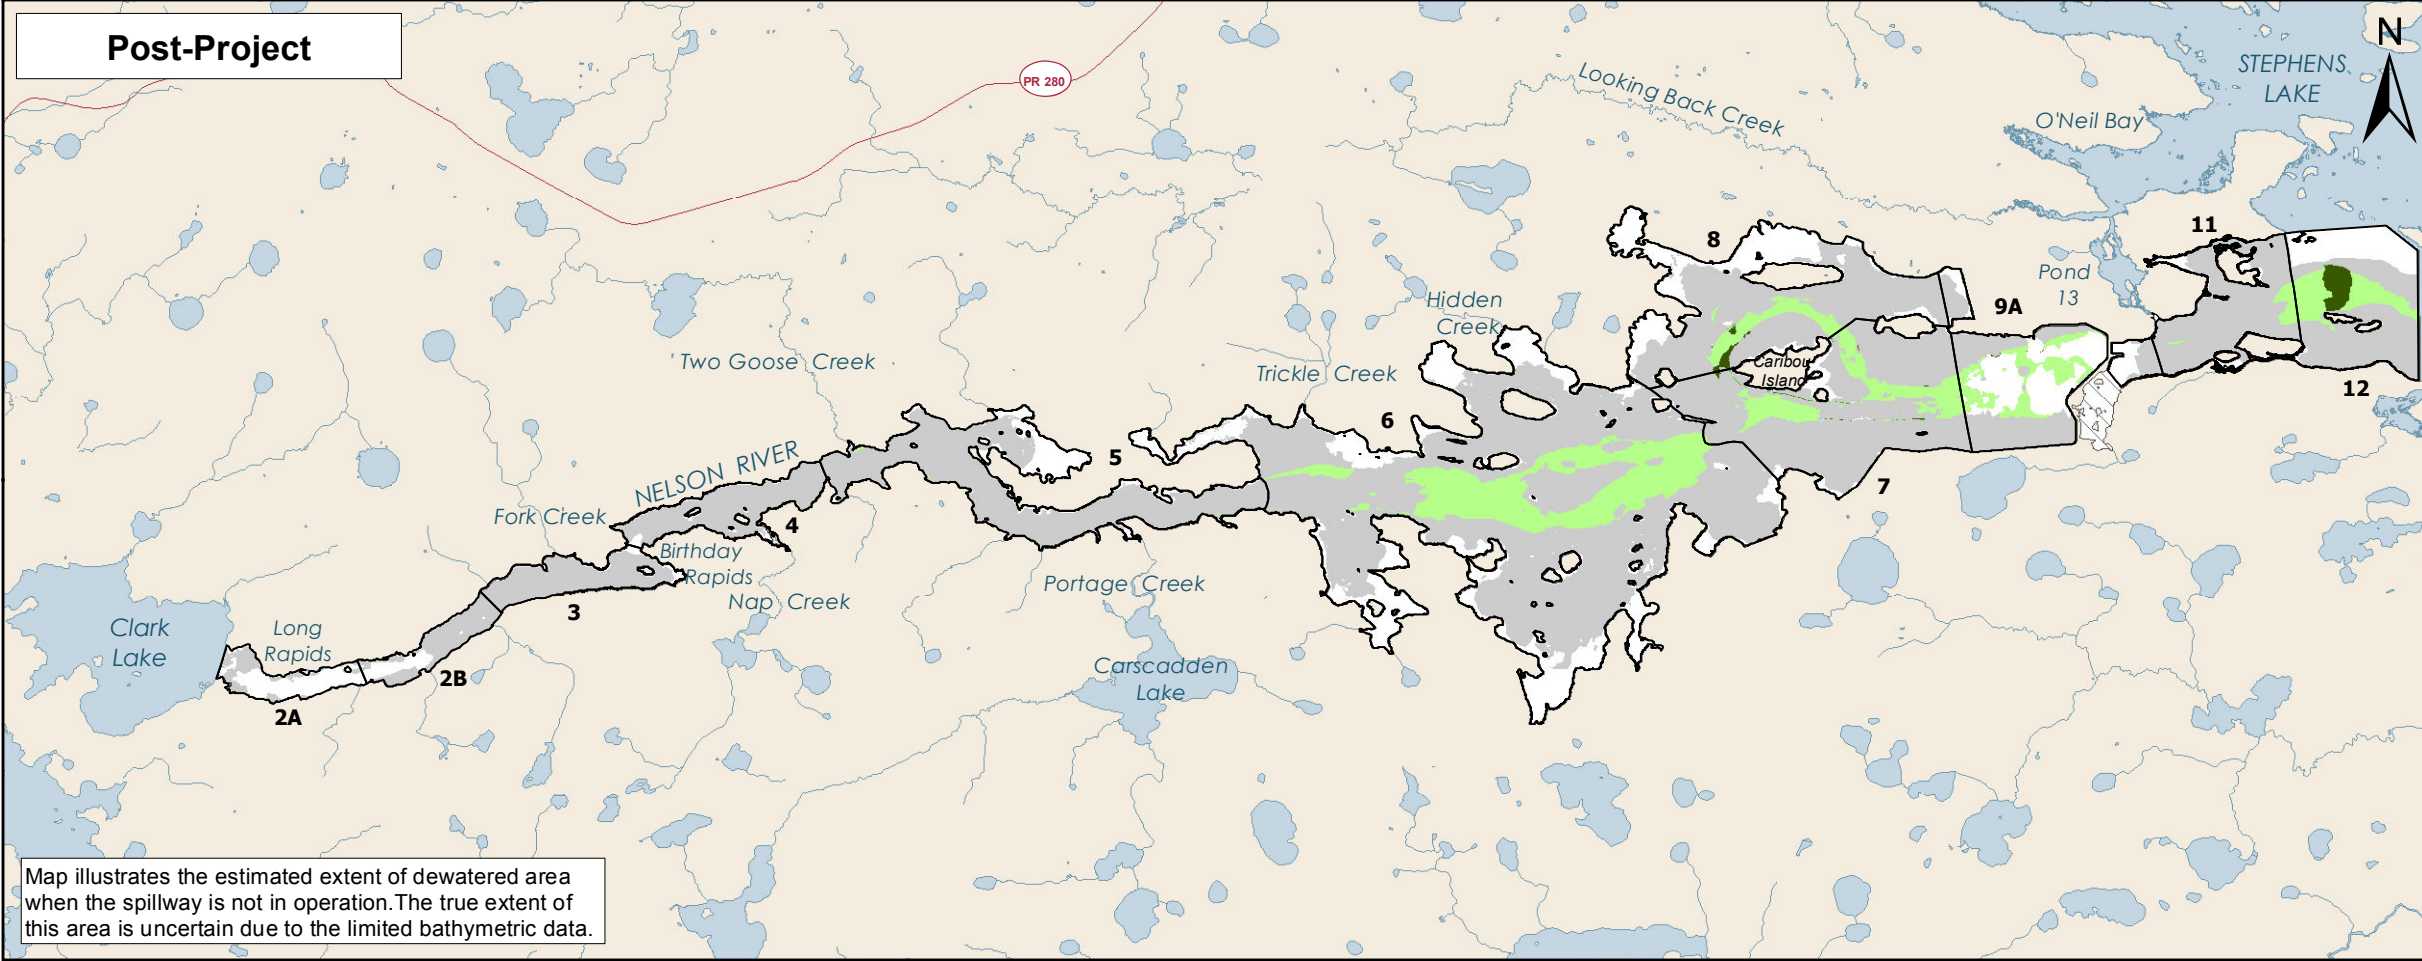
**Young-of-the-Year Lake Sturgeon
 Habitat at 95th Percentile Inflow
 Habitat Suitability Index Model**

Note: Existing Environment frame shows 95th percentile inflow and Stephens Lake level of 141.1m. Post-Project frame shows Year 30 shoreline, reservoir at 159 metres and 95th percentile inflow with 7 unit full gate plant operation with spill and Stephens Lake level of 141.1m. Mitigation measures are not shown. Extents of dewatered area are estimated based on the existing environment 95th percentile flow.

Map illustrates the estimated extent of dewatered area when the spillway is not in operation. The true extent of this area is uncertain due to the limited bathymetric data.
