Keeyask Generation Project Environmental Impact Statement

Supporting Volume Physical Environment

KEEYASK GENERATION
PROJECT
PHYSICAL ENVIRONMENT
SUPPORTING VOLUME
DEBRIS

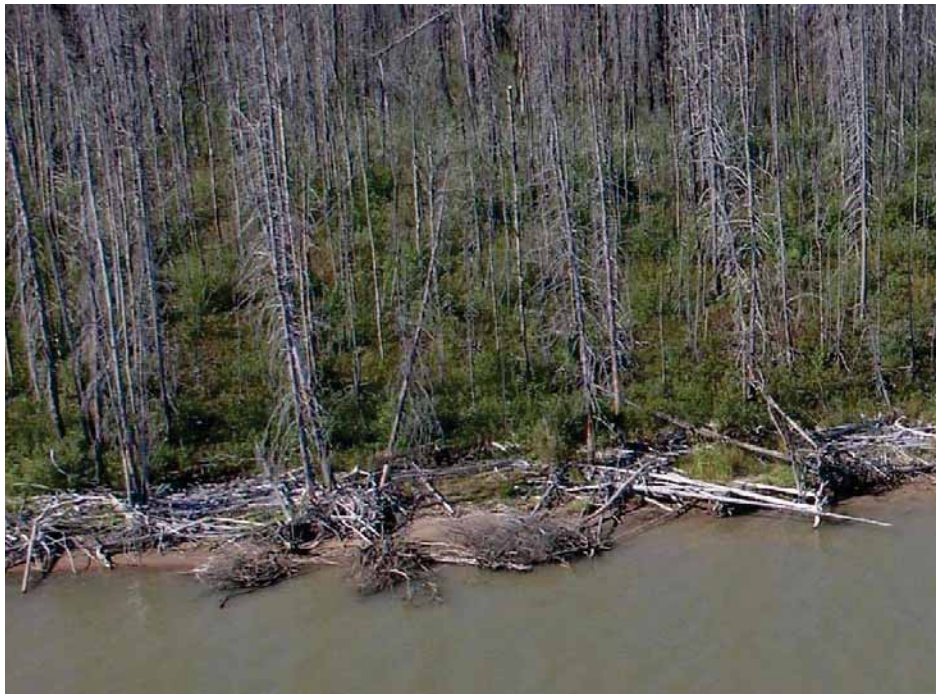
Photo 10.2-1: Example of Densely Distributed Beached Woody Debris Found on the South Shore of Gull Lake

1. Beached Woody Debris: debris that is found at or above the average water level along the shore (Photo 10.2-1 and Photo 10.2-2).
2. Standing Dead Trees: flooded trees that are still standing but no longer alive (Photo 10.2-5).

- Density = 1: low density and sparsely distributed (Photo 10.2-2).
- Density = 2: medium density distribution (Photo 10.2-3).
- Density = 3: densely distributed debris (Photo 10.2-1).

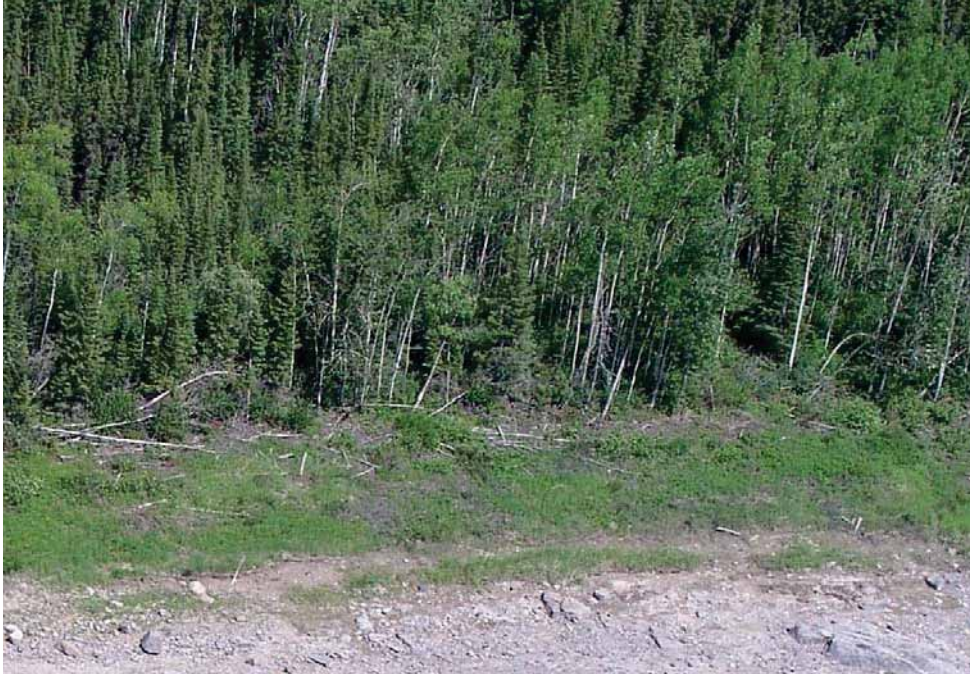
Photo 10.2-2: Beached Debris that is of Light Density and Sparsely Distributed

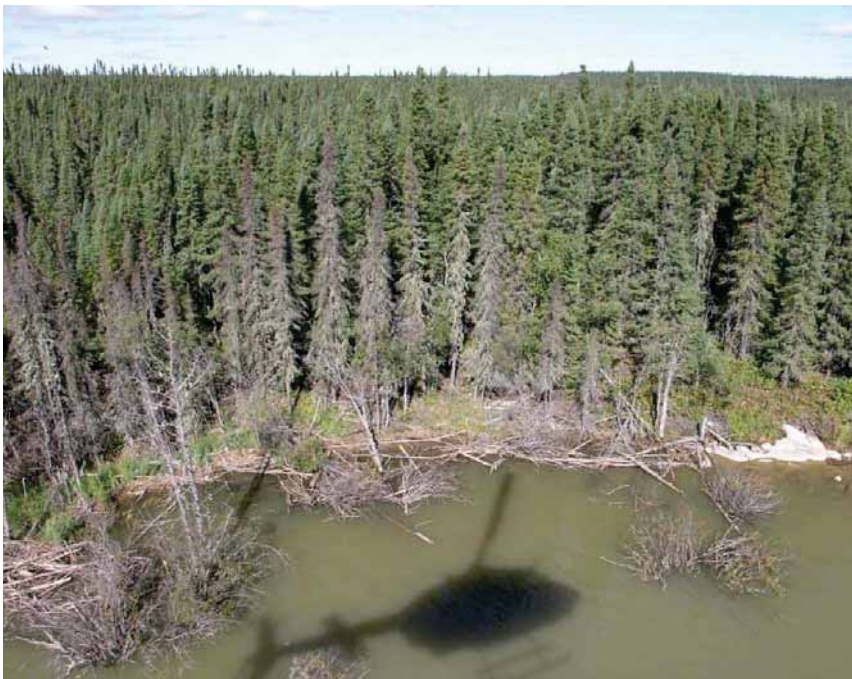
Photo 10.2-3: Medium Density Floating as well as Light Submerged Debris can be seen here on the North Shore of Gull Lake

debris floats loosely near the shore (Photo 10.2-3), but is not entangled amongst other debris, as with rafted debris.

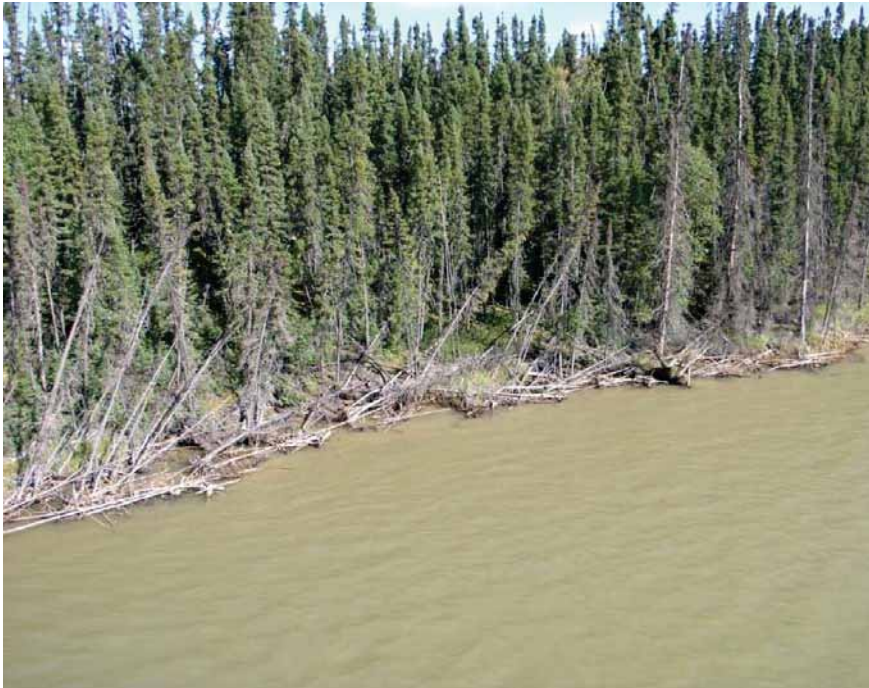
Photo 10.2-4: Leaning Trees of Medium Density on the North Shore of Gull Lake

5. Leaning Trees: trees along the shoreline that are tipping towards the water due to shoreline erosion of their root structure. In most cases, leaning trees will eventually enter the water after the shoreline upon which they are rooted has eroded (Photo 10.2-4).
6. Submerged Debris: trees or brush that are in the water but are not mobile (Photo 10.2-3). Typically, submerged logs are those below the surface and can occasionally be seen in areas of clear shallow water or when there is a high water level condition.
7. Deadheads: trees which are in the waterway but not mobile. Deadheads have one end floating just at the surface while the other end is either on the bottom **substrate** or embedded into it.

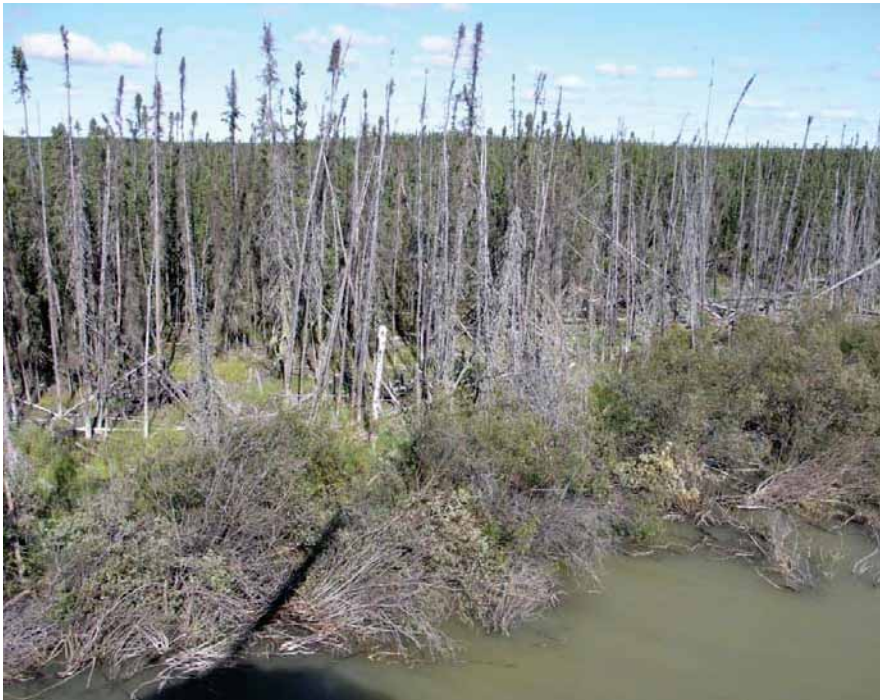
Photo 10.2-5: Medium Density Standing Dead Trees in an Inlet on the North Side of the Nelson River

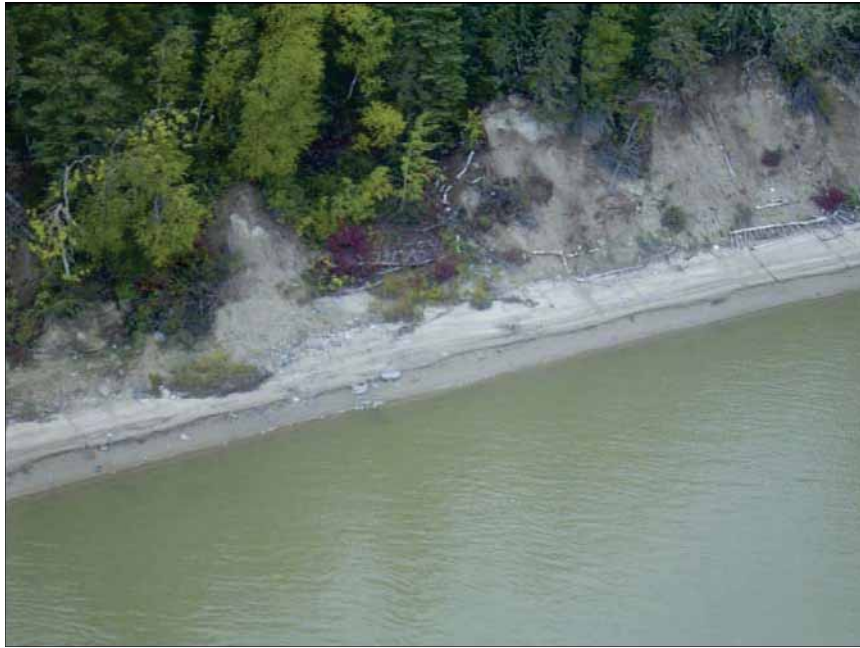
Photo 10.3-1 Eroding Mineral Soil Bank Between Clark Lake and Birthday Rapids.
Photo Taken 19 September 2007

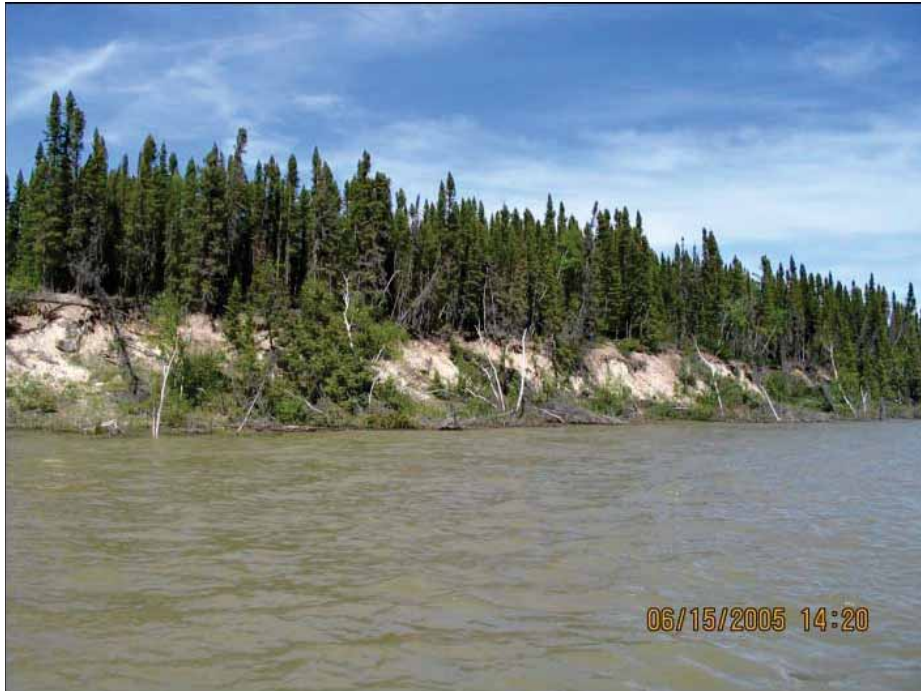
Photo 10.3-2: High Banks, South Side of Caribou Island, in Gull Lake Upstream from Gull Rapids

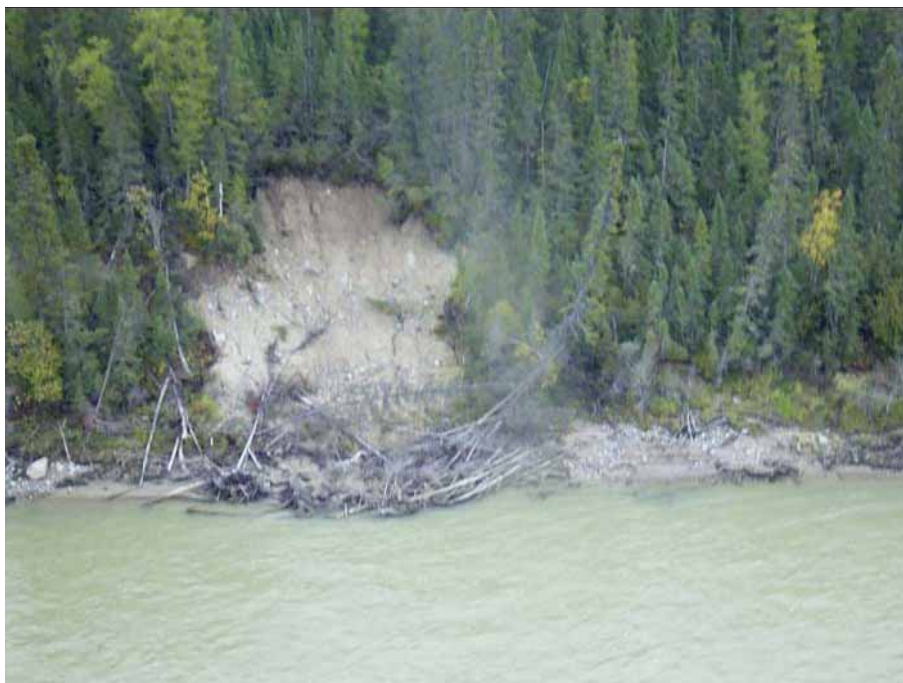
Photo 10.3-3: Localized Slope Failure in Mineral Soil Bank Between Clark Lake and Birthday Rapids. Photo Taken 19 September 2007

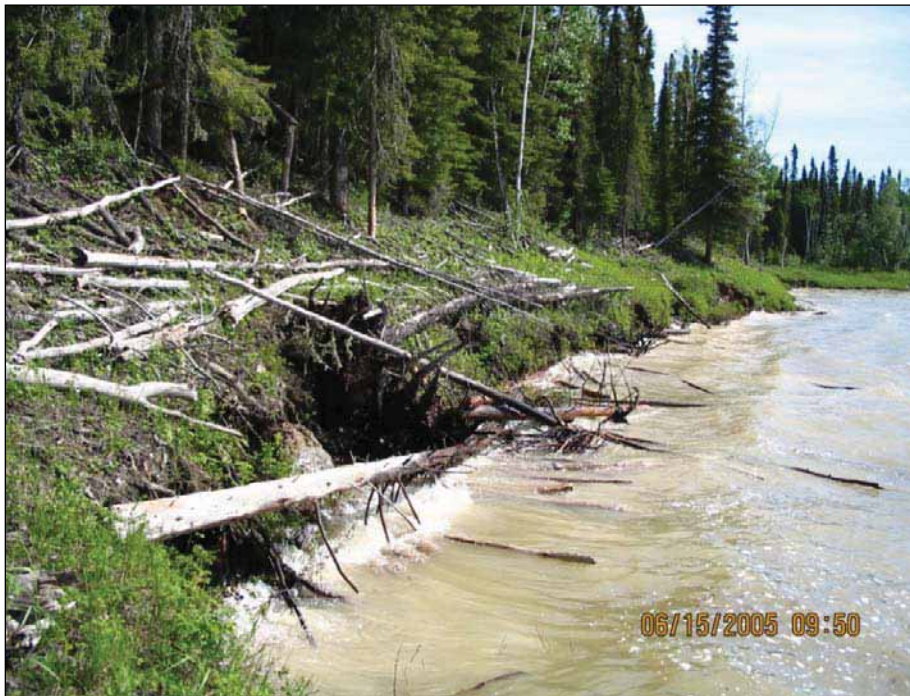
Photo 10.3-4: Example of Low Eroding Mineral Soil Bank and Ice-Scour Zone Below Trees in River Reach Between Birthday Rapids and Gull Lake

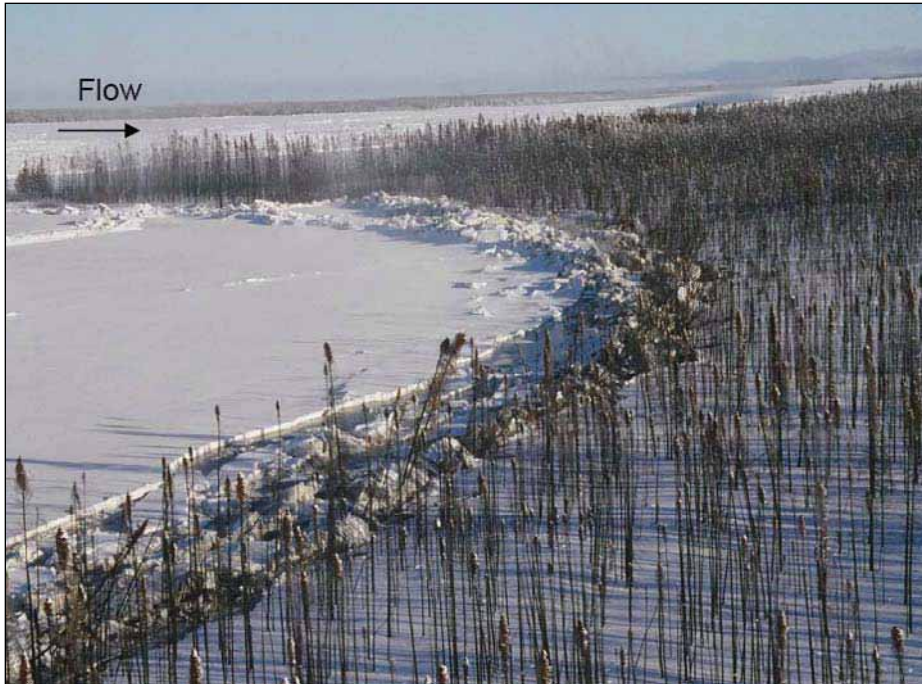
Photo 10.3-5: Example of River Ice Bull Dozing Trees Along Shoreline

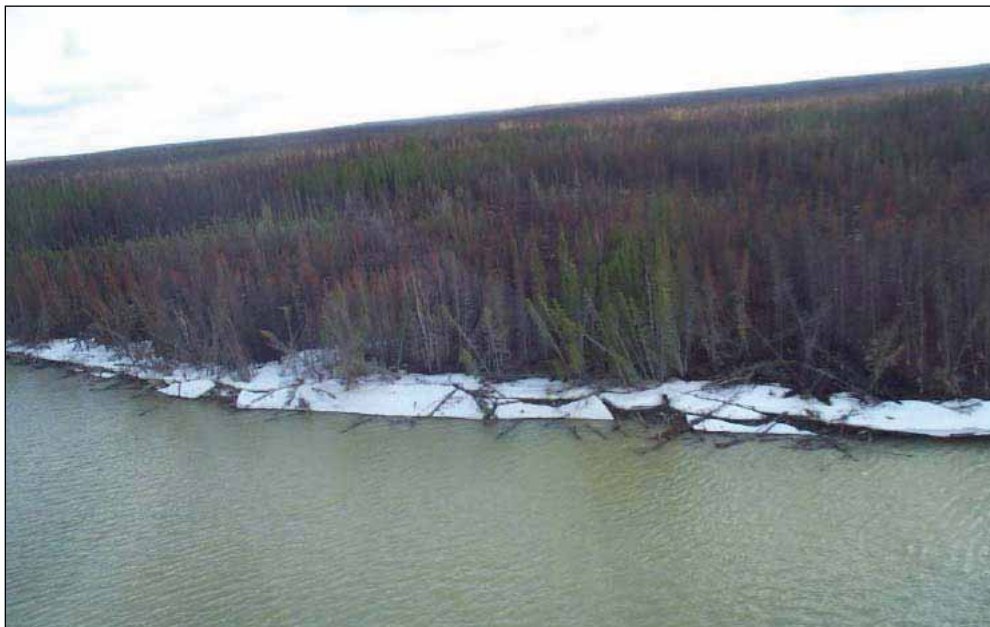
Photo 10.3-6: Example of Border Ice Collapsing Onto Shore Zone Where Woody Debris is Pulled into the River by the Ice

open water elevation. In some locations, ice has shoved coarse **gravel, cobbles** and **boulders** onto the shore, effectively protecting these shorelines from erosion. In other places, the ice shoving pushes over trees and other vegetation (Photo 10.3-4 and Photo 10.3-5). There are certain areas of Gull Lake where the shores may be protected by **border ice** that remains attached to the shore, thereby acting as a **buffer** to ice shoving. Border ice, however, may create new debris if it causes woody or peat material to be pulled away from the shore when the ice recedes in spring (Photo 10.3-6).
