# LAKE STURGEON STEWARDSHIP & ENHANCEMENT PROGRAM

Construction of Shoals to Enhance  
Lake Sturgeon Spawning Habitat  
in the Winnipeg River  
at Pointe du Bois:  
2010 Monitoring Program

Report 10-01  
April 2011

**North /South Consultants Publication # 5900**

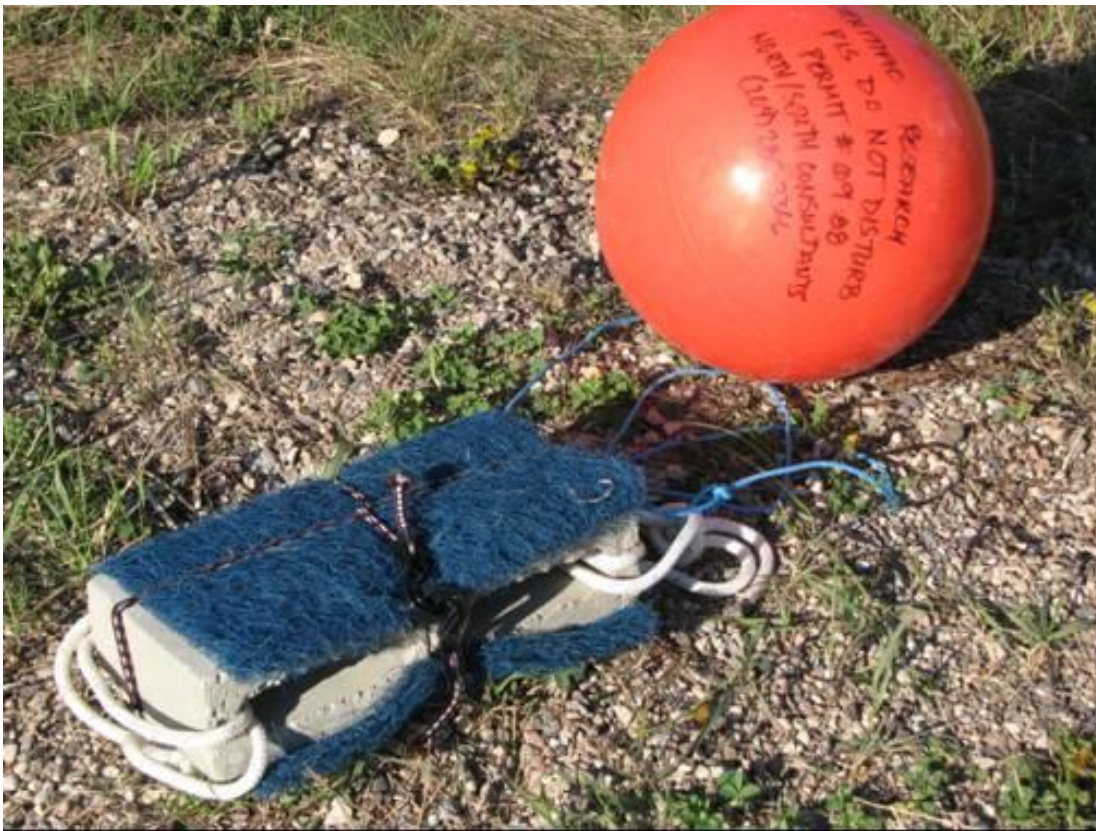
Figure 10. Egg collection mat used to monitor spawning on and near the constructed shoals.

Egg collection mats were placed on and around the constructed shoals to search for direct evidence of spawning. Egg mats consisted of a 30 x 90 cm portion of furnace filter material wrapped around a 39 x 19 x 9 cm cinder block and held in place with bungee cords (Figure 10). Lake sturgeon eggs readily adhere to

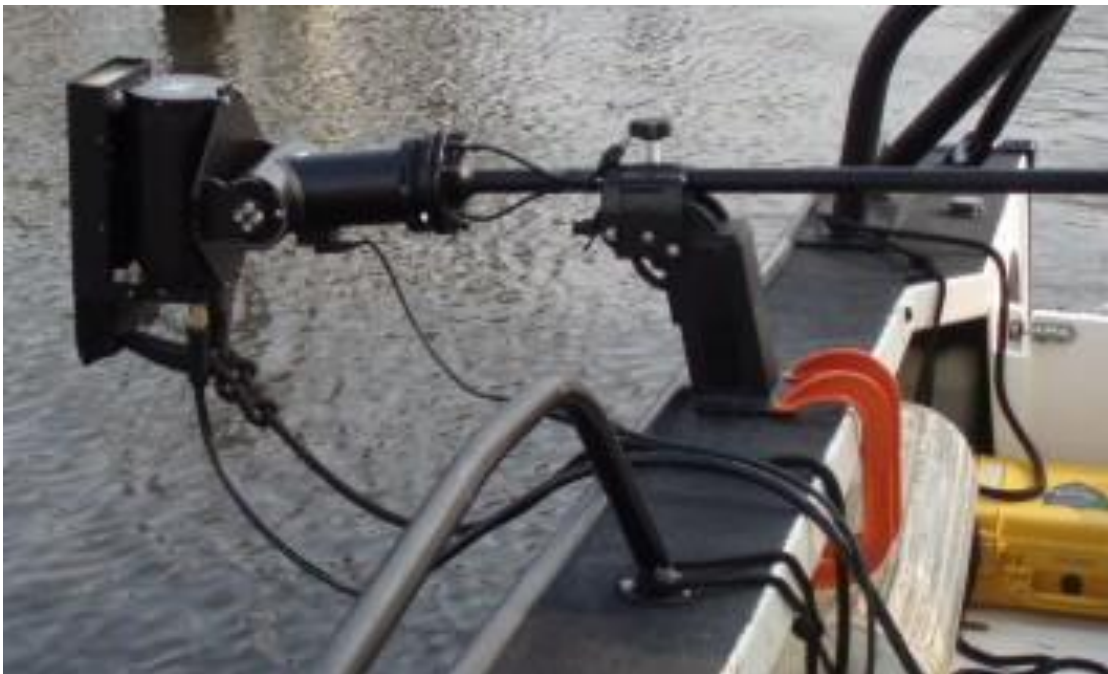
Figure 11. DIDSON acoustic camera and pole mount used to monitor the constructed shoals.

A DIDSON sonar camera was used to monitor the constructed shoals and surrounding areas during the spawning period to determine if lake sturgeon were utilizing and/or spawning in the vicinity of the constructed spawning shoals. The setup consisted of a DIDSON camera unit attached to a pan & tilt rotator (PT-25) that was mounted on a swiveling Viper Fish Pole (Rented from Ocean Marine Industries Inc., Virginia, USA) (Figure 11). A custom built mounting bracket was bolted to the seat of the boat (constructed by Anything Custom Ltd. Winnipeg, Manitoba) and the pole, rotator, and camera were attached to it. The setup allowed the camera to be lowered approximately 1 m below the surface for monitoring, raised for travel. The boat was moored differently at each of the constructed shoal locations for optimal camera operation. To monitor the constructed shoal downstream of Unit 16, the boat was moored immediately downstream of the shoal and the camera was pointed upstream. At the Unit 13 shoal, the boat was tied directly to the station and the camera was pointed downstream at the shoal. Attempts were made to moor near the Unit 5 shoal, but flow conditions prevented the capture of steady images. The constructed shoal downstream of Unit 1 was monitored by mooring the boat in the calmer water east of the shoal. Each constructed shoal was monitored throughout the spawning period for approximately 2 hours each day, and the time of day that each shoal was monitored was changed daily. Digital images were recorded whenever there was evidence of fish use. The digital data were reviewed and summarized at a later date to describe the frequency of lake sturgeon observations and spawning behaviour.

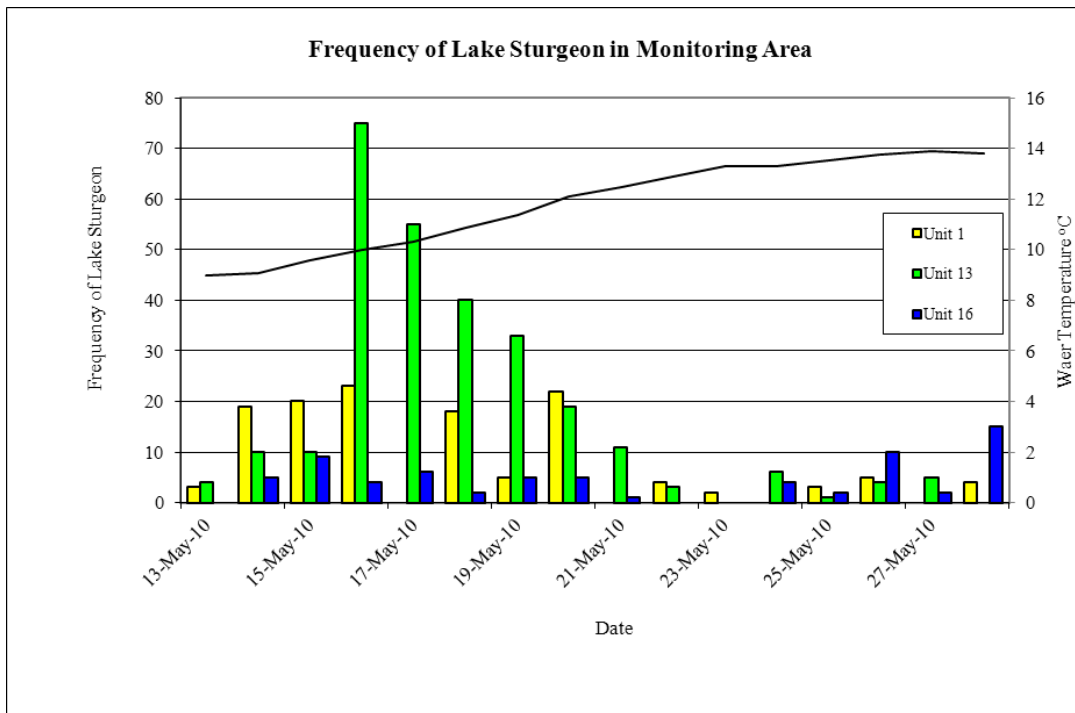
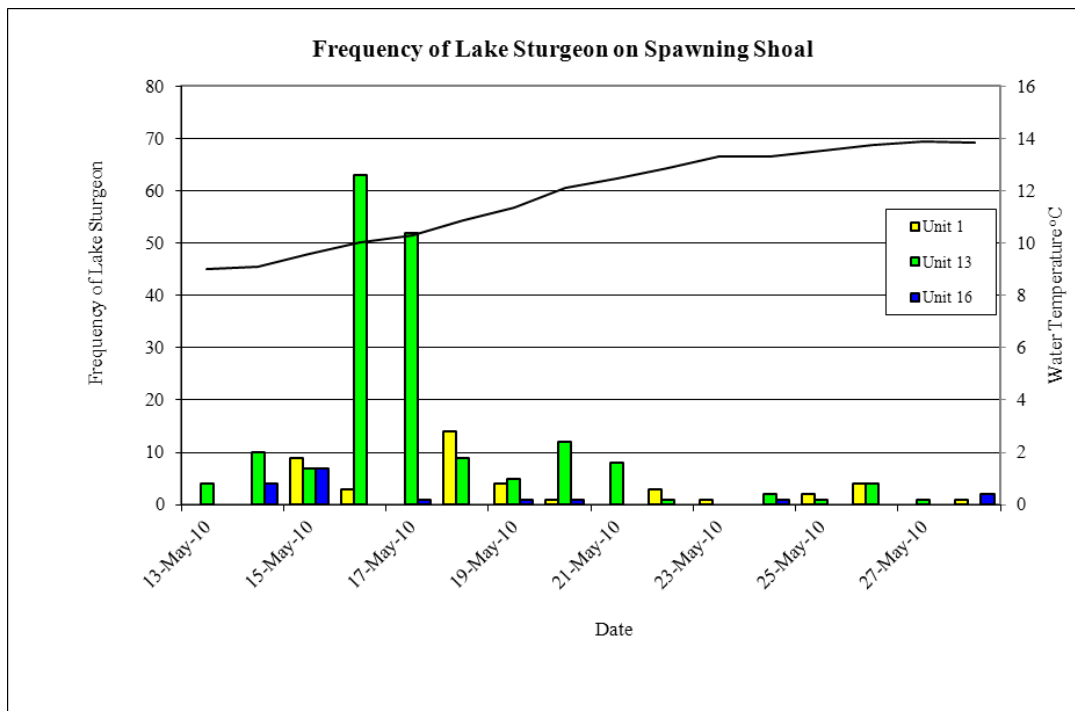
Figure 16. Frequency of lake sturgeon observed within the monitoring areas including constructed shoals (top) and within the constructed shoals (bottom). Water temperature during the monitoring period is indicated on the secondary vertical axis.

Large numbers of adult lake sturgeon (< 800 mm fork length) were observed lined up along the bottom adjacent to the shoal. Prior to the spawning period the sturgeon were relatively inactive, with activity progressively increasing on a daily basis as water temperatures increased. Very few lake sturgeon were observed actually on the shoal. Lake sturgeon were first observed on the shoal on 15 May with the highest number of observations occurring on 18 May (n=14) (Figure 16). Following the spawning period, the number of sturgeon observed on or near the shoal decreased. None were observed on the shoal on 21 May and only a few individuals were observed thereafter (Figure 16).

Initially, few lake sturgeon were observed on or near the Unit 13 shoal. As water temperatures increased, the number and activity level of sturgeon observed on the shoal also increased, with the highest number of observations occurring on 16 and 17 May (n=63 and n=52 respectively, Figure 16). During this time sturgeon were frequently observed swimming around the boulders at the upstream end of the shoal, the unit openings (units not in operation), as well as a bedrock outcrop surrounded by boulders (Figure 15). Although no direct evidence of spawning activity was observed on the shoal, there did appear to be spawning activity adjacent to the shoal, including the bedrock outcrop pictured in Figure 15. Sturgeon were also frequently observed swimming around an egg mat placed upstream of the shoal near the wall of the GS, however, no eggs were collected at this location (Figure 15). Following the peak spawning period, the number of lake sturgeon observations on the shoal steadily decreased (Figure 16). It should be noted that the units in closest proximity to this constructed shoal (i.e., units 12, 13, and 14) were not in operation during the peak spawning period.

The shoal downstream of Unit 16 had the lowest frequency of lake sturgeon observations of all constructed shoals monitored. As water temperatures increased, the number of observations remained very infrequent (Figure 16). No visible evidence of spawning activity was observed on or near the shoal throughout the monitoring period. There was an increase in the number of sturgeon observations toward the end of the monitoring period.
