Construction of Shoals to Enhance Lake Sturgeon Spawning Habitat in the Winnipeg River at Pointe du Bois: 2011 Monitoring Program

Report 11-05
March 2012

North/South Consultants Inc.
Aquatic Environment Specialists

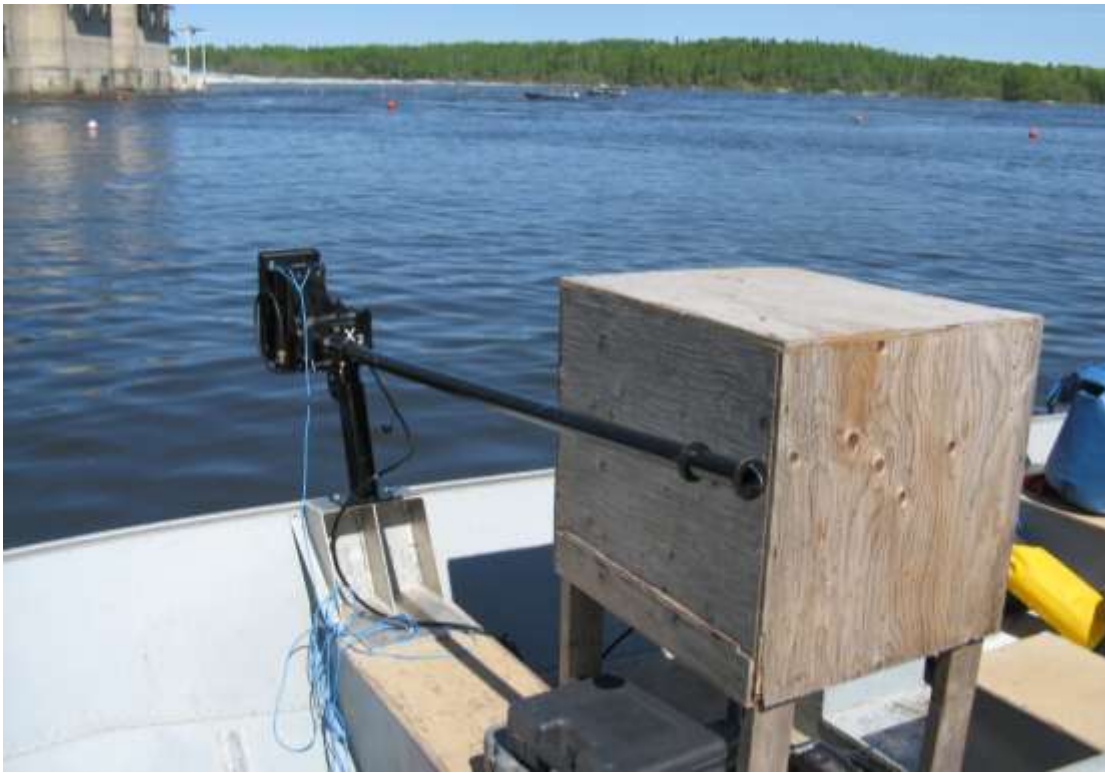
Figure 3. DIDSON acoustic camera and pole mount used to monitor the constructed shoals.

The DIDSON monitoring setup consisted of a camera unit attached to a X² pan & tilt rotator (Soundmetrics Corp., Lake Forest Park, Washington, USA) mounted on a swiveling pole mount (constructed by Anything Custom Ltd, Winnipeg, Canada) (Figure 3). A custom built mounting bracket (also constructed by Anything Custom Ltd., Winnipeg, Manitoba) was bolted to the seat of the boat and the pole, rotator, and camera were attached to it. The setup allowed the camera to be lowered approximately 1 m below the water surface for monitoring and raised for travelling.

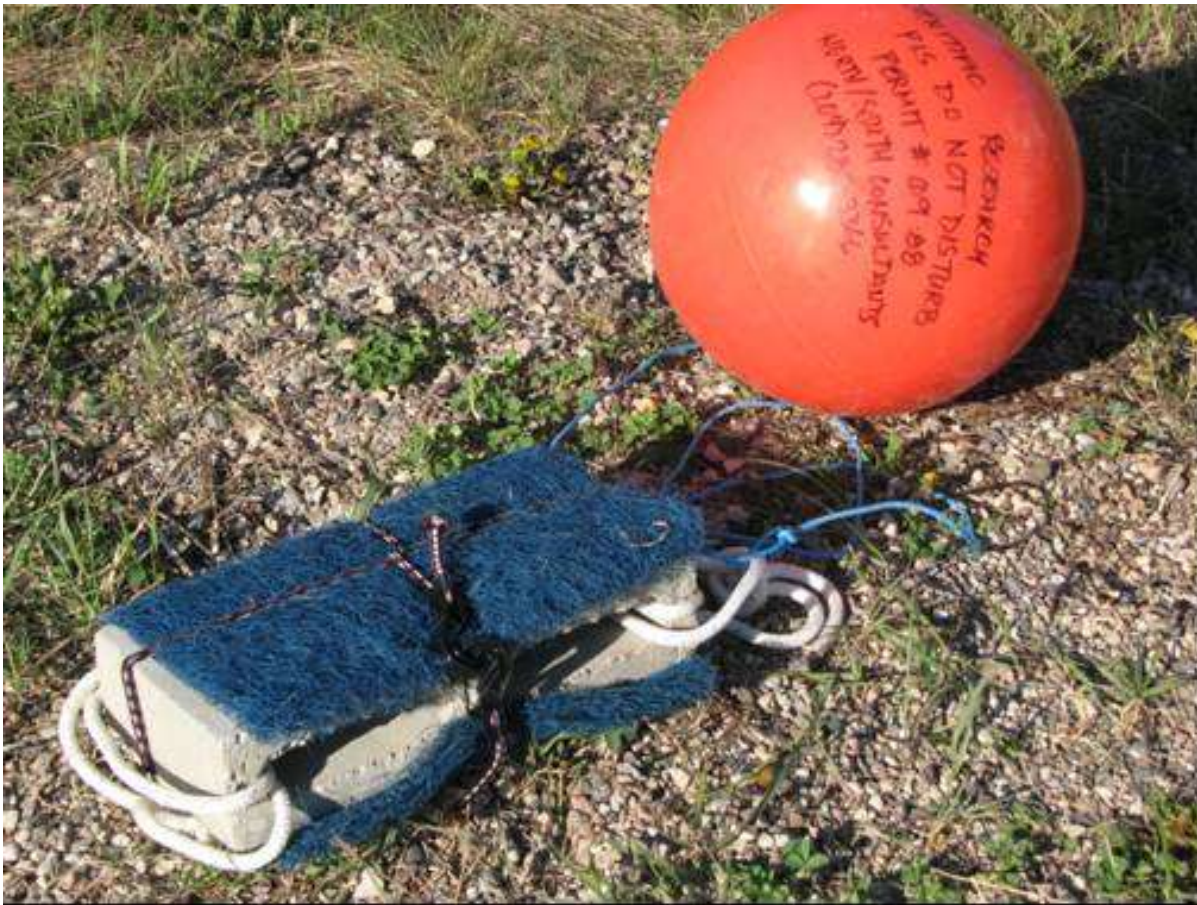
Figure 7. Egg collection mat used to monitor spawning on and near the constructed shoals.

Egg collection mats were placed on and around the constructed shoals to monitor egg deposition. Each egg mat consisted of a 30 x 90 cm portion of furnace filter material wrapped around a 39 x 19 x 9 cm cinder block and held in place with bungee cords (Figure 7). Lake Sturgeon eggs readily adhere to furnace filter material and the presence of eggs on the mats provides an indication that spawning has occurred in close proximity.
