Keeyask Infrastructure Project

Environmental Protection Plan

Annual Report 2012-2013

December 2013

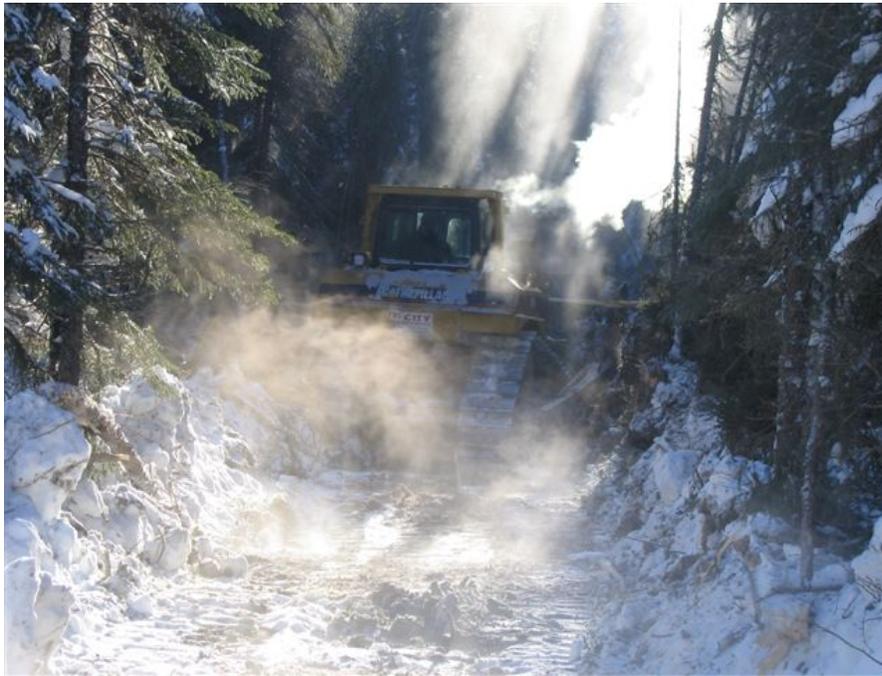
Construction of the Project commenced with clearing and grubbing of trees for the road right-of-way and the start-up camp components. The majority of the trees were cleared using a bulldozer (Figure 1). Depending on the proximity to sensitive areas, hand clearing took place, as outlined in the EnvPP.

Figure 1. Clearing of vegetation using a bulldozer.

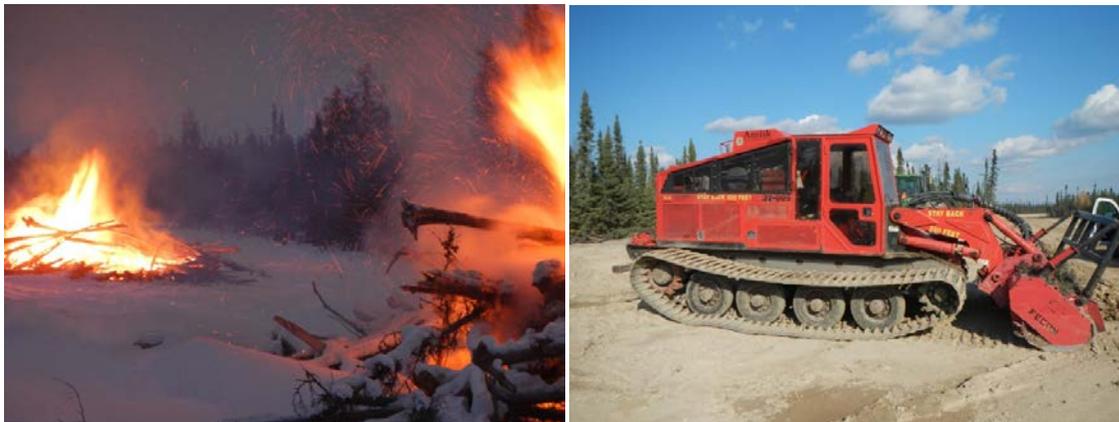
Trees that were cleared were burned in piles during the winter at various points along the road and in borrow pit areas (Figure 2). Manitoba Conservation and Water Stewardship (MCWS) was notified of the burning that took place between November 15 and March 1, and outside of those timelines a burn permit was obtained from MCWS. During the burning of slash, the fires were attended to by the contractor's staff and also monitored by Manitoba Hydro site staff.

Further into the 2012 construction season, the contractor introduced a commercial-sized mulching machine that was able to clear the road right-of-way in an efficient manner. The mulched material was left on the ground and will decompose over time, which reduced the volume of materials that required burning.

Figure 2. Disposal of cleared vegetation using burning (left) and mulching (right) methods.

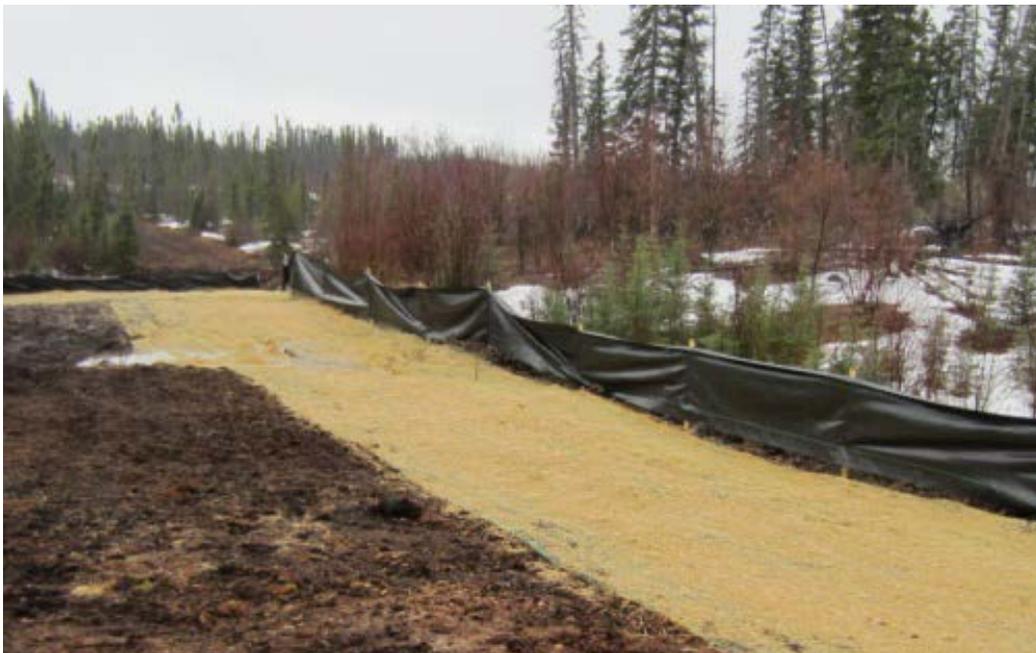
Sediment fence was also installed as a protective measure along a section of the trail leading up to the winter ice crossing over Looking Back Creek (Figure 3). The road to the crossing is on a downwards slope towards the creek and in order to ensure that winter construction activities did not have an adverse effect on the sloped area, erosion control blanket and sediment fence were installed.

Figure 3. Sediment fence and erosion control blanket installed near the winter ice crossing at Looking Back Creek.

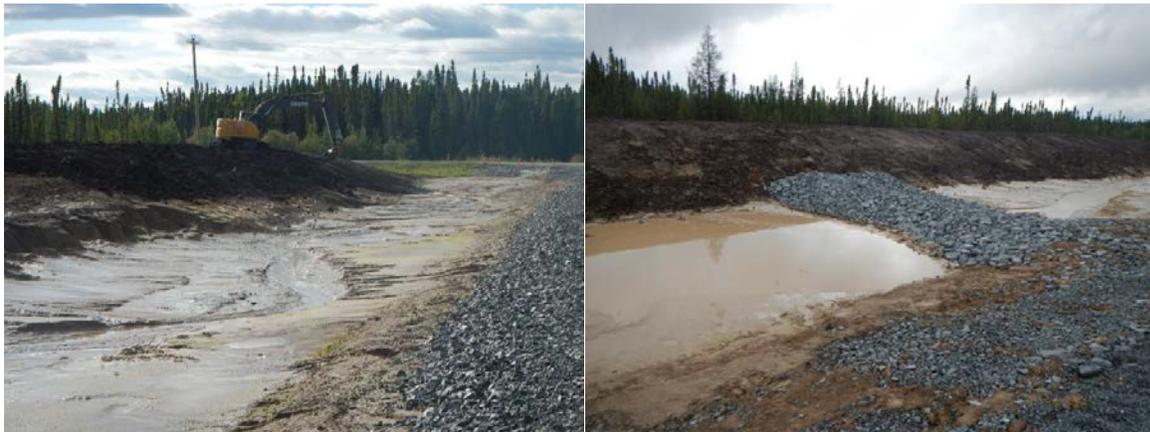
Rip rap is an effective measure for erosion control. It was placed at the entrance and exits to culverts and ditch checks along the road in areas that were prone to erosion during large rain events, and also used along embankment at Looking Back Creek and to line the unnamed tributary.

Figure 4 and Figure 5 show before and after pictures of rip rap being used as erosion and sediment control measures.

Figure 4. The access road before and after the placement of rock ditch checks.

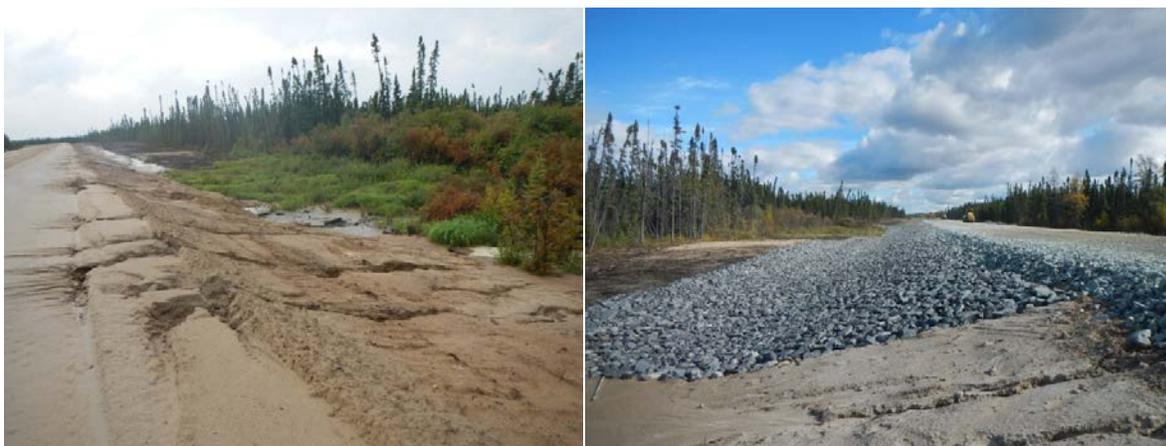
Figure 5. The unnamed tributary before and after the placement of rip rap.

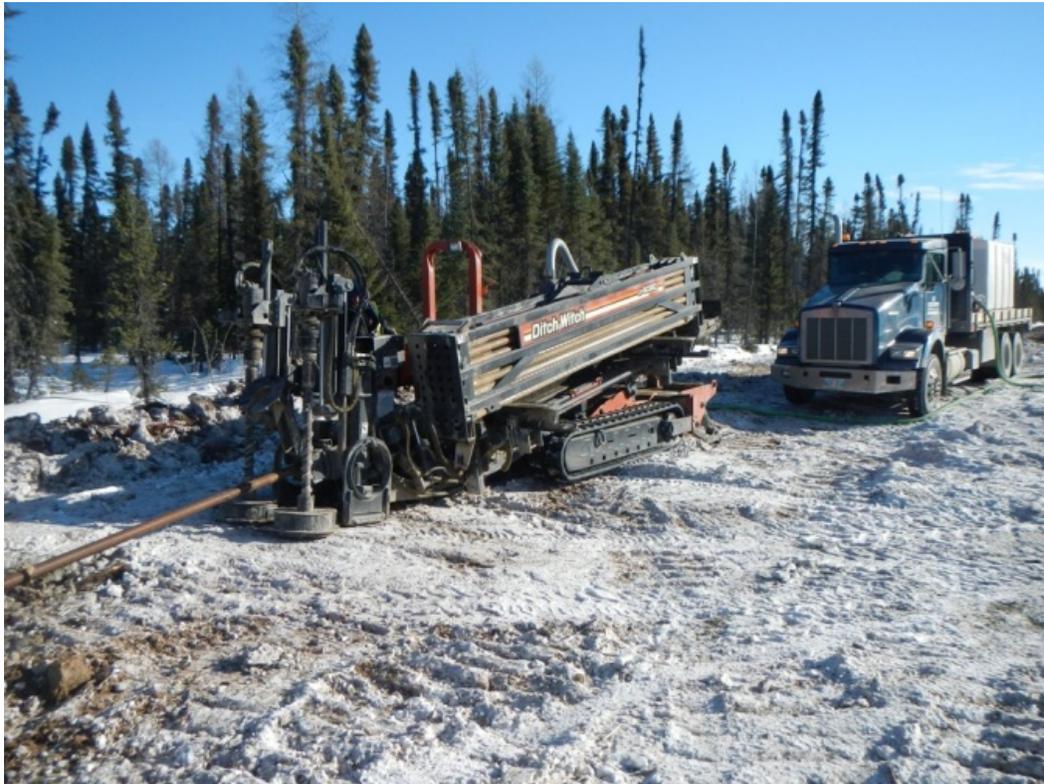
Construction of the Main Camp fibre optic cables were directionally drilled at Looking Back Creek and at the unnamed tributary in February 2013 with no issues (Figure 6).

Figure 6. Machinery used in the directional drilling of the fibre optic cables at Looking Back Creek.

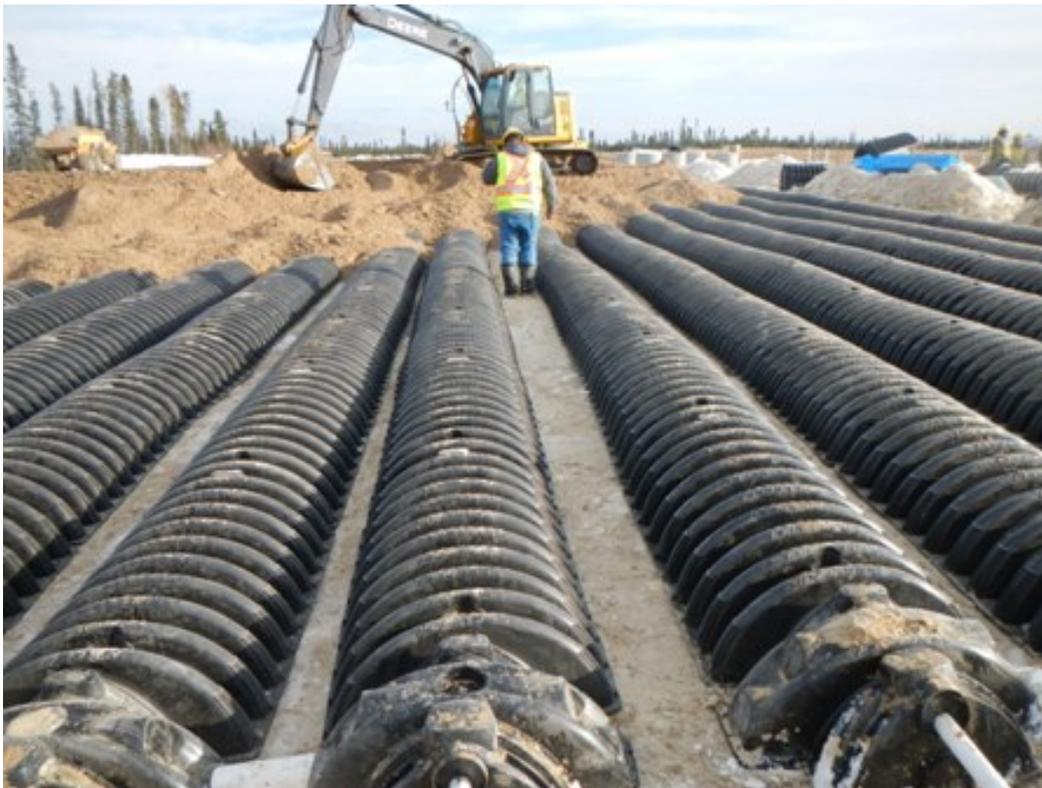
Construction of the wastewater drainage field began in 2012 with the final filtration chambers installed in the winter of 2013. The drainage field consists of 4 cells that are able to handle the capacity of the Start-Up Camp. One of the four cells was operational at the end of the reporting period. The cells consist of filtration chambers that allow the wastewater to percolate into the ground. The chambers are backfilled (Figure 7) and organic material is placed on top.

Figure 7. Filtration chambers in the drainage field being backfilled.

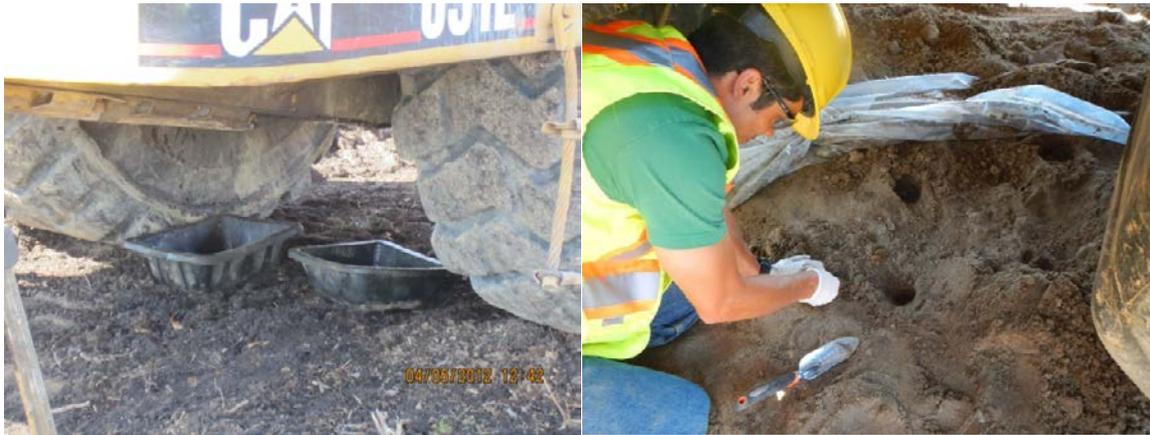
In all cases, regardless of the amount of the release, a spill report is submitted to the Area Spill Response Coordinator, who is also the Site Environmental Officer (SEO), within a 24-hour period. All releases that are considered reportable are to be reported to the external regulatory agencies immediately upon noticing (or being notified of) the release. The contractor is responsible for all their releases and the clean-up and reporting of the releases to Manitoba Hydro and external agencies such as Manitoba Conservation and Water Stewardship (MCWS), and in some cases, Environment Canada. The hazardous materials reporting is required to ensure the environment is protected and that any serious environmental effects are reduced, both through mitigation and preventative measures (Figure 8).

The most common type of release involved hydraulic fluid. The preventative measures identified for the machinery were more regular inspections and reporting of any issues. All releases of hazardous materials on the Project site have been internally documented and remediated as per the requirements of the HMSRP.

Figure 8. Mitigating potential releases using drip trays under construction equipment (left) and collecting soil samples after a hydraulic fluid release (right).

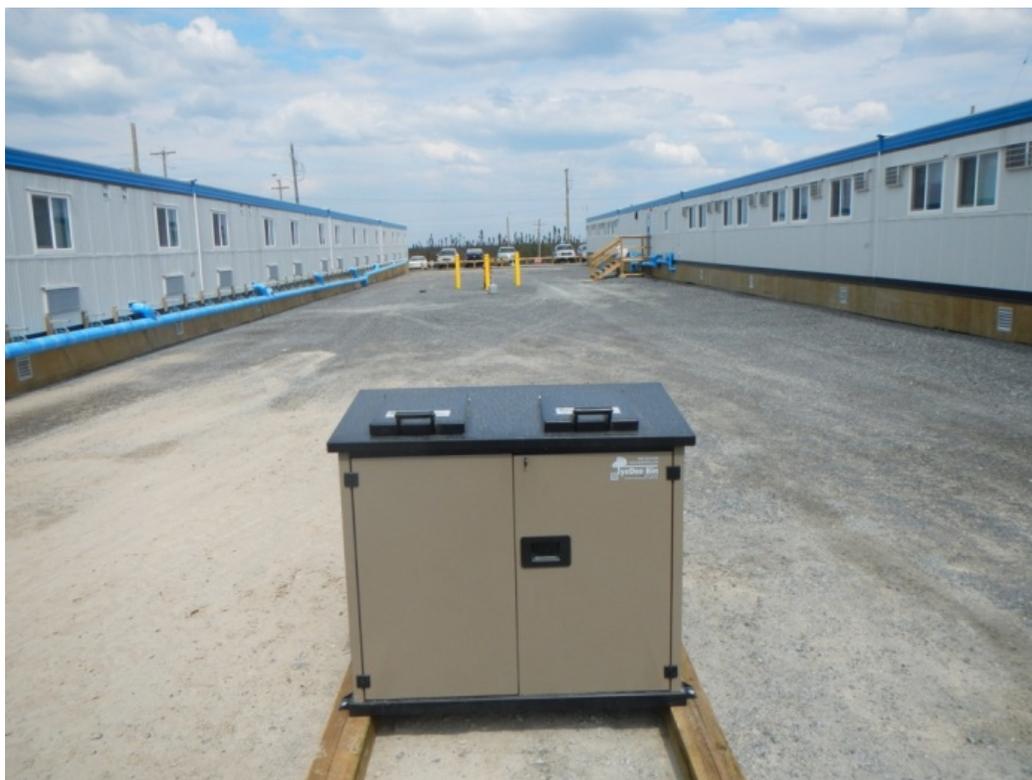
As mitigation, the contractor installed two panel pieces on the main garbage storage area, and all small garbage containers were changed to be bear-proof. “Tydee Bins” garbage receptacles were set up within the camp area (Figure 9). The bins are constructed of metal, have a twist handle that is able to lock in place after opening, and are typically the types of receptacles that are found in Provincial and National Parks. In addition, all garbage was hauled to the dump at the end of the day.

Figure 9. Tydee Bins located around the start-up camp.
