Keeyask Infrastructure Project Terrestrial and Aquatic Monitoring Plan

Plants, Habitat and Ecosystems Monitoring Annual Report 2012-2013

Terrestrial Plants, Habitat and Ecosystems Monitoring: Annual Report 2012 – 2013

ECOSTEM Ltd.

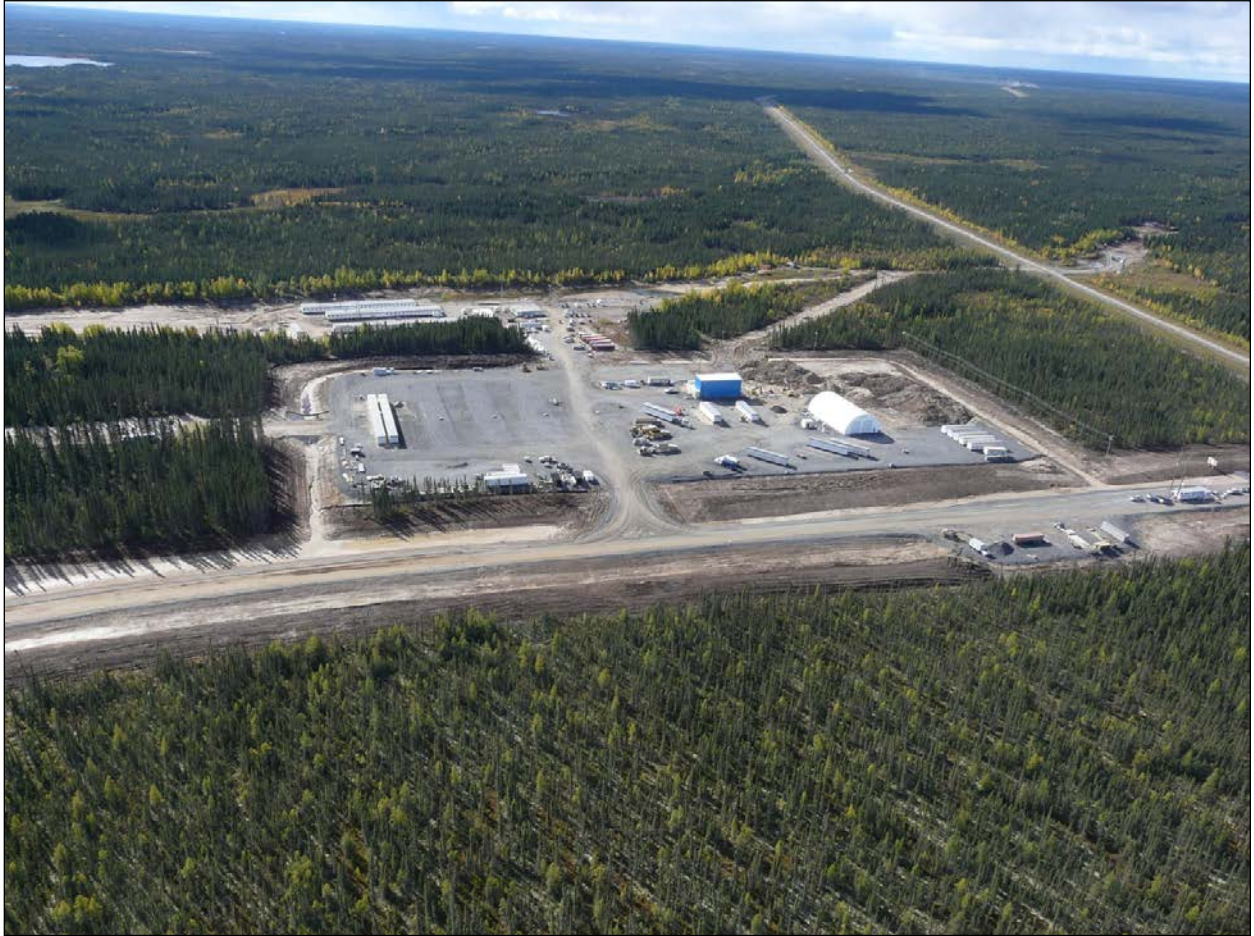
Figure 2-2: Start-up camp and work area near PR 280 (September 20, 2012).

The start-up camp and work area were cleared and graveled at the time of the aerial survey (Figure 2-2). The adjacent borrow area was cleared and in use. One large pit and several trailers were present (Figure 2-3). All clearing and construction in this area was within the planned KIP Footprint boundary.

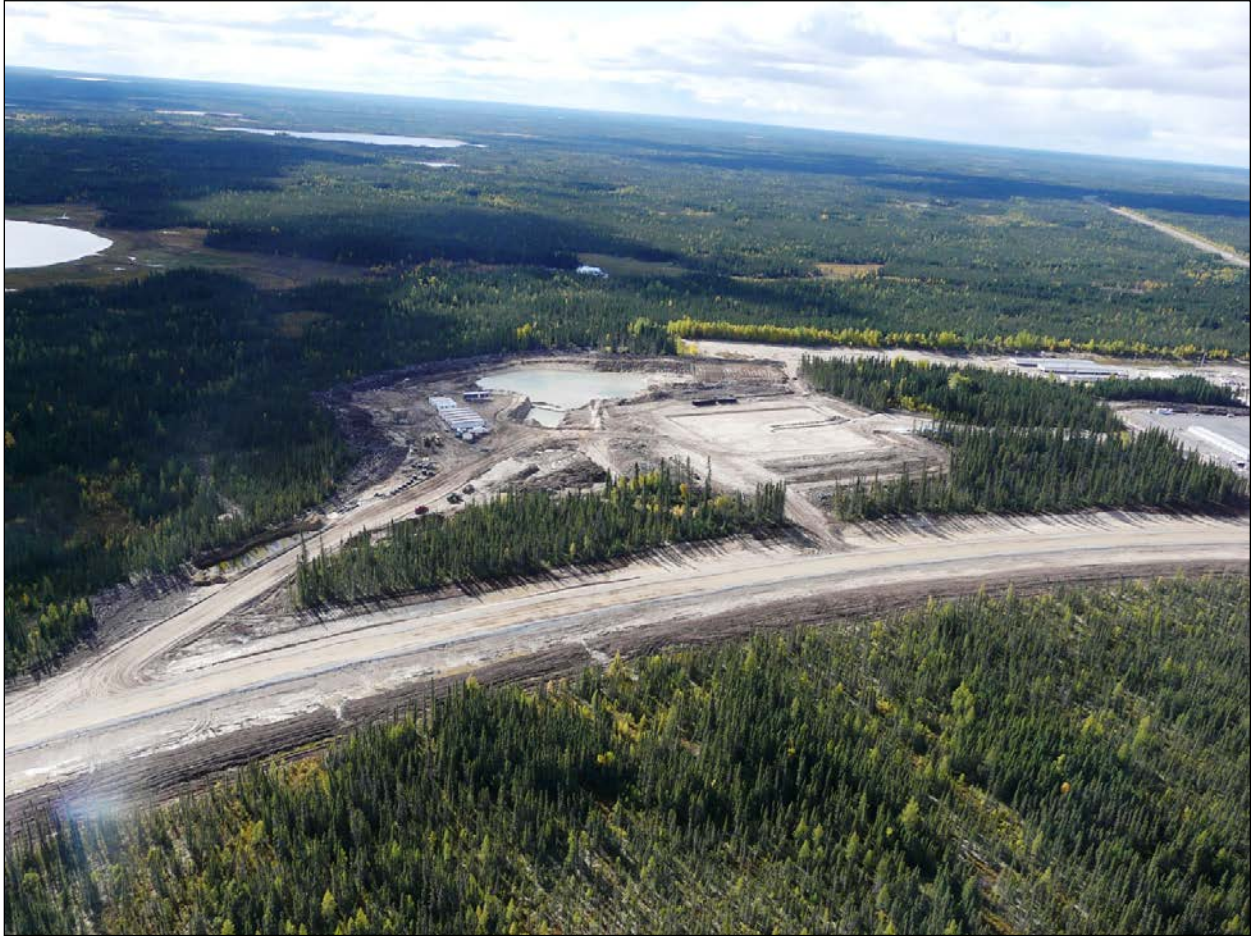
Figure 2-3: Borrow area adjacent to the start-up camp and work area (September 20, 2012).

Water had ponded in three of the borrow areas when surveys were conducted in 2012. The large pits in the borrow area adjacent to the start-up camp, approximately 3 km from PR 280 and approximately 9 km from PR 280 had filled with water.

Several of the borrow areas had ponded water when the field surveys were conducted. These borrow areas should be investigated for their potential to be rehabilitated as marsh wetlands after construction is complete.

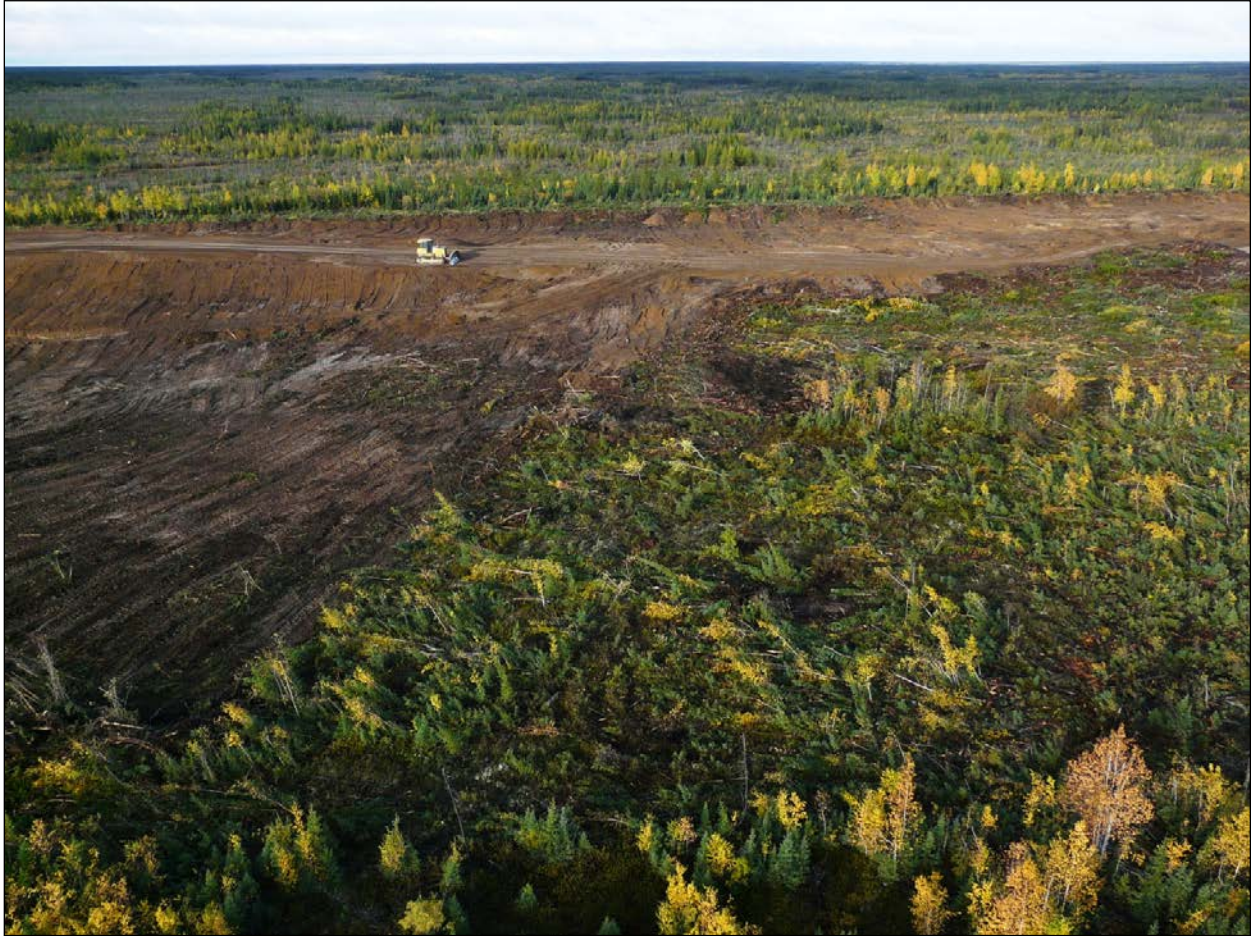
Figure 2-4: Clearing and excavation underway at G-5 borrow area (September 20, 2012).

Portions of the G-5 borrow area on the north side of PR 280 were being cleared at the time of the aerial survey (Figure 2-4). Geotechnical test sites were observed along a gravelled road at the northern end of the borrow area (Figure 2-5). All construction activities in this area were within the planned KIP Footprint boundary.

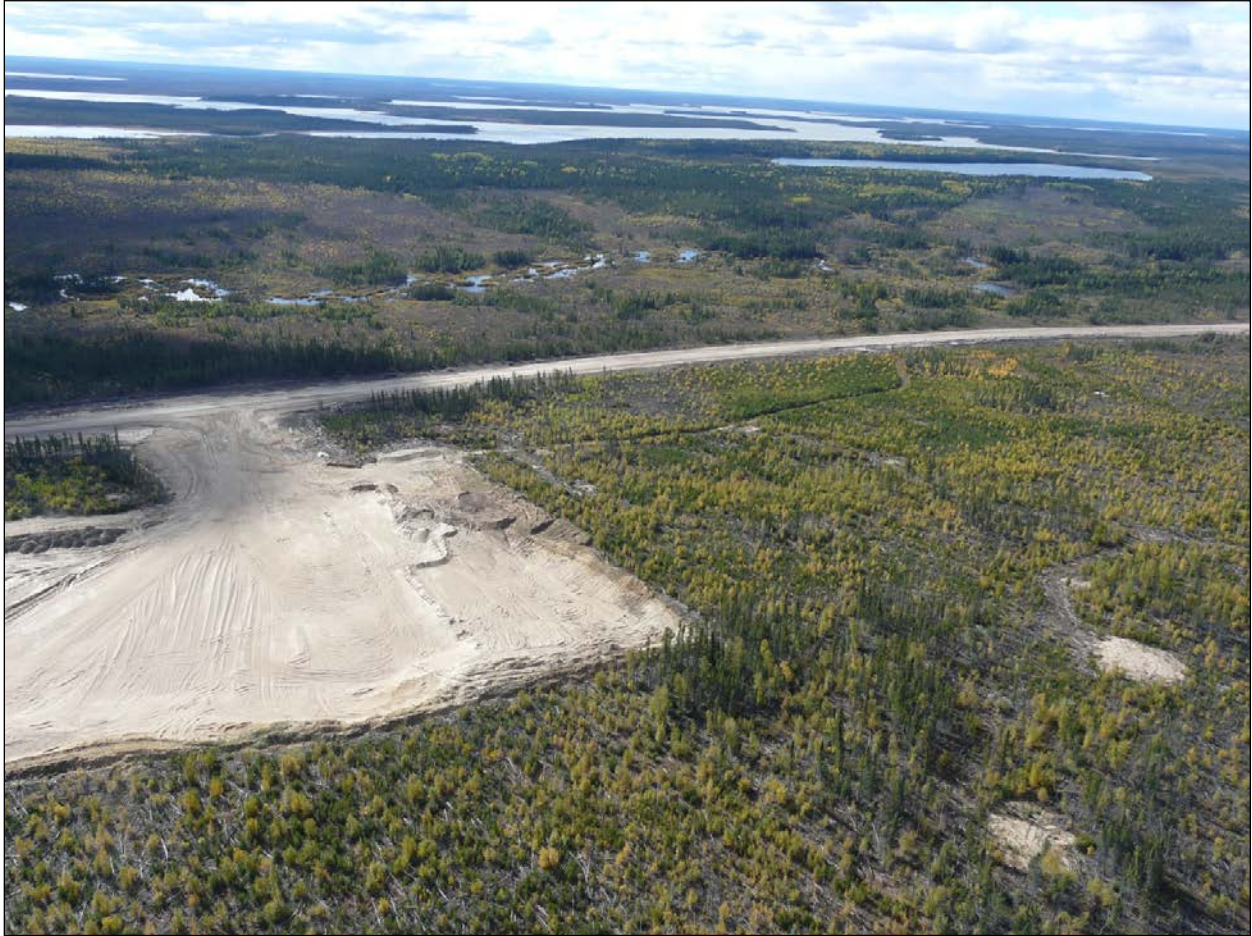
Figure 2-6: Clearing and excavation in G-1 borrow area, and nearby geotechnical test sites (September 20, 2012).

The G-1 borrow area on the north side of the road, approximately 15 km from PR 280 was in use at the time of the survey. This borrow area included access road, two cleared areas, several geotechnical test sites and cutlines (Figure 2-6). All construction activities in this area were within the planned KIP Footprint boundary.

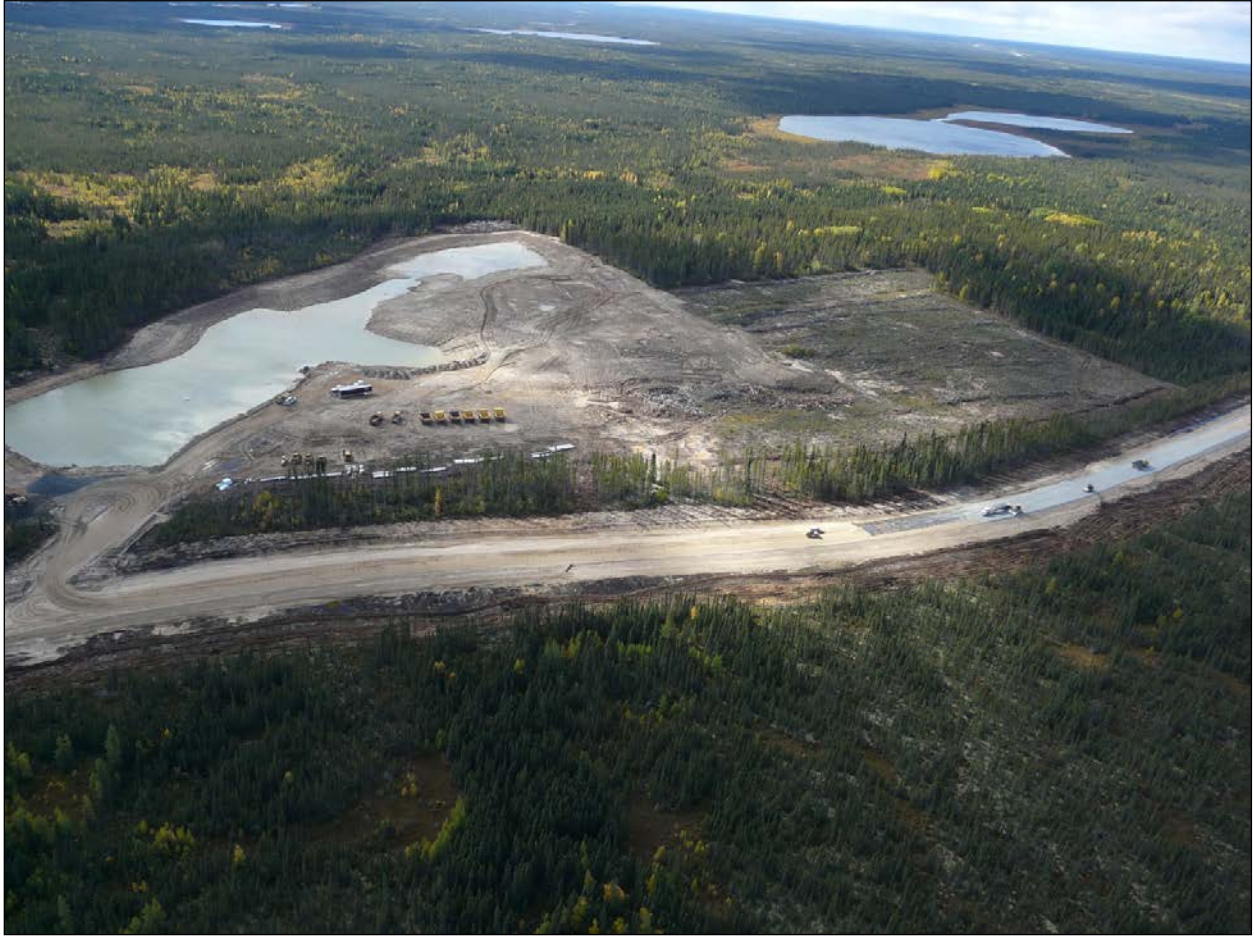
Figure 2-7: Clearing and excavation in borrow area approximately 3 km from PR 280 (September 20, 2012).

A borrow area south of the road, approximately 3 km from PR 280 had been cleared and was in use during aerial surveys (Figure 2-7). Cutlines were observed adjacent to the cleared area. All construction activities in this area were within the planned KIP Footprint boundary.

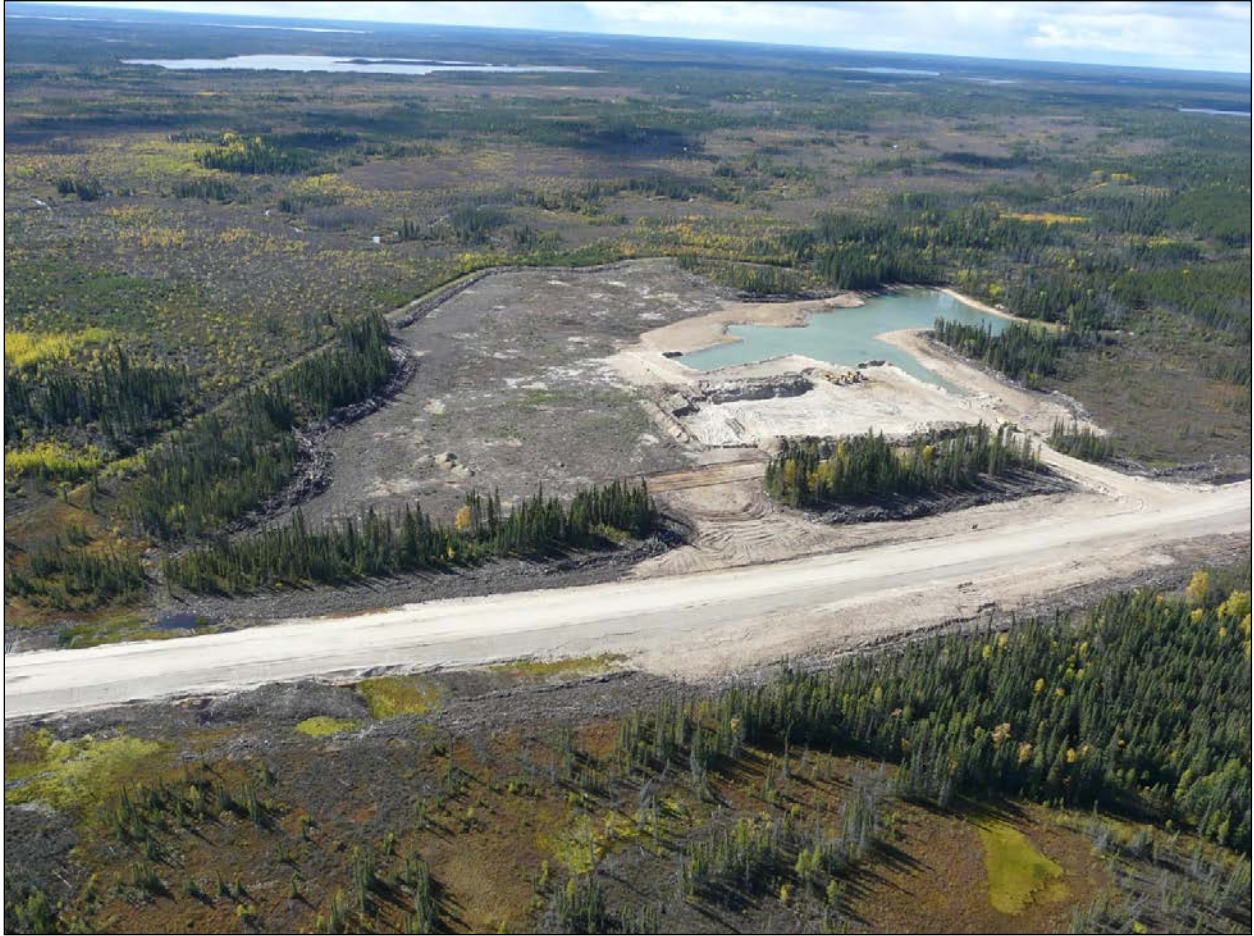
Figure 2-8: Clearing and excavation in borrow area approximately 9 km from PR 280 (September 20, 2012).

Approximately 9 km from PR 280, south of the road, a borrow area was cleared and in use (Figure 2-8). This borrow area was inside the planned KIP Footprint except for a 0.6 ha area at the west end of the borrow area. The portion of the borrow area outside of the planned KIP Footprint included a pit with ponded water (upper right corner of Figure 2-8).

With one 0.6 ha exception, all clearing and physical disturbance documented during the 2012 field surveys was within the planned KIP Footprint. The single small exception was located adjacent to a planned borrow pit located 9 km from PR 280. The magnitude of effects on the terrestrial habitat included in this small additional area is within that which was assessed in the EA Report.

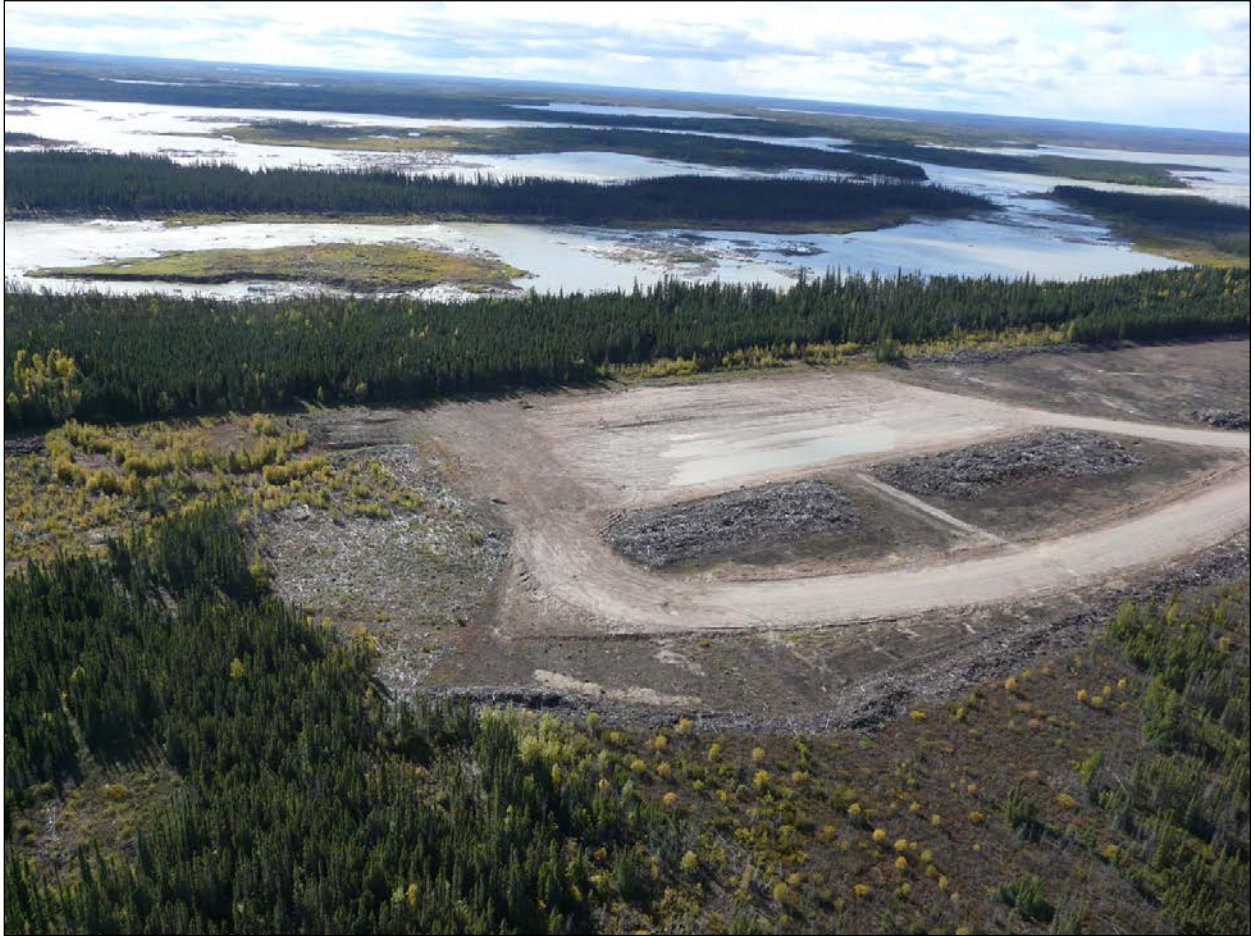
Figure 2-9: Clearing and grading at south end of Main Camp – Phase 1 (September 20, 2012).

Work on the main camp and well areas had not begun at survey time, aside from some clearing at the south end of the main camp area, where the road ends (Figure 2-9). All clearing in this area was within the planned KIP Footprint boundary.

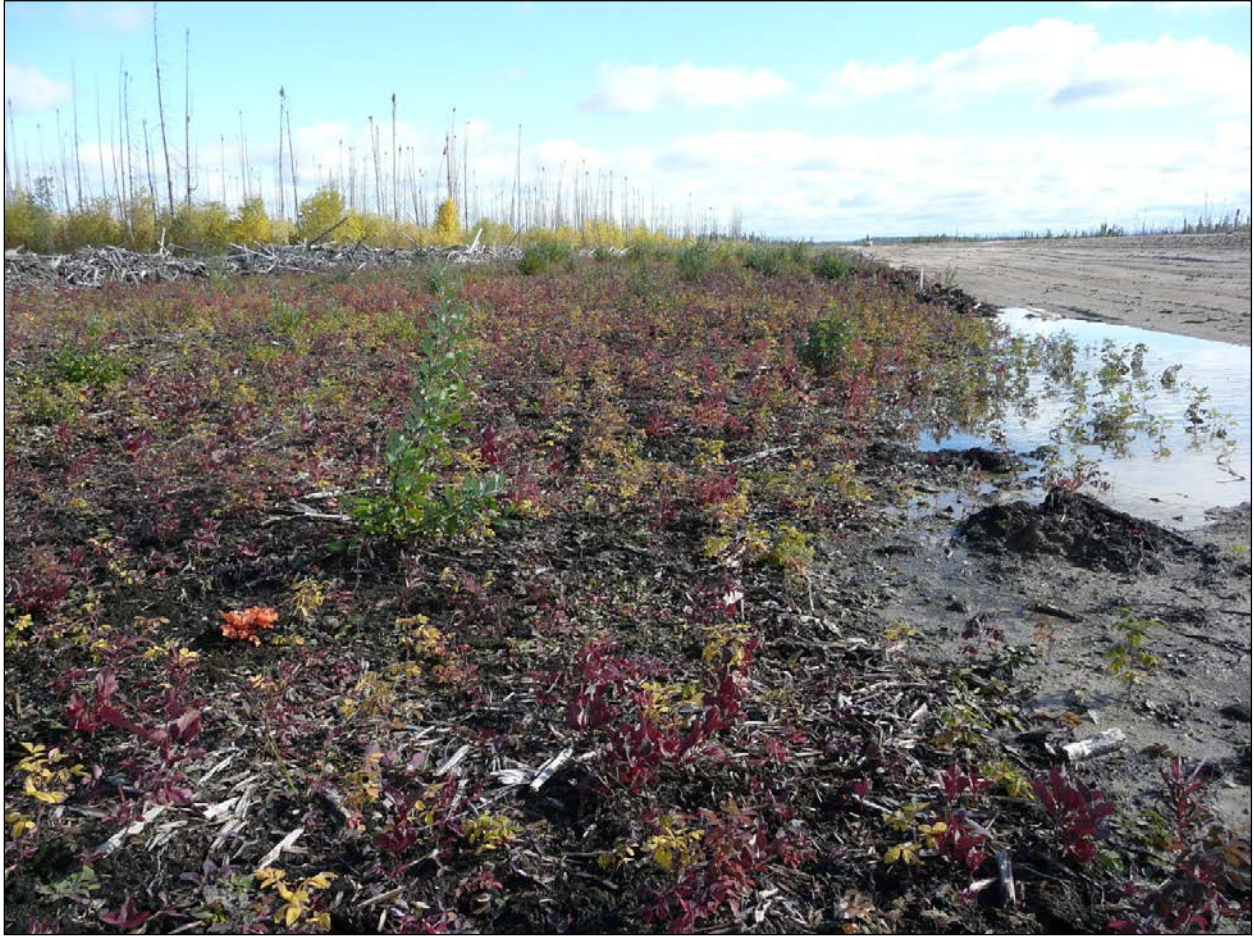
Figure 4-1: Location along the road spot-checked for invasive and non-native plants (September 20, 2012).

Map 4-1 shows the 2012 areas surveyed by helicopter for invasive and non-native plants. One location was ground surveyed (Map 4-1). No invasive or non-native species were observed from the helicopter, incidentally during S1 and S2 plant surveys, or at the single ground spot check during the helicopter survey (Figure 4-1).
