Keeyask Infrastructure Project

Terrestrial and Aquatic Monitoring Plan

Plants, Habitat and Ecosystems Monitoring

Annual Report 2014-2015

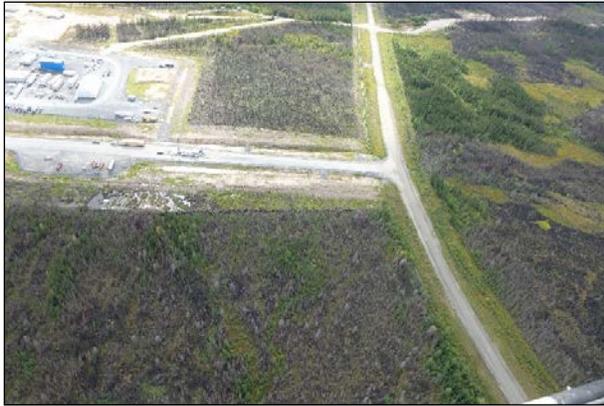
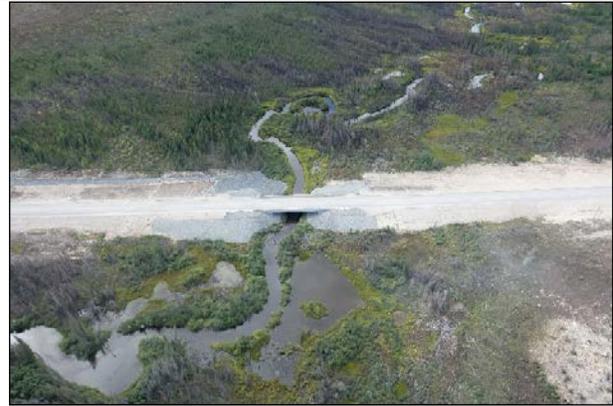
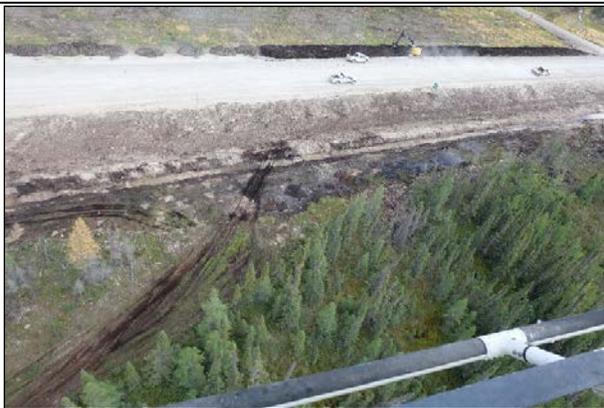
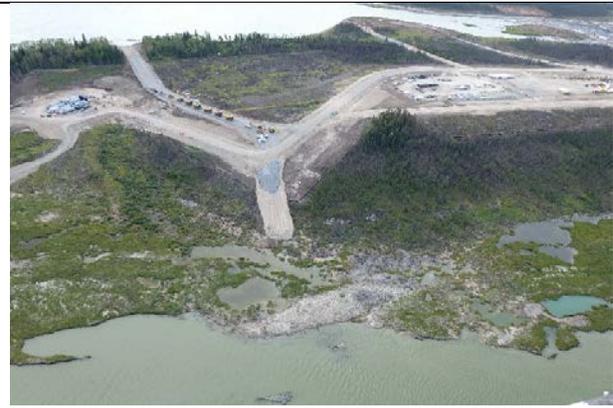
Figure 3-1: Construction areas along the main access road (September 9, 2014).

Access road at the PR280 junction

Bridge at Looking Back Creek

Access road ditch work

End of the access road at survey time

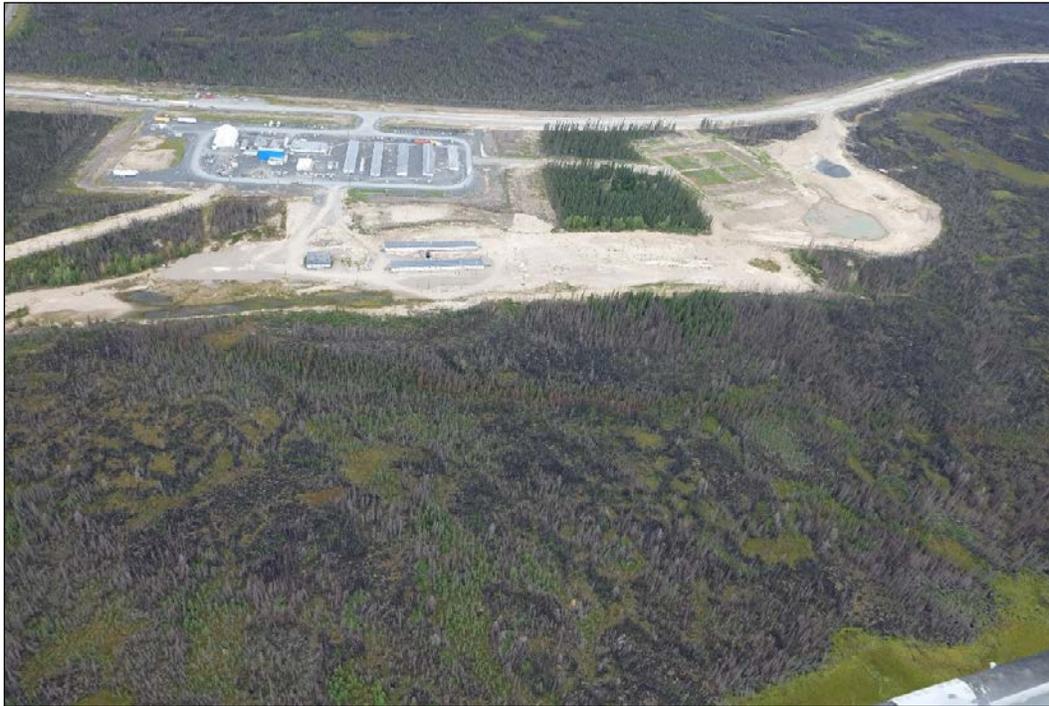
Figure 3-2: Start-up camp and work area near PR 280 (September 9, 2014).

The borrow area next to the start-up camp (KM-1) was cleared and in use at the time of the 2012 survey. While activity was not observed during the 2013 or 2014 surveys, it appeared that the borrow area was still being used in 2013. In 2014, seeded grass was observed growing within the septic/drainage field and the surrounding area (top left of Figure 3-4). The majority of construction activities in this area were within the planned KIP Footprint boundary with the exception of approximately 1.4 ha.

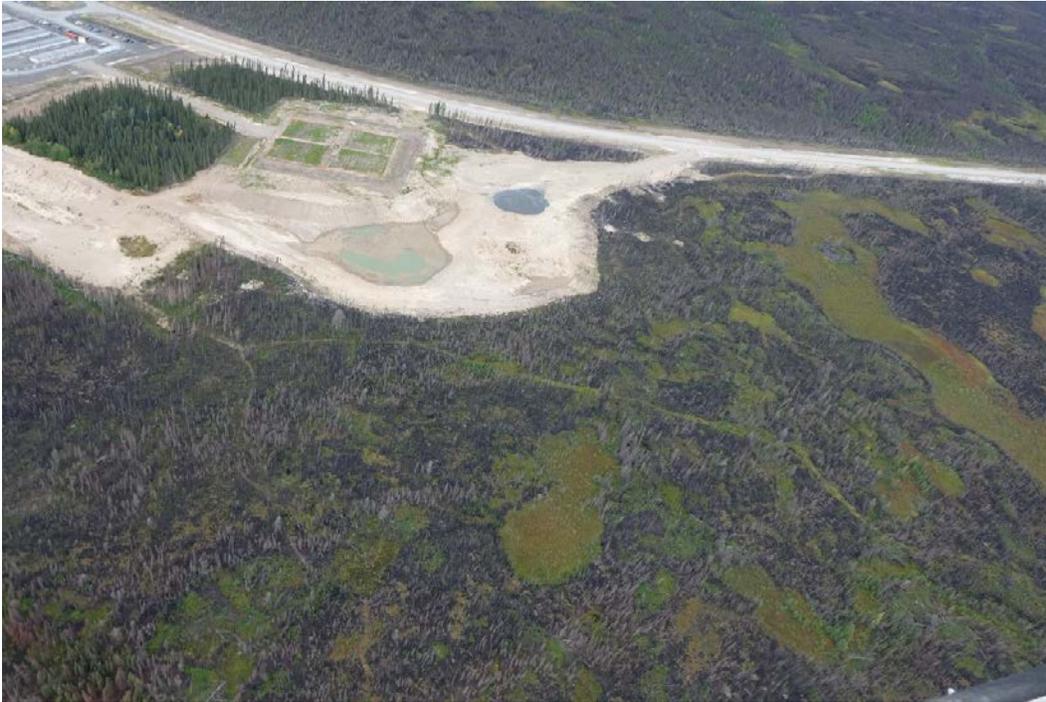
Figure 3-4: Borrow area showing grass growth and ponding (September 9, 2014).

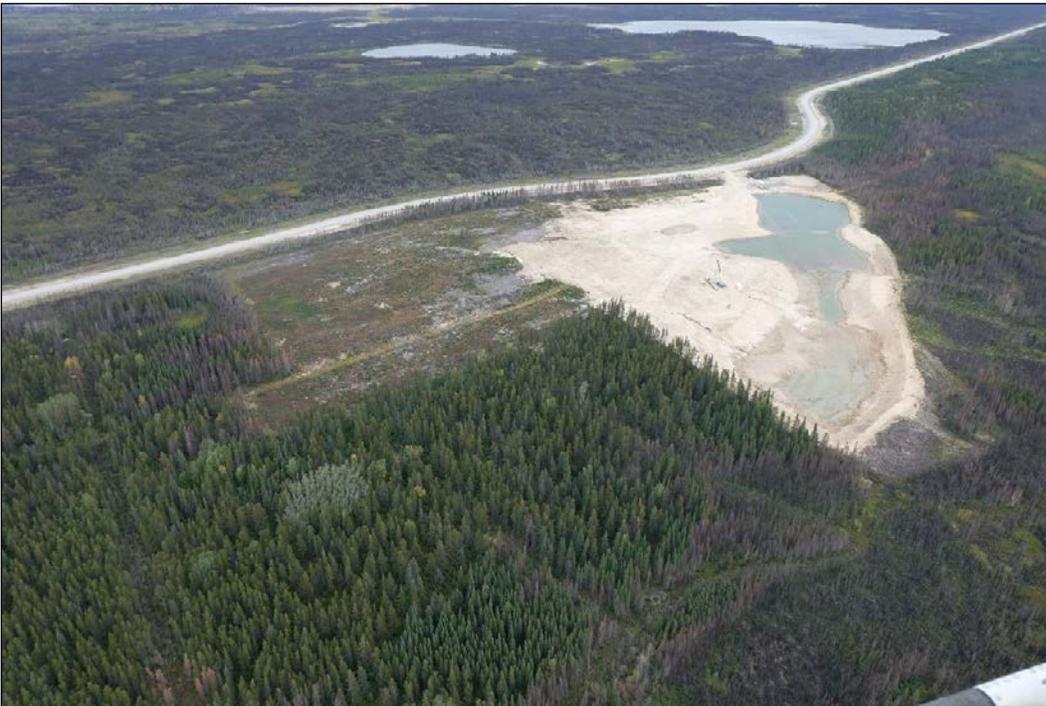
Figure 3-5: Clearing and ponding in KM-4 borrow area (September 9, 2014).

The borrow area near the access road located four kilometres from PR 280 (KM-4) had been cleared and was in use during the 2012 aerial surveys. In 2013 and 2014 (Figure 3-5), no additional clearing was observed from what had been cleared during the 2012 surveys. All construction activities in this area were within the planned KIP Footprint boundary.

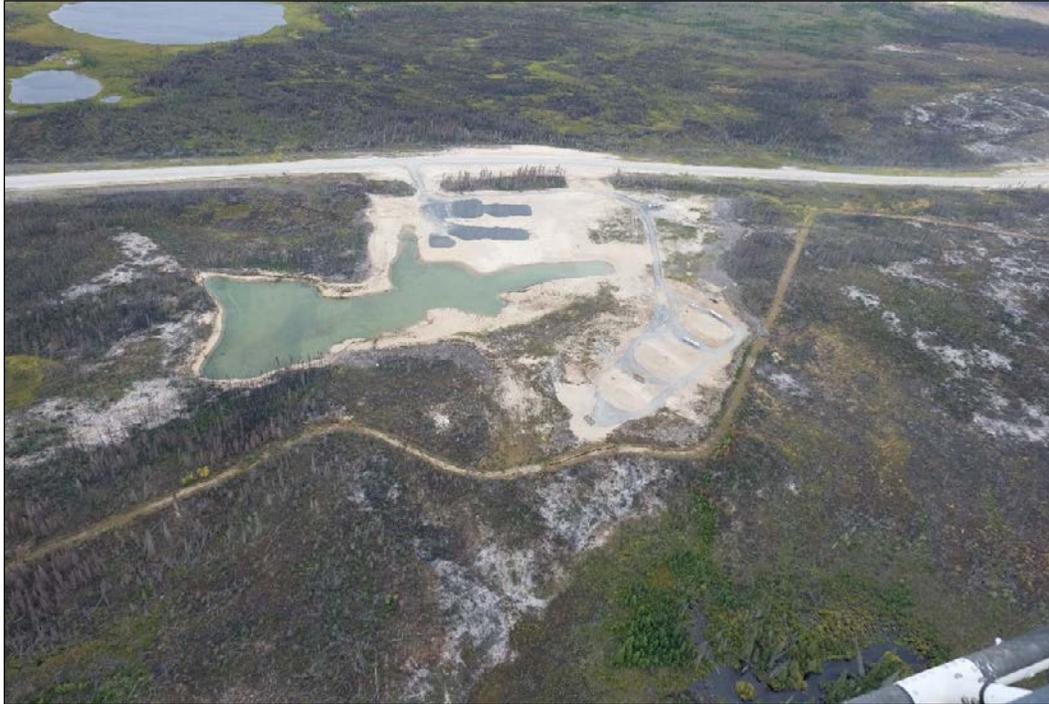
Figure 3-6: Clearing and ponding in KM-9 borrow area (September 9, 2014).

The borrow area near the access road located nine kilometres from PR 280 (KM-9), was cleared and in use in 2012. A 0.7 ha portion of the cleared borrow area was observed outside of the planned KIP Footprint (Map 3-1). No additional clearing was observed at this location in 2013 compared with what had been cleared at the time of the 2012 survey. The reported area increased from the 2012 report because more accurate mapping data was available after information was collected during the 2013 ground surveys. In 2014, an additional 0.04 ha of clearing was observed at this location after ground surveys. Three large gravel berms had been piled between

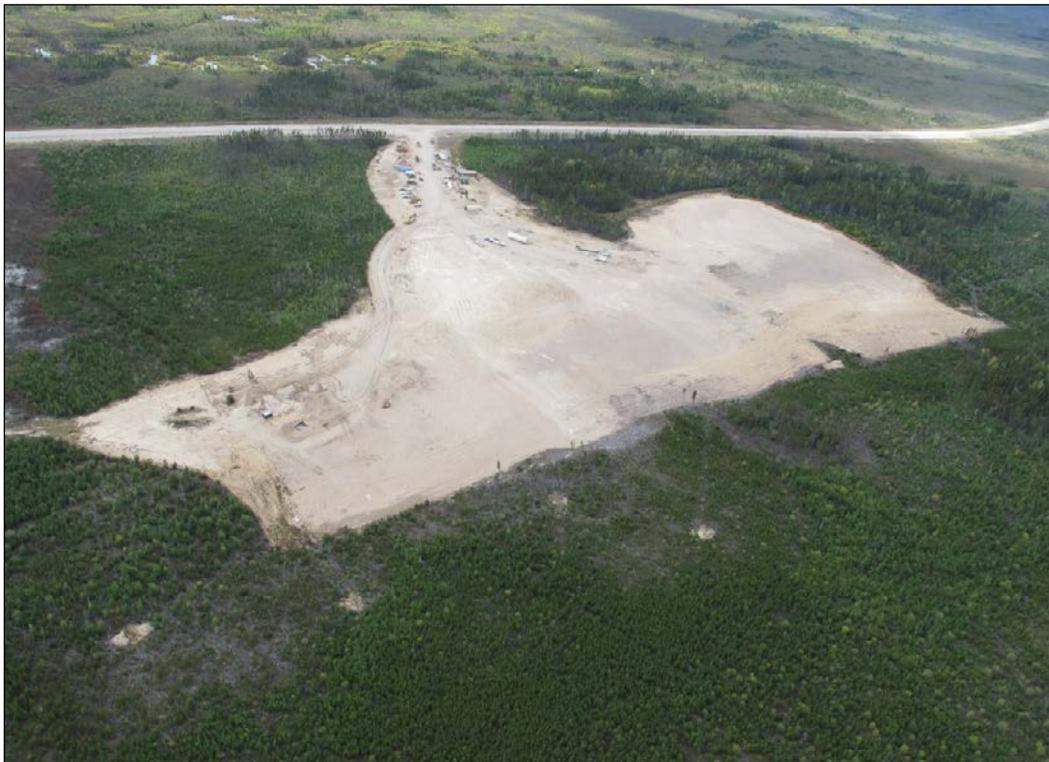
Figure 3-7: Clearing and excavation in KM-15 borrow area, west side of G-1 (September 9, 2014).

The G-1 borrow area, accessed at kilometre 15 and 17 along the access road, was in use at the time of the 2012 and 2013 surveys. This borrow area included access roads, two cleared areas, several geotechnical test sites and cutlines. A 3.8 ha cleared area was observed outside of the planned KIP Footprint on the south side of this borrow area in 2012 (Map 3-1). Figure 3-7 shows that in 2014, the storage area and most of the machinery had been removed from G-1 at km 15 and the area was not in use. G-1 was in use at km 17 during the 2014 season (Figure 3-8); however, no additional clearing was observed from the previous years.

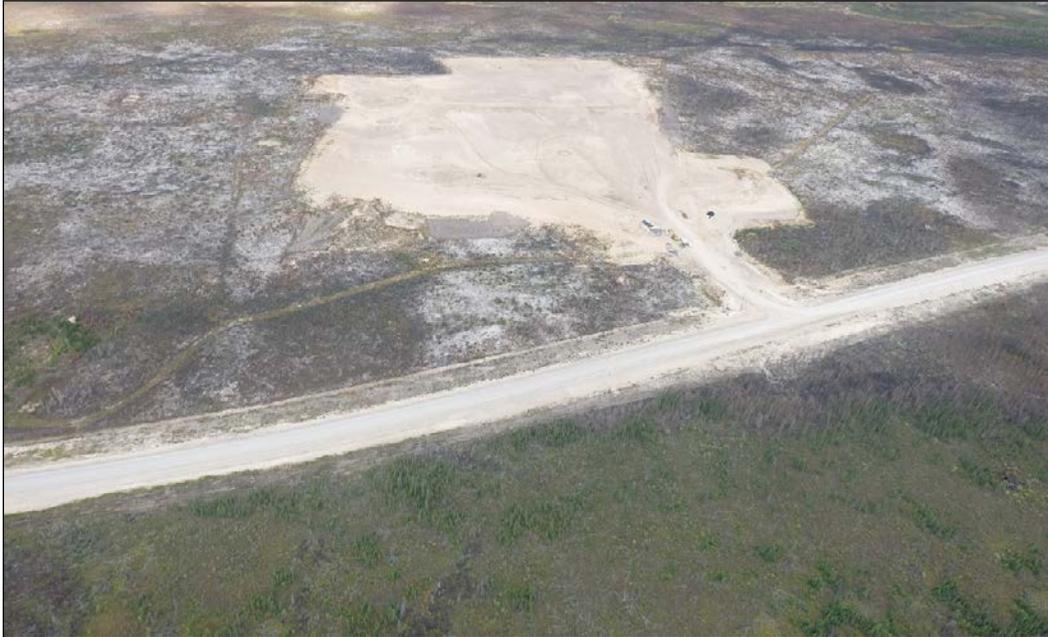
Figure 3-8: Clearing and excavation in KM-17 borrow area, east side (September 9, 2014).

Note: The bare areas surrounding the borrow area were created by the 2013 wildfire.

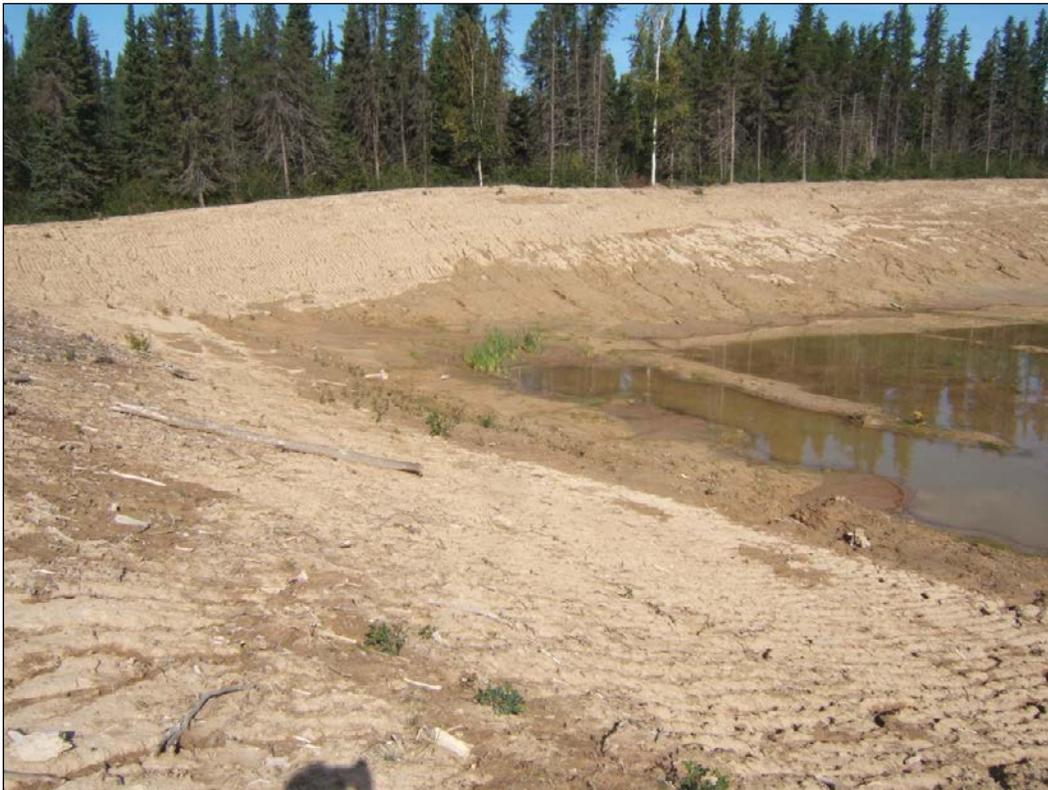
Figure 3-9: Semi-aquatic vegetation growing in the margins of the KM-4 borrow area pond (August 26, 2014).

Except for in the active portions of borrow areas G-1 and G-5, ponded water was present in all of the borrow areas when surveys were conducted in 2012 and 2013. In 2014, ponding was observed in the borrow areas at kms 1, 4 and 9. Semi-aquatic vegetation was observed growing on the margins of the pond in the KM-4 borrow area (Figure 3-9).

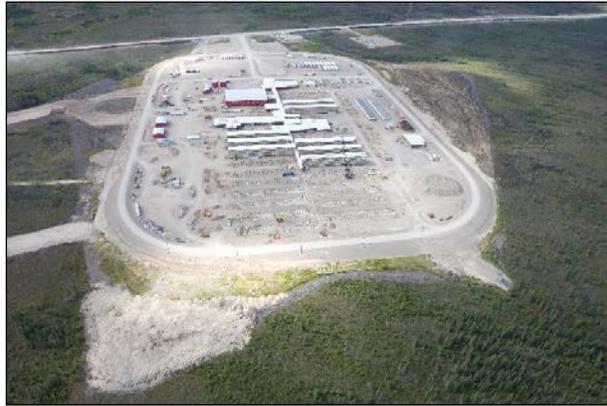
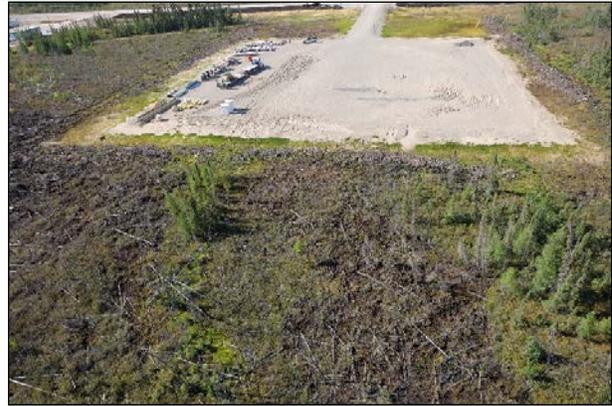
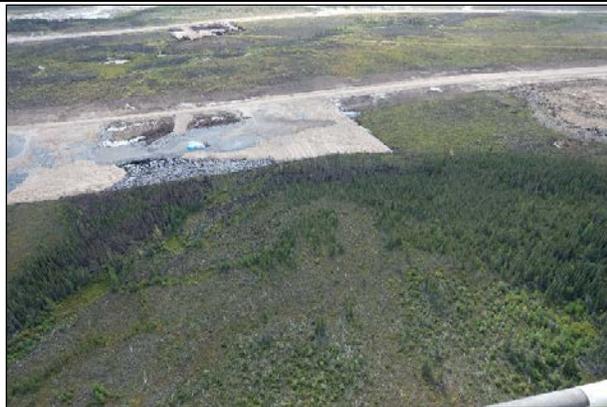
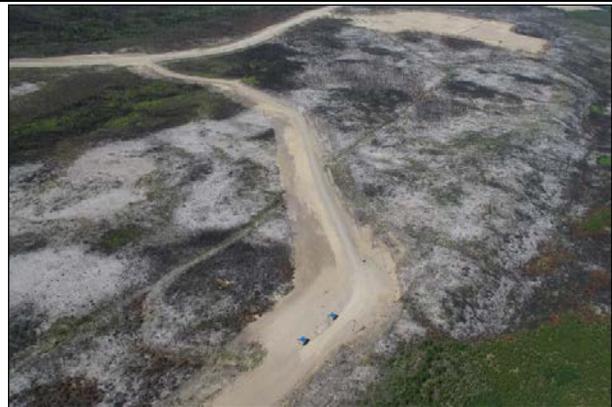
Figure 3-10: Clearing and construction in the main camp and well road areas (September 9, 2014).

Note: The bare areas near the well road were created by the 2013 wildfire.

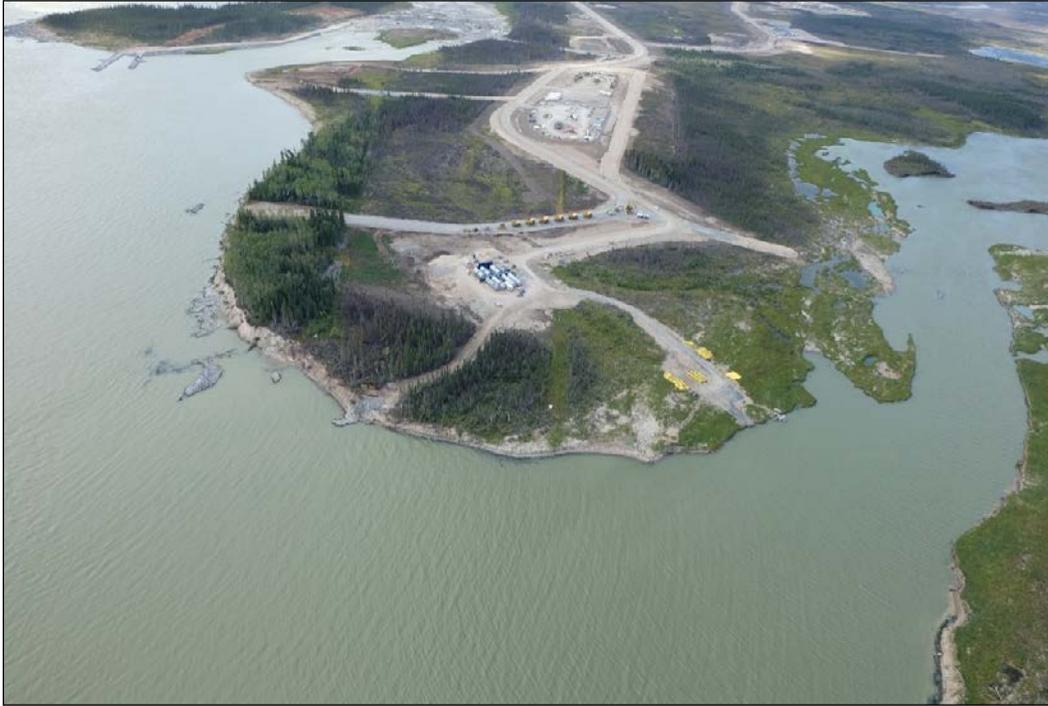
South of Work Area A, a construction office and storage area (north of the access road) was complete and was being used in 2014. Several other areas had been cleared and were in use near the end of the access road at Gull Rapids (Figure 3-11). Clearing in the three work areas was within the planned KIP Footprint boundary with the exception of approximately 0.01 ha.

Figure 3-11: GS construction office and other work areas near Gull Rapids (September 9, 2014).

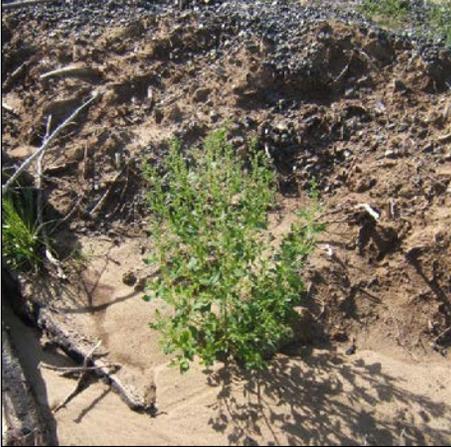
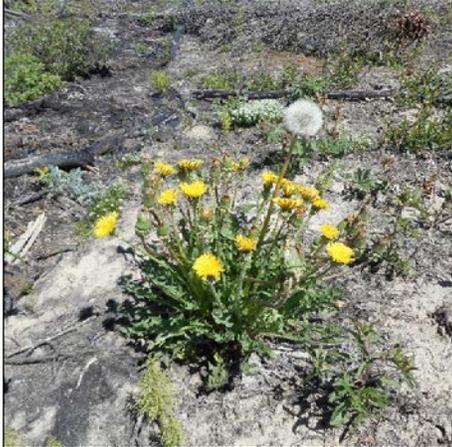
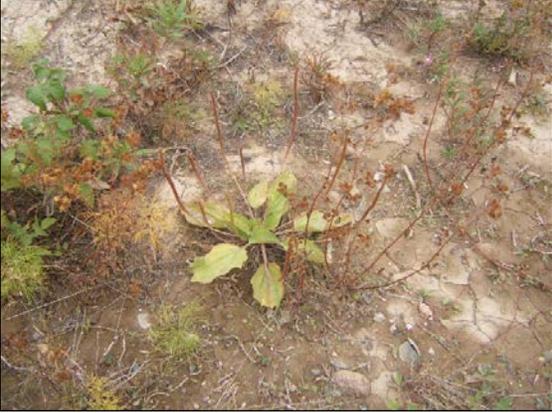
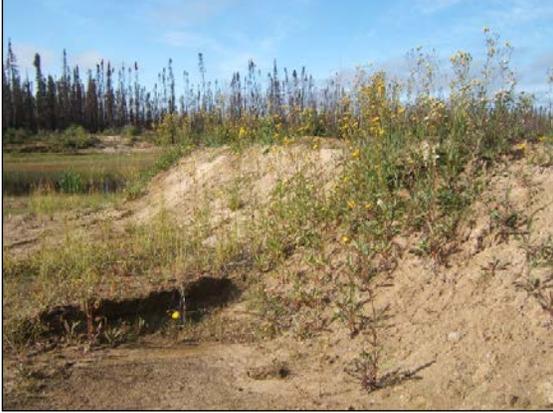
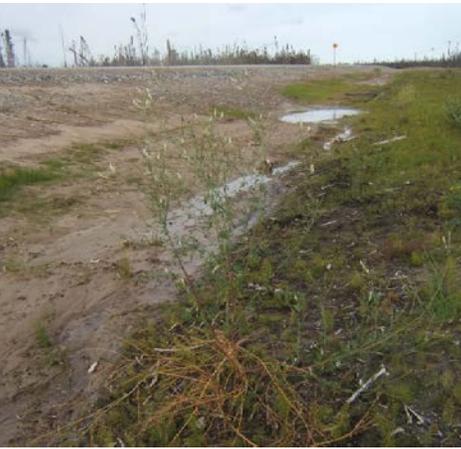
Figure 3-12: Invasive species observed during spring and fall surveys (June 25-27, 2014).

Lamb's quarters (*Chenopodium album*), sweet clover (*Melilotus* spp), alfalfa (*Medicago sativa*), common plantain (*Plantago major*), perennial sow thistle (*Sonchus arvensis*) and common dandelion (*Taraxacum officinale*) were observed during the spring 2014 survey. In addition, wild

Spring surveys found that common dandelion was the most common invasive species, followed by sweet clover (14 locations). It is believed that the sweet clover identified in the spring was white sweet clover that had not yet flowered. Lamb's quarters, alfalfa and common plantain had the fewest locations, with two each.

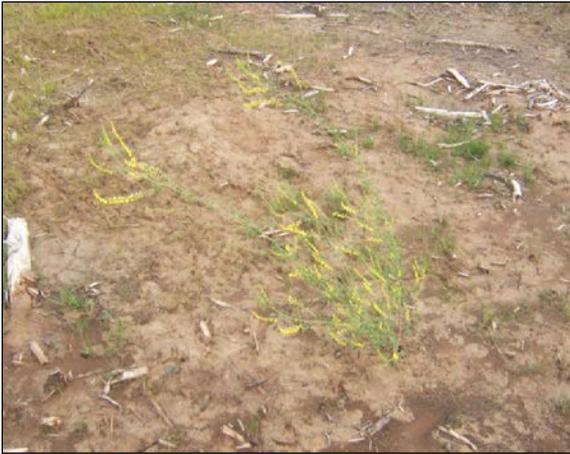
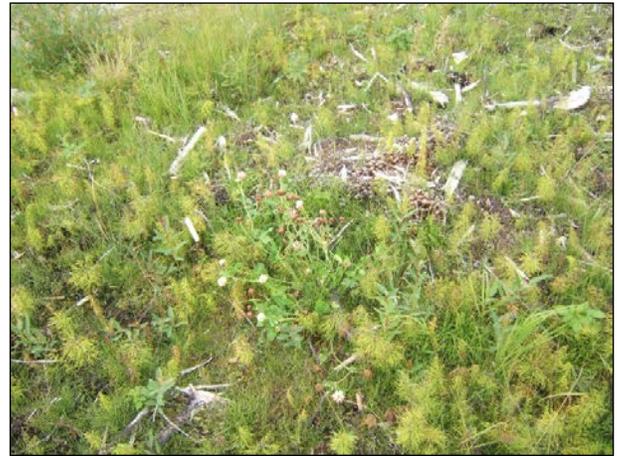
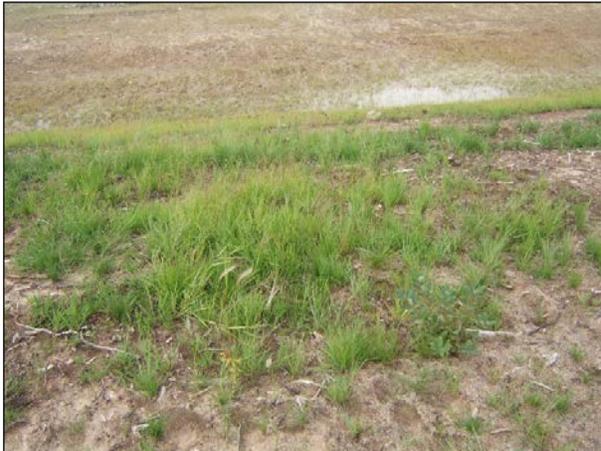
Figure 3-13: Invasive species observed for the first time during the fall survey (August 24-26, 2014).

barley (*Hordeum jubatum*), black medic (*Medicago lupulina*), white and yellow sweet clover (*Melilotus albus* and *M. officinalis*) and alsike, red and white clover (*Trifolium hybridum*, *T. pratense* and *T. repens*) were observed during the fall 2014 survey. Figure 3-12 and Figure 3-13 provide example photos of invasive plants found during the surveys.

Fall surveys found that common dandelion was the most common invasive species (98 locations), followed by white sweet clover (65-81 locations) and lamb's quarters (64 locations). White sweet clover was recorded in the startup camp, the KM-1 borrow area and the entrance to the G5 borrow area, the well road and borrow areas at KM-4 and 15. Lamb's quarters was observed in the startup camp, the aggregate area, the well road and the borrow areas at KM-4, 9 and 15. Black medic, yellow sweet clover, alsike and white clover were the least common invasives, with two or fewer recorded locations each.

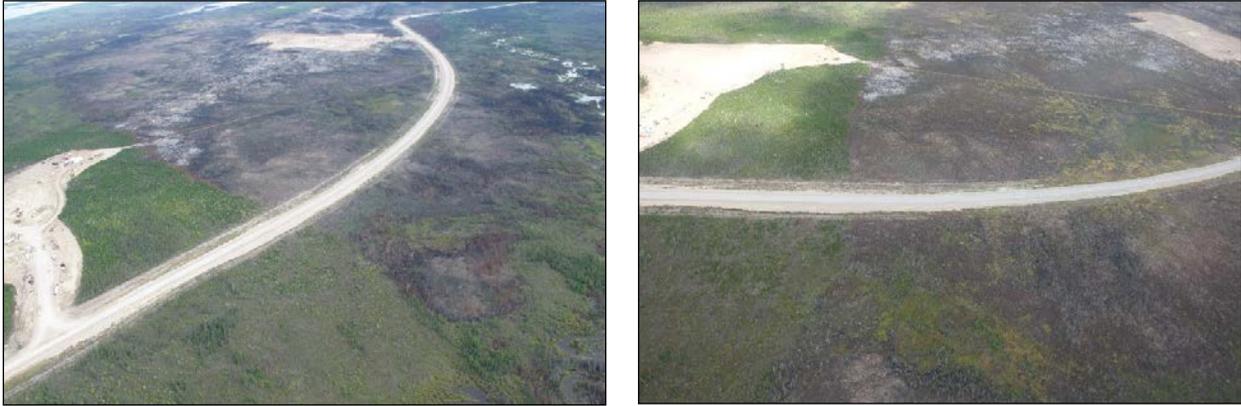
Figure 3-14: An area burned and skipped by the 2013 fire, as seen in from a helicopter in September 2013 (left) and September 2014 (right).

Several large fires started by sources other than the KIP occurred in 2013. Map 3-7 shows the approximate locations of burned areas, as mapped from Landsat imagery acquired in summer 2014. These burned areas were consistent with those observed during aerial surveys on September 2, 2013, and June 25, 2014, when aerial surveys photographed the extent of burned area in the Local Study Area. The fire that swept through the Local Study Area burned right into the KIP Footprint in multiple areas (Map 3-7; see Figure 3-14 for example photos).

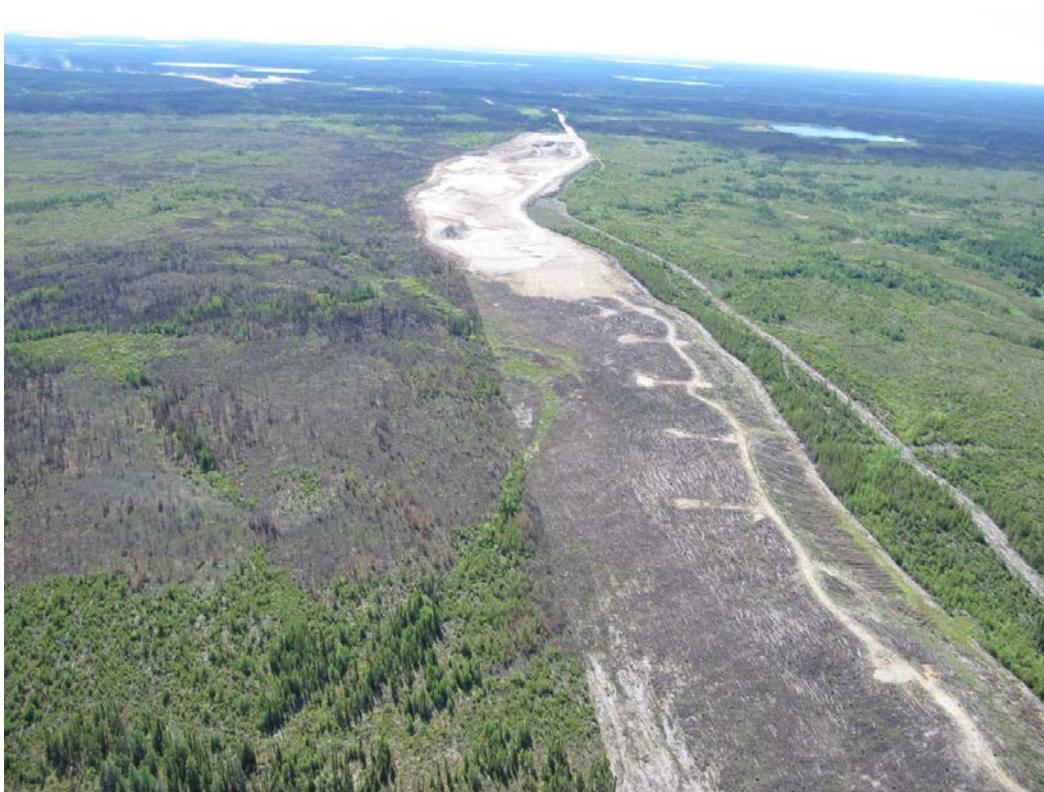
Figure 3-15: View of the borrow area G-5 north of PR280, from the north looking south, with burned forest on the east (left) side and unburned forest on the west (right) side (June 25, 2014).

The wide clearing at the north end of the Footprint (north of PR280) appeared to halt the progress of the fire (Figure 3-15), as the burn appears to have stopped at the eastern edge of the clearing. Portions of a skipped area on the south side of the access road were partially burned between the road and the treeline (Figure 3-16), indicating that the fire had begun to cross the road. The areas that appeared to be severely burned, adjacent to the access road, had burned down to the sand substrate (appeared white in the photos) (Figure 3-17). However, other areas also had severe burns down to darker mineral substrates (Figure 3-17). The sandier locations happened to be located on the esker where the access road is located, making it appear in the mapping that the burn had been more intense adjacent to the access road.

Helicopter surveys confirmed that the wide clearing at the northwest extent of the footprint appeared to halt the progress of the fire, with the burning stopping at the eastern edge of the clearing. At the other location of interest, ground surveys indicated that the fire did in fact begin to cross the access road, evidenced by burned vegetation between the road and the skip. This suggests that the road may only have served as a fire break when the burn was already dying out or changing direction.

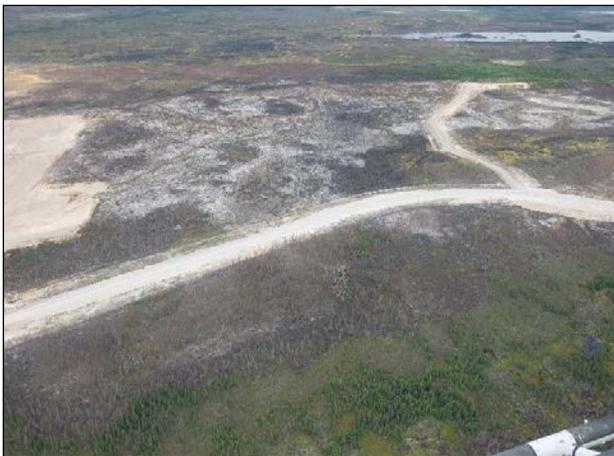
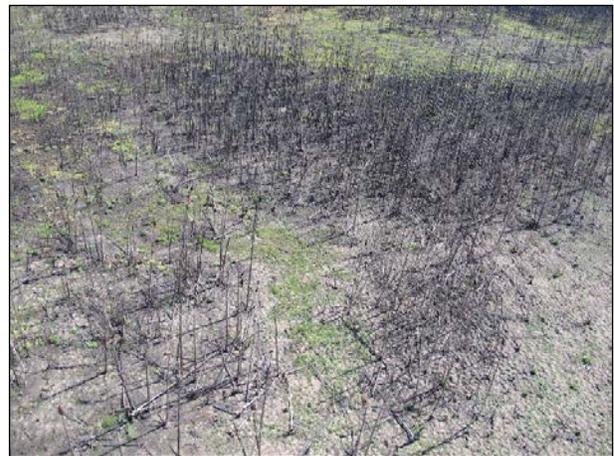
Figure 3-17: View of a sandy substrate adjacent to the Footprint (left) and a darker mineral substrate away from the Footprint (right), both showing severe burn intensity (June 25, 2014)

KIP did not appear to affect burn severity. Ground color differences in the remote sensing (white versus black) adjacent to the footprint suggested that KIP may have increased burn severity. However, ground surveys indicated that color differences reflected substrates rather than amount of burned off organic layer (white areas were sand while black areas were usually a clayey substrate). Most of the burned sand substrate happened to be concentrated along the esker where the road was being constructed. Additionally, visual examination of the regeneration in different burned ecosite types (shallow peatland, permafrost peatland, thin peatland and mineral) did not suggest that there were any differences in fire behaviour in areas surrounding the KIP footprint compared with areas away from the footprint.

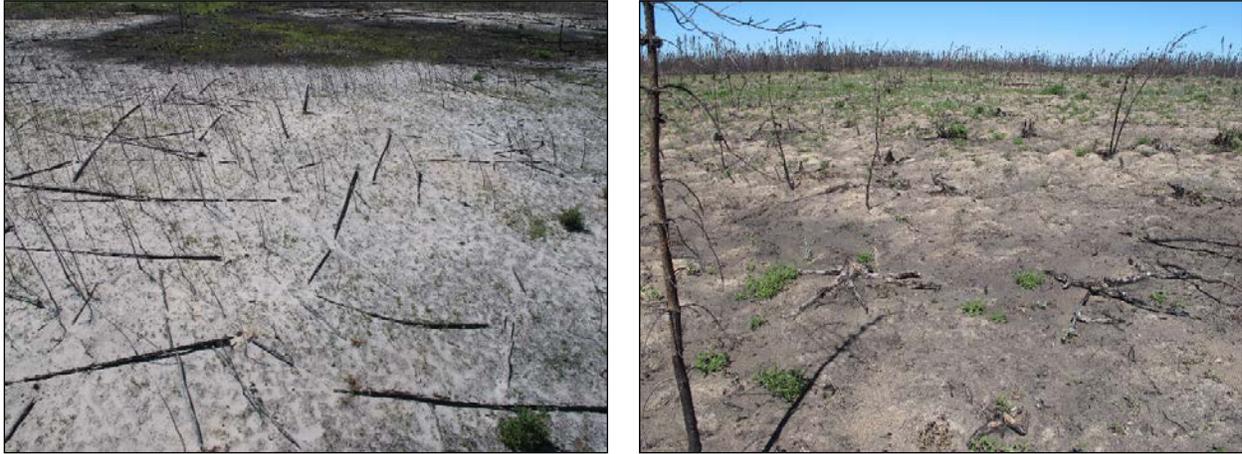
Figure 3-18: Regeneration on sandy sites adjacent to (left) and away from (right) the Project Footprint (June 25, 2014).

Visual examination of the regeneration in different burned ecosite types did not suggest that there was a difference in regeneration at sites adjacent to, or away from the KIP Footprint (Figure 3-18). In general, regeneration was sparse to absent on burned peatlands, but was denser on thinner peatlands and mineral sites. Clayey bare mineral sites tended to have denser regeneration than sandy sites, and regeneration appeared to be denser under burned broadleaf (aspen) and jack pine stands than under burned black spruce stands.

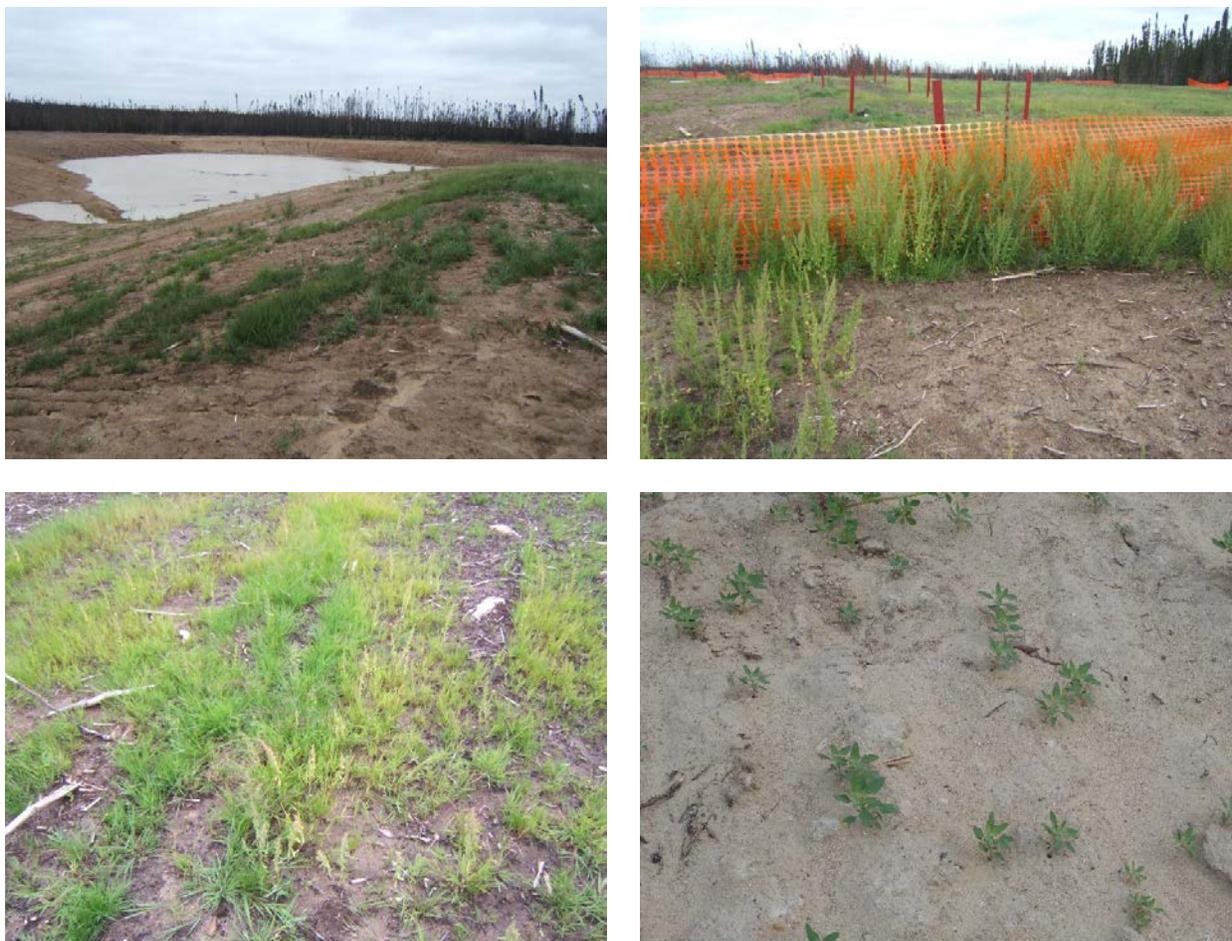
Figure 4-1: Lamb's quarters growing in the aggregate area and possibly associated with rehabilitation hydroseeding (August 24-26, 2014).

One of these species, lamb's quarters, was associated with areas that appeared to have been seeded prior to the 2014 field surveys (Figure 4-1). It is recommended that this possibility be investigated further and, if determined likely to have occurred, measures be developed to prevent future occurrences.

It is also recommended that site staff be trained to recognize the noxious weed species occurring in the area so they can initiate hand pulling between the monitoring surveys, so as to minimize further spread of these species. Hand pulling will generally be easier if it is undertaken early in the growing season before the roots of young plants become well established. Alternative control measures may be needed in locations where large patches have established.
