Keeyask Infrastructure Project

Terrestrial and Aquatic Monitoring Plan

Water Quality Monitoring

Annual Report 2013-2014

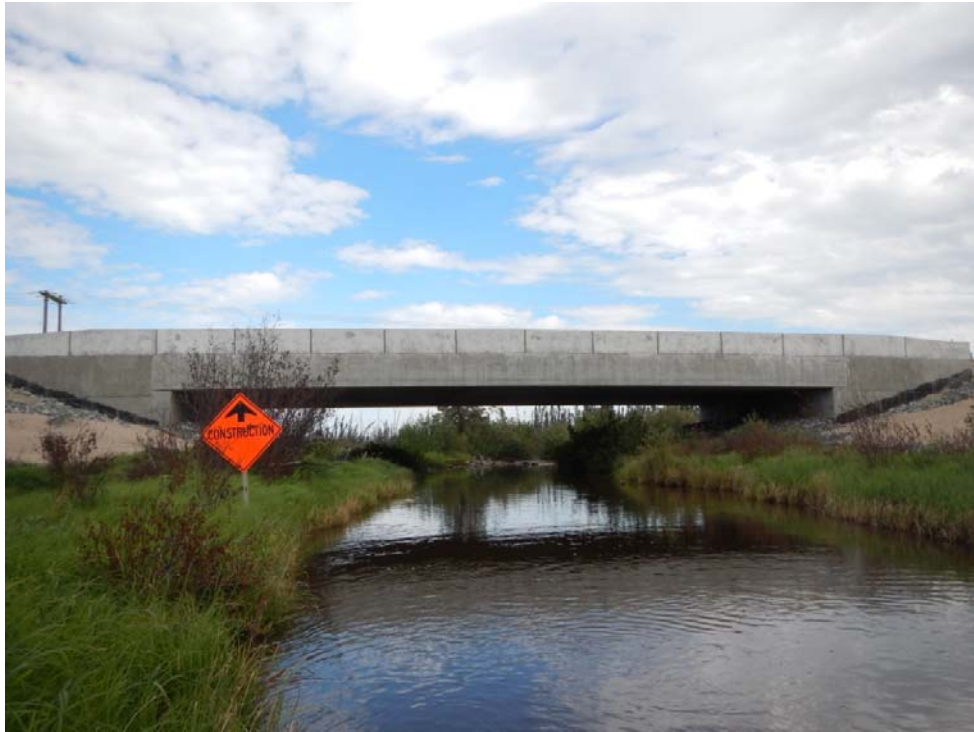
Figure 2. Clear-span bridge over Looking Back Creek.

A permanent clear-span bridge was constructed over Looking Back Creek during 2012/early 2013 (Figure 2) and a culvert was installed in the unnamed tributary in early 2012 (Figure 3). Monitoring conducted in 2013 was intended to assess whether there were any differences in water quality upstream and downstream of each of the road crossings, post-construction. The water quality monitoring program is focussed on measurement of turbidity and total suspended solids (TSS) but also includes monitoring for nutrients during one sampling event.

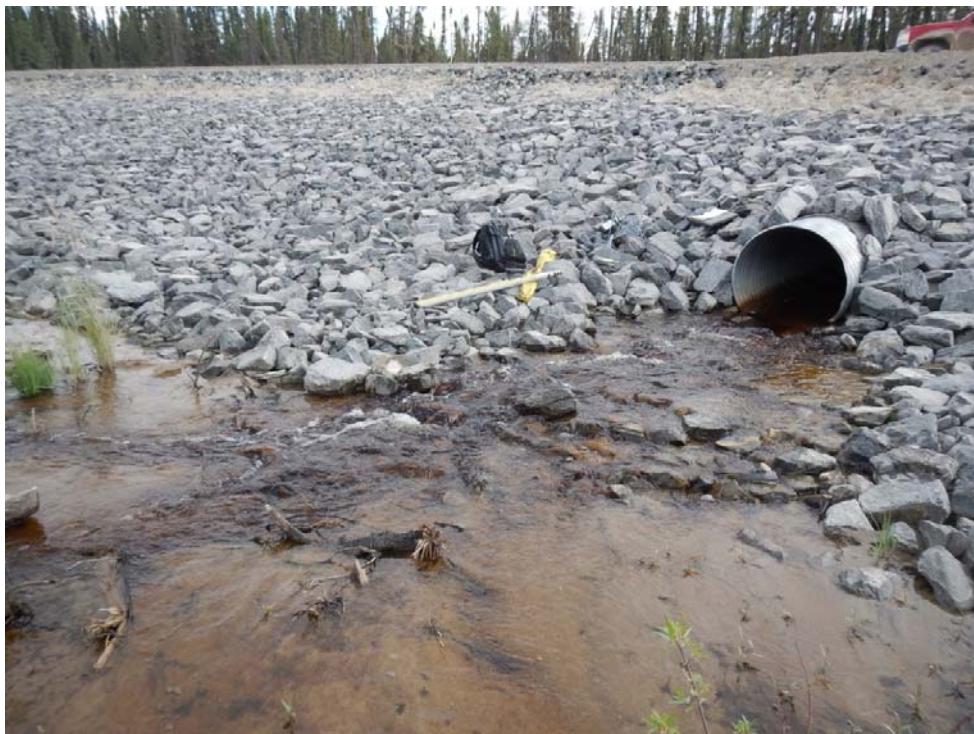
Figure 3. Road crossing for the unnamed tributary.

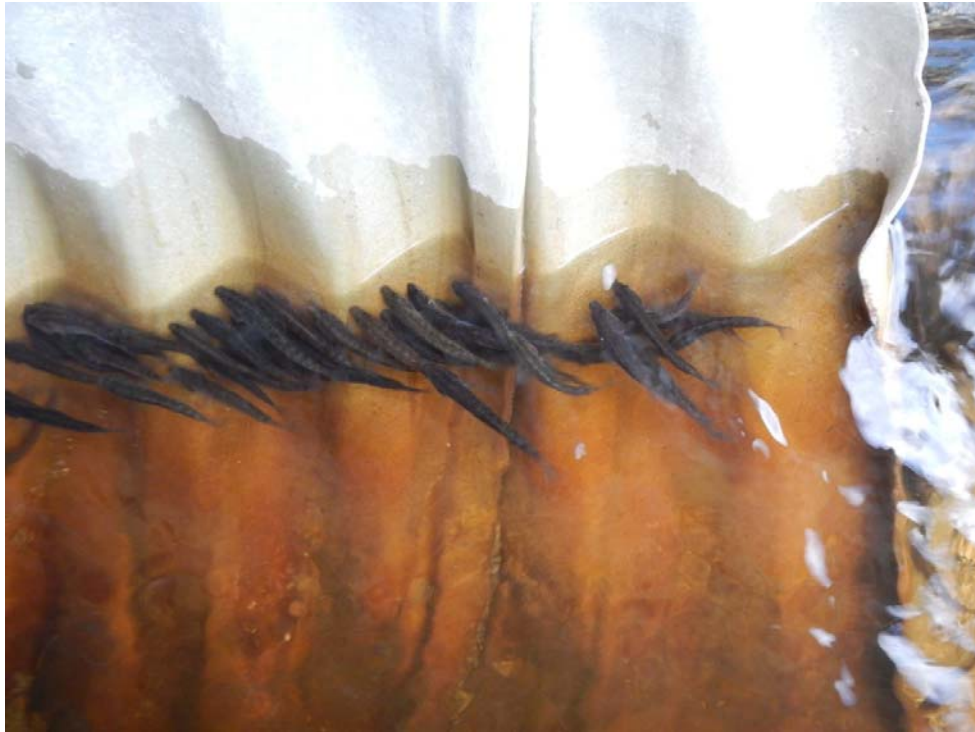
Looking Back Creek supports upstream movements of Walleye (*Sander vitreus*) and Northern Pike (*Esox lucius*) at the crossing location. The Department of Fisheries and Oceans Canada deemed the installation of a culvert at the unnamed tributary to be of low risk to fish and fish habitat and no fish were observed in surveys conducted prior to 2013. During one sampling period in 2013 (August), several Brook Stickleback (*Culaea inconstans*; Figure 4) and small Northern Pike were observed at the crossing.

Figure 4. Brook Stickleback in the culvert at the unnamed tributary on August 20, 2013.

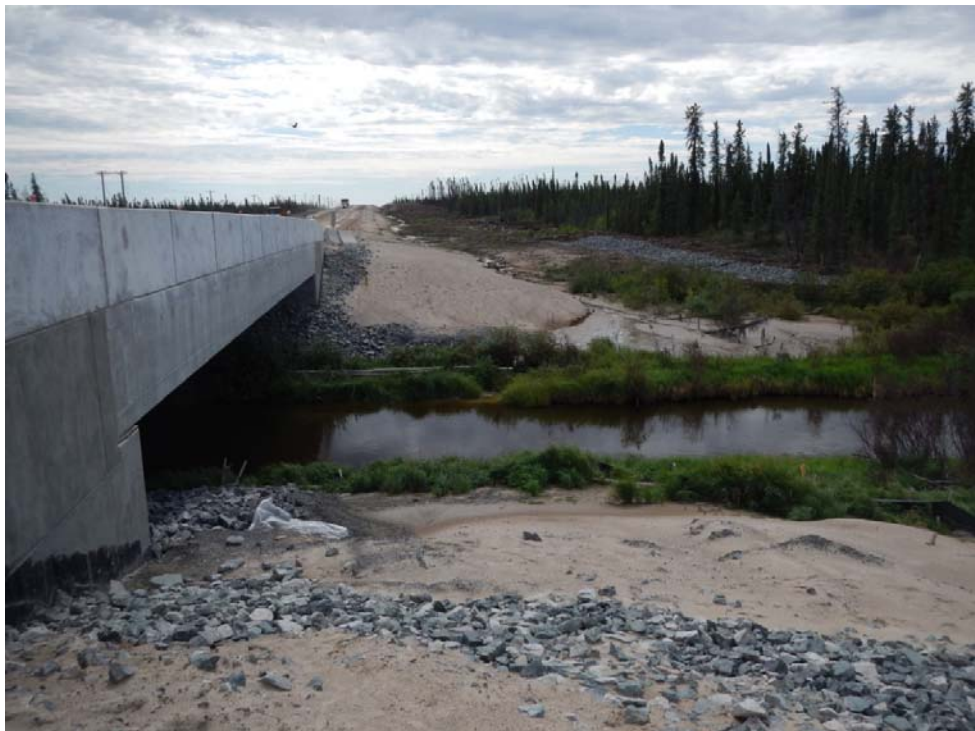
At the initiation of monitoring on August 20, the sampling crew noted a sediment plume in Looking Back Creek (Figures 5 and 6). Monitoring was suspended and the Environmental Officer at the Keeyask Camp was notified. Additional rip-rap was installed on August 27 as sediment/erosion control (Figure 7). As noted above, water quality was similar upstream and downstream of the crossing following installation of the rip-rap, indicating the mitigation was effective.

Figure 5. Exposed shorelines at Looking Back Creek on August 20, 2013.

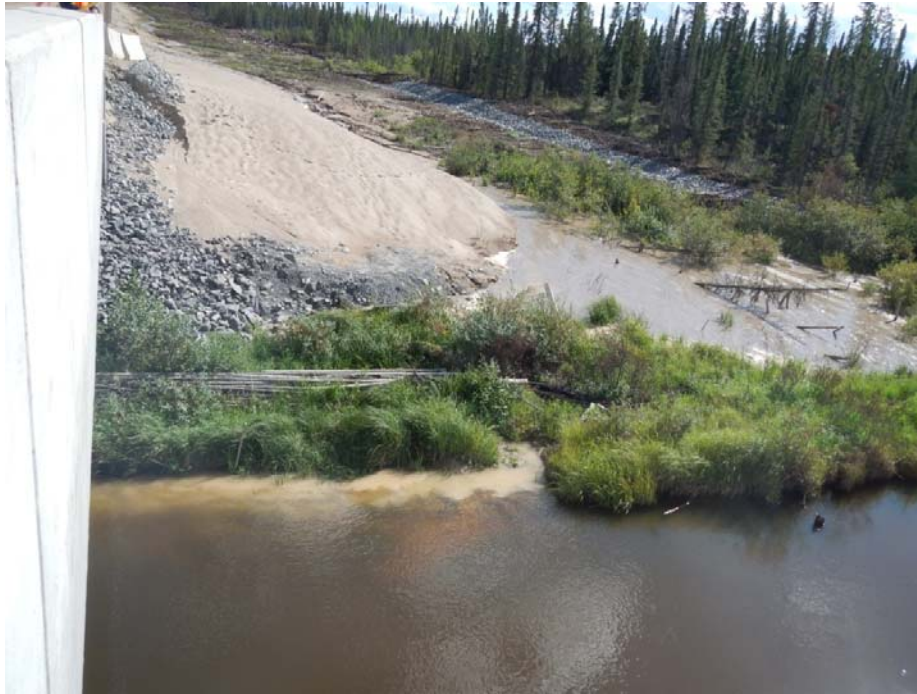
Figure 6. Sediment plume entering Looking Back Creek from the left-hand bank, August 20, 2013.

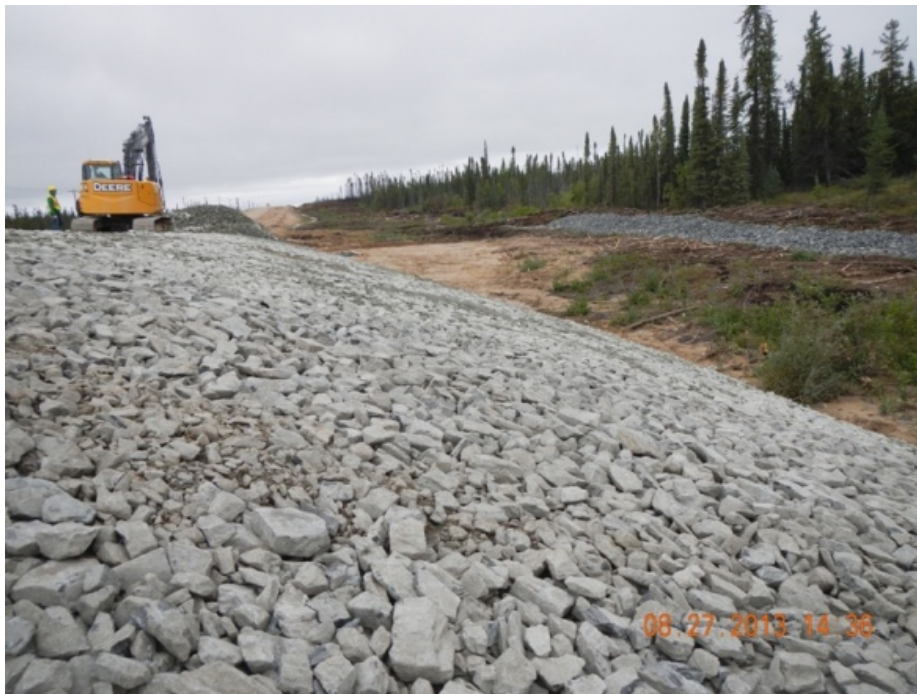
Figure 7. Rip rap installation on each shore surrounding the clear-span bridge at Looking Back Creek, August 27, 2013.
