Keeyask Generation Project Terrestrial Effects Monitoring Plan

Invasive Plant Spread and Control Monitoring Report

TEMP-2017-05

Manitoba Hydro

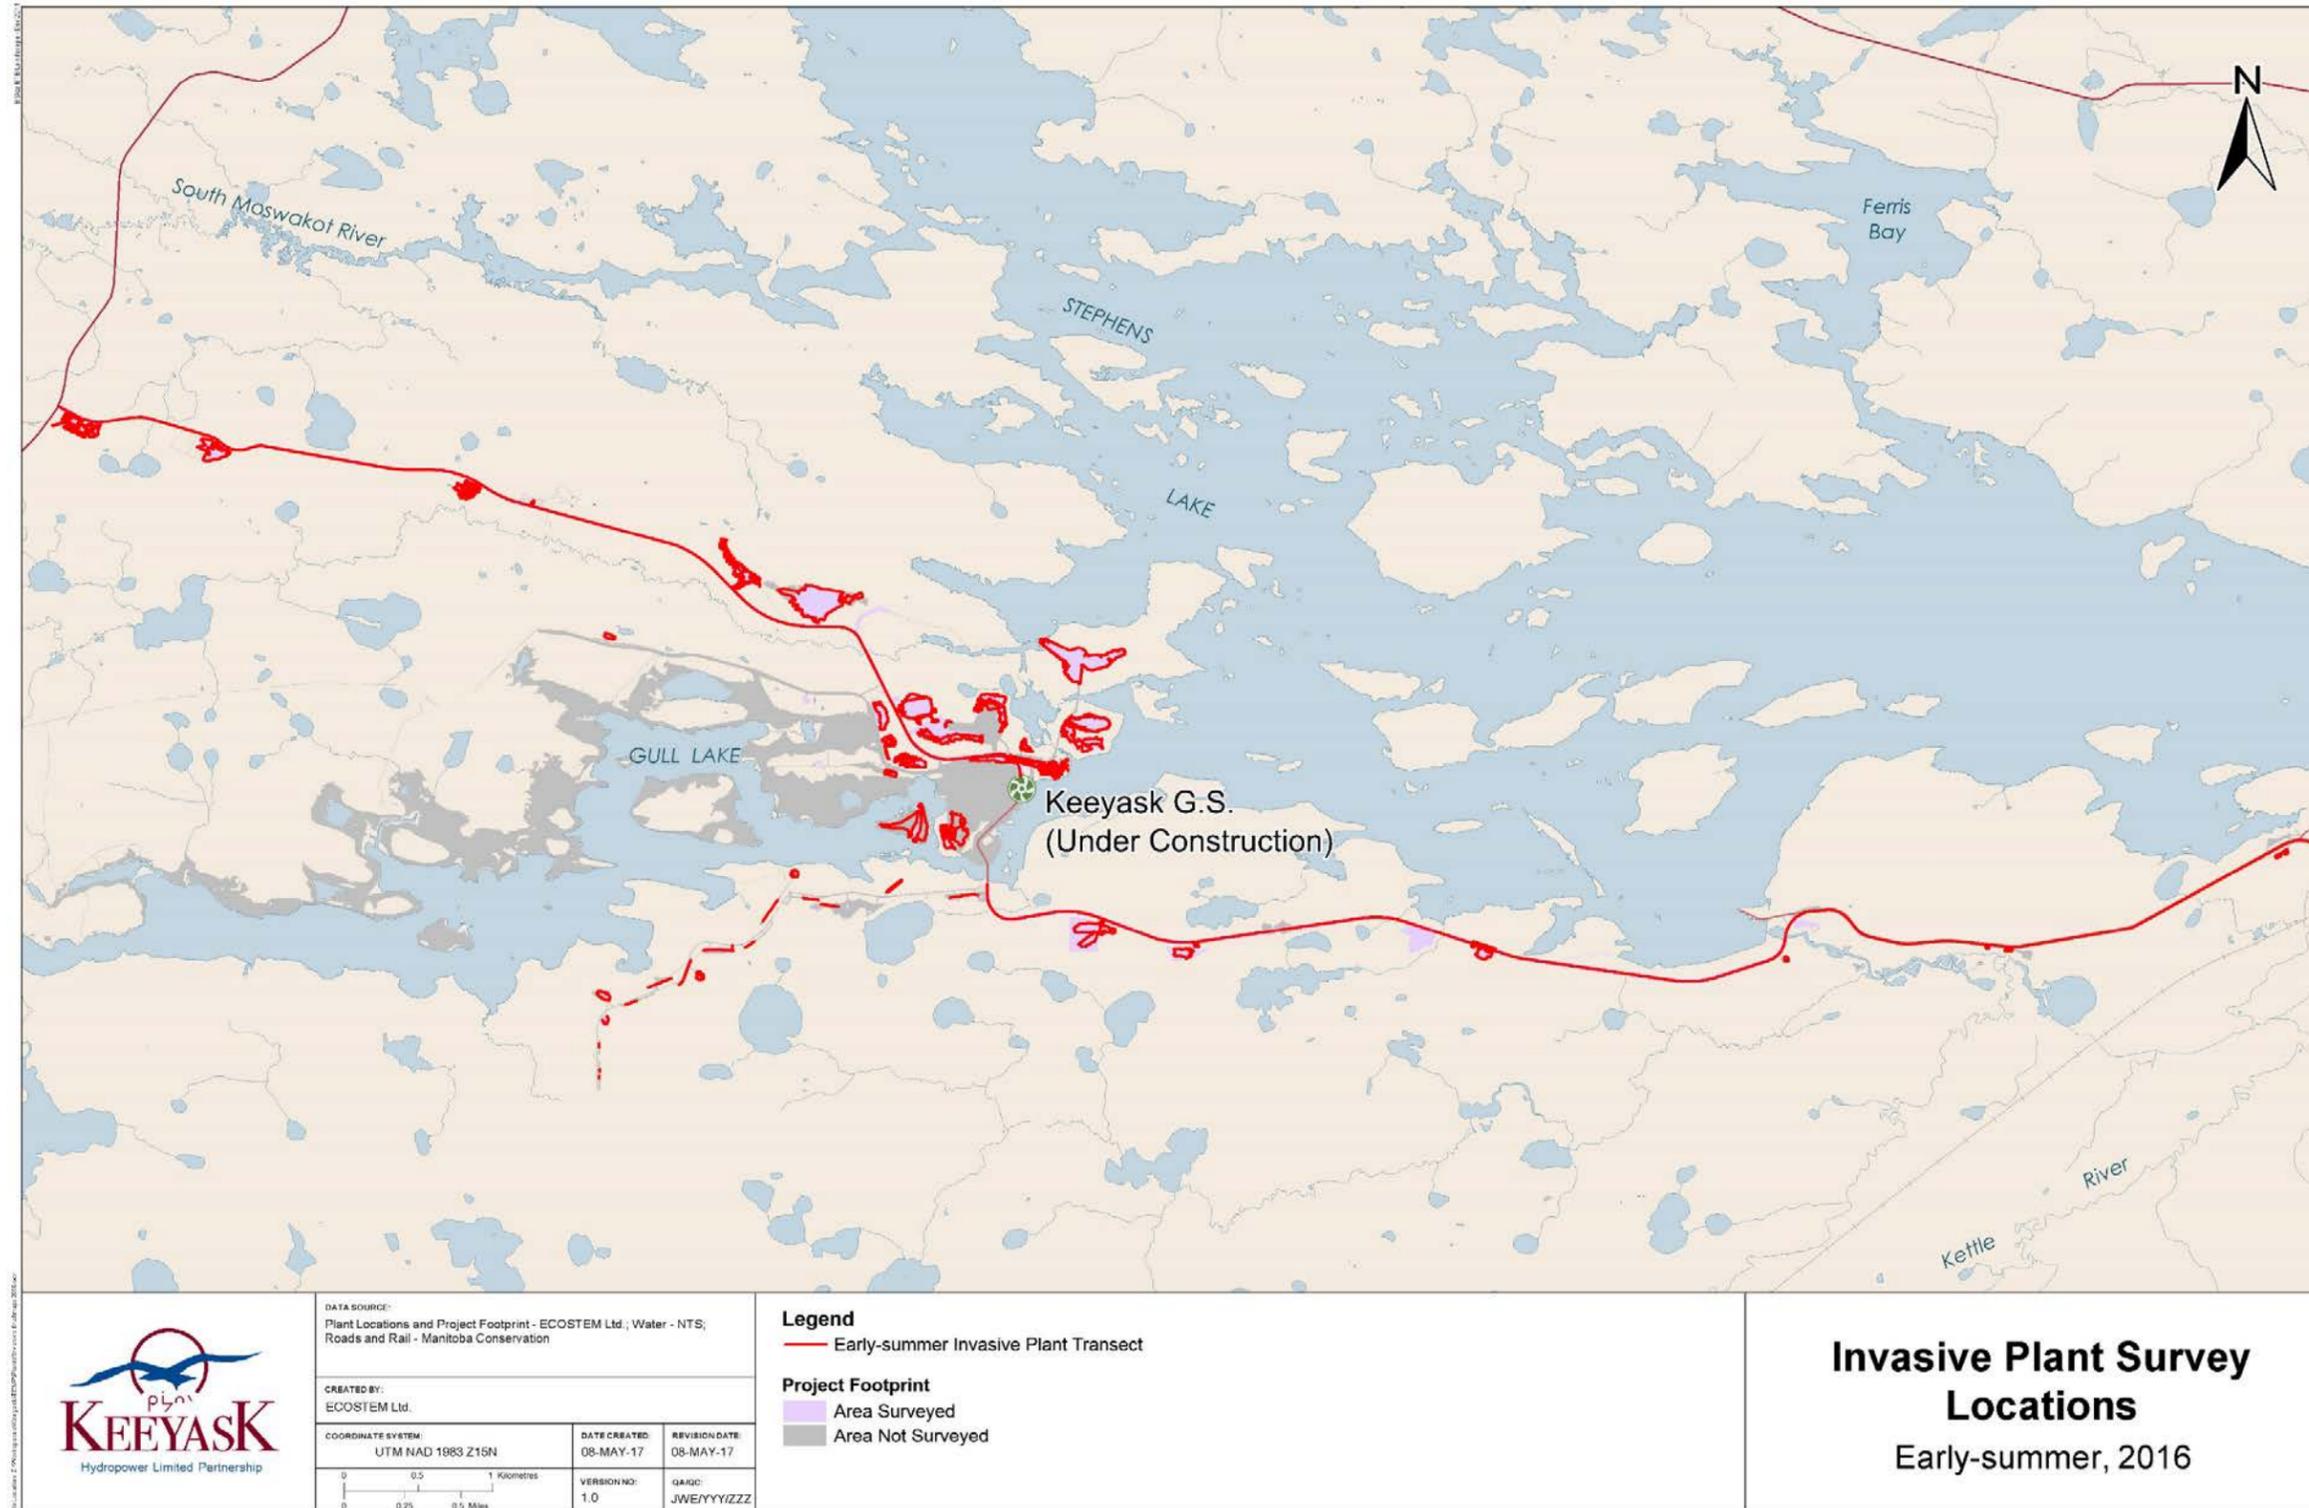
Map 2-1: Early summer invasive/non-native plant survey locations

Early summer surveys were conducted from July 5 to 11, 2016 at the locations shown in Map 2-1. Late summer surveys were conducted from August 22 to 28, 2016 at the locations shown in Map 2-2.

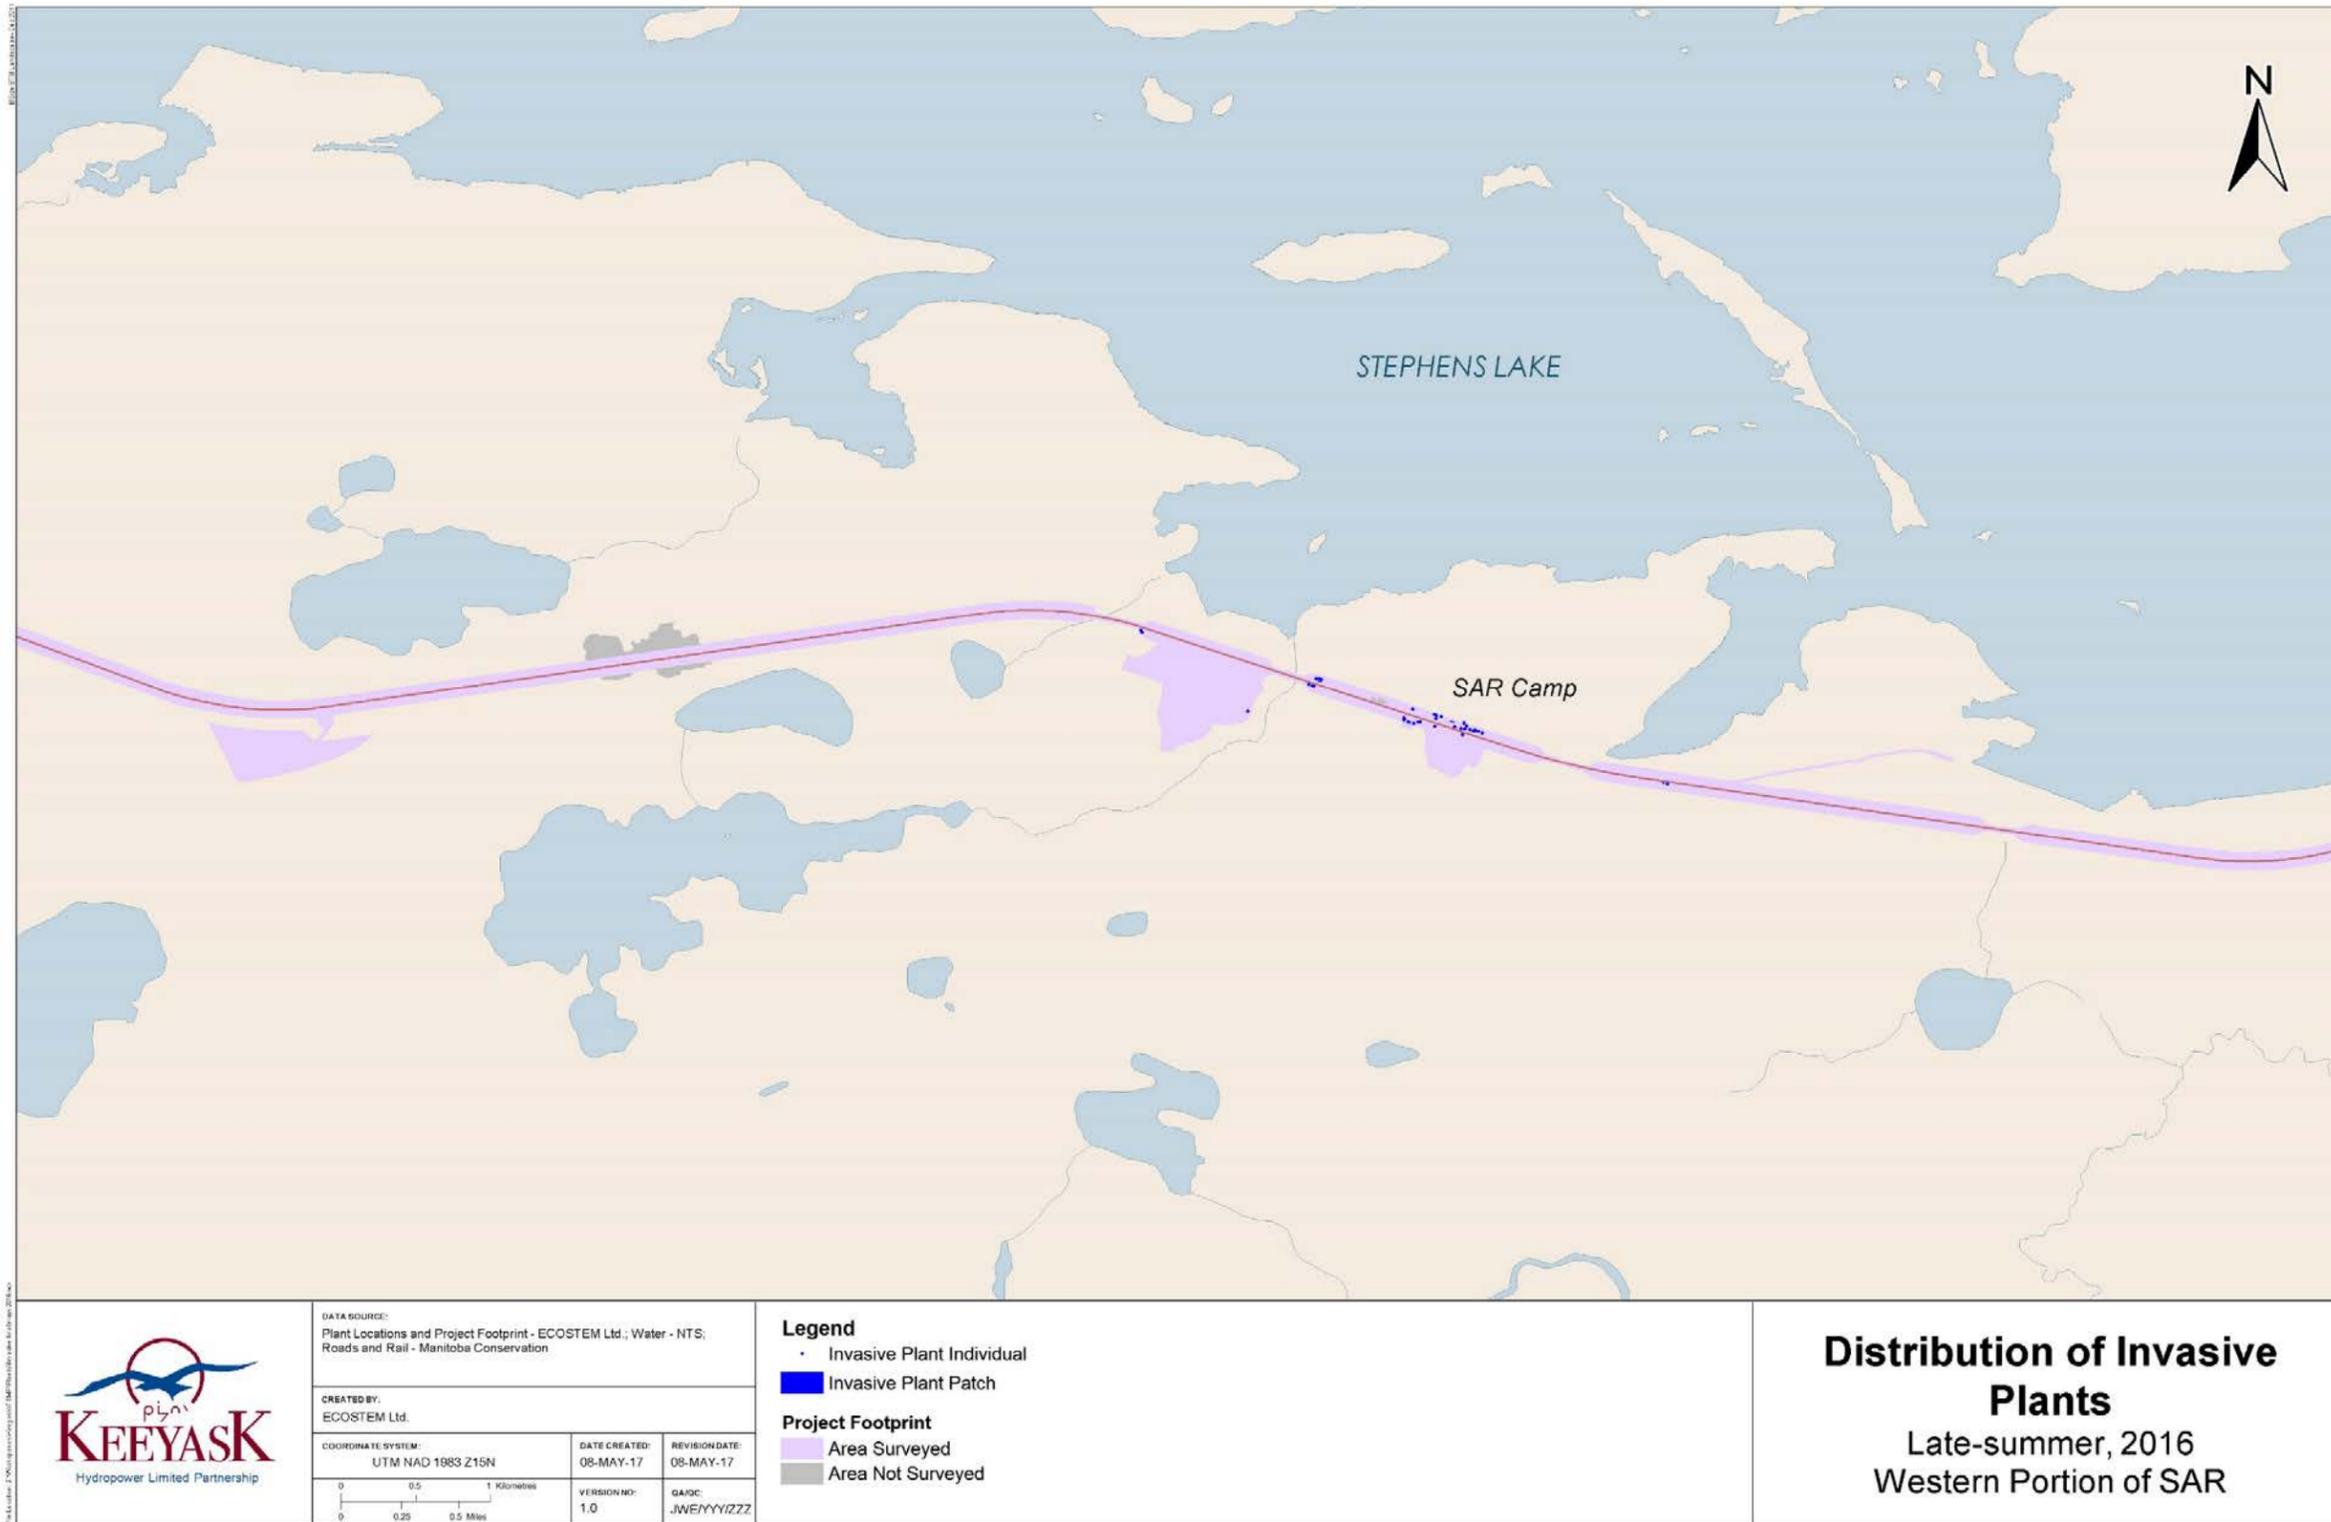
Map 3-3: Distribution of invasive/non-native plants during late summer, 2016, in footprints along the western portion of the south access road

Completion of most of the south access road (SAR) allowed that portion of the Project footprint to be surveyed for the first time in summer 2016. Along reaches west of the Butnau Road, invasive/non-native plants had established around the offices and the SAR camp, and a few individuals were found in the access road ditches near the camp and in the Q-9 borrow area (Map 3-3). No invasive/non-native plants were found along the remainder of the road, or in the borrow areas that had been newly developed for the SAR construction. Along reaches adjacent to the Butnau Road, invasive/non-native plants were establishing within existing borrow areas that were redeveloped for the SAR construction (Map 3-4).

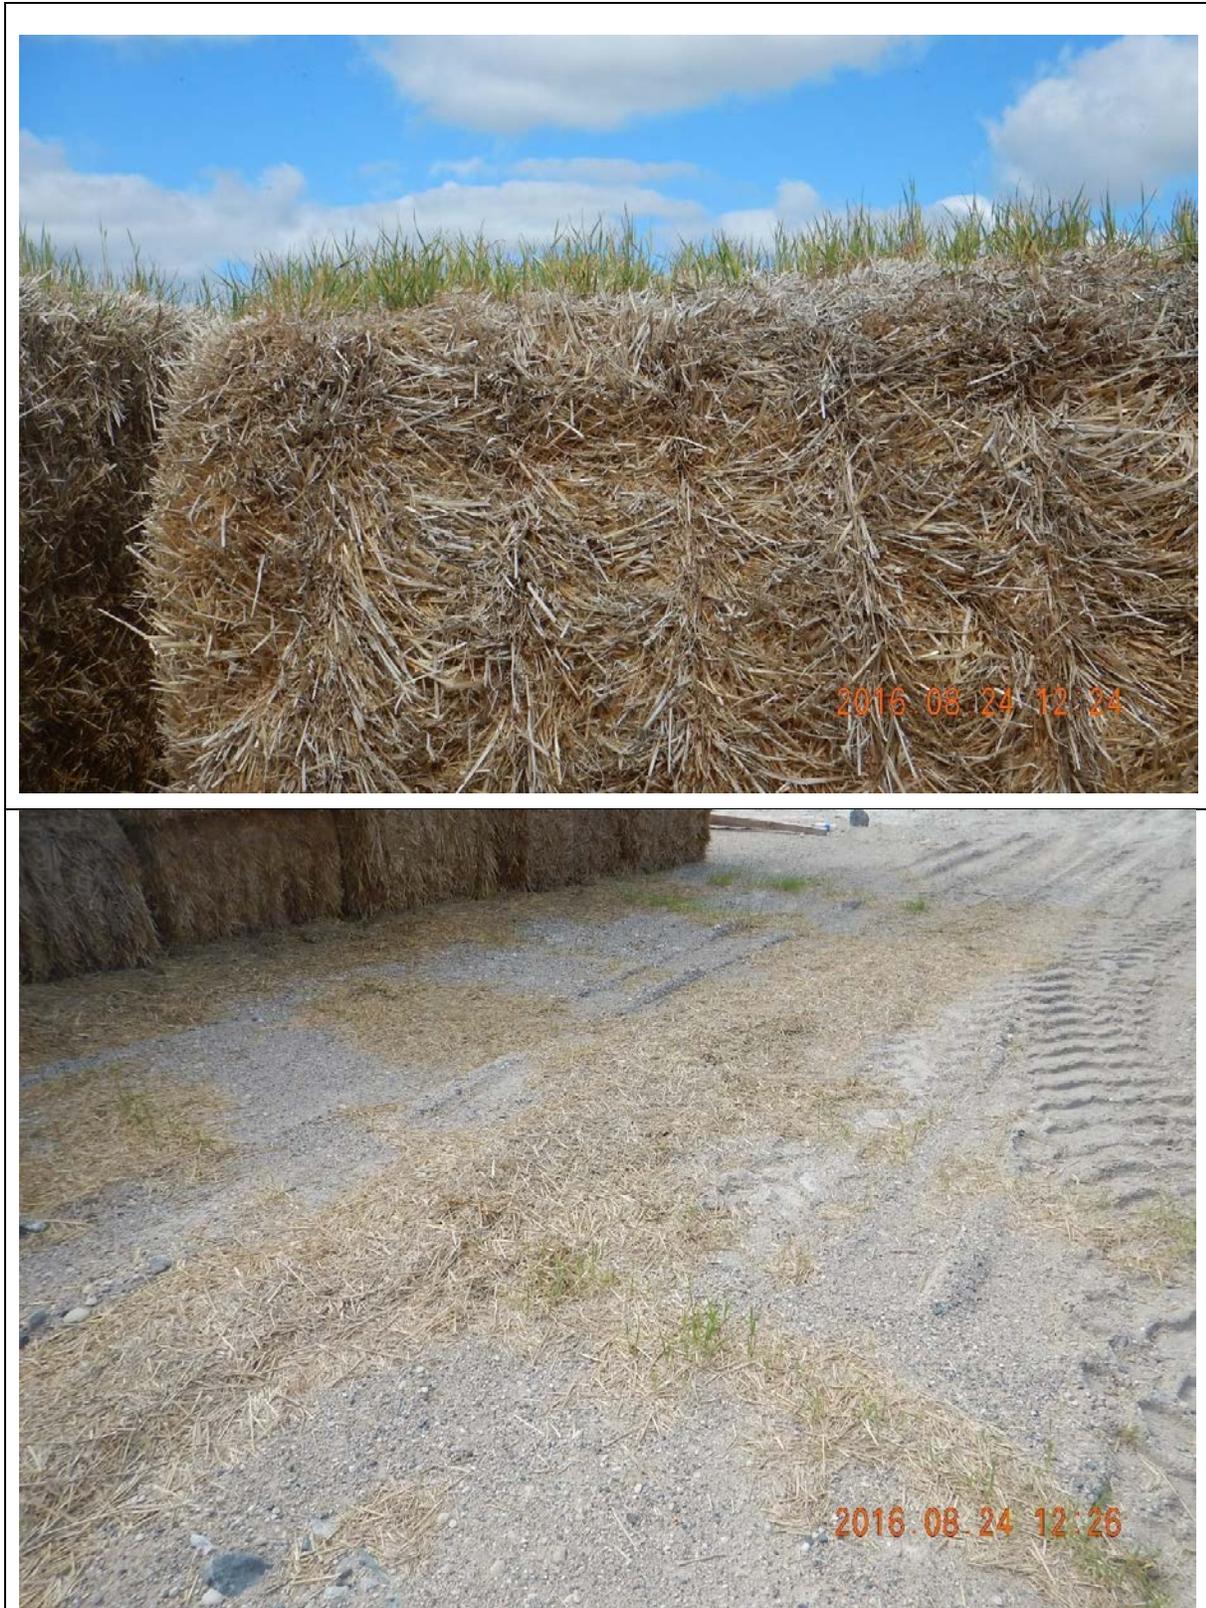
Figure 3-1: Wheat plants growing on top of straw bales and on the ground in straw

The late summer rare plant survey reported the presence of healthy wheat plants in the spillway laydown area. These plants were growing on top of straw bales and on the ground in straw that had fallen off bales (Figure 3-1). These straw bales were brought to site to control erosion. Given the developmental stage of the plants at that time, it appeared unlikely that they could produce viable seed before a fall frost would kill the plants. These areas will be revisited during 2017 surveys to confirm this.

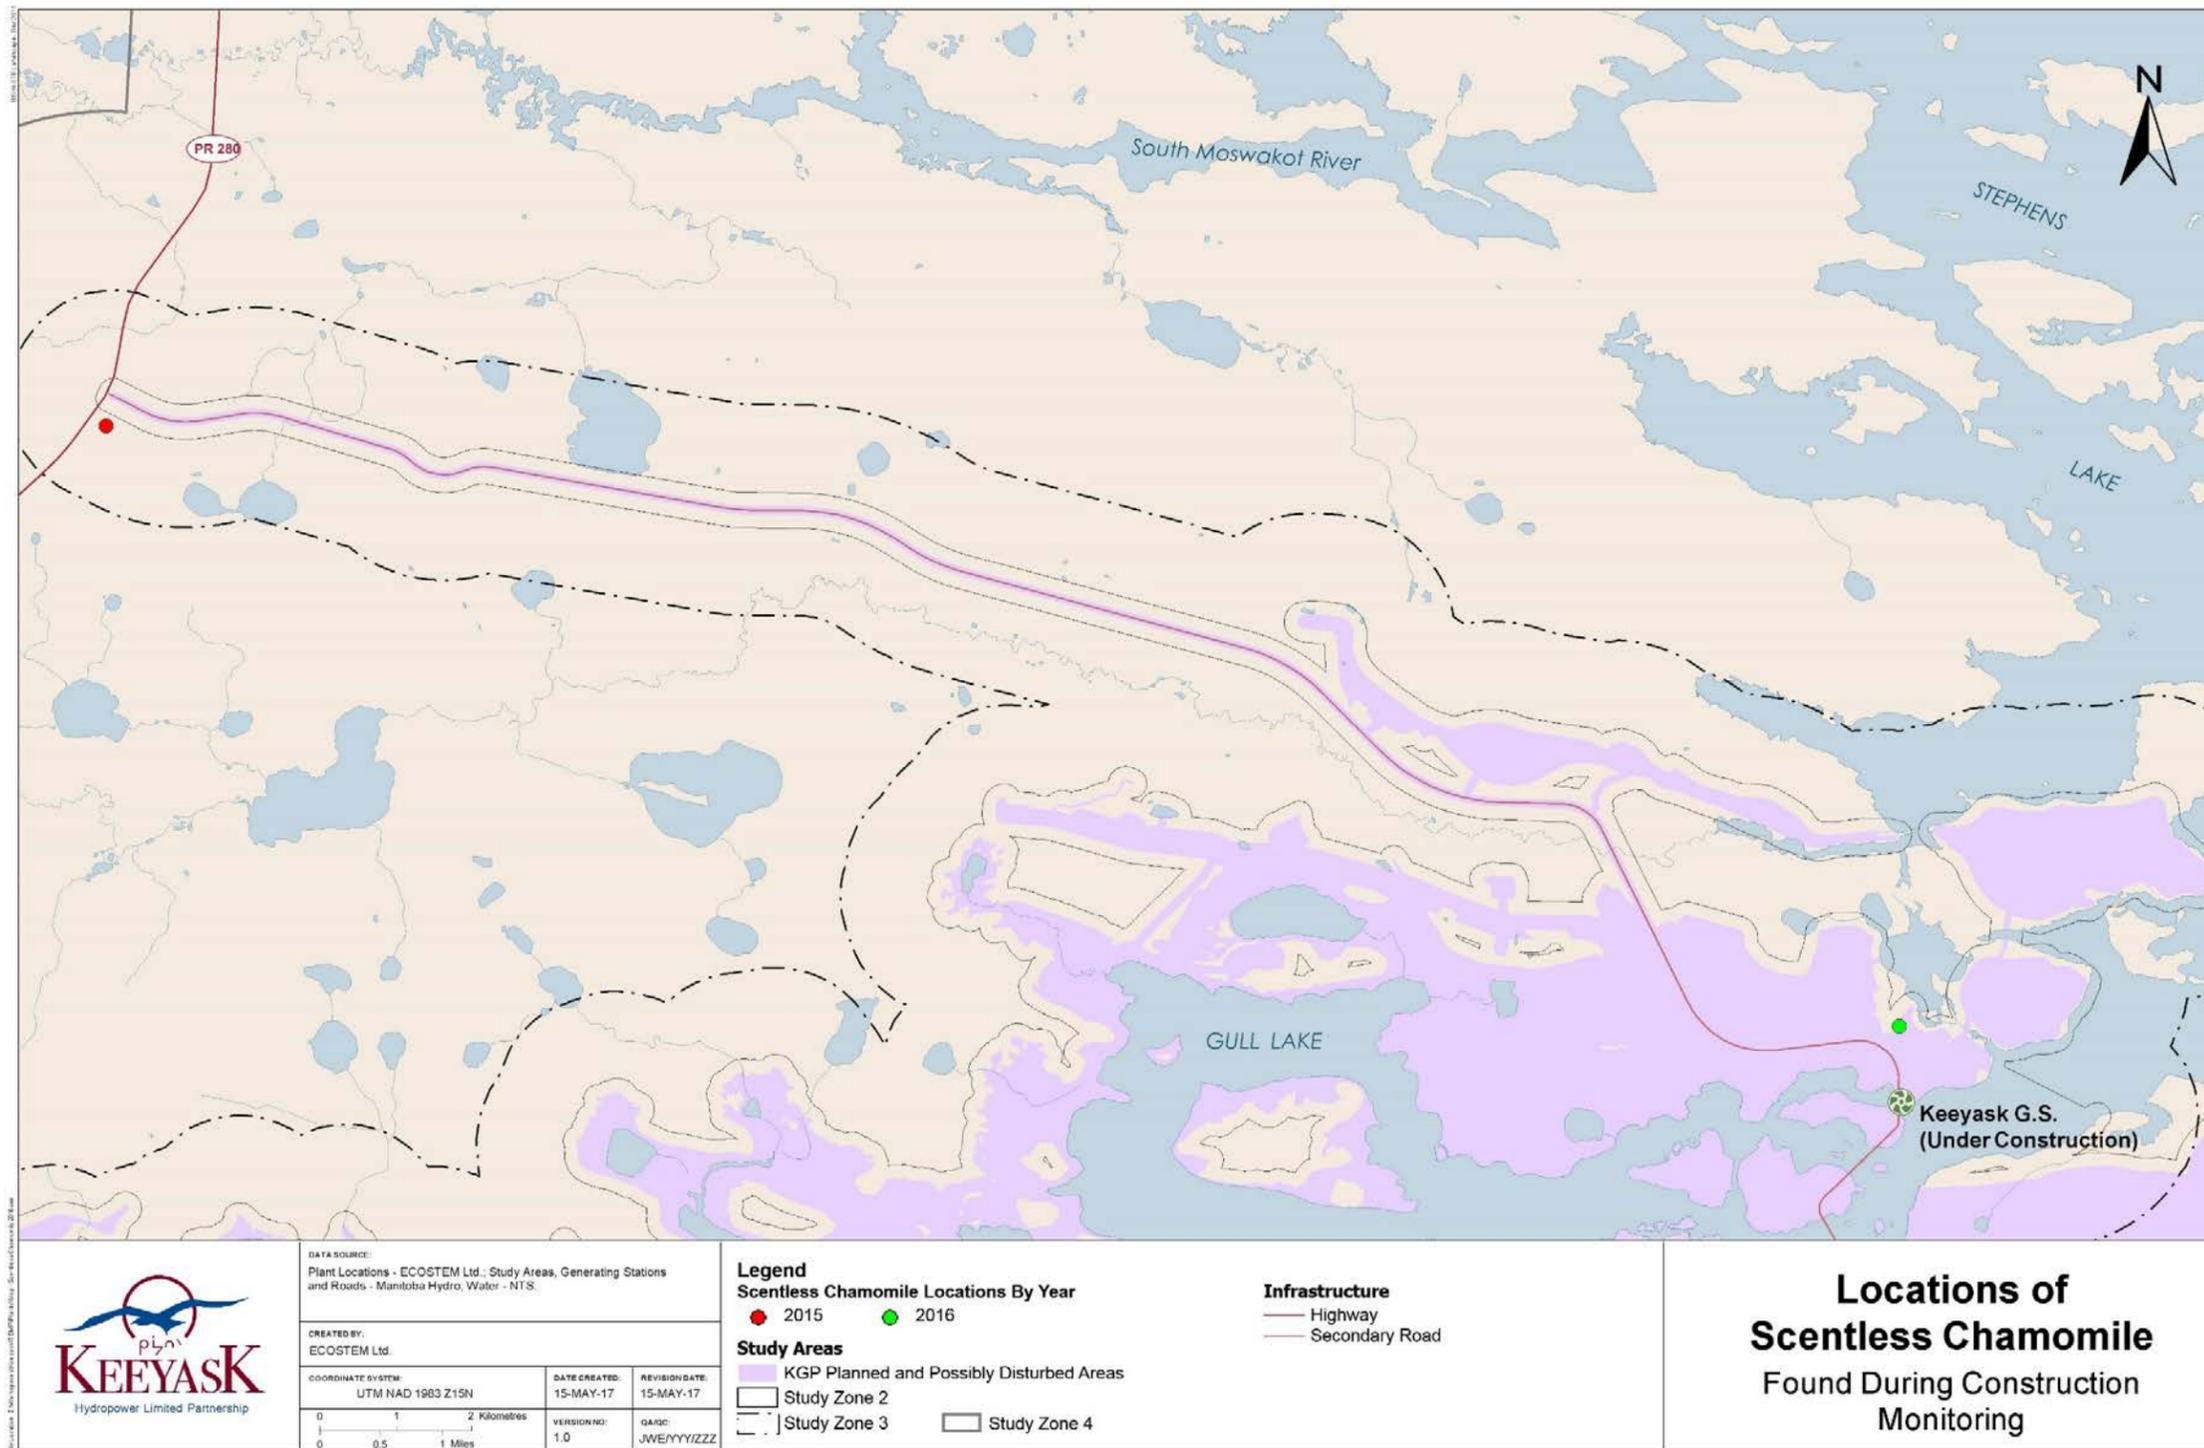
Map 3-14: Locations of scentless chamomile identified during construction monitoring

Scentless chamomile is a fast growing, prolific seed producer that can form dense monocultures (Leafy Spurge Stakeholders Group (LSSG) 2010). Field surveys during 2015 identified one scentless chamomile plant within the road ROW between the start-up camp and the camp well (Map 3-14), while 2016 surveys identified a second location. In both cases, it was recommended shortly after the species was found that Manitoba Hydro site staff carefully: hand-pull the plant; remove the soil from around the base of the plant; place all material into a double layer of garbage bags prior to disposal; and, if feasible, burn all of the collected material. Manitoba Hydro site staff carried out the scentless chamomile plant removal shortly thereafter.

One single scentless chamomile plant was identified within EMPA D17. After its discovery, it was recommended that the plant be carefully removed and disposed of. On the day after its discovery, Manitoba Hydro field staff removed and disposed of the scentless chamomile plant and the soil material. The other location where scentless chamomile had been found in 2015, and then removed by site staff, did not have any new plants in 2016.

Scentless chamomile was the only invasive plant species recorded in 2016 for which the ISCM recommends rapid response. The preferred method for removal and disposal of such plants is: hand-pull the plant; remove the soil from around the base of the plant; place all material into a double layer of garbage bags prior to disposal; and, dispose of all of the collected material, preferably by burning it.

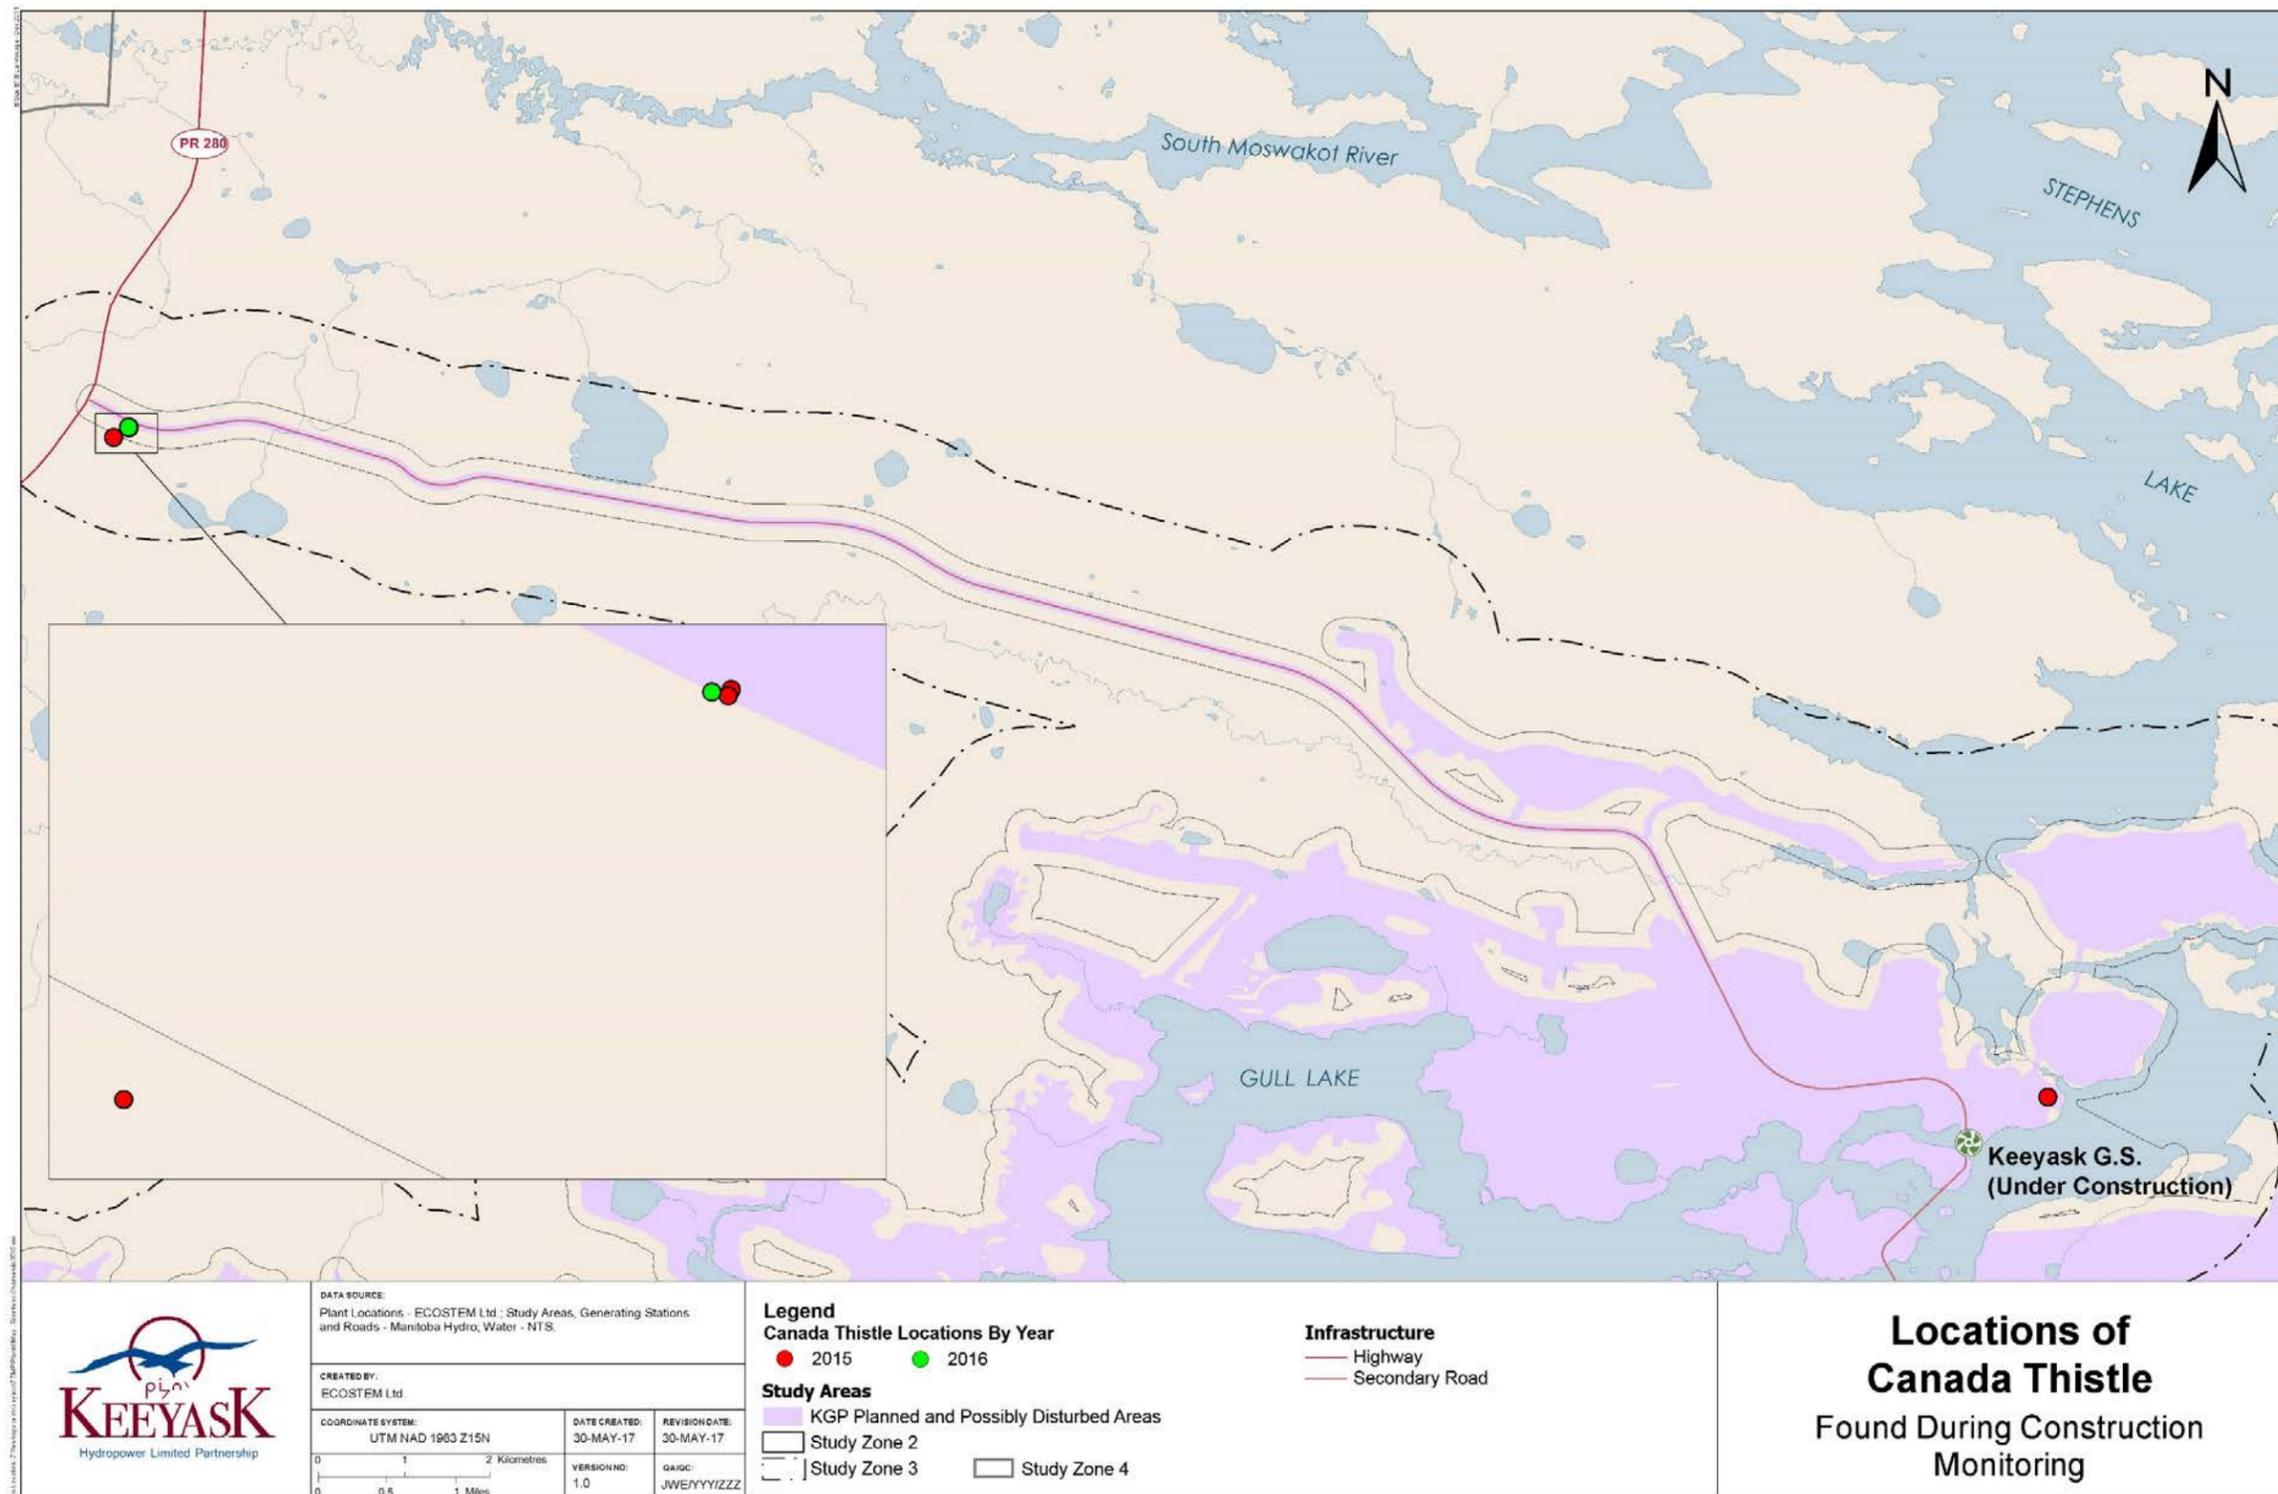
Map 3-16: Canada thistle locations

Canada thistle is classified as an invasive of "other" concern in Manitoba, a moderate invasive in Canada and a weed seed in Canada (Table 3-7). On this basis, it was recommended that the plants identified during the fall 2015 surveys be removed when they emerge in the spring. The preferred disposal method was the same as the one described above for scentless chamomile. The 2015 and 2016 surveys found three Canada thistle locations (Map 3-16). One location found in spring 2015 has not been observed since then. The remaining two locations were included in the areas treated with herbicides (see below).

For the three of the four species that ISCM classifies as “other” invasives (common burdock, Canada thistle and tufted vetch), it is recommended that the plants be removed and disposed of using the same method as for scentless chamomile. These species are of relatively high invasive concern and were found at only a few locations each.

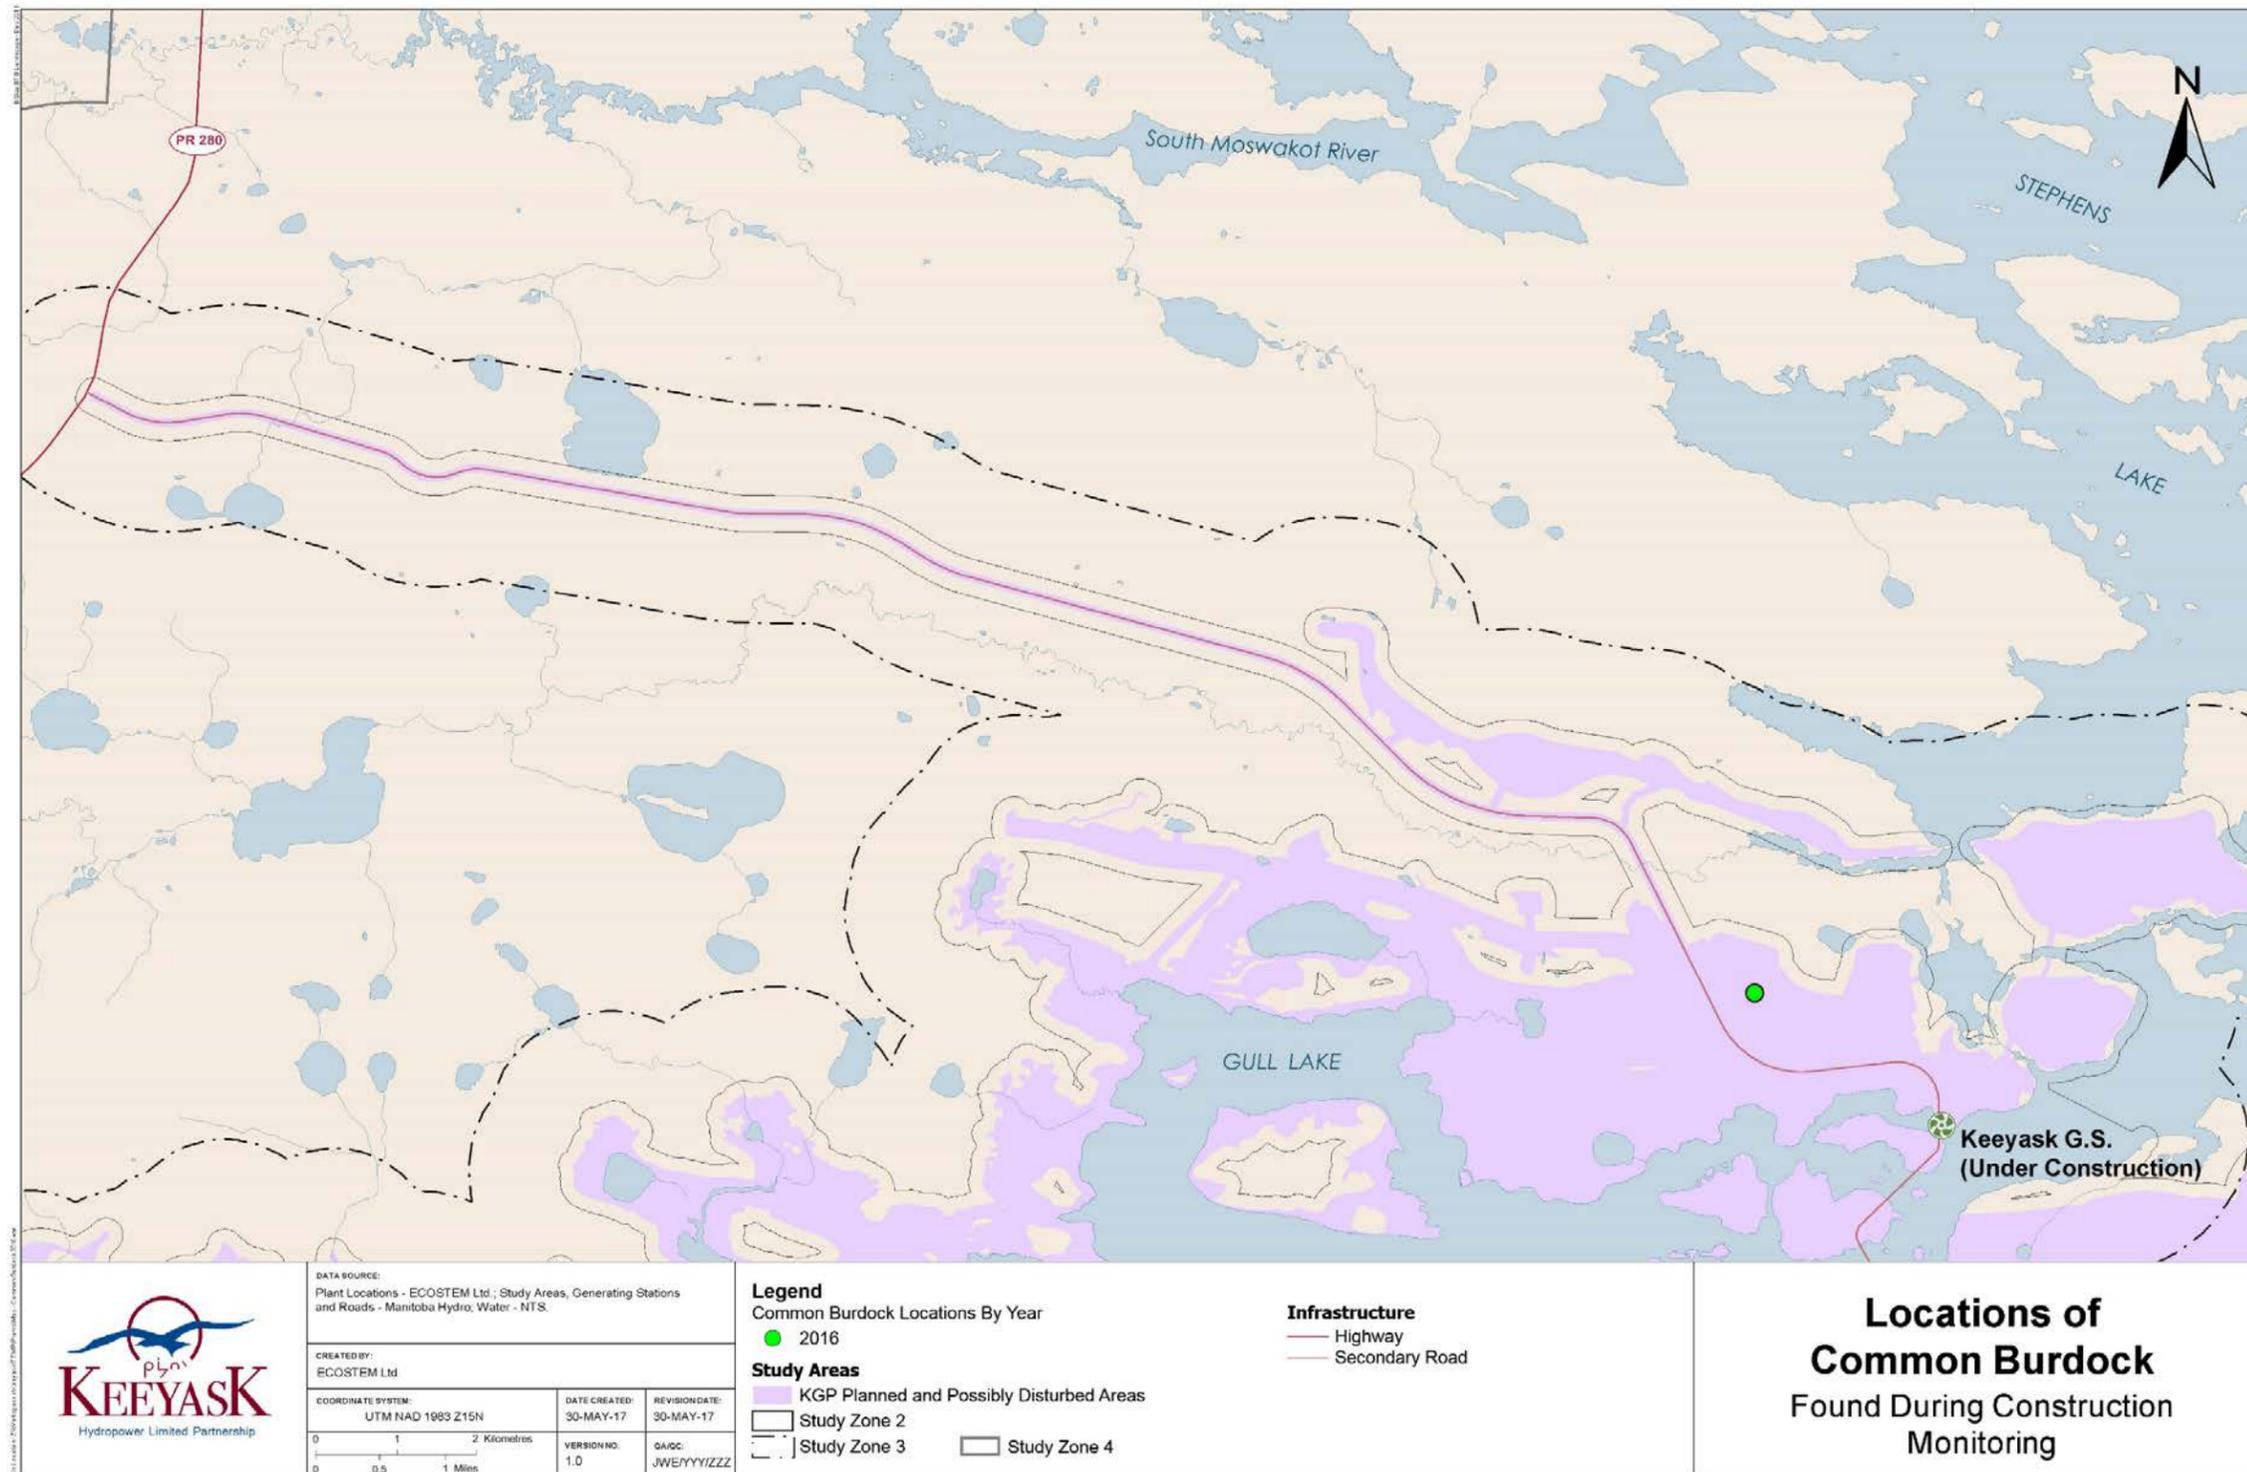
Map 3-17: Common burdock location

Common burdock is classified as an invasive of "other" concern in Manitoba and considered to be a noxious weed in Manitoba (Table 3-7). The large basal leaves can shade out smaller plants. Its seed is spread via burrs that attach to clothing and vehicles (ISCM 2017). It is recommended that burrs on dead stems of the plant identified in late summer 2016 (Map 3-17) be removed early in the spring, and the rest of the plant when it emerges in the spring. The preferred disposal method is the same as the one described above for scentless chamomile.
