Keeyask Generation Project Terrestrial Effects Monitoring Plan

Invasive Plant Spread and Control Monitoring Report

TEMP-2017-05

Manitoba Hydro

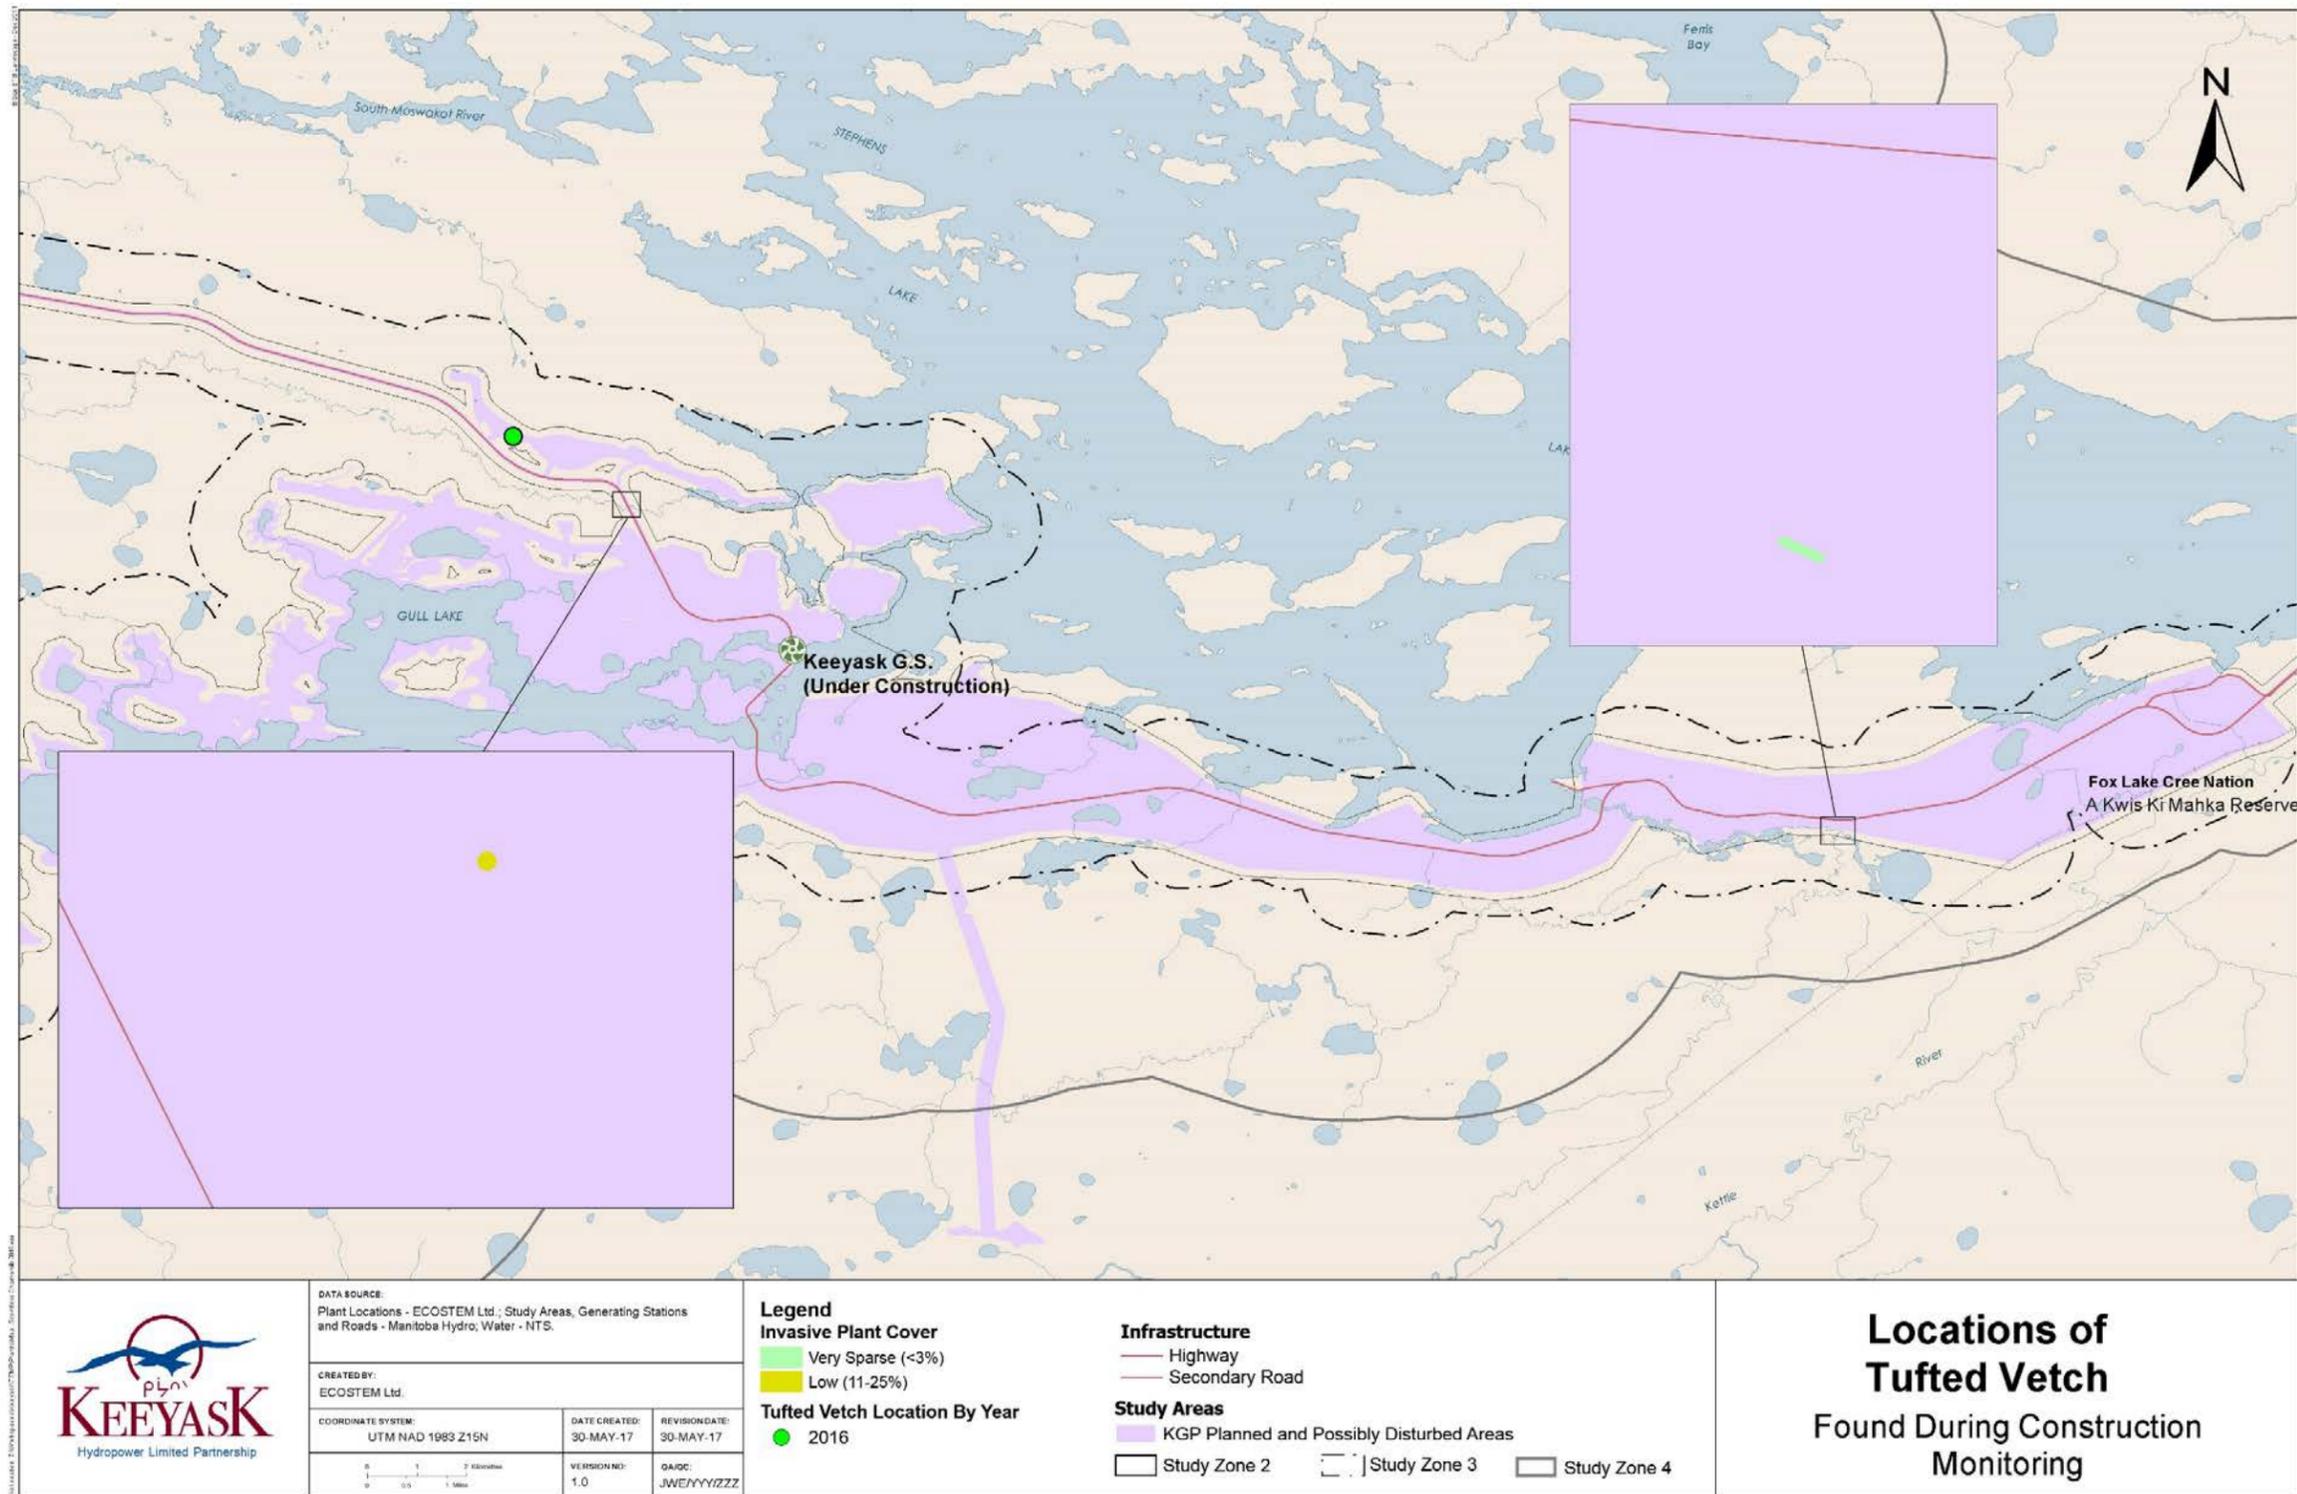
Map 3-18: Tufted vetch locations

Tufted vetch is classified as a species of some concern in Manitoba (Table 3-7). The species can spread aggressively, crowding out native vegetation. The plant was found at only three locations during late summer 2016 surveys (Map 3-18). It is recommended that the plants be removed when they emerge in the spring. The preferred disposal method is the same as the one described above for scentless chamomile.

For the three of the four species that ISCM classifies as “other” invasives (common burdock, Canada thistle and tufted vetch), it is recommended that the plants be removed and disposed of using the same method as for scentless chamomile. These species are of relatively high invasive concern and were found at only a few locations each.
