Keeyask Generation Project Environmental Impact Statement

Supporting Volume Physical Environment

June 2012

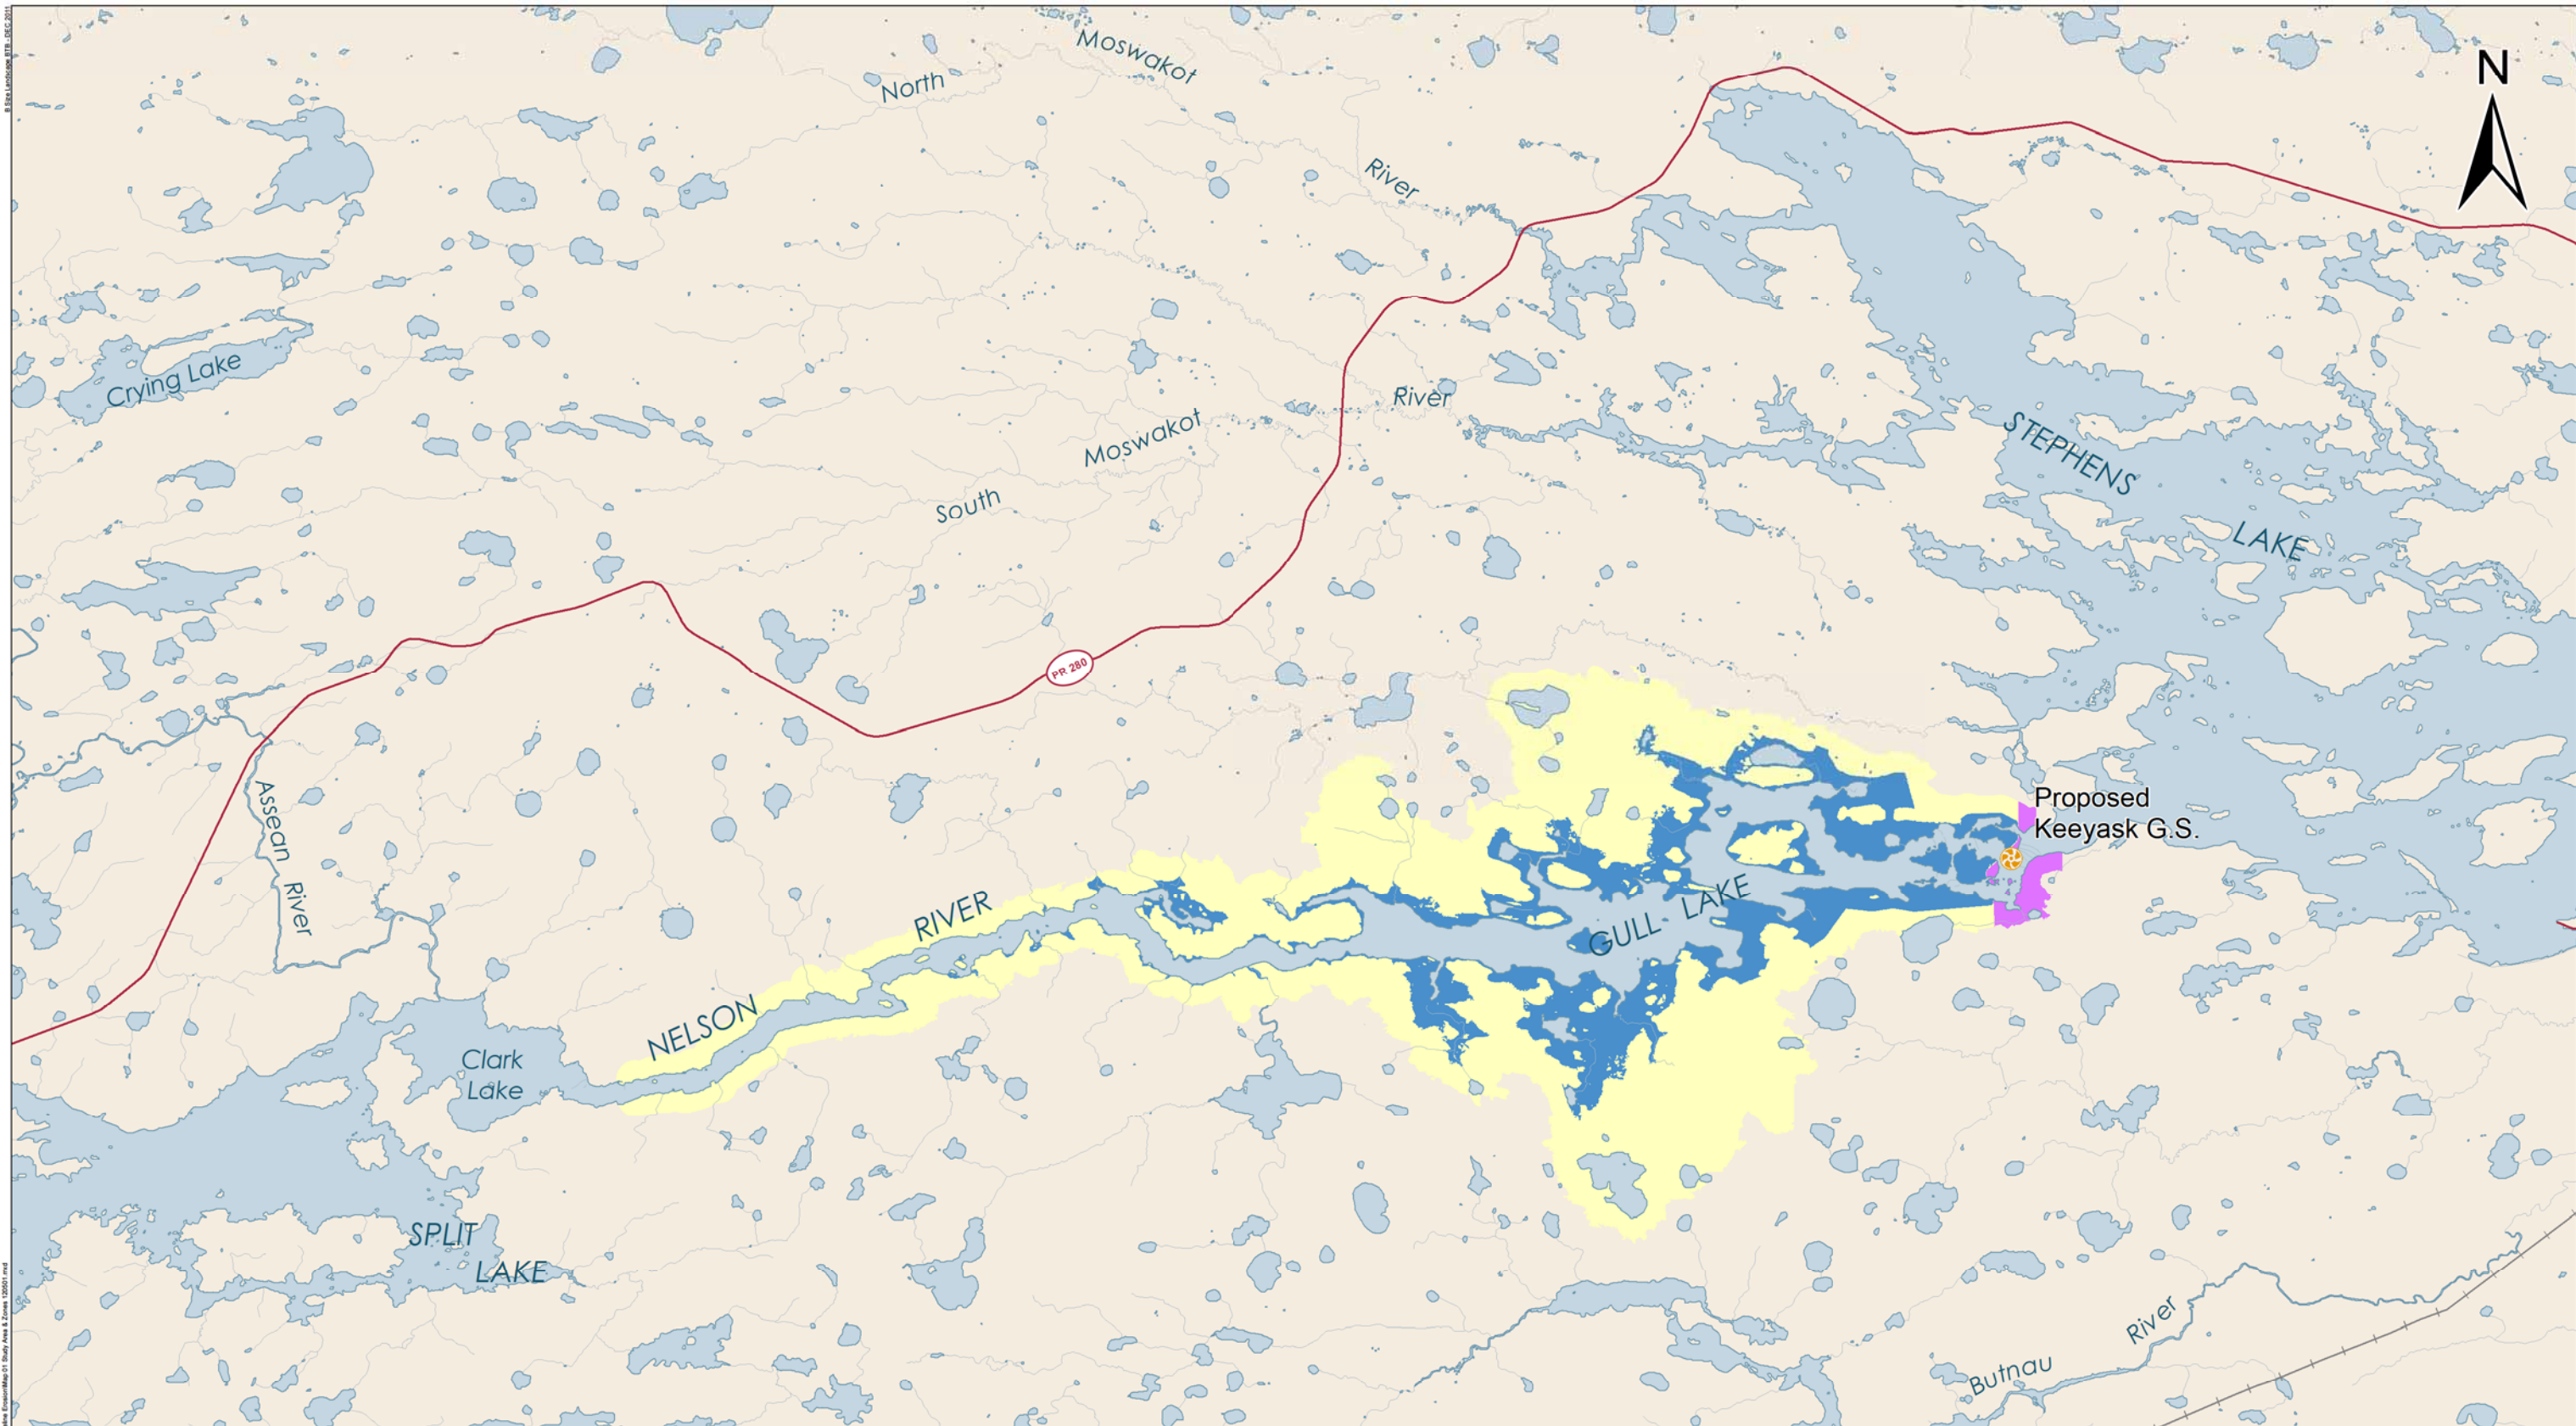
Shoreline Erosion Study Area and Zones

DATA SOURCE:
 Study areas - ECOSTEM Ltd.; Existing Nelson River shoreline (gull-ee-95perc-4327cms-rev3) and initial flooding (pp-95perc-4327-159-shore-rev5) - Manitoba Hydro; Water - NTS; Roads and rail - Manitoba Conservation.

Study Area Zones

Initial Flooded Area (159 m)

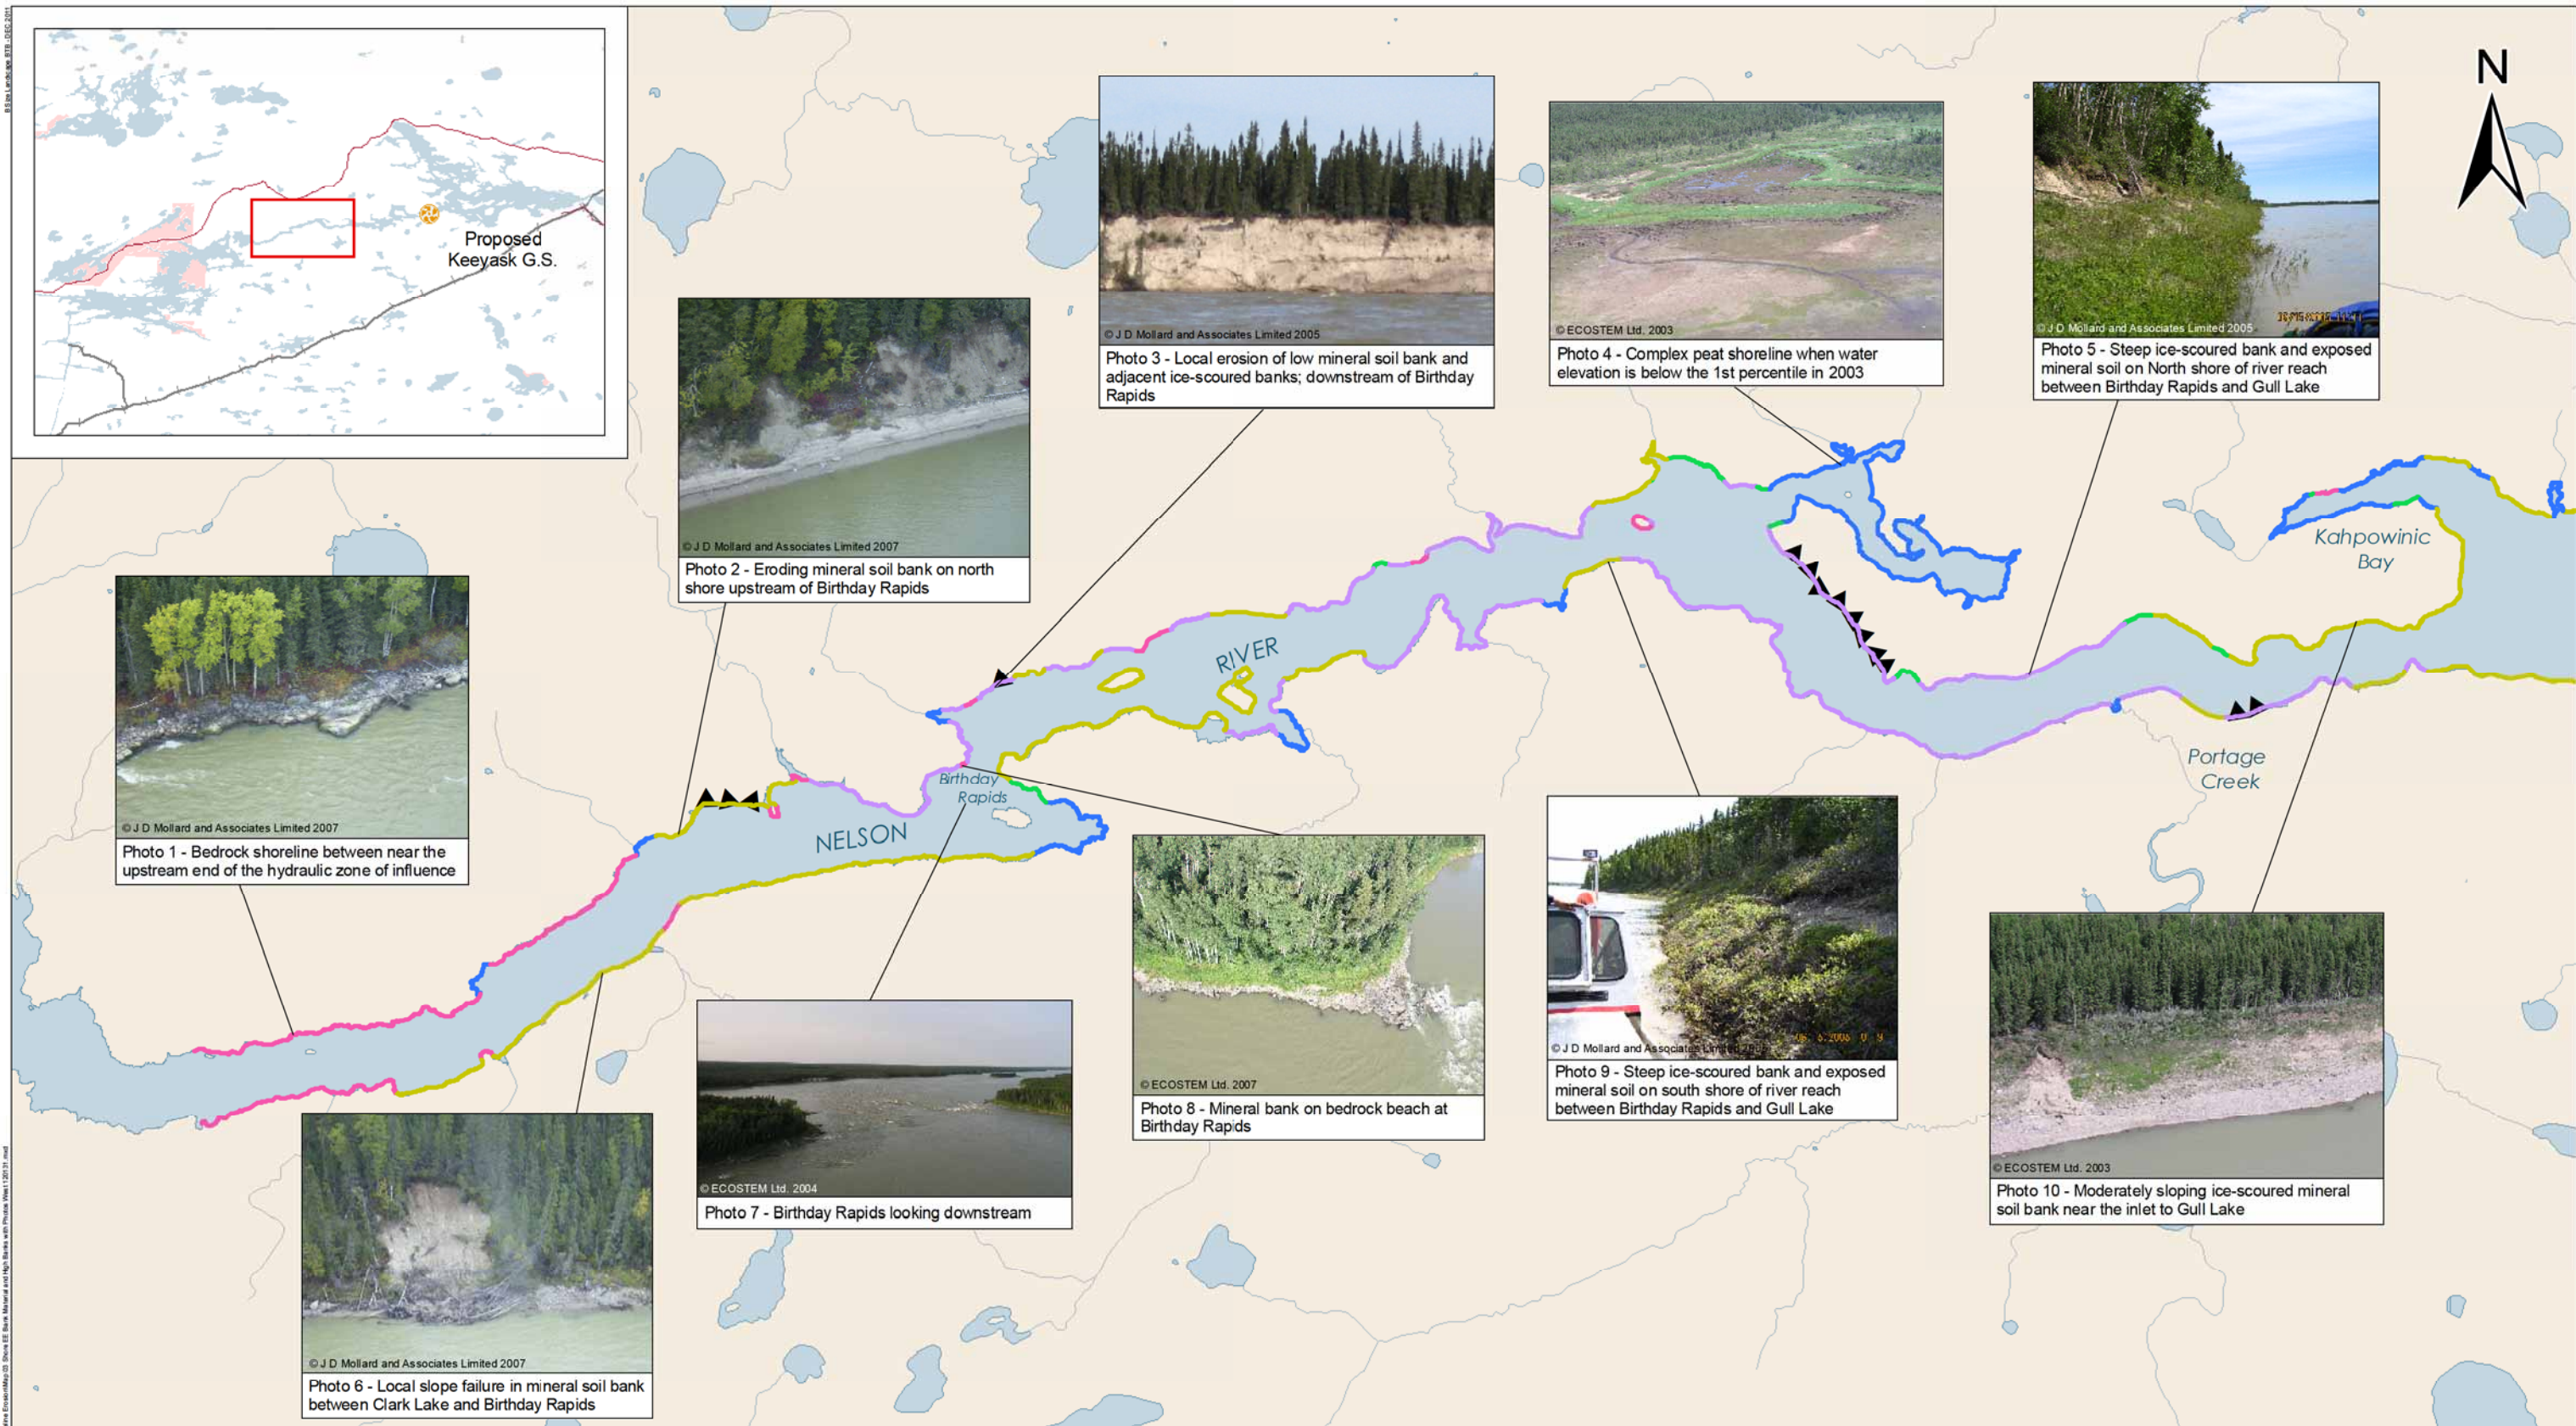
Nelson River Bank Material Type and Segments With High Banks in Western Upstream Reaches

Shore Material

- Bedrock
- Coarse Mineral
- Fine Mineral
- Mineral Overlain By Peat
- Peat
- Shore At Least 3m High

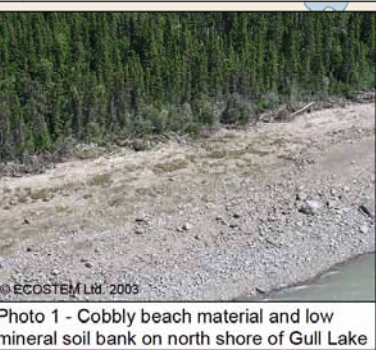
Photo 1 - Cobble beach material and low mineral soil bank on north shore of Gull Lake

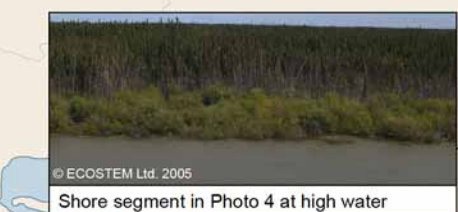
Shore segment in Photo 4 at high water

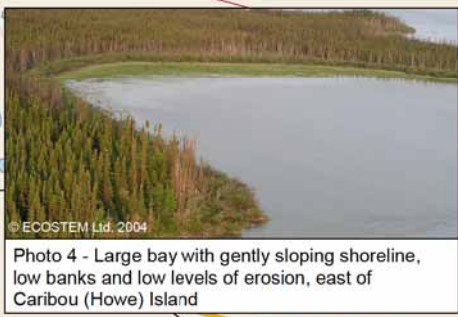
Photo 4 - Large bay with gently sloping shoreline, low banks and low levels of erosion, east of Caribou (Howe) Island

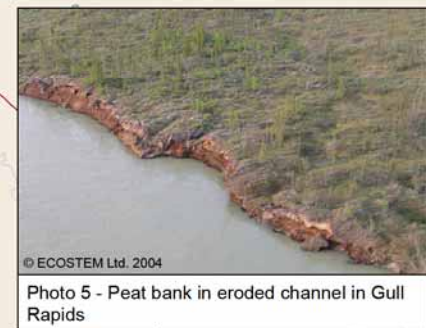
Photo 5 - Peat bank in eroded channel in Gull Rapids

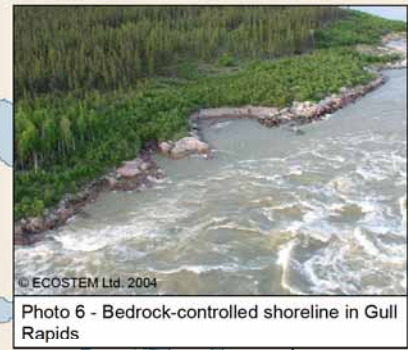
Photo 6 - Bedrock-controlled shoreline in Gull Rapids

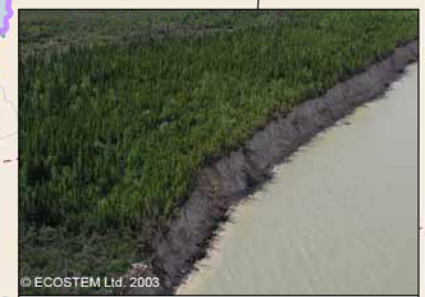
Photo 13 - Actively eroding high mineral bank on the south shore of Stephens Lake, downstream of Gull Rapids

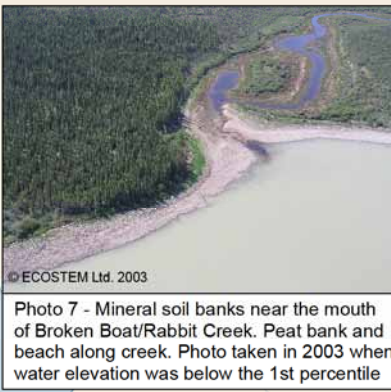
Photo 7 - Mineral soil banks near the mouth of Broken Boat/Rabbit Creek. Peat bank and beach along creek. Photo taken in 2003 when water elevation was below the 1st percentile

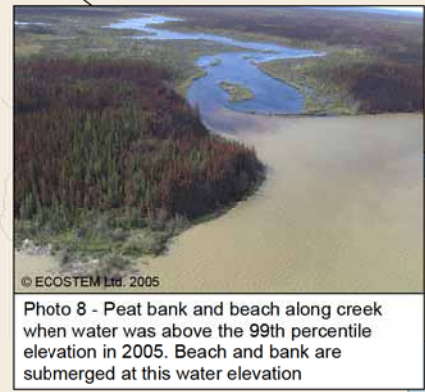
Photo 8 - Peat bank and beach along creek when water was above the 99th percentile elevation in 2005. Beach and bank are submerged at this water elevation

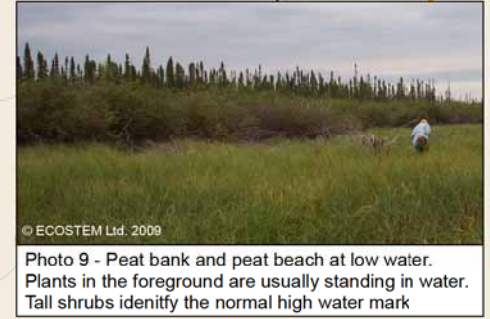
Photo 9 - Peat bank and peat beach at low water. Plants in the foreground are usually standing in water. Tall shrubs identify the normal high water mark

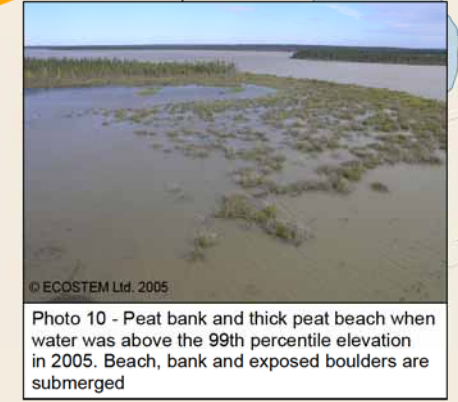
Photo 10 - Peat bank and thick peat beach when water was above the 99th percentile elevation in 2005. Beach, bank and exposed boulders are submerged

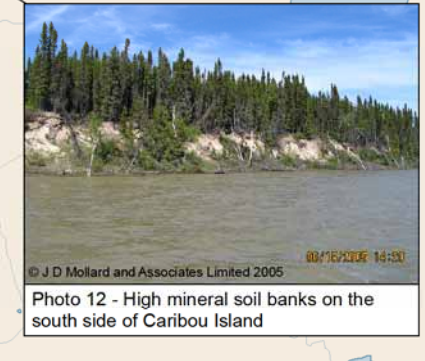
Photo 12 - High mineral soil banks on the south side of Caribou Island
