KEYYASK INFRASTRUCTURE PROJECT

TERRESTRIAL AND AQUATIC MONITORING PLAN

Water Quality: Annual Report 2012 - 2013

Environmental Licensing & Protection Department
Power Planning Division
Manitoba Hydro

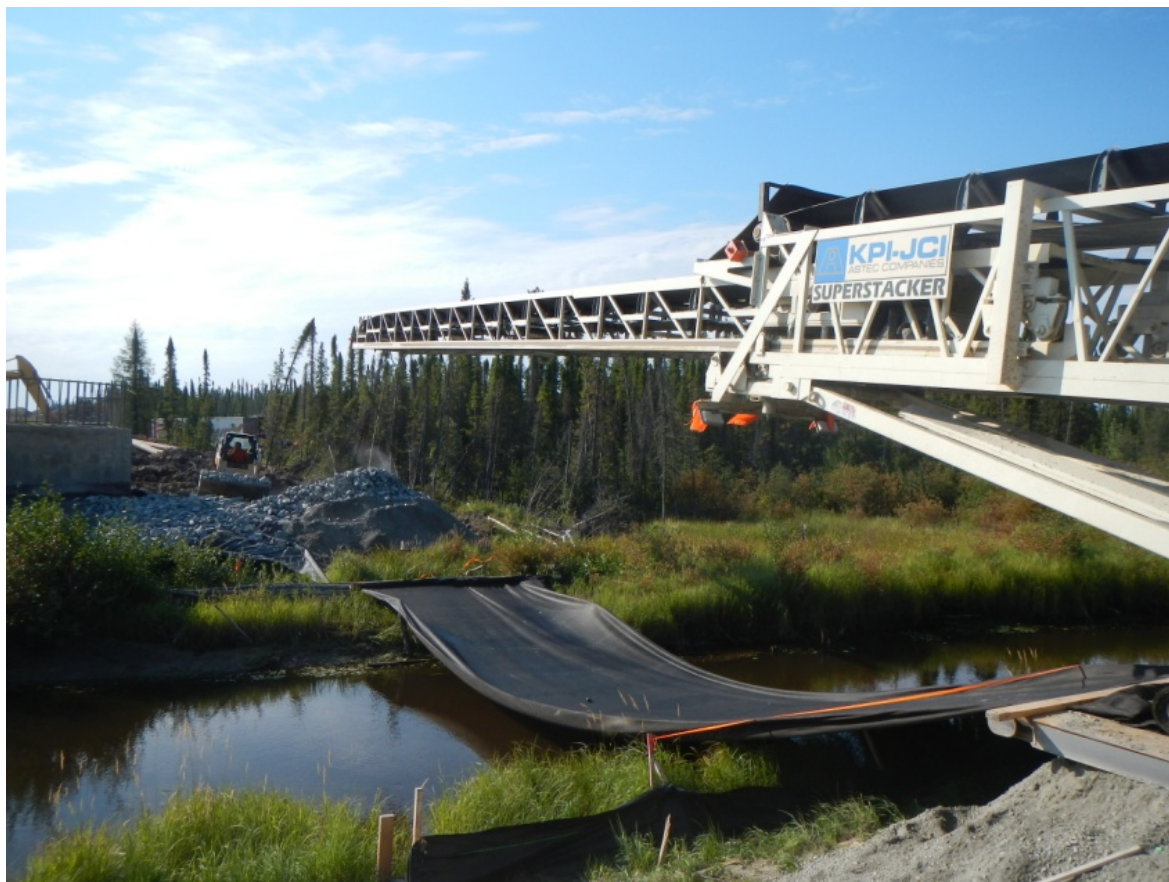
Figure 2. Conveyor belt moving material from the north to south side of Looking Back Creek at the crossing location.

Turbidity monitoring at Looking Back Creek took place on August 10, 12 and 21, 2012. These dates were selected to monitor for effects on water quality caused by construction activities taking place directly over the creek during the open water period. Work over the creek at this time consisted of a conveyor belt moving rock material across the water to construct an abutment on the opposite side (Figure 2). This was the only activity that took place over Looking Back Creek during the open water period. The remainder of the clear span bridge was installed during the winter months, when the creek was covered with ice, so no additional water quality monitoring was carried out.

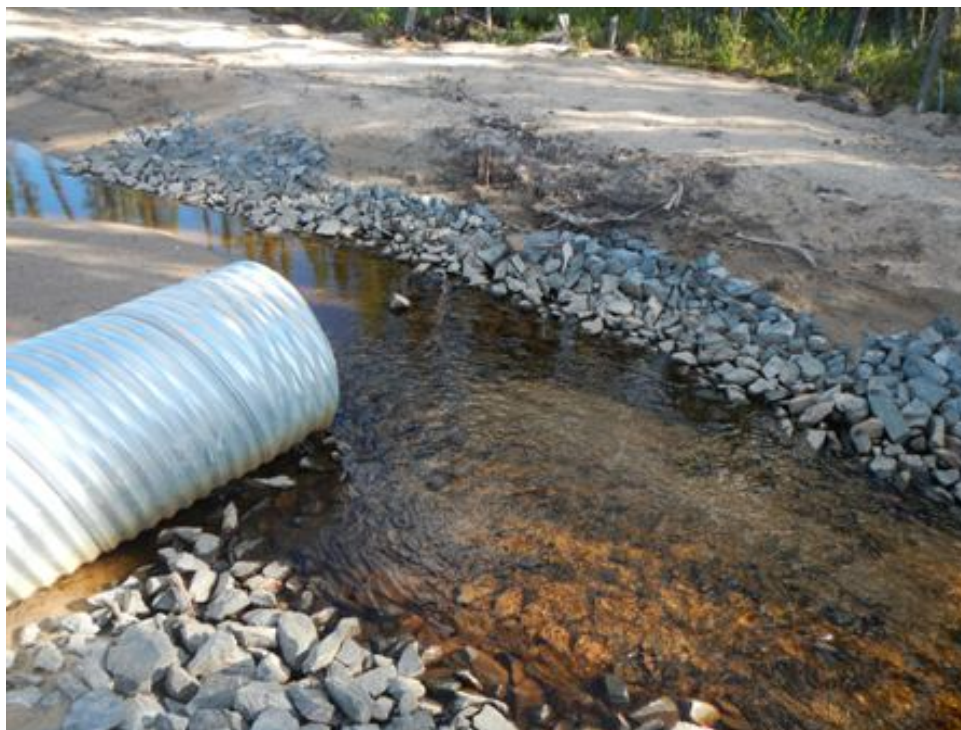
Figure 4. Unnamed tributary flowing through the culvert during construction – rip rap placed to control erosion of material.

Water quality monitoring at the unnamed tributary was conducted on August 9, 12-14, 16-18, 24, 25 and September 2, 2012. During this time, the construction activities being carried out were grading of slopes (ditches) immediately adjacent to the unnamed tributary crossing (Figure 3), and installing rip rap as a measure to prevent erosion and sedimentation in the adjacent ditches (Figure 4). Monitoring in 2012 concluded once the rip rap installation was complete (Figure 5).

A large rain event on August 24 generated sufficient flow to resume turbidity monitoring. After the rain, erosion around the culvert indicated a need for additional erosion control measures to be implemented at this location. The contractor placed rip rap in the ditch and on the banks between August 26 and September 1. During this time, the turbidity in the unnamed tributary was monitored and the results varied (see Table 3 and Table 4). On August 25, an intense rainfall took place in the morning, during sampling. A sediment plume was evident. The site was revisited later that day and the turbidity was much higher as a result of sediment being carried downstream (as high as 84 NTU, 10 m downstream of the culvert). By September 2, all rip rap in the vicinity of the unnamed tributary had been placed. A final round of sampling during a second rainfall event indicated the turbidity did rise through the culvert (56 NTU) but had dropped back down to the baseline turbidity levels measured upstream (1.06 NTU) 30 m downstream from the culvert. This indicated the rip rap placed along the unnamed tributary and in the ditches was effective in preventing additional erosion. No further turbidity monitoring was conducted in 2012.

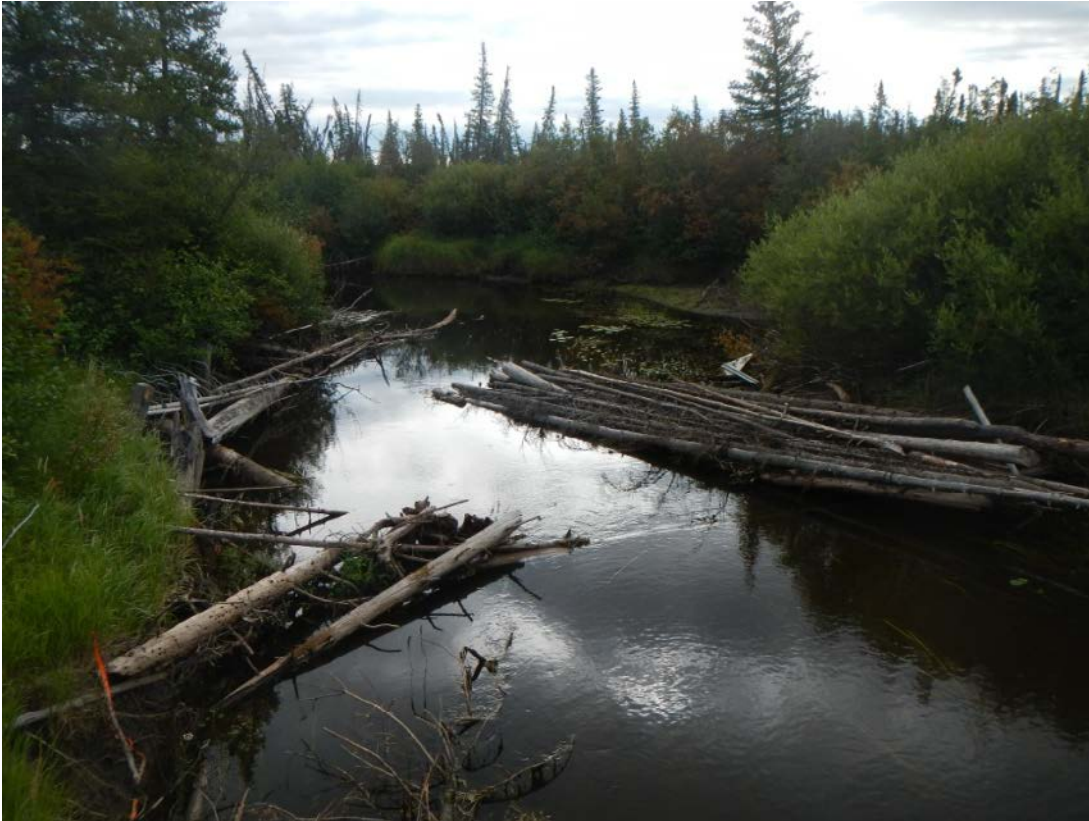
Figure 6. Debris in Looking Back Creek downstream from the crossing site.
