Keeyask Infrastructure Project

Terrestrial and Aquatic Monitoring Plan

Water Quality Monitoring

Annual Report 2012-2013

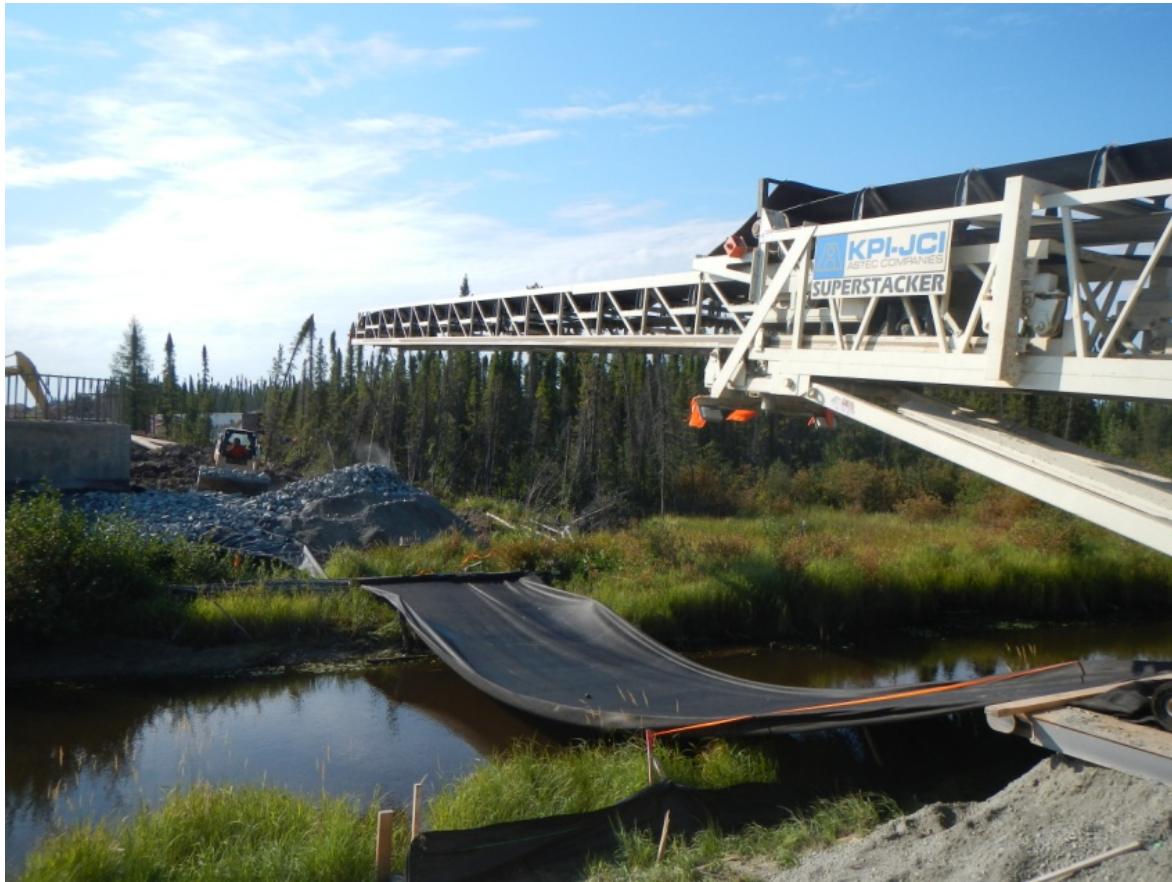
Turbidity monitoring at Looking Back Creek took place on August 10, 12 and 21, 2012. These dates were selected to monitor for effects on water quality caused by construction activities taking place directly over the creek during the open water period. Work over the creek at this time consisted of a conveyor belt moving rock material across the water to construct an abutment on the opposite side (Figure 2). This was the only activity that took place over Looking Back Creek during the open water period. The remainder of the clear span bridge was installed during the winter months, when the creek was covered with ice, so no additional water quality monitoring was carried out.

Figure 2. Conveyor belt moving material from the north to south side of Looking Back Creek at the crossing location.

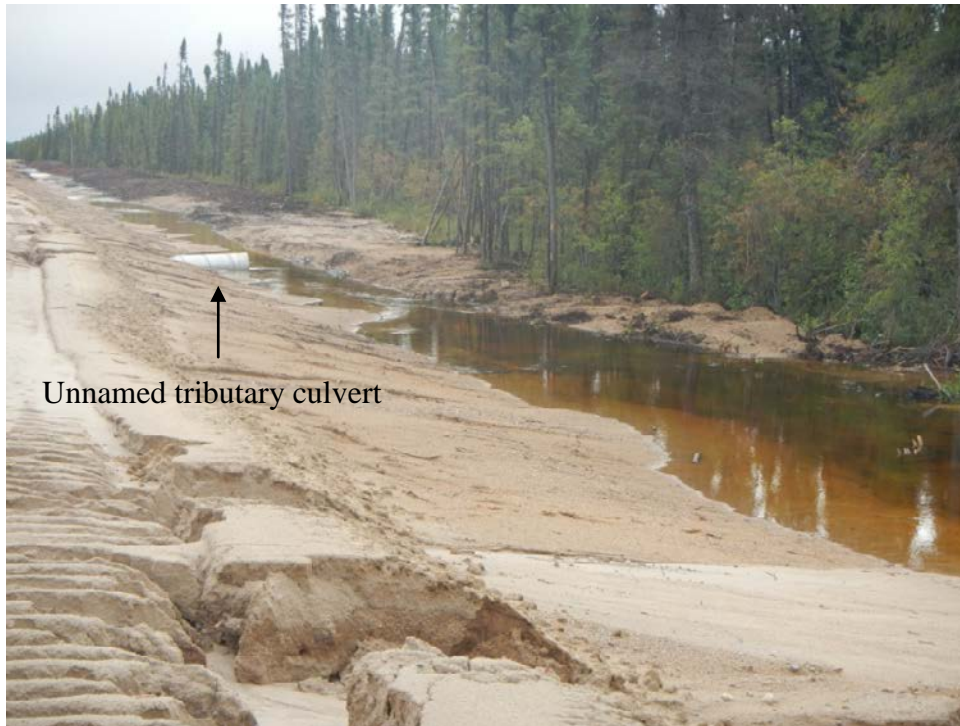
Water quality monitoring at the unnamed tributary was conducted on August 9, 12-14, 16-18, 24, 25 and September 2, 2012. During this time, the construction activities being carried out were grading of slopes (ditches) immediately adjacent to the unnamed tributary crossing (Figure 3), and installing rip rap as a measure to prevent erosion and sedimentation in the adjacent ditches (Figure 4). Monitoring in 2012 concluded once the rip rap installation was complete (Figure 5).

Figure 3. Area in vicinity of the culvert crossing during construction.

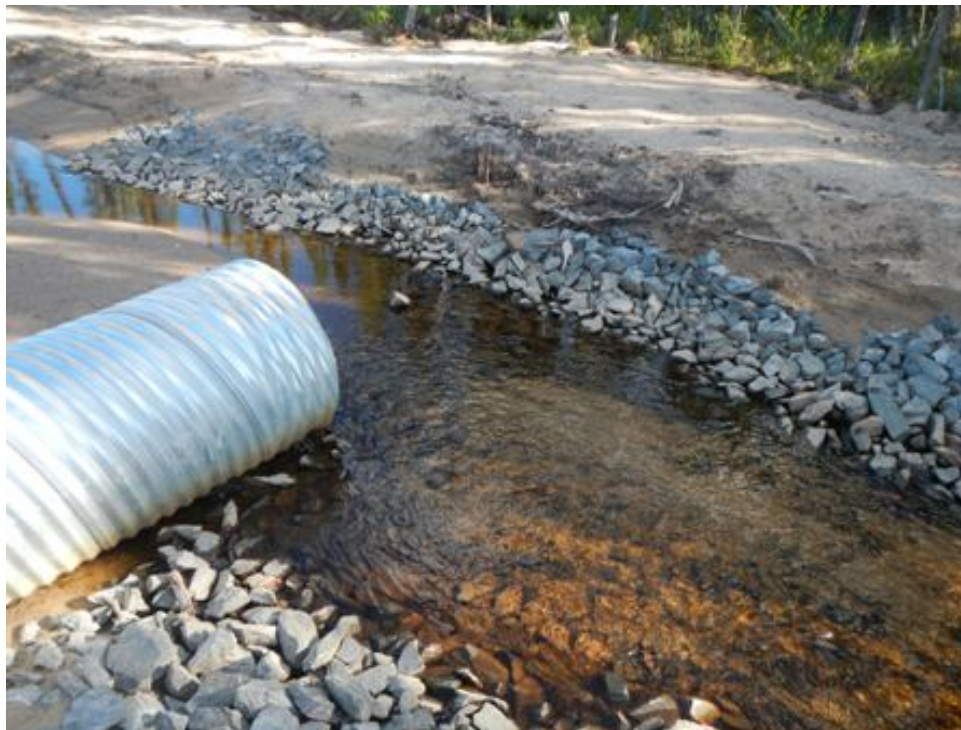
Figure 4. Unnamed tributary flowing through the culvert during construction – rip rap placed to control erosion of material.

A large rain event on August 24 generated sufficient flow to resume turbidity monitoring. After the rain, erosion around the culvert indicated a need for additional erosion control measures to be implemented at this location. The contractor placed rip rap in the ditch and on the banks between August 26 and September 1. During this time, the turbidity in the unnamed tributary was monitored and the results varied (see Table 3 and Table 4). On August 25, an intense rainfall took place in the morning, during sampling. A sediment plume was evident. The site was revisited later that day and the turbidity was much higher as a result of sediment being carried downstream (as high as 84 NTU, 10 m downstream of the culvert). By September 2, all rip rap in the vicinity of the unnamed tributary had been placed. A final round of sampling during a second rainfall event indicated the turbidity did rise through the culvert (56 NTU) but had dropped back down to the baseline turbidity levels measured upstream (1.06 NTU) 30 m downstream from the culvert. This indicated the rip rap placed along the unnamed tributary and in the ditches was effective in preventing additional erosion. No further turbidity monitoring was conducted in 2012.

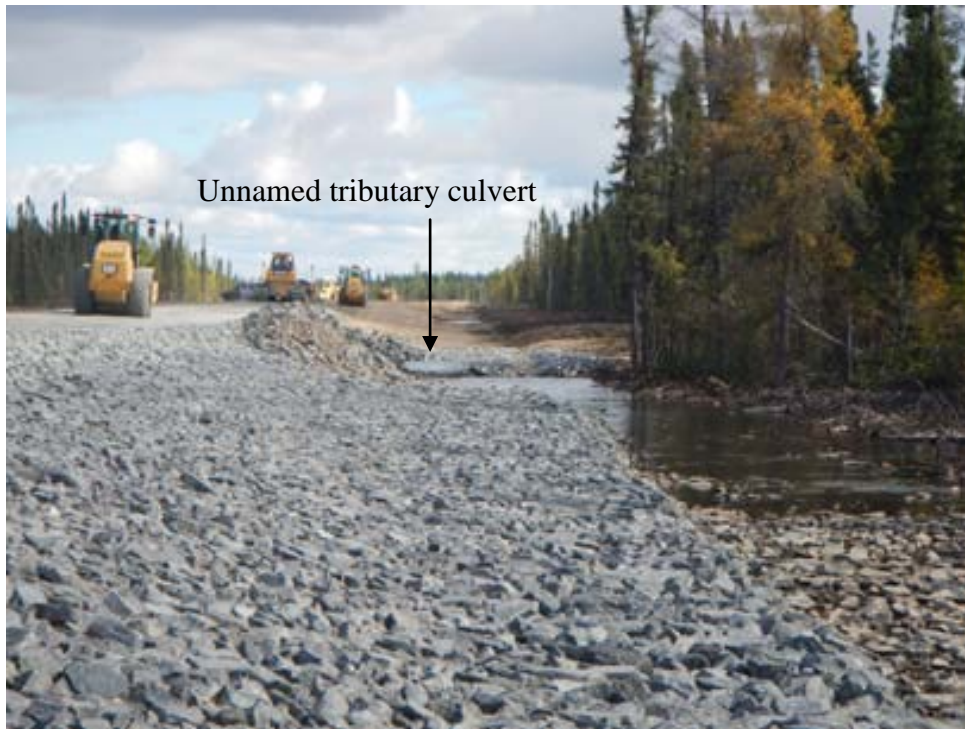
Figure 5. Erosion control (rip rap) complete along ditches and banks of the unnamed tributary.

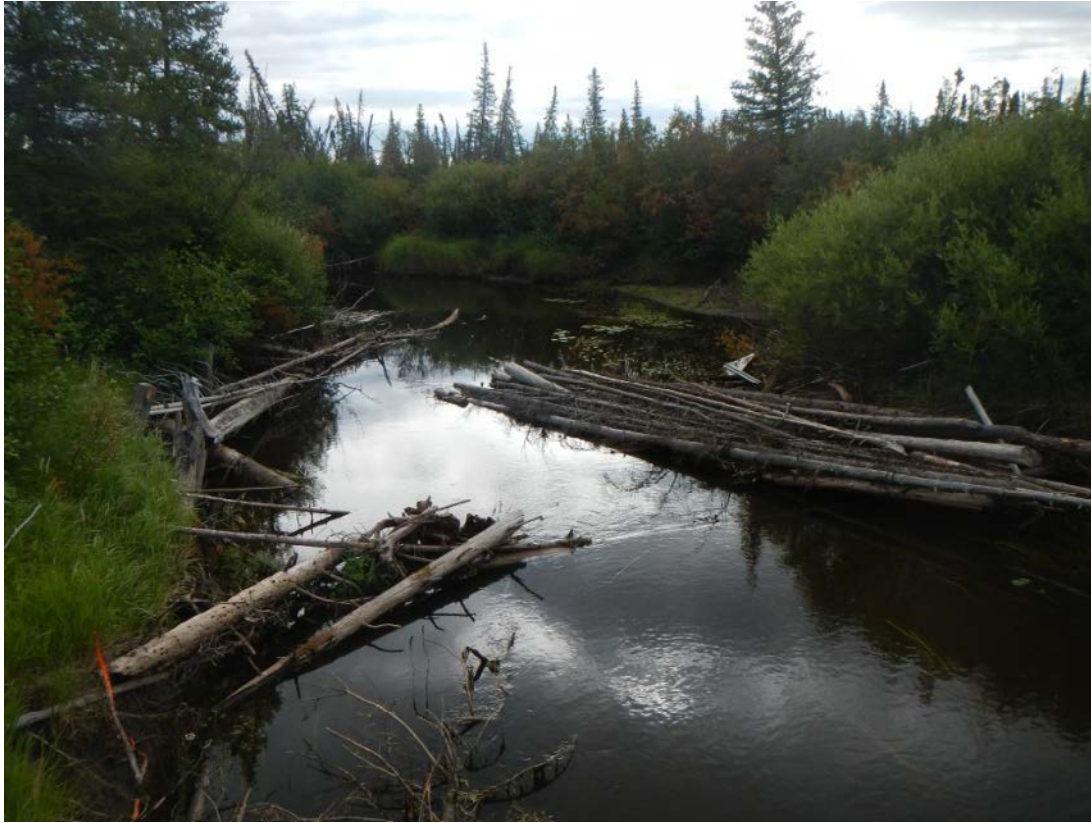
unsafe to access the area near the creek. Sampling immediately downstream of the bridge site was taken via the pedestrian bridge; however, further areas downstream were not entirely accessible by foot, particularly the 100m downstream transect, which required the use a canoe.

Figure 6. Debris in Looking Back Creek downstream from the crossing site.
