The Keeyask Hydropower Limited Partnership (KHLP) is constructing the Keeyask Infrastructure Project (the Project or KIP). The Project is located approximately 40 km southwest of Gillam, extending between Provincial Road (PR) 280 and Gull Rapids on the Nelson River. The Project includes a start-up camp and associated infrastructure, a 25 km all-weather access road and the first phase of a main camp (see Map 1).

As stated in the EnvPP, an annual report will be produced on the compliance monitoring undertaken in connection with the construction of the Project. Manitoba Hydro will report on the status and results of the monitoring in connection with this EnvPP to Manitoba Conservation and Water Stewardship. This report covers the period April 1, 2013 to March 31, 2014.

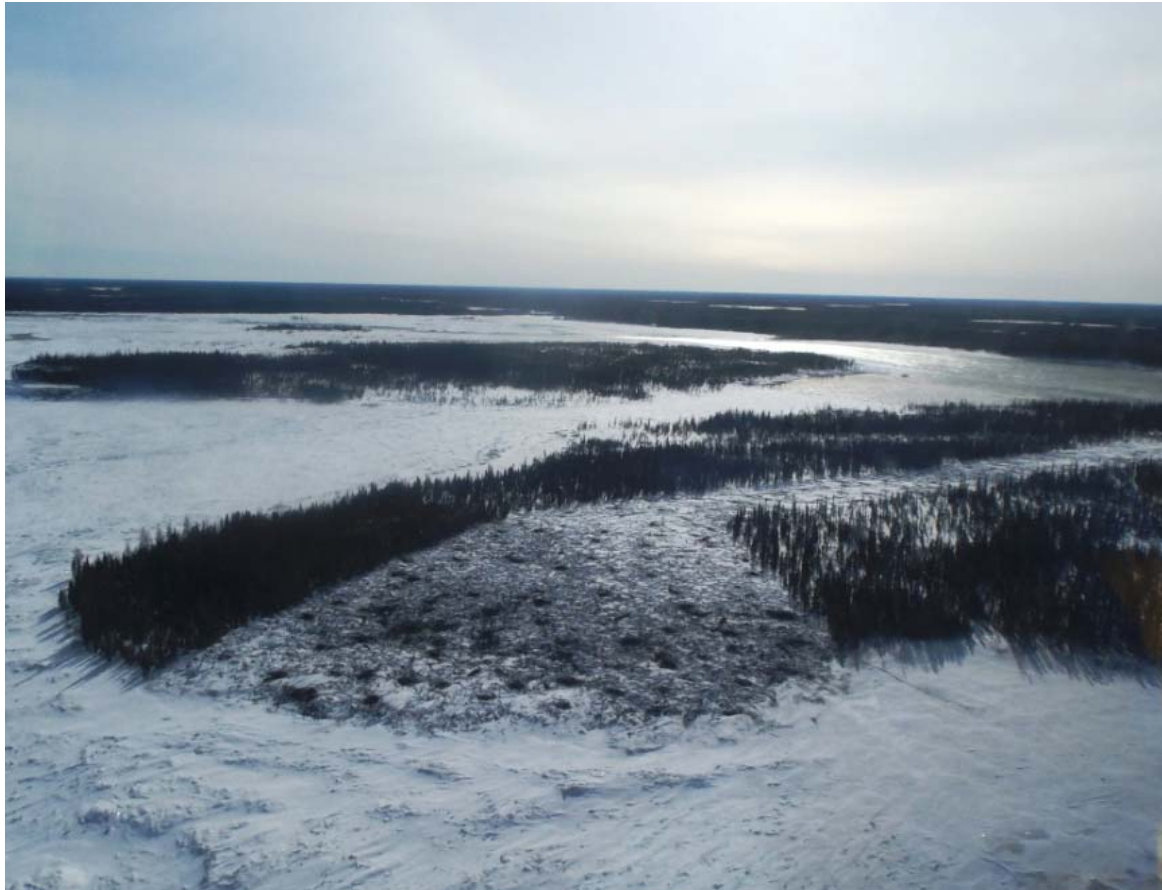
Approximately 31 hectares of land was cleared during the reporting period. All clearing occurred between September 1 and March 31 to avoid impacts to breeding birds. Work included hand clearing in sensitive areas and machine clearing of all other areas (Figure 1). All material was piled in situ and burned (Figure 2).

Figure 1: Example of an area cleared at site.

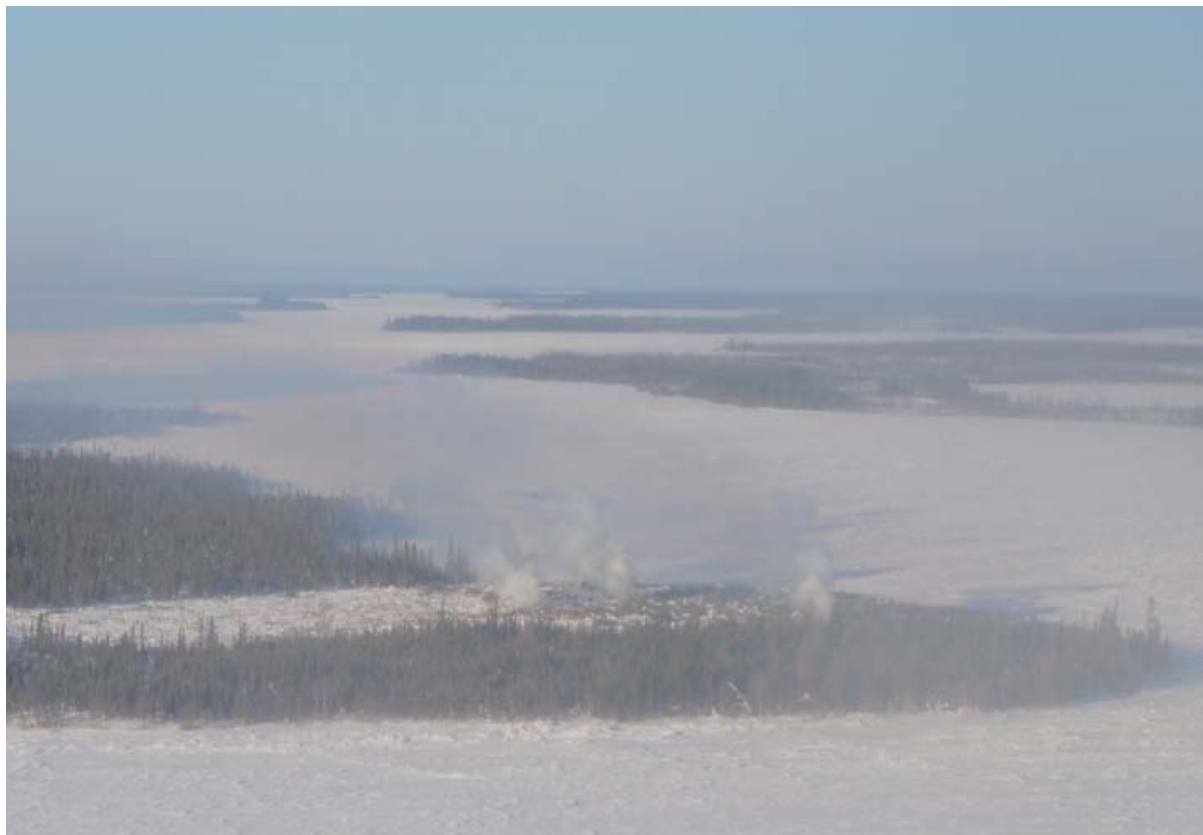
Figure 2: Burning of cleared debris.

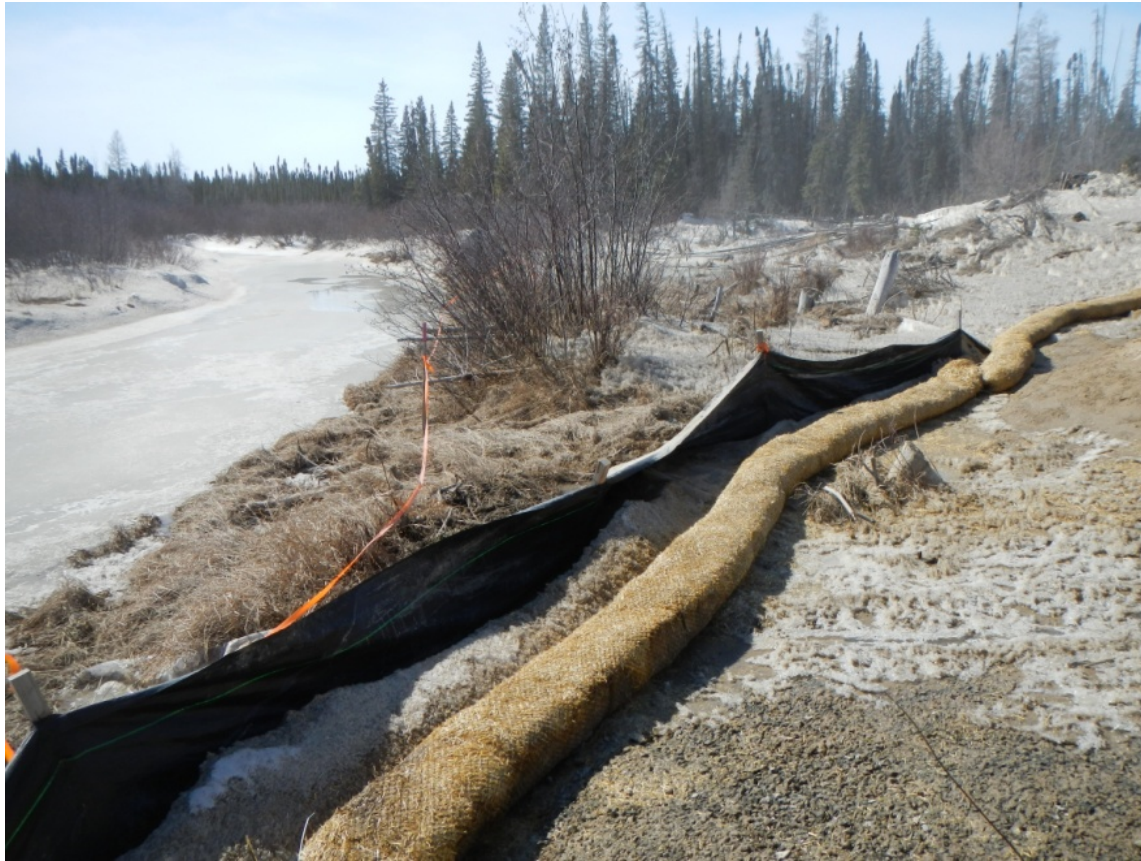
Straw rolls were placed along the existing sediment fence and rip rap at Looking Back Creek Bridge as an extra layer of protection, to mitigate sediment from entering the creek in the event of heavy rain (Figure 3).

Figure 3: Straw rolls installed at Looking Back Creek.

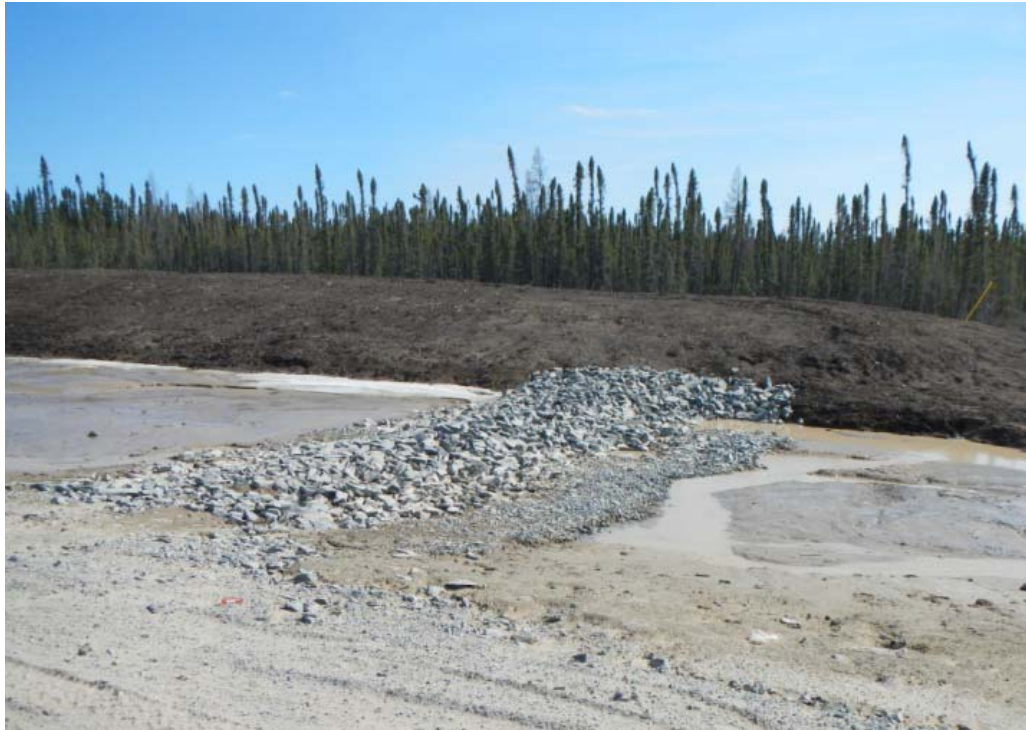
Rip rap is an effective measure for erosion control. It was placed at the entrance and exits to culverts and ditch checks (Figure 4) along the road in areas that were prone to erosion during large rain events, and also used along embankment at Looking Back Creek (Figure 5), which will reduce erosion.

Figure 4: A ditch check along the access road.

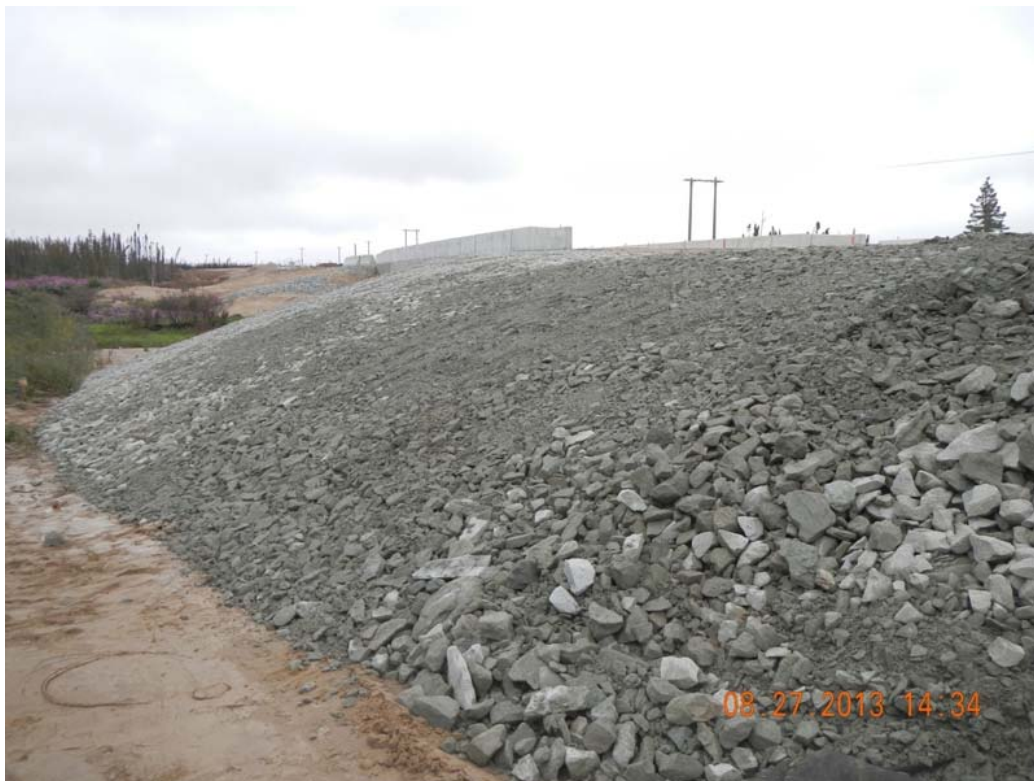
Figure 5: Rip rap on the embankment approaching Looking Back Creek.

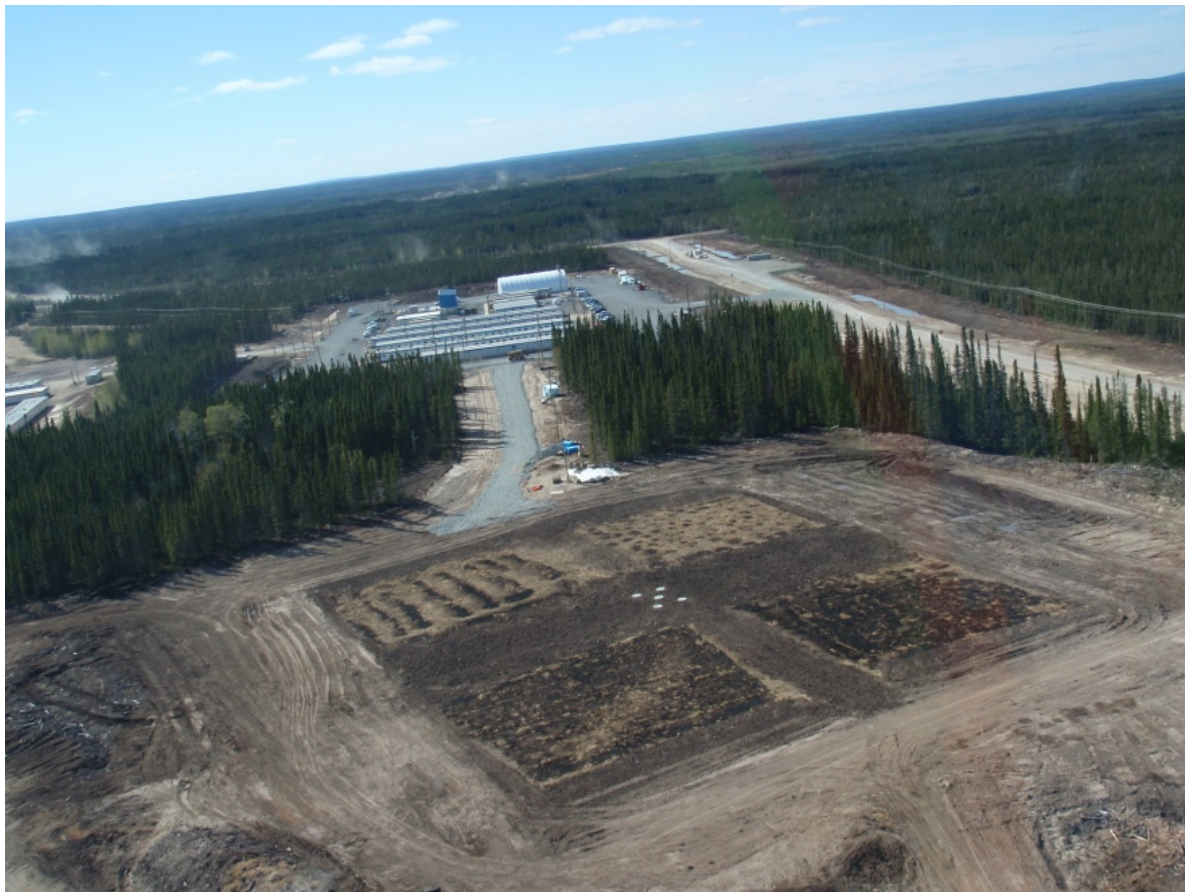
Final grading of the wastewater drain field (Figure 6) was completed and an access road was constructed to the drain field from the start-up camp.

Figure 6: Start-up camp wastewater drain field.
