# Keeyask Infrastructure Project

## Terrestrial and Aquatic Monitoring Plan

### **Water Quality: Annual Report 2014 - 2015**

**December 2015**

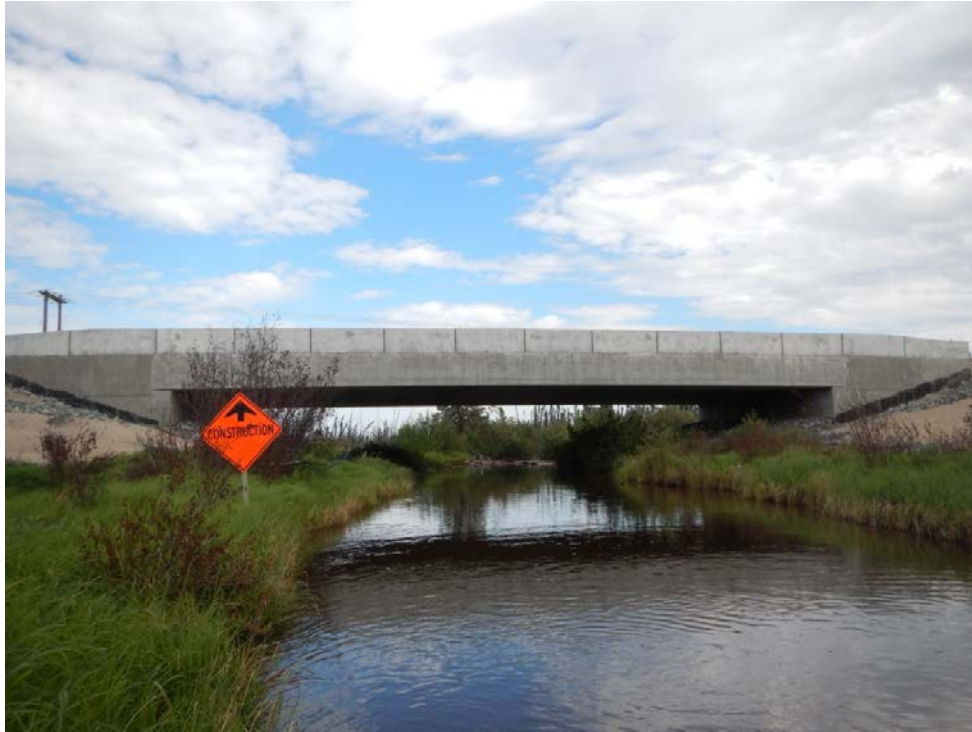
**Figure 1:** Clear-span bridge over Looking Back Creek.

A permanent clear-span bridge was constructed over Looking Back Creek during 2012/early 2013 (Figure 2) and a culvert was installed in the Unnamed Tributary in early 2012 (Figure 3). Monitoring conducted in 2014 represents the second and final year of post-construction water quality monitoring; the program is designed to determine if there are any differences in water quality upstream versus downstream of each of the road crossings. The water quality monitoring program is focussed on measurement of turbidity and total suspended solids (TSS) but also includes monitoring for nutrients during one sampling event.

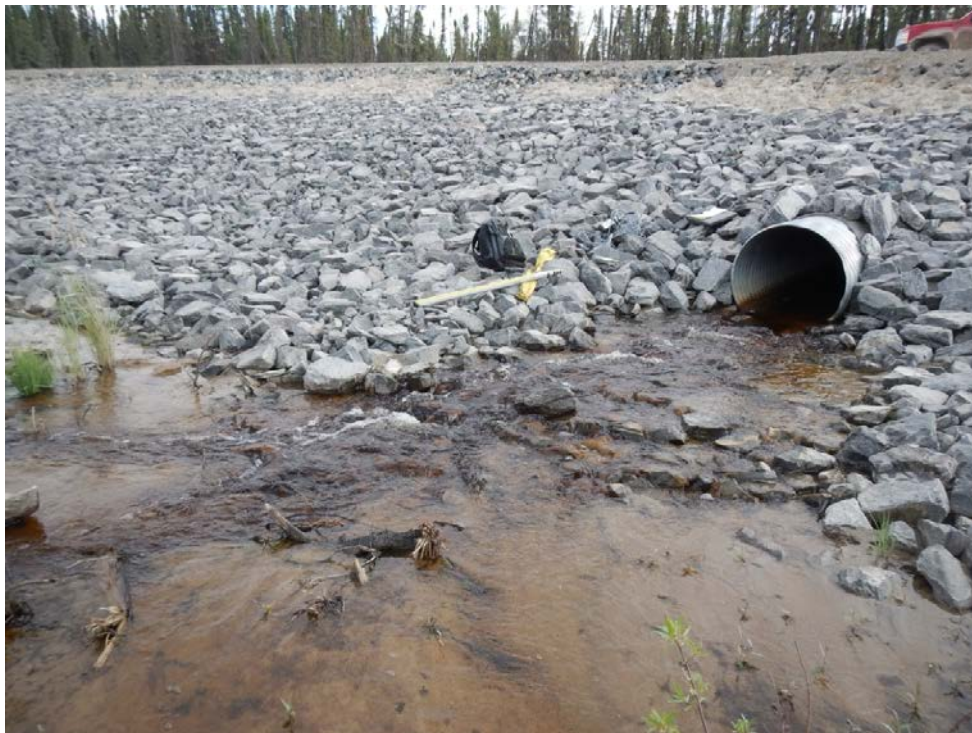
**Figure 2:** Road crossing for the Unnamed Tributary.

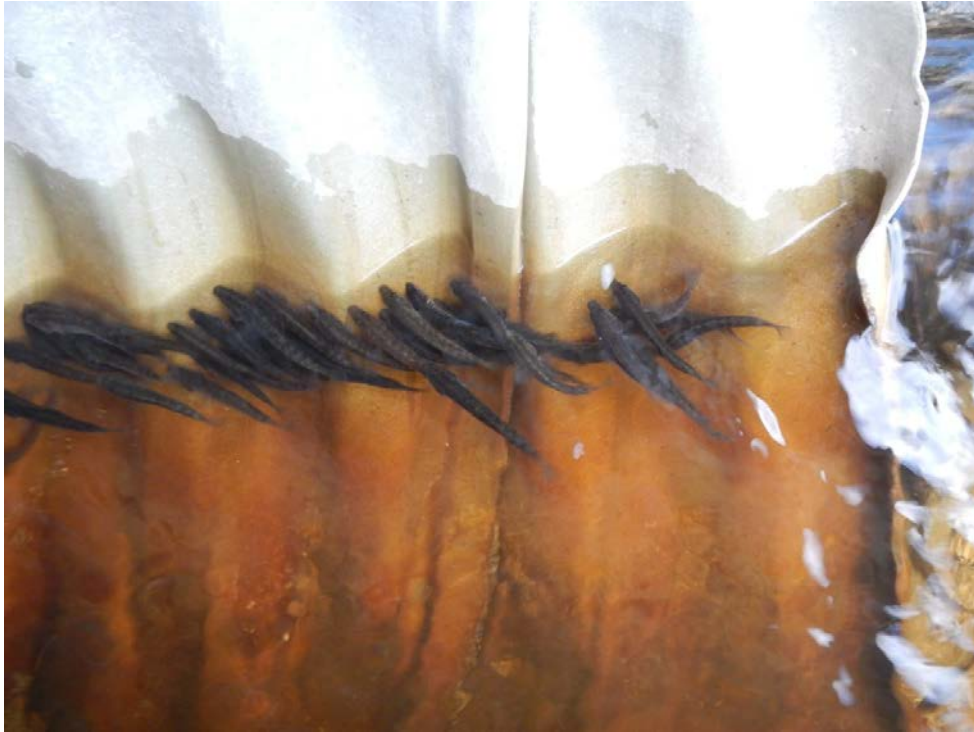
**Figure 3: Brook Stickleback in the culvert at the Unnamed Tributary on August 20, 2013.**

The Department of Fisheries and Oceans Canada deemed the installation of a culvert at the Unnamed Tributary to be of low risk to fish and fish habitat and no fish were observed in surveys conducted prior to 2013. During one sampling period in 2013 and 2014 (June), Brook Stickleback (*Culaea inconstans*; Figure 4) and small Northern Pike were observed at the crossing.
