Peatland Disintegration and Erosion in the Eastern Upstream Reaches During First 30 Years of Operation

PE - 7

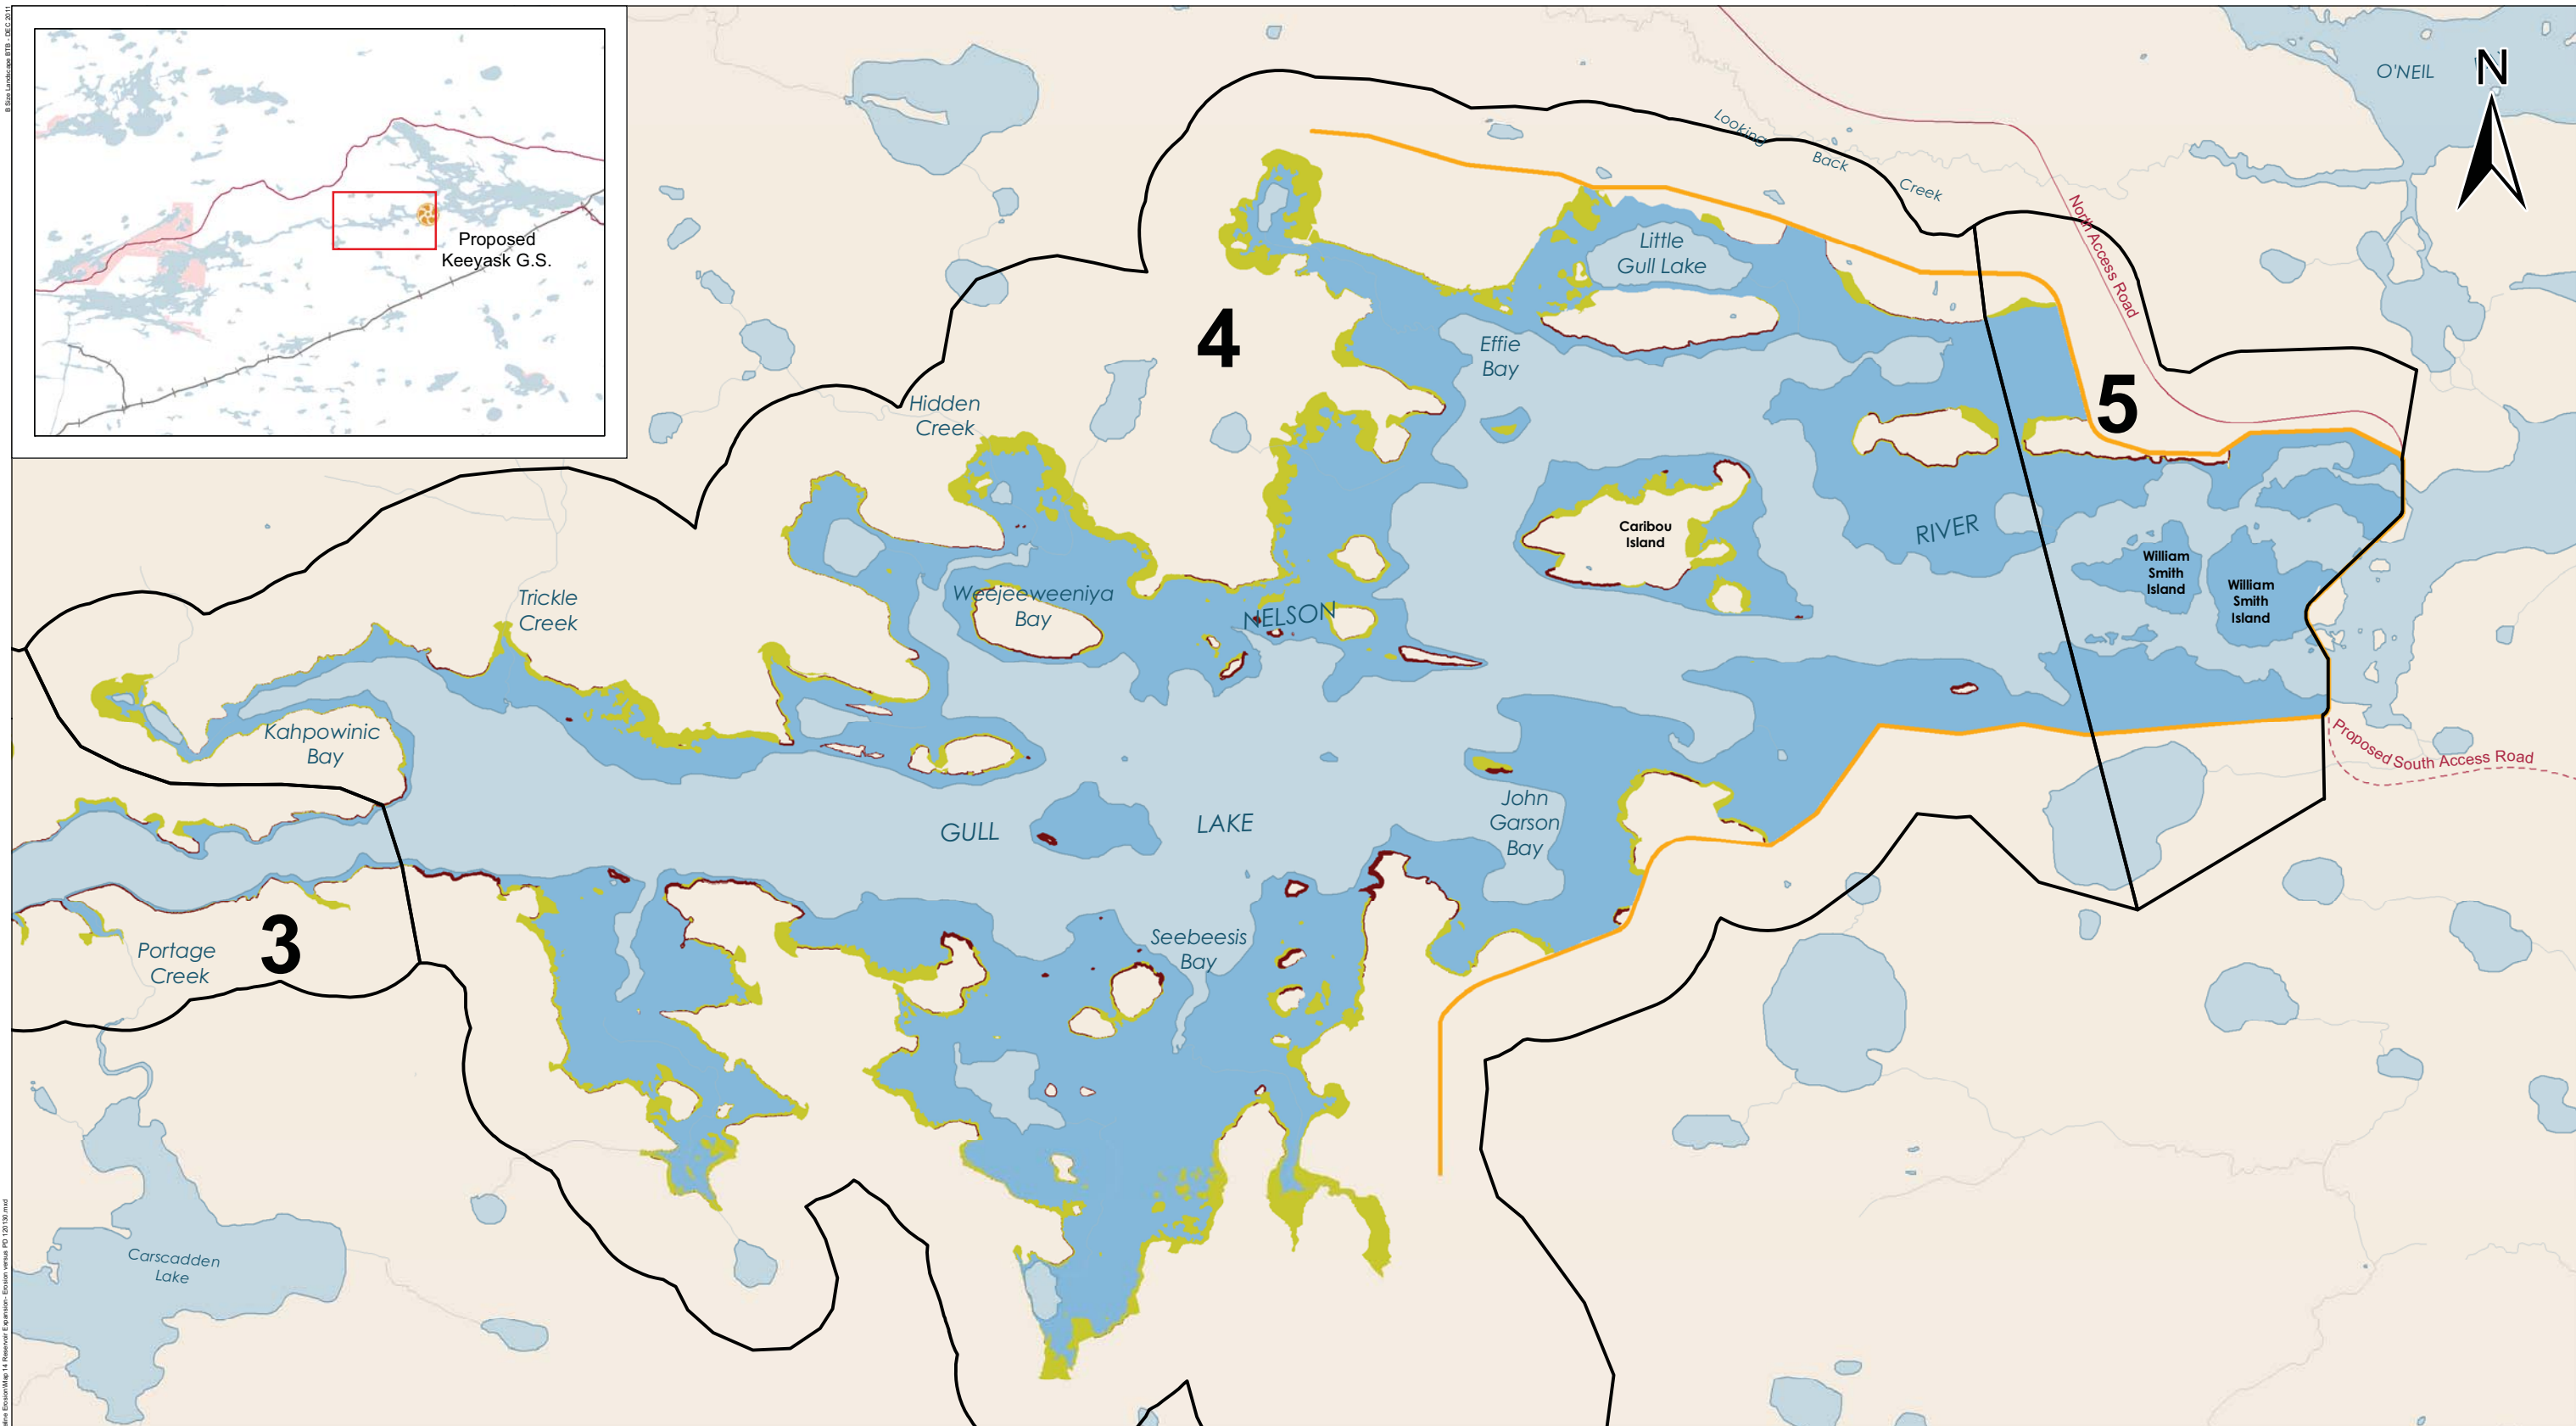
Existing Water Surface Area	Initial Flooded Area (159 m)
Peatland Disintegration	Mineral Bank Erosion

3 = Riverine Shore Zones Downstream of Birthday Rapids to the Inlet of Gull Lake	5 = Riverine Shore Zones at Gull Rapids
4 = Lake Shore Zones in Gull Lake
