Keeyask Generation Project Physical Environment Monitoring Plan

REPORT #PEMP-2015-01

2014 – 2015 Physical Environment Monitoring Report: Year 1 Construction

Prepared for
Manitoba Hydro

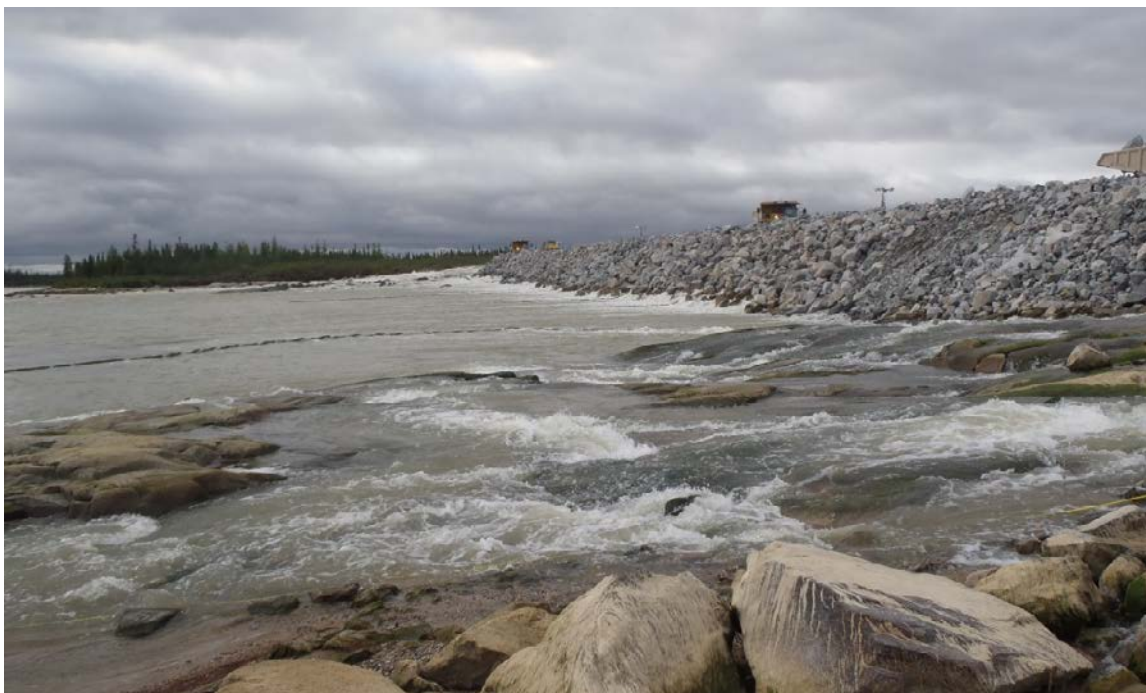
North channel rock groin under construction, August 2015

River diversion measures were implemented to divert water from construction areas in Gull Rapids. Construction of the north channel rock groin near the head of Gull Rapids diverted most of the flow to the south channel of Gull Rapids and caused an increase in upstream water levels. The water level in Gull Lake at the gauge at Caribou Island increased by approximately 1.3 metres (m) (4.3 feet). The amount of water level change due to this groin diminished in the upstream direction and caused no change in water levels at the gauge just downstream of Birthday Rapids and thus had no effects on levels further upstream. The observed water level increases were consistent with the predicted increases due to the north channel rock groin.

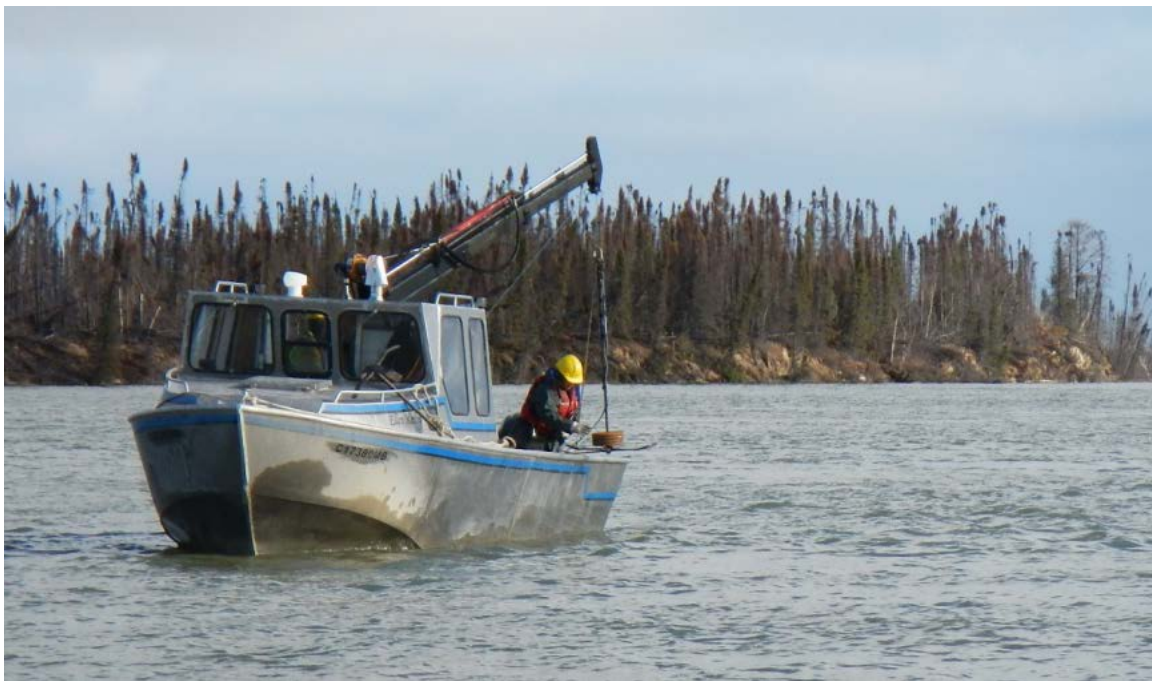
Placing a turbidity sensor at a monitoring site

Turbidity monitoring is done with a turbidity sensor that is placed into the water that measures the murkiness of the water. It is a convenient parameter to monitor as the data can be collected on an automated, continuous basis without collecting samples for laboratory analysis.

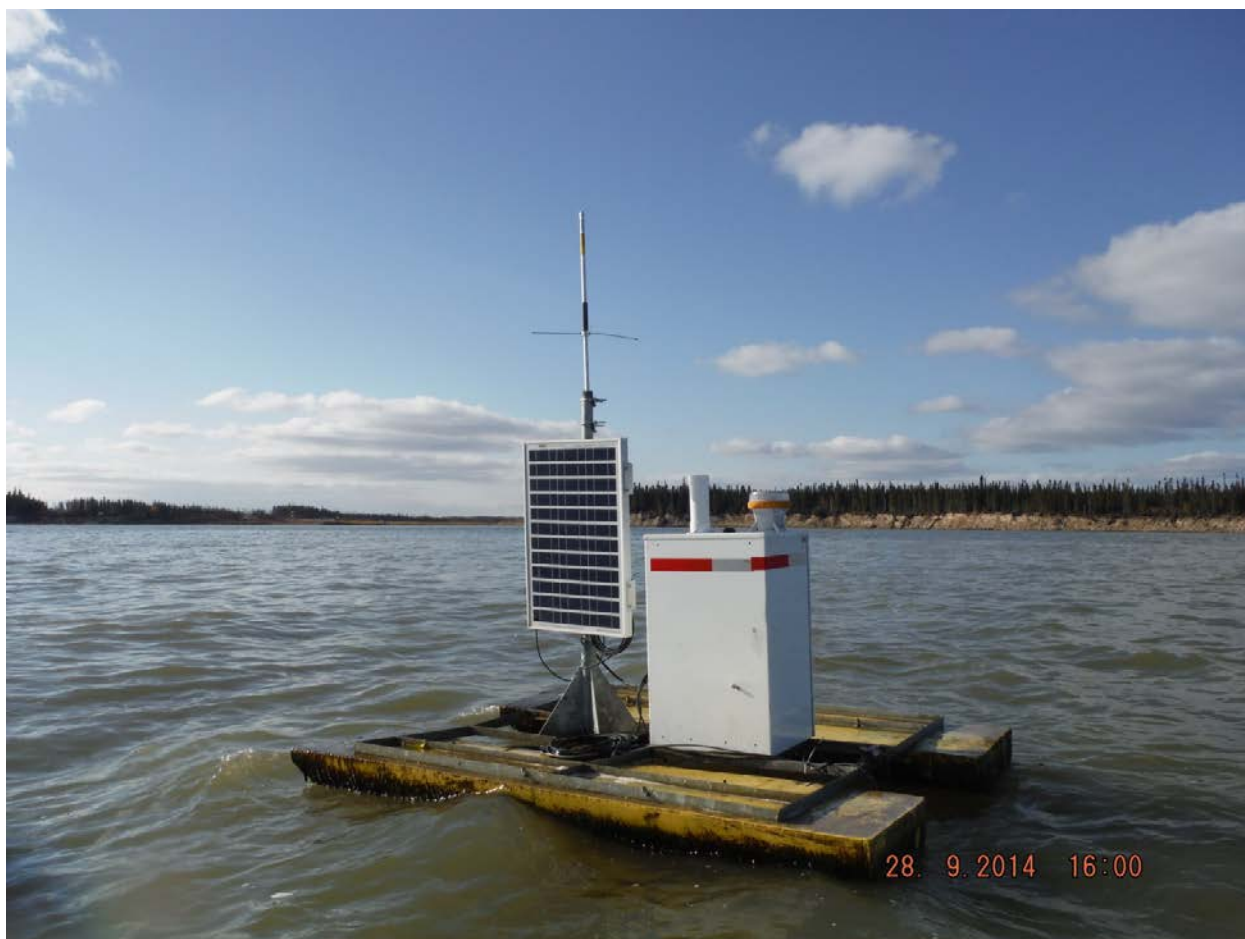
Continuous turbidity monitoring site – turbidity sensors suspended below catamaran that supports solar power panel and electronics housing

Between Clark Lake and the Kettle GS, continuous turbidity meters were installed at five locations in summer and three locations in winter. Sediment traps were also placed at two locations to monitor deposition in the waterway while two additional sites were monitored to obtain samples of sediment moving along the bottom of the river. No effects on sediment transport were observed in the summer period of 2014.

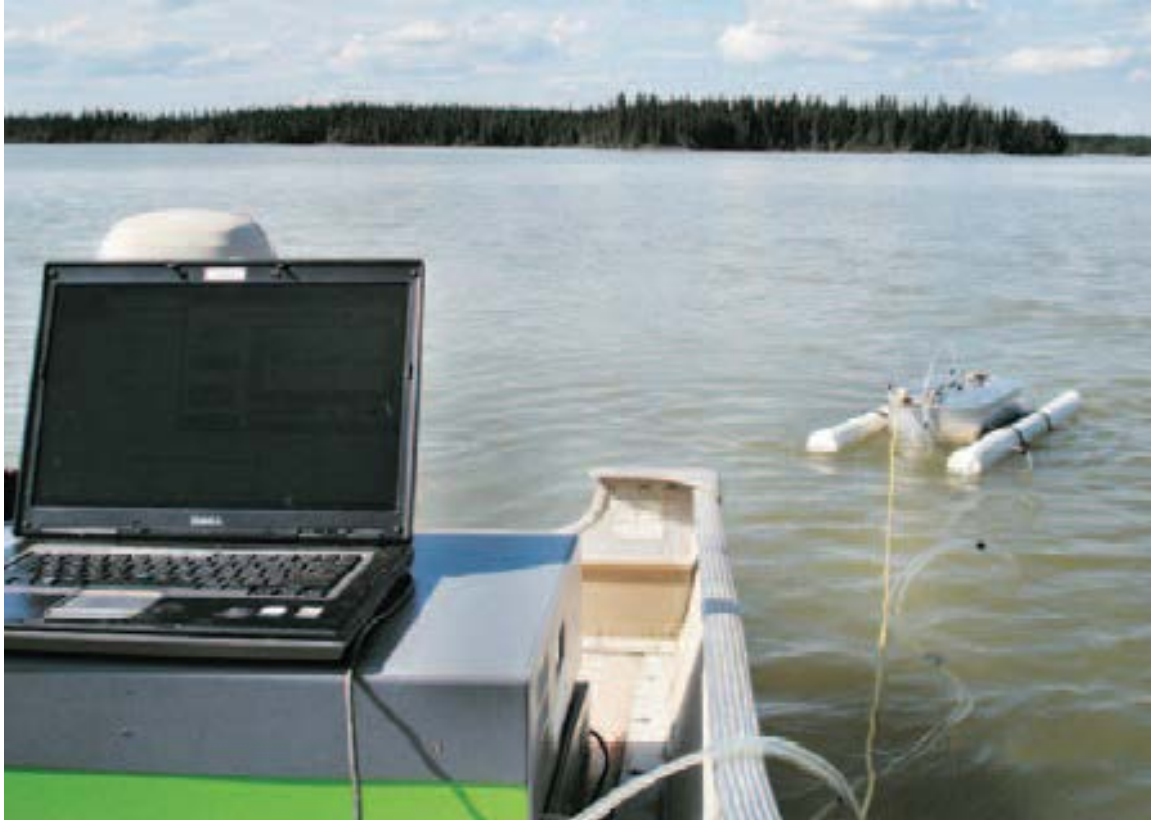
Emission of greenhouse gases, primarily carbon dioxide and methane, were monitored in the waterway to confirm the amount of greenhouse gas emissions from the water prior to flooding. Monitoring results showed that emissions levels in 2014/15 were similar to emissions observed in previous years.

Measuring greenhouse gas emissions

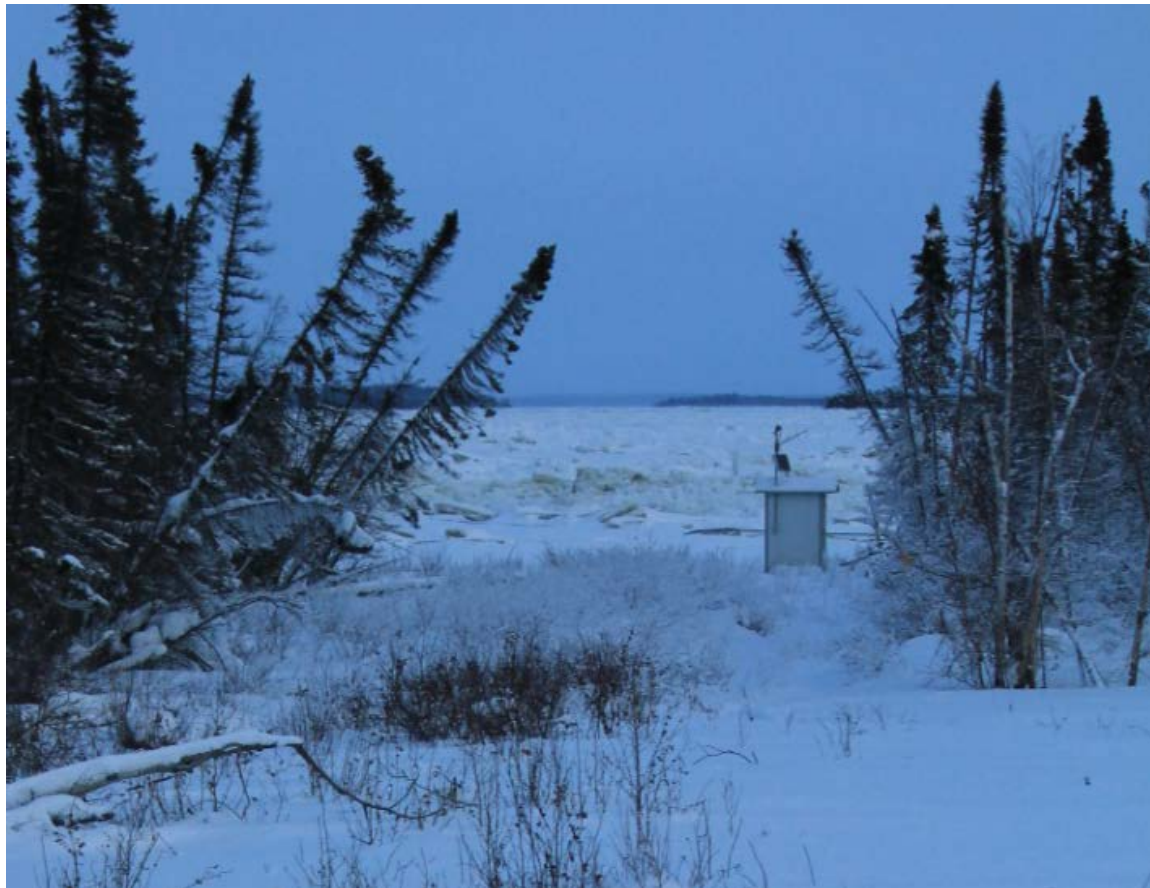
**Photo 1: Water Level Gauge Station in Winter**

Water levels have been monitored at six sites in the study area from Clark Lake to Gull Rapids (Table 1, Map 2). A typical water level gauge is shown in Photo 1. The two Clark Lake sites have been monitored regularly since 2003, while the Gull Lake gauge was installed at the start of construction in mid July. The other three sites were installed once the necessary permits and heritage surveys were complete, which were applied for and done after the environment act licence was received in early July.

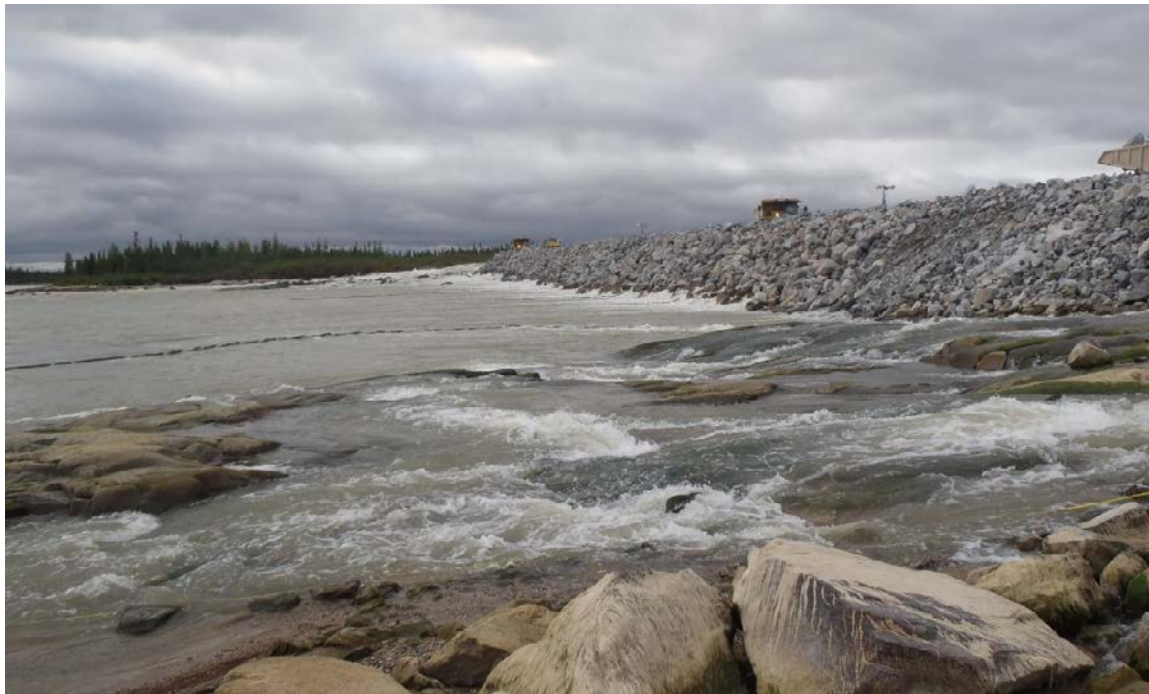
Photo 2: Construction of the North Channel Rock Groin

Construction of the north channel rock groin began on August 5 by placing rock in the river and by August 29 rock had been placed across the channel to the north shore of the central island (Photo 2). This rock groin caused most of the flow to be diverted to the south channel of Gull Rapids. Some water seeps through the groin because it is not designed to be sealed.

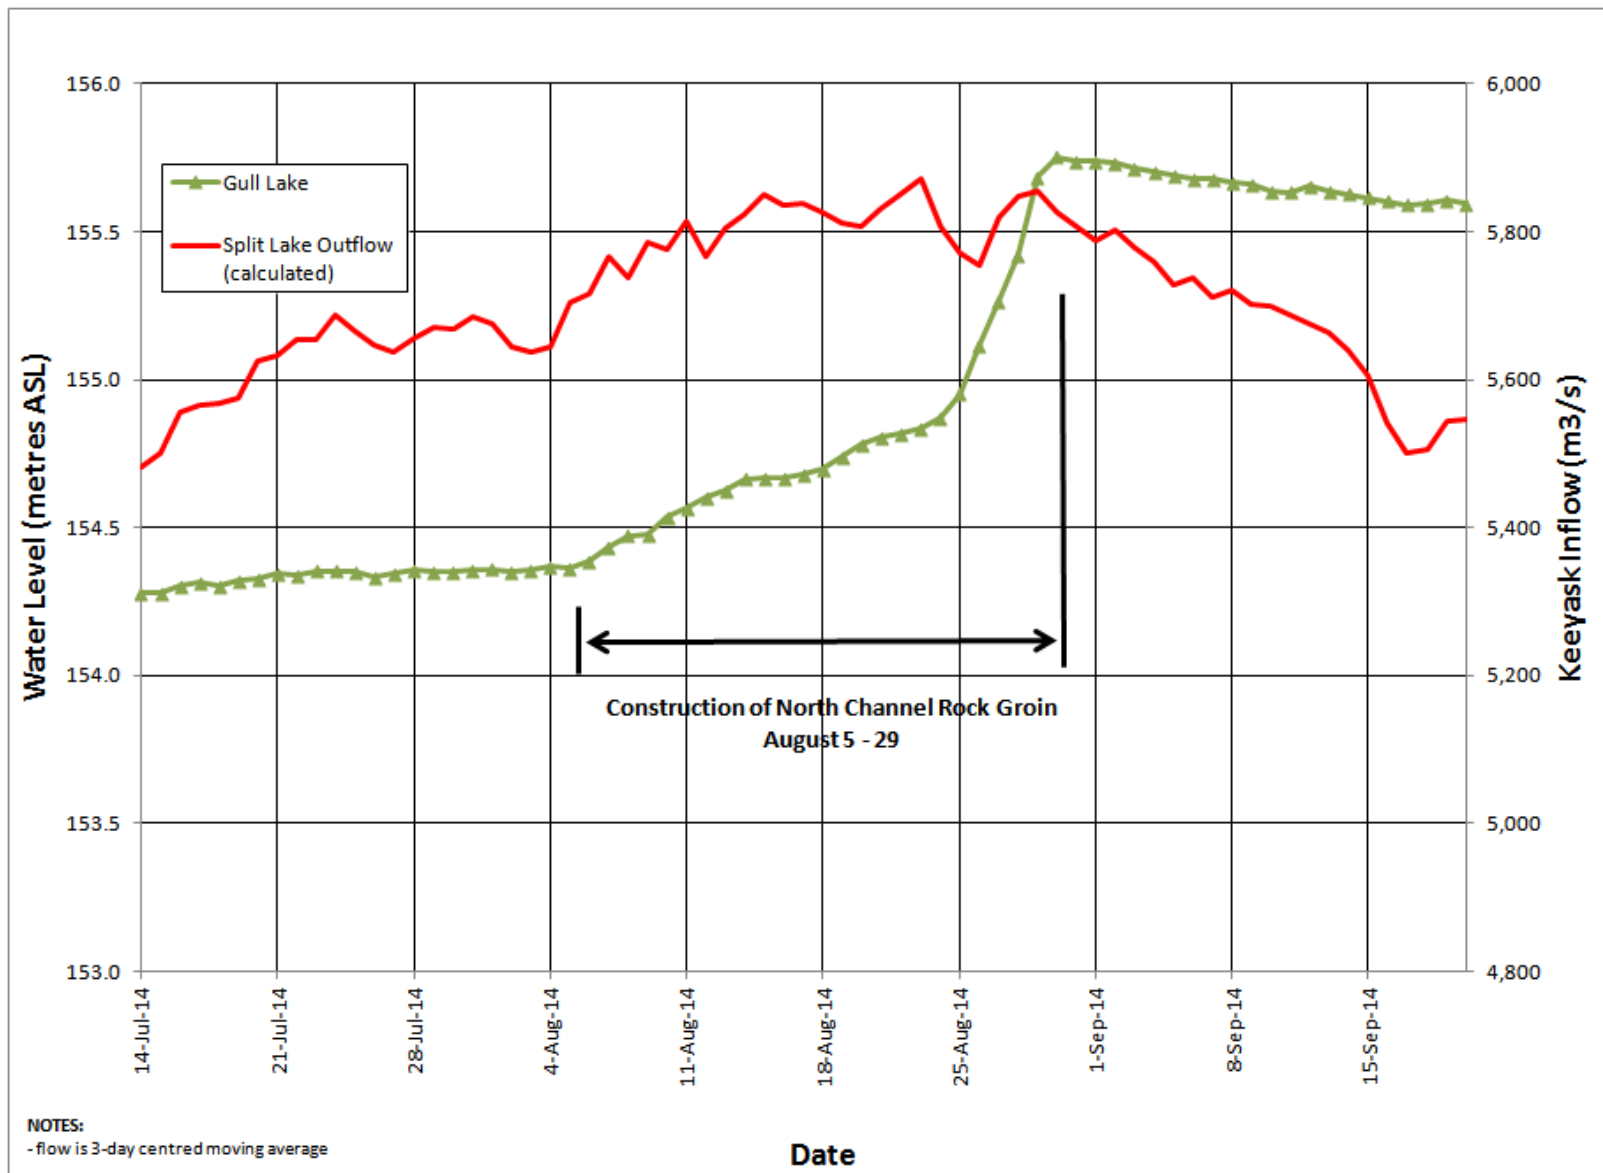
Figure 3: Gull Lake Water Level Increase during Construction of North Channel Rock Groin

Gull Lake levels gradually increased from about August 5-18 with increasing flow and in-stream rock placement (Figure 3). From about August 18-23 levels continued to rise due to rock placement while flows are steady. From about August 24-29 there is a steeper increase in Gull Lake level as the rock groin neared the opposite shore and finally closed the channel. Water level increased approximately 1.5 m from August 5-29 due to the flow increase and groin construction (Figure 3). The Gull Lake water level at a flow of about 5,400 m³/s on October 5 is approximately 1.3 m higher than the level before construction on July 14 at roughly the same flow. The observed water level increases were consistent with the predicted increases.

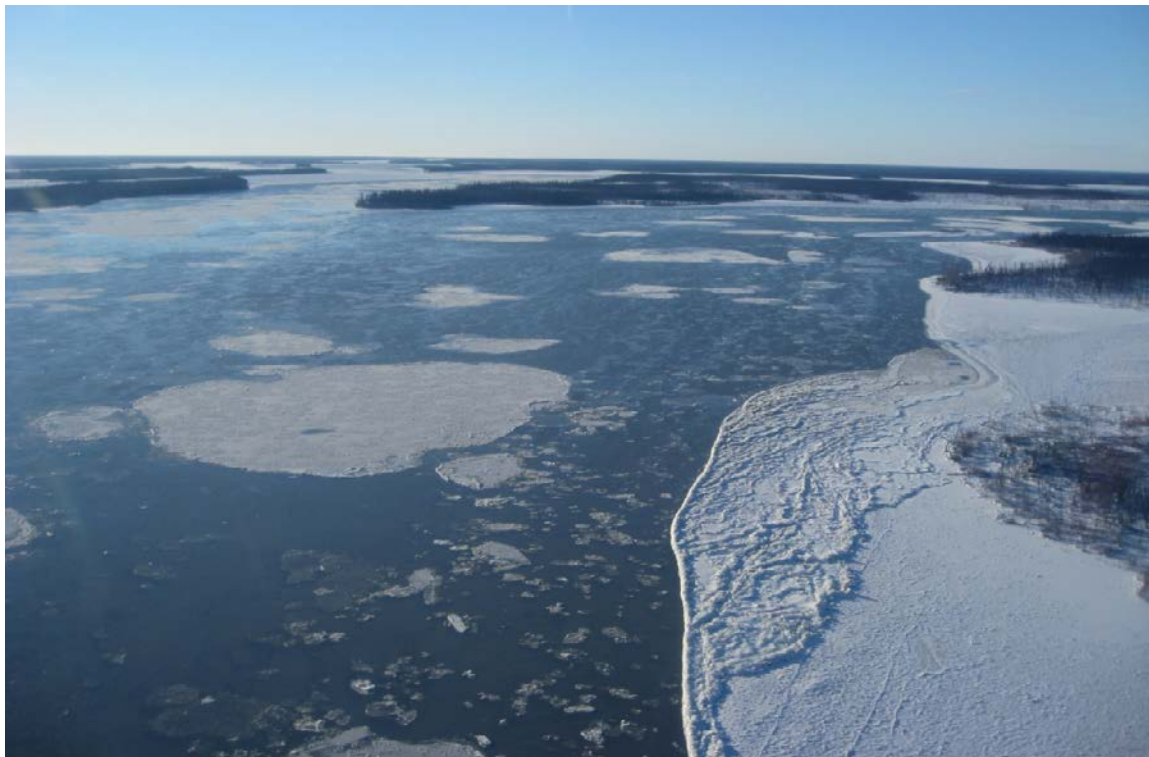
Photo 3: Ice Pans Flowing Down the Nelson River

An ice cover develops in an upstream direction once larger ice pans jam up and form an ice bridge across the central open water channel between the border ice on opposite shorelines (Photo 3). It was anticipated that each winter during construction an ice cover would develop between the head of Gull Rapids to at least Birthday Rapids due to the installation of an ice-boom across the river just upstream of Gull Rapids. The ice boom was designed to create an ice bridge early in the winter that would force an upstream ice cover to develop even at high flows. A full ice cover is shown in Photo 4.

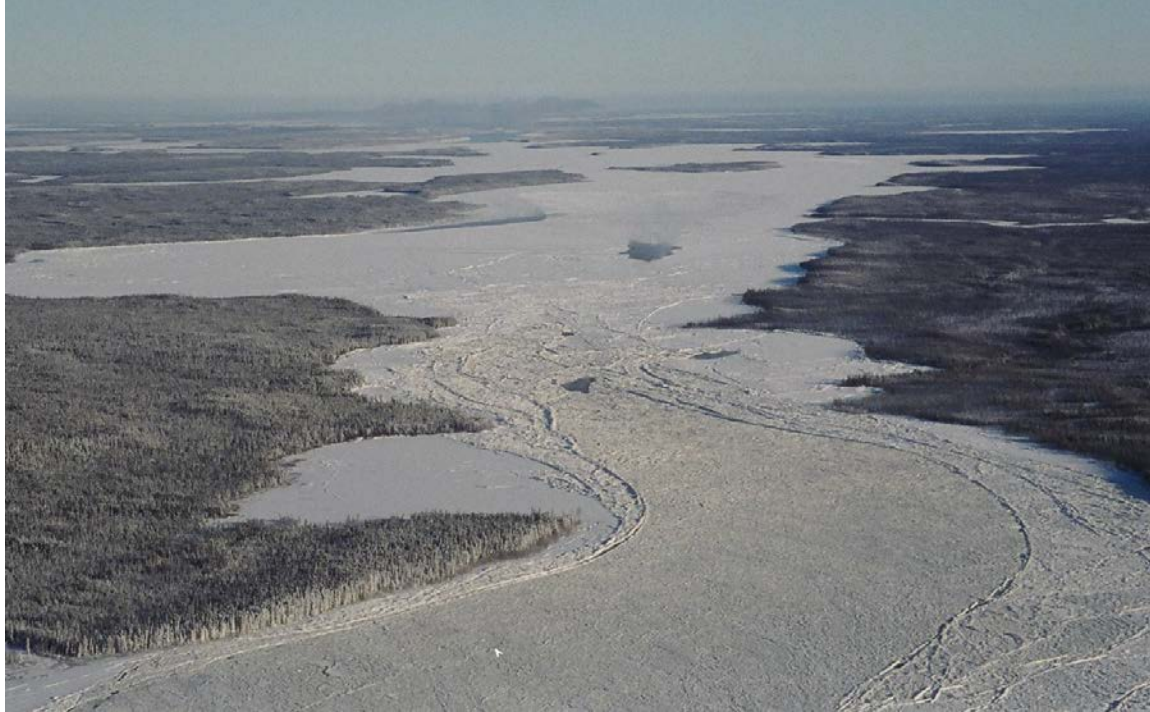
Photo 4: Full Ice Cover on the Nelson River

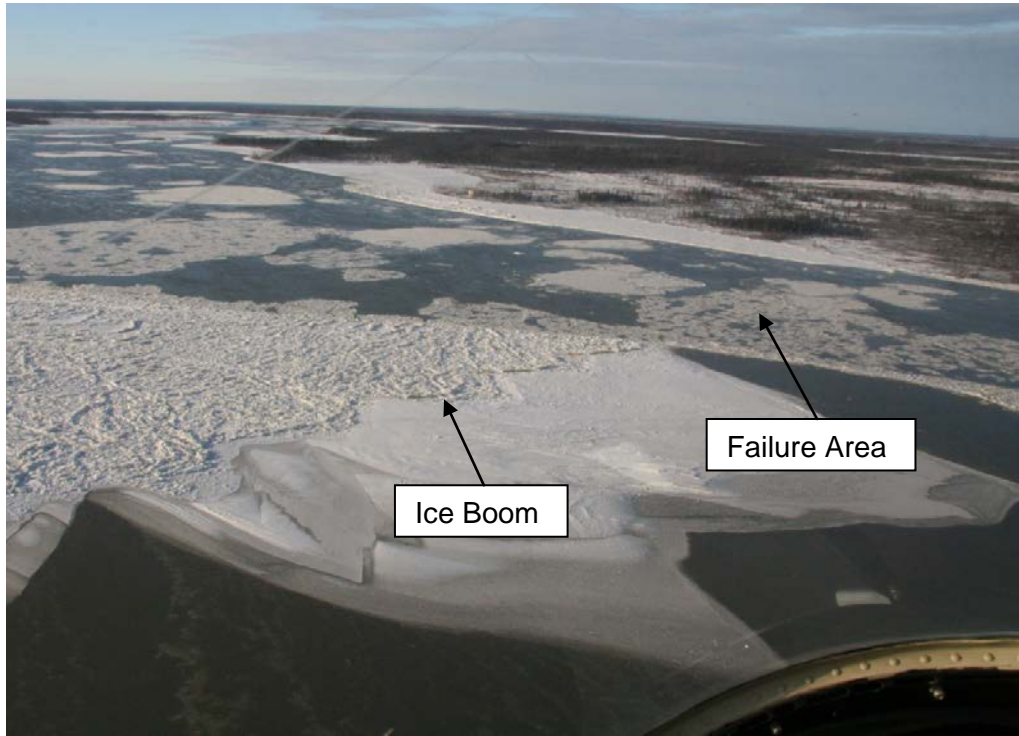
Photo 5: Ice Flowing Past the Failed Ice Boom

Around the start of November ice was observed forming. By November 9, border ice was forming and ice had bridged behind the ice boom as expected (Figure 7). On that same day a portion of the boom failed so that, although part of the boom remained, an open channel on the north side was observed (Photo 5, Figure 8). As a result, a channel of open water remained in place between Split Lake and Stephens Lake, including north and south of Caribou Island, until mid-January.

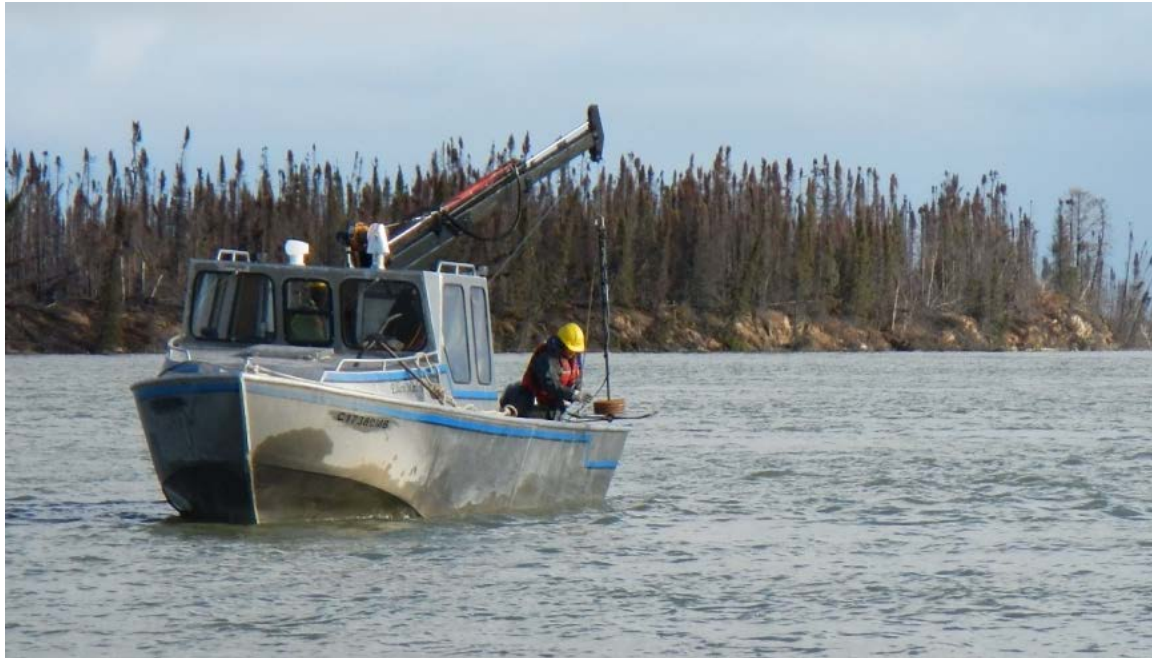
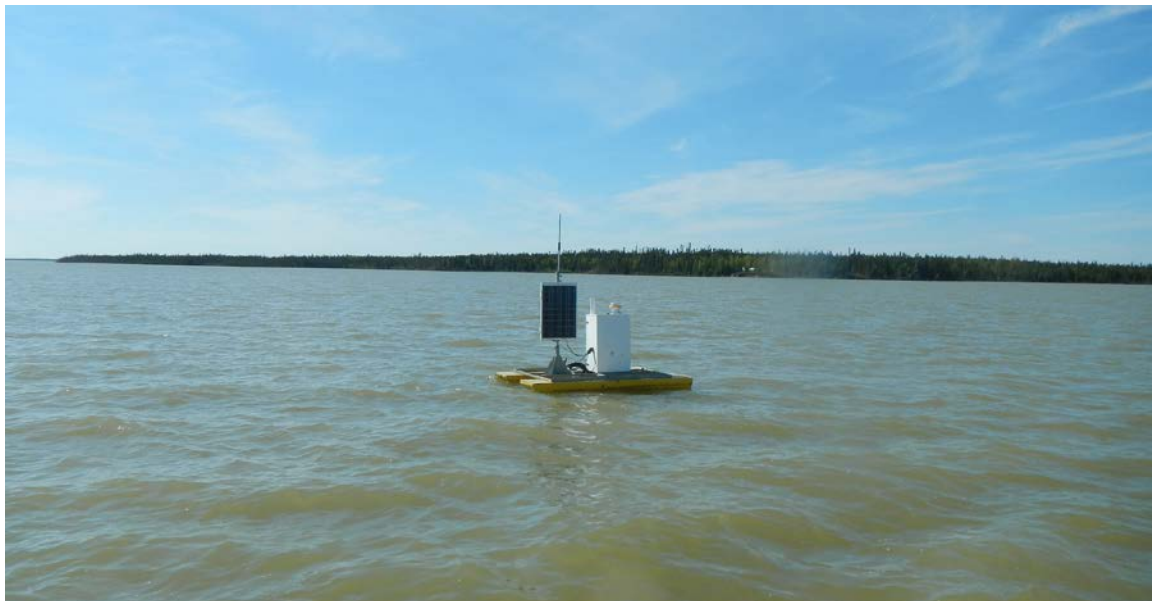
Photo 6: Installing Turbidity Monitoring Equipment and a Station after Installation

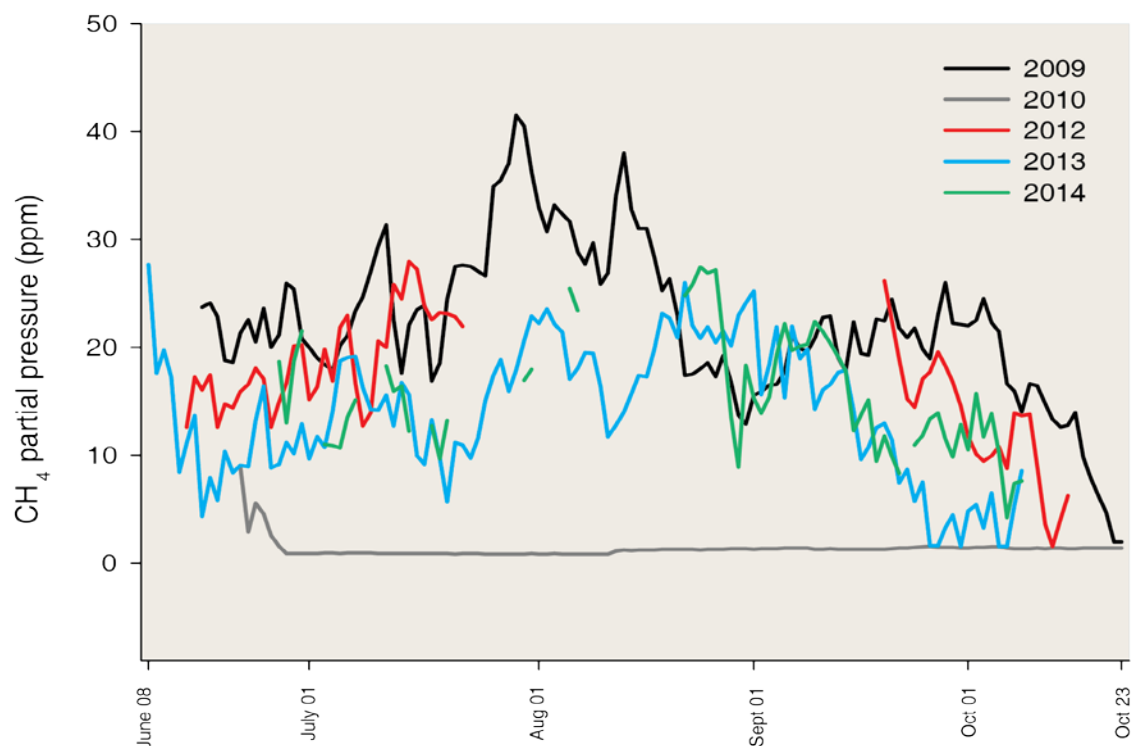
Figure 14: Gull Lake Continuous Monitoring of CH₄ Concentrations

Minimum, maximum and mean concentrations of methane (pCH_4) measured on a continuous basis from June 25 to October 2, 2014 in the main channel of Gull Lake were 4 ppm, 27 ppm and 16 ppm, respectively. These results are within the range of minimum, maximum and mean values measured during the pre-Project period of 2009 to 2013 (Figure 14).

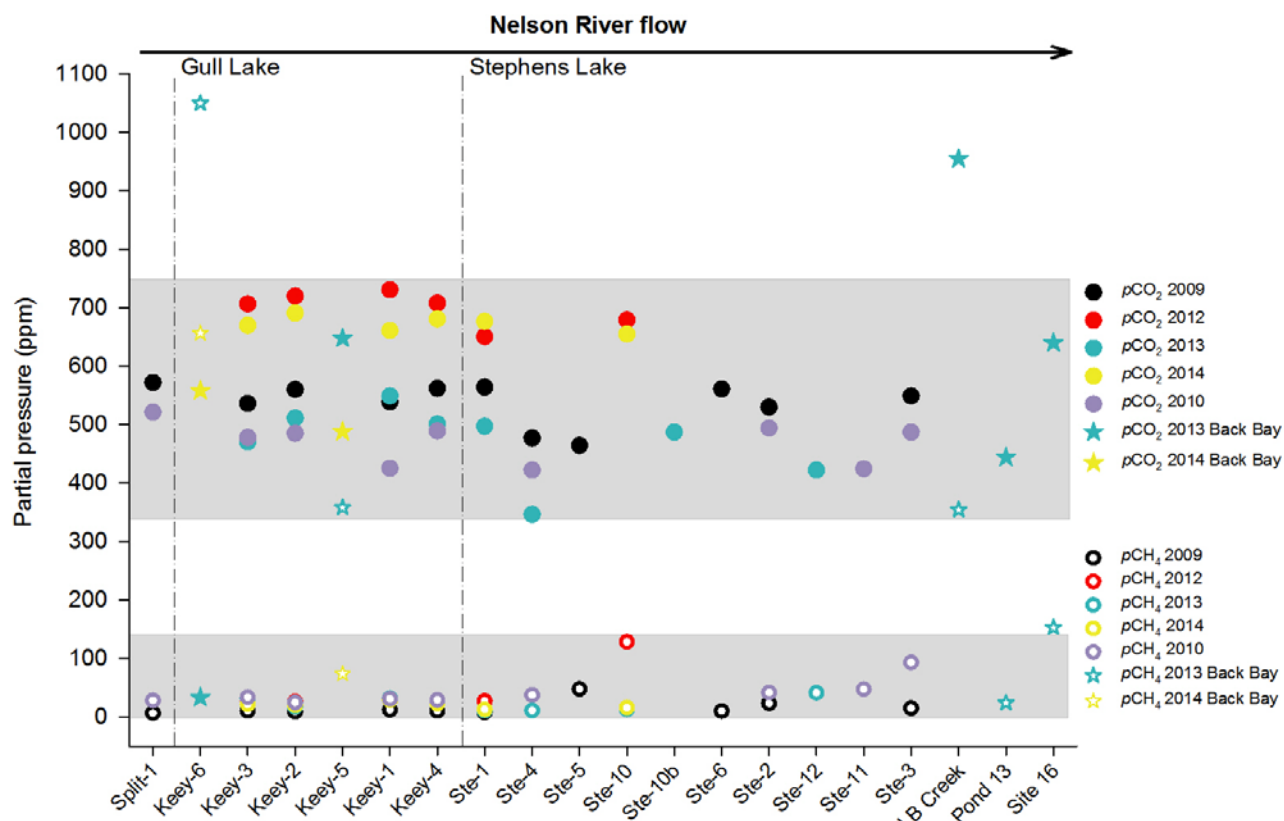
Figure 15: Gull Lake and Stephens Lake Spatial Monitoring of CO₂ and CH₄ Concentrations

Discrete measurements of pCO_2 ranged from 661 ppm to 691 ppm during 2014. These values were within the range measured during the pre-project period of 2009 to 2013 (Figure 15). Discrete measurements of pCH_4 ranged from 19 ppm to 28 ppm during 2014, which were within the range measured during the pre-project period (Figure 15).

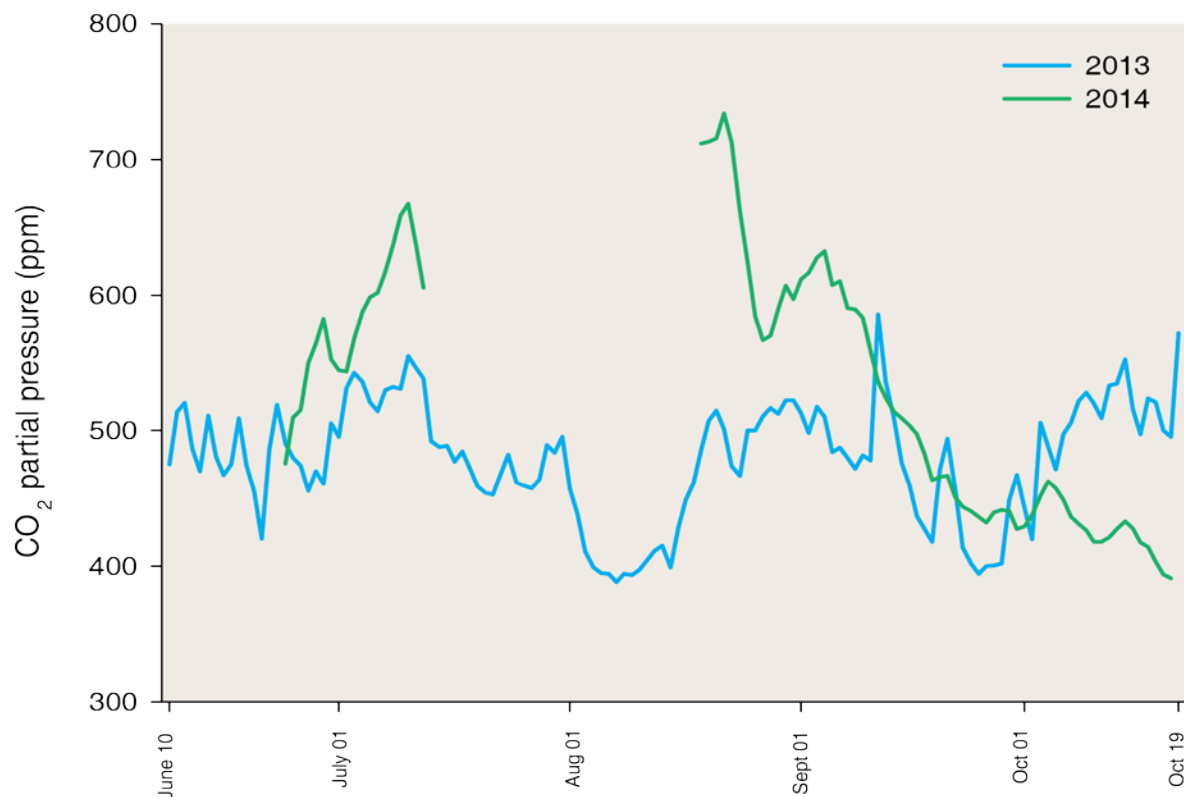
Figure 16: Stephens Lake Continuous Monitoring of CO₂ Concentrations
