Keeyask Generation Project

Physical Environment Monitoring Plan

REPORT #PEMP-2016-01

YEAR 2 CONSTRUCTION

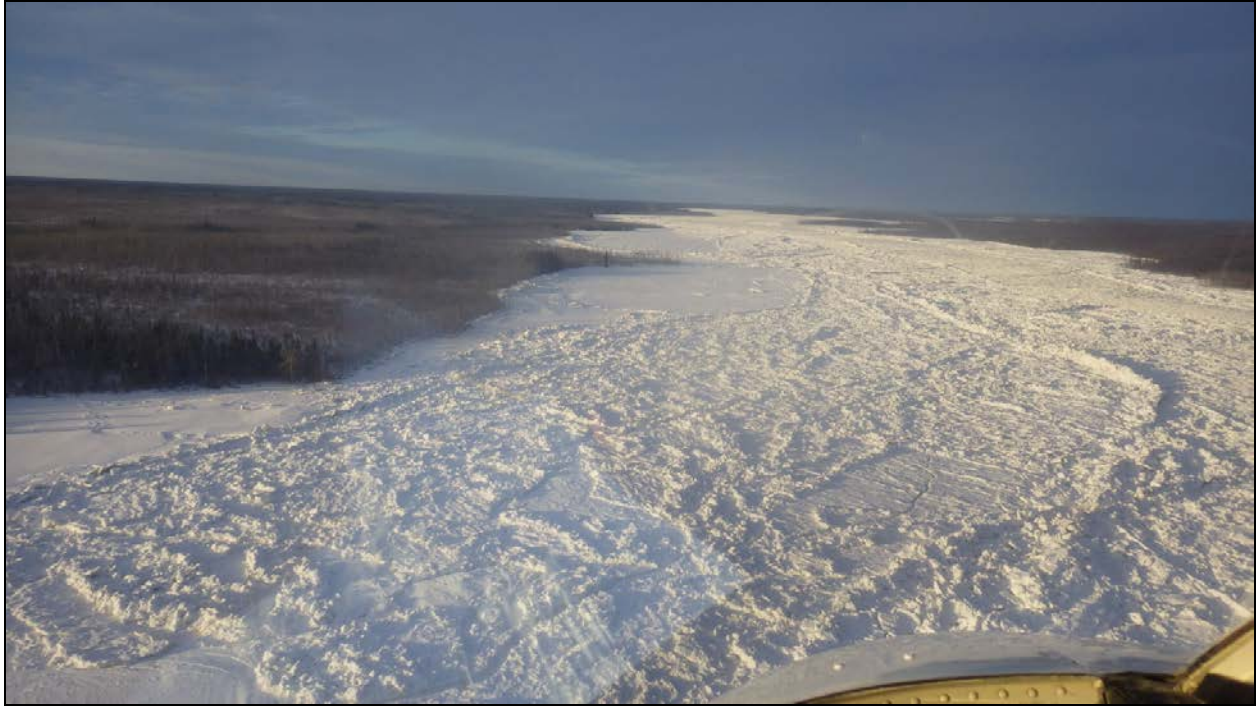
Rough Ice Due to Shoving and Piling Up at the Entrance to Gull Lake (Jan. 21, 2016)

In winter, water levels at the gauge site at the upstream end of Gull Lake experienced maximum increases of almost 3 m (10') and about 5.5 m (18') at Birthday Rapids due to ice accumulation at the entrance to Gull Lake and upstream. The increases diminished upstream. Based on observed water level conditions, neither Clark Lake nor Split Lake water levels were affected due to the Project. While the ice cover likely formed sooner due to the Project ice boom, the observed water level increases are still consistent with those that could be anticipated without the Keeyask Project when an ice bridge forms on Gull Lake and an upstream ice cover develops.

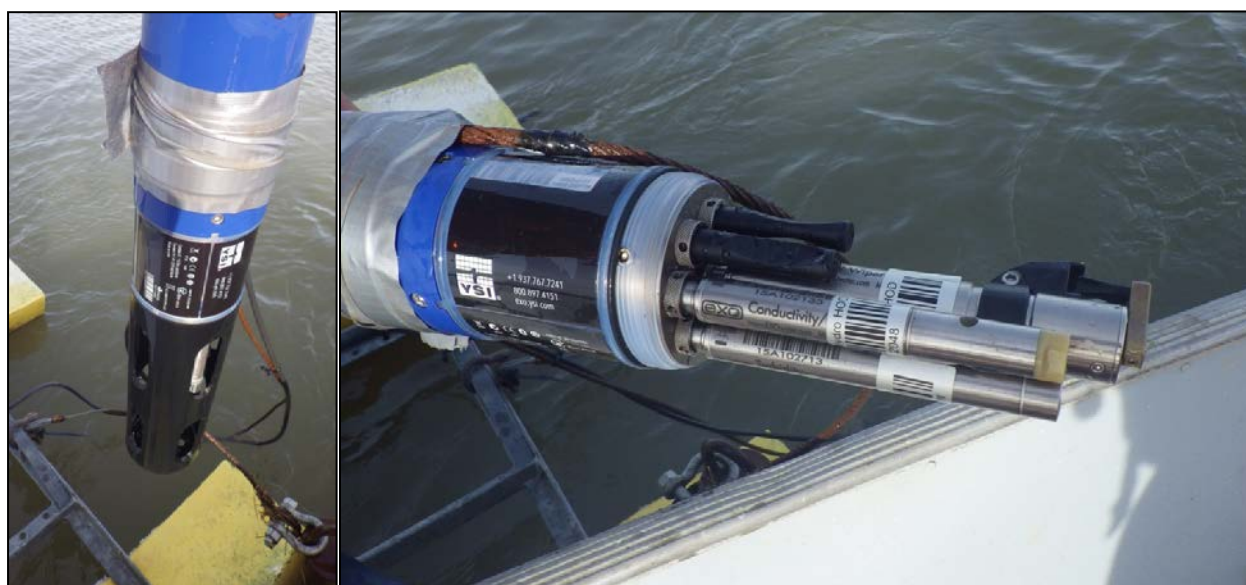
Probe used for continuous turbidity monitoring can be equipped with multiple sensors to measure additional parameters if needed

Turbidity monitoring is done with a turbidity probe placed into the water that uses an optical sensor that measures the murkiness of the water. It is a convenient parameter to monitor as the data can be collected on an automated, continuous basis without collecting samples for laboratory analysis. Between Clark Lake and the Kettle GS, continuous turbidity meters were installed at five locations in summer and three locations in winter. Sediment traps were also placed at two locations to monitor deposition in the waterway while two additional sites were monitored to obtain samples of sediment moving along the bottom of the river. There were no apparent effects of the Project on sediment transport during the 2015/16 reporting period.

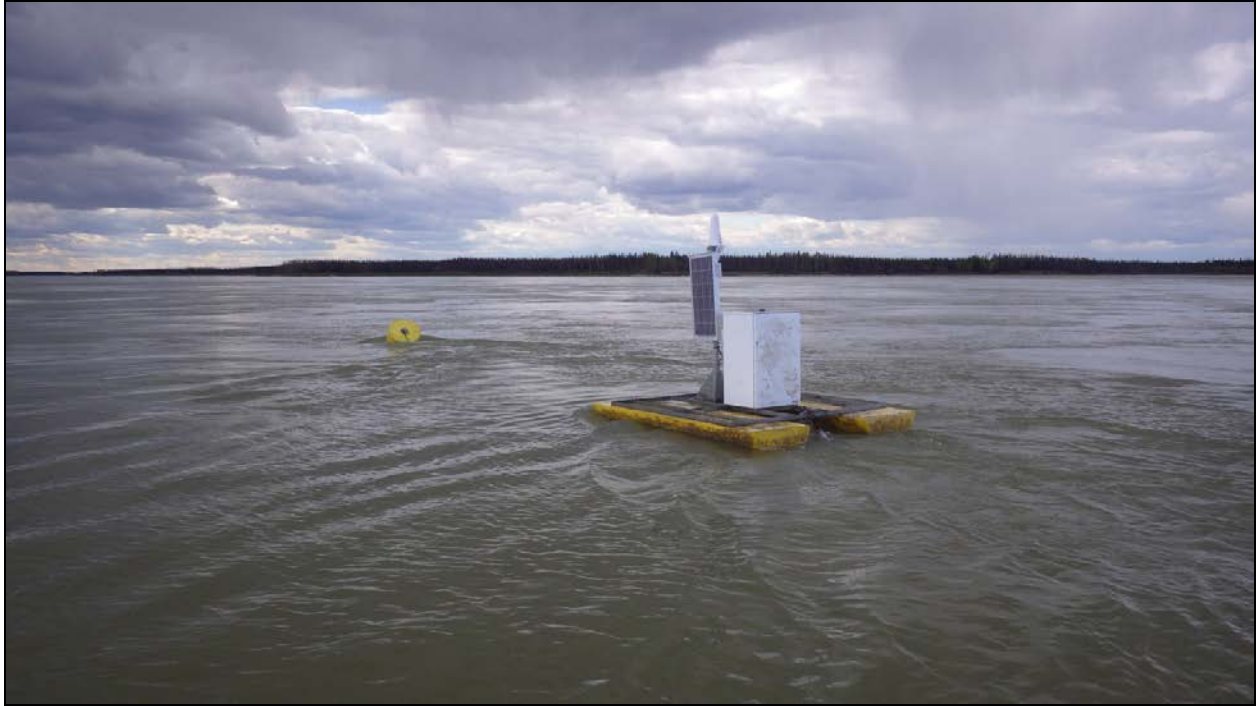
Continuous turbidity monitoring site – turbidity sensors suspended below catamaran that supports solar power panel and electronics housing

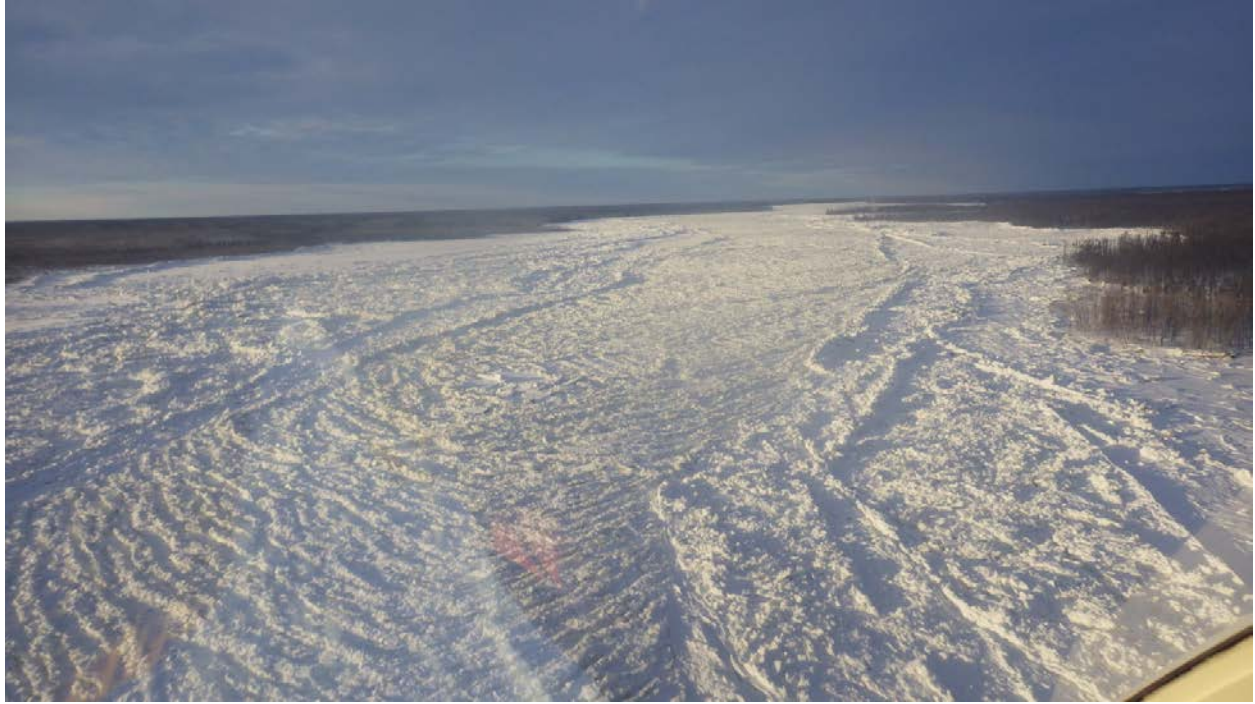
Photo 4: Rough Ice Cover Upstream of Gull Lake

Previously it was noted that data were missing from some water level sites due to the effects of ice on the gauging stations. Challenging ice conditions occur in the river section where the gauge site upstream of Gull Lake is situated. Slush ice and ice pans moving downstream tend to build up in this reach, creating a very rough ice cover that shifts and shoves over time. This is demonstrated in a photo from January 21, 2016, which shows heavily jumbled ice with ridges that may be a couple metres more in height (Photo 4). As the ice piles up, it shoves along the shore which can remove sensors placed in the water while increased water levels and ice pushed onto shore can destroy equipment placed there.

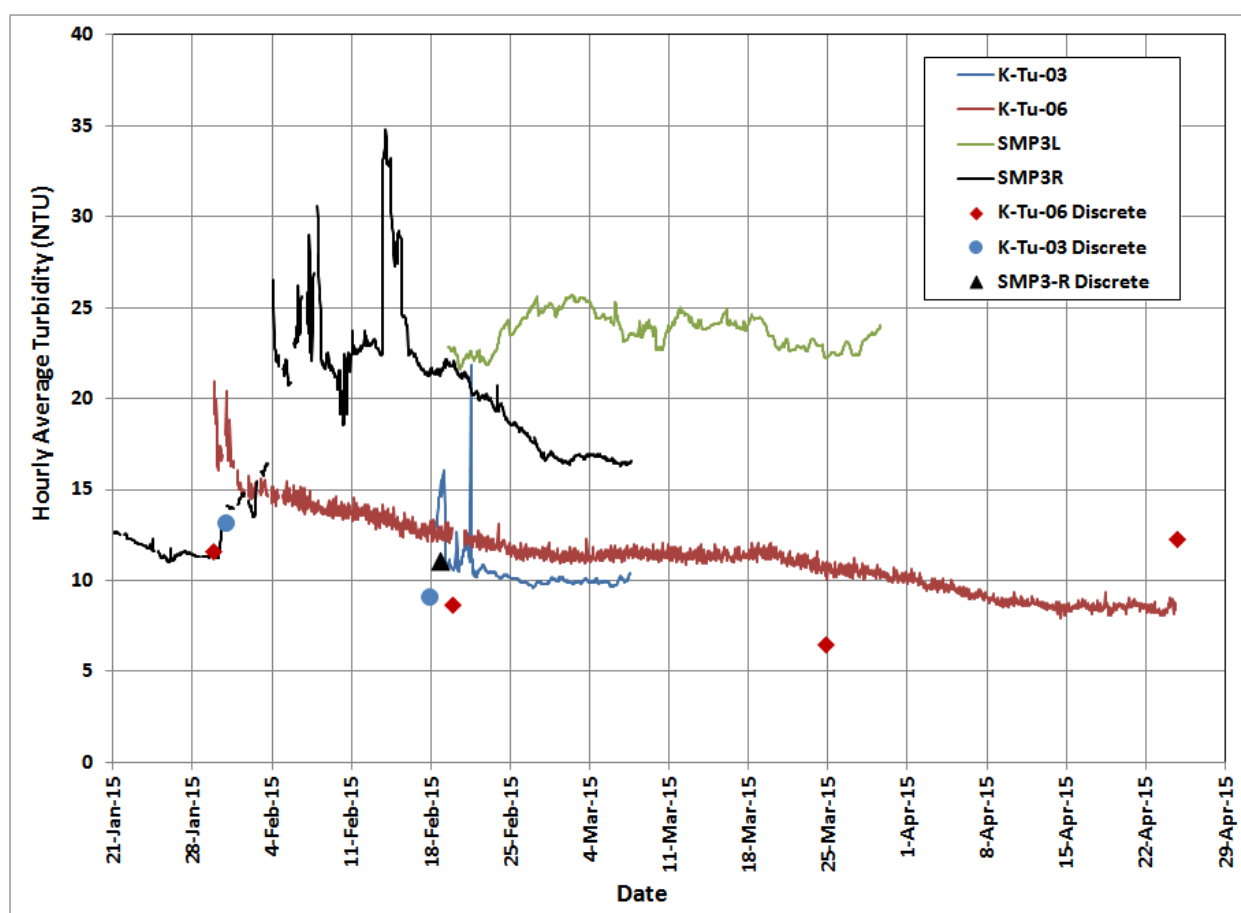
**Figure 7: Continuous and Discrete Turbidity (Winter 2014/15)**

Figure 7 shows turbidity data collected in the January to April period. Monitoring during the winter is particularly challenging due to the effects of ice on the equipment. While several probes were placed earlier in January, the results are shown after January 21 because of poor data quality earlier in the month due to ice. Similarly, records show data gaps and end before April because of poor quality data due to ice. The best continuous record is for site K-Tu-06 at Clark Lake, which has a relatively complete data set from its installation on January 29 to its removal at the end of April. From a peak of about 20 NTU at installation, the turbidity gradually declines from about 15 NTU to 8 NTU in April. At the outlet of a large lake like Split Lake, this pattern of turbidity decline over winter would be anticipated as there are no upstream processes likely to contribute sediment to the water during winter. Though the record is shortened due to ice effects on the data, the results for site K-Tu-03 are similar to those upstream at K-Tu-06, which may be expected as significant additional sediment entrainment would not generally be expected between the two locations, although open water upstream could create slush ice that could influence the K-Tu-03 location.

The downstream SMP3 turbidity results are roughly 10-15 NTU higher for both the left (SMP3L) and right (SMP3R) locations. This is likely due in part to ice effects as significant slush ice can be transported into this area from upstream, which caused data issues earlier in January. Some additional sediment may also be entrained because the upstream hanging ice dam at the entrance to Stephens Lake can redirect the river flow and increase flow velocities over erodible materials under the ice.

Overall, the observed turbidity upstream of Gull Rapids (K-Tu-06, K-Tu-03) from January to April was generally lower than observed in preceding summer (2014) while the results from SMP3 were of a similar magnitude.

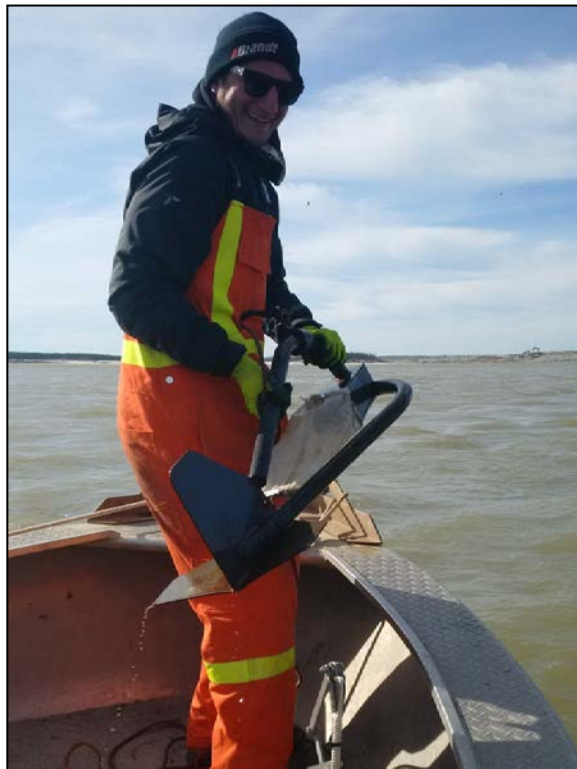
Photo 8: Worker Preparing to Use a Helley-Smith Bedload Sampler

The PEMP document noted that if bedload monitoring was unable to obtain samples in the first two years of construction then bedload monitoring would not take place in the remaining years of construction. Therefore, bedload monitoring will not be performed in 2016 and the remaining years of construction.

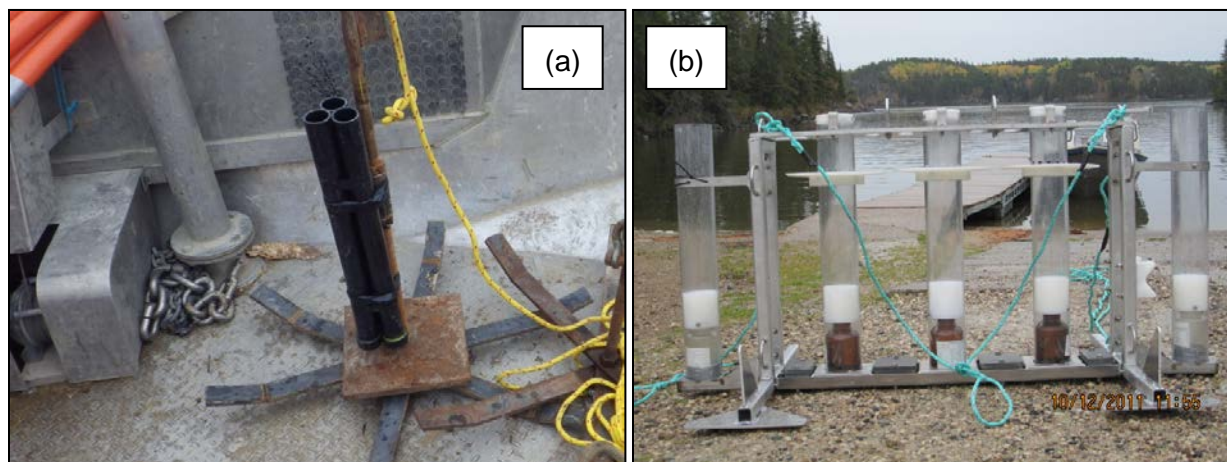
Photo 9: Sediment Traps used at Site K-ST-02: a) 3-tube; b) 5-tube

drilled around their circumference and will trap more sediment that is being advected horizontally with the flow.

The monitoring found the deposition rates over the 72 days of deployment in summer 2015 were almost twice as high as the rate over the 277 days of deployment over winter from October 2014 to July 2015 (Table 3). Almost all of the sediment collected was comprised of fine silt and clay material, with six of the samples having a 90th percentile grain size of less than 0.07 mm (i.e., only 10% of the sample has a grain size larger than the 90th percentile size). Two of the over-winter samples had somewhat larger 90th percentile values, but the bulk of each sample was in the silt to clay size range. Grain sizes were less than 0.3 mm in all of the samples. The fact the five samples from the 5-tube sediment trap were uniform for each parameter measured is consistent with the transported sediment being almost entirely fine material with no coarser material that would be settling vertically.

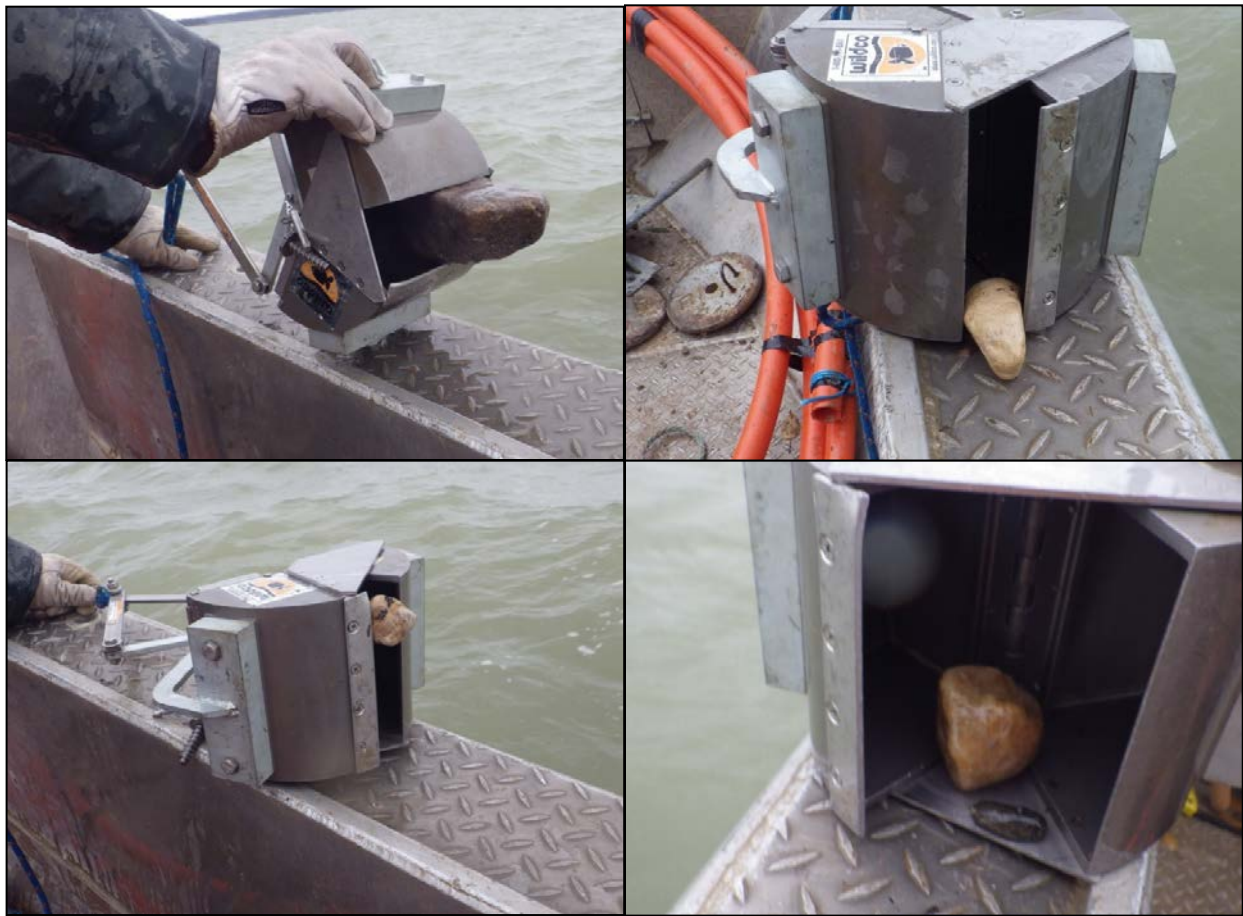
Photo 10: Coarse Substrate Material at Site K-ST-02

large for the ponar to grab. From these results, it is clear that the fine material captured by the sediment trap is not being deposited and accumulated on the lake bed.
