Keeyask Generation Project

Sediment Management Plan for In-stream Construction

Report #SMP-2016-01

Annual Report April 2015 – March 2016: Year 2 Construction

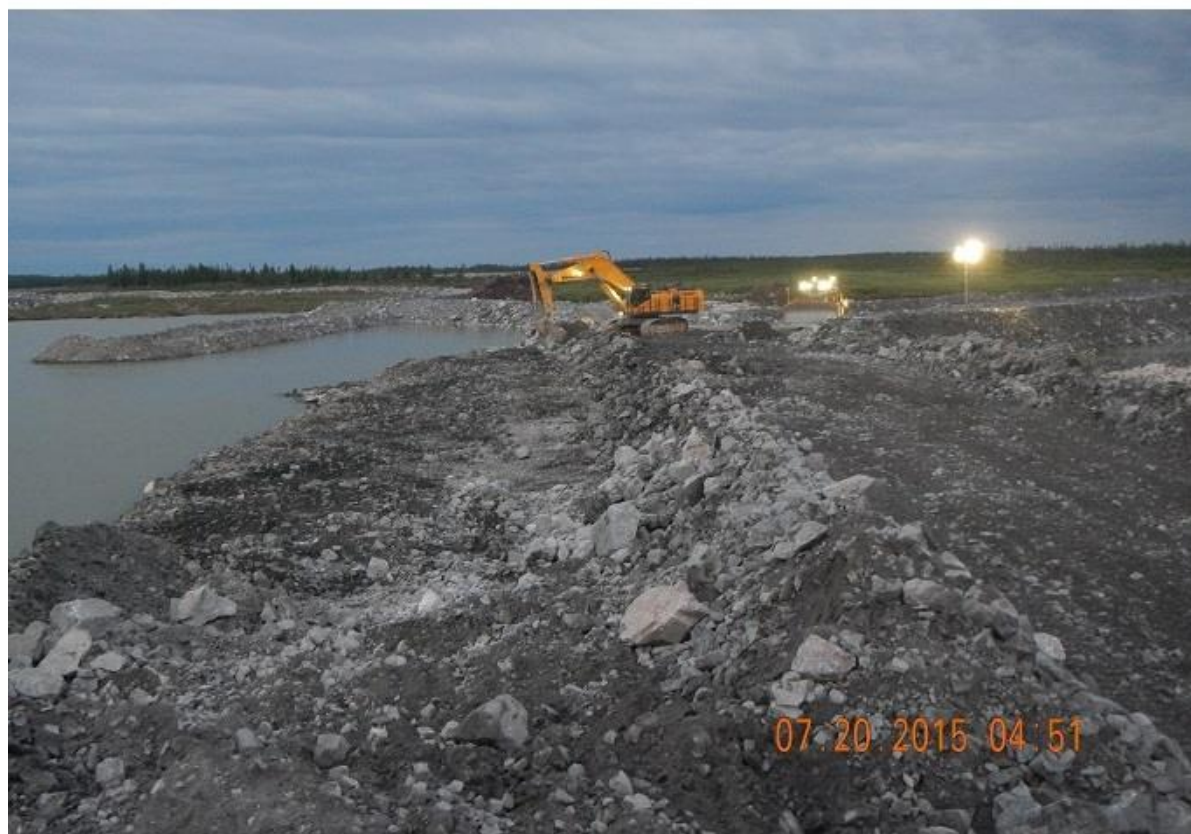
Figure 2: Central Dam Cofferdam outer rock groin construction

The Central Dam Cofferdam across the centre channel consists of inner and outer rock groins between which impervious Class A & B fill is placed. The inner rock groin was constructed in 2014. The cofferdam was completed 2015 by extending the outer rock groin across the centre channel, parallel to the inner groin, and then filling between the groins with impervious fill. The original plan for the Central Dam Cofferdam involved constructing a single groin with impervious material placed on the slope facing the river. The actual construction using two rock groins is a modification to the original plan and the work in 2015 was not proposed during the planning phase prior to the start of construction in 2014. The in-stream construction of the Central Dam Cofferdam outer rock groin (see Figures 2 and 3) commenced on July 16, 2015 and was completed on August 6, 2015. The impervious Class A & B material was placed between August 25 and September 13, 2015; however, this was not considered an in-stream work activity as it did not involve material placement within the flow of the river.

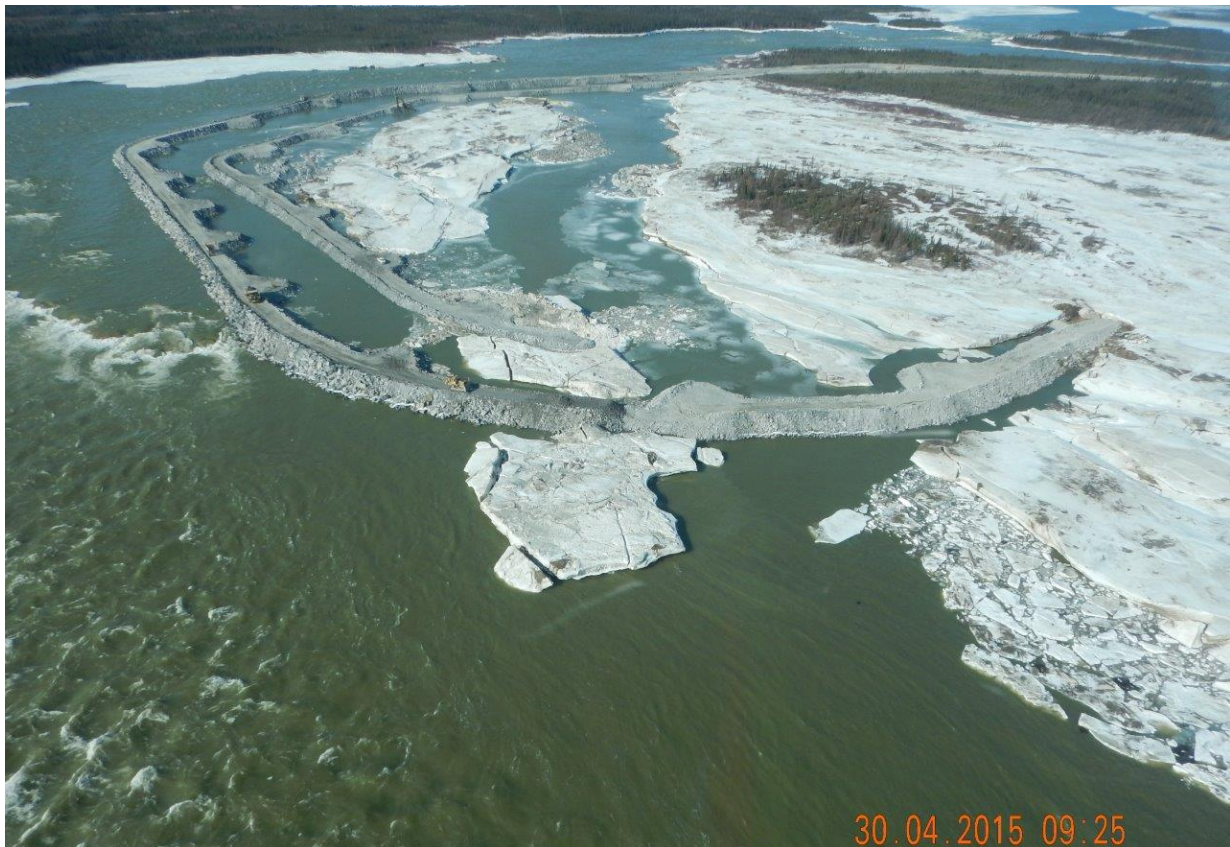
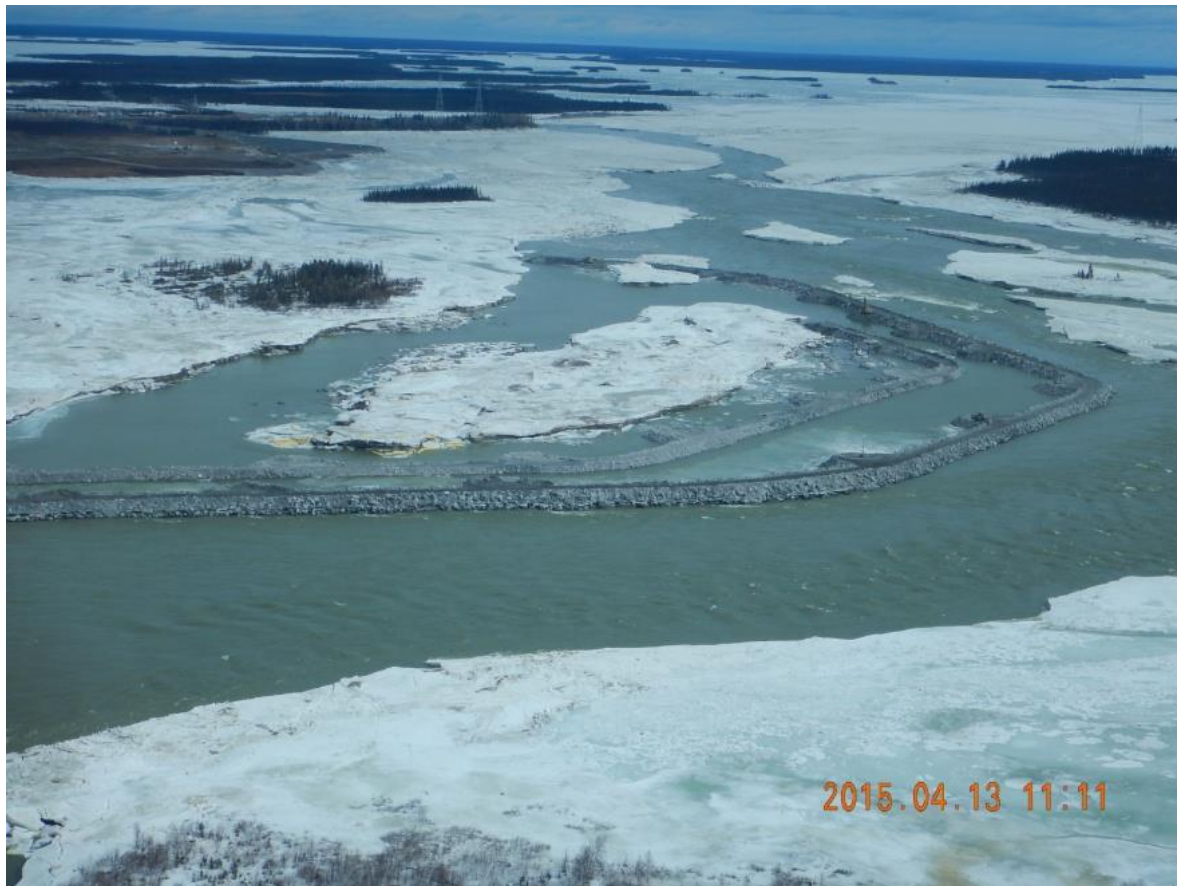
In-stream work for the construction of the Spillway Cofferdam rock groins (see Figures 6 and 7) commenced on February 27, 2015 and was completed May 6, 2015. The Spillway Cofferdam was completed later by placing impervious Class A & B material between the two rock groins in summer 2015, between June 9 and August 24. Placement of the impervious fill was not considered an in-stream work activity as it did not involve material placement within the river flow.

Figure 6: Aerial photo - Spillway Cofferdam

Figure 7: Aerial photo - Spillway Cofferdam
