Keeyask Generation Project Terrestrial Effects Monitoring Plan

Terrestrial Plant, Habitat and Ecosystem Monitoring Report

TEMP-2016-01

ECOSTEM Ltd.

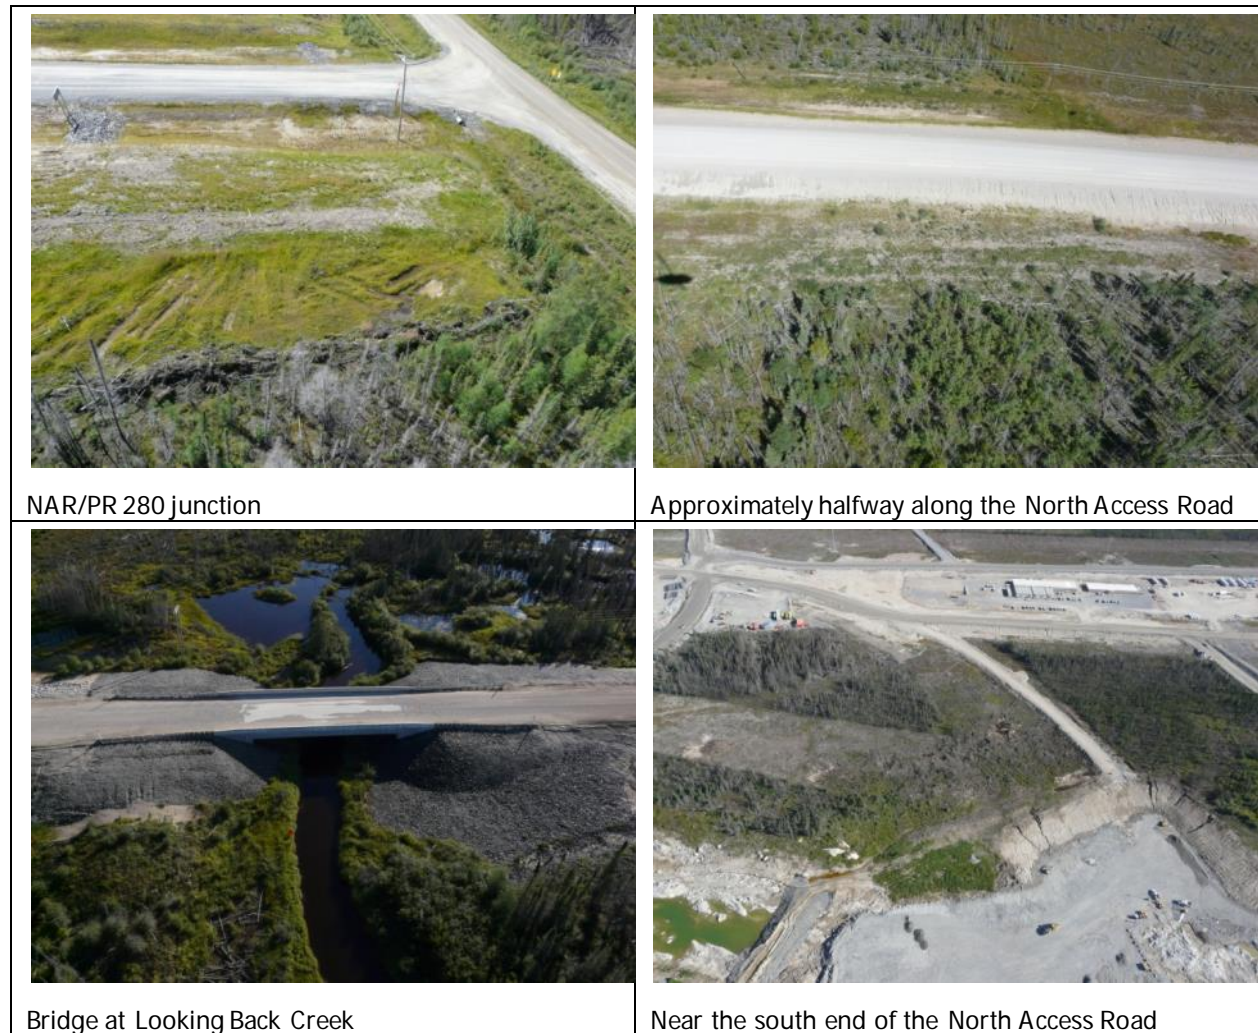
Figure 2-1: Footprint areas along the North Access Road (August 25, 2015)

All North Access Road (NAR) clearing observed in September 2015 (Figure 2-1) was within the planned Project footprint boundary. Construction of the South Access Road (SAR) was underway during the surveys. The SAR ROW had been cleared from Kettle Creek at the Butnau boat launch to the south shore of Gull Rapids (Figure 2-2), and gravelled from approximately 1.2 km south of Kettle Creek and Borrow Area S-a (approximately 2.4 km southeast of the south shore of Gull Rapids; Figure 2-3). A small access road off the end of the Butnau dyke was finished and in use (Figure 2-4). A small camp and work area approximately 1 km west of the Butnau access road (Figure 2-5) was gravelled and in use.

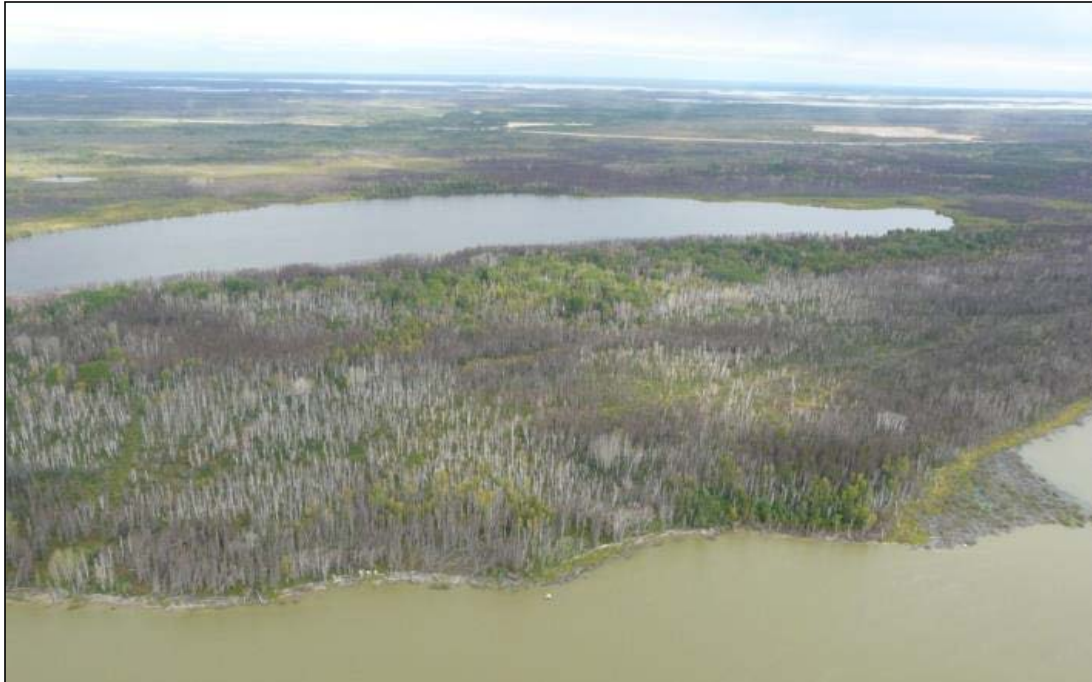
Photo 3-1: N-6 priority habitat site was intact in 2015 (the 2013 fire burned portions of the area)

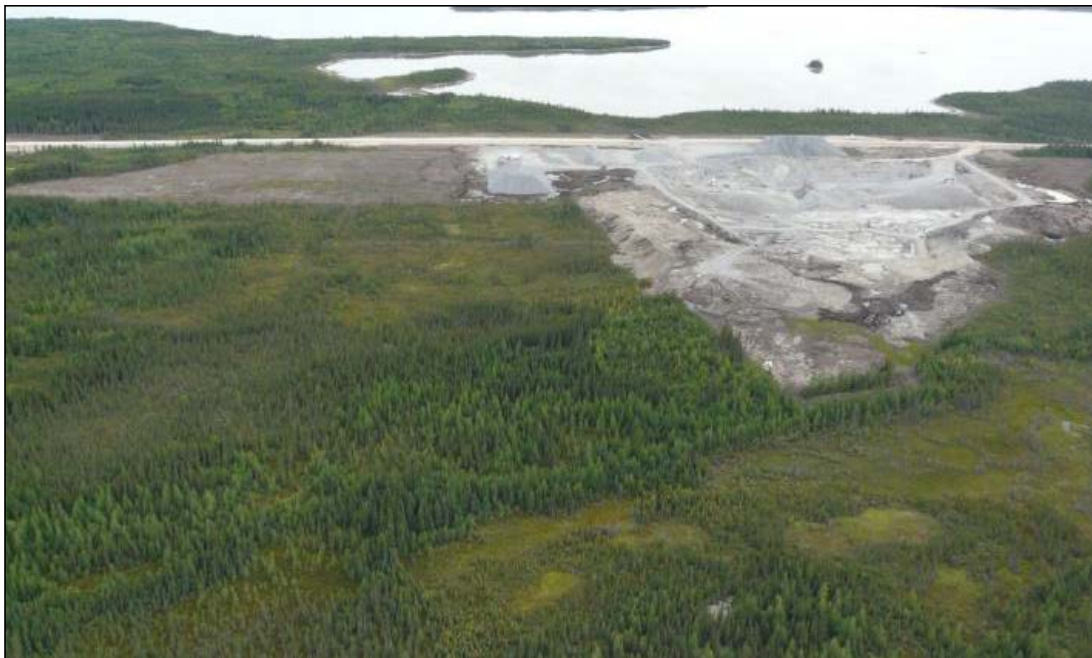
Photo 3-2: Tamarack dominant vegetation on thin peatland (taller trees in the foreground), partially cleared by Borrow Area Q-9

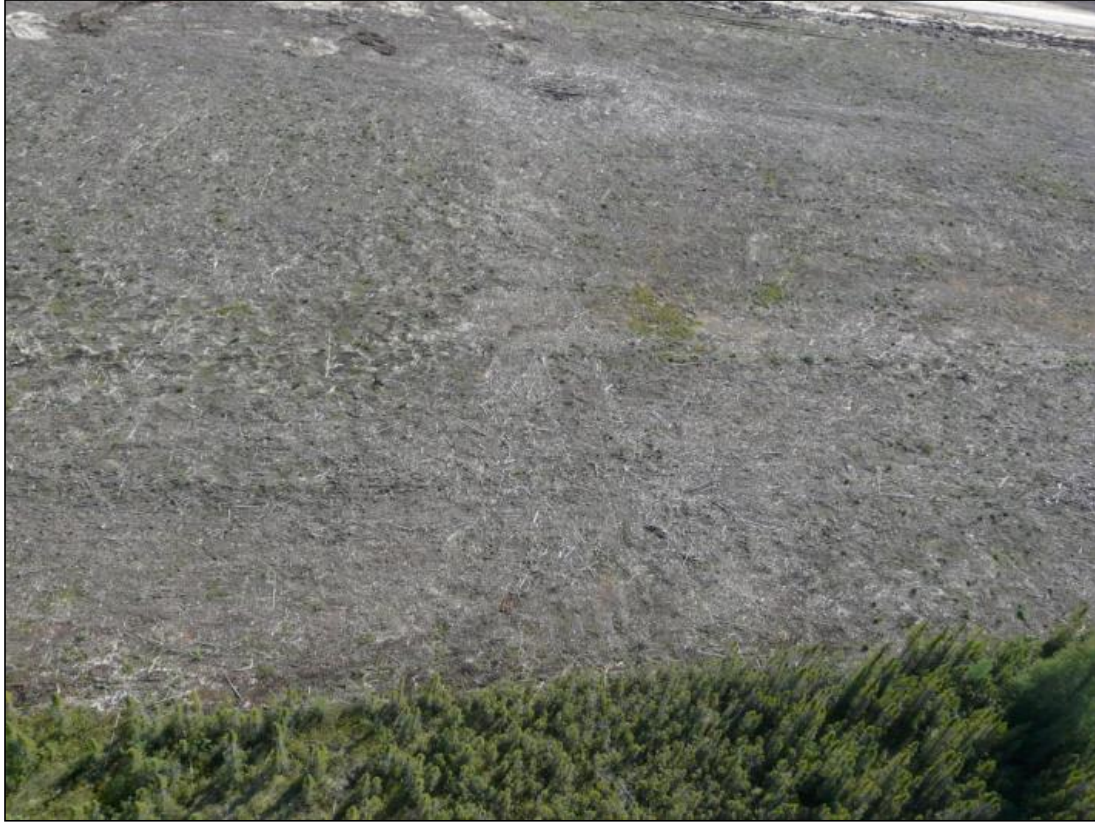
Photo 3-3: Example of a cleared black spruce mixture vegetation on mineral ecosystem sensitive site within the Project footprint

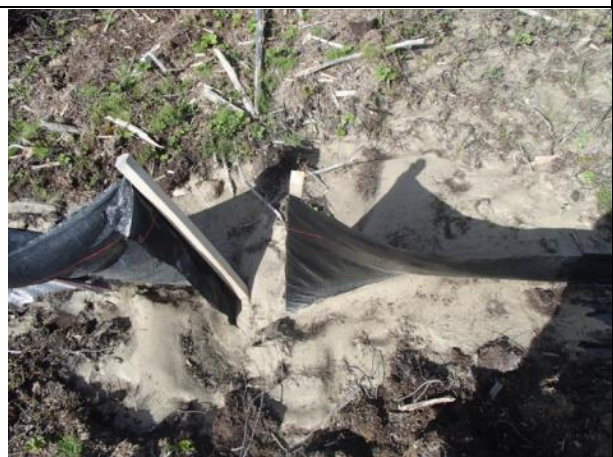
Siltation leak through fence
