Keeyask Generation Project Terrestrial Effects Monitoring Plan

Colonial Waterbird Habitat Enhancement Monitoring Report

TEMP-2016-04

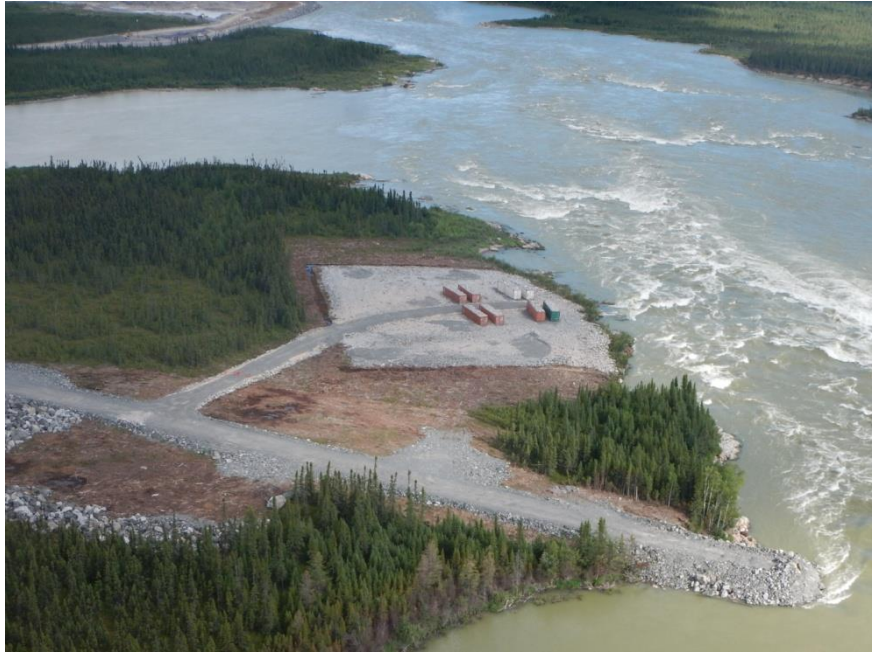
William Smith Island habitat enhancement area for gulls

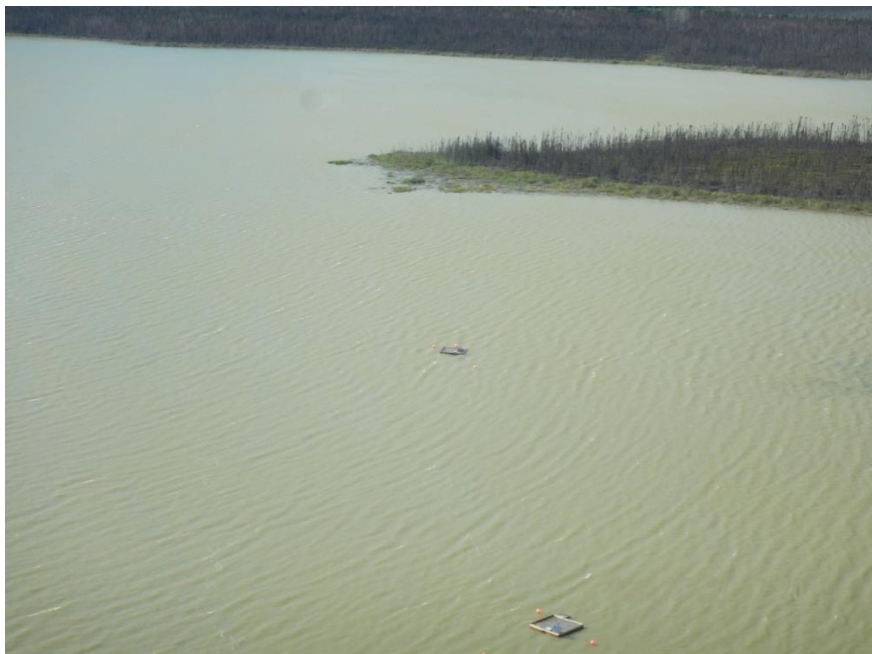
Floating platforms for common terns

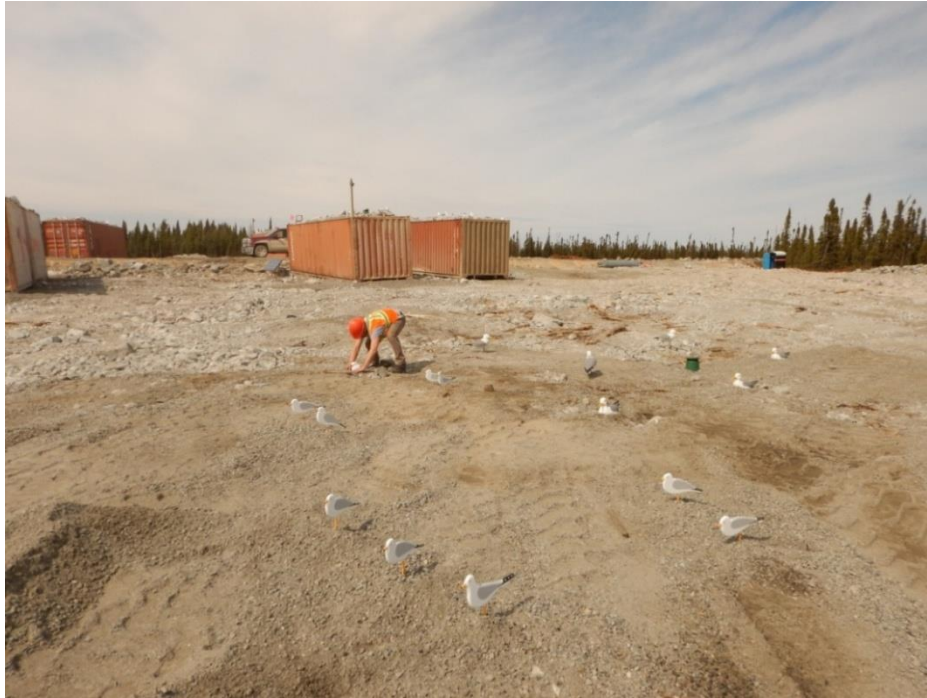
Photo 1-1: Gull Decoys and Audio Equipment Installation at the William Smith Island Gull Habitat Enhancement Area

To offset loss of colonial waterbird nesting habitat at Gull Rapids, habitat replacement areas/platforms (e.g., created nesting habitat and floating platforms) were implemented and monitored to determine their effectiveness (KHLP 2015). For gulls, the southern shore of William Smith Island (Map 1-1) was cleared of vegetation and graded with rocky substrate to emulate a natural nesting island (Photo 1-1). At this site large shipping containers were placed in the graded area and rocky substrate was placed on top to provide nesting habitat elevated from potential terrestrial predators. On April 30, 2015, concrete and wooden gull decoys and audio equipment broadcasting breeding gull vocalizations, were installed on top of the containers and at ground-level (Photo 1-2) to enhance the social attractiveness of the site to gulls.

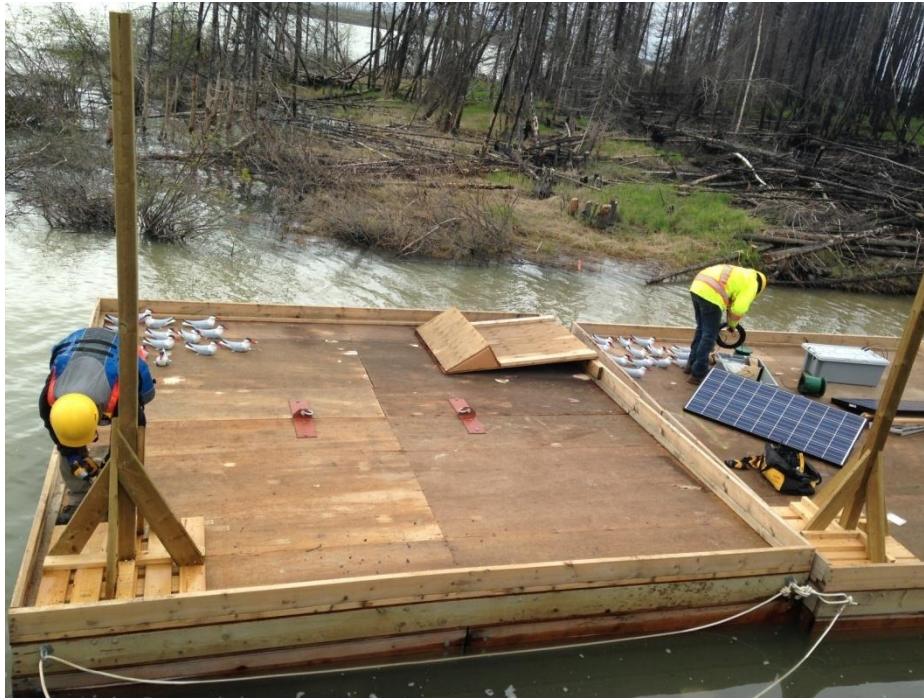
Photo 1-3: Tern Decoys and Audio Equipment Installation on the Floating Platforms

Two floating platforms were deployed for terns approximately five km upstream of Gull Rapids on June 16 and 17, 2015 (Map 1-1). This was after most gulls should have initiated their nests, so as to minimize competition from gulls for the floating platforms. These two platforms provide a total of approximately 50 m² of replacement habitat designed to accommodate 50 tern pairs per platform. Each floating platform was topped with gravel to emulate a natural nesting island and equipped with a ramp to allow access to the platform from the water (Photo 1-3). Wooden tern decoys, and audio equipment broadcasting breeding tern vocalizations (Photo 1-4) were installed to increase the social attractiveness of the floating platforms to terns.

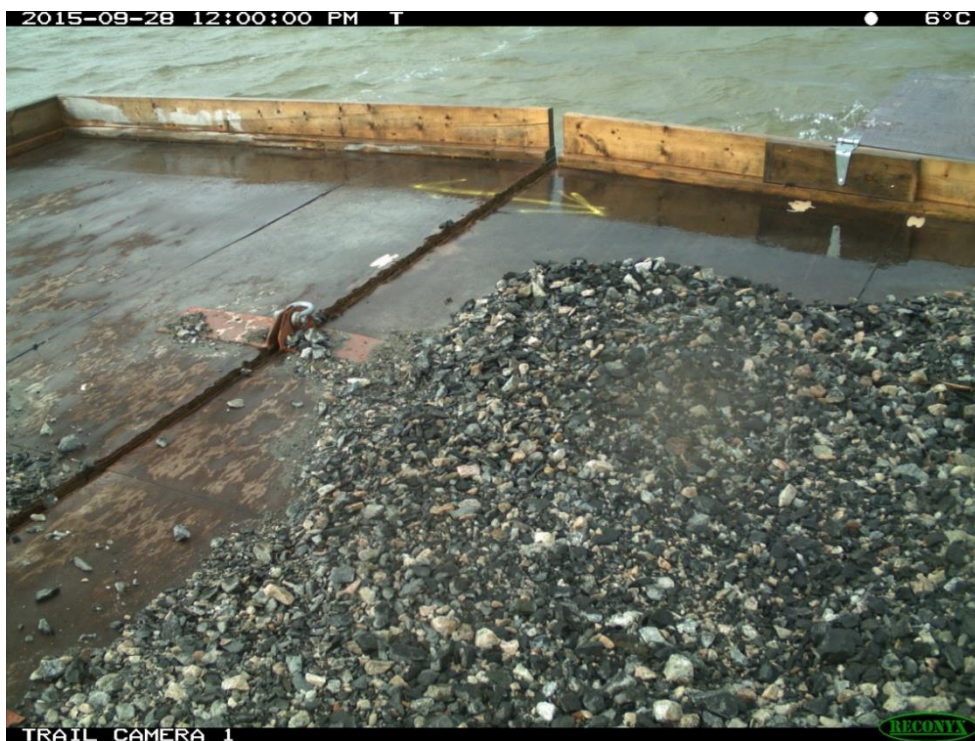
Photo 3-2: Floating Platform A Damaged After a Storm

High winds in late September challenged the structural integrity of the floating platforms. When northwesterly winds surpassed 50 km/h on September 22 and 27, waves caused both platforms to buckle, resulting in the gravel layer shifting to one side of the platforms (Photos 3-2 and 3-3).

The effects of late September storms on the floating platforms demonstrated that nests and eggs on the platforms may be at risk from water inundation and shifting nesting substrate when winds are high. Ridges or baffles mounted on the main platform surface should restrict the gravel substrate from substantially shifting when the platform is being rocked by waves. Several storms of similar strength occurred earlier in the breeding season that did not alter the habitat structure of the platforms. This may also suggest that part of the structure may have failed, causing it to rock more than usual, thus resulting in the excessive shifting of nesting substrate. The attractiveness of the floating platforms to terns could be further improved by tying floating driftwood to the platform to provide additional loafing areas next to the raft, and by scattering driftwood, large cinderblocks and chick shelters on top of the platform surface (Jarvie and Blokpoel 1996, Environment Canada 2013).

- Remove large rocks from on top of the shipping containers and replace with gravel;
- Paint the shipping containers in neutral colours;
- Monitor the presence of predators and humans through motion and infrared triggered cameras;
- Further discourage access to the site by erecting signage indicating 24/7 video surveillance;
- Deploy the floating platforms earlier in June;
- Prevent shifting nesting substrate on the floating platforms by adding ridges; and
- Increase the attractiveness of the floating platforms by scattering driftwood, large cinderblocks and chick shelters on top of the floating platform surface.

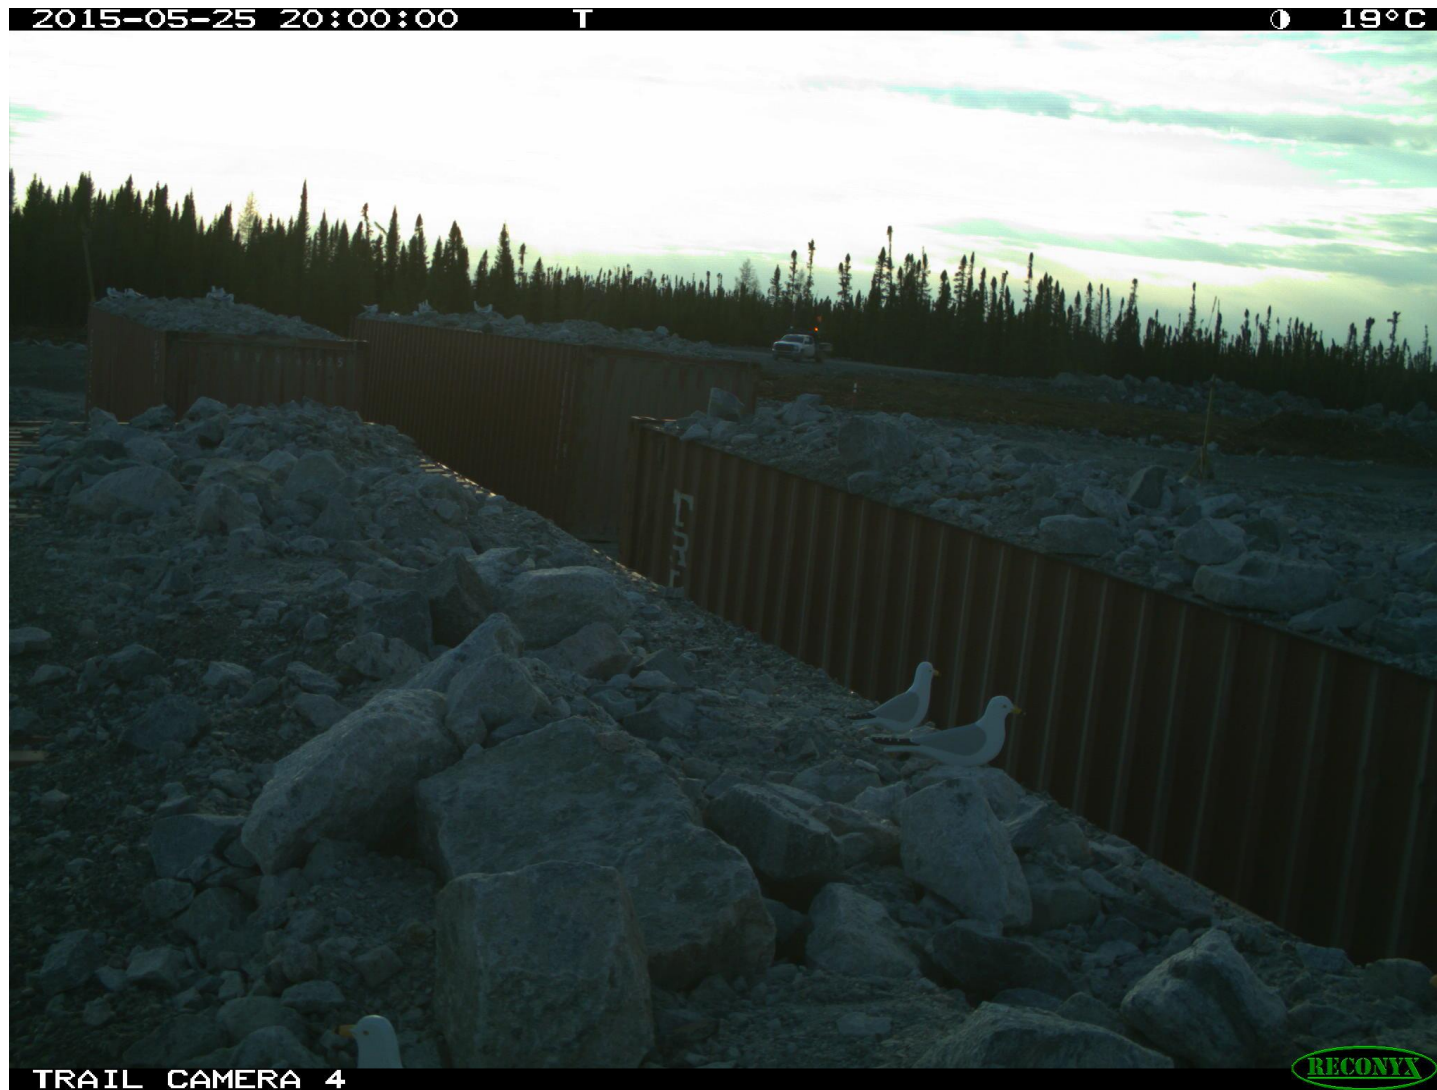
The William Smith Island habitat enhancement area did not successfully attract gulls or other wildlife to the site in 2015. At this site, a total of 2,741 images were captured over 101 days of operation. Colonial waterbirds were not captured nesting in any of the photographs, and no nest development was observed. Only three photographs contained images of wildlife. One photograph captured a single gull flying over the Nelson River at 5 a.m. on June 2 (Appendix A; Photo A-1), another captured two gulls flying over the road leading to the habitat enhancement area at noon on June 14 (Appendix A; Photo A-2), and a third photograph captured two unknown birds (possibly gull species) in flight over the road at 4 p.m. on July 15 (Appendix A; Photo A-3). Incidentally, cameras at the William Smith Island habitat enhancement area captured trucks at the threshold of this access-restricted site (Appendix A; Photos A-4 and A-5).

Photo A-4: Unidentified Truck parked at William Smith Island Habitat Enhancement Area at 8 p.m. on May 25, 2015

The potential presence of terrestrial predators and visits by humans at the gull habitat enhancement area may have contributed to breeding gulls not being attracted to the site. Humans may be attracted to the site out of curiosity. By installing signs that indicate 24/7 video surveillance, curious humans may be further discouraged from approaching the area. Although no predators were photographed at the site, it is possible that a predator event occurred between timed photographs. Installing motion and infrared sensing cameras will assist in monitoring predators that may visit the site. Predators may be attracted to the habitat enhancement area by the sight of gull decoys, the sound of the gull vocalizations playback, or potentially the scent of nesting waterbirds in future years.

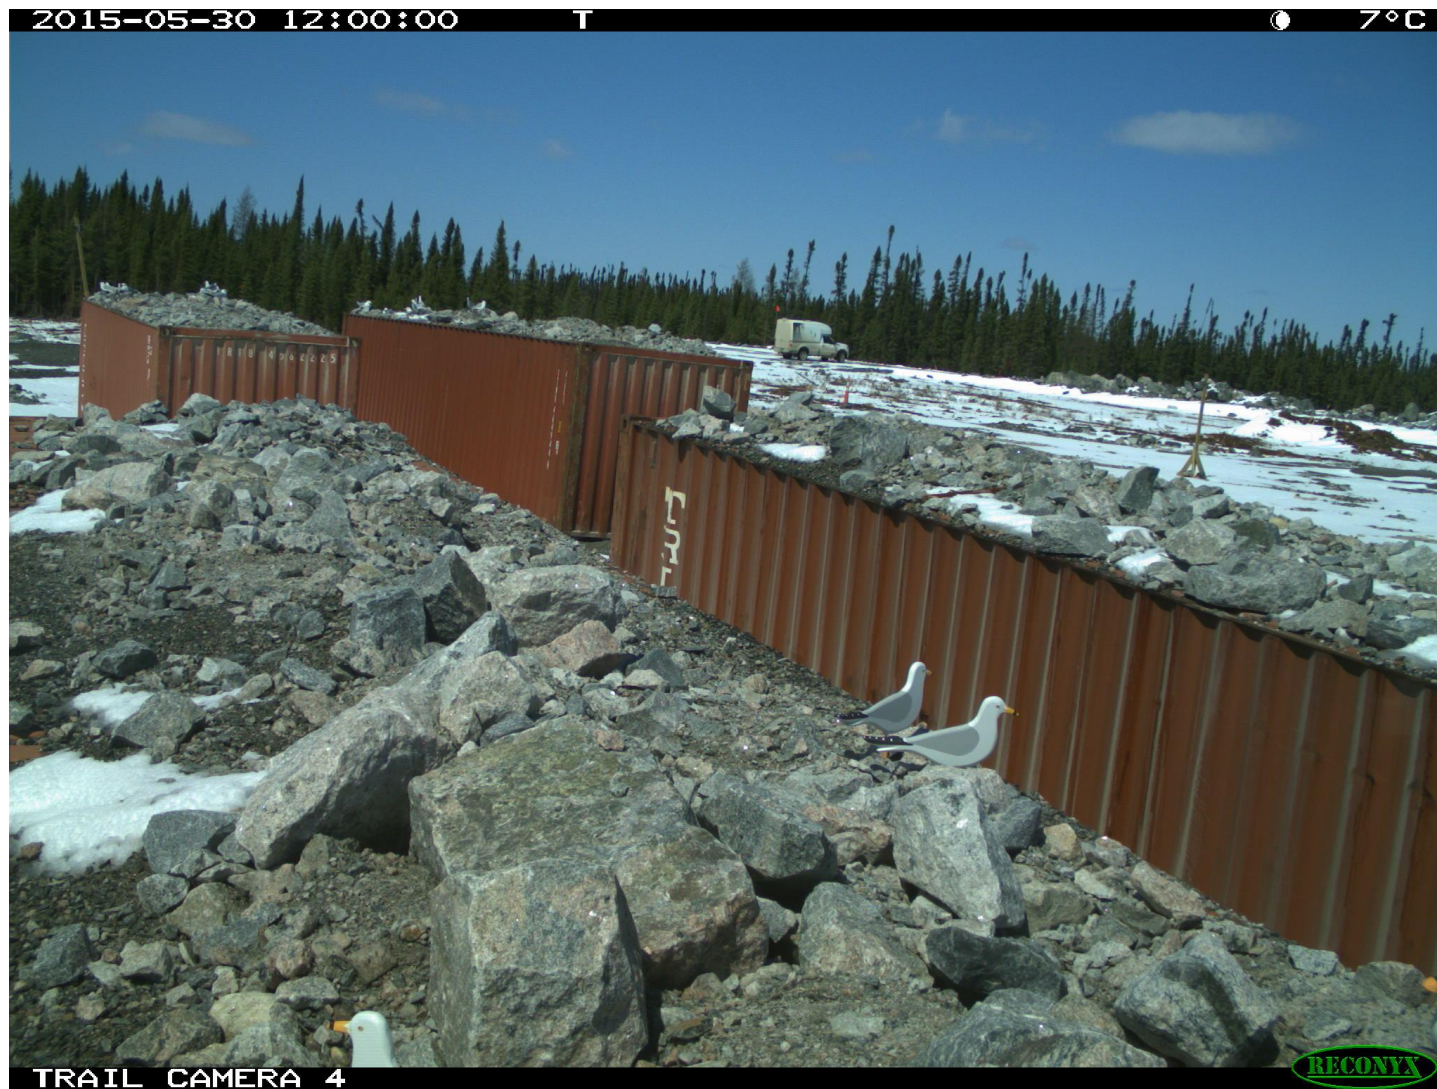
Photo A-5: Unidentified Truck parked at William Smith Island Habitat Enhancement Area at 12 p.m. on May 30, 2015
