## Keeyask Generation Project Physical Environment Monitoring Plan

# Physical Environment Monitoring Report

PEMP-2017-01

### **2016-2017 PHYSICAL ENVIRONMENT MONITORING REPORT: YEAR 3 CONSTRUCTION**

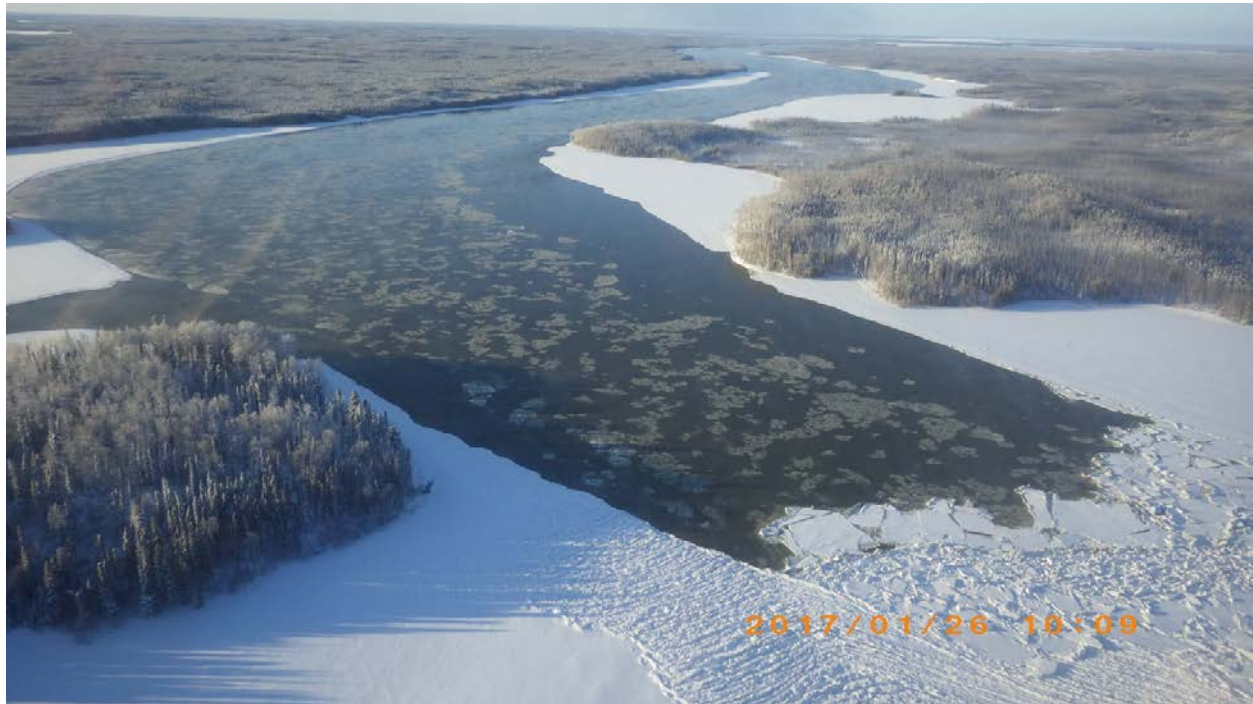
#### **Ice accumulation below Birthday Rapids and ice pans being transported from upstream.**

A complete ice cover began forming on Gull Lake in early December, growing in an upstream direction until it progressed to the base of Birthday Rapids by early January. Water levels rose on Gull Lake and upstream to Birthday Rapids as the ice cover developed. Ice pans (small ice sheets) continued to move downstream from Clark Lake to Birthday Rapids and much of it would have been swept under the ice cover at Birthday Rapids. The ongoing accumulation of ice under the existing ice cover would gradually block the flow channel causing water levels to rise gradually. By early March, the gradual increase in levels reduced flow velocities in Birthday Rapids, which allowed the ice cover to progress upstream until the cover eventually reached about 6 km upstream of the rapids. This is about 2 km further upstream of the rapids than the ice cover reached in 2015. This is consistent with pre-Project observations that in years when the ice cover progressed through Birthday Rapids it would likely stop about 5 km upstream of the rapids.

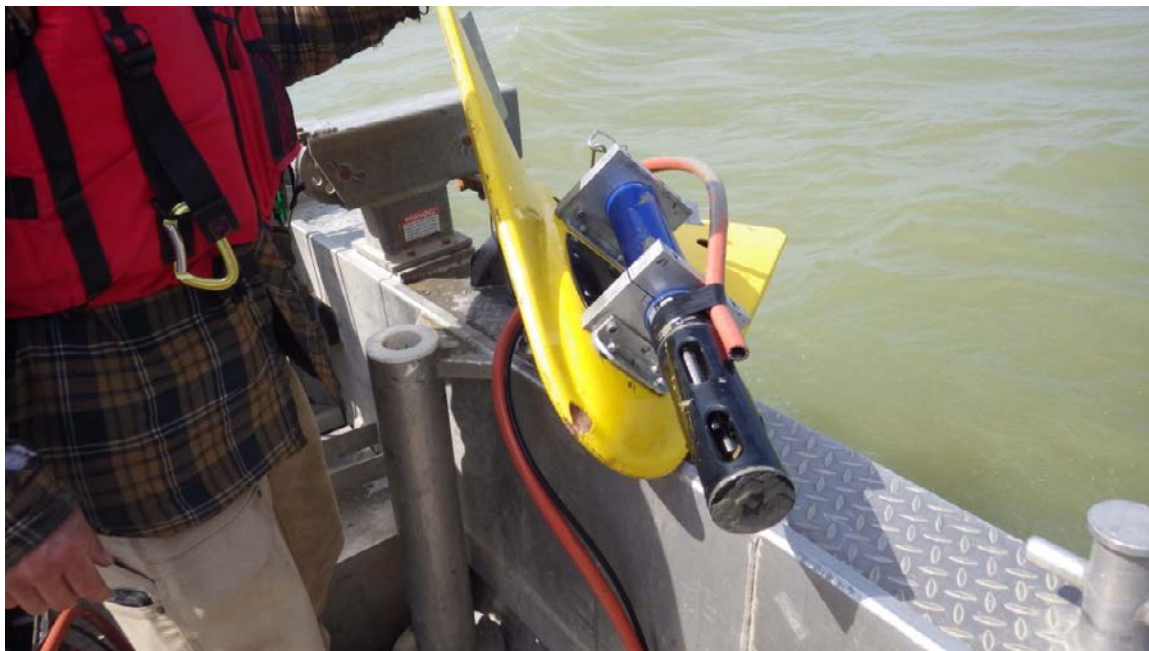
**Botwing device (yellow) with mounted probe for turbidity sampling and hose for collection of water samples for laboratory testing**

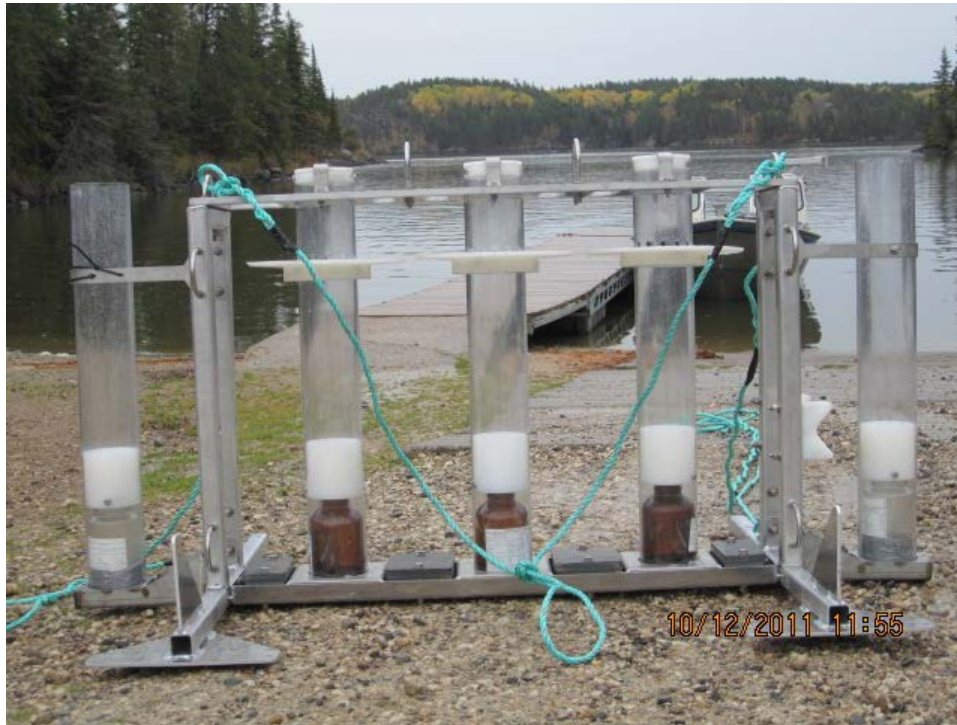
A sediment trap generally consists of five open-ended plastic tubes standing vertically in a metal frame that sits on the lakebed. Sediment settling out of the water enters an opening in the tube and accumulates in a sample jar at the bottom of the tube until the trap is recovered and the sediment samples are sent to a laboratory for grain size analyses. In 2016, a sediment trap was placed at the entrance to Stephens Lake. Originally, a sediment trap was to also be placed at the upstream end of Gull Lake. However, a sediment trap was not placed at this site in 2016 because of adverse conditions that previously resulted in losing monitoring equipment at this location.

#### **Five tube sediment trap used in PEMP deposition monitoring**

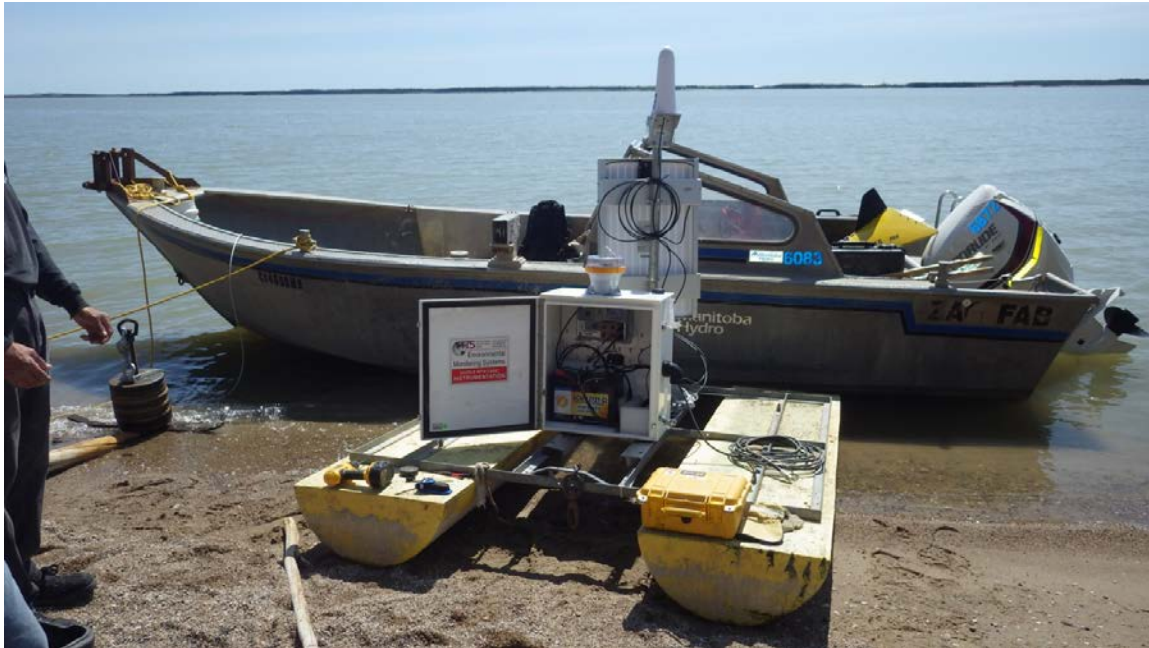
**Continuous turbidity monitoring equipment being prepared for deployment – electronics cabinet and solar panel on a catamaran below which a turbidity sensor will be suspended in the water**

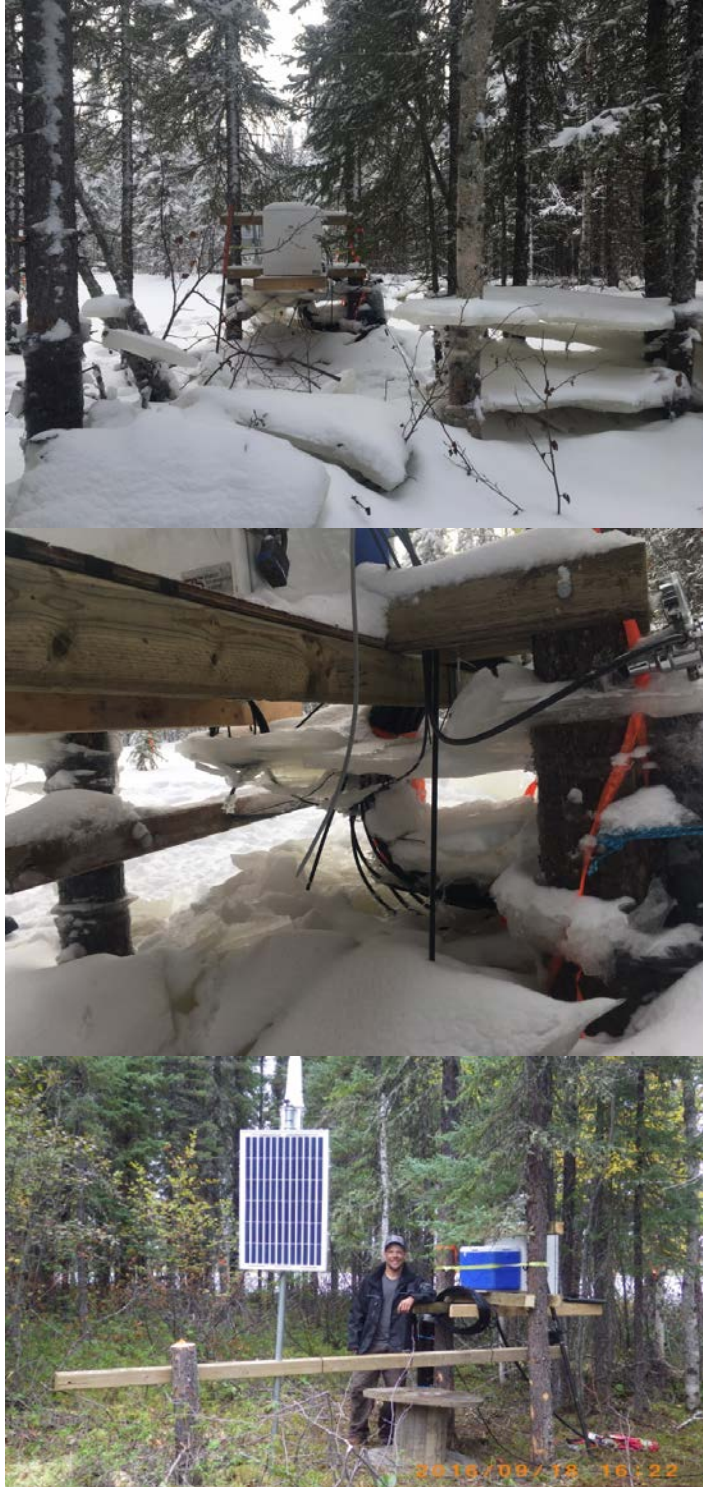
**Photo 2:** Suspended ice at water level gauge 05UF587 upstream of Gull Lake with a summer image for reference

Levels increased 5-6 m at the sites upstream of Gull Lake and below Birthday Rapids. Erratic data was observed at the site upstream of Gull Lake (05UF587), which was likely due to ice effects on the equipment. A site visit in January 2017 found different levels of suspended ice (i.e., layers of ice frozen into the trees) at this gauge site, with ice right up to the base of the main equipment platform and ice on equipment and cabling below the platform (Photo 2). Water levels at the site above Birthday Rapids rose about 2.5 m in December and steadily rose through the winter, likely due to growth of shore ice and accumulation of ice at Birthday Rapids. Up to March, winter staging (i.e., an increase in water level not associated with an increase in flow) of about 1.3 m occurred below Clark Lake, about 0.8 m on Clark Lake, and about 0.7 m on Split Lake. The staging on Split Lake is typical of winter increases seen before construction (KHLP 2012b, Sec. 4.3.1.3).

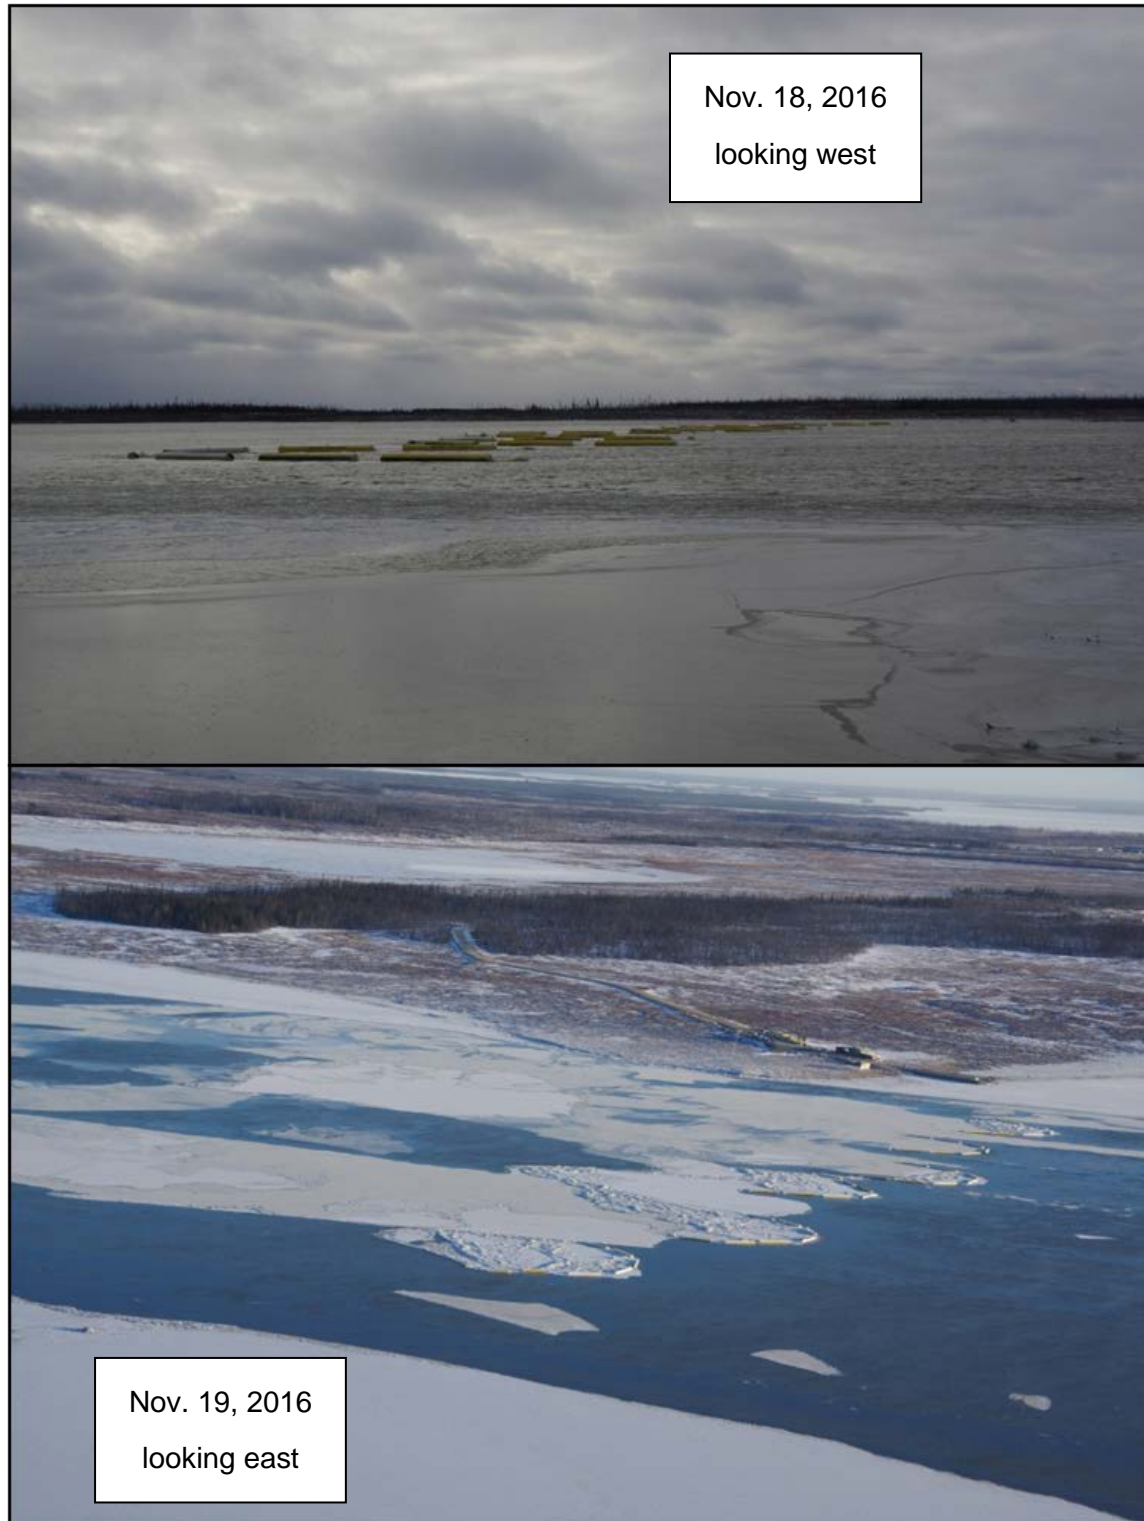
**Photo 3: Ice Boom A on east side of Caribou Island (Nov. 18, 19, 2016)**

In 2016, open water conditions persisted until about November 19 when air temperatures dropped sharply and ice formation increased, as evidenced by increasing water levels at gauge sites above Gull Lake and on Clark and Split lakes. Little ice was present at the ice booms on November 18, but ice had begun to accumulate on the 19<sup>th</sup> and water levels increased (Photo 3). Levels subsequently dropped on Gull Lake when temperatures increased, but by December 1, the Gull Lake levels were gradually increasing. About December 6, the temperatures dropped and levels began a sharper rise as the upstream ice cover progression increased. While ice had accumulated at Ice Boom B south of Caribou Island on November 19 (Photo 4) the ice had moved away from it in the following days. By December 3, the ice had bridged across the river

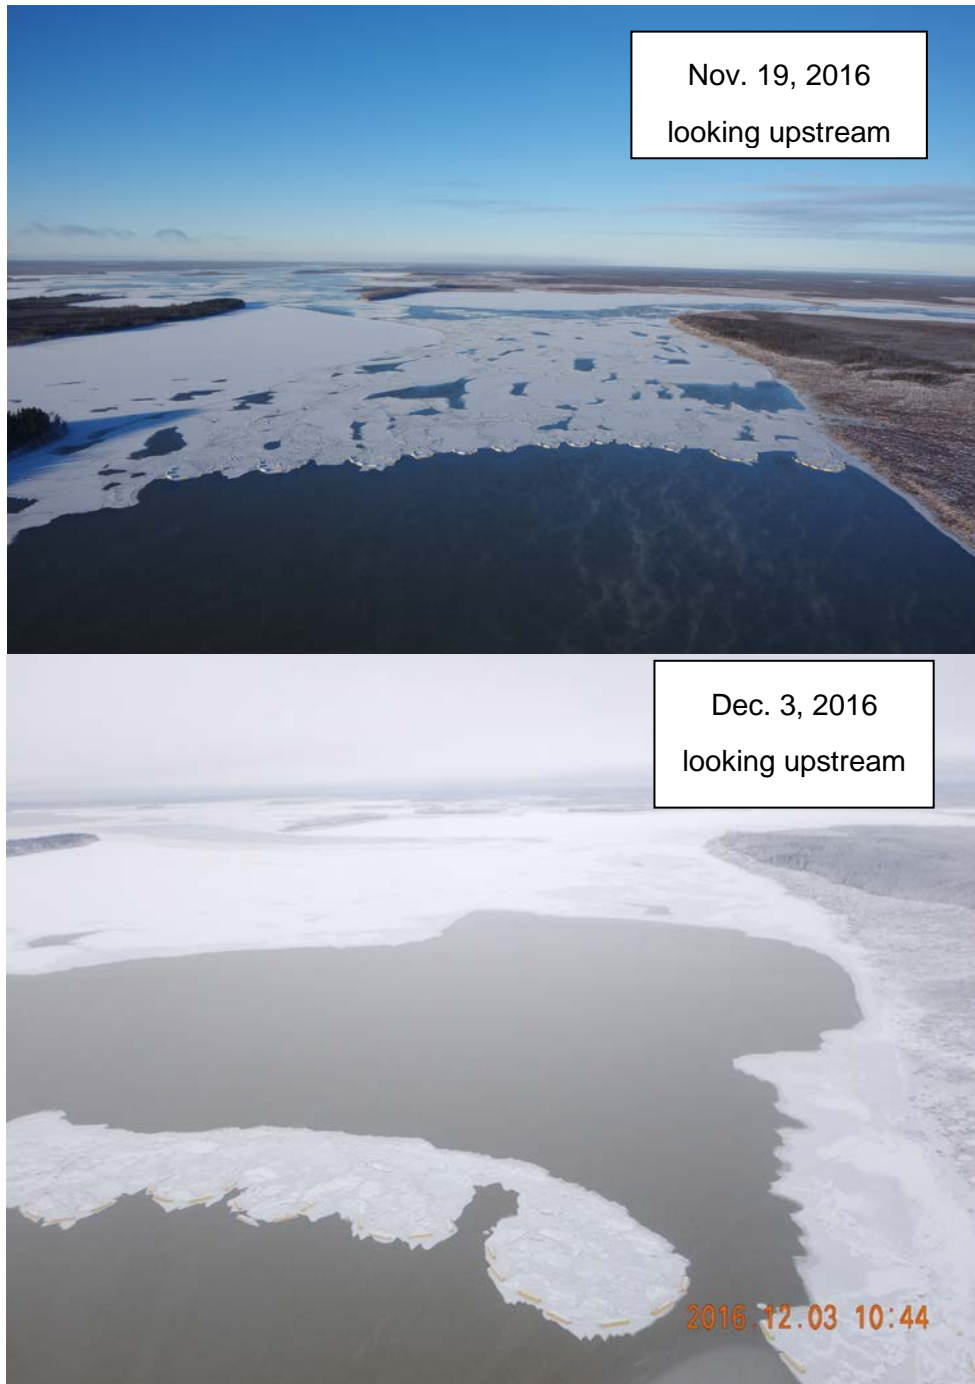
**Photo 4: Ice Boom B on south side of Caribou Island (Nov. 19 & Dec. 3, 2016)**

just upstream of the boom, leaving open water between the boom and the ice bridge (Photo 4). This open water gap gradually iced over until it closed up by about mid January.

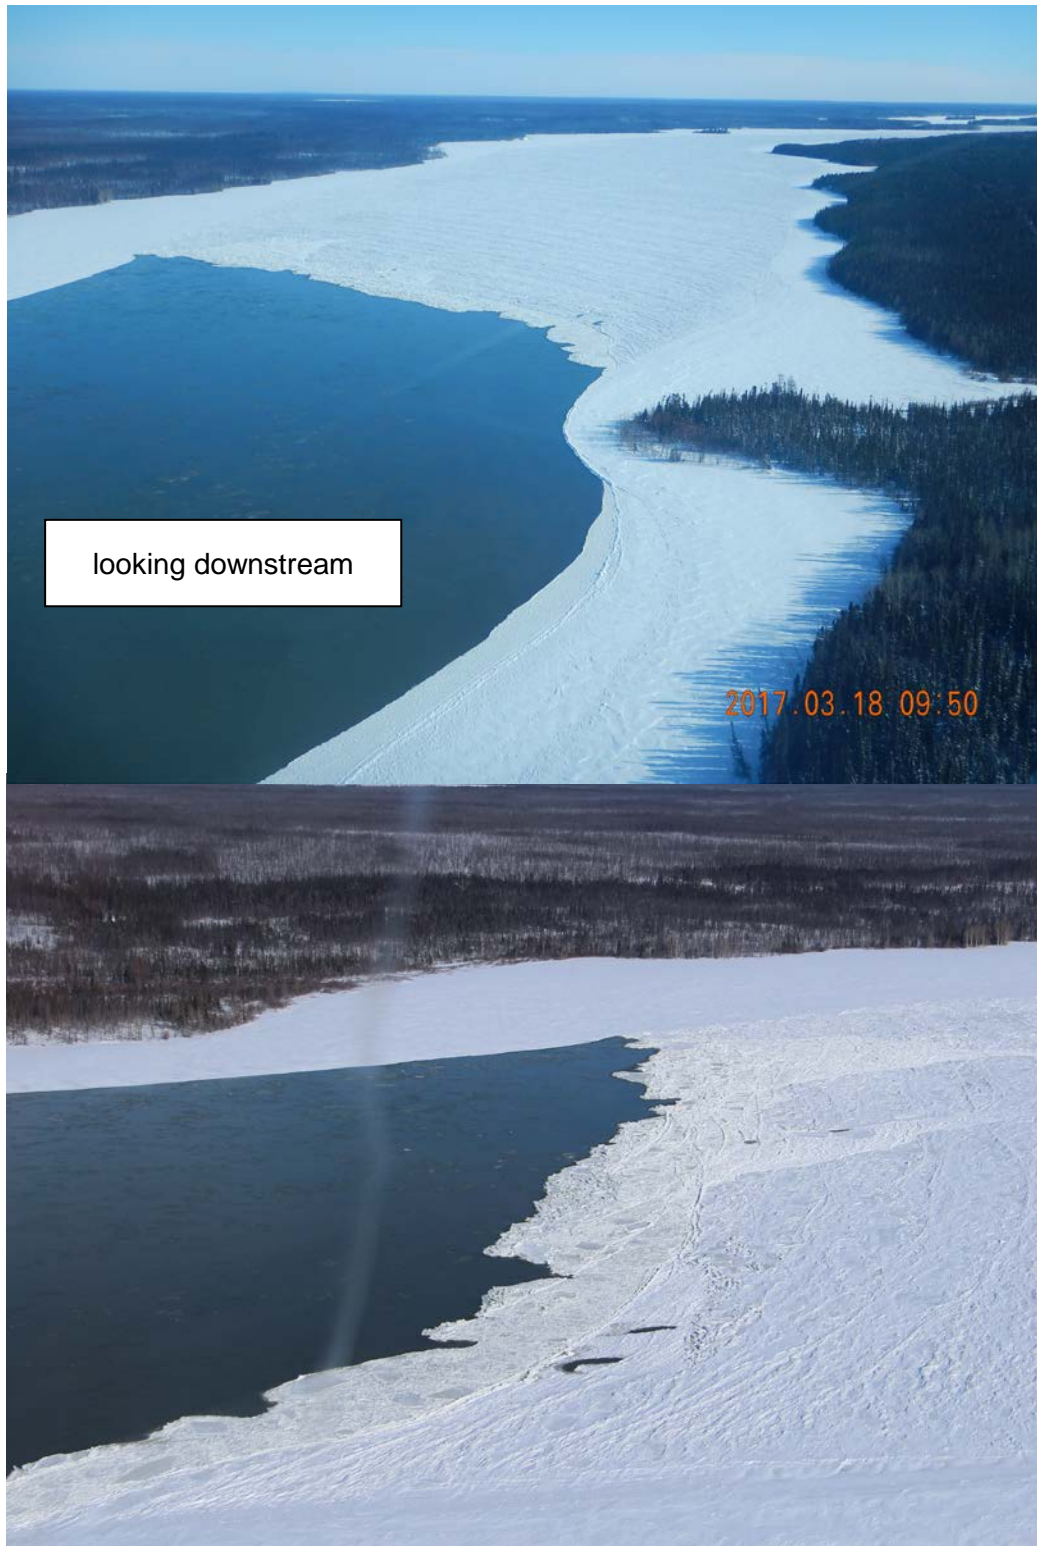
**Photo 5: Leading edge of ice cover upstream of Birthday Rapids (March 18, 2017)**

There are no cloud free satellite images available during the period of initial freeze-up from about November 19 to December 6. A Landsat 8 image from December 9 shows that by that date the ice front had progressed to about 1 km upstream of Gull Lake (Figure 5). The ice front gradually progressed upstream and the next available satellite image on Jan 1, 2017, shows the ice front stalled at the base of Birthday Rapids (Figure 5). As noted above, the ice front progressed through Birthday Rapids about March 4. By the time of the next available satellite image on March 22, the ice front had progressed about 6 km upstream of Birthday Rapids (Figure 5). As noted in the 2015/2016 annual PEMP report (Manitoba Hydro 2016), the ice front also progressed through Birthday Rapids in March 2016 and progressed to at least 4 km upstream. The Keeyask EIS had also noted that in the pre-Project environment if the ice front progressed through Birthday Rapids, it would typically stall about 5 km upstream (KHLP 2012b). By the time of the next satellite image on March 31, 2017, the ice front had begun to recede downstream and continued to recede in subsequent images. Like the ice cover that forms in the river channel below Birthday Rapids, the upstream cover formed as ice piled up at the leading edge, pushing and shoving as more accumulated, resulting in a rough, jumbled ice surface (Photo 5, Photo 6).

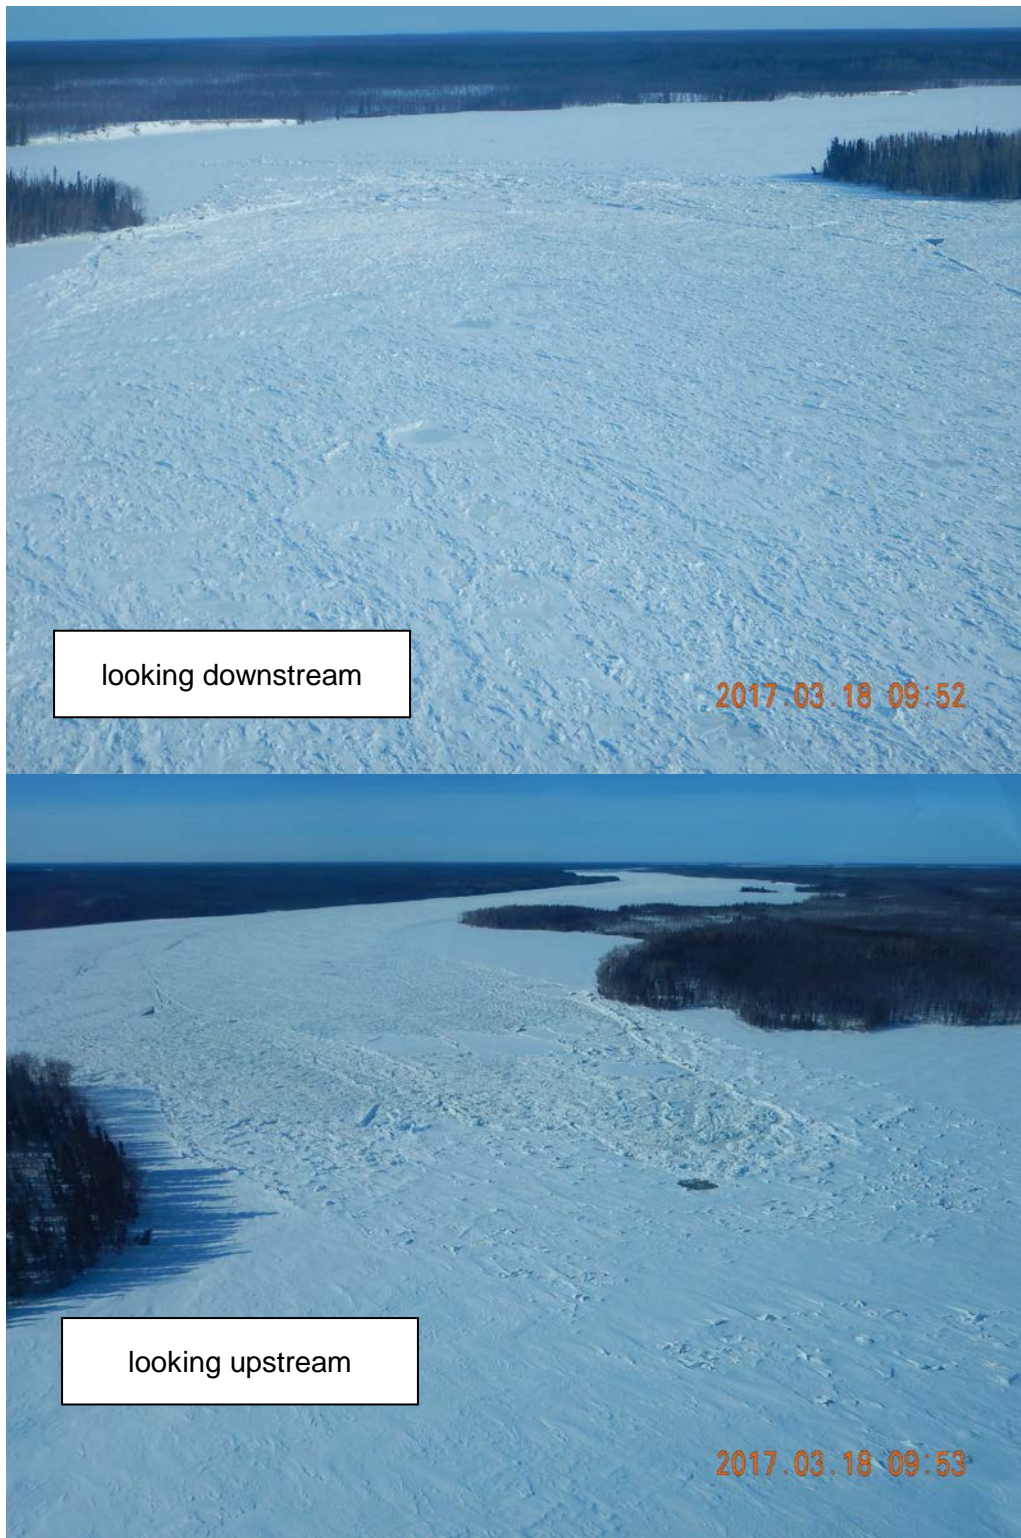
**Photo 6: Ice cover at Birthday Rapids (March 18, 2017)**

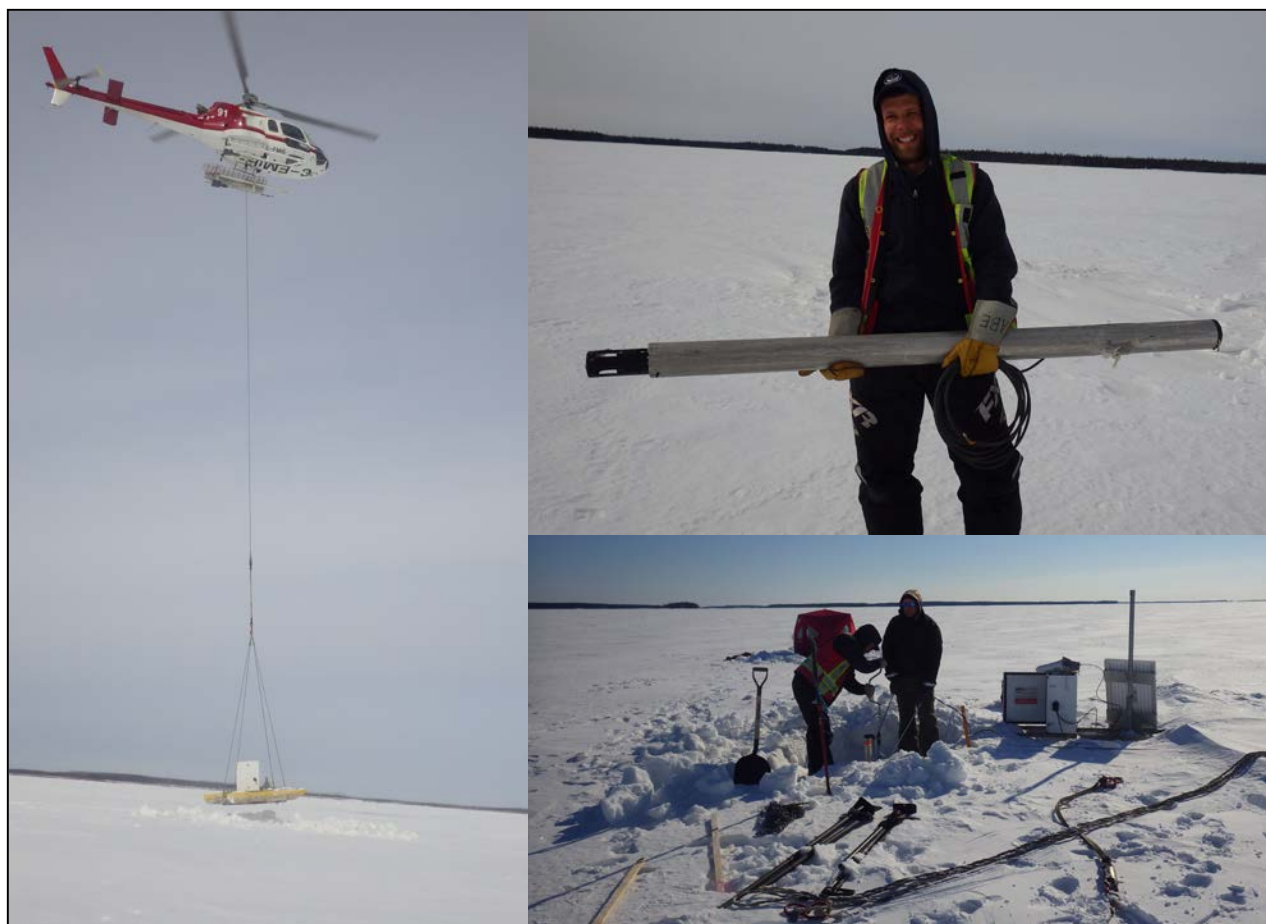
Winter monitoring involves the use of the summer monitoring platforms placed on the ice (Photo 7). An aluminum pipe is placed through the ice and the turbidity probe is suspended in the pipe so that the sensor Projects out of the tube below the bottom of the ice. Winter monitoring faces unique difficulties due to factors such as slush below the ice and freezing of equipment.

**Photo 7: Winter installation of continuous turbidity monitoring site**

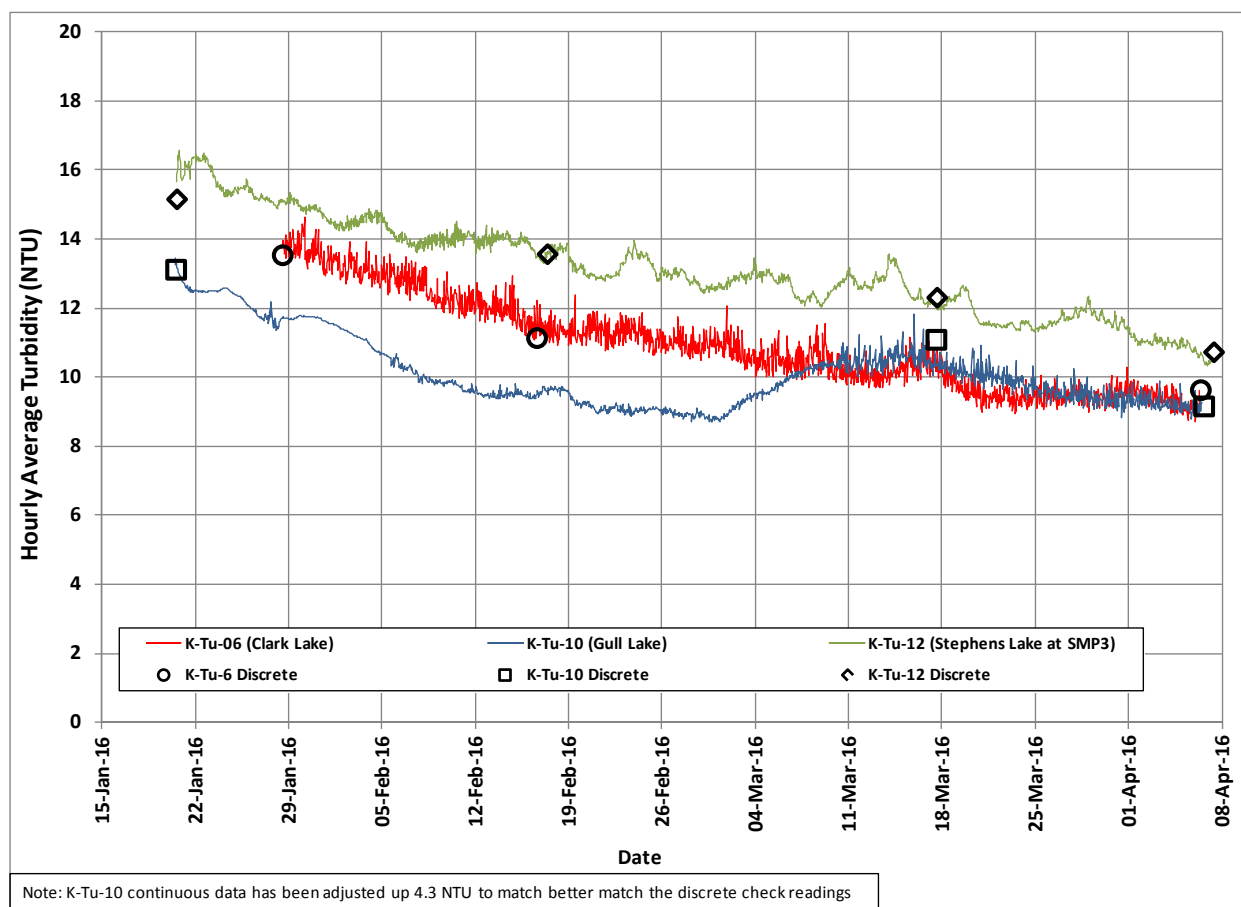
**Figure 6: Winter 2015/2016 continuous and discrete turbidity**

Figure 6 shows turbidity data collected in the January to April period. On three visits to site K-Tu-10 the discrete turbidity readings obtained using a separate check probe were consistently greater than the value from the continuous probe. The continuous probe likely had a low bias, therefore the continuous values were adjusted up by 4.3 NTU to better align with the discrete check readings. Turbidity generally declined at all three sites by about 4-6 NTU during the monitoring period. Turbidity was highest at K-Tu-12 in Stephens Lake, although K-Tu-06 was only lower by about 1 NTU over the whole period, as was K-Tu-10 over about the last month. A difference of 1 NTU is not particularly large. Turbidity at K-Tu-10 in Gull Lake was lower than at K-Tu-06 and K-Tu-12 by 2-3 NTU over about the first 5 weeks of monitoring before rising at the start of March. Though it cannot be confirmed, this may be due in part to additional water level staging at and upstream of Birthday Rapids at about the same time, as noted in Section 2.2. Conditions observed at K-Tu-06 are much the same as observed the previous winter (2014/2015) while results for site K-Tu-10 in Gull Lake are similar to the short period of data from Gull Lake in winter 2014/2015. Results at K-Tu-12 are much lower than observed the previous year, possibly due to less interference from ice and differences in under-ice erosion conditions.

As with the continuous turbidity, the discrete turbidity values showed a decline from the start to the end of the monitoring period (Table 2). Discrete TSS concentrations were higher in January but, except for a low value of 2.7 mg/L, only varied over a small range from 4.3 mg/L to 5.5 mg/L from February to April, a negligible difference of 1.2 mg/L. These TSS concentrations are similar to those observed in winter 2014/2015. Low TSS concentrations were observed in winter on Gull Lake prior to construction (2008, 2009), however some higher values of up about 40-80 mg/L were also measured in the pre-Project sampling (KGS Acres 2011). Below Gull Rapids, the pre-construction TSS concentrations were higher than observed in 2015/2016, having varied from about 20 mg/L to a maximum of 156 mg/L. The past higher TSS levels may result from ice accumulation at the entrance to Stephens Lake, which can redirect flows and increase flow velocities over erodible bottom material causing sediment to be suspended in the water. During construction, the upstream ice-boom reduces the accumulation of ice at the entrance to Stephens Lake, which may reduce the effects on TSS due to under-ice flow re-direction.

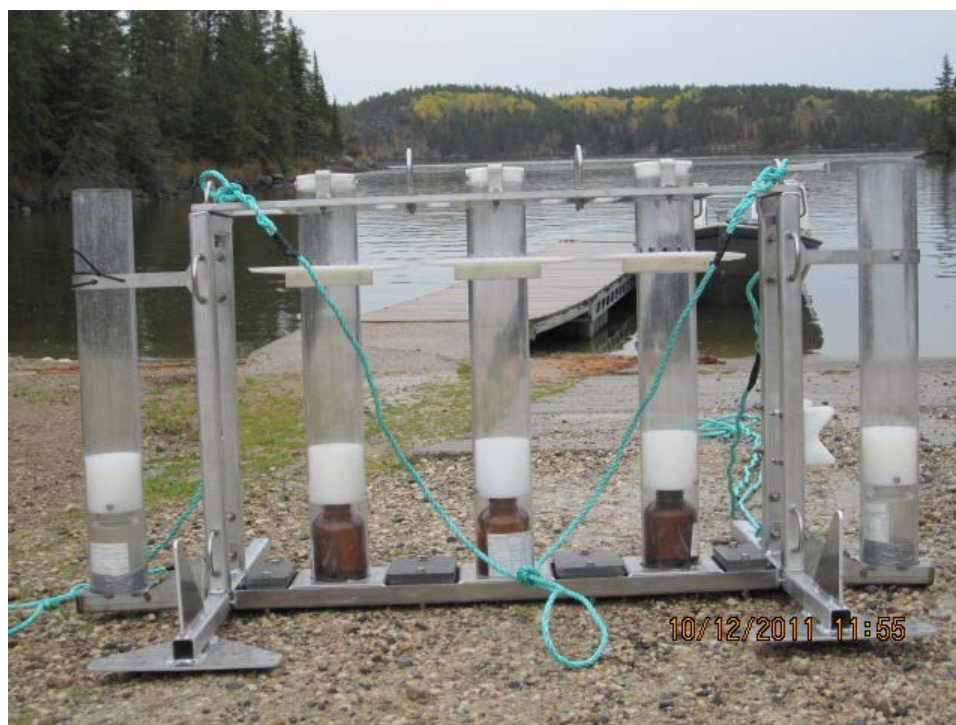
**Photo 9: 5-Tube sediment trap used at site K-ST-02**

A sediment trap was deployed at the K-ST-02 site in Stephens Lake on October 2, 2015, and was recovered 309 days later on August 6, 2016 to obtain sediment samples collected in the trap (referred to as the winter period). It was redeployed on August 6 and recovered 68 days later on October 13, 2016 (referred to as the open water period), after which it was again redeployed to be in place until summer 2017. The trap consists of five 10-cm diameter tubes (Photo 9) that have jars at the bottom in which sediment is deposited. The two outer tubes (settling tubes) have open tops to better catch vertically settling sediment while the three middle tubes (flow tubes) have closed tops with a dozen 18 mm holes drilled around their circumference to catch sediment being advected horizontally with the flow.

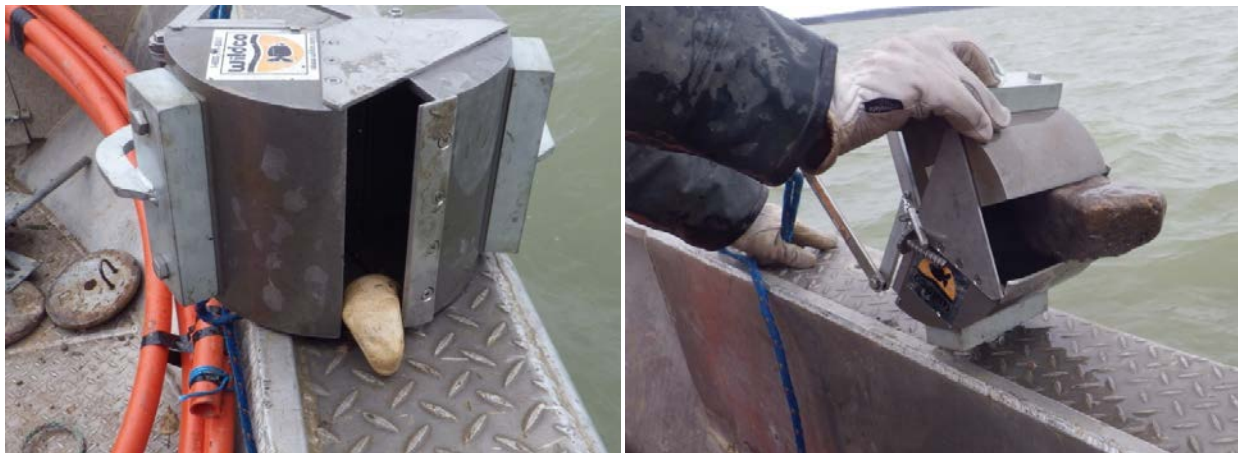
**Photo 10: Coarse substrate material at site K-ST-02 in 2015**

Substrate sampling was not performed in 2016 because sampling in 2015 found the bottom to be comprised of large cobble type material at both K-ST-01 and K-ST-02. As noted in the 2015/2016 PEMP annual report, based on the presence of a cobble bottom at site K-ST-02 it is apparent that fine material captured by the sediment trap is not being deposited and accumulated on the lake bed in this area (Manitoba Hydro 2016).
