Keeyask Generation Project

Sediment Management Plan for In-stream Construction

REPORT #SMP-2017-01

April 2016 – March 2017: Year 3 Construction

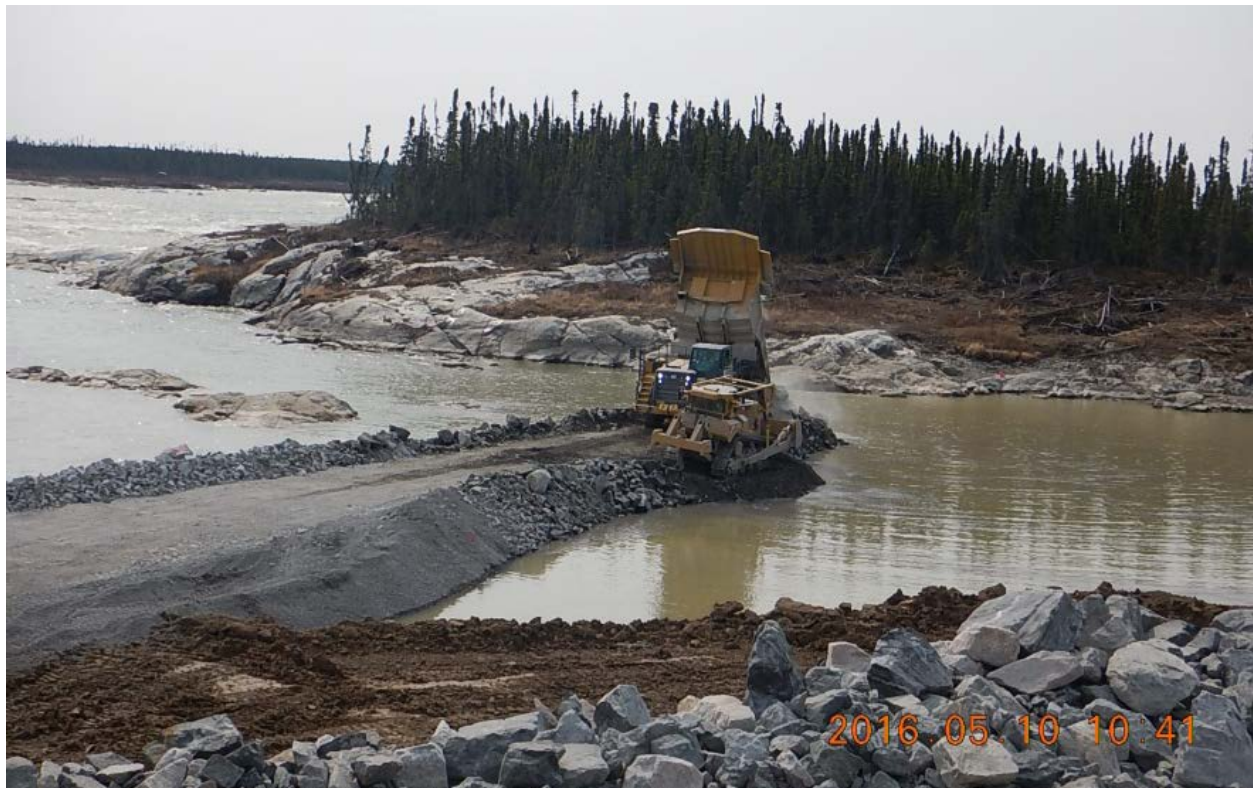
Figure 4: Constructing a rock groin for the Central Dam Cofferdam Extension on May 10, 2016.

The Central Dam Cofferdam (CDCD) Extension consists of two additional short cofferdams (which are comprised of upstream and downstream rock groins (Figure 4), between which impervious, sandy-silt material is placed) to connect the existing CDCD to the island shown in Figure 1. The extension was constructed during the spring of 2016 to reduce the volume of seepage through the Central Dam Cofferdam (Figure 1). The blanket is a modification to the original design of the Central Dam Cofferdam and the work in 2016 was not proposed during the planning phase prior to the start of construction in 2014. (An alteration to *Environment Act* Licence 3107 was issued to expand the CDCD beyond the footprint limits.)

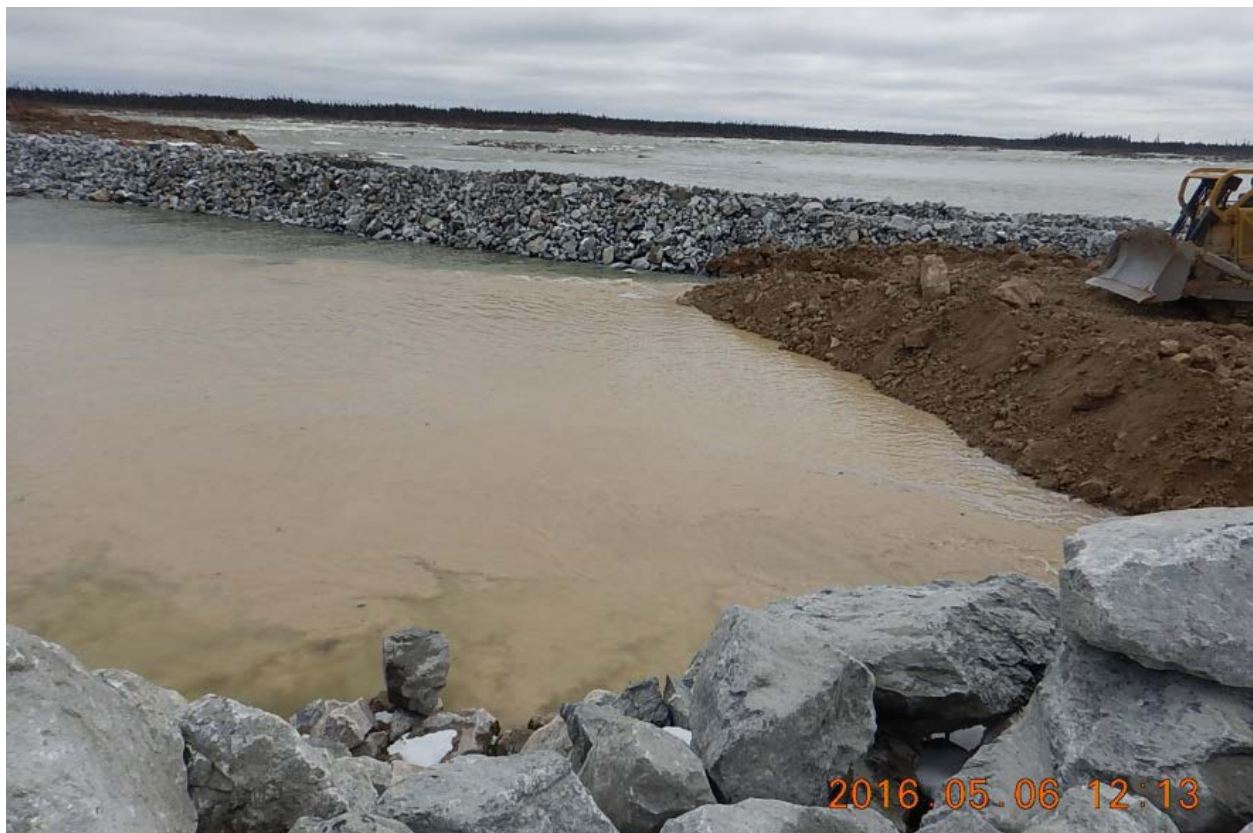
On May 6, 2016, a sediment plume was observed during the placement of impervious material adjacent to the outer rock groin (Figure 5). This plume quickly dissipated once it reached higher flows within Gull Rapids; however, upon its discovery, the placement of impervious material was halted. In order to mitigate the loss of the impervious material to the river, the following day, a groin was constructed using coarse rockfill material with the intention that it would act as a barrier to reduce the amount of impervious material entering the river (Figure 6). Once this was complete, placement of impervious material resumed during the night shift on May 7, 2016. The construction of this additional, coarse rockfill, center groin was successful in minimizing sediment entering the Nelson River due to placement of impervious material and no additional plumes were observed.

Figure 5: On May 6, 2016, a sediment plume developed while placing impervious material at the Central Dam Cofferdam Extension, which is shown in the background.

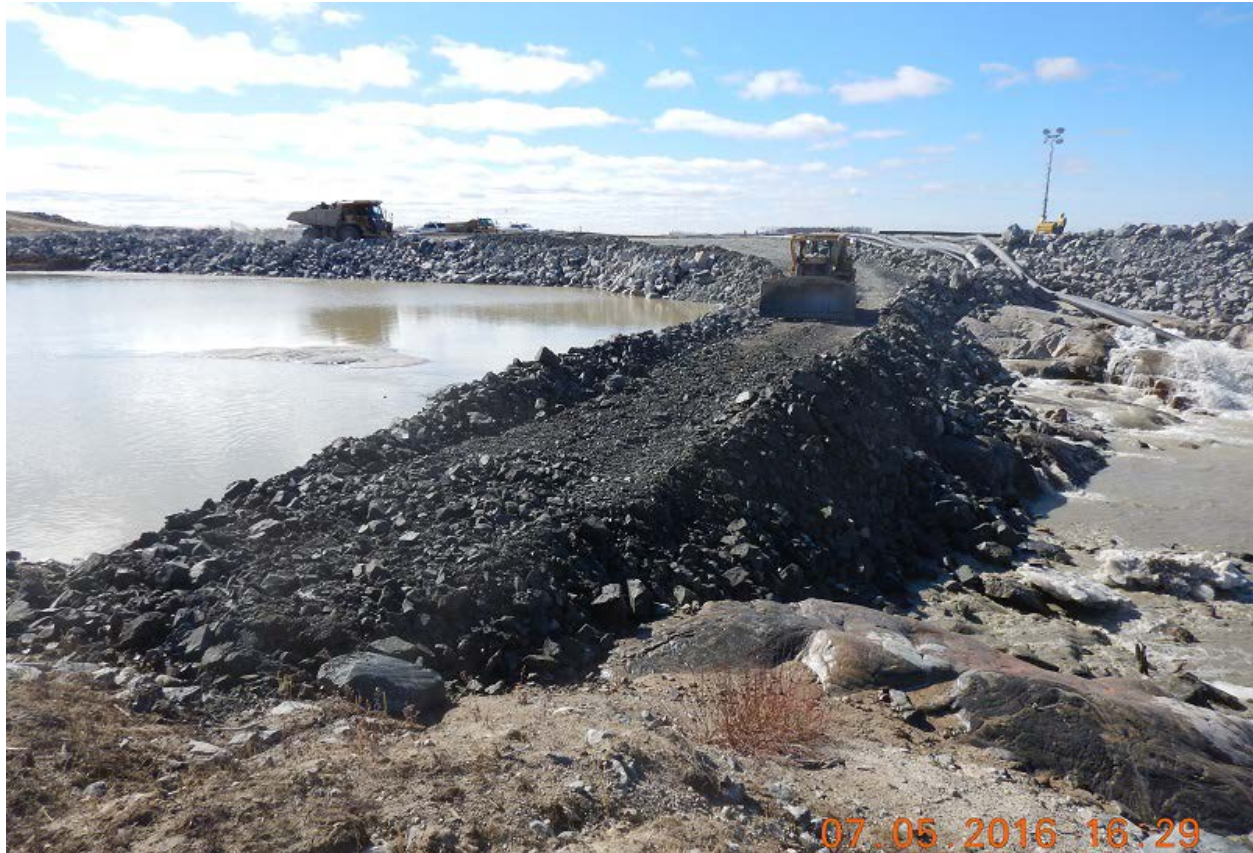
Figure 6: Dozer placing coarse rockfill to create a barrier to prevent impervious material from entering the river (May 7, 2016)

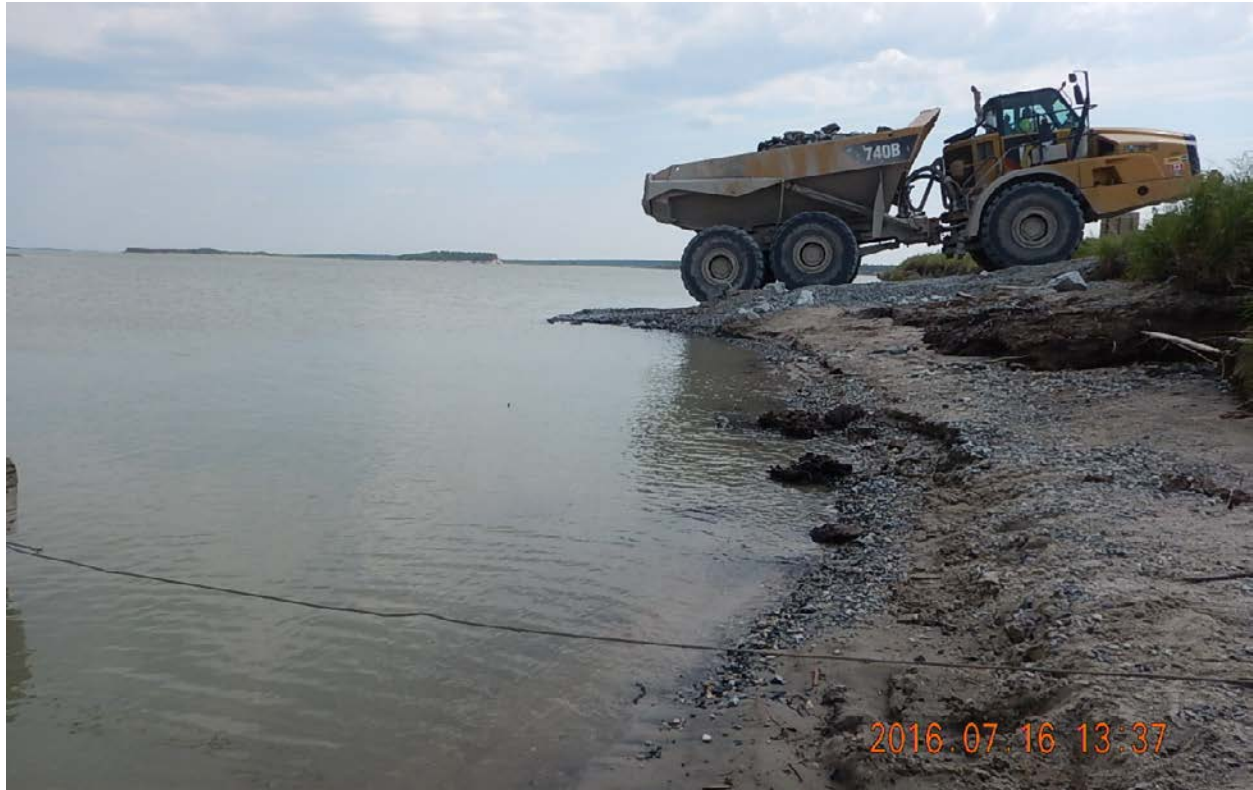
Figure 7: Cat 740 haul truck placing rock for the repair of the Downstream Boat Launch on July 16, 2016

The Downstream Boat Launch is a rockfill ramp that extends into Stephens Lake below Gull Rapids. The design of the boat launch cannot withstand the movement of ice during freeze-up and break-up and must be repaired every spring. Attempts to repair the Downstream Boat Launch on May 2, 2016 were hampered by the presence of ice, but it was eventually repaired on July 16, 2016. This included the placement of C1 rockfill (Figure 7), and the shaping and rebuilding of the boat launch ramp using an excavator (Figure 8).

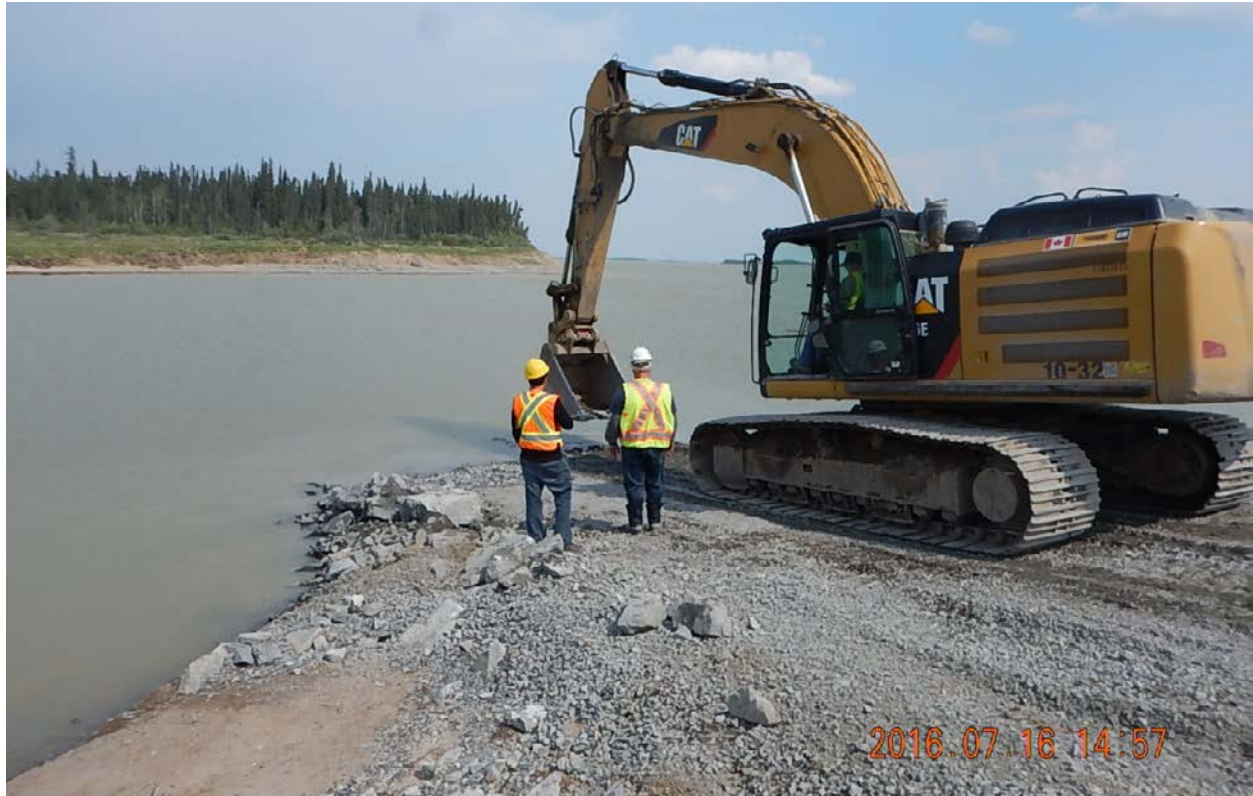
Figure 8: Excavator placing and shaping rockfill during the repair of the Downstream Boat Launch ramp on July 16, 2016

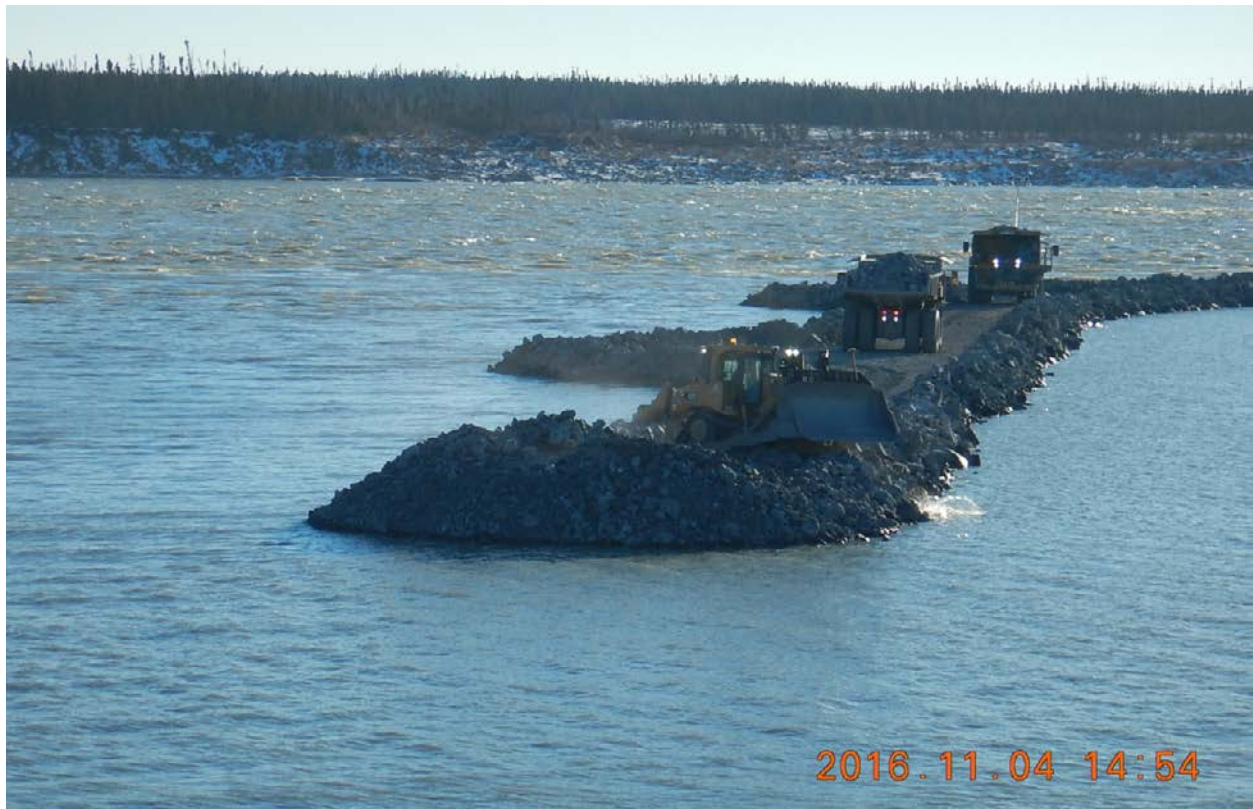
Figure 11: Placement of Class C1/C2 rockfill and riprap on the outer groin of the Tailrace Summer Level Cofferdam on November 4, 2016

In-stream work to construct the Tailrace Summer Level Cofferdam rock groins (Figure 11 & Figure 12) commenced on August 4, 2016 using Class C1 rockfill and Class C2 riprap. After August 5, changes to the design and schedule delayed further work on the cofferdam until October 2016. In-stream work resumed on October 7, 2016 and included placing C1 and C2 rock to construct a boat launch off the inner groin of the cofferdam to allow water access for emergencies and spill response. Construction ceased for the winter after December 2 and an opening was left in the cofferdam to allow fish to move freely out of the area throughout the winter months (visible in Figure 13).

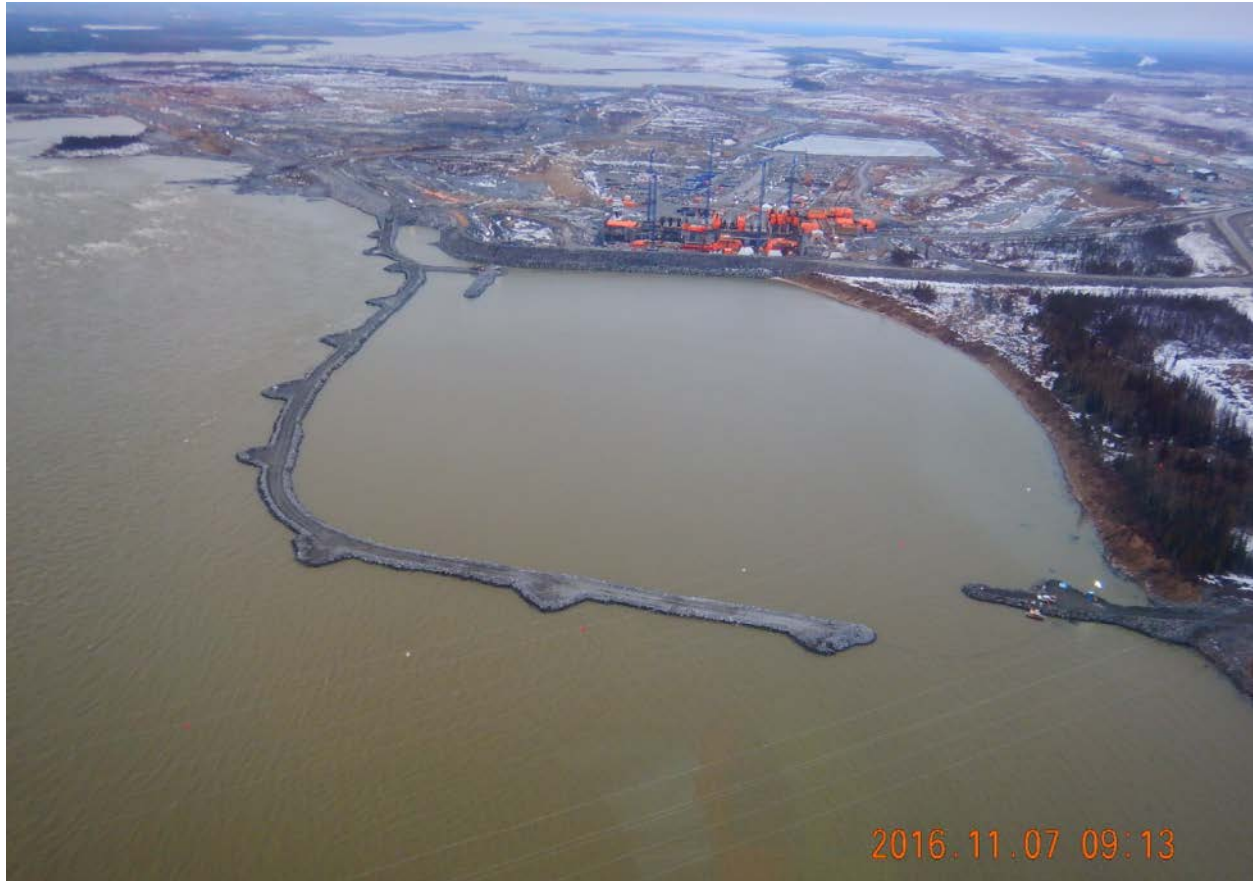
Figure 12: Aerial view of the incomplete Tailrace Summer Level Cofferdam, showing the outer rock groin (extending from the left) and a spur of the inner rock groin (extending from the right) on November 7, 2016

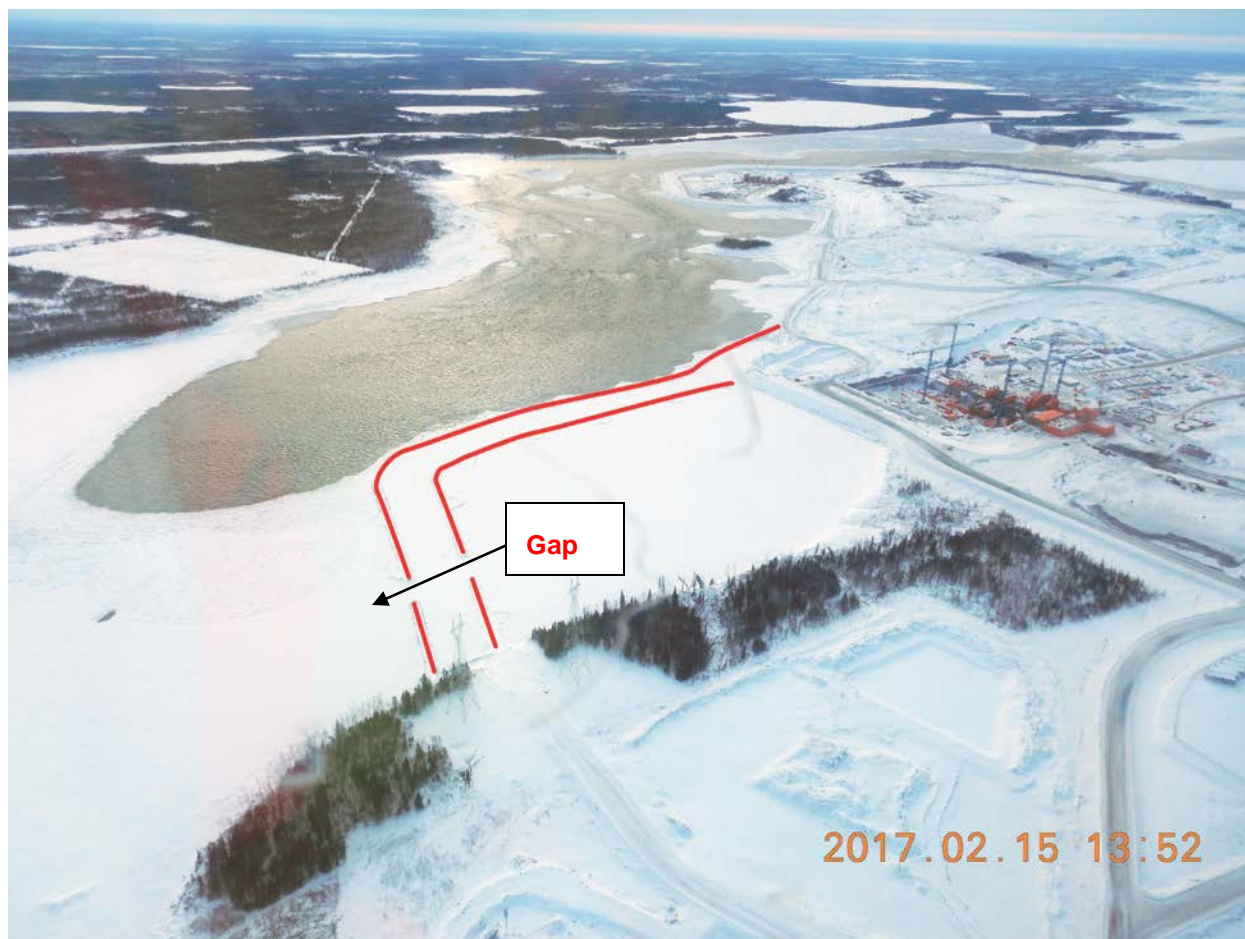
Figure 13: Aerial view of the Tailrace Summer Level Cofferdam in the winter, showing the inner and outer rock groins (red lines) and gap left for fish movement.

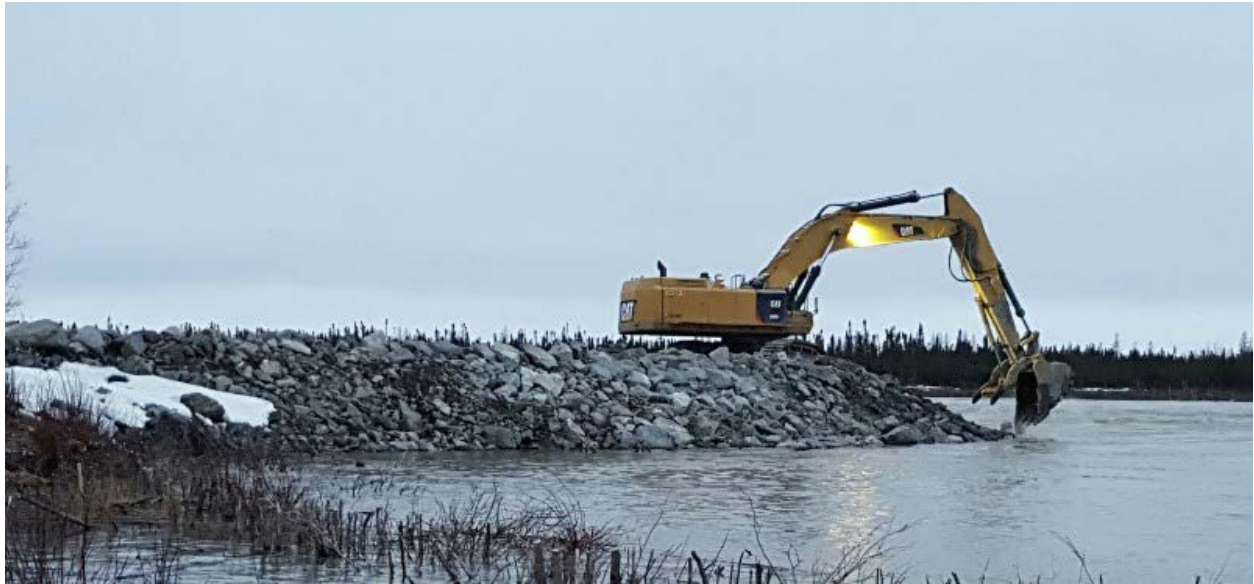
Figure 18: Excavator placing C3 material at the North Channel Rock Groin Extension on November 14, 2016

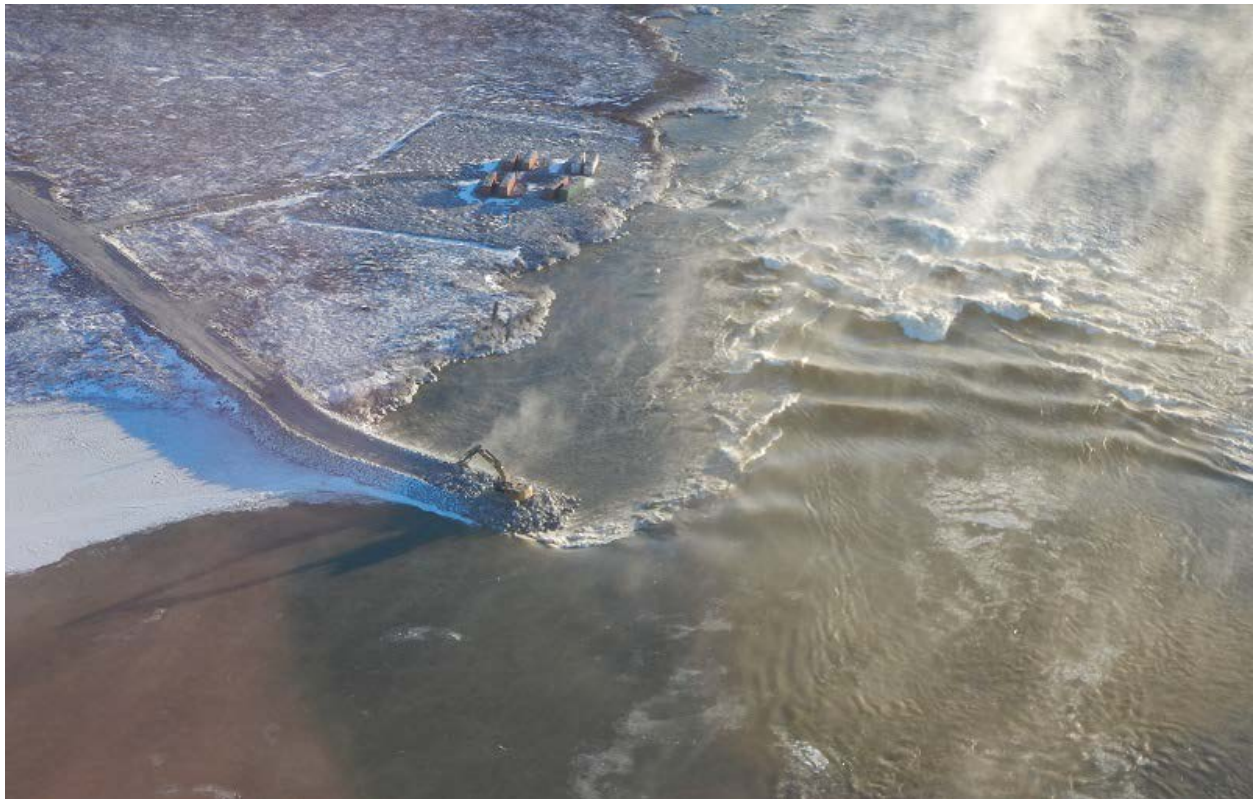
Figure 19: Aerial view of a Cat 390D excavator placing C3 material at the North Channel Rock Groin Extension on November 19, 2016

proximity to and downstream from the in-stream work (Figure 19). No sediment plumes were observed during the course of the work.

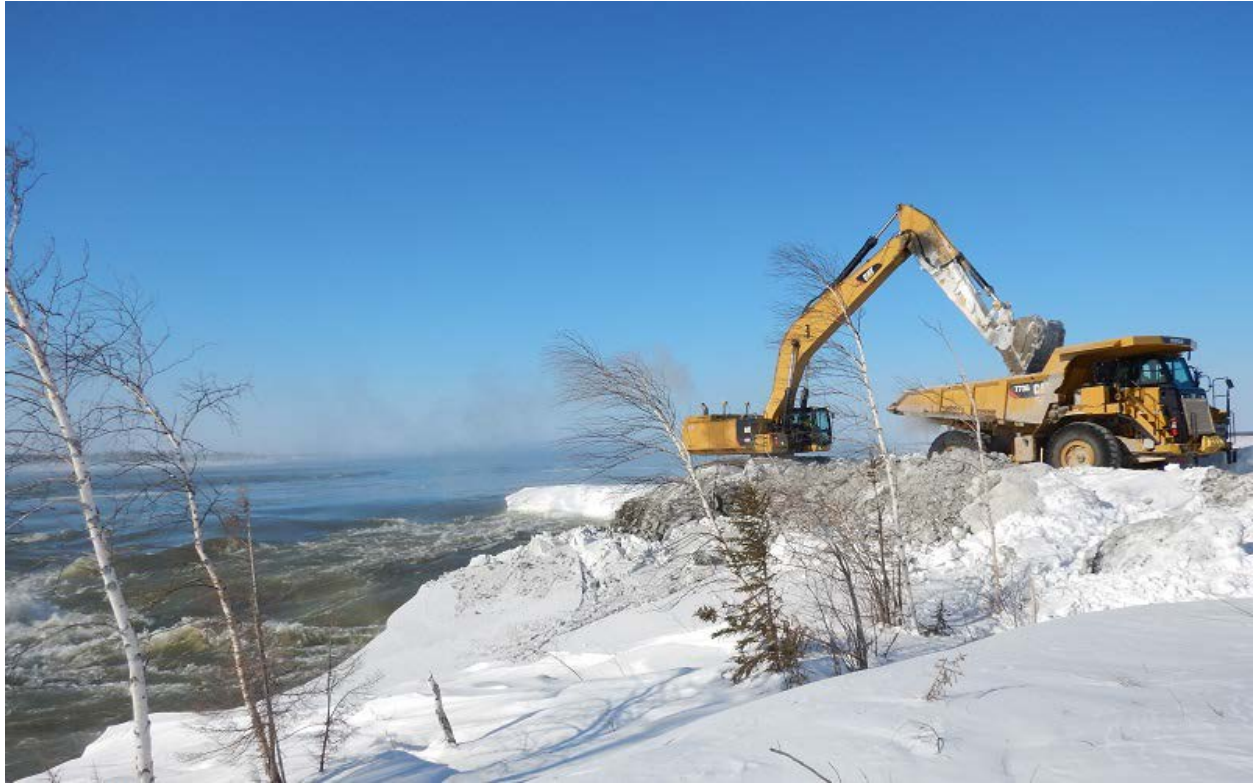
Figure 20: Excavator placing material removed from the North Channel Rock Groin Extension into a haul truck on March 11, 2017
