Keeyask Generation Project Terrestrial Effects Monitoring Plan

Habitat Loss and Disturbance Monitoring Report

TEMP-2017-01

ECOSTEM Ltd.

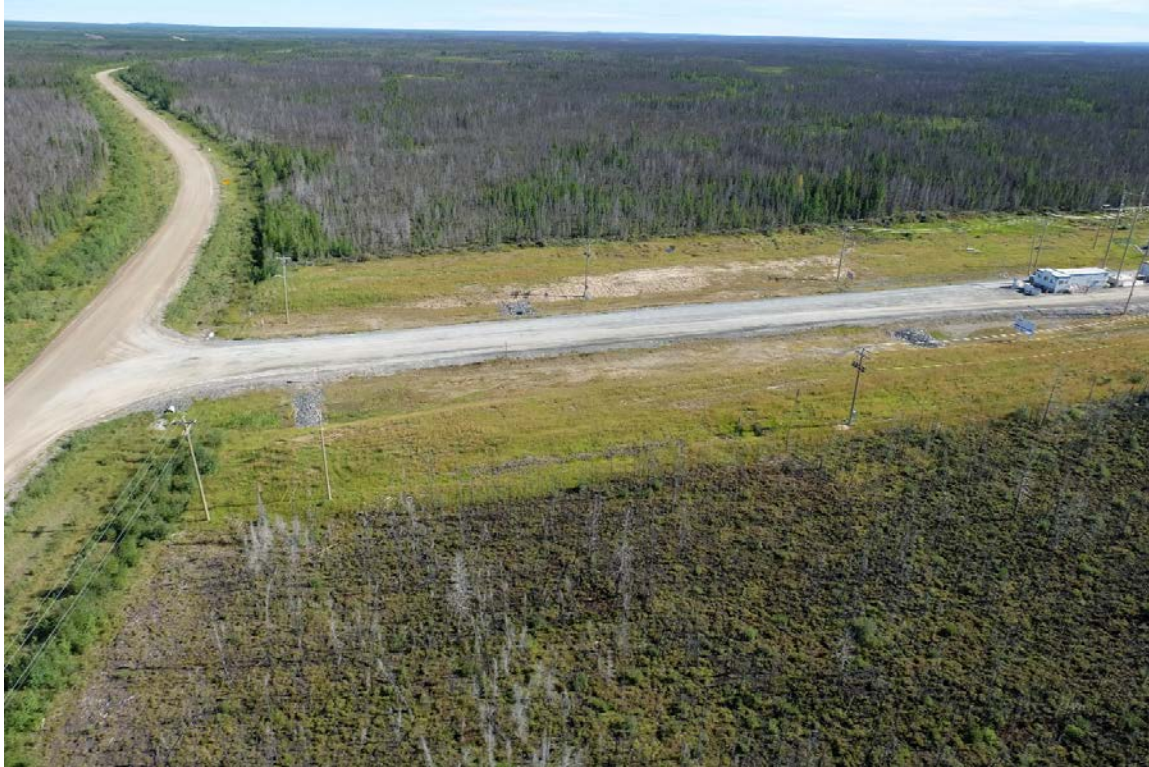
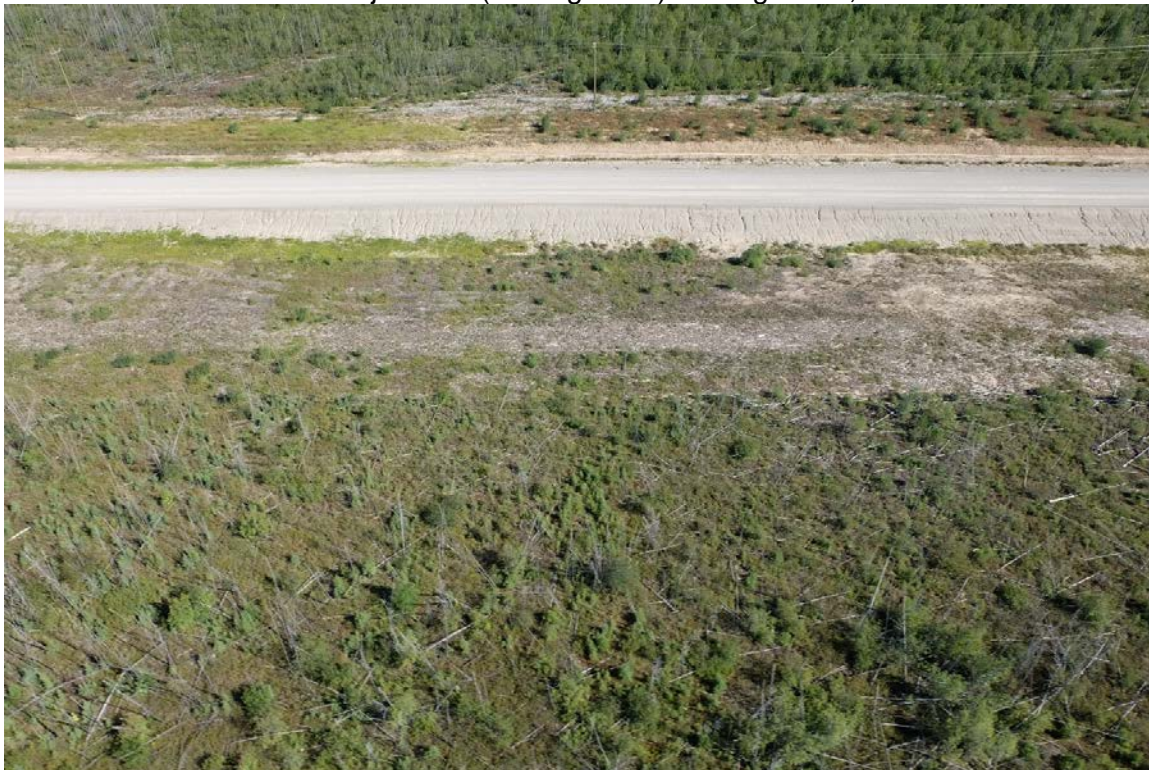
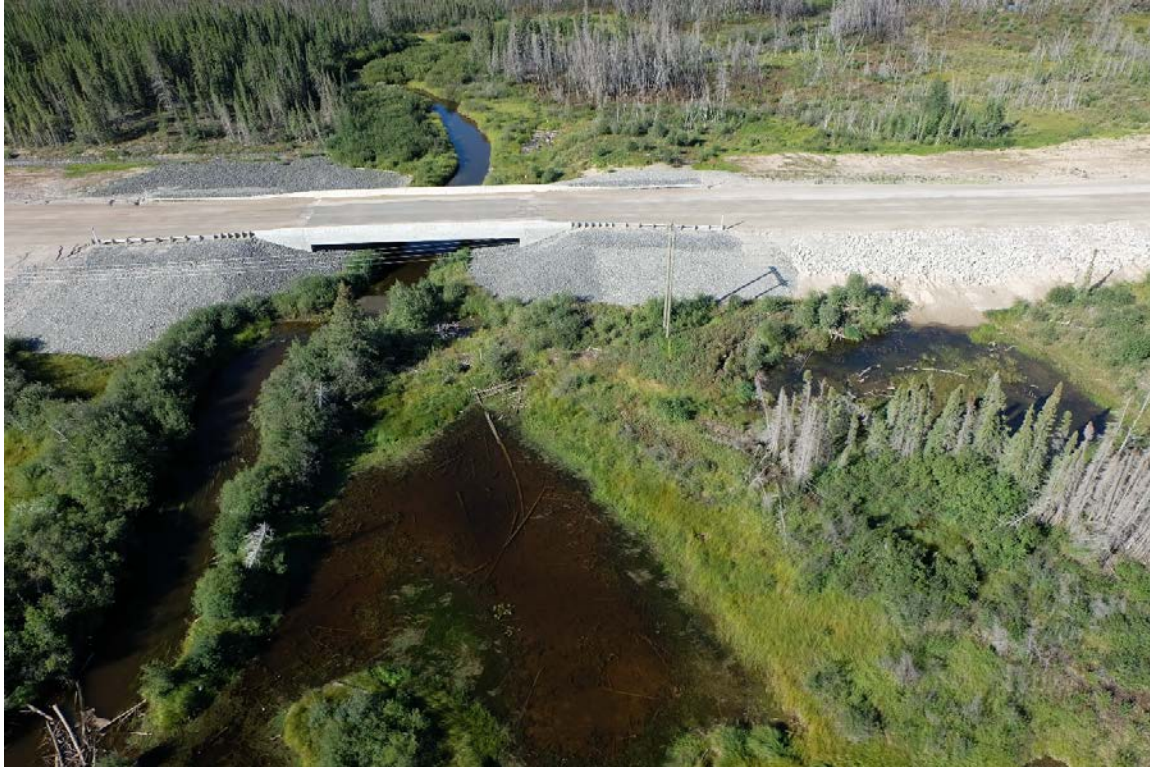
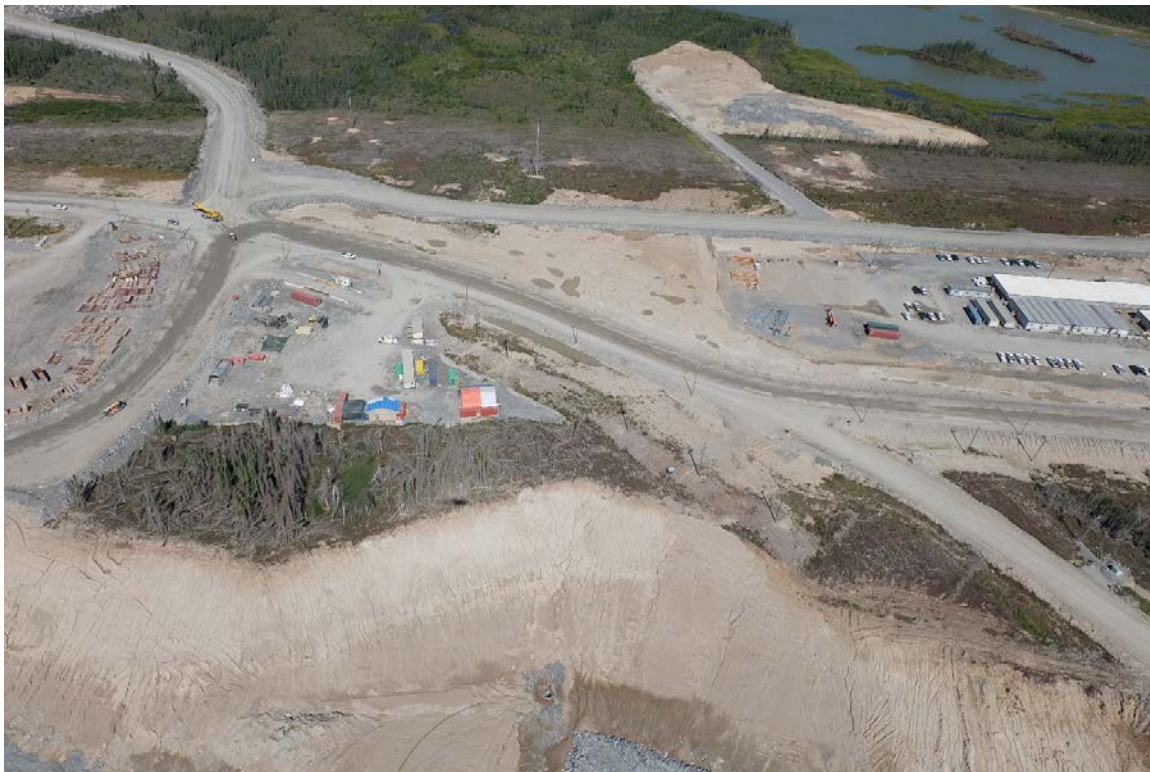
Figure 3-1: Clearing and other impacts along the North Access Road

North Access Road/PR 280 junction (looking north) on August 20, 2016

Approximately halfway along the North Access Road (looking north) on August 20, 2016

Bridge at Looking Back Creek (looking south) on August 20, 2016

Near the south end of the North Access Road (looking north) on August 20, 2016

All North Access Road (NAR) clearing observed in September 2016 was within the planned Project footprint boundary, and was unchanged from September 2015 (Figure 3-1).

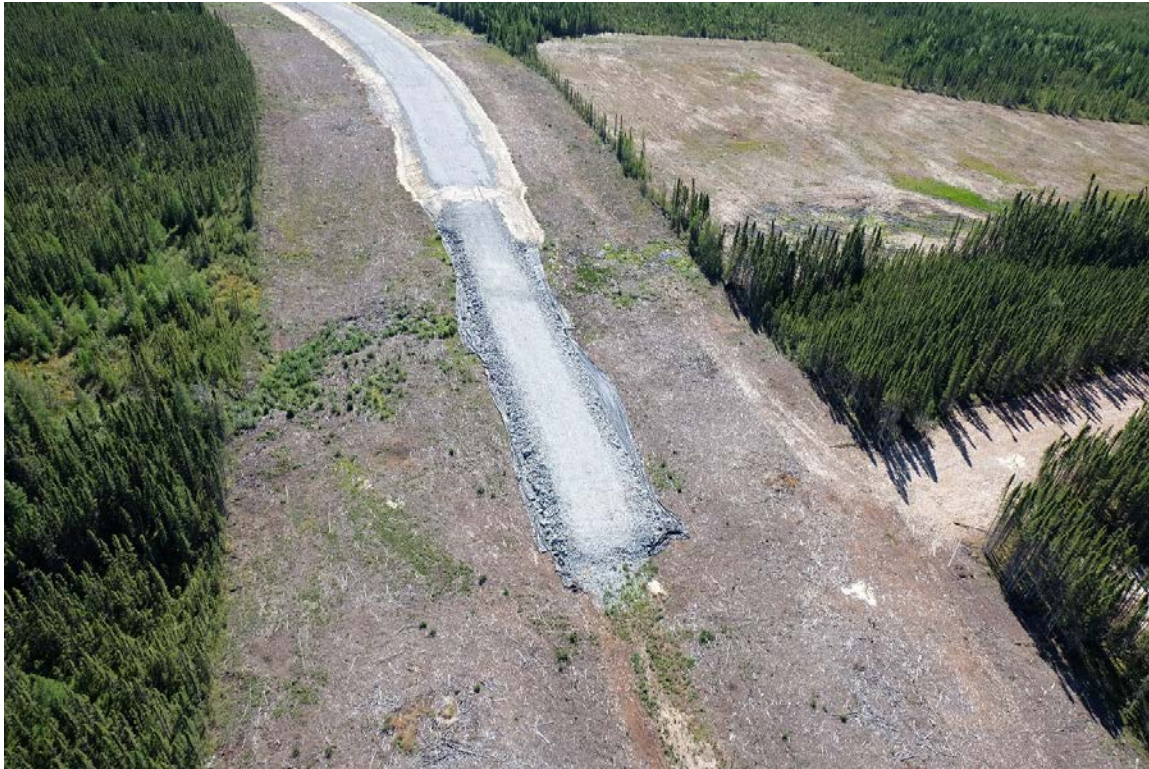
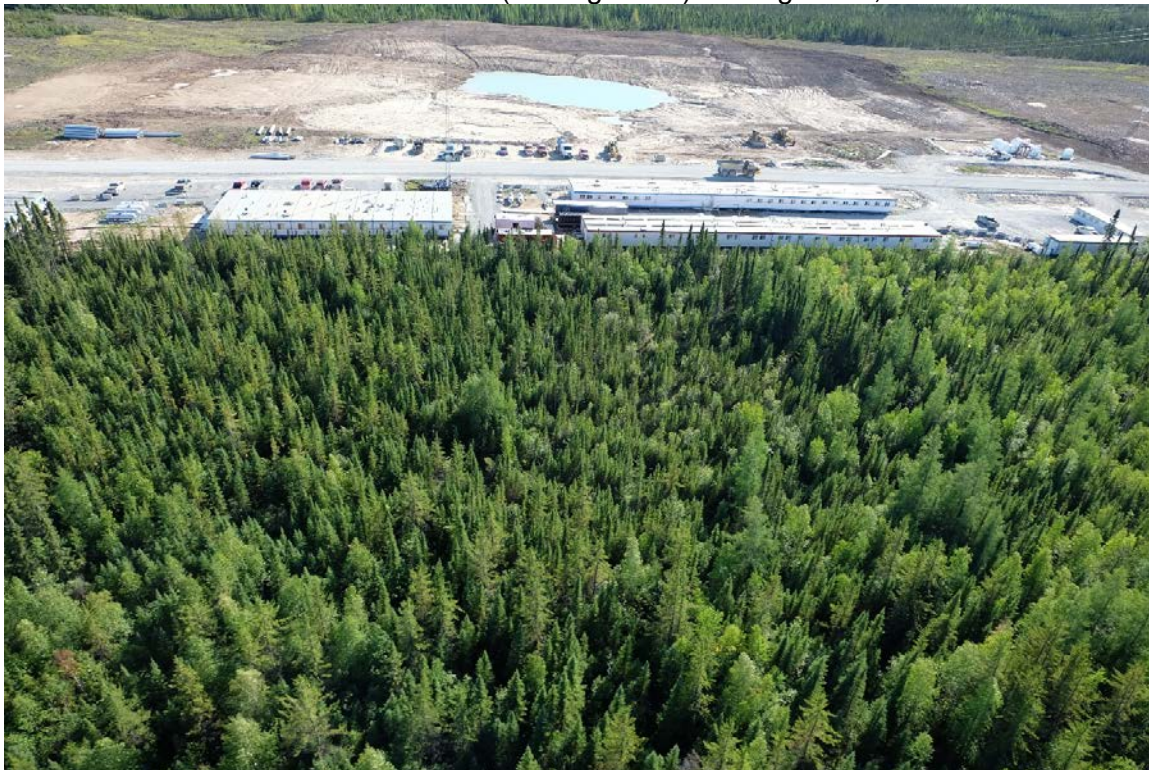
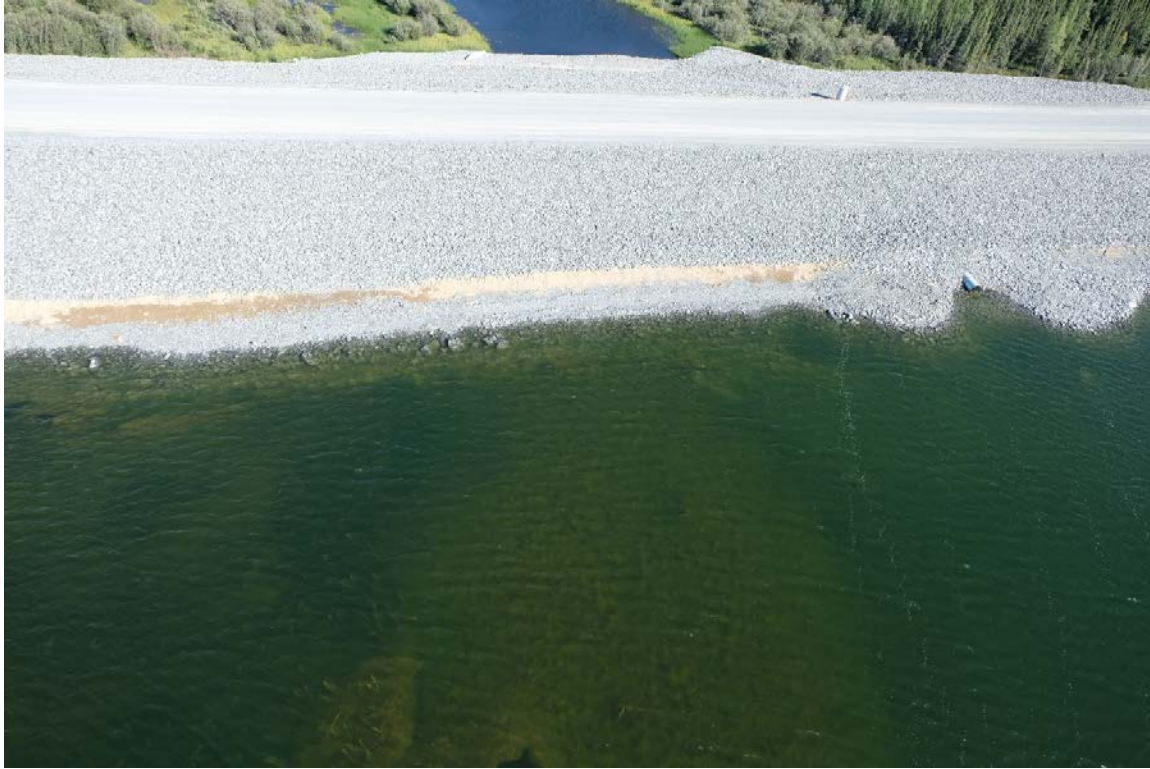
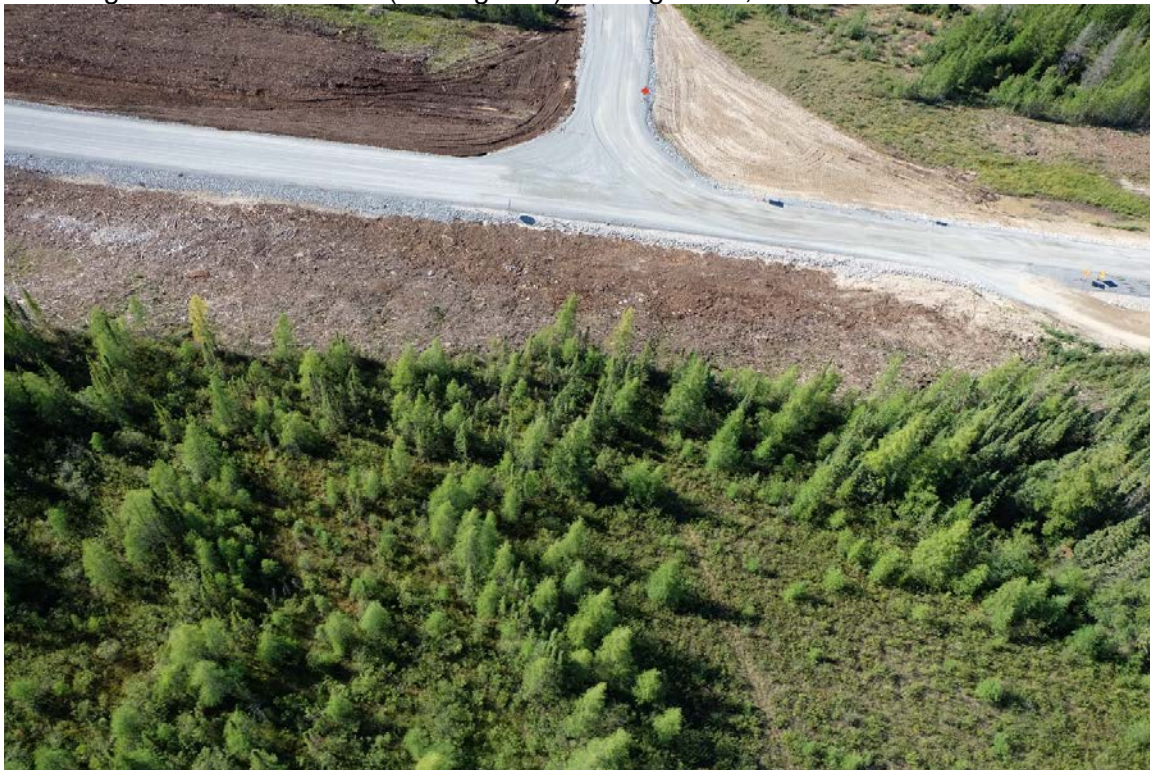
Figure 3-2: Clearing and other impacts along the South Access Road

Northwest end of South Access Road (looking south) on August 20, 2016

View of the South Access Road camp (looking south) on August 20, 2016

Crossing at the Butnau River (looking east) on August 20, 2016

Near the east end, junction with the old Butnau Road route (looking north) on August 20, 2016

Construction of the South Access Road (SAR) roadbed appeared to be complete as of the 2016 surveys. The SAR right-of-way (ROW) had been cleared, and road construction completed from the Gillam access road to the south shore of Gull Rapids (Figure 3-2). The visible clearing outside of the access road ROW was completed by the Keeyask Transmission Project (KTP) and, as such, is not included in the results except where a Project borrow area overlaps the same area.

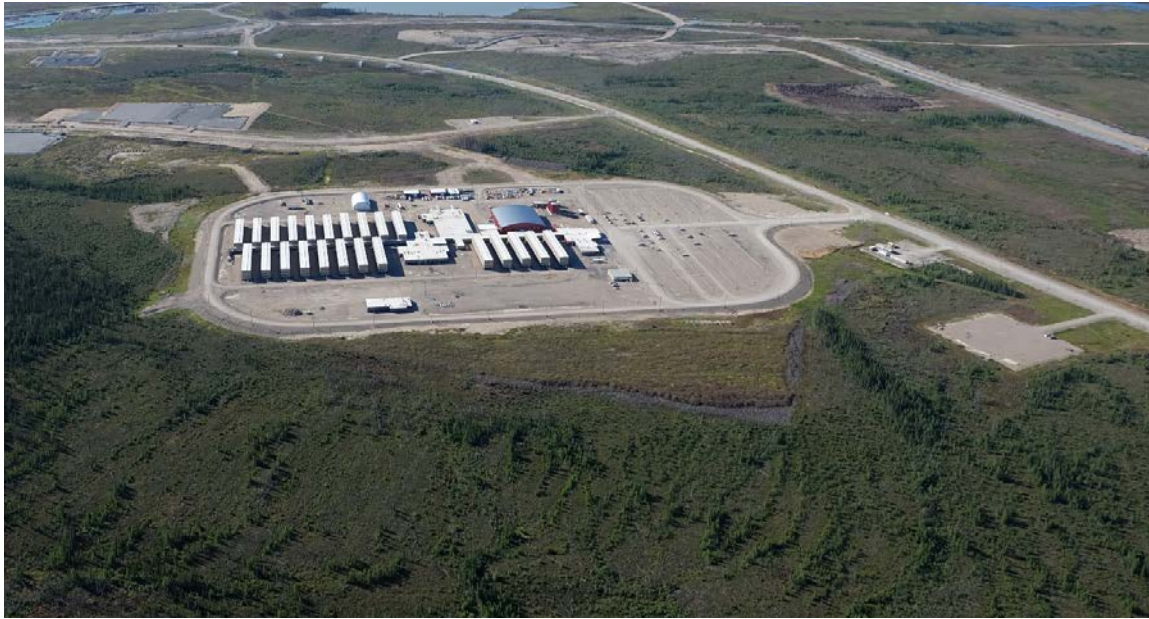
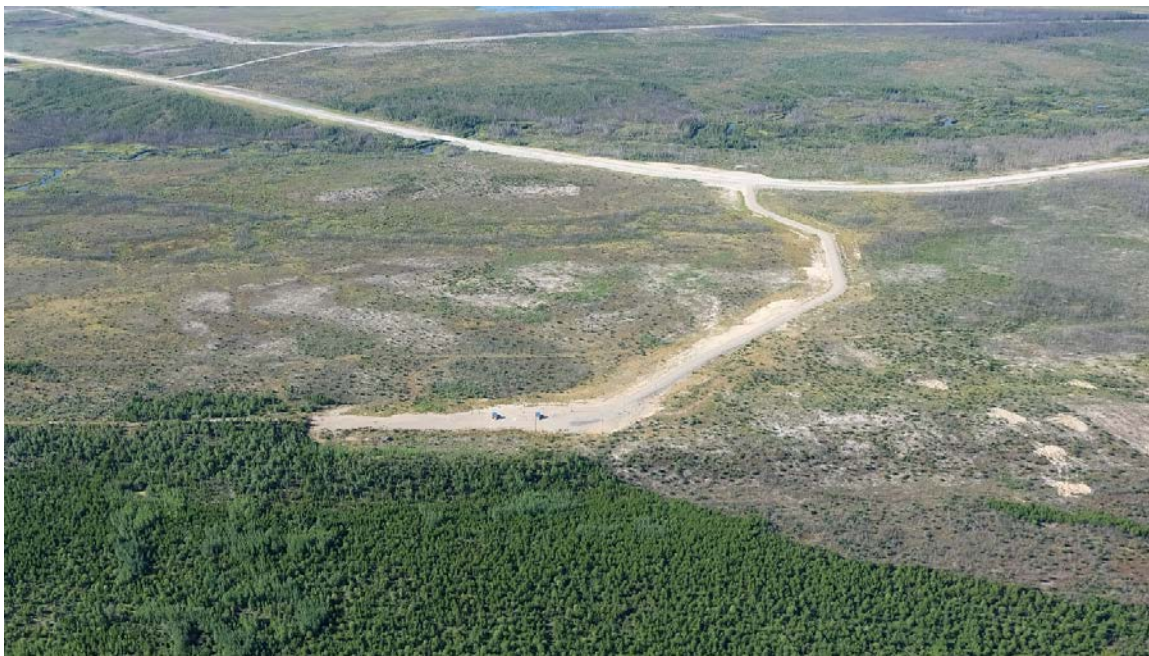
Figure 3-3: Main camp, helicopter pad and well road

Main camp and helicopter pad (looking south) on August 21, 2016

Well road (looking south) on August 21, 2016

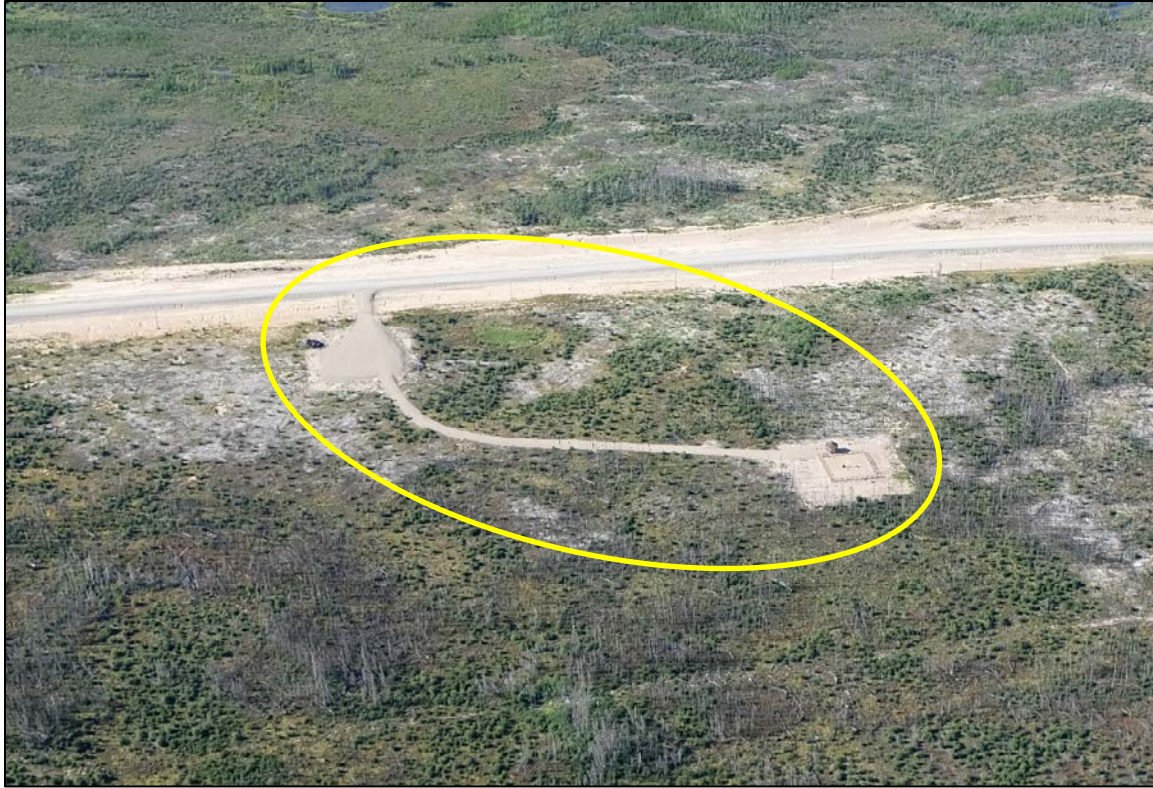
Figure 3-4: Cemetery site along the North Access Road (August 21, 2016)

A TCN cemetery site, approximately 0.7 ha in size, was cleared and developed near KM 10 of the NAR (Figure 3-4). This area is one of the areas that was subsequently approved by the Province.

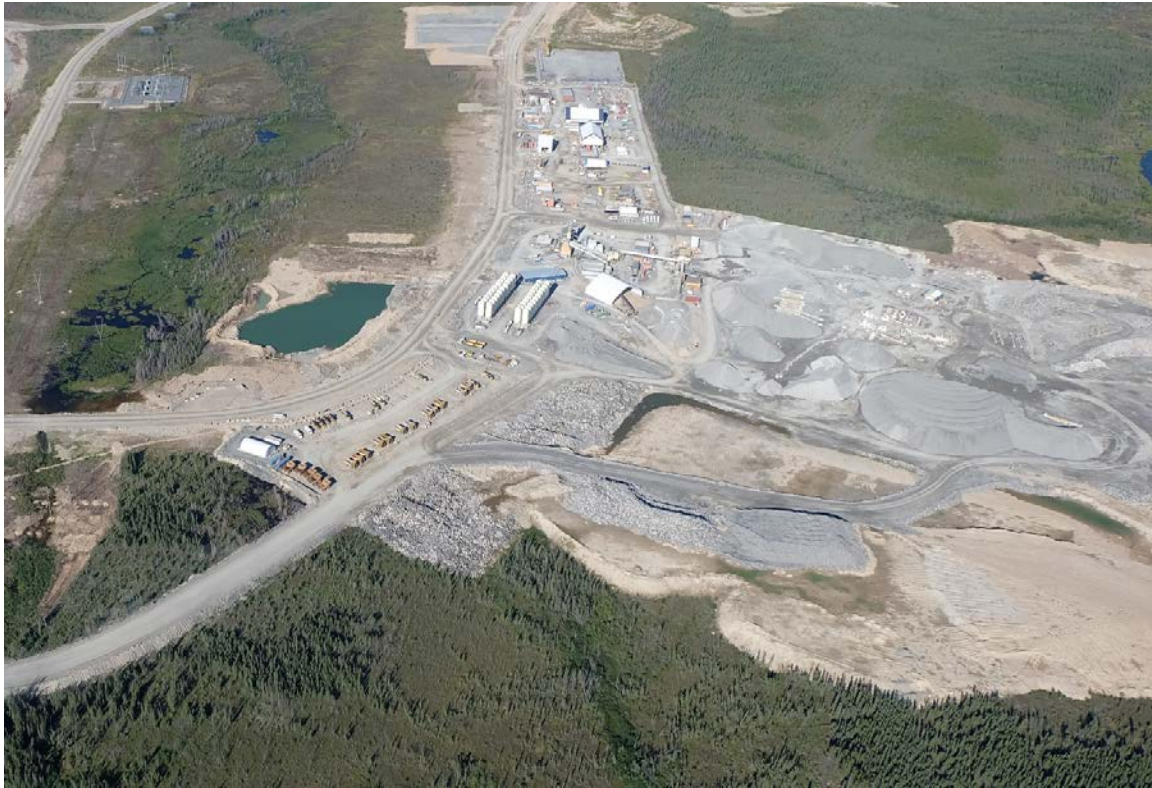
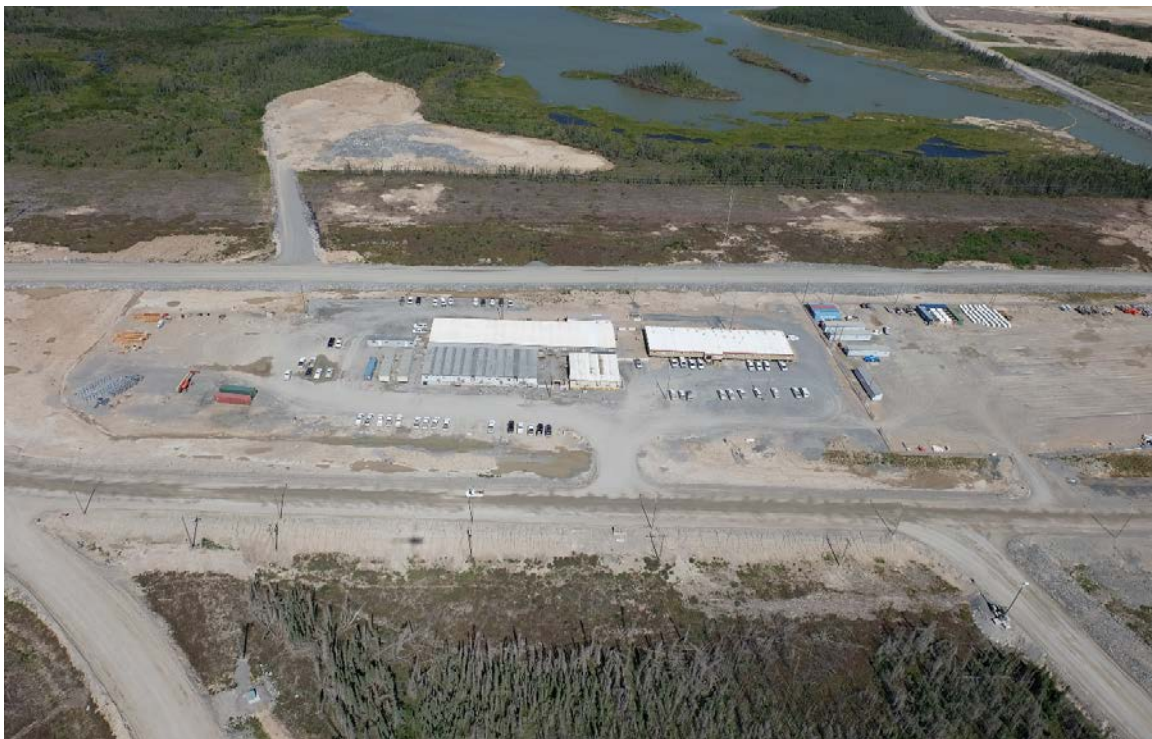
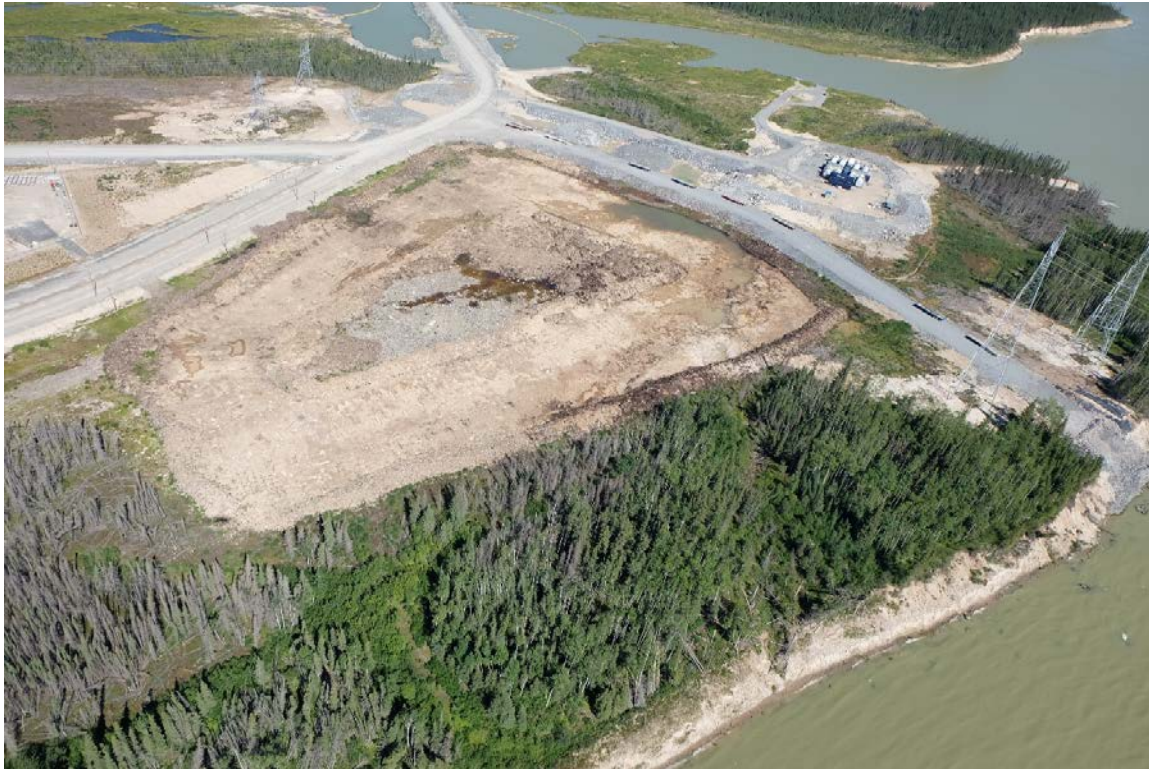
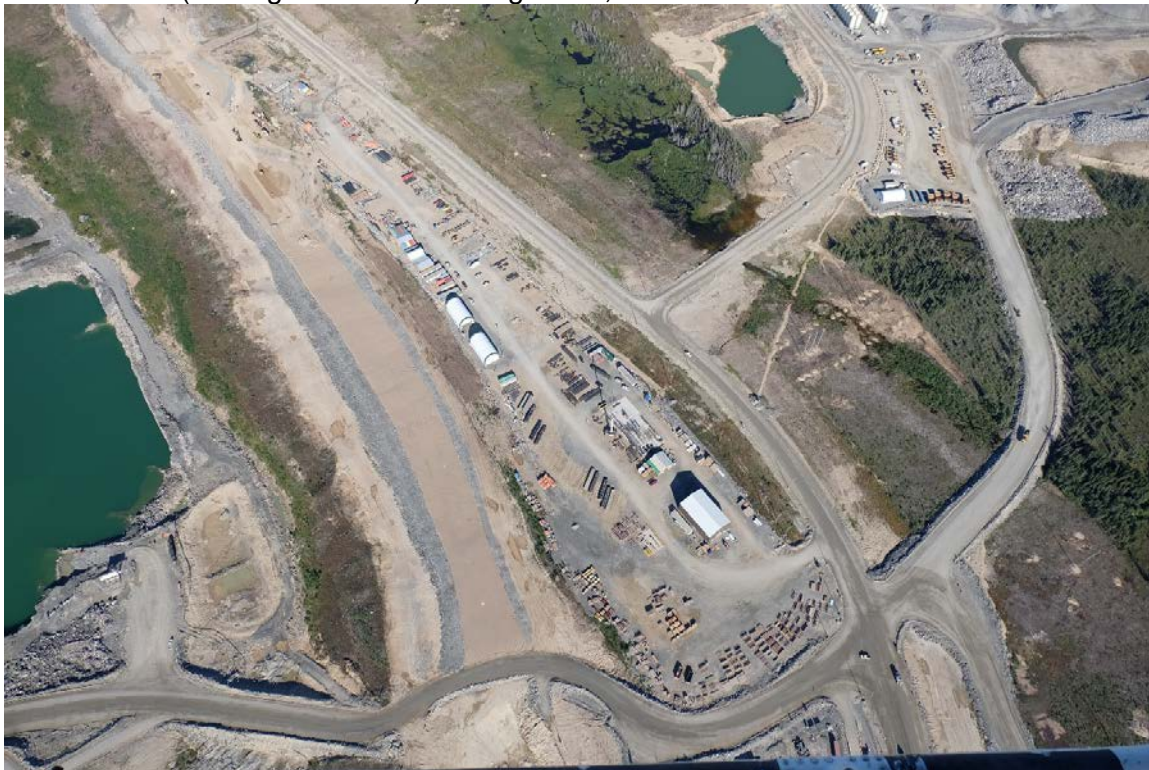
Figure 3-5: Work areas

Work Area A (looking west) on August 21, 2016

Work Area B (looking north) on August 20, 2016

Work Area C (looking northeast) on August 20, 2016

Work Area N-22 (west) on August 21, 2016

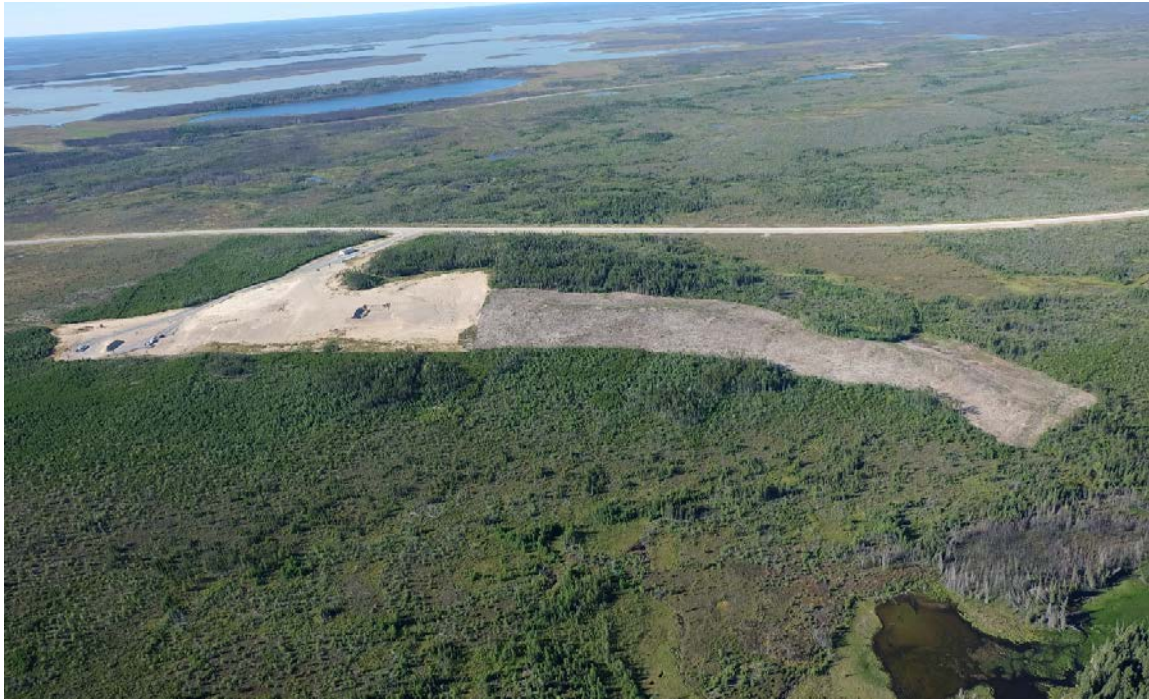
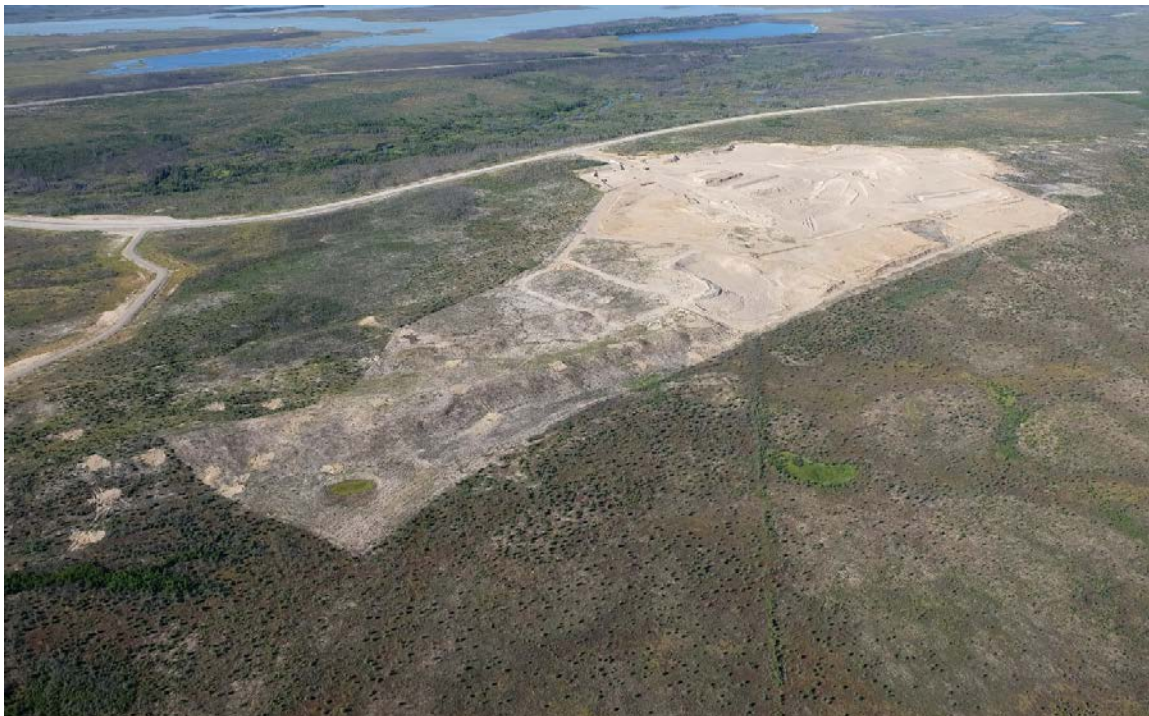
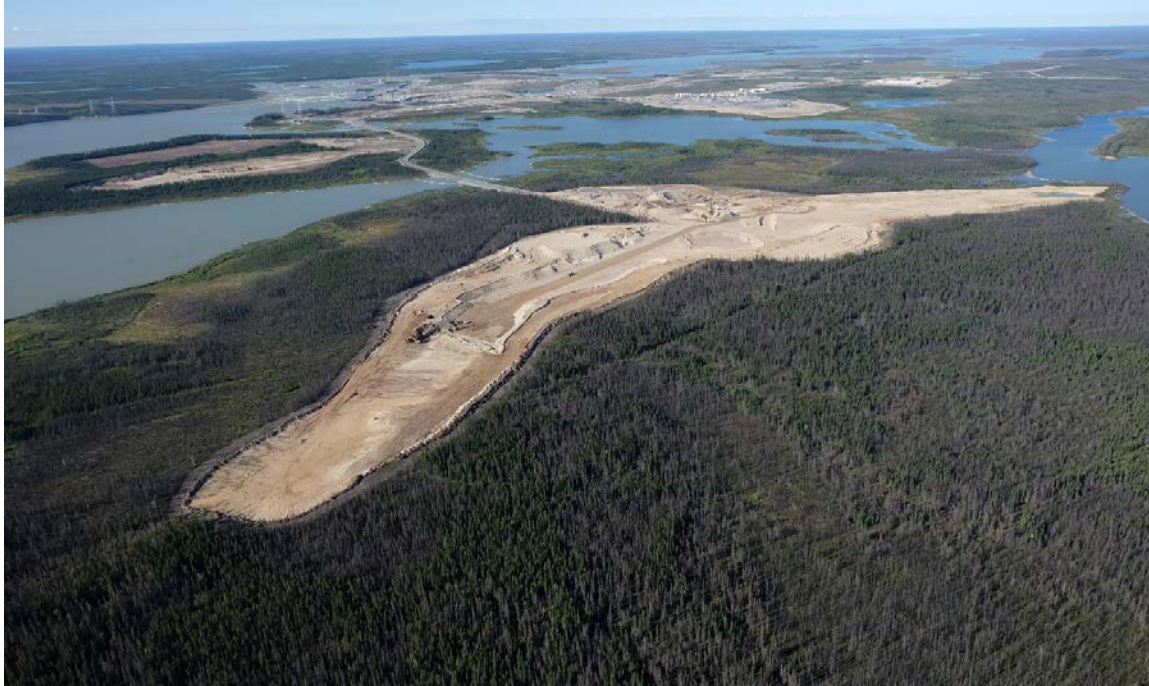
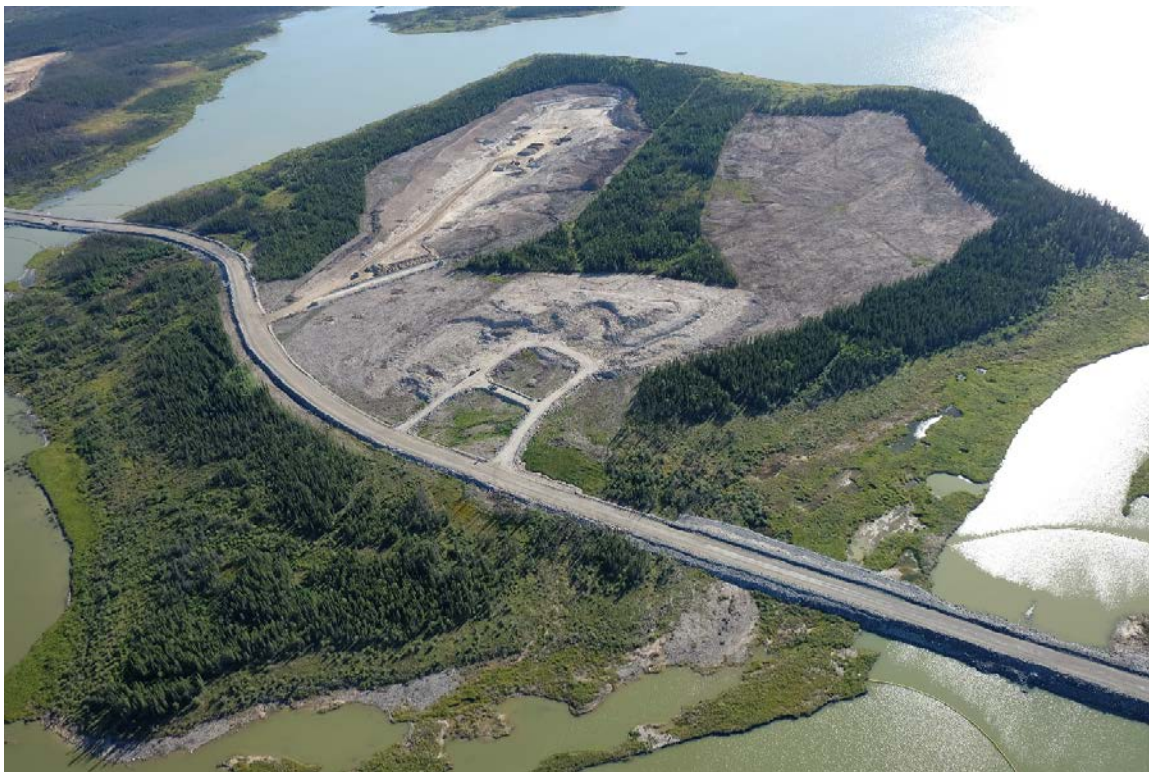
Figure 3-6: Clearing and excavation in borrow areas north of the Nelson River

Borrow Area G-1 at KM-15 (looking southwest) on August 21, 2016

Borrow Area G-1 at KM-17 (looking southwest) on August 21, 2016

Borrow Area G-3 (looking southwest) on August 21, 2016

Borrow Area N-5 (looking east) on August 21, 2016
