Keeyask Generation Project Terrestrial Effects Monitoring Plan

Habitat Loss and Disturbance Monitoring Report

TEMP-2017-01

ECOSTEM Ltd.

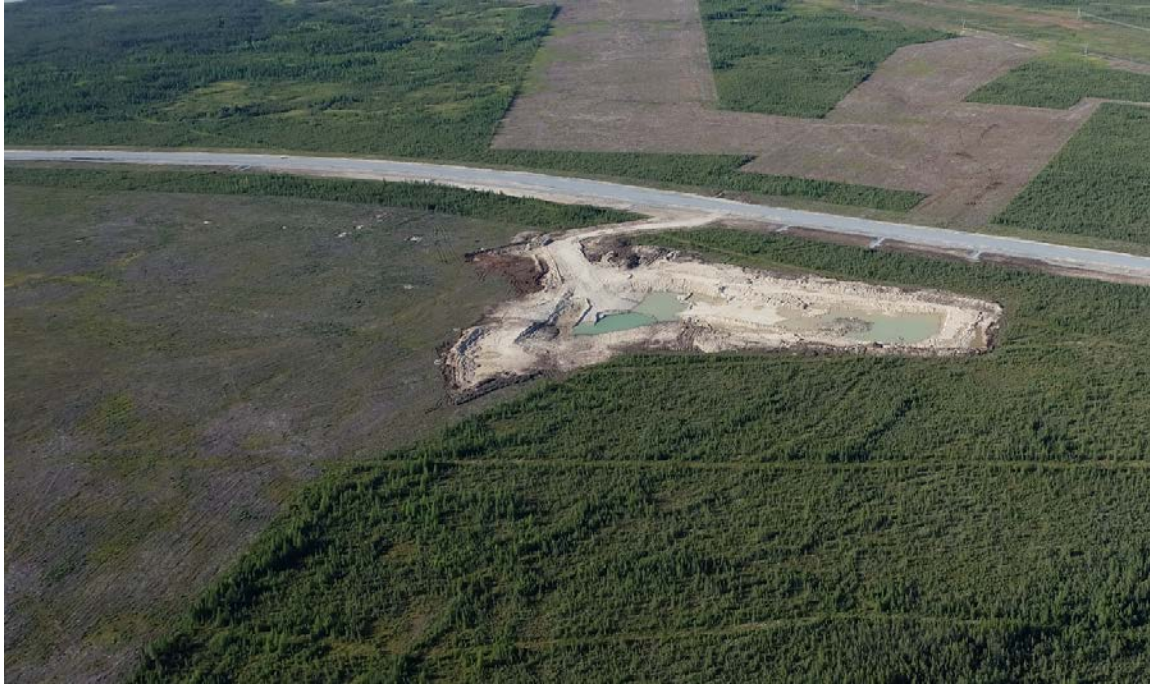
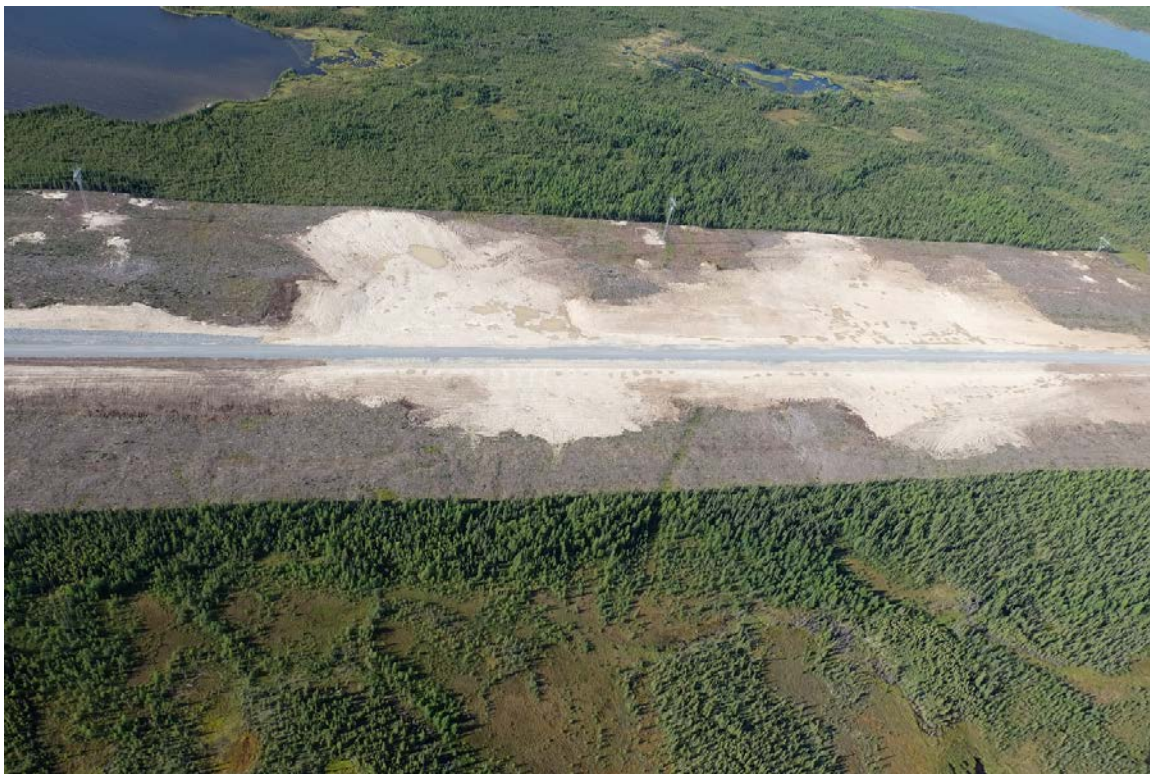
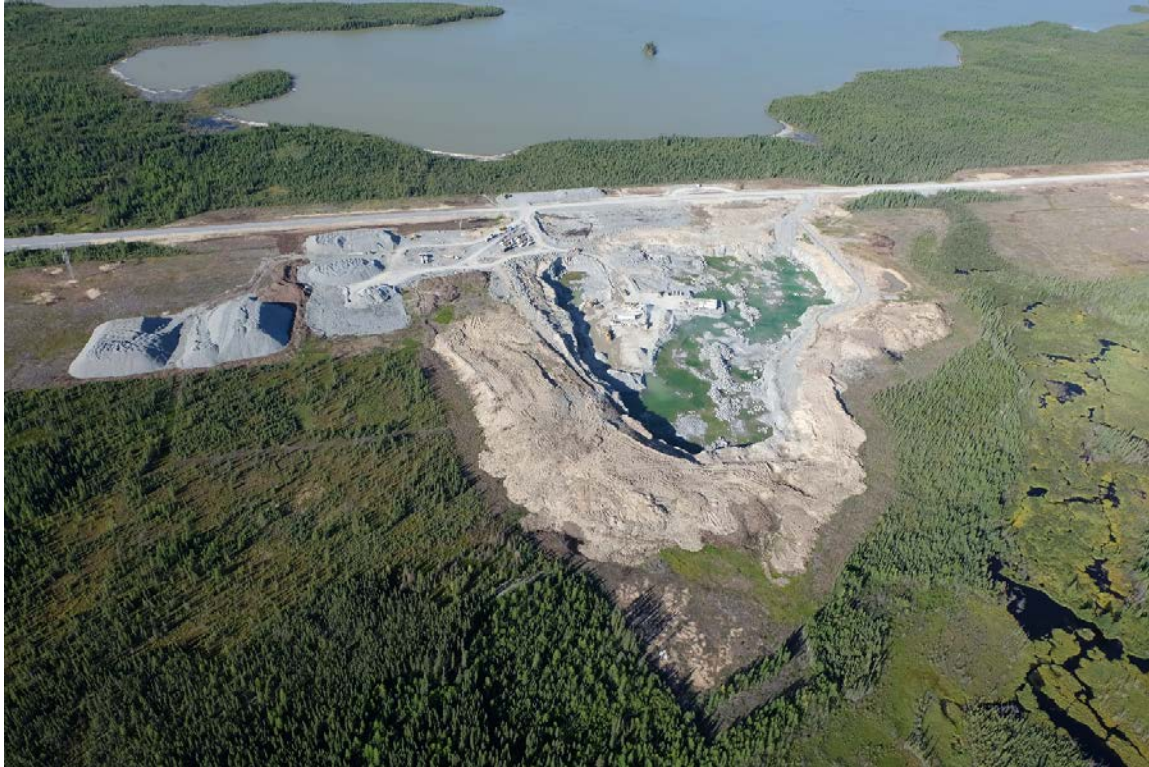
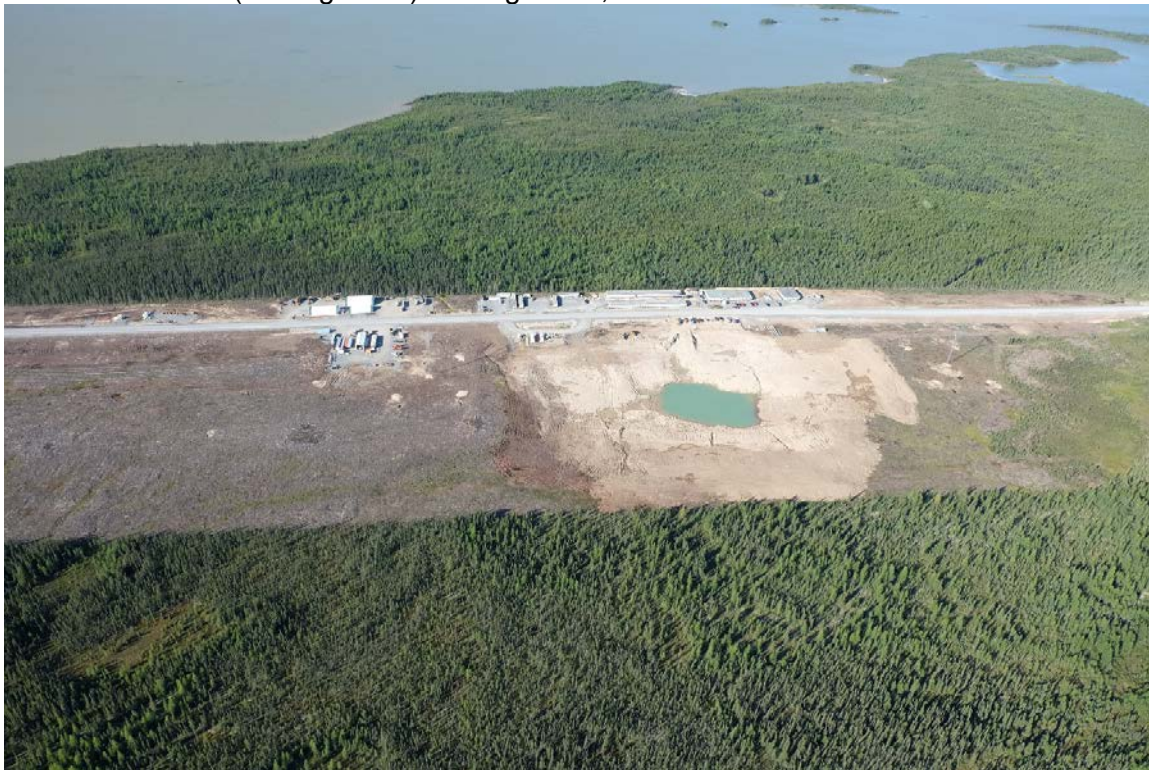
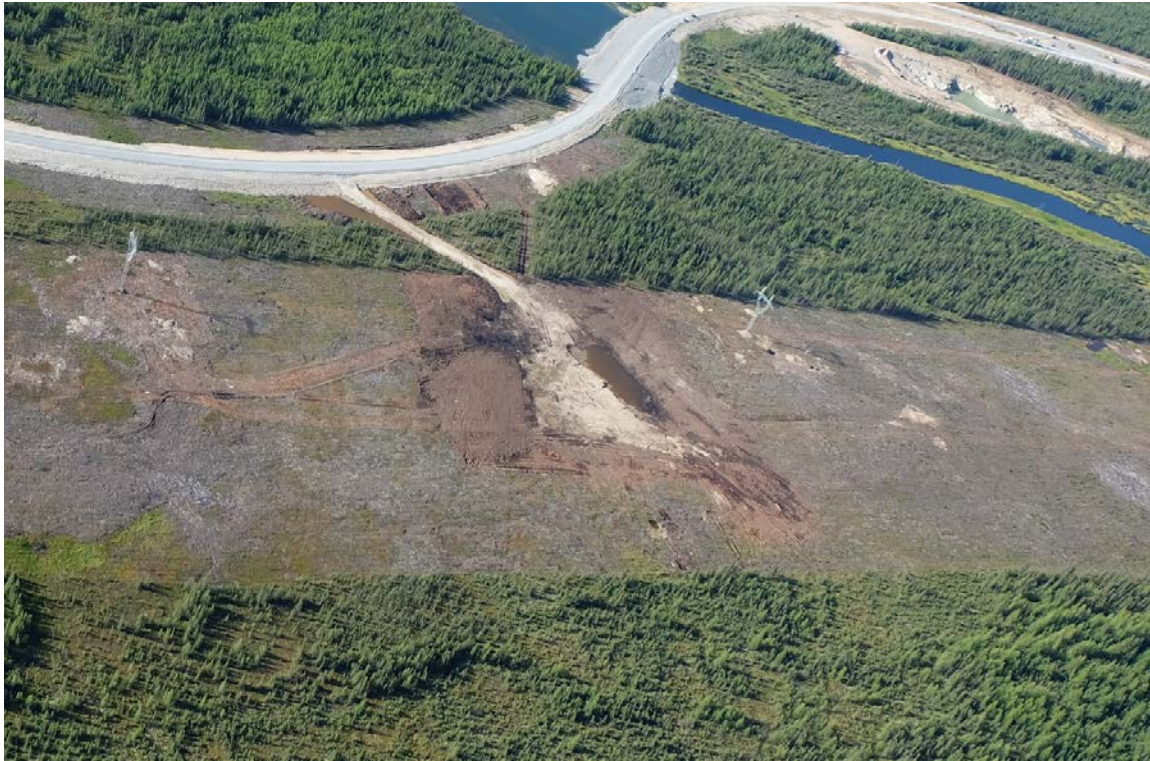
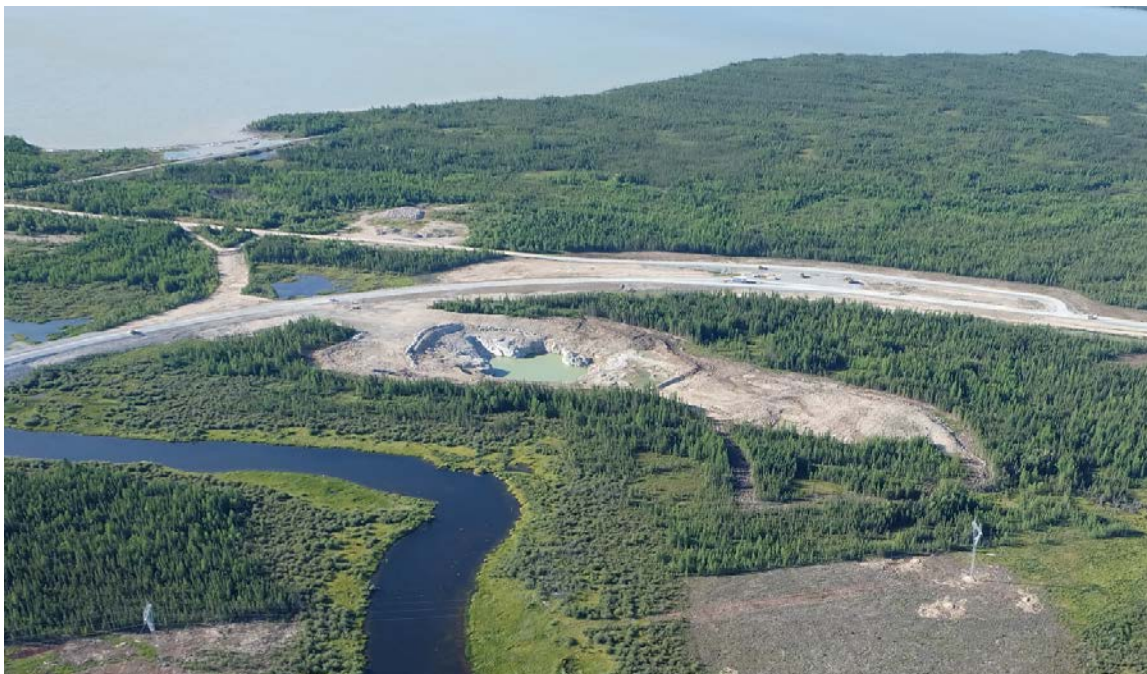
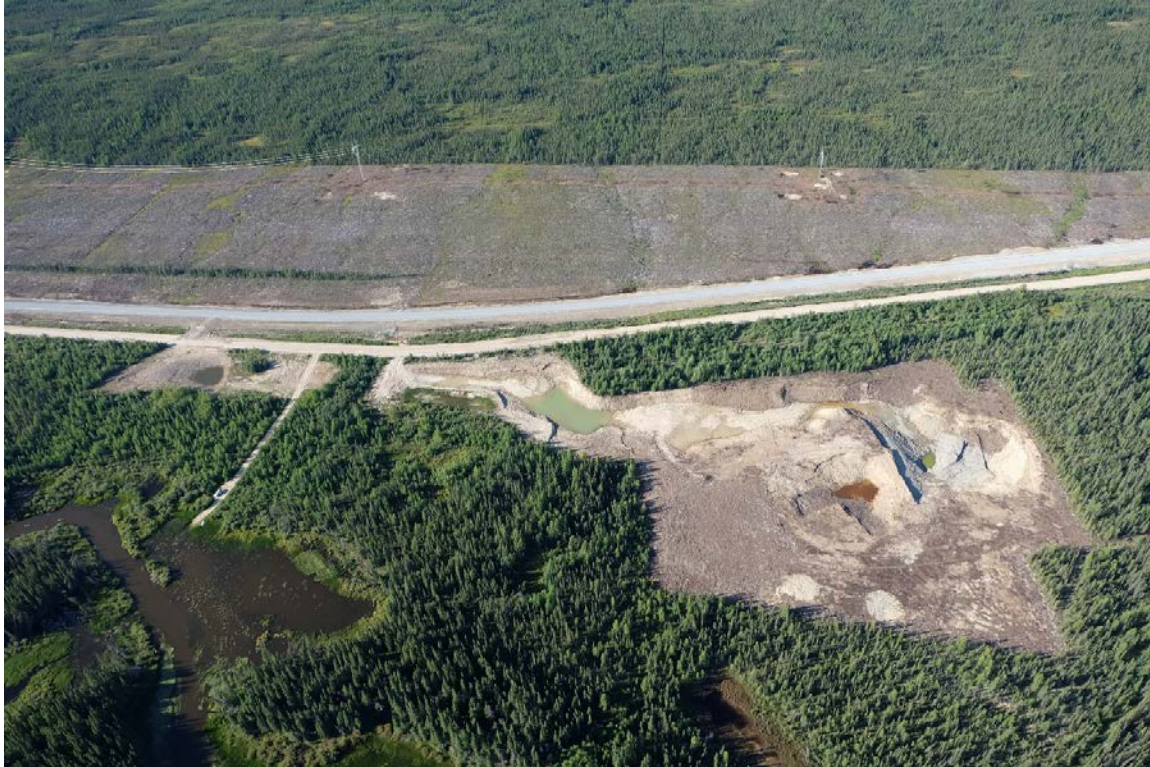
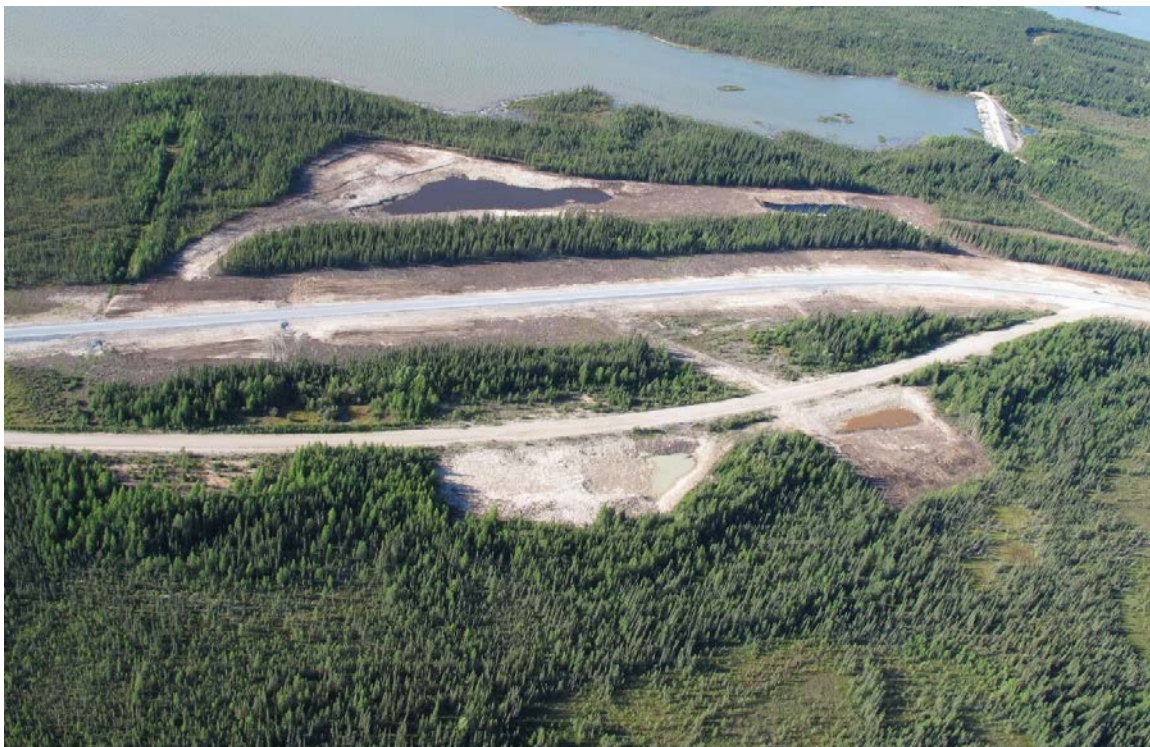
Figure 3-7: Clearing and excavation in borrow areas south of the Nelson River

Borrow Area S-2a (looking north) on August 20, 2016

Borrow Area B-2 (looking north) on August 20, 2016

Borrow Area Q-9 (looking north) on August 20, 2016

Borrow Area B-3 (looking north) on August 20, 2016

Borrow Area B-5 (looking north) on August 20, 2016

Borrow Area B-6 west portion (looking north) on August 20, 2016

Borrow Area B-6 east portion (looking north) on August 20, 2016

Borrow Area B-8 (looking north) on August 20, 2016

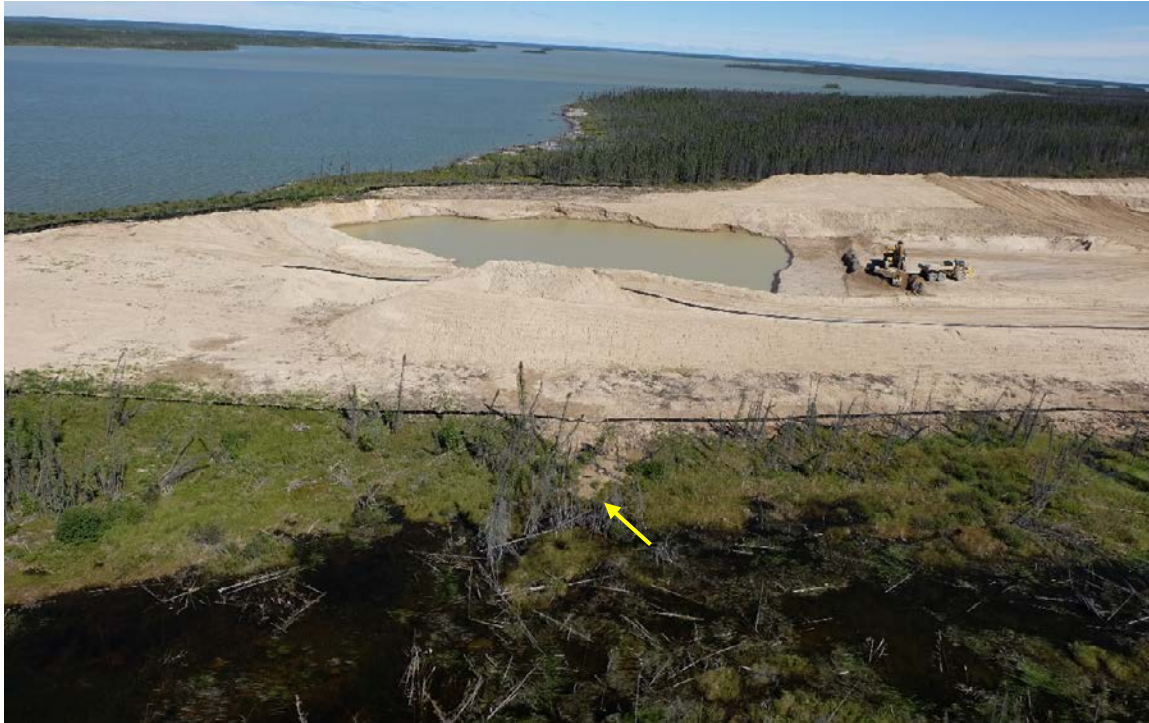
Figure 3-8: Sedimentation into adjacent undisturbed habitat at borrow area G-3

Borrow Area G-3 (looking north) on August 20, 2016

During the 2016 surveys, erosion had caused sedimentation from Borrow Area G-3 into the adjacent uncleared forest toward a waterway connected to Stephens Lake. In this case, flowing sediment broke through a silt fence (Figure 3-8).

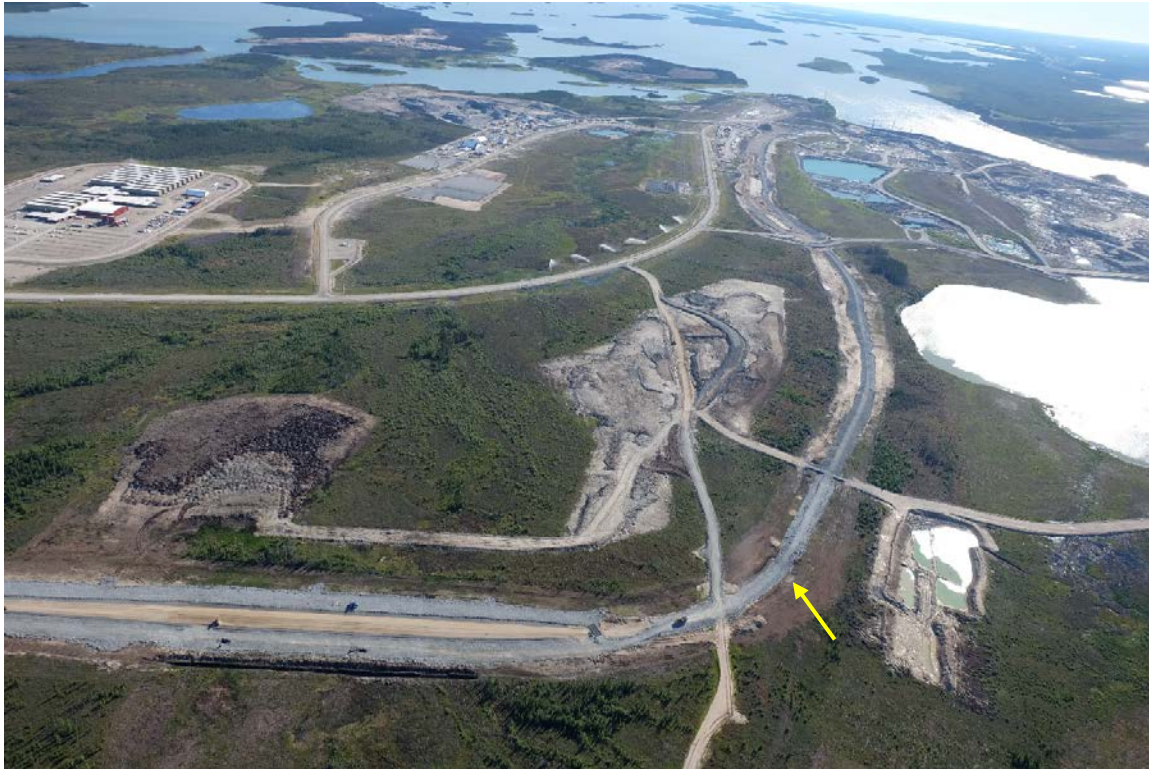
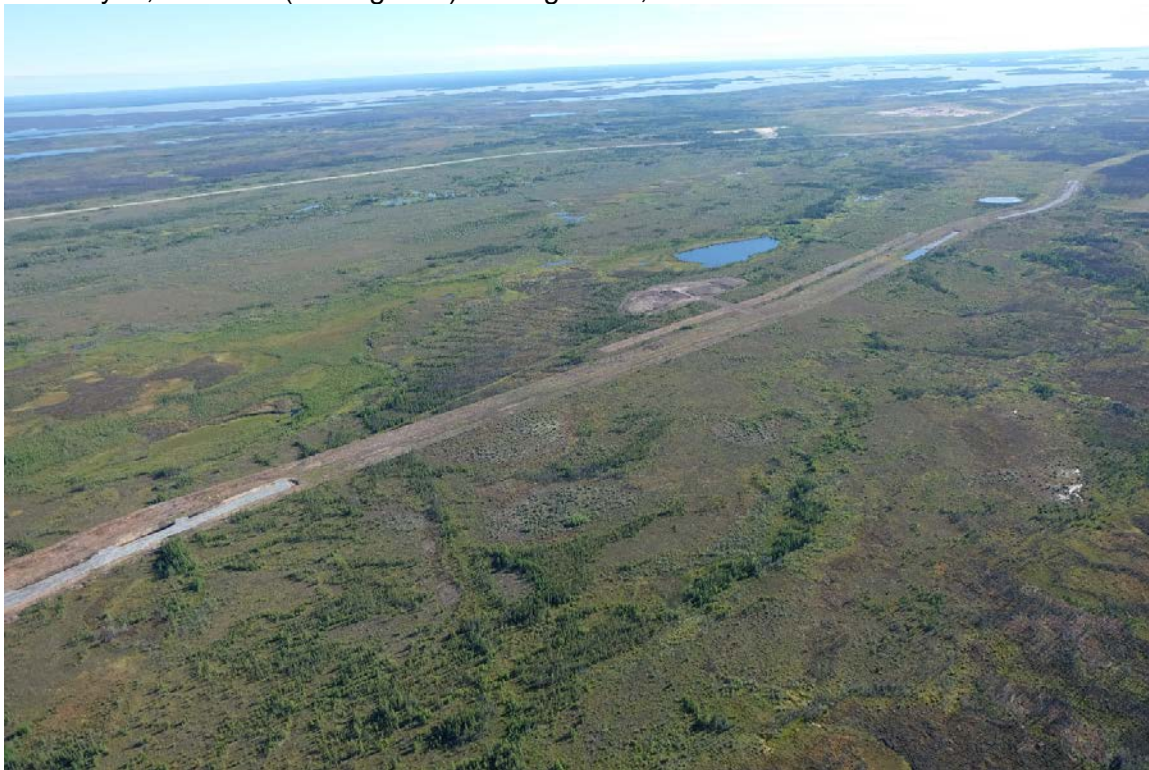
Figure 3-9: North dyke

North dyke, east end (looking east) on August 21, 2016

North dyke, west end (looking northeast) on August 21, 2016

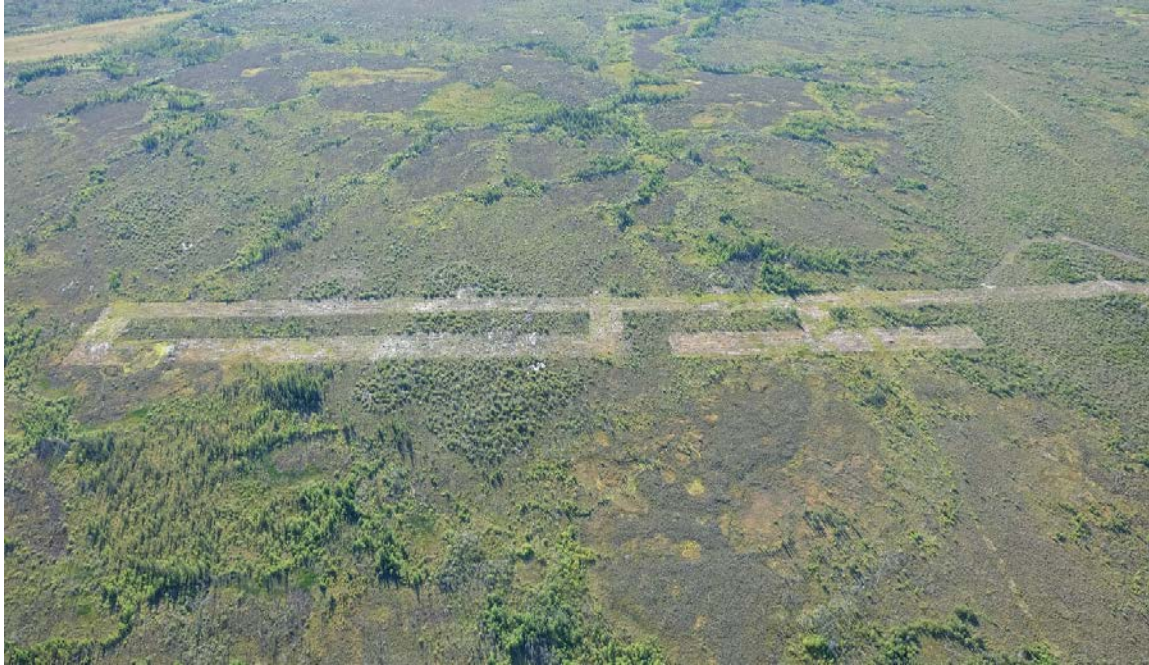
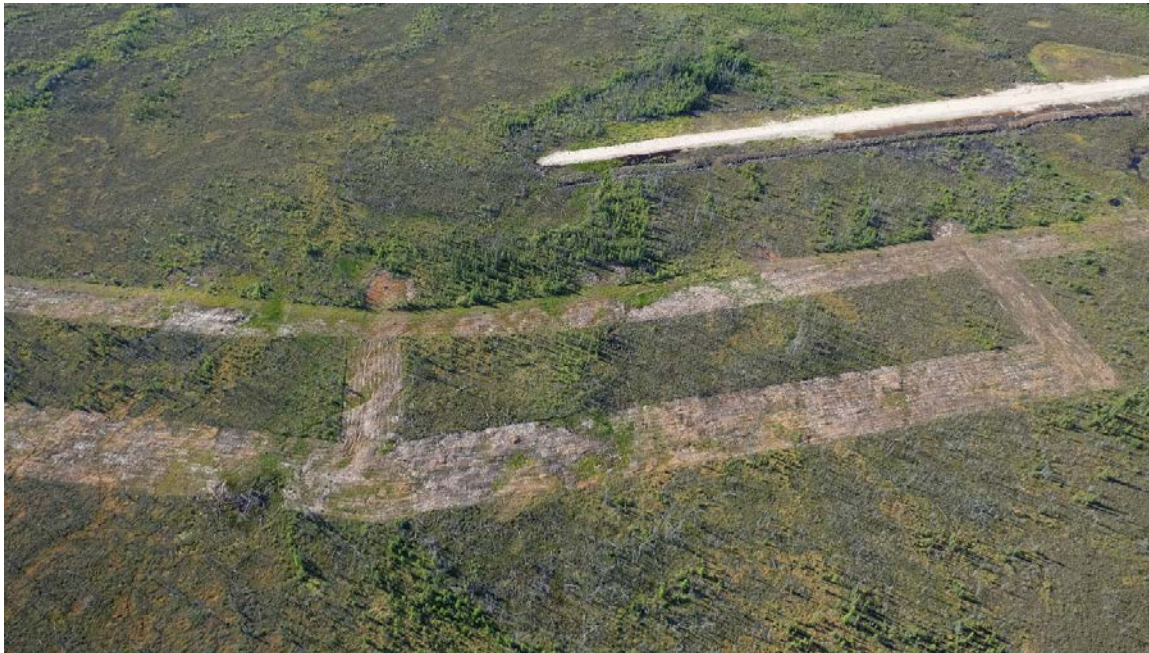
Figure 3-10: South dyke

South dyke, southwest end (looking west) on August 20, 2016

South dyke, central area (looking northwest) on August 20, 2016

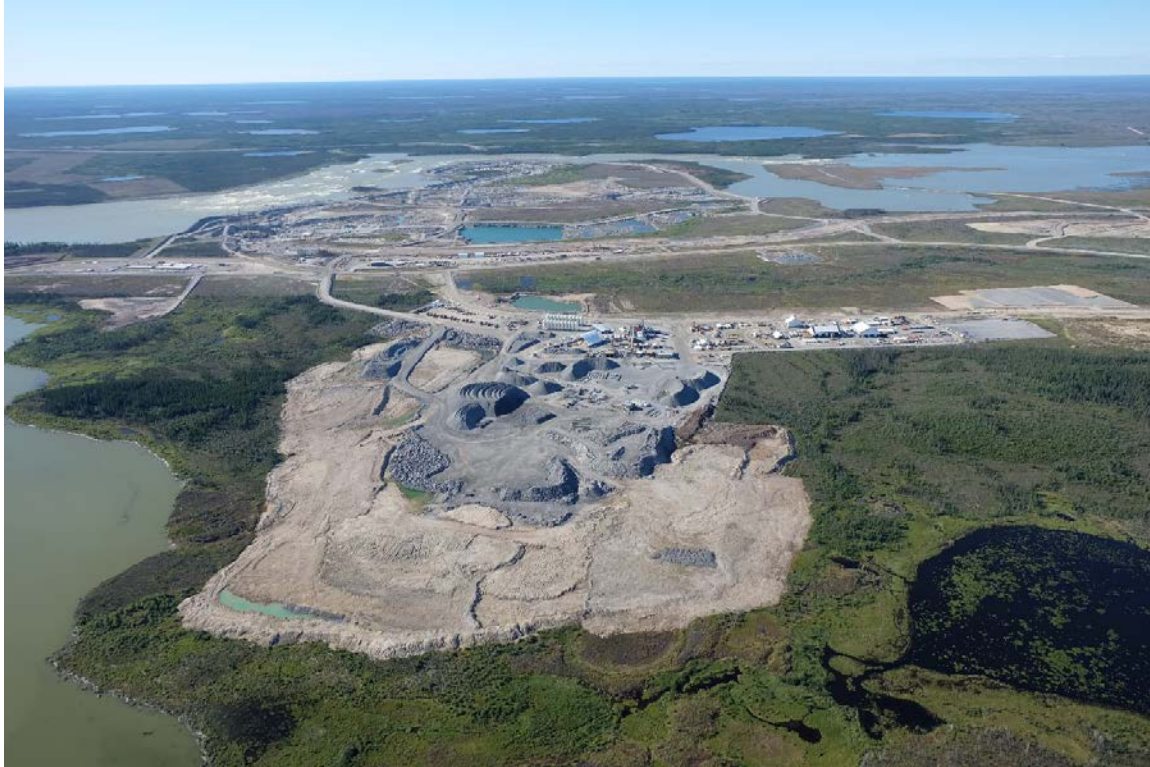
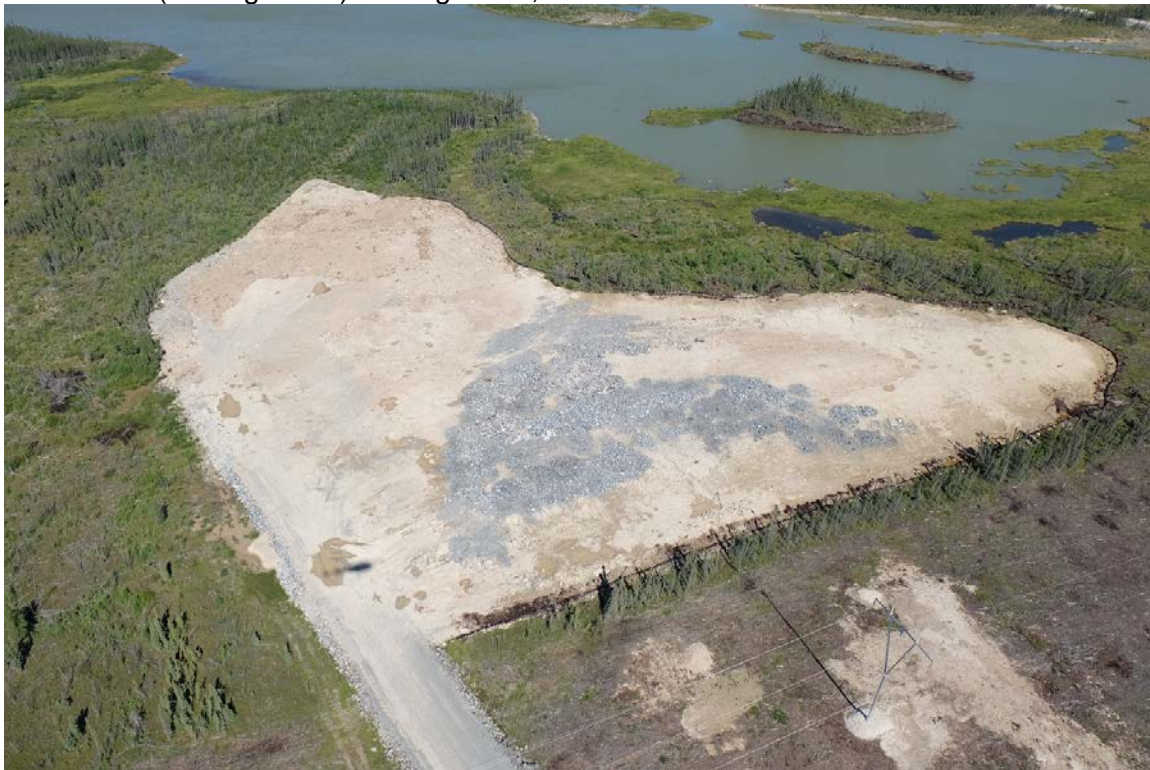
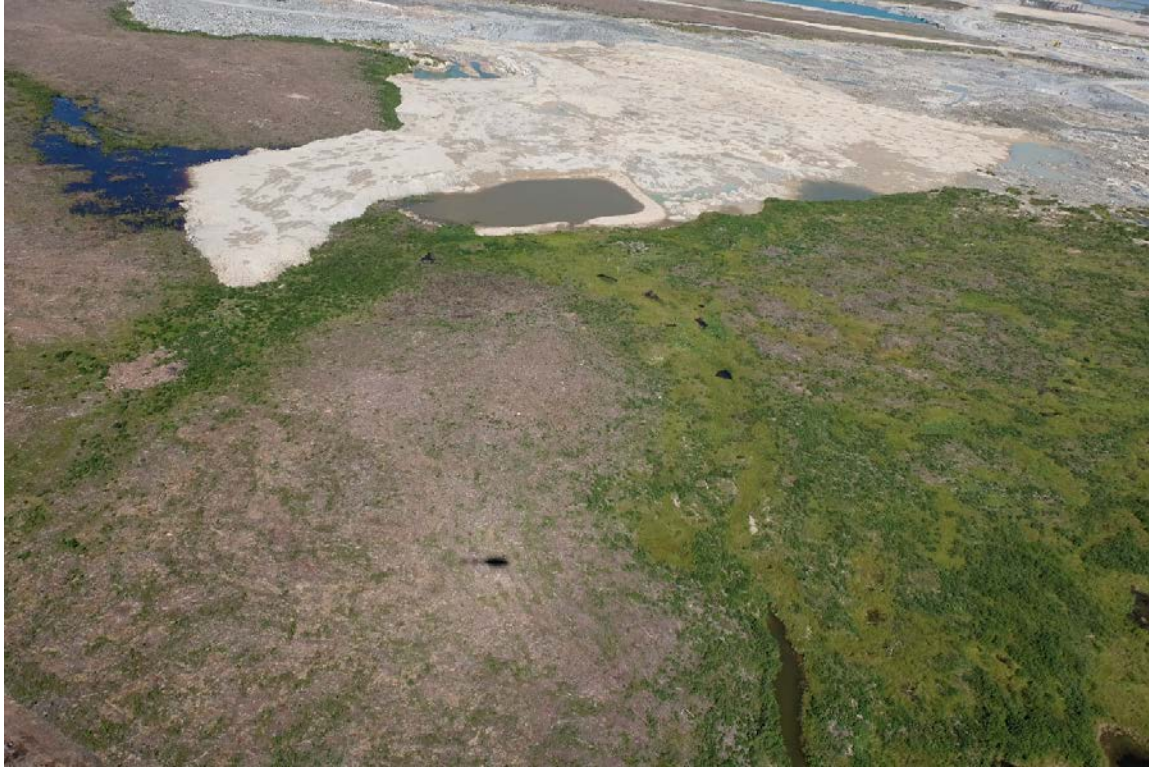
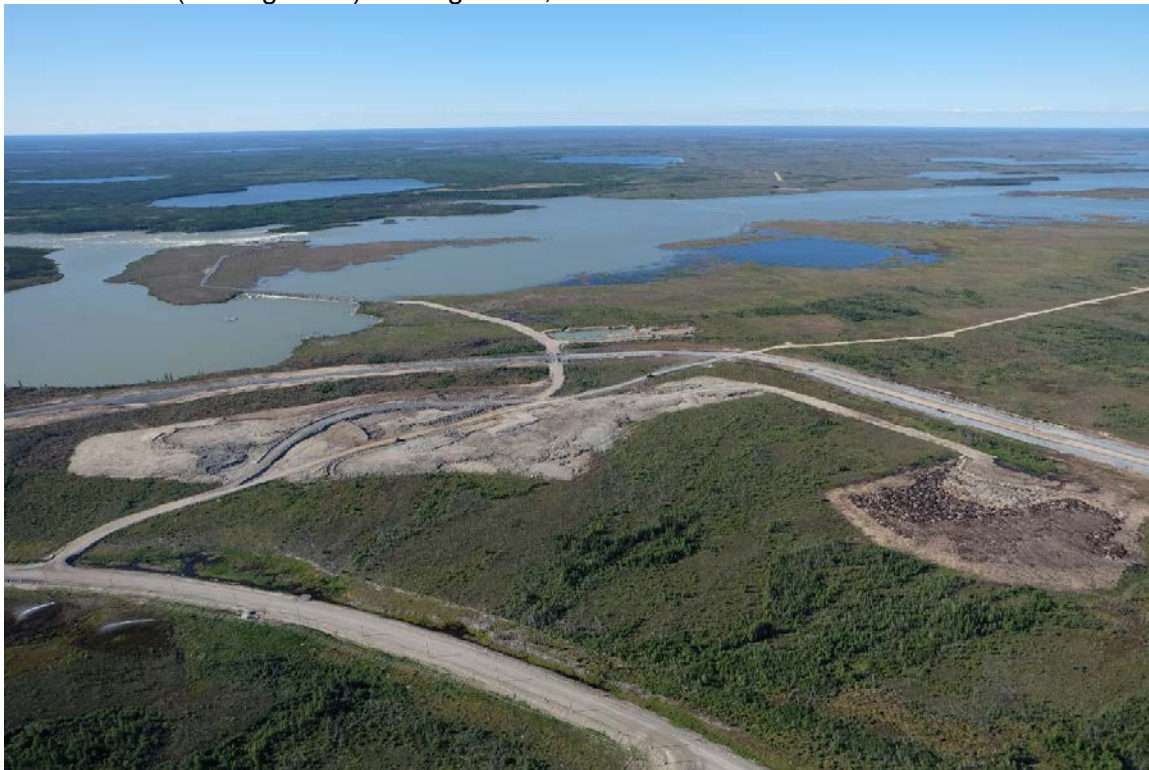
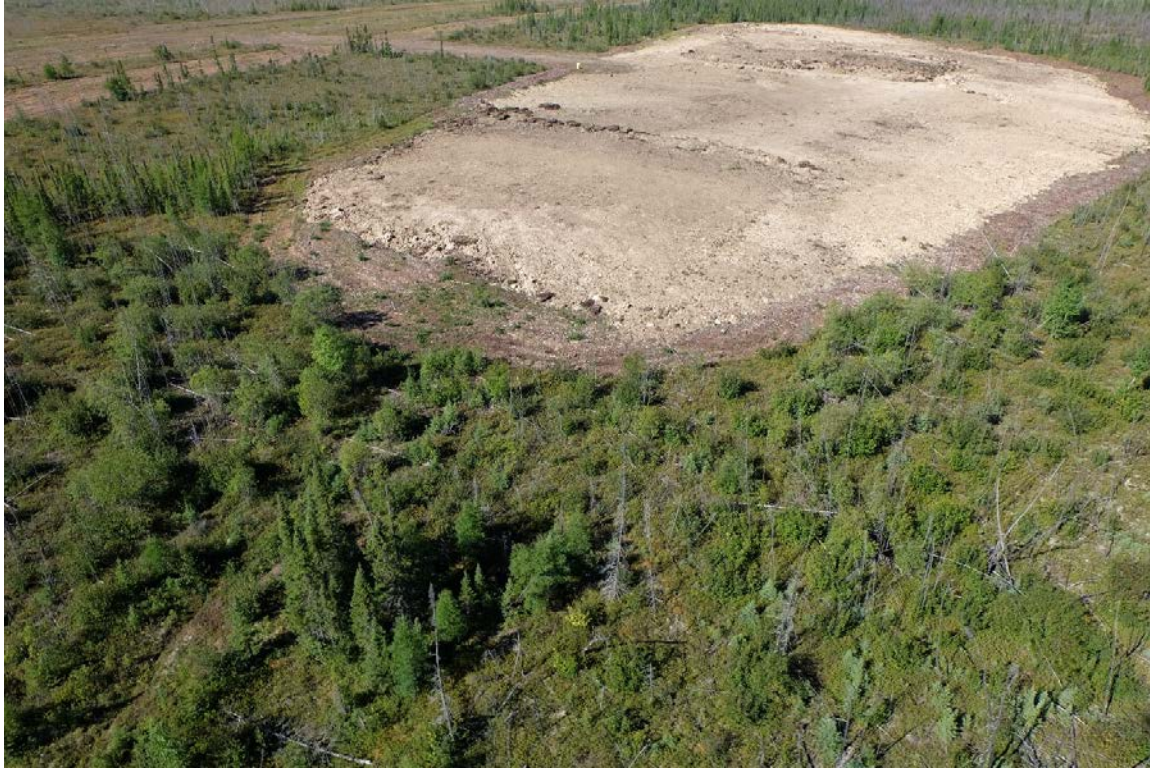
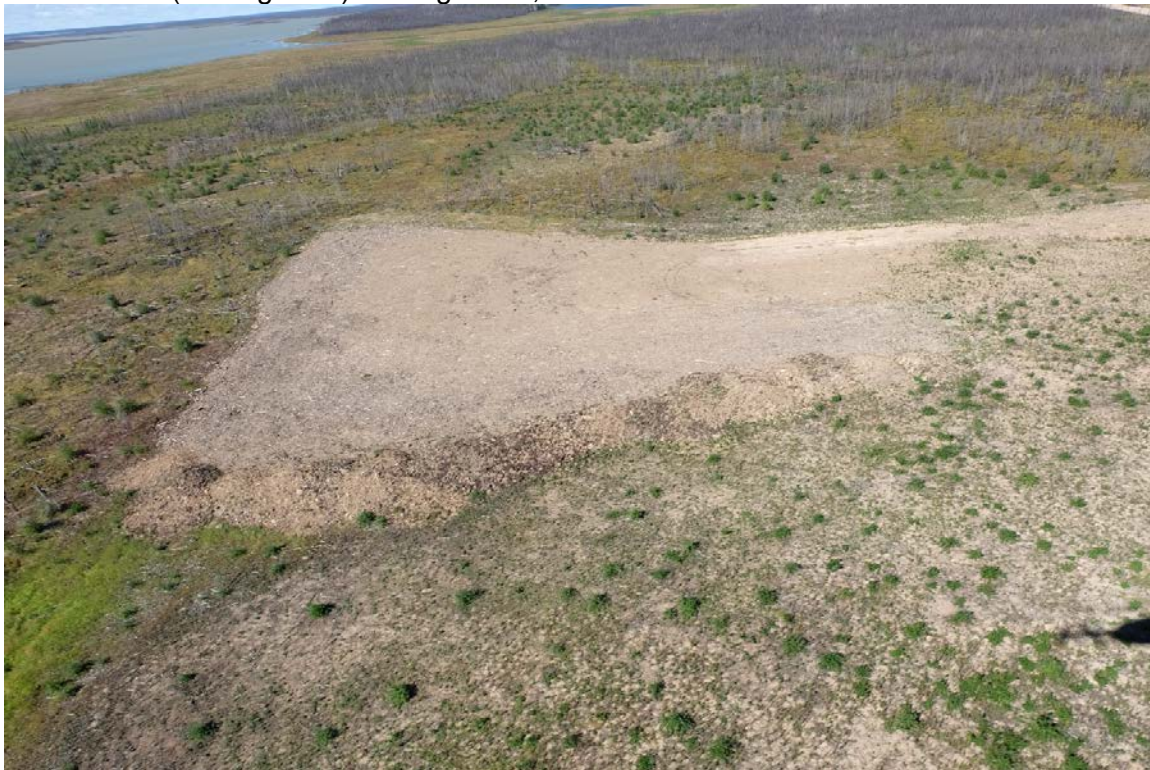
Figure 3-11: Excavated material placement areas in use

EMPA D16 (looking south) on August 21, 2016

EMPA D17 (looking northeast) on August 20, 2016

EMPA D19-I (looking north) on August 20, 2016

Portion of EMPA D12 (looking southwest) on August 21, 2016

EMPA D3-E (looking west) on August 20, 2016

EMPA D9-I (looking west) on August 20, 2016

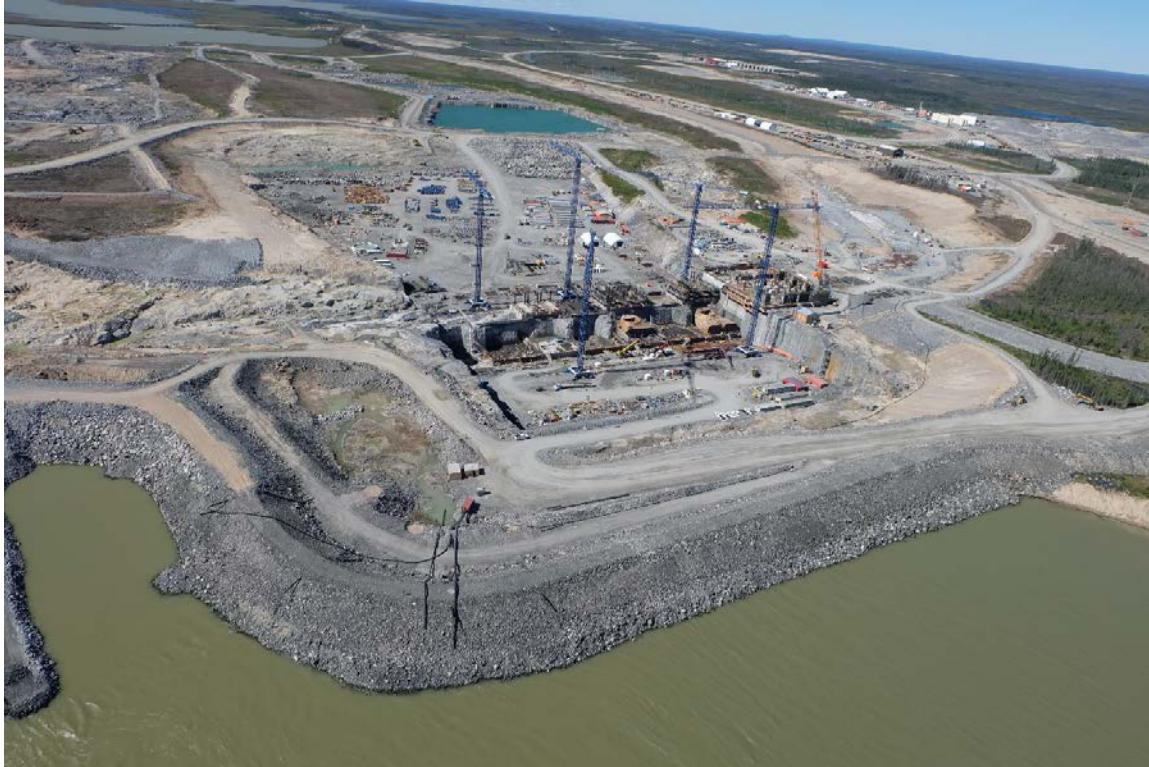
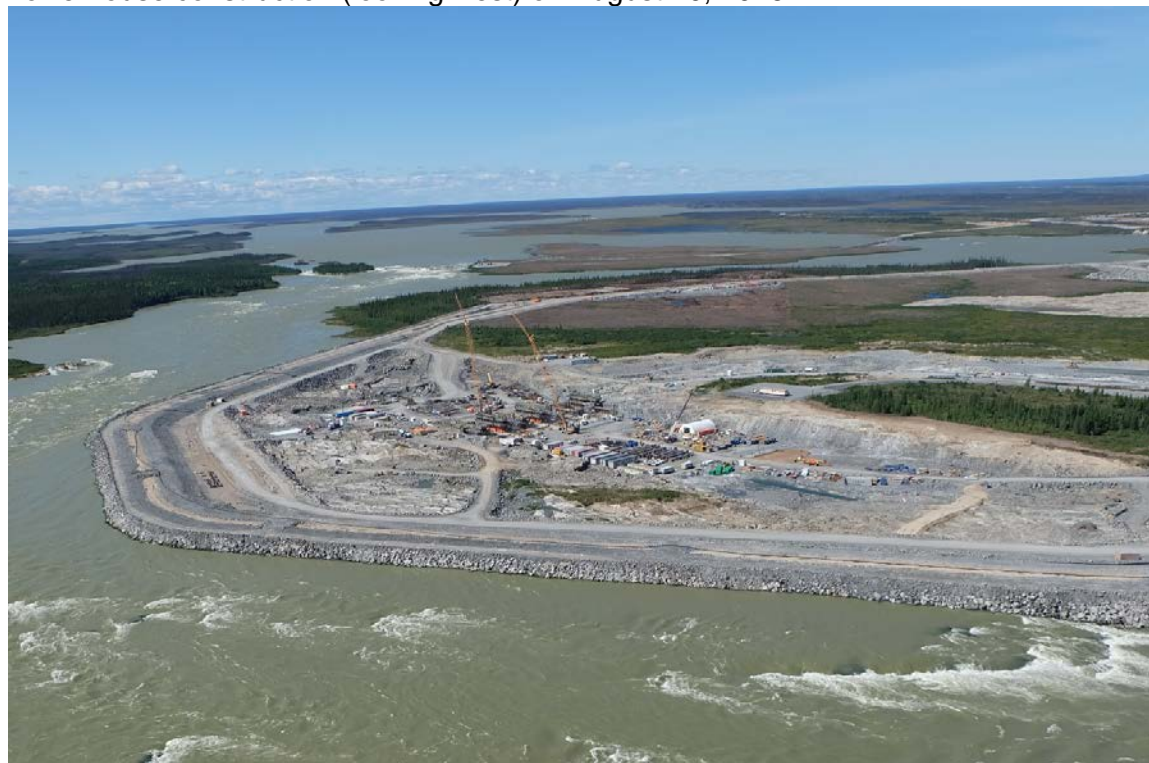
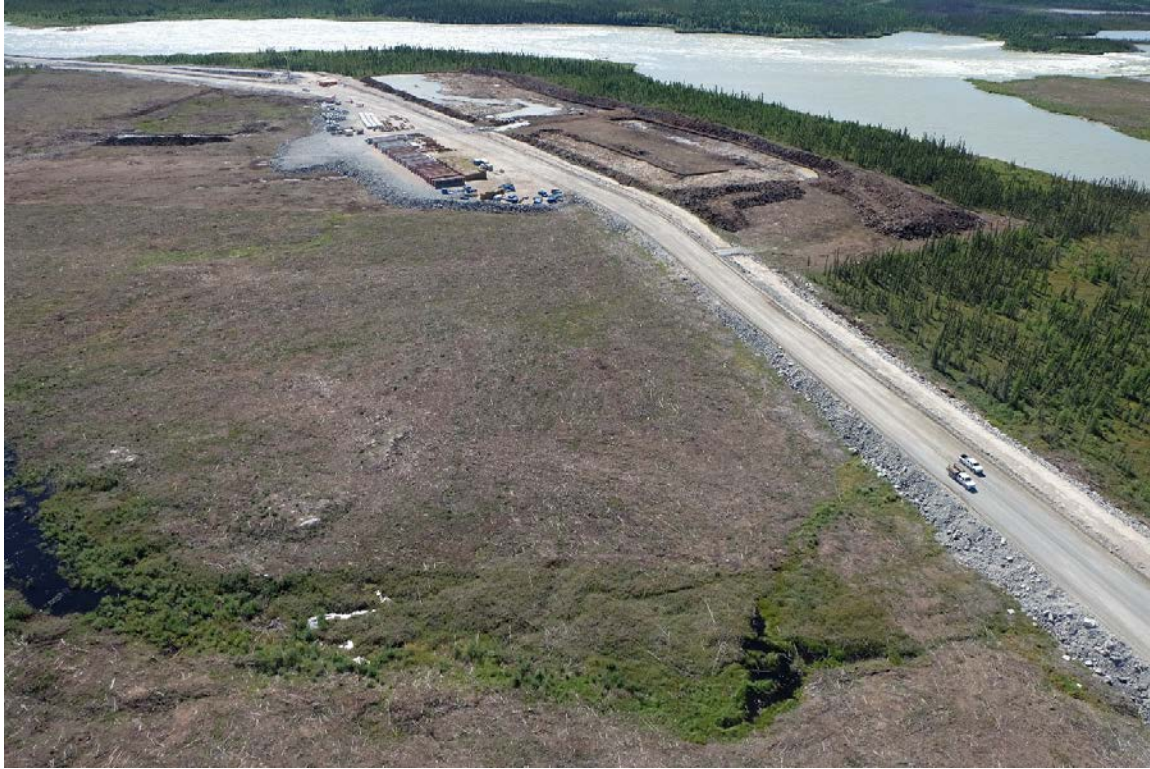
Figure 3-12: Features in the river works footprint component

Powerhouse construction (looking west) on August 20, 2016

Spillway construction (looking west) on August 20, 2016

Spillway laydown area (looking south) on August 20, 2016

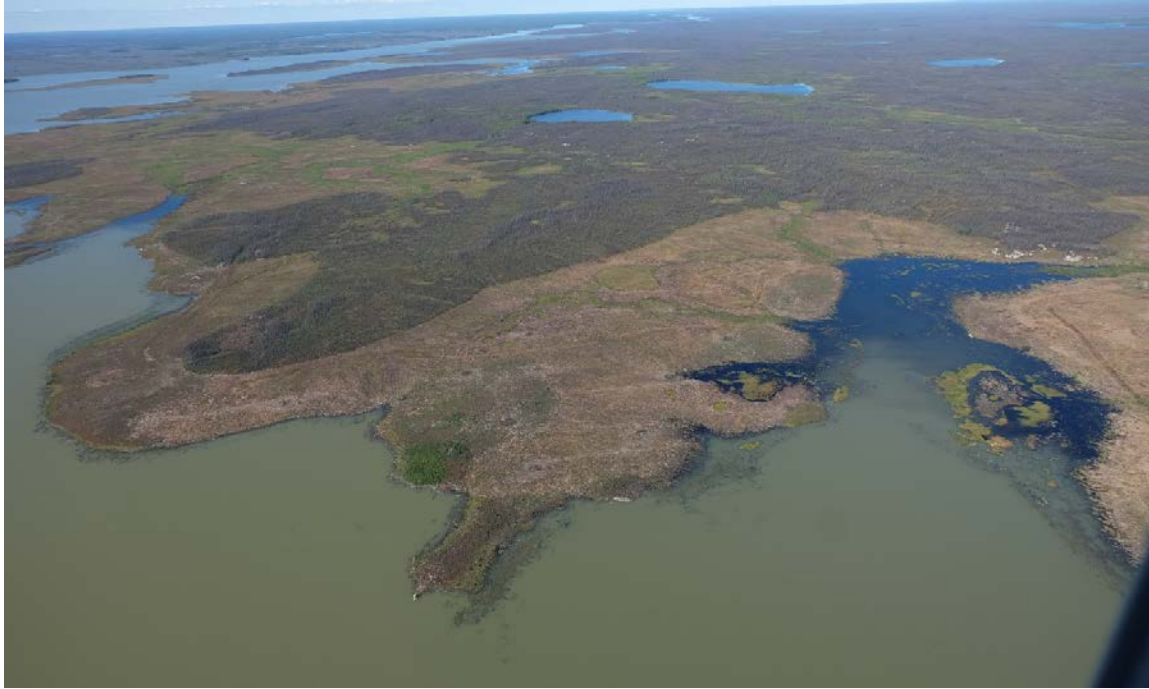
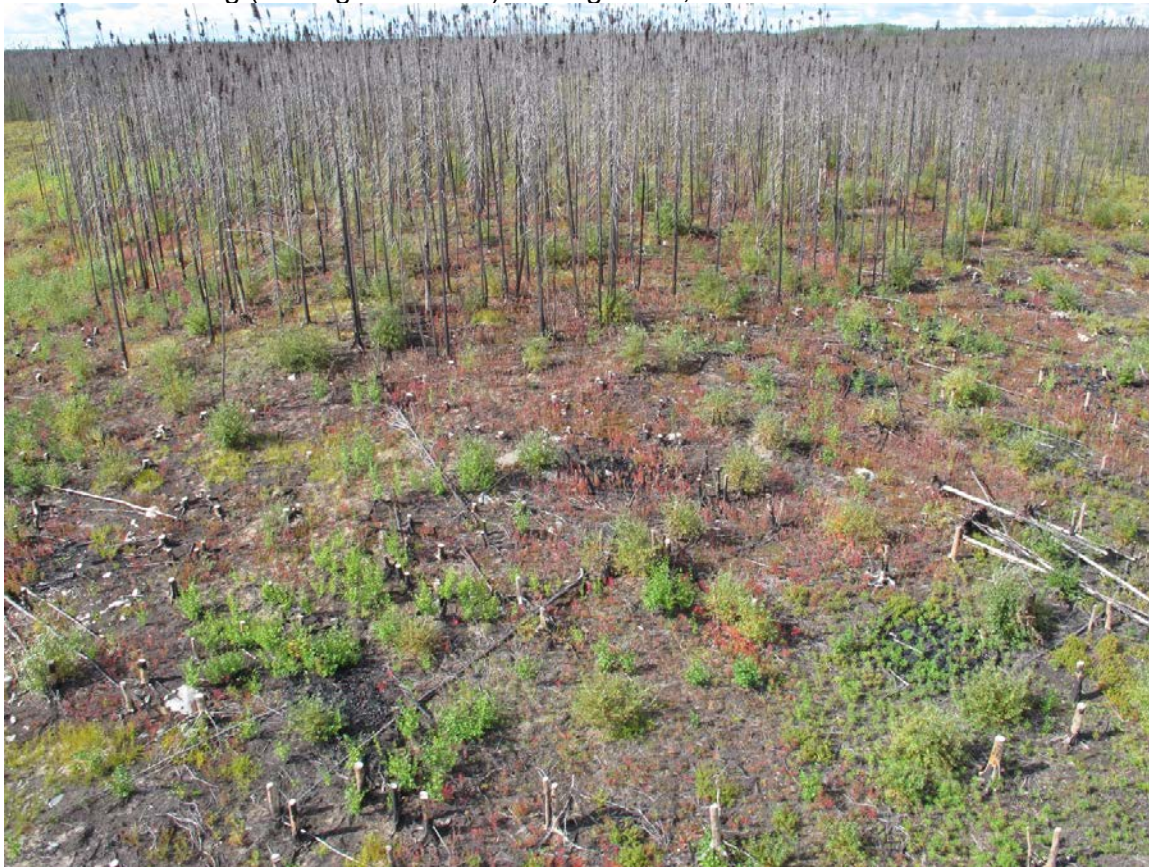
Figure 3-13: Reservoir clearing

Reservoir clearing (looking southwest) on August 21, 2016

Reservoir clearing, close-up view on September 7, 2016

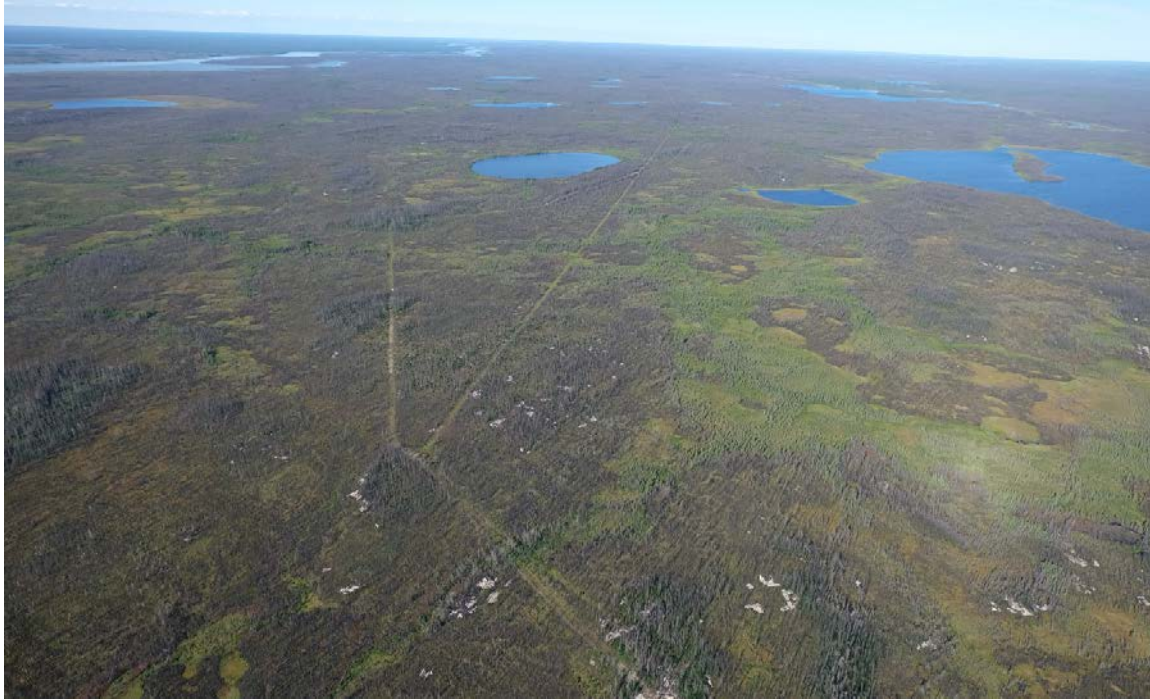
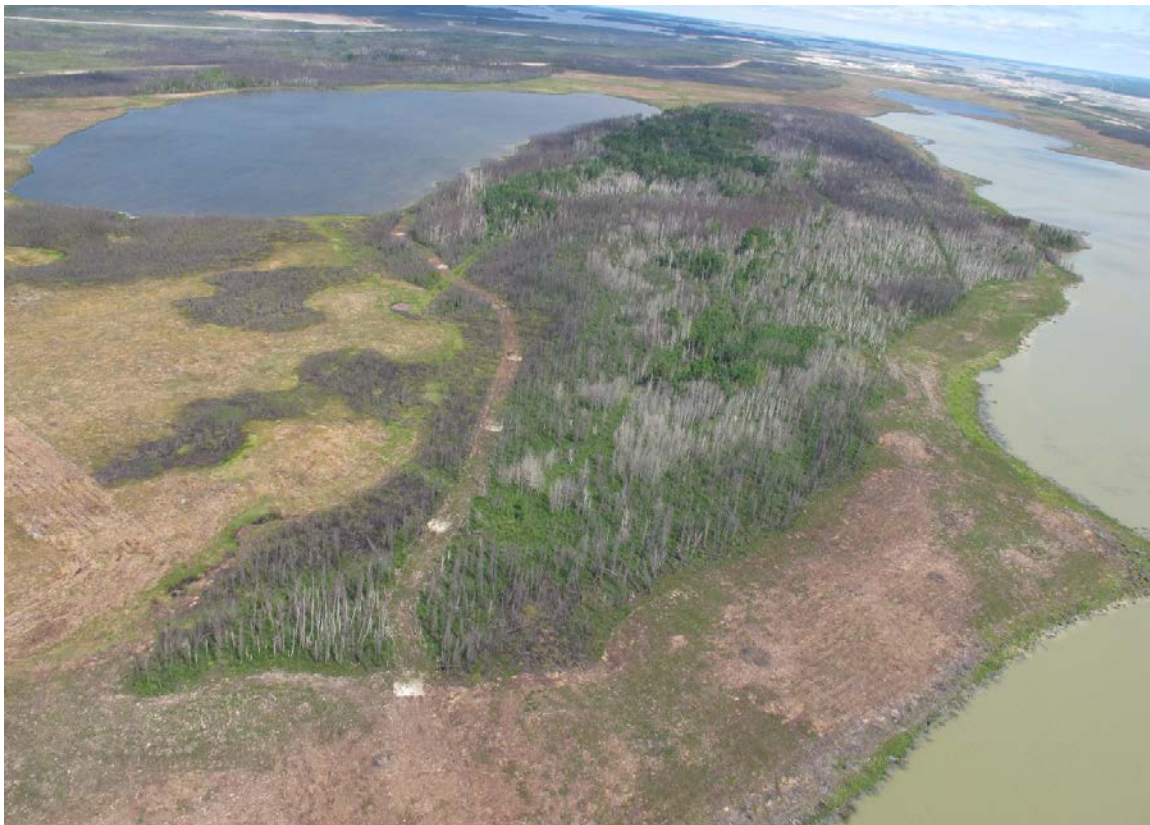
Figure 3-14: New and pre-existing cutlines used for the project

Pre-existing cutline for access to reservoir clearing (looking west) on August 21, 2016

Cutline for geotechnical exploration work (looking northeast) on July 7, 2016
