Keeyask Generation Project Terrestrial Effects Monitoring Plan

Wetland Loss and Disturbance Monitoring Report

TEMP-2017-03

ECOSTEM Ltd.

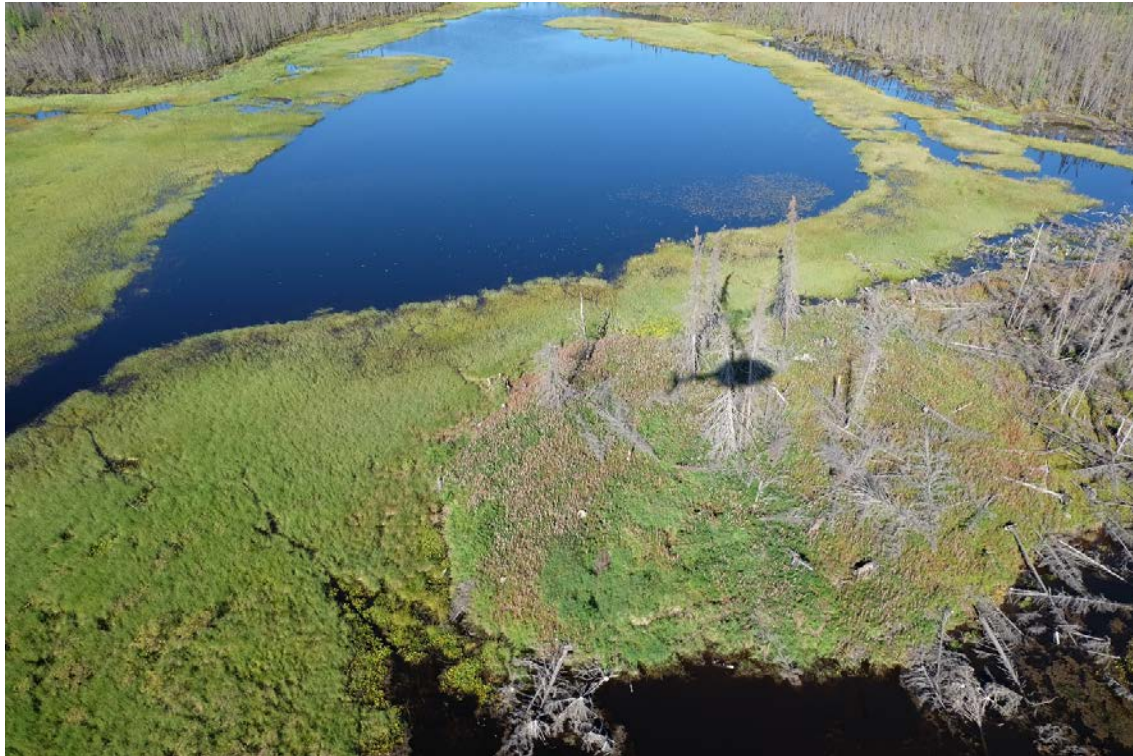
Figure 3-1: Aerial views of Wetland 3 and 17 on August 20, 2016

Wetland 3 (Figure 3-1) is 5.0 ha in size (Table 3-1), and located about 1 km from the Nelson River, approximately 21 km west of the generating station site (Map 2-1). Marsh habitat comprises 1.1 ha of the wetland's total area. Approximately 90% of the buffer zone (*i.e.*, a 100 m buffer of the marsh habitat; see Section 2.0) burned in a 2013 wildfire that was unrelated to the Project.

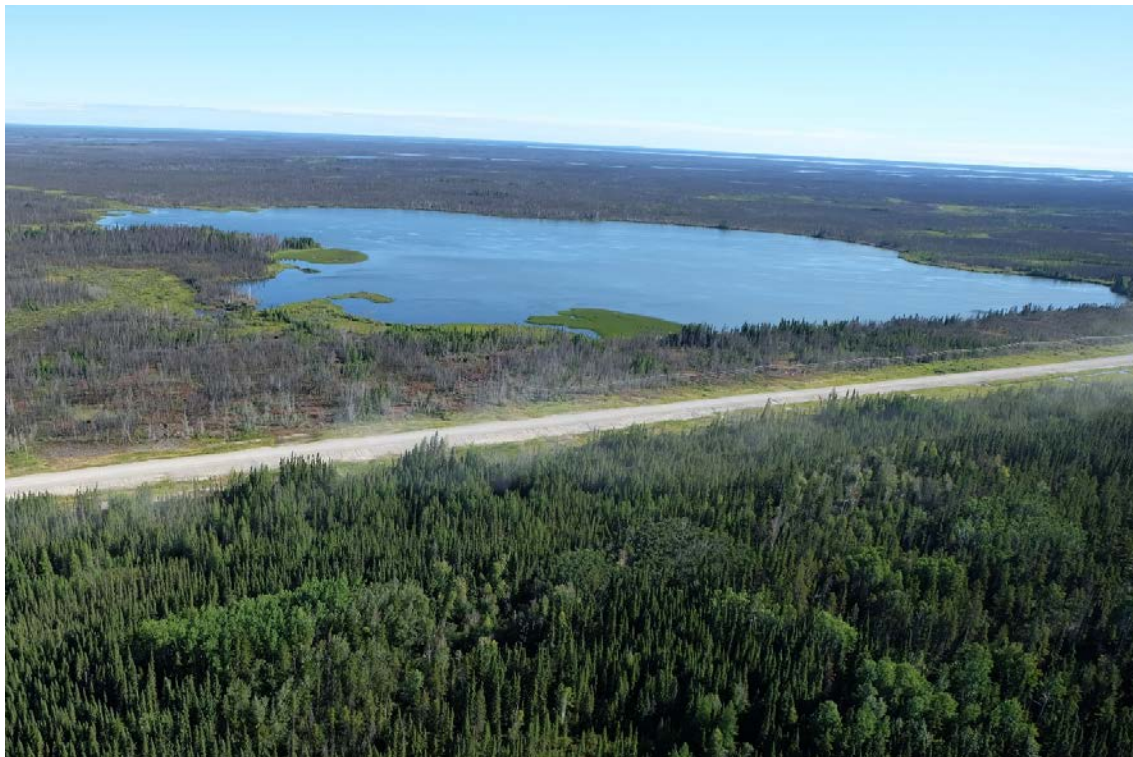
Wetland 17 (Figure 3-1) is 135.1 ha in size, and located on the southwest shore of a small lake situated at approximately kilometre 6 along the north access road (NAR; Map 2-1). Marsh habitat comprises 97.5 ha of the wetland's total area. Approximately 85% of the buffer zone burned in the 2013 wildfire.

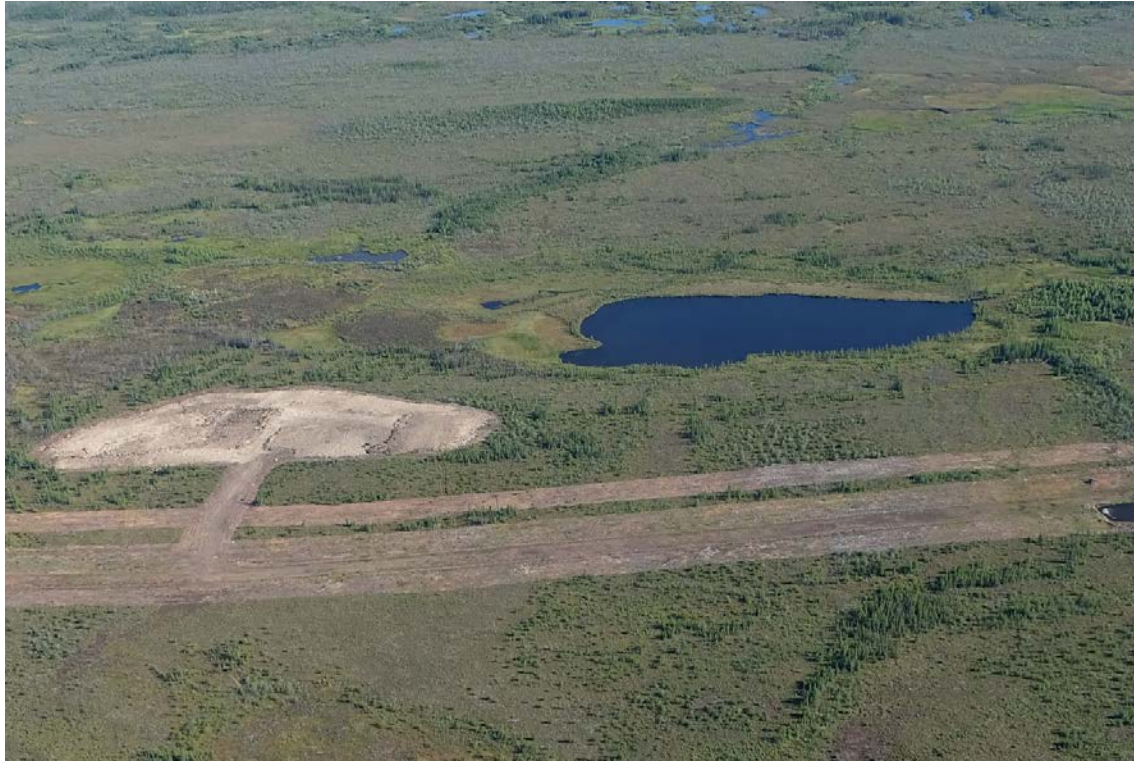
Figure 3-2: Aerial views of Wetland 37 and 40 on August 20, 2016

Wetland 37 (Figure 3-2) is 17.0 ha in size, and situated near the north dyke, adjacent to EMPA D3-E (Map 2-1). Marsh habitat comprises X ha of the wetland's total area. Approximately 5% of the buffer zone burned in the 2013 wildfire.

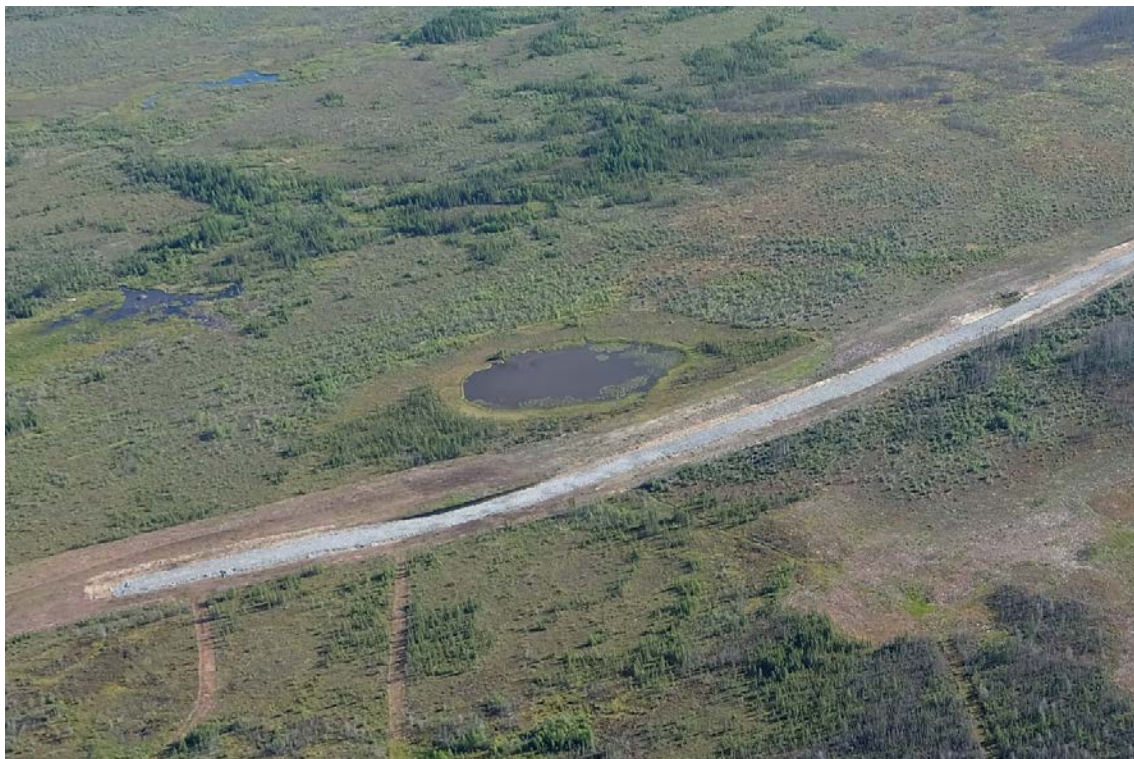
Wetland 40 (Figure 3-2) is 7.9 ha in size, and located along the north dyke, approximately 750 m east of Wetland 37 (Map 2-1). Marsh habitat comprises 1.2 ha of the wetland's total area. Approximately 10% of the buffer zone burned in the 2013 wildfire.

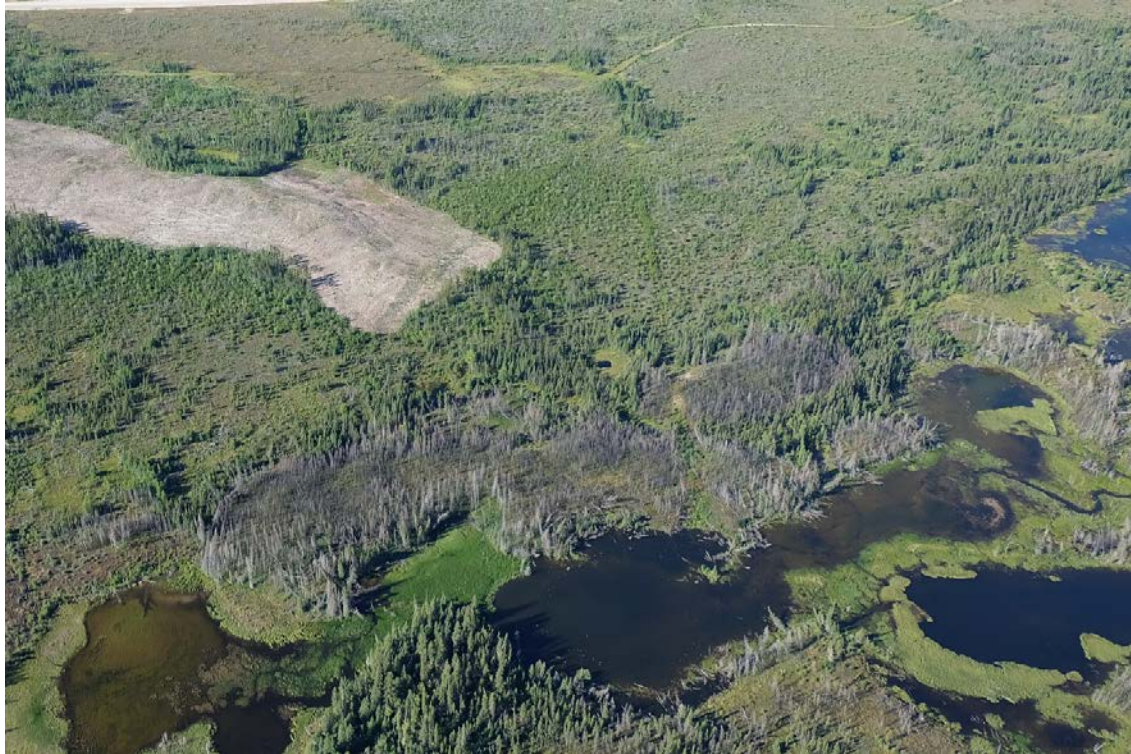
Figure 3-3: Aerial views of Wetland 42 and 45 on August 20, 2016

Wetland 42 (Figure 3-3) is 15.5 ha in size, and located approximately 750 m north of the NAR at kilometre 14, at the northwestern end of Borrow Area KM15 (Map 2-1). Marsh habitat comprises 2.9 ha of the wetland's total area. Approximately 50% of the buffer zone burned in the 2013 wildfire.

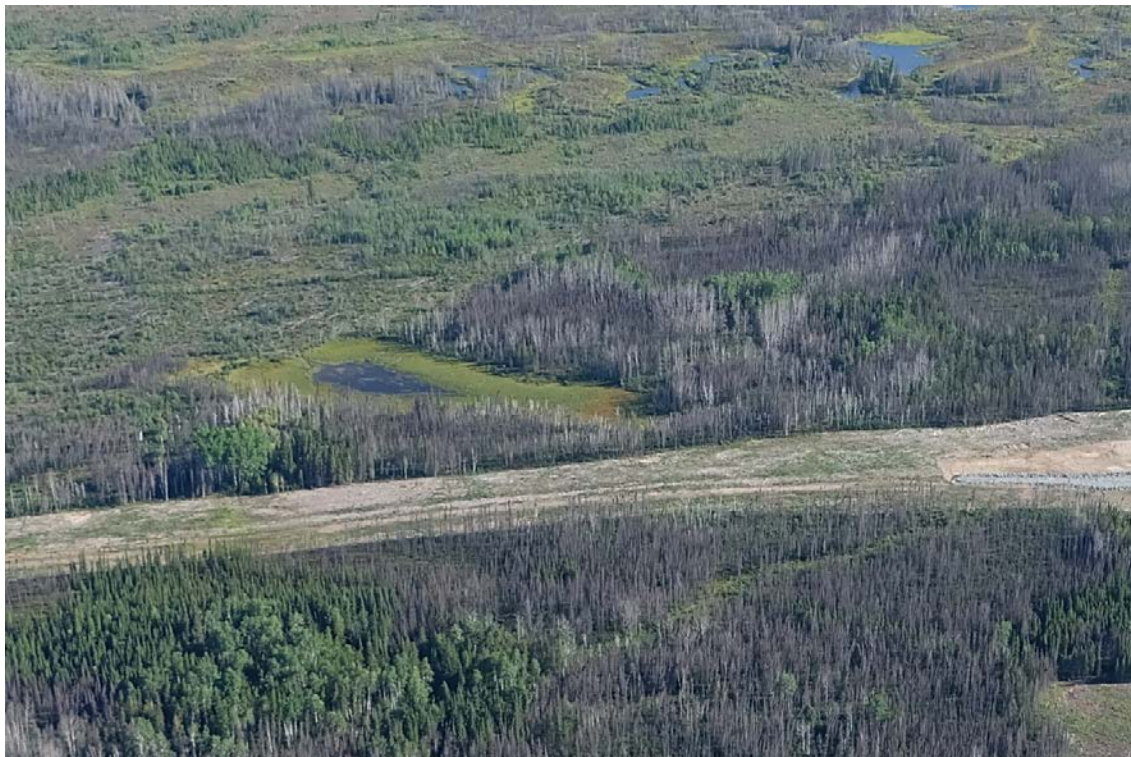
Wetland 45 (Figure 3-3) is 7.3 ha in size, and located along the north dyke, approximately 1.5 km east of Wetland 40 (Map 2-1). Marsh habitat comprises 0.8 ha of the wetland's total area. Approximately 50% of the buffer zone burned in the 2013 wildfire. Some of the burned area was between the planned north dyke and the marsh habitat, and some sites within this area had either a thin layer of organic matter or exposed mineral substrate.

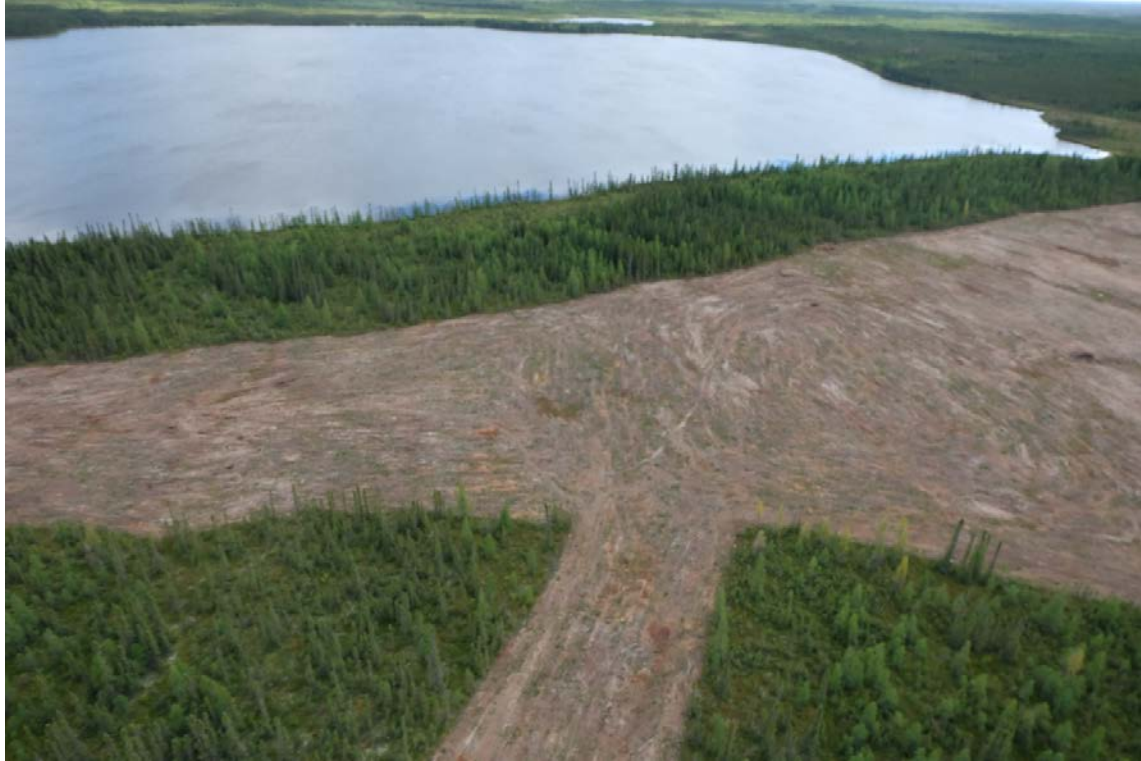
Figure 3-4: Aerial views of Wetland 47 and 51 on August 20, 2016

Wetland 47 (Figure 3-4; Figure 3-16) is 189.1 ha in size, and located approximately 100 m southeast of EMPA D27(4)-E (Map 2-1). Marsh habitat comprises 140.1 ha of the wetland's total area. None of the buffer zone burned in the 2013 wildfire.

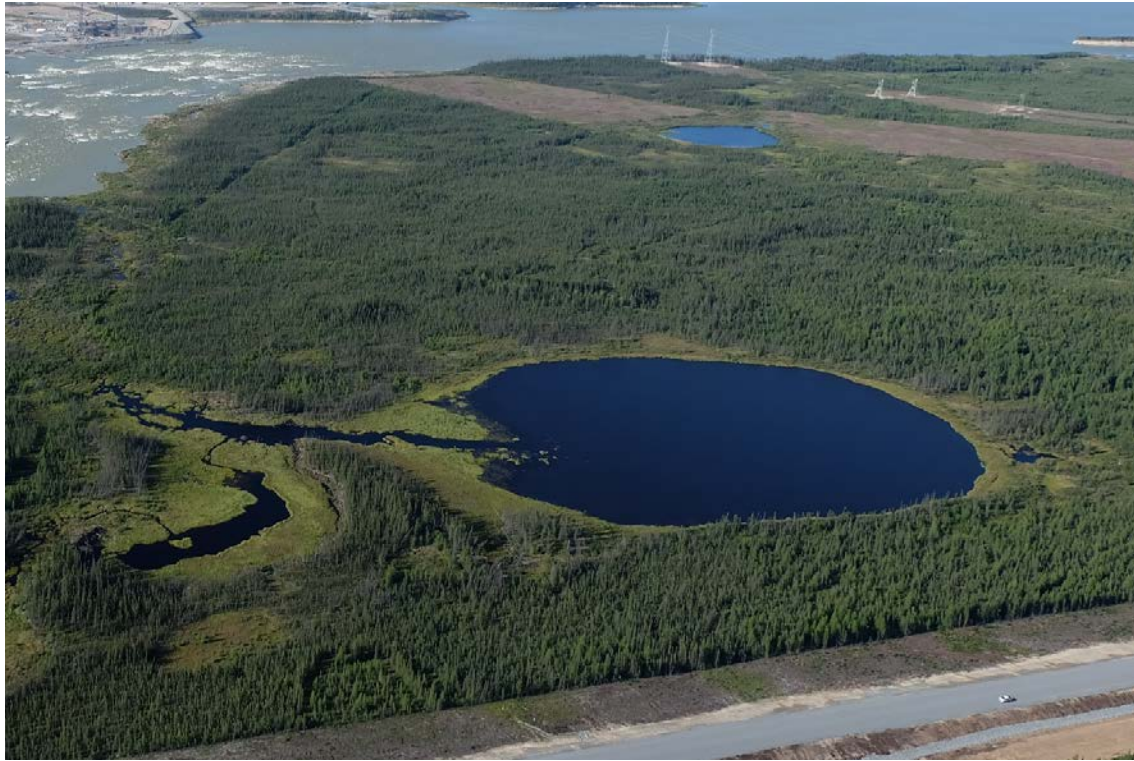
Figure 3-5: Aerial views of Wetland 52 and 53 on August 20, 2016

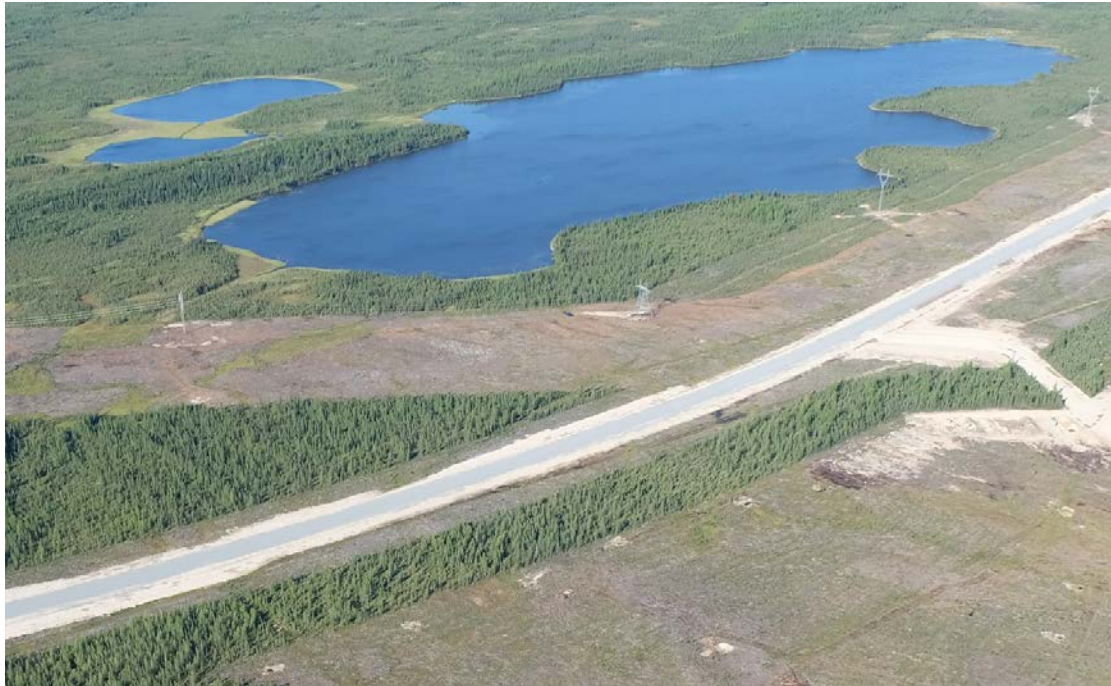
Figure 3-6: Aerial views of Wetland 54 and 57 on August 20, 2016

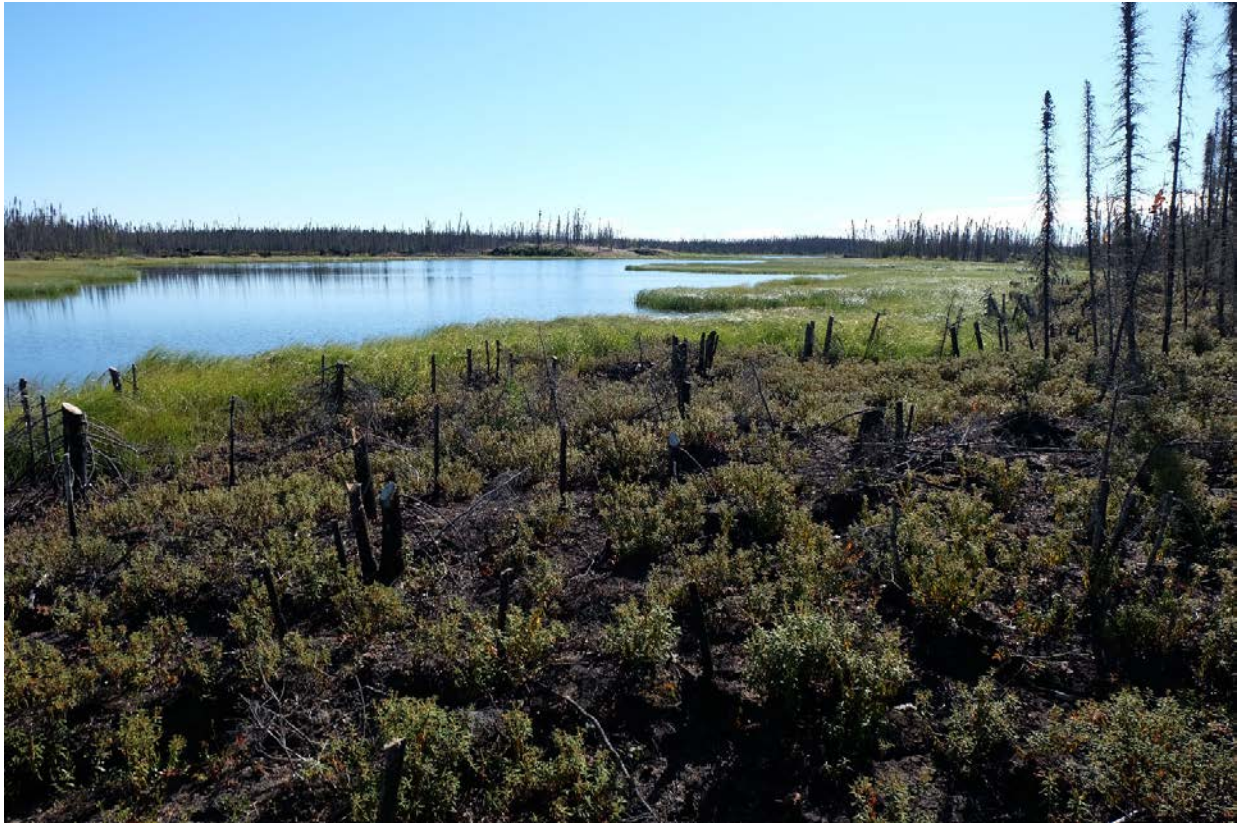
At the time of ground surveys in August 2016, a band of trees ranging from approximately 1 to 10 m wide in the marsh habitat (Figure 3-7, Figure 3-8), as well as within the buffer zone, had been removed by reservoir clearing. This clearing, which was situated along the shoreline, impacted 0.25 ha of the total 5.0 ha marsh area, including 0.01 ha of marsh habitat (Table 3-1). All of this clearing was within an EnvPP red zone. No other Project impacts (*e.g.*, sedimentation, hydrological alterations) were noted at Wetland 3 in 2016.

Figure 3-7: Cleared trees along the Nelson River shoreline in the marsh habitat of Wetland 3 in August, 2016

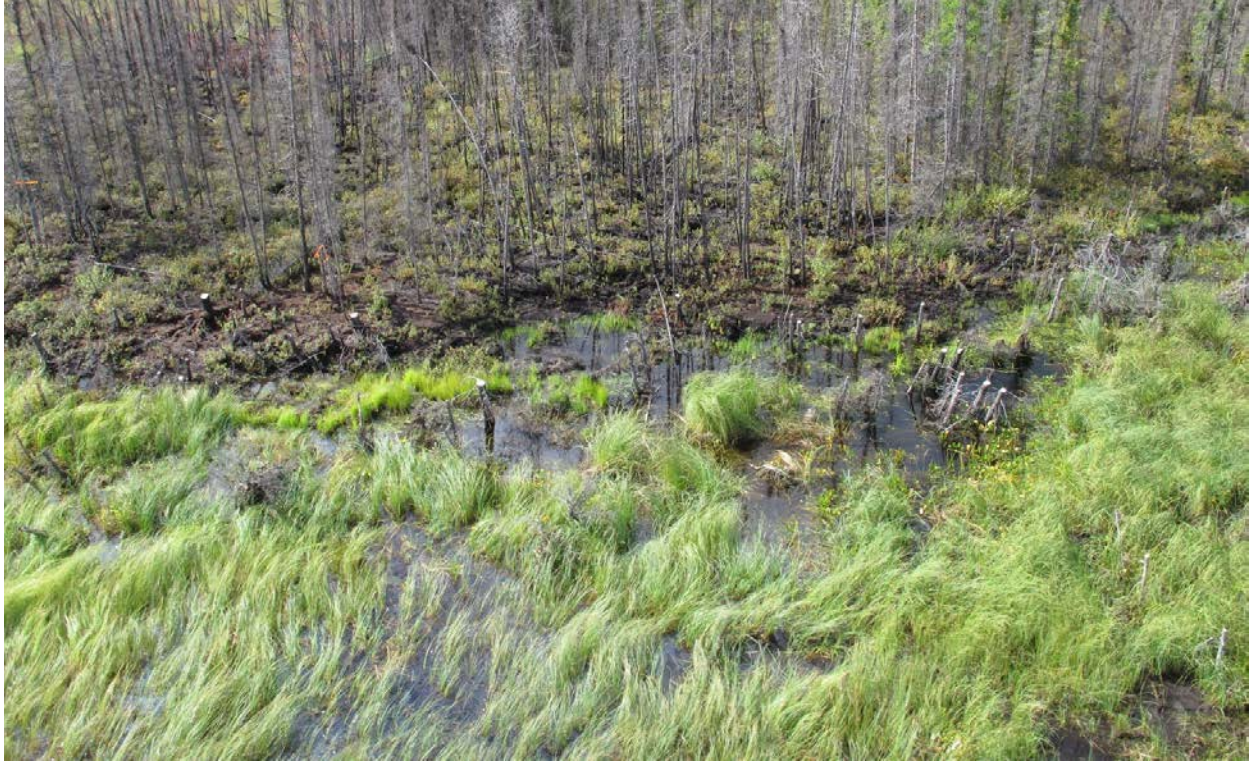
Figure 3-8: Aerial view of cleared trees in the marsh habitat of Wetland 3 in August, 2016

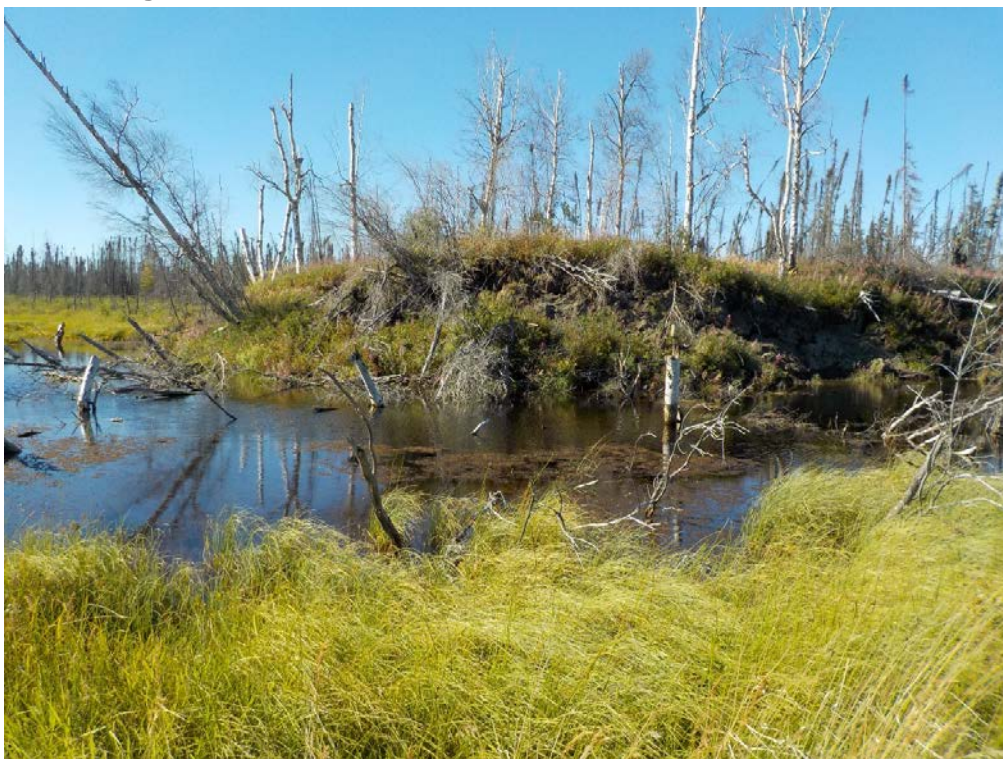
Shoreline slumping was observed around the southwestern edge of the marsh (Figure 3-9) was observed in 2015. Given its distance from the NAR, this slumping was likely caused by melting massive ground ice in peat (which the EIS showed was naturally occurring in the region).

Ground ice melting was likely accelerated in locations burned during the 2013 wildfire. No incremental changes were observed in these locations in 2016.

Ground slump along the southwestern edge of Wetland 17 (likely due to melting ground ice in peat plateau bog)

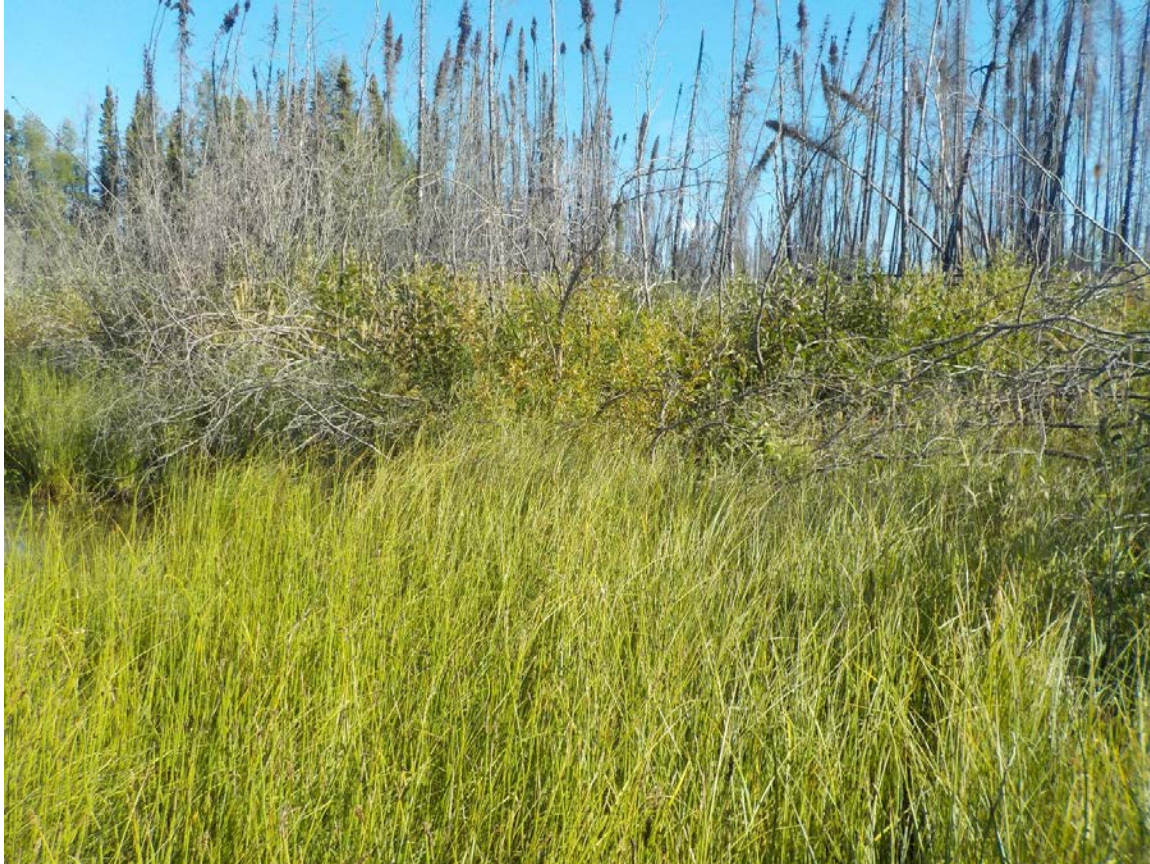
Some shrub and white birch mortality were observed in 2015 along the south side of this marsh at the shoreline (Figure 3-9), with some of the dead stems emerging from the water. The cause of this vegetation mortality was unclear. Some possibilities include the 2013 wildfire, depth to groundwater changes after the wildfire, ground slumping after massive ground ice below the peat had melted (see next paragraph), or indirect hydrological effects of nearby construction. No incremental changes were observed in these locations in 2016.

Shrub mortality at Wetland 17

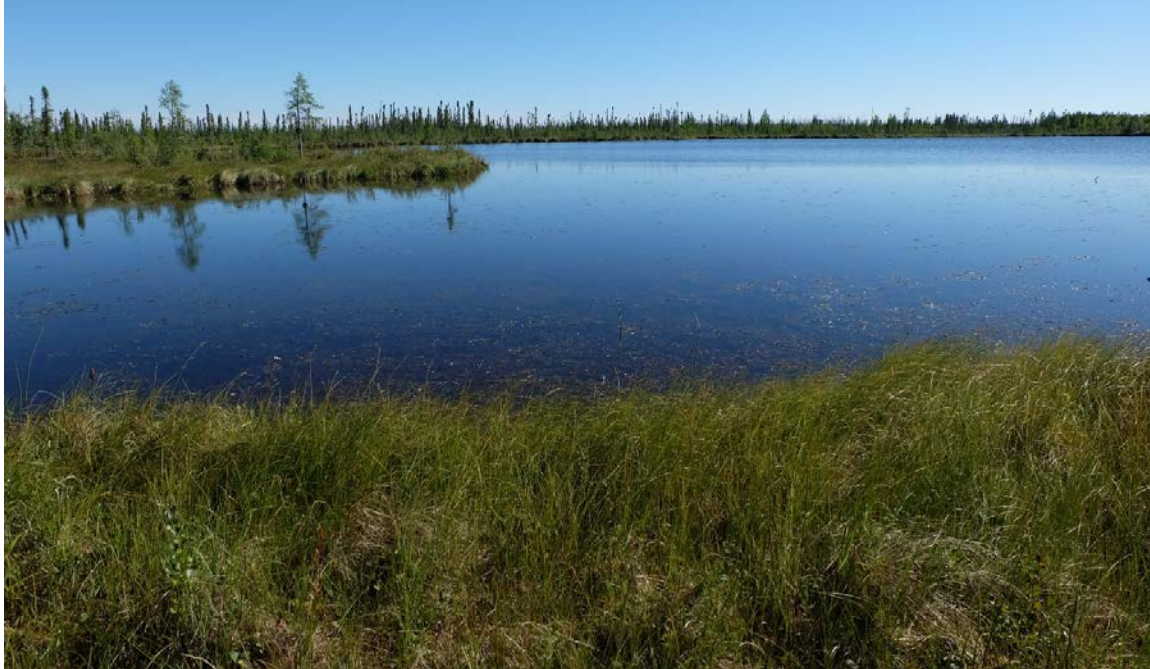
Figure 3-10: Ground photos of Wetland 37 in August 2016

The 2016 ground survey found that a very small amount of EMPA clearing (< 0.01 ha; Table 3-1) extended into the buffer zone (Figure 3-10). All of this clearing was within the Project's possibly disturbed area. No other Project impacts were noted at Wetland 3 in 2016. Mitigation measures were not observed in this area in 2016.

View along the shores of Wetland 37

It is recommended that further clearing of the northeastern edge of this EMPA be limited to minimize the potential impacts on the marsh habitat in Wetland 37. These should be monitored for any potential effects from runoff as they are downslope of the cleared area.

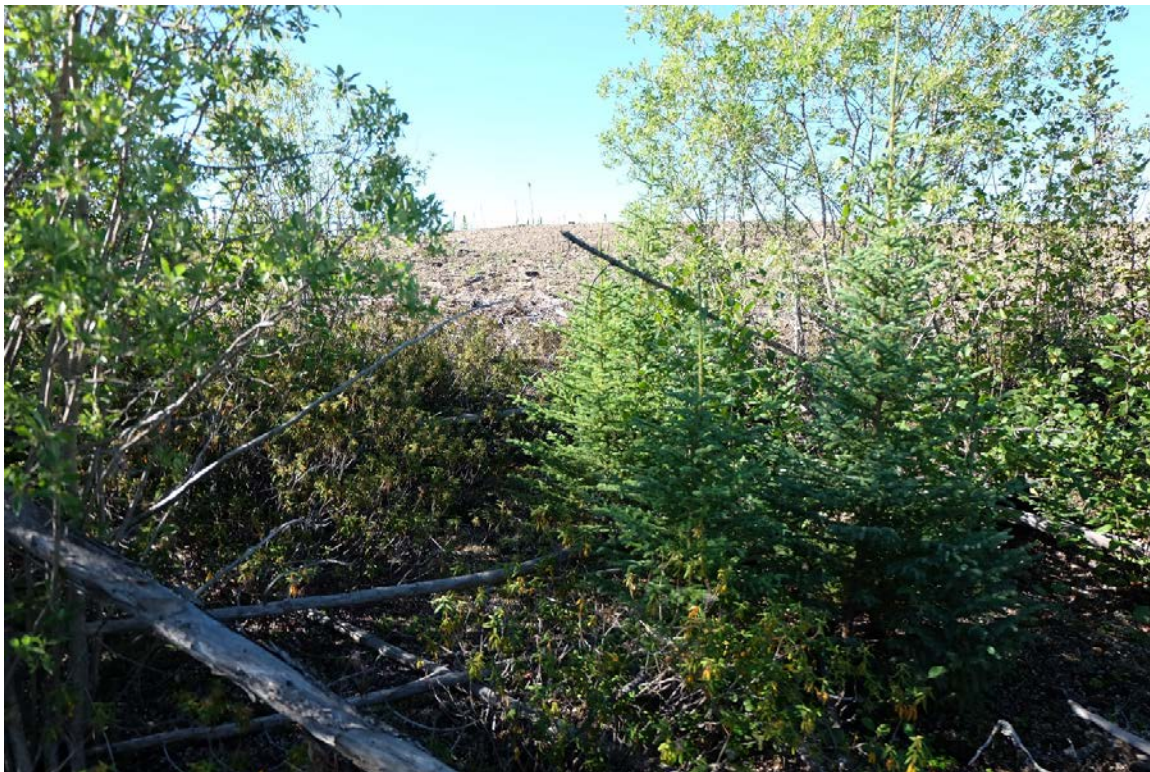
Clearing into the Wetland 37 buffer

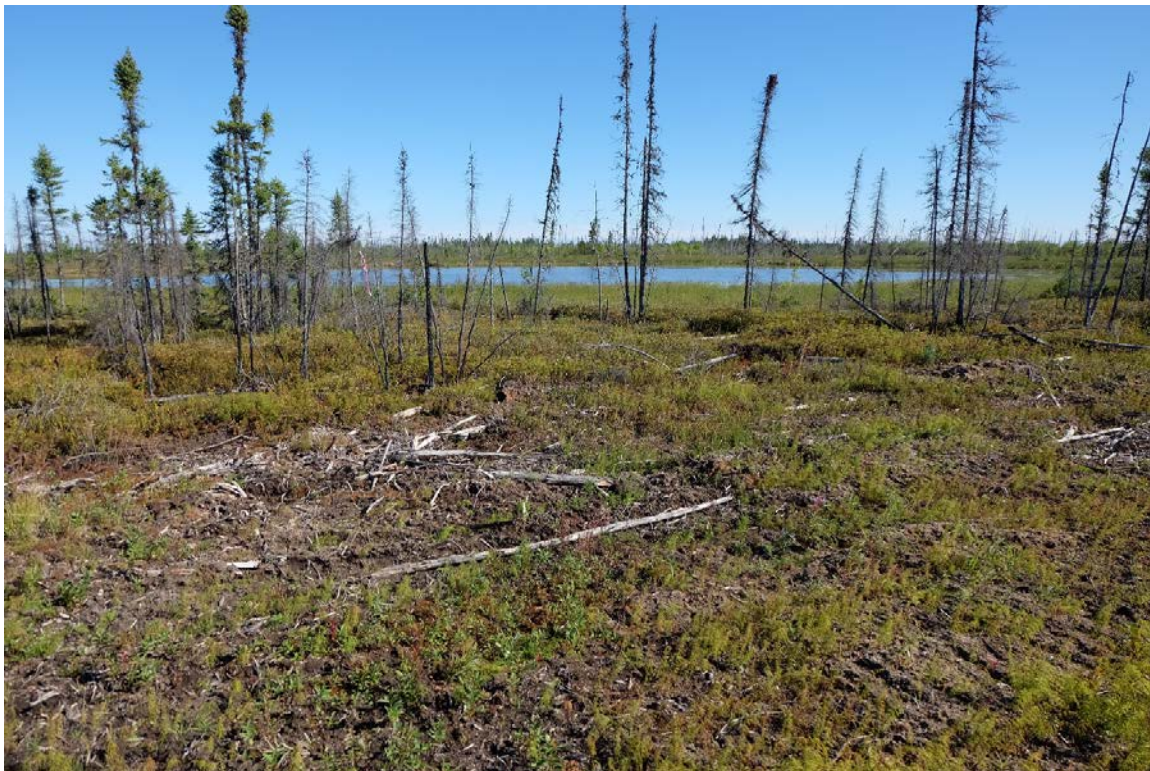
By the time of the 2016 survey, planned dyke clearing had impacted the southern portion of Wetland 40 (Figure 3-11), extending to approximately 3 m away from the of the marsh habitat (Figure 3-12). Some of the marsh habitat within the planned clearing (or EnvPP green zone) had been avoided. No other Project impacts were noted at this wetland in 2016.

Clearing and burned area close to Wetland 40

It is recommended that site staff evaluate and implement sediment control measures where needed to prevent sediment and other runoff from entering the marsh site (e.g., a silt fence be erected at the base of the slope). It is also recommended that a northward extension of the existing dyke clearing be avoided, if possible, to limit additional impacts on Wetland 40.

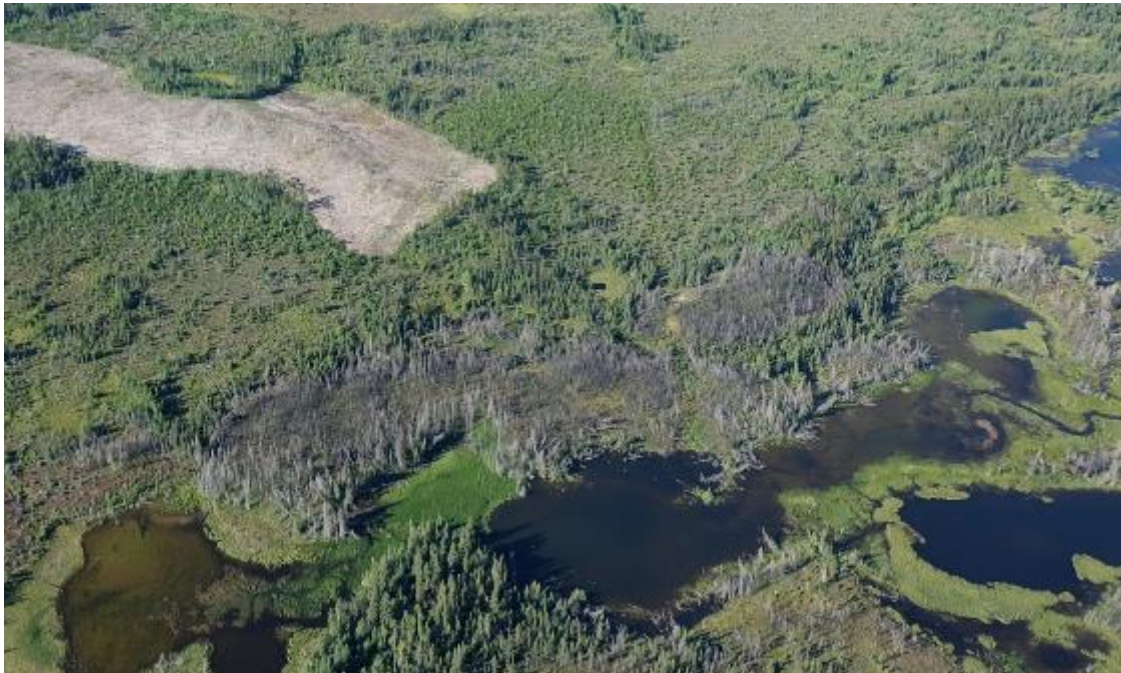
During the 2016 aerial survey, it was noted that there was a significant slope downwards from Borrow Area KM15 clearing to the southern edge of the wetland (Figure 3-13). A sediment control recommendation was not made given the amount of undisturbed vegetation between the exposed mineral area and the marsh habitat. This area will continue to be monitored in order to determine if there is any erosion or surface runoff from the slope into the marsh.

Figure 3-13: Aerial view of Wetland 42 from the northeast and Borrow Area KM15 clearing to the south in August 2016

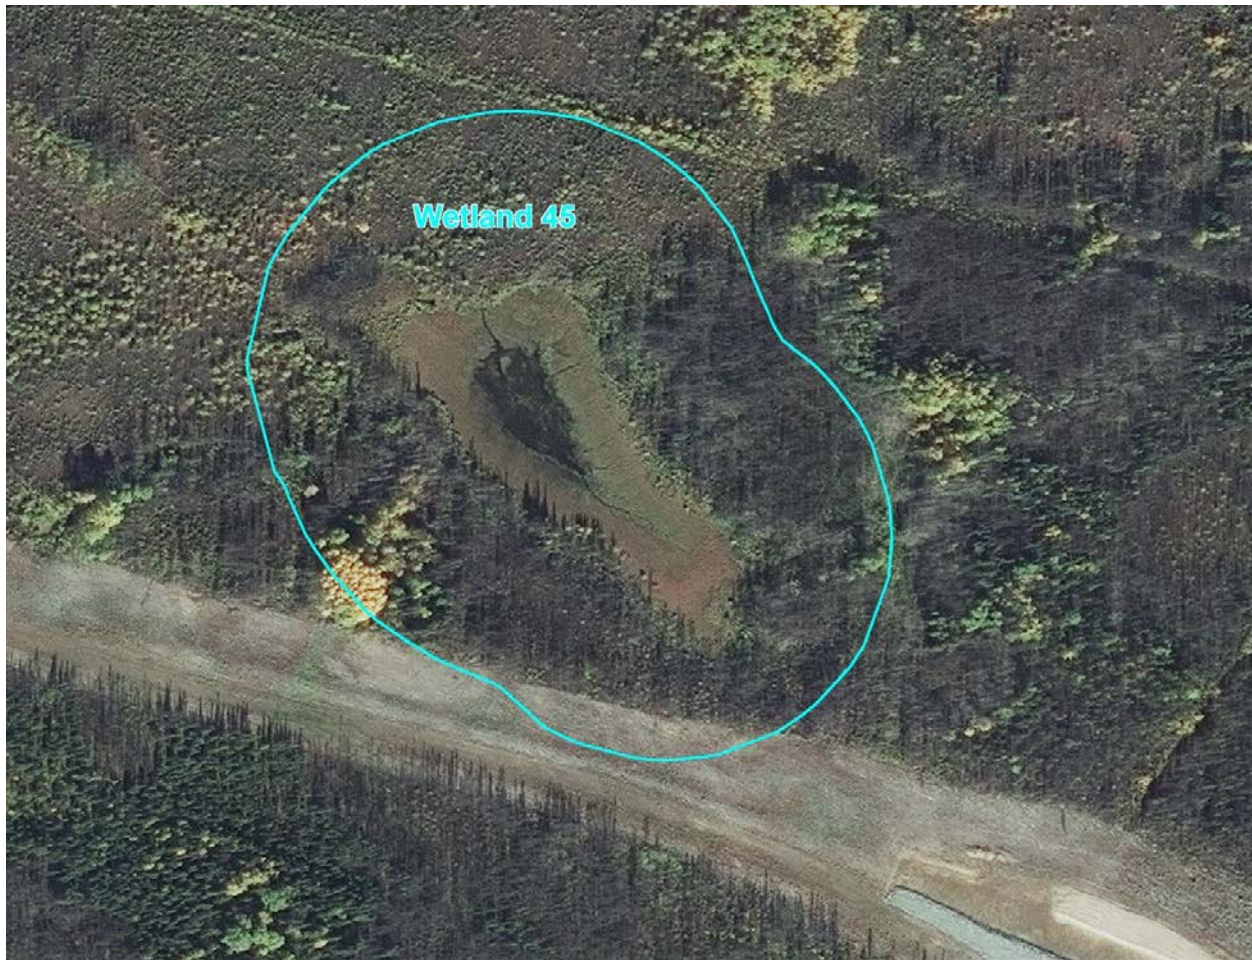
By the time of the 2016 ground survey, north dyke clearing had been extended to approximately 25 m into the wetland buffer zone (Figure 3-14 and Figure 3-15). All of this clearing was within an EnvPP green zone. No other Project impacts were noted at this wetland in 2016. All of the dyke clearing within Wetland 45 was also within the above noted burned area.

Figure 3-14: North dyke clearing (all within an EnvPP green zone) at Wetland 45 in September 2016

It is recommended that site staff evaluate and implement sediment control measures where needed to prevent sediment and other runoff from entering the marsh site (e.g., a silt fence be erected at the base of the slope). It is also recommended that a northward extension of the existing clearing be avoided to minimize additional impacts on Wetland 45.

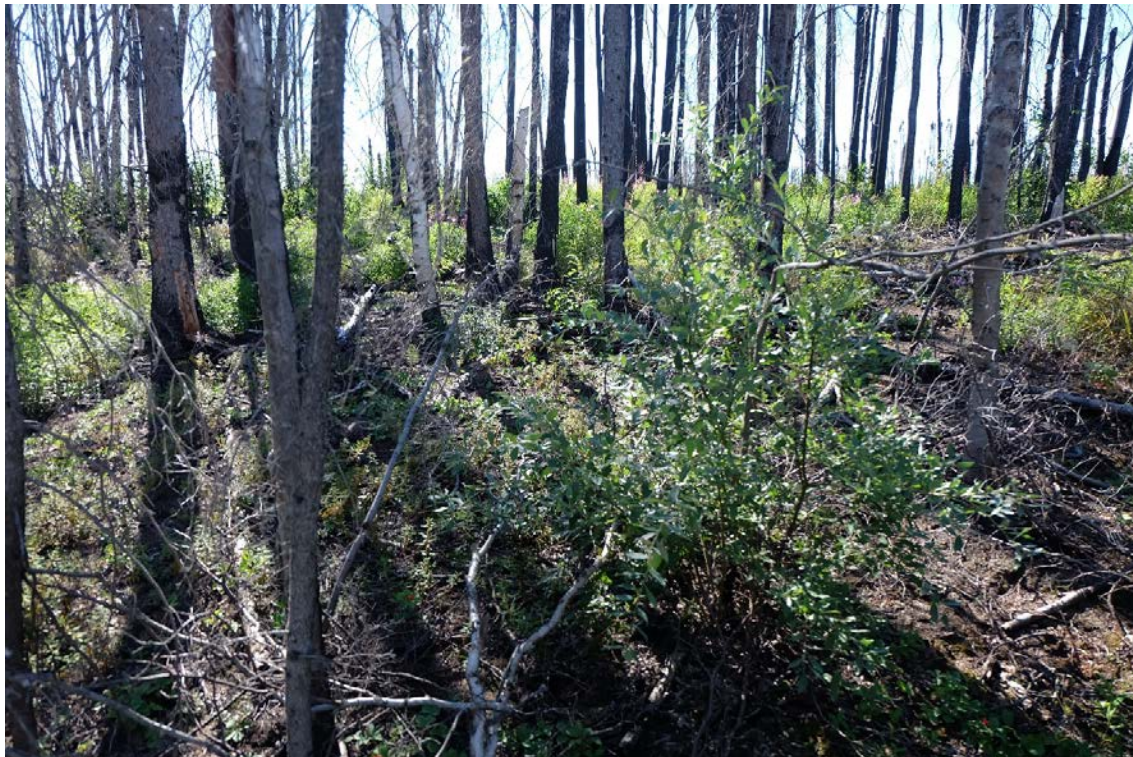
A 15% slope through the dyke clearing to the marsh habitat created the potential for future surface runoff to carry material into the marsh habitat. In addition to the slope containing exposed mineral material in the cleared area (Figure 3-15), the entire slope had been burned with some sites having virtually all vegetation removed. These areas will be monitored for any potential effects from runoff.

Exposed mineral on slope in burned forest between north dyke and Wetland 45

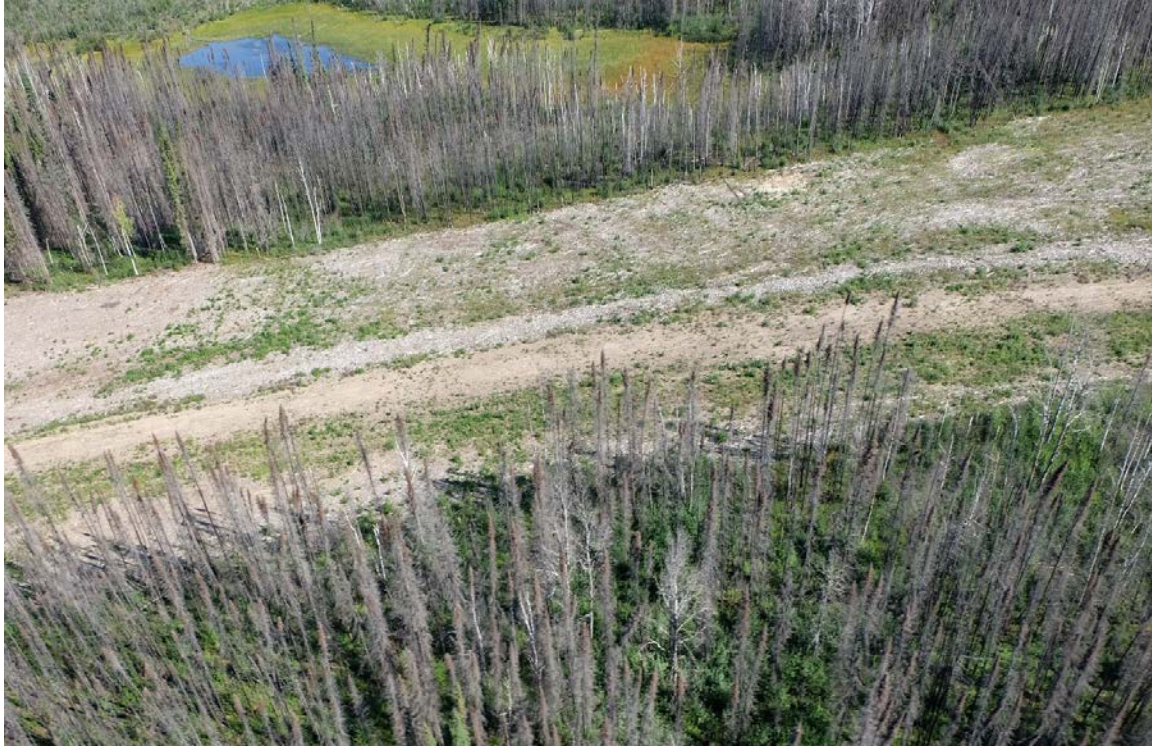
Aerial view showing the proximity of north dyke clearing to Wetland 45

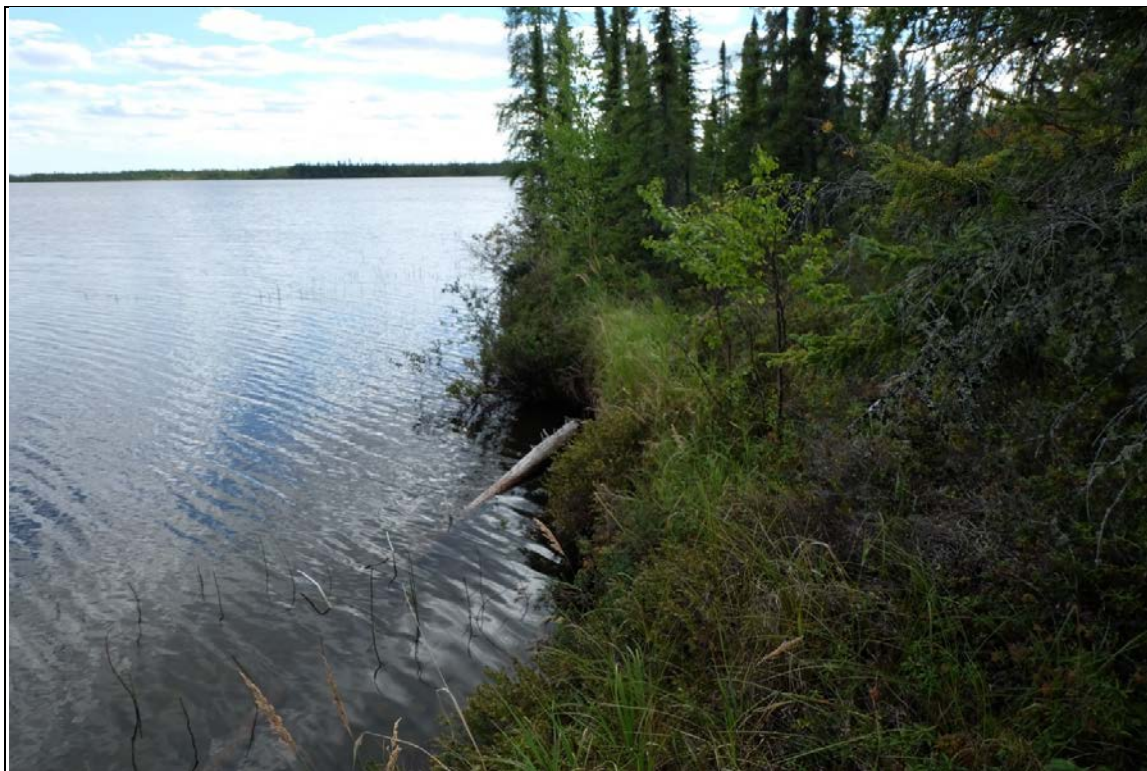
Figure 3-16: View along the Wetland 47 shore

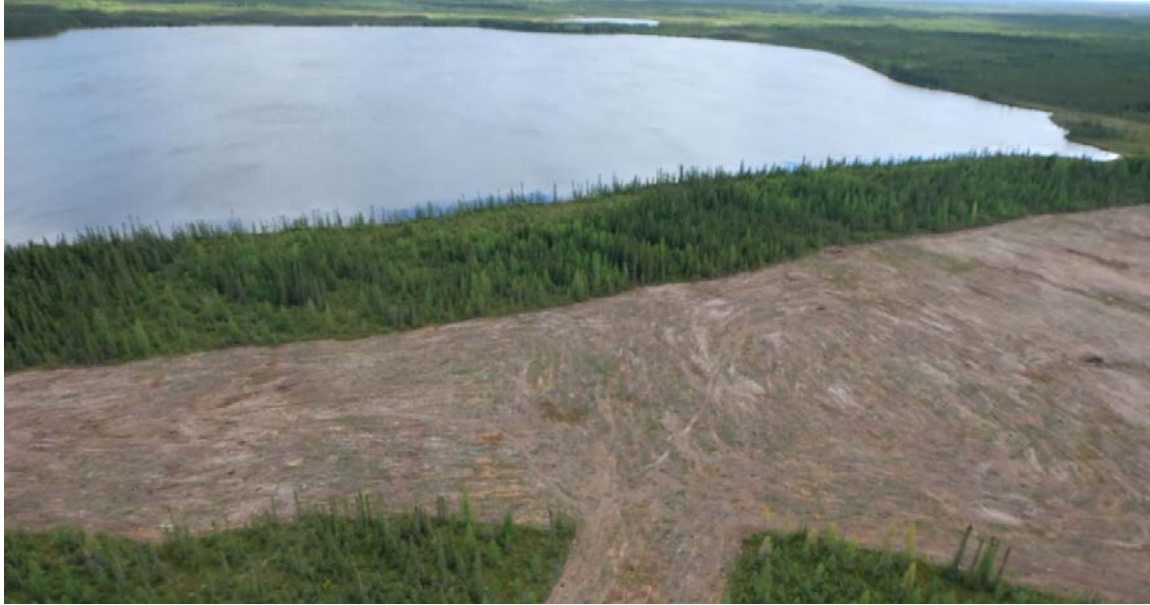
The 2016 ground surveys found that a very small amount of EMPA clearing (approximately 0.02 ha) extended into the Wetland 47 buffer along the northwestern edge (Figure 3-17). All of this clearing was within an EnvPP red zone. A small amount of clearing from a cutline (approximately 0.03 ha) extended into the buffer zone on the northeastern edge of the wetland, all of which was in an EnvPP green zone. No other Project impacts were noted at this wetland in 2016.

Aerial view showing the proximity of north dyke clearing to Wetland 47

It is recommended that a southeastern extension of the existing clearing be avoided to minimize additional impacts on Wetland 47.

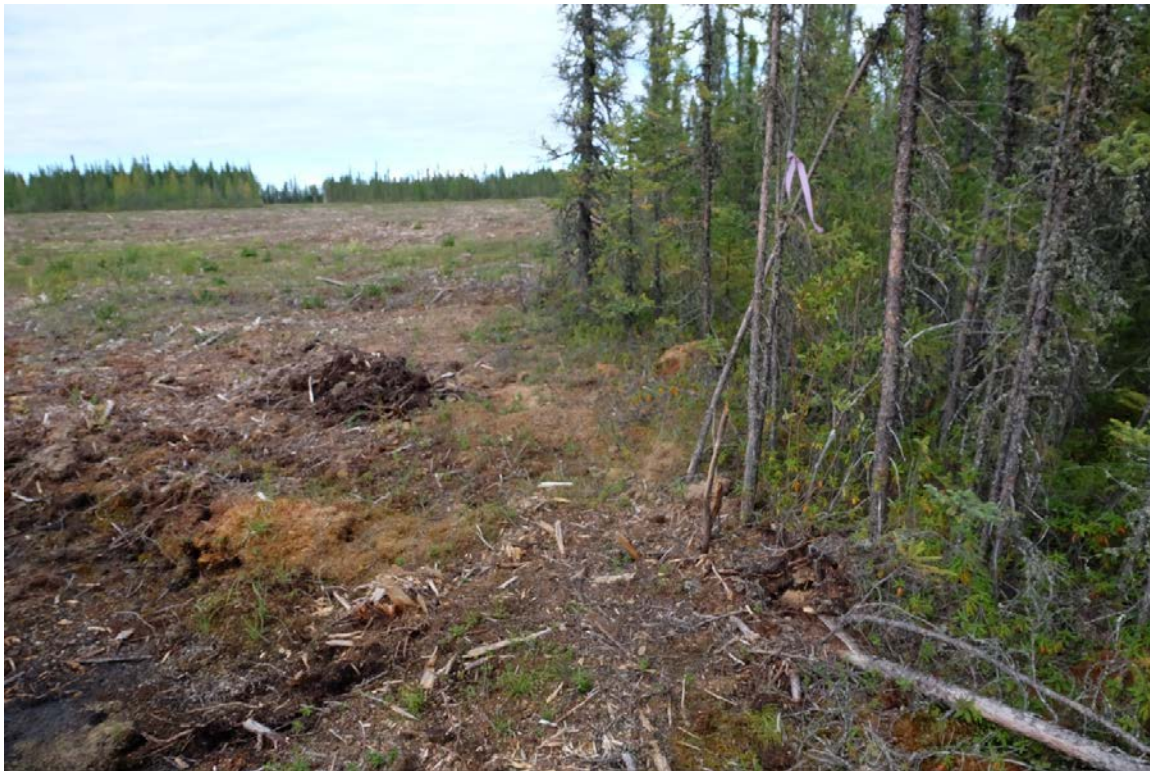
Clearing into the Wetland 47 buffer

Figure 3-17: Clearing into the Wetland 47 buffer in August 2016
