Keeyask Generation Project Terrestrial Effects Monitoring Plan

Wetland Loss and Disturbance Monitoring Report

TEMP-2017-03

ECOSTEM Ltd.

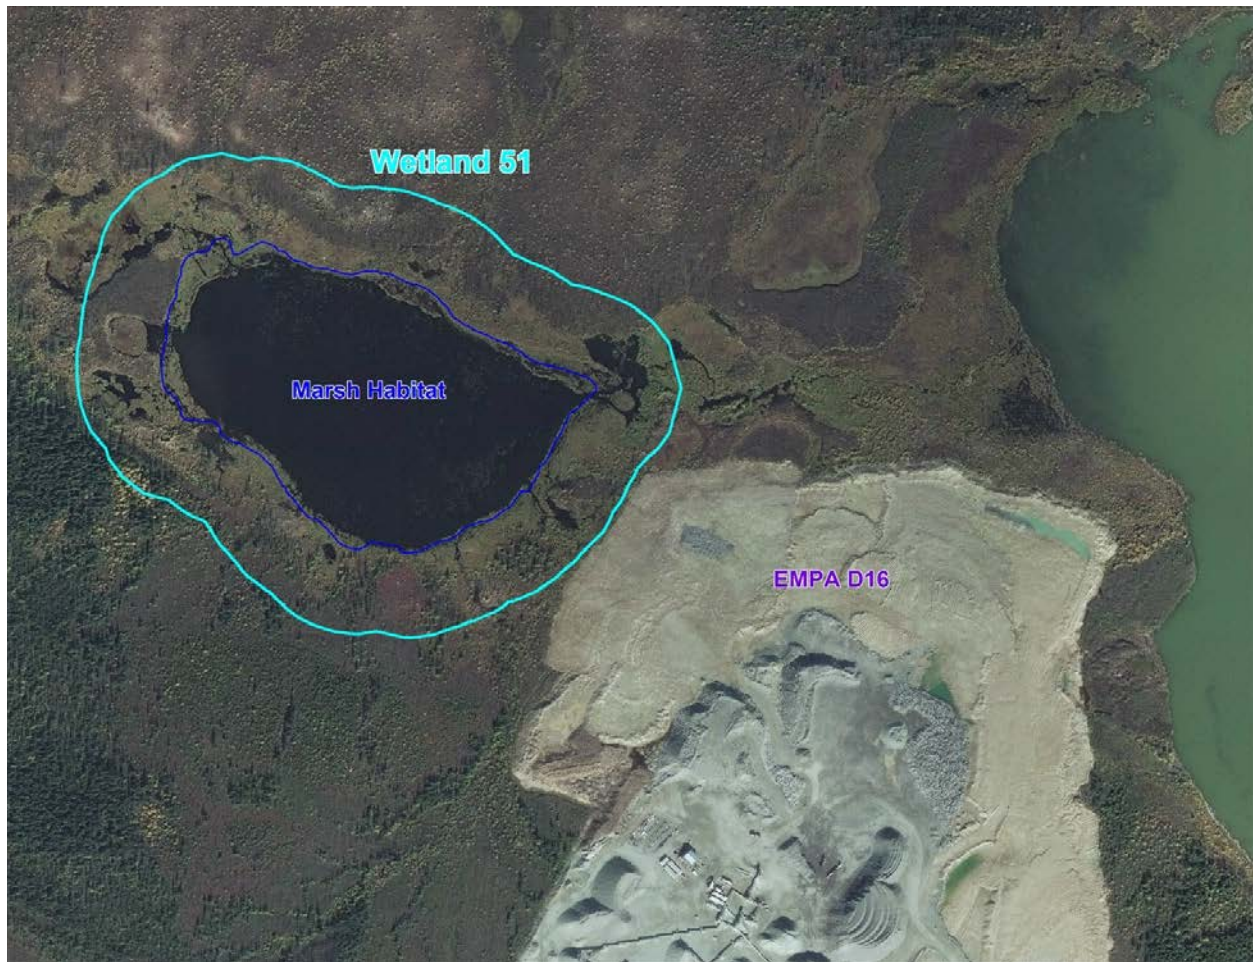
By the time of the 2016 ground survey, some EMPA banks had been graded (Figure 3-18), creating gentler slopes on the northwestern edges. This grading extended the toe of the EMPA banks to approximately 2 m away from the Wetland 51 boundaries (Figure 3-19). Also, the heavy machinery rutting, soil berm, fallen silt fence locations, dying vegetation and erosion and sedimentation into waterways connected to Wetland 51 that had been observed in 2015 were no longer present (Figure 3-19). No Project clearing, disturbance or other impacts were observed within Wetland 51 in 2016.

Figure 3-18: Aerial imagery of Wetland 51 in September 2016

It is recommended that sediment control measures be placed at strategic locations along the northwestern, northern and eastern EMPA banks to prevent further spread towards the northwest. The strategic locations are as follows: where the undisturbed area adjacent to the EMPA has moderate to steep slopes; where there is open water near the base of the slope; or, where the undisturbed peat appears to be floating. Both of the latter two conditions may facilitate sediment transport into the marsh habitat or into the waterway leading from the marsh into the channel between the Nelson River and Stephens Lake. It is also recommended that, if

this EMPA receives further excavated material, then it should be placed to the southwest of the existing material or on existing areas well back from the top of the bank.

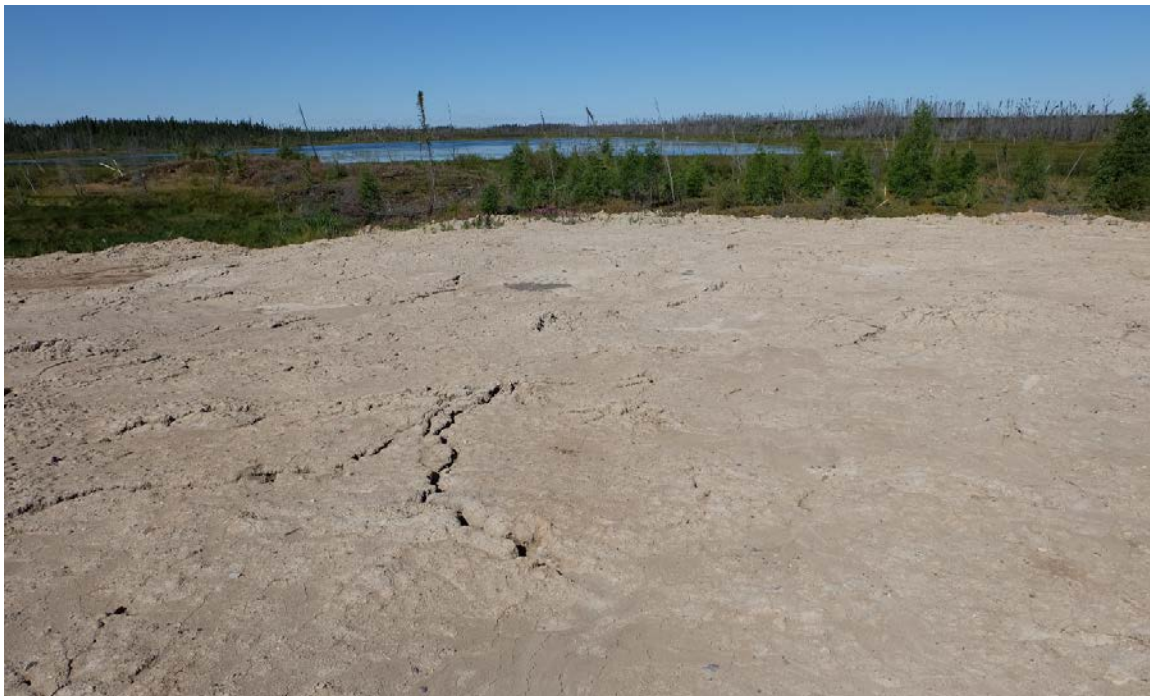
Graded slope between EMPA and Wetland 51, where disturbances and other impacts were noted in 2015

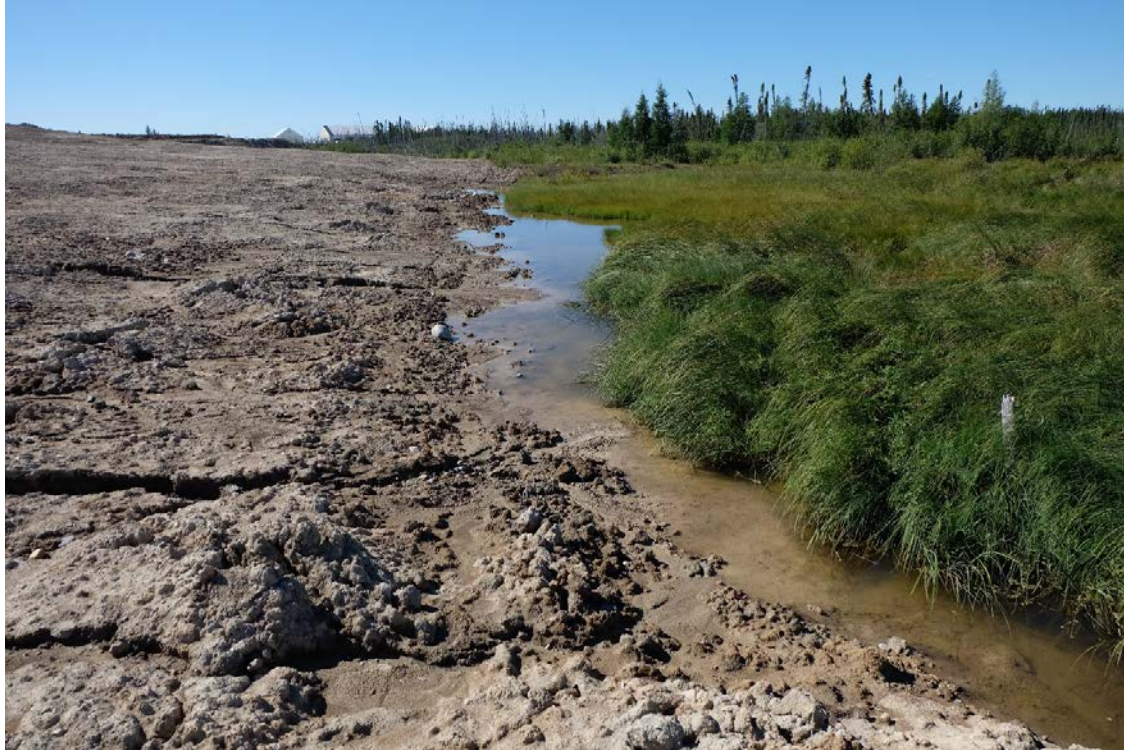
EMPA approaches Wetland 51 boundary

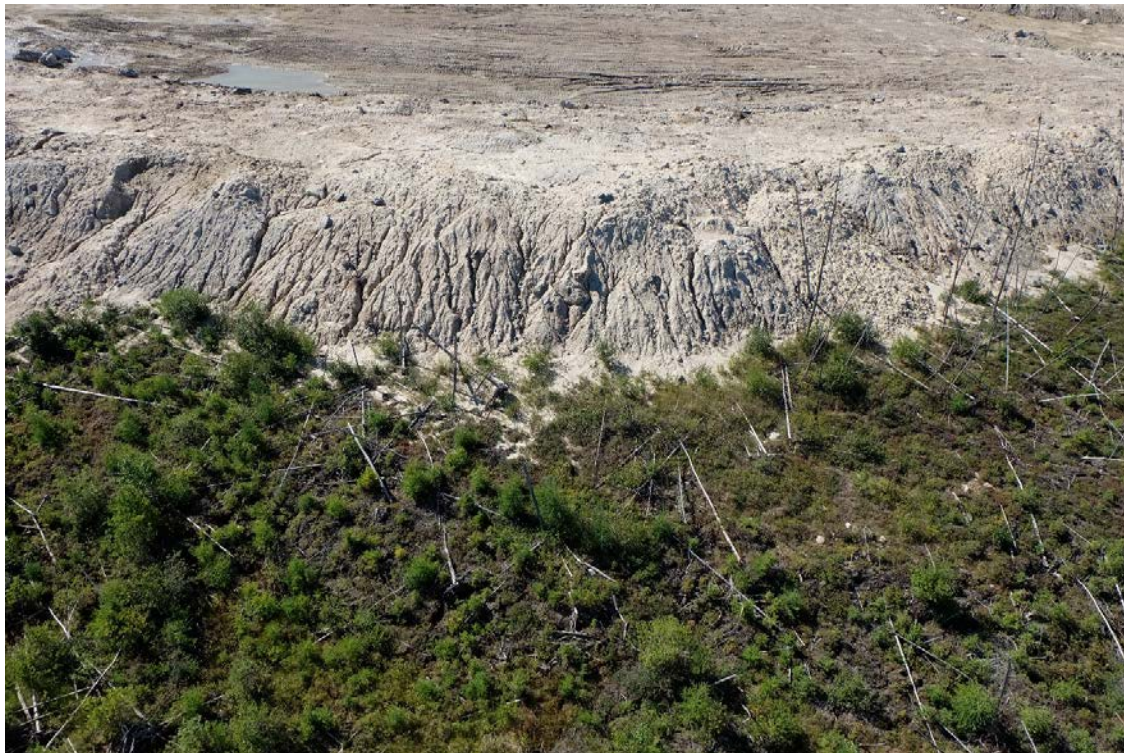
While erosion and sedimentation at the base of the EMPA slopes on the northern and northeastern edges were observed in 2016 (Figure 3-19), there were no signs that this sediment had yet entered the channel between the Nelson River and Stephens Lake or the waterway running from the marsh habitat into this channel. Investigations in the area found that the undisturbed peat appeared to be capturing surface movement of materials. To date, there has been no evidence of sediment being transported through the peat, however, heavy rainfalls could produce substantial erosion and sedimentation. Additionally, EMPA banks are within 100 m of the channel between the Nelson River and Stephens Lake as well as a waterway running from the marsh habitat into this channel (Figure 3-18).

Erosion and sedimentation at base of slope on northern EMPA banks

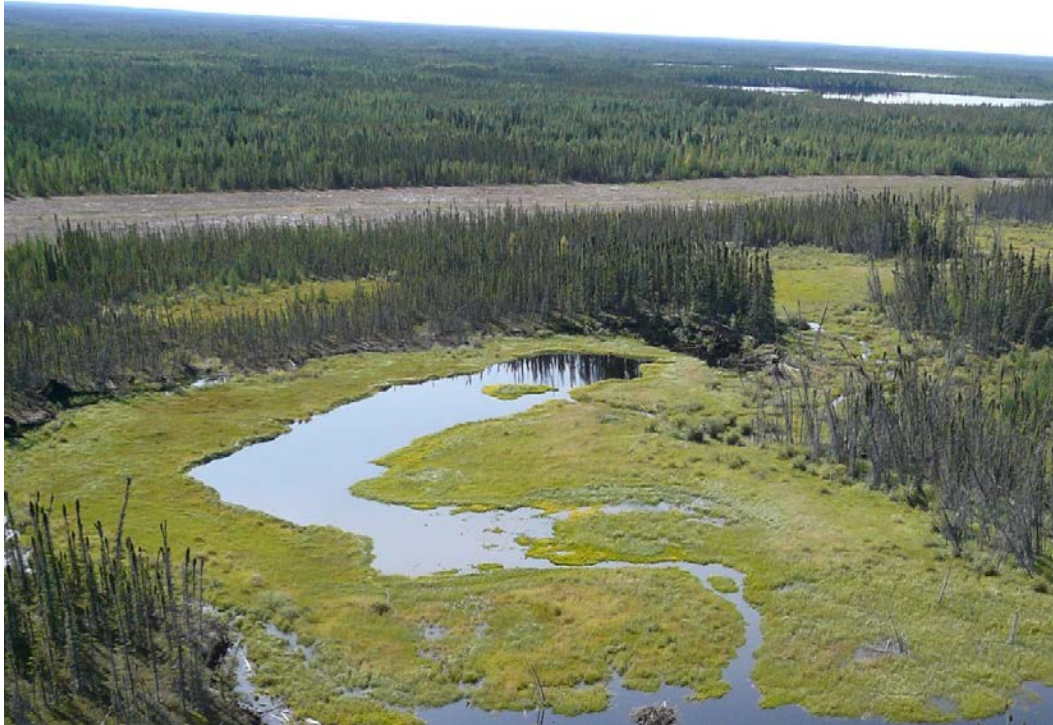
For other potential Project impacts, one instance of a potential hydrological effect was found in 2016. A culvert on the north side of the SAR was draining water into a woodland south of the marsh, creating pooling water at and into the woodland edge (Figure 3-20). Closer to the marsh, the water table was at or above ground level in a natural depression between the SAR and Wetland 52. It was unknown at the time of the survey whether runoff from the SAR was contributing to an elevated water table in this area. However, it appeared that a high peat plateau bog (which contains ground ice) between the actual marsh area and the natural depression (Figure 3-20) was likely raising the water table by impeding drainage. In any event, if there had been additional flow into the marsh habitat from the SAR, it appeared that the drainage outlet for this wetland was passing such flows downstream into a bay on the Nelson River. Future monitoring of water levels and the condition of the marsh outlet will help determine if runoff from the SAR is affecting this wetland.

Aerial view of south shore with surrounding peat plateau bog between the SAR and Wetland 52

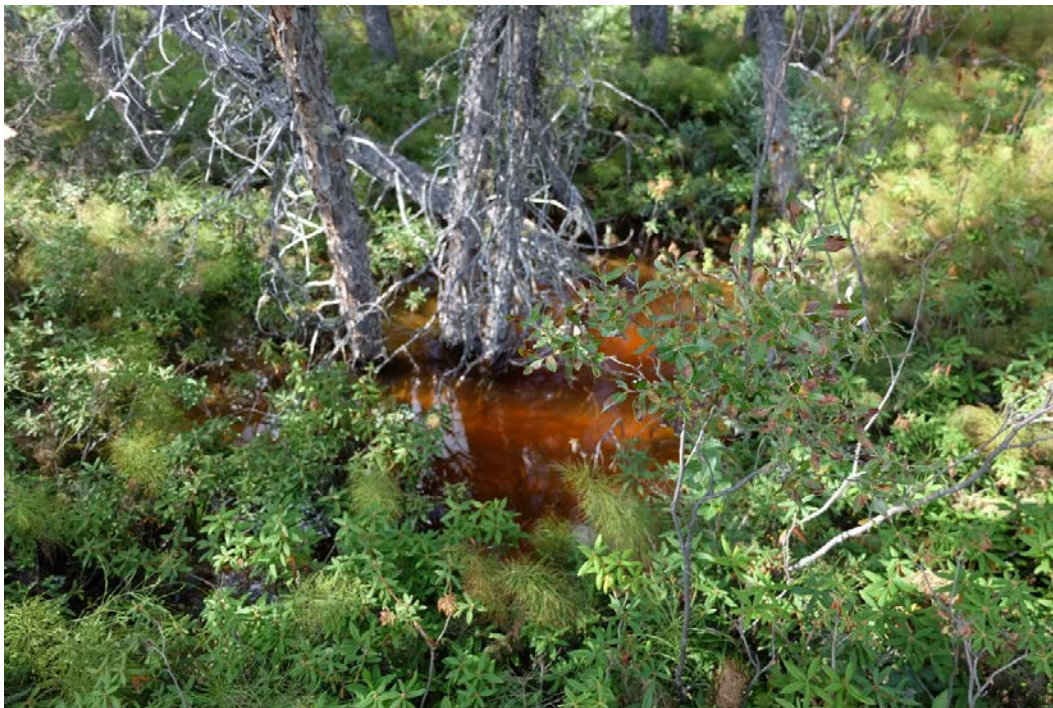
Pooling water at tree line edge on the north side of the SAR

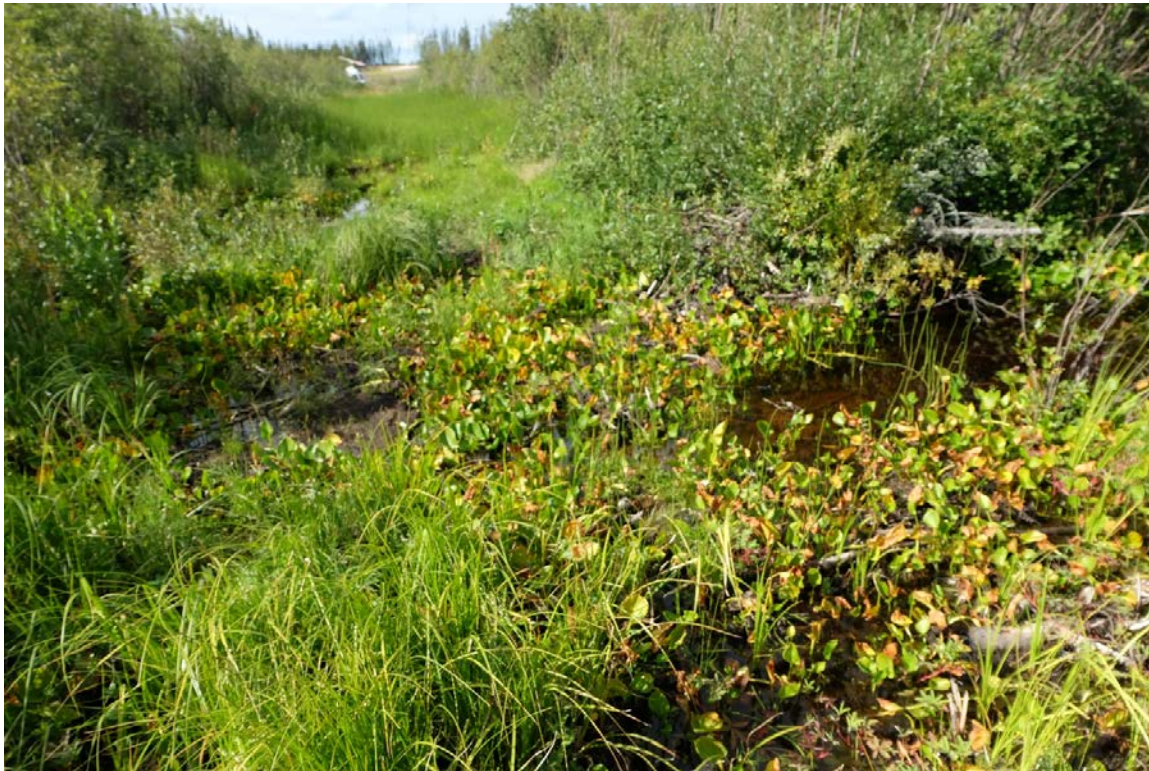
Figure 3-21: Ground photos of Wetland 53 in August 2016

The clearing in the marsh buffer that was visible in the 2015 imagery and DOIs (e.g., cut trees, an access trail through the east side of the marsh buffer) was associated with the Keeyask Transmission Project ROW. These were the only impacts found in the marsh buffer during the 2015 ground survey (Figure 3-21). Some flooded vegetation at the cleared transition zone between the creek/marsh and the degrading peat plateau bog, just outside of the marsh buffer, was also found in 2015.

Ground surveys in 2016 found no expansion of the impacts recorded in 2015. No new clearing, disturbance or other impacts were observed in 2016.

View along the Wetland 53 shore

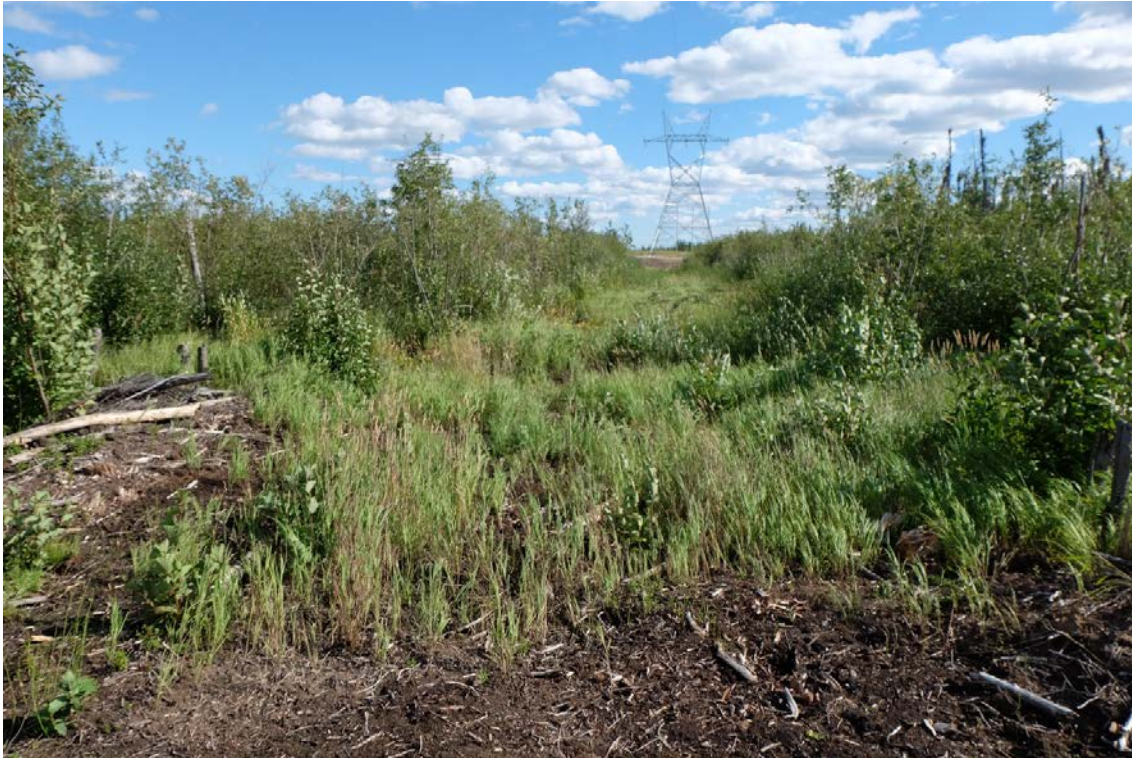
Access trail through east side of Wetland 53 buffer

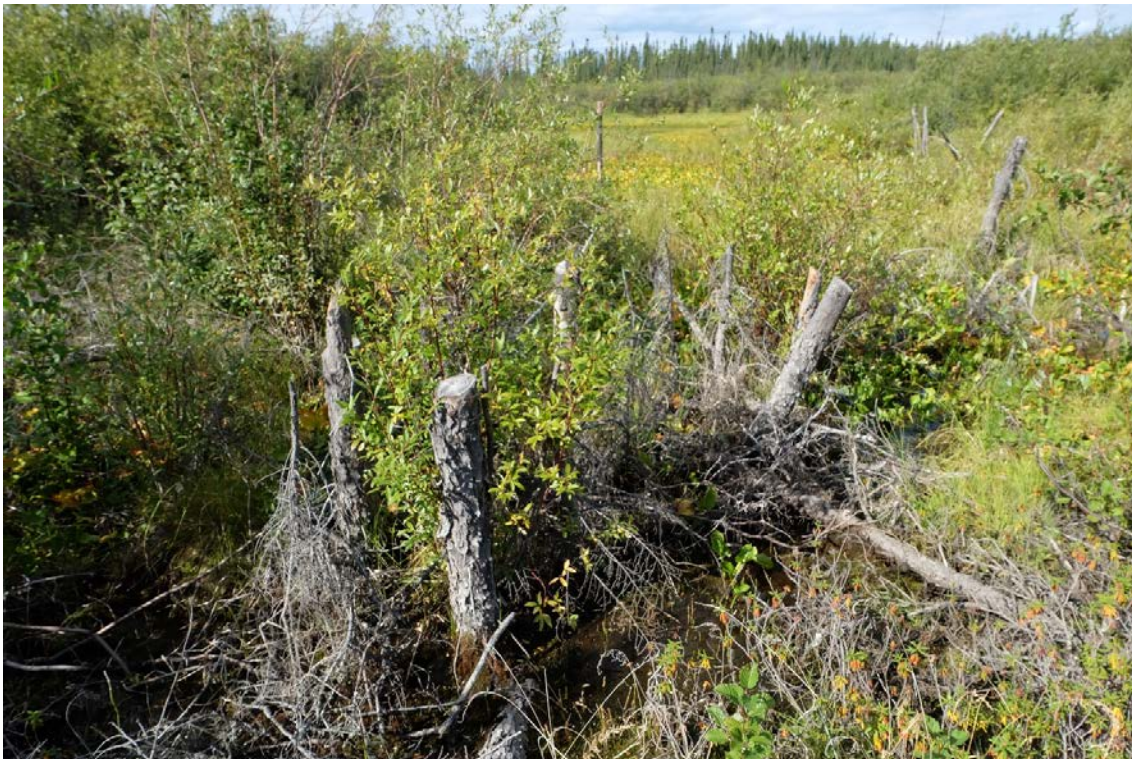
Cut trees in the Wetland 53 buffer

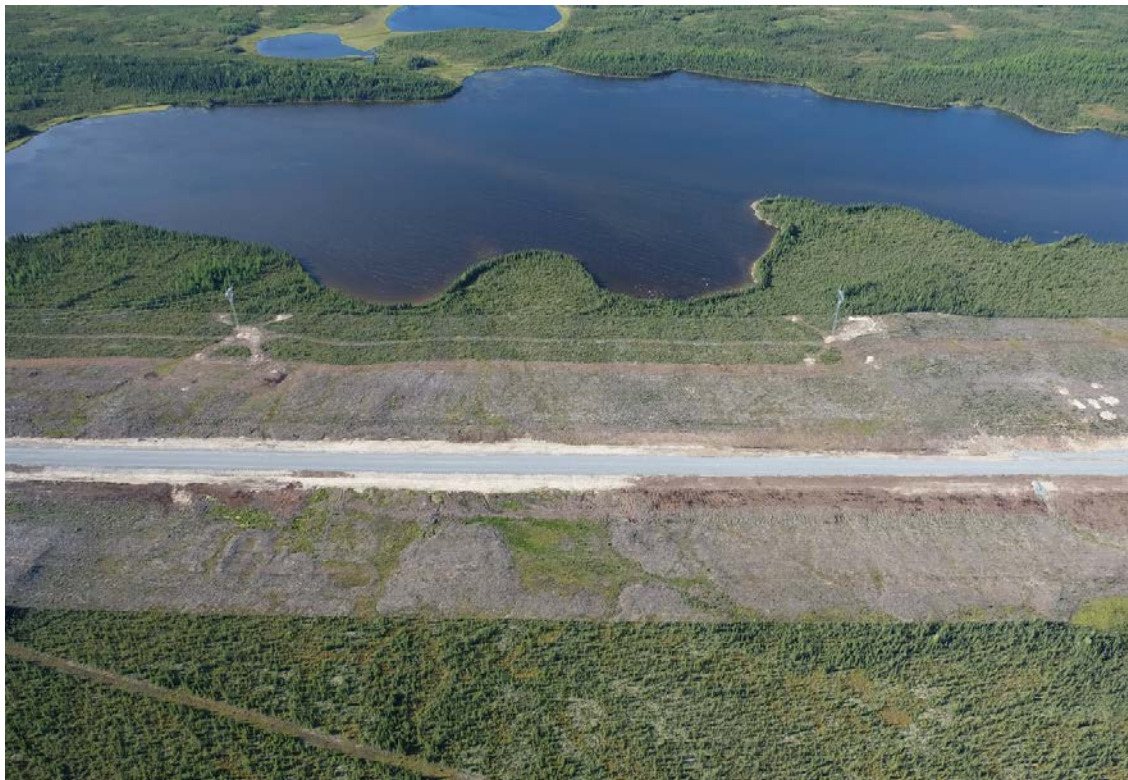
Ground surveys in 2016 found no expansion of the impacts recorded in 2015. New impacts were limited to clearing and disturbance for two Keeyask Transmission Project towers south of the marsh, which came right up to the marsh buffer boundary (Figure 3-23).

Transmission towers adjacent to Wetland 54 buffer

The relatively dense existing low vegetation in the cleared areas within 100 m of the marsh should be adequate to stabilize soils and facilitate revegetation.

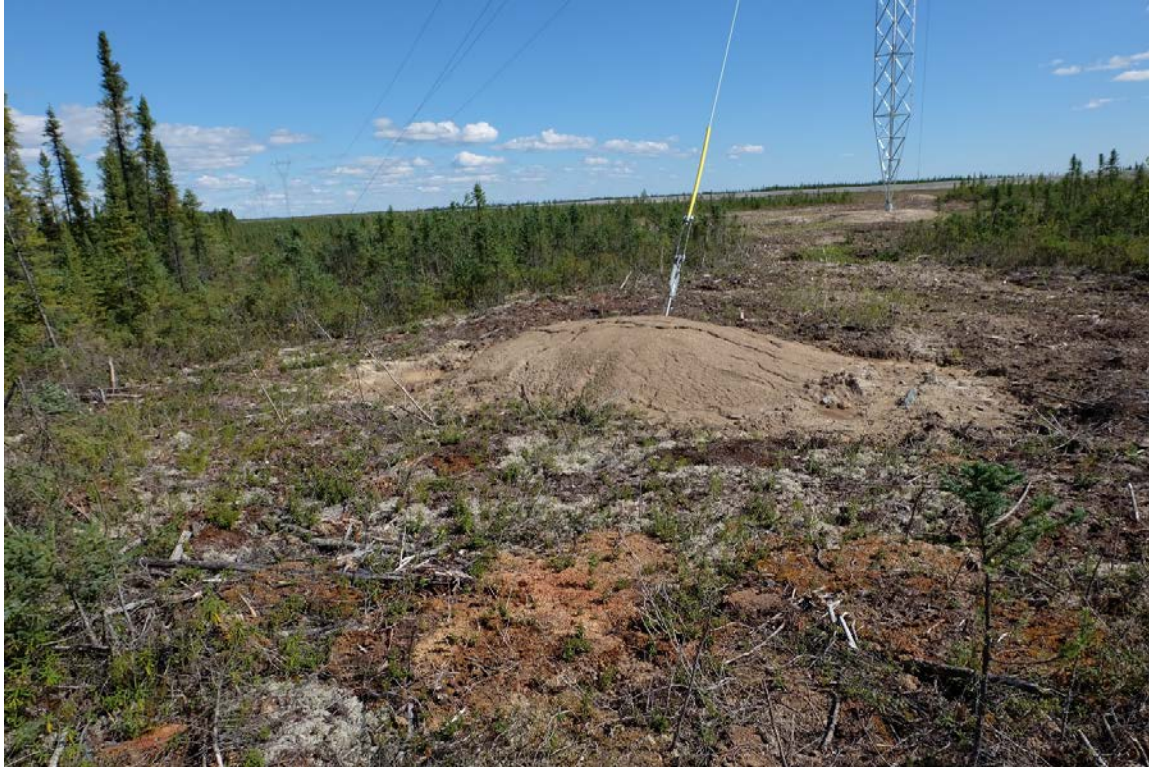
Ground view of transmission tower clearing and disturbance adjacent to Wetland 54 buffer

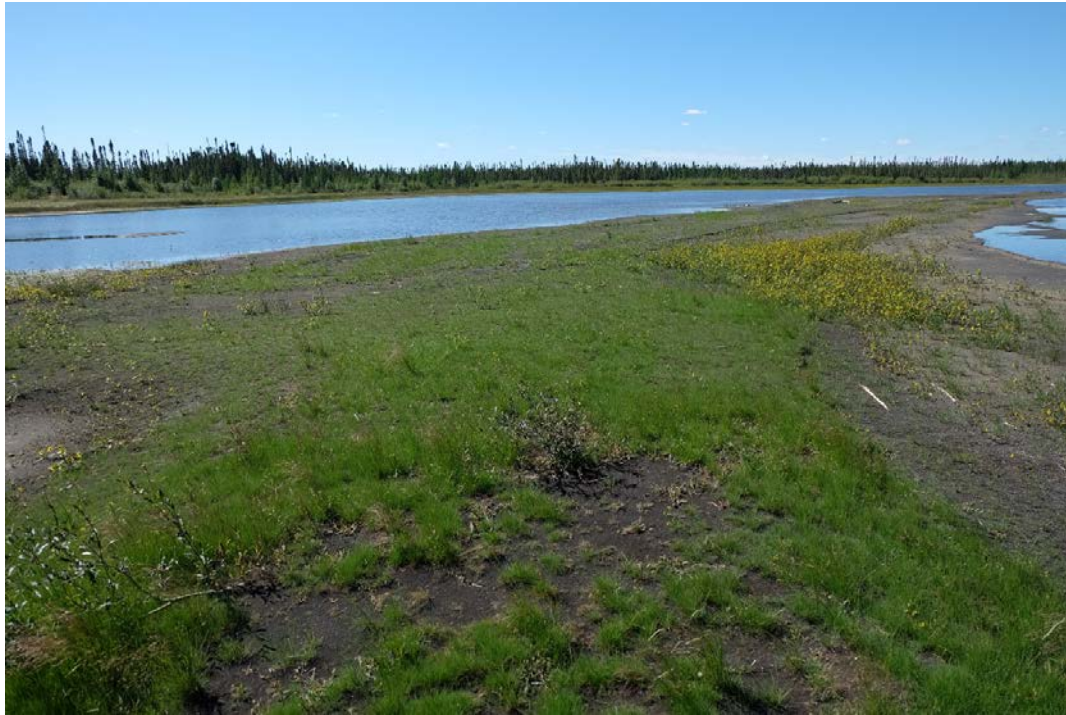
Figure 3-24: Ground photos of Wetland 57 in August 2016

Ground surveys in 2016 found that the SAR clearing at the southern edge of the buffer zone had increased to 0.89 ha, which was 0.68 ha higher than in 2015 (Figure 3-24). All of the clearing was still within EnvPP green zone. No clearing or disturbance was found in the marsh habitat in 2016.

In terms of other potential Project impacts, a ditch from the SAR drains into the marsh habitat. The observed water levels in the marsh in 2016 were very low compared to those observed in 2015. Some of the possible causes were lower water levels on Stephens Lake (marsh habitat is

within 75 m of Stephens Lake) or altered hydrology due to road construction. These and other possible causes for low water levels will be investigated during the 2017 surveys.

View along the Wetland 57 shore

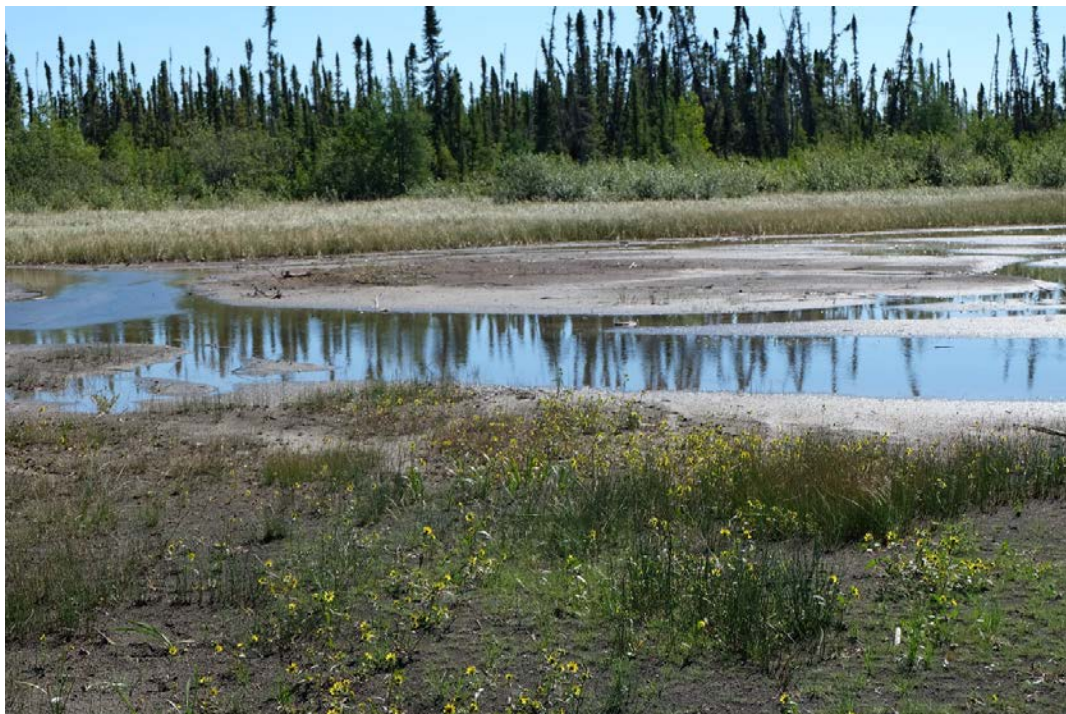
Water levels were lower than those in 2015
