Keeyask Generation Project Physical Environment Monitoring Plan

Physical Environment Monitoring Report

PEMP-2018-01

2017-2018 PHYSICAL ENVIRONMENT MONITORING REPORT: YEAR 4 CONSTRUCTION

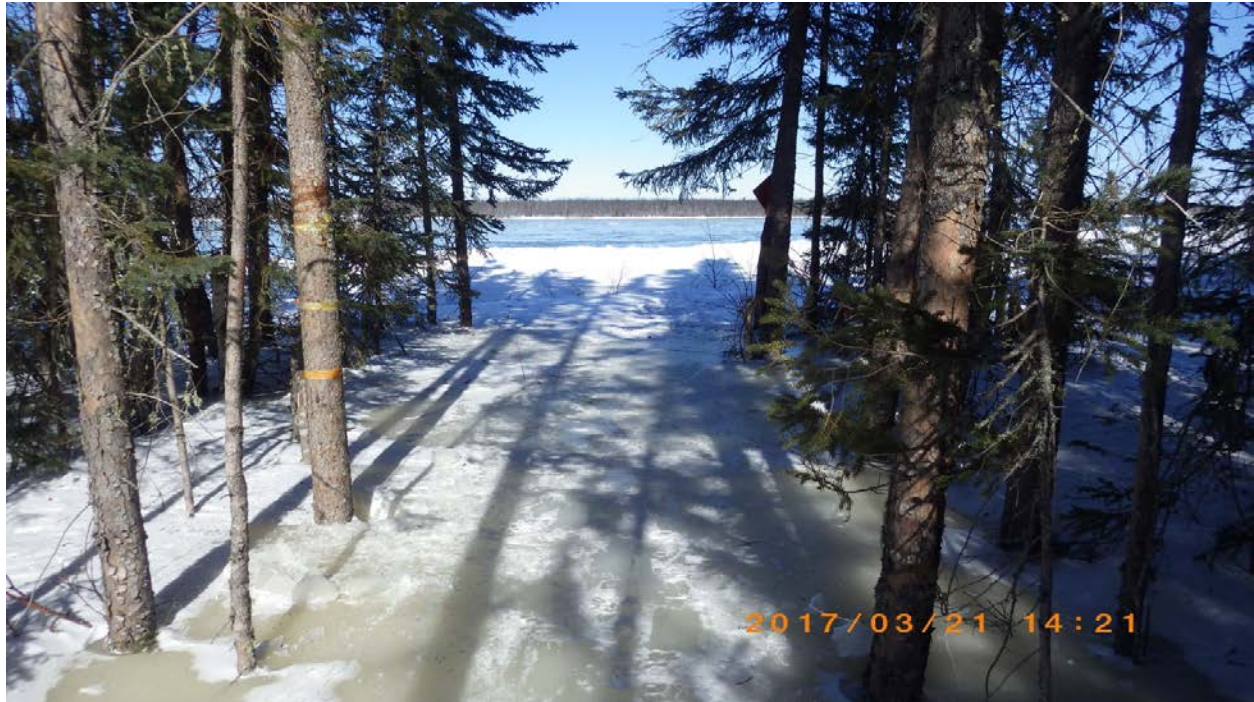
Ice Extends into Trees

Ice monitoring is done using satellite imagery and photographs taken along the length of the study area during monthly field trips. The 2017/18 winter saw the earliest ice cover formation on Gull Lake since construction started, about 2 weeks earlier than the previous two winters with the ice boom in place. The leading ice front reached about 5 to 6 kms upstream of Birthday Rapids by the end of January, remaining there until mid-April, similar to the previous winter.

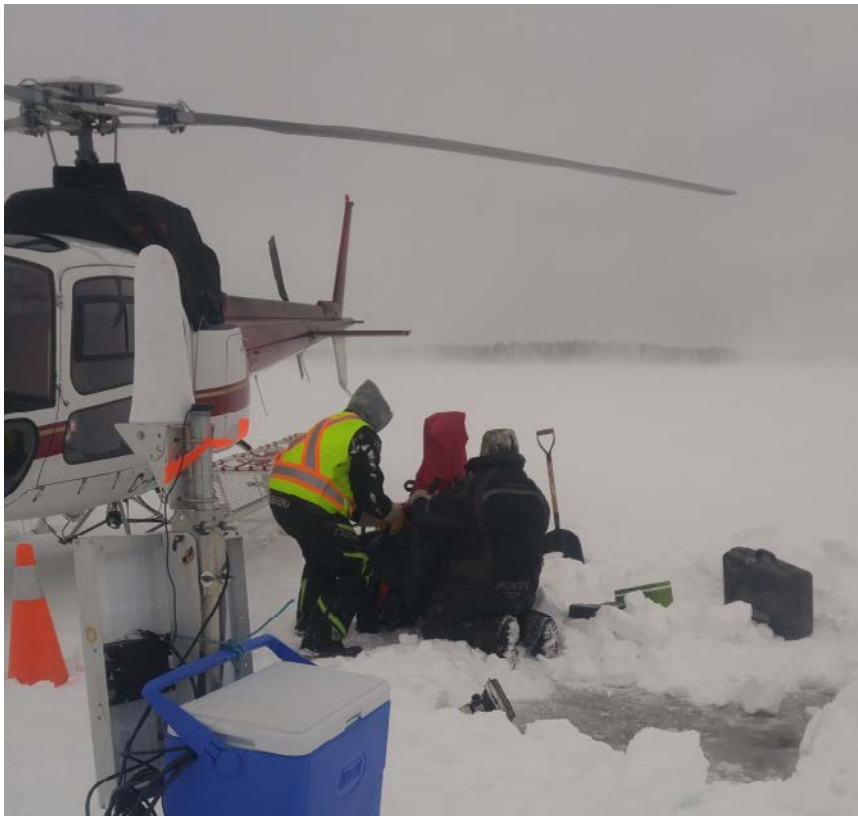
Winter Sedimentation Monitoring

A sediment trap generally consists of five open-ended plastic tubes standing vertically in a metal frame that sits on the lakebed. Sediment settling out of the water enters an opening in the tube

and accumulates in a sample jar at the bottom of the tube until the trap is recovered and the sediment samples are sent to a laboratory for grain size analyses. In 2017, a sediment trap was placed at the entrance to Stephens Lake. Originally, a sediment trap was to also be placed at the upstream end of Gull Lake. However, a sediment trap was not placed at this site in 2016 and 2017 because of adverse conditions that previously resulted in losing monitoring equipment at this location.

Monitoring found sediment collected at a greater rate in the trap at the Stephens Lake site for the 2016/2017 winter monitoring period compared with the previous two winters. Very high flows were experienced in the spring which likely explains higher accumulation rates seen in 2016/17. Higher flows would increase water velocities and increase the erosion potential and the river's ability to transport sediment.

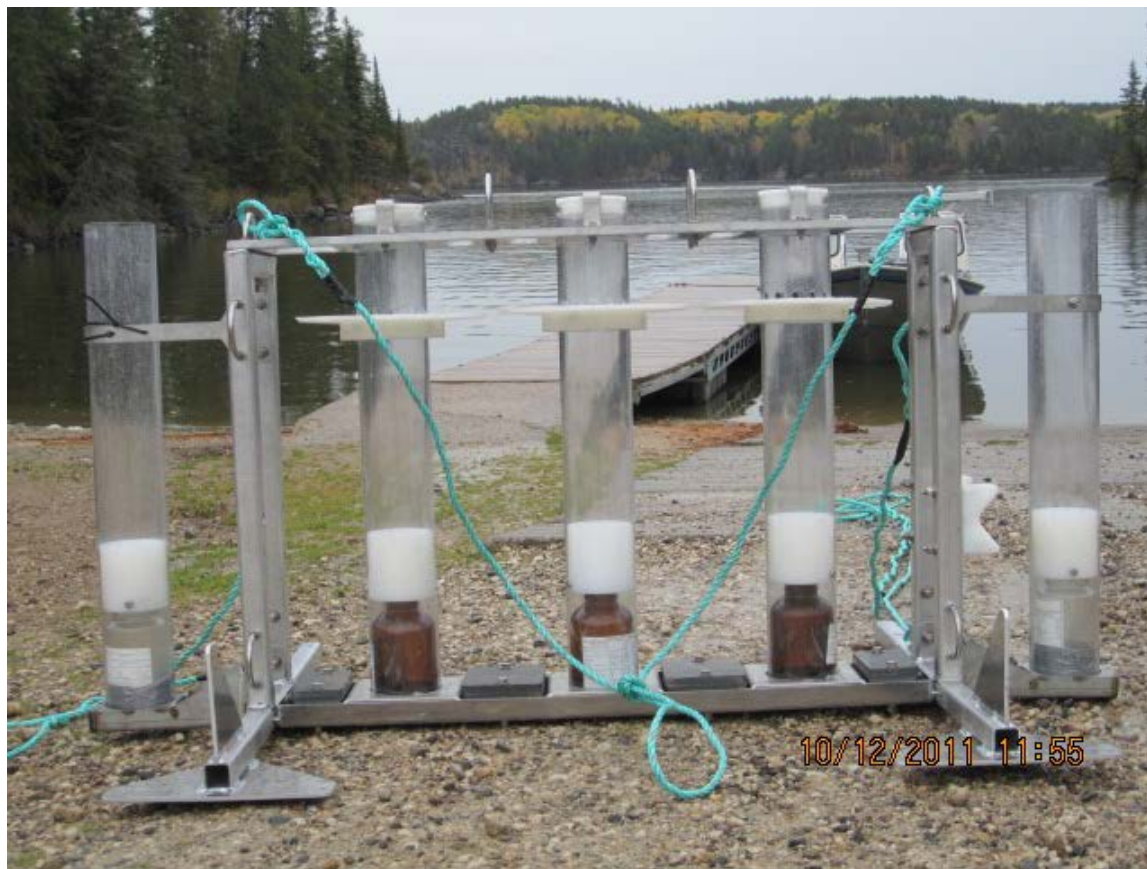
Five tube sediment trap used in PEMP deposition monitoring

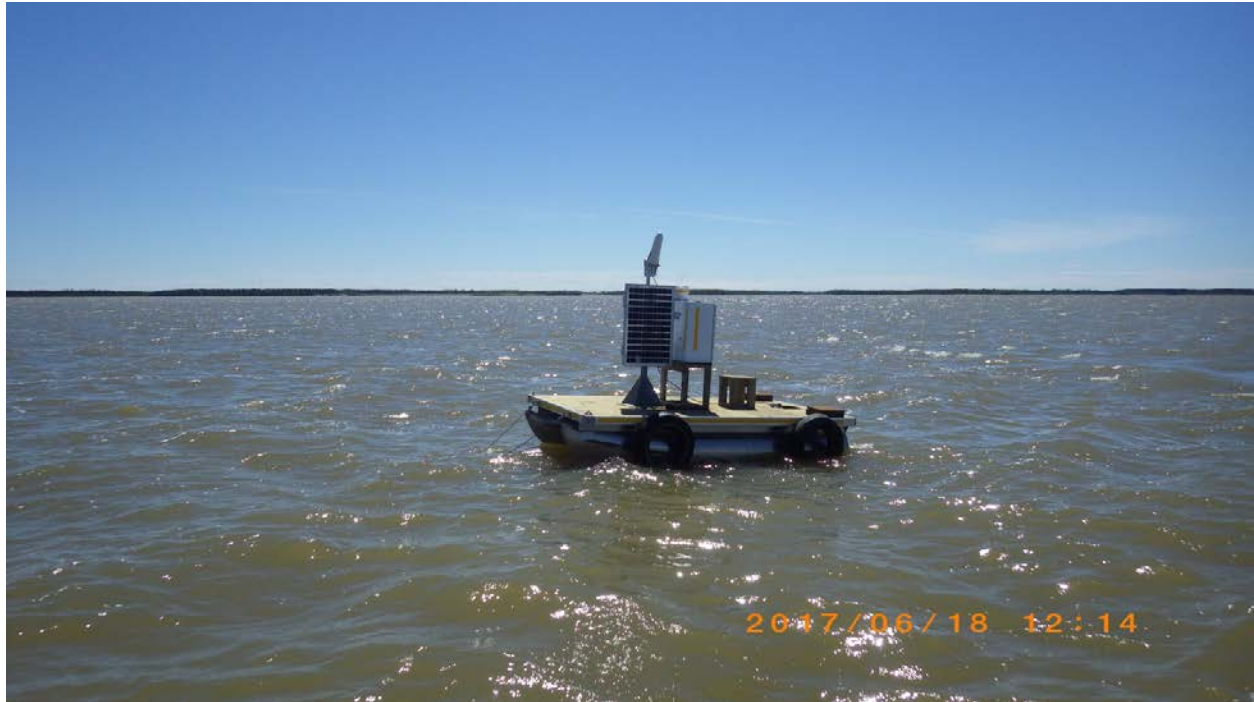
Continuous turbidity monitoring equipment – electronics cabinet and solar panel on a catamaran below which a turbidity sensor is suspended in the water

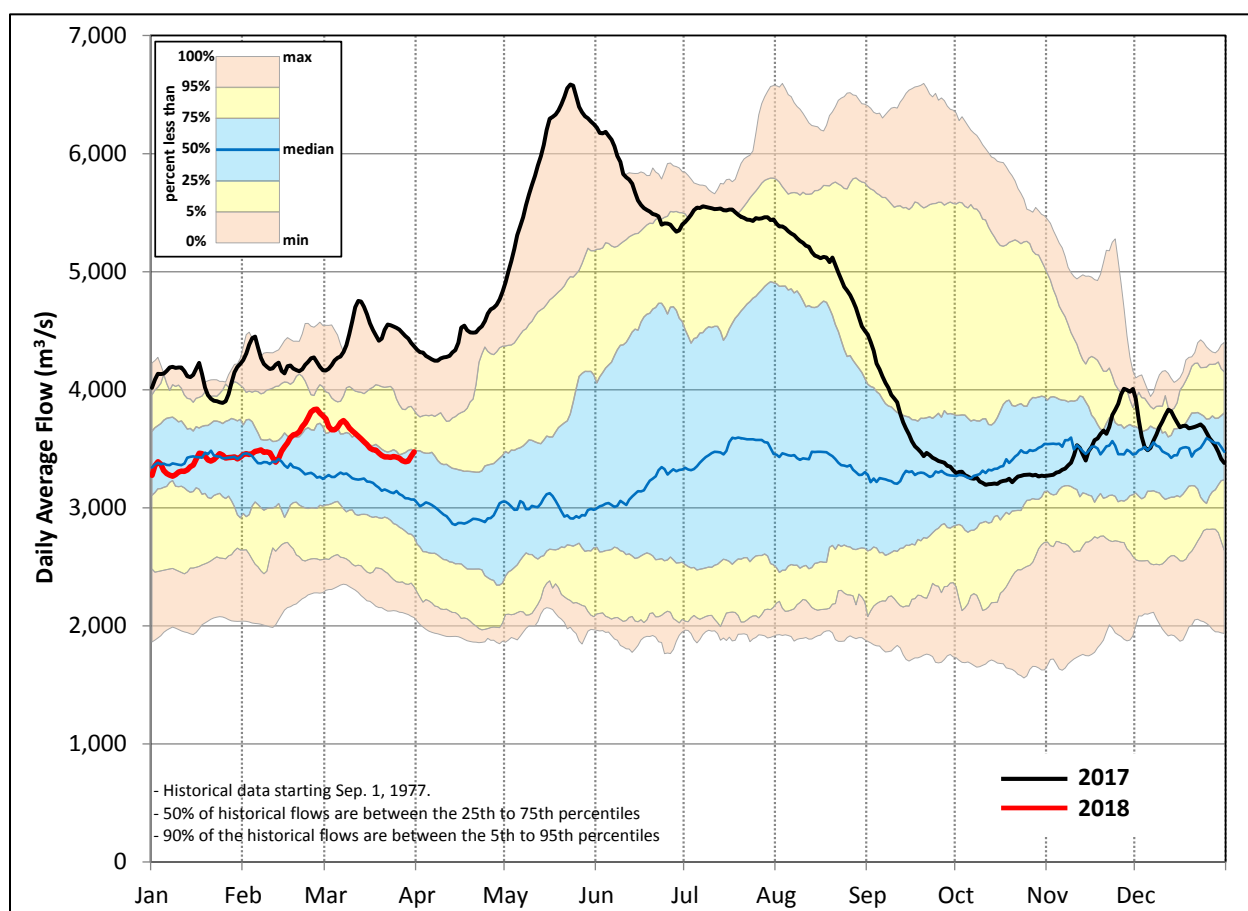
Figure 1: Split Lake 2016/2017 daily average outflow and historical statistics

Flows in the Nelson River have been greater than the historical daily median flows during most of the reporting period from April 2017 to March 2018 (Figure 1). The flow has ranged from approximately 3,200 m³/s (113,010 cfs) in October 2017 to almost 6,600 m³/s (233,080 cfs) in May 2017. Flows were high in the first half of 2017, exceeding the 95th percentile flow over most

of the period from January through late June. In fact, record high flows occurred from about early March to early June as a result of high runoff in the Nelson River system. The peak flow of almost 6,600 m³/s in May was much larger than the previous May high flow of about 5,300 m³/s in 1985 and 2005. The 2017 high flow was close to historical high flows of 6,500-6,600 m³/s observed in the high flow years of 2005 (early Aug. and late Sep) and 2011 (late Aug.). After the spring peak, flows in 2017 steadily dropped to a little below median flow by early October and have generally been between the 25th and 75th percentile flows since then.

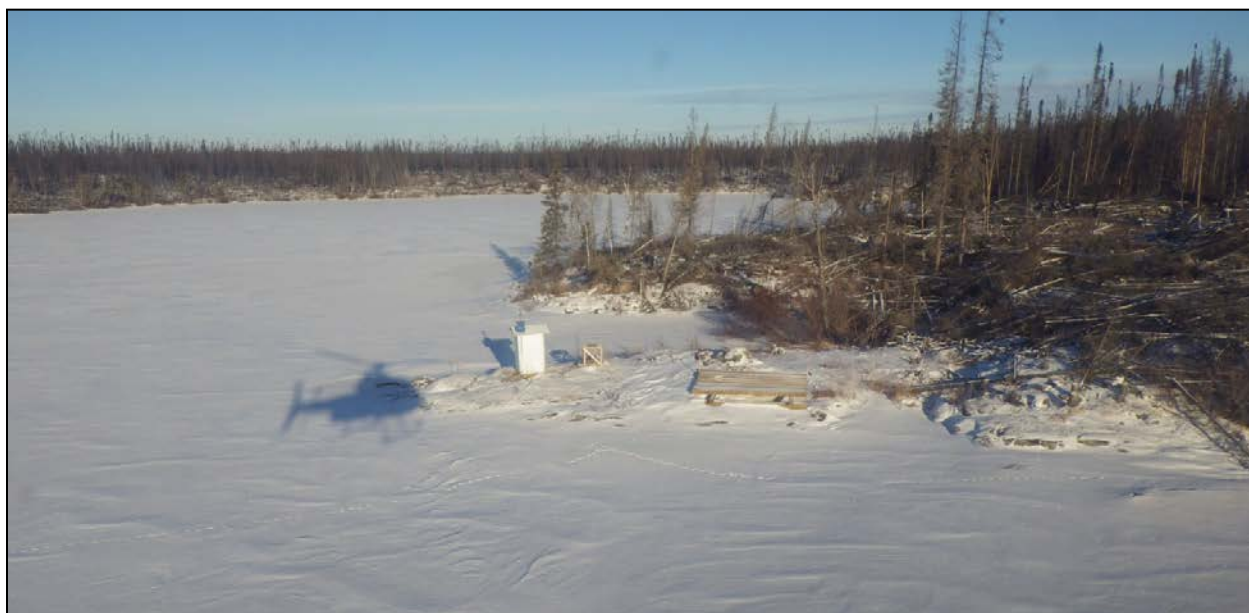
Photo 1: Water level gauging station in winter

Water levels have been monitored at six sites from Clark Lake to Gull Rapids (Table 1, Map 2). A typical water level gauge is shown in Photo 1. The two Clark Lake sites have been monitored regularly since 2003, while the Gull Lake gauge was installed at the start of construction in mid July 2014. The other three sites were installed after construction started, once the necessary permits and heritage surveys were complete, which were applied for and done after the Environment Act licence was received in early July 2014. The original gauge at the upstream end of Gull Lake (05UF749) was wrecked by ice and was discontinued in May 2016. The gauge

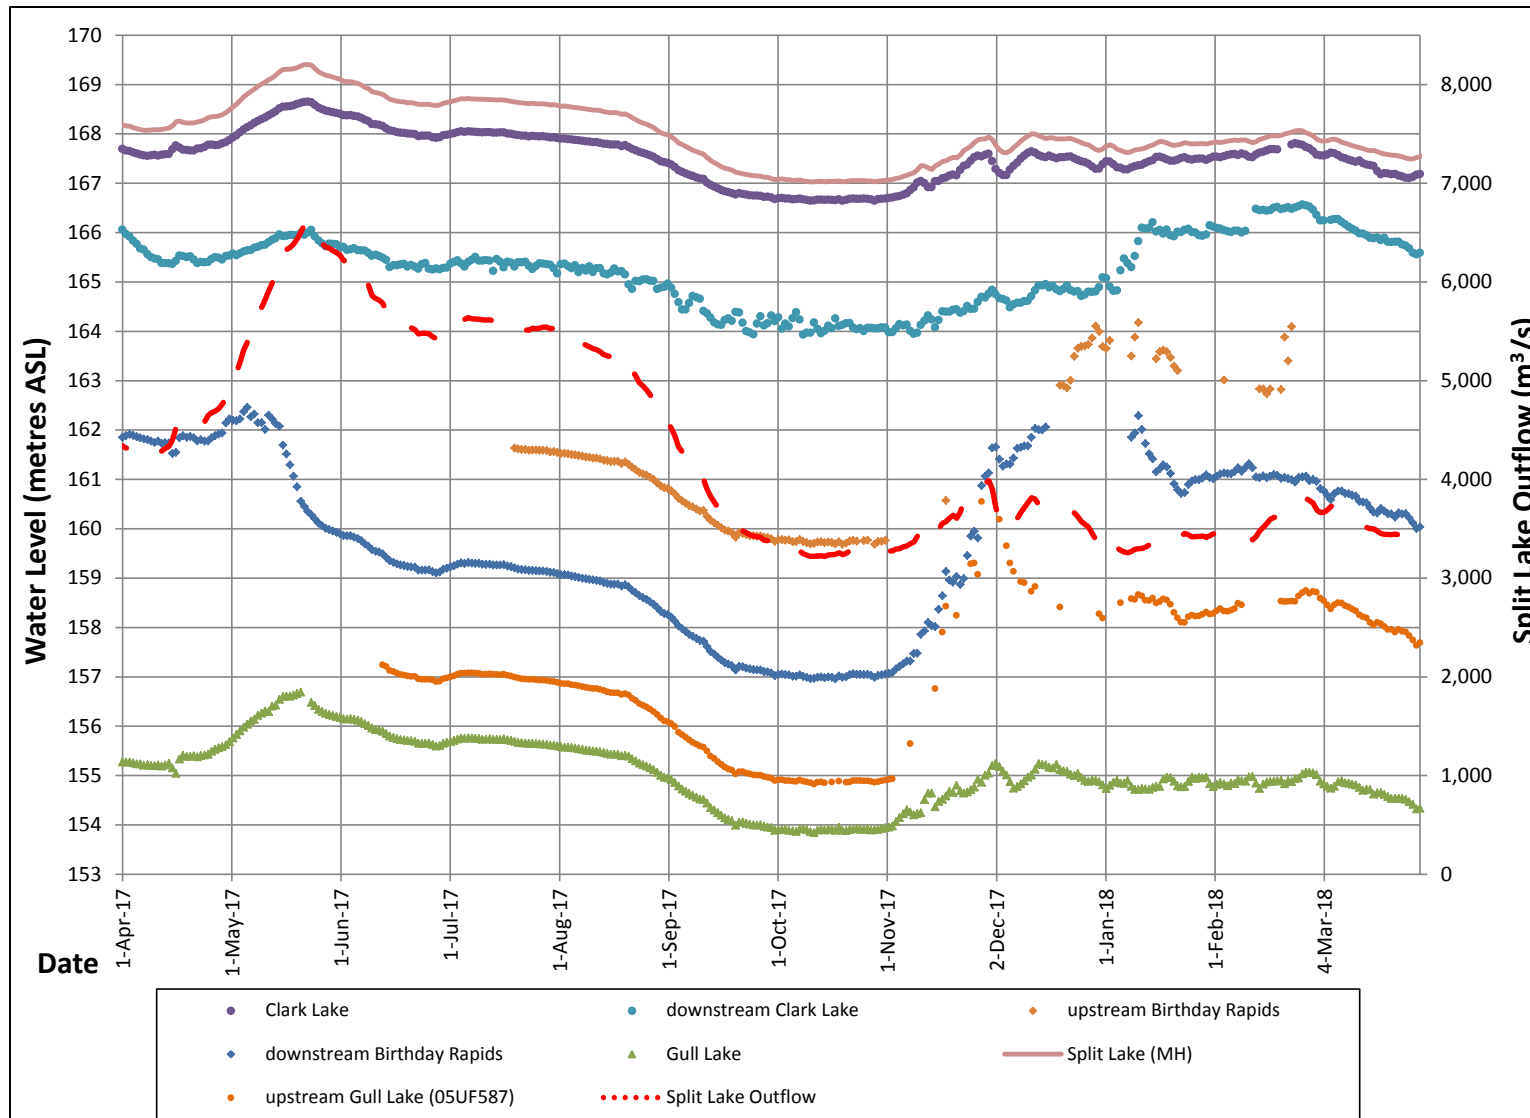
Figure 2: Observed water levels at PEMP monitoring sites in 2017/2018

In early November, flows began to gradually increase, causing levels to rise (Figure 2). At the same time, air temperatures dropped and ice began to form behind the ice booms and on the lakes and rivers, which also caused levels to rise. On Clark and Split lakes, ice causes levels to rise about 0.7 m higher than open water levels under similar flow conditions.

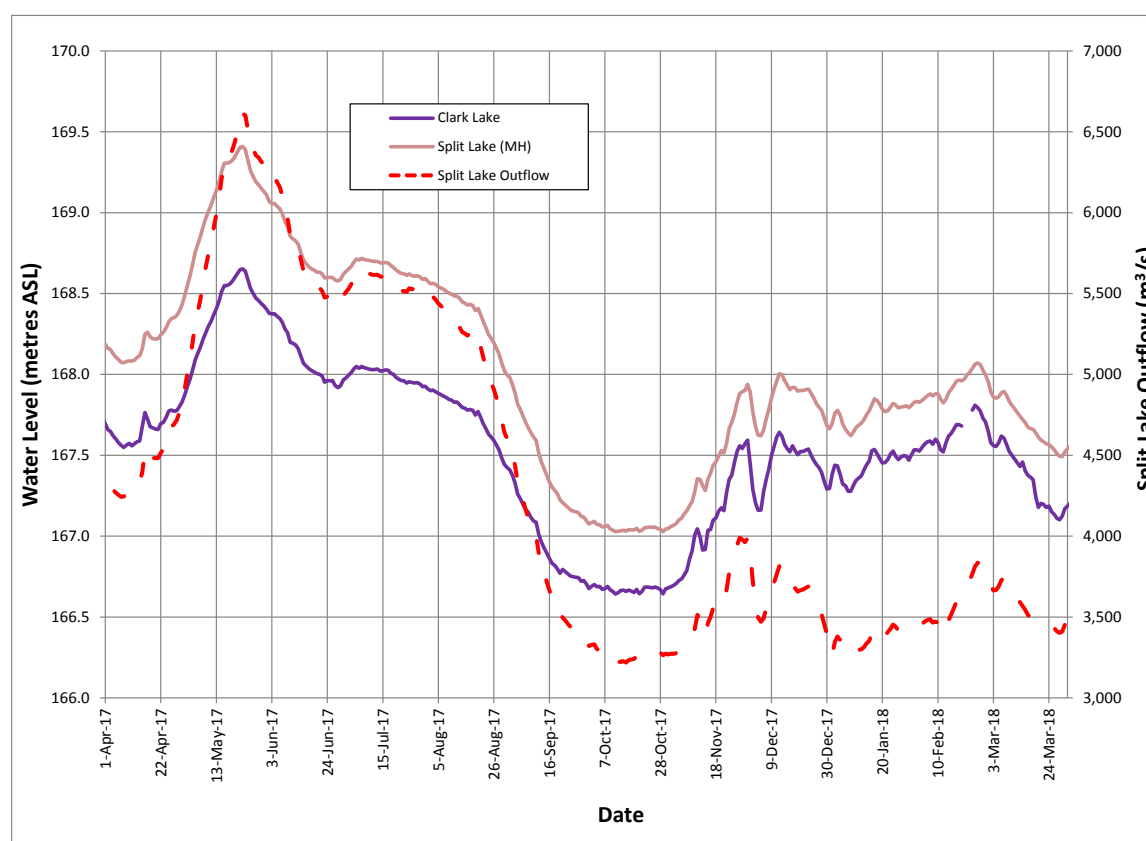
Figure 3: Observed water levels at Clark Lake and Split Lake in 2016/2017

Split Lake water level data from the existing Split Lake Community gauging station (Site ID: 05UF701) were obtained and plotted along with the levels for the PEMP site on Clark Lake (Figure 3). The levels on these two lakes show the same pattern of variation, differing by about 0.25-0.75 m with an average difference of approximately 0.5 m. During open water periods, both sites show a clear correlation to variations in flow and generally during winter as well. There is no impact on these levels due to the Project during the open water period. As noted above, the observed winter staging of up to about 0.7 m on Split Lake is typical for this lake. The PESV noted that winter staging on Split Lake in the pre-Project environment could range from 0.3 m to 1.2 m, and averaged about 0.6 m (KHLP 2012b, Section 4.3).

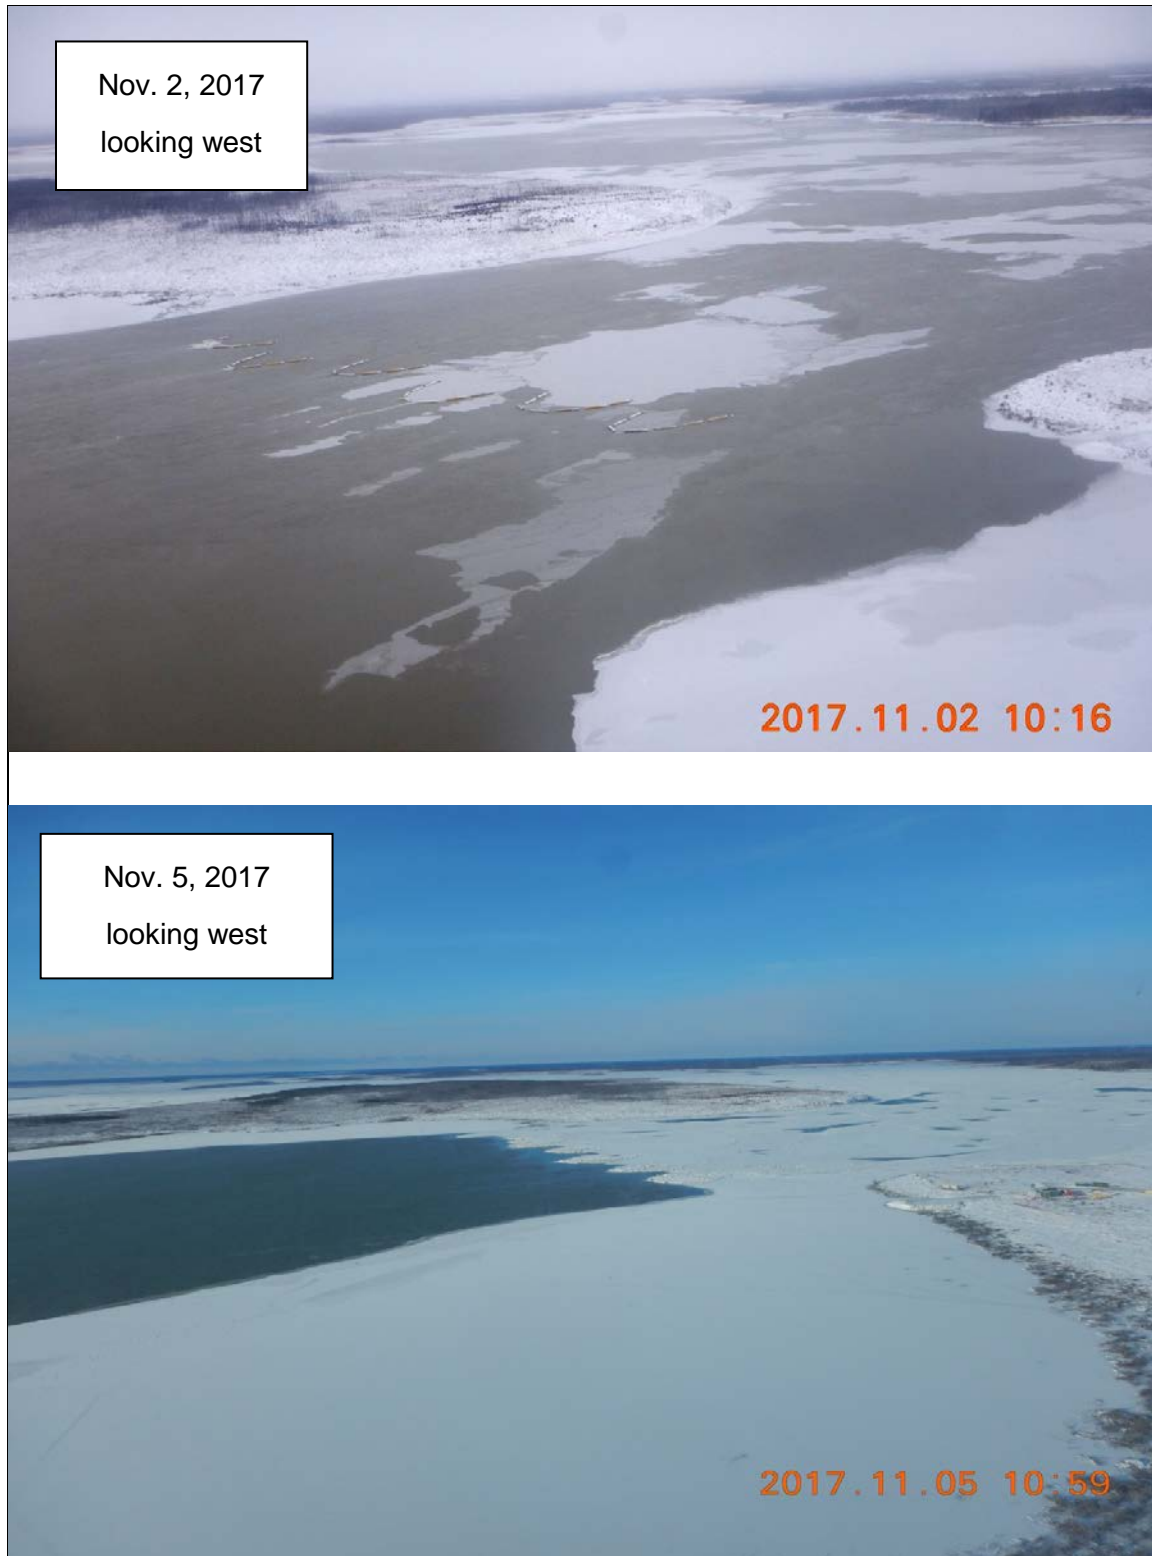
Photo 2: Ice Boom A on east side of Caribou Island (Nov. 2 & 5, 2017)

In 2017, average daytime temperatures dropped to below freezing in late October and ice formed upstream of the ice booms on November 4 as seen in Photo 2 and Photo 3 which were taken before and after ice developed. Figure 4 shows satellite images of the ice cover as it advances upstream during the winter. By November 10, the leading edge of the ice front was at the upstream end of Gull Lake. The ice front continued to advance upstream reaching Birthday Rapids by early January. The leading edge of the ice front reached about 5 to 6 km upstream of Birthday Rapids (Photo 4) by the end of January, remaining there till mid-April, similar to the previous winter. Gull Lake became predominately ice free around the same date as last winter.

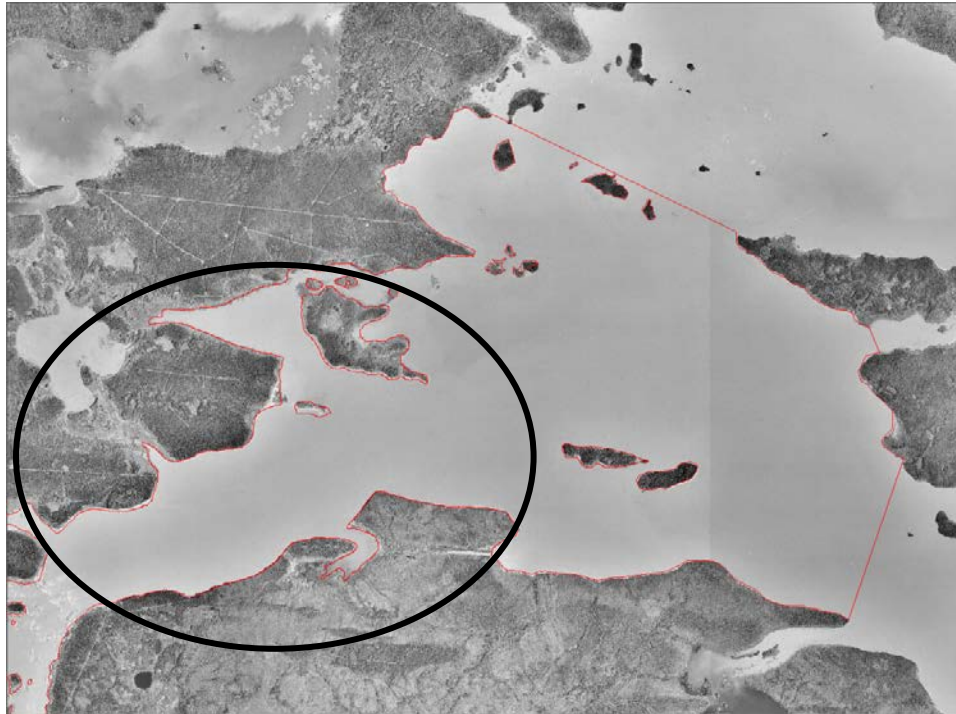
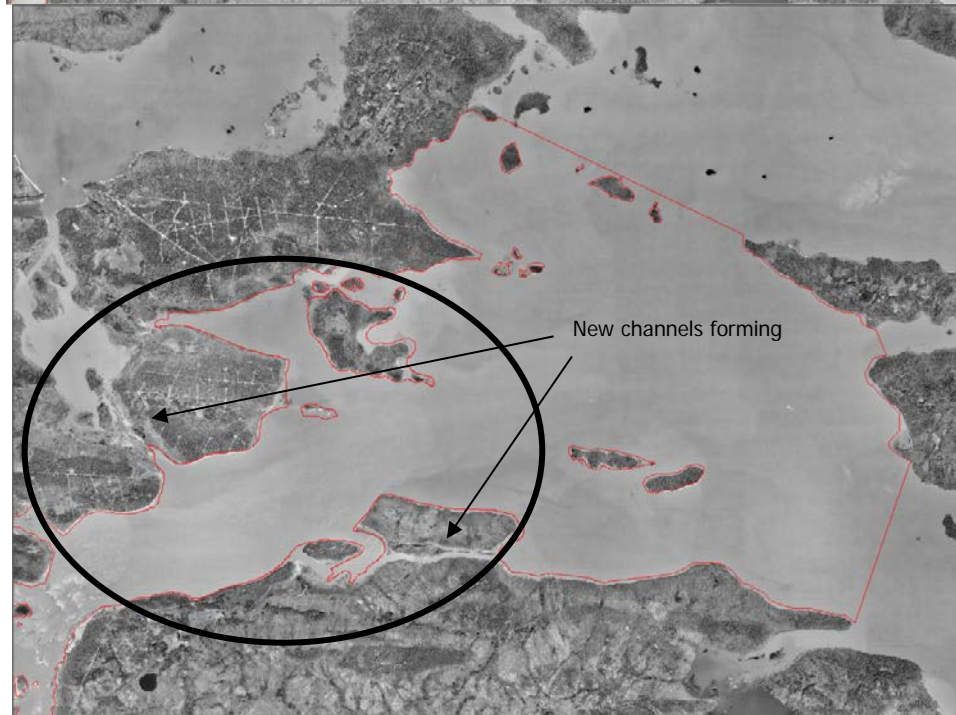
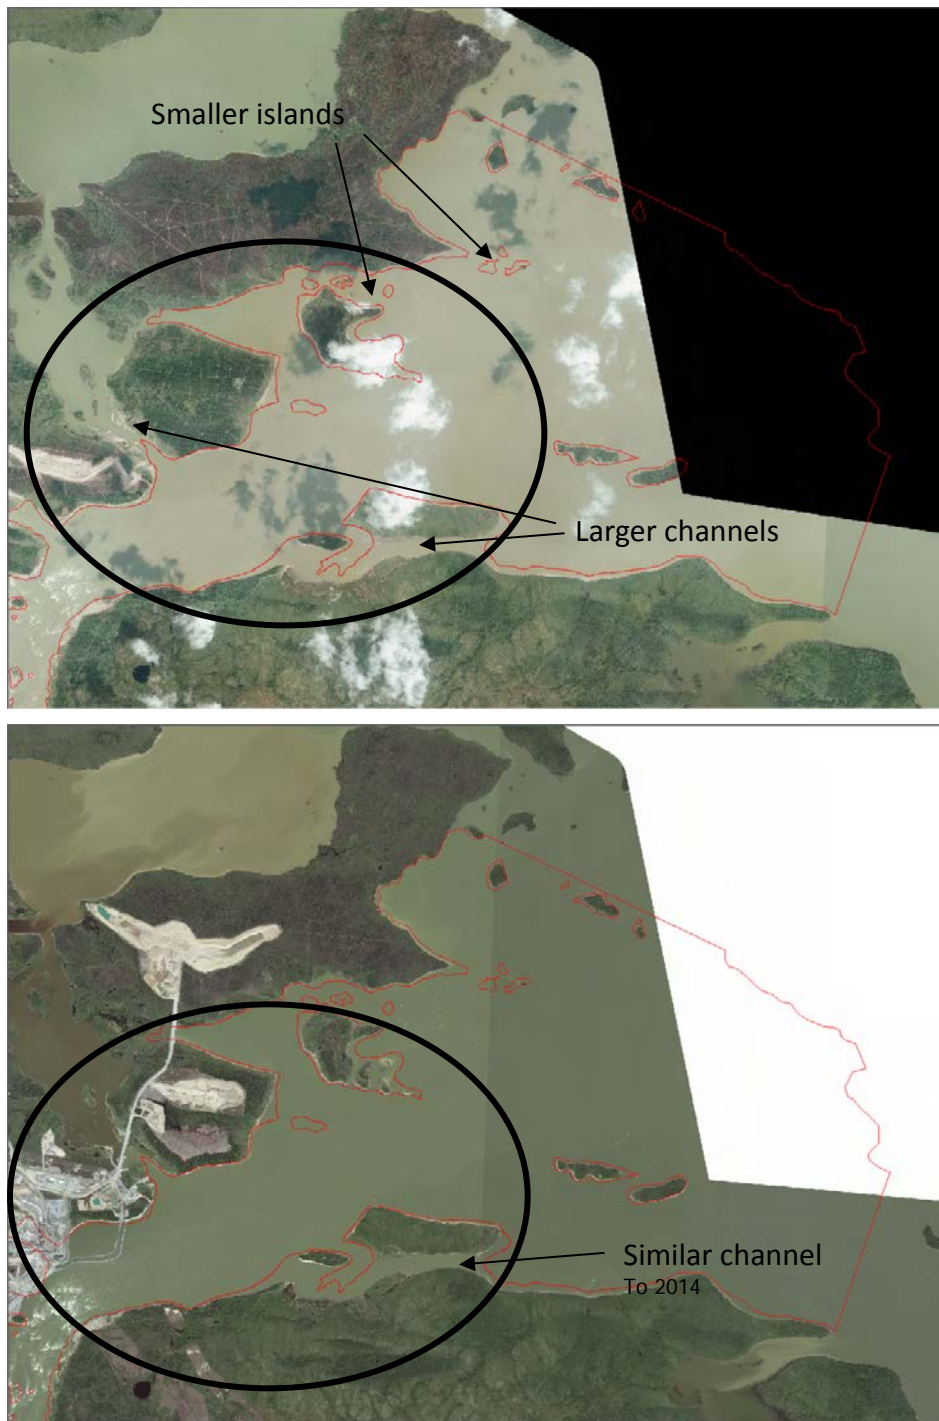
While the assessment is qualitative, large scale changes are seen between the 1999, 2006 and 2014 images (see circled area in photos below). The shoreline receded in many places, as observed by changes from the original shoreline shown in red. There are locations where new channels formed creating new islands, or smaller island disappearing entirely. Changes to the shorelines appear to have been minimal between the 2014 and 2017 images suggesting erosion rates have decreased, with changes to the land where construction activities have taken place. Work will continue on monitoring the shorelines and changes to erosion rates.

Image taken just prior to in-stream construction work starting

Little change from 2014

A review of aerial and satellite imagery near the entrance to Stephens Lake suggests that erosion rates have reduced in this area. This was first detected by lower winter turbidity results in Stephens Lake than had been seen in the past.

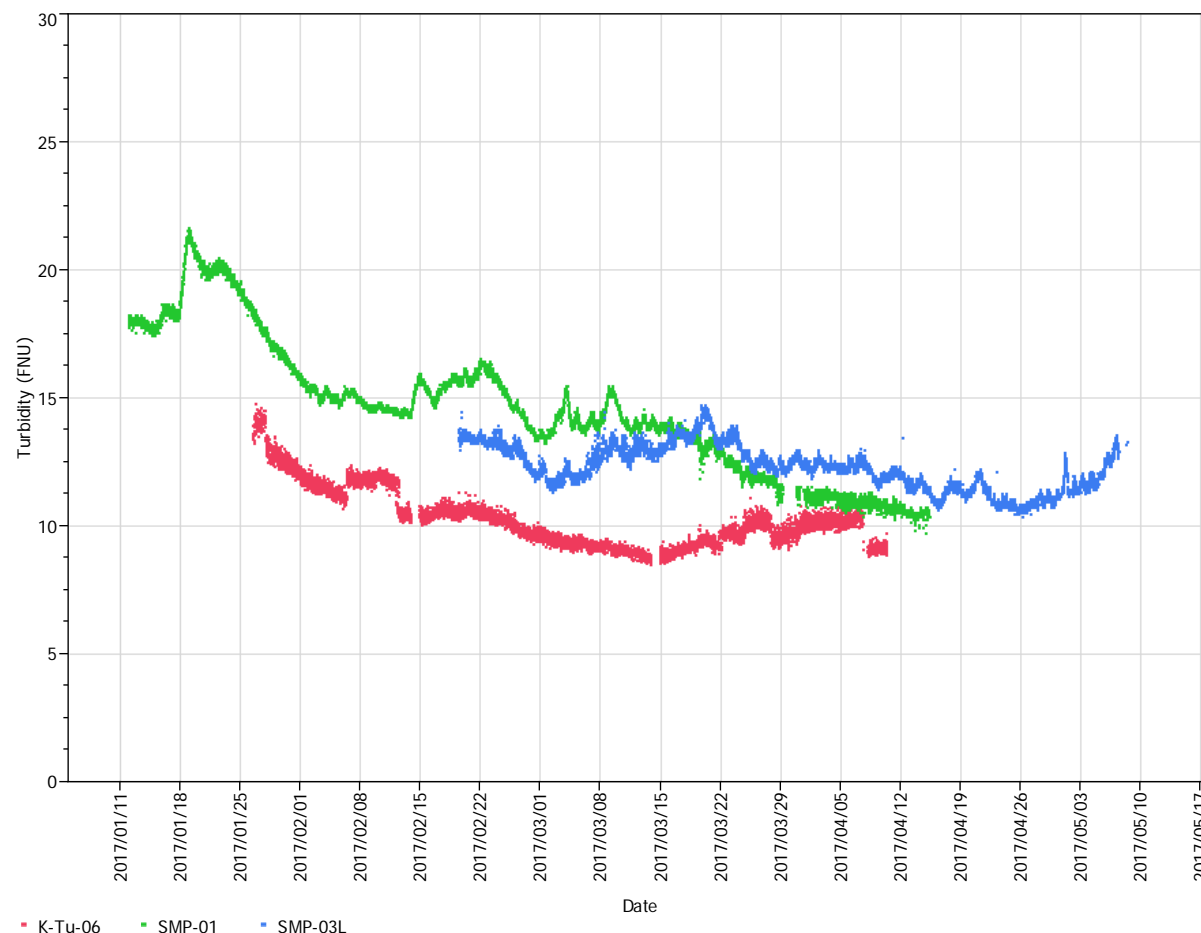
**Figure 6: 2016-2017 Winter Continuous Turbidity**

Turbidity levels were relatively consistent throughout the winter, with highest levels observed in late January followed by a decreasing trend over the winter; this pattern is commonly seen throughout a winter. In the 2016-17, the turbidity in Gull Lake (SMP-01) was higher than Clark Lake (K-Tu-06) for most of the winter period (Figure 6). Although previously there were short periods of times when Gull Lake was higher it has typically been lower than Clark Lake. However, the turbidity levels were observed to be generally equal or lower than pre-construction conditions (Figure 7). An increase in turbidity suggests a net increase in sediment (i.e. that some erosion of the shoreline or river bed was occurring) between Clark and Gull Lake monitoring sites. A review of river discharge and water levels showed that due to the ice conditions in 2016-17 the water levels were lower for the same or higher discharge rates than in

previous years. Having higher flows with lower levels would result in higher velocities in 2016-17 than in 2015-16 and would result in an increased erosion potential. It is likely that this is one of the reasons for the higher turbidity at Gull Lake in 2016-17.

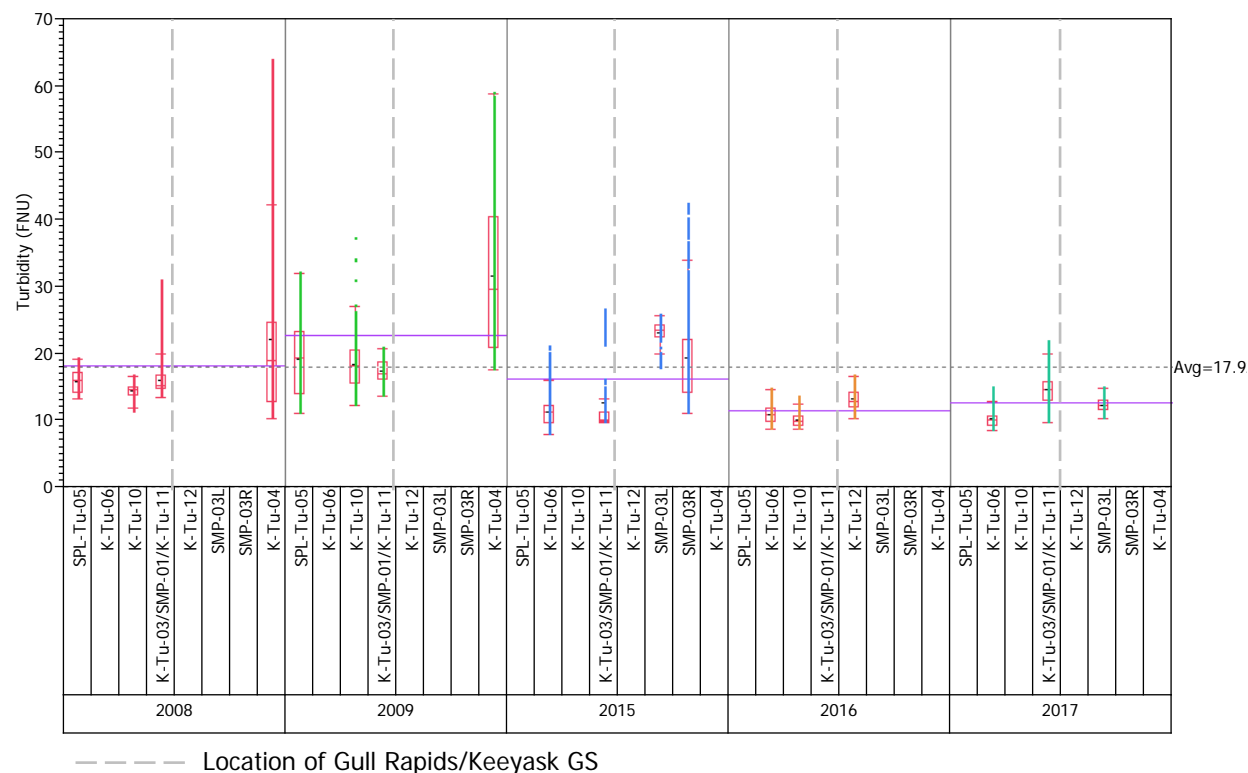
Figure 7: Summary of Winter Continuous Turbidity

As reported in 2015-16, the turbidity downstream of the Project in Stephens Lake (SMP-03) was similar to upstream levels in Gull Lake (Figure 7) in 2016-17. During pre-construction winter monitoring (2007-08 shown in Figure 8 and 2008-09) and in 2014-15 when the ice boom failed, it was observed that turbidity/sediment levels could be much higher in Stephens Lake (K-Tu-04) than in Gull Lake (K-Tu-10 and K-Tu-11), particularly early in the monitoring season. The higher levels in Stephens Lake likely resulted from ice accumulation at the entrance to Stephens Lake, which redirected flows and increased flow velocities causing erosion and increased sediment in the water. These elevated levels were also observed further downstream in the Limestone forebay prior to construction (Figure 9).

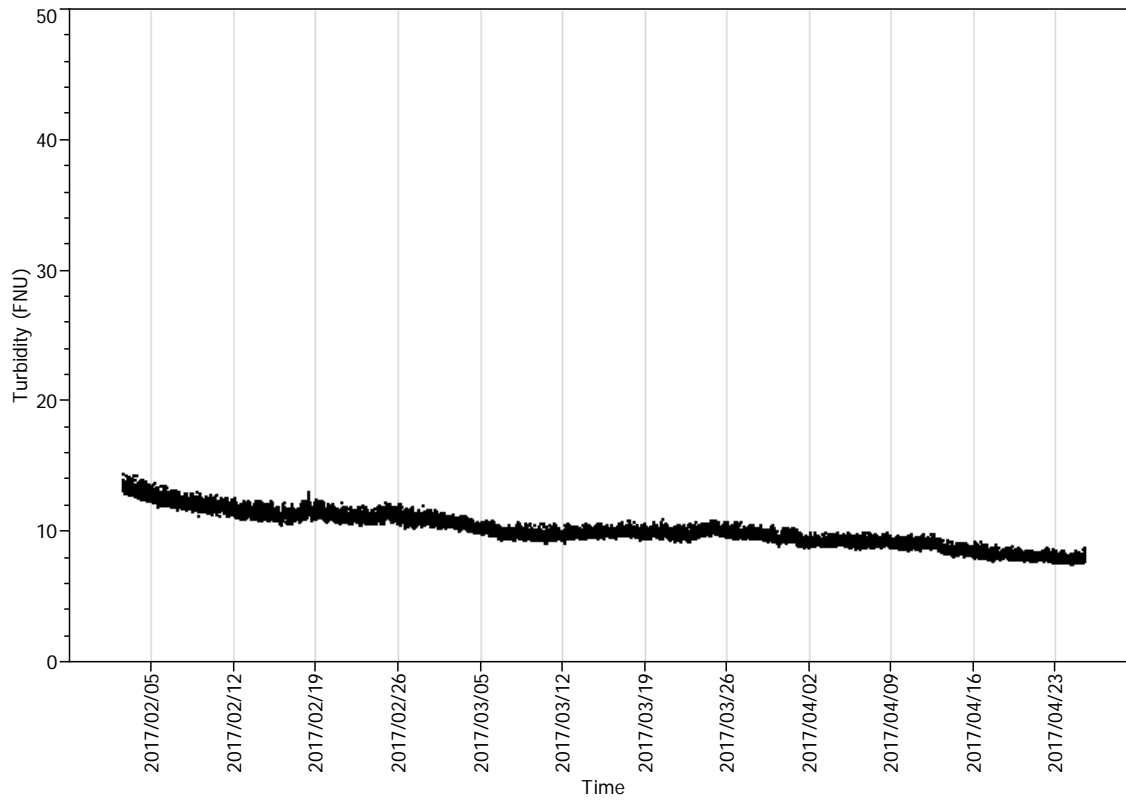
Figure 10: 2016-17 Limestone Forebay Turbidity

The lower turbidity was also observed downstream of Stephens Lake in the Limestone GS reservoir as shown in Figure 10 (CAMP, pending). While reduced erosion that may lead to decreases in downstream TSS during the ice-cover season was predicted, the Physical Environment Support Volumes did not explicitly say that the effect of lower TSS would extend downstream, although it would be expected. Under open water conditions, however, effects on TSS are not expected to extend past Stephens Lake.

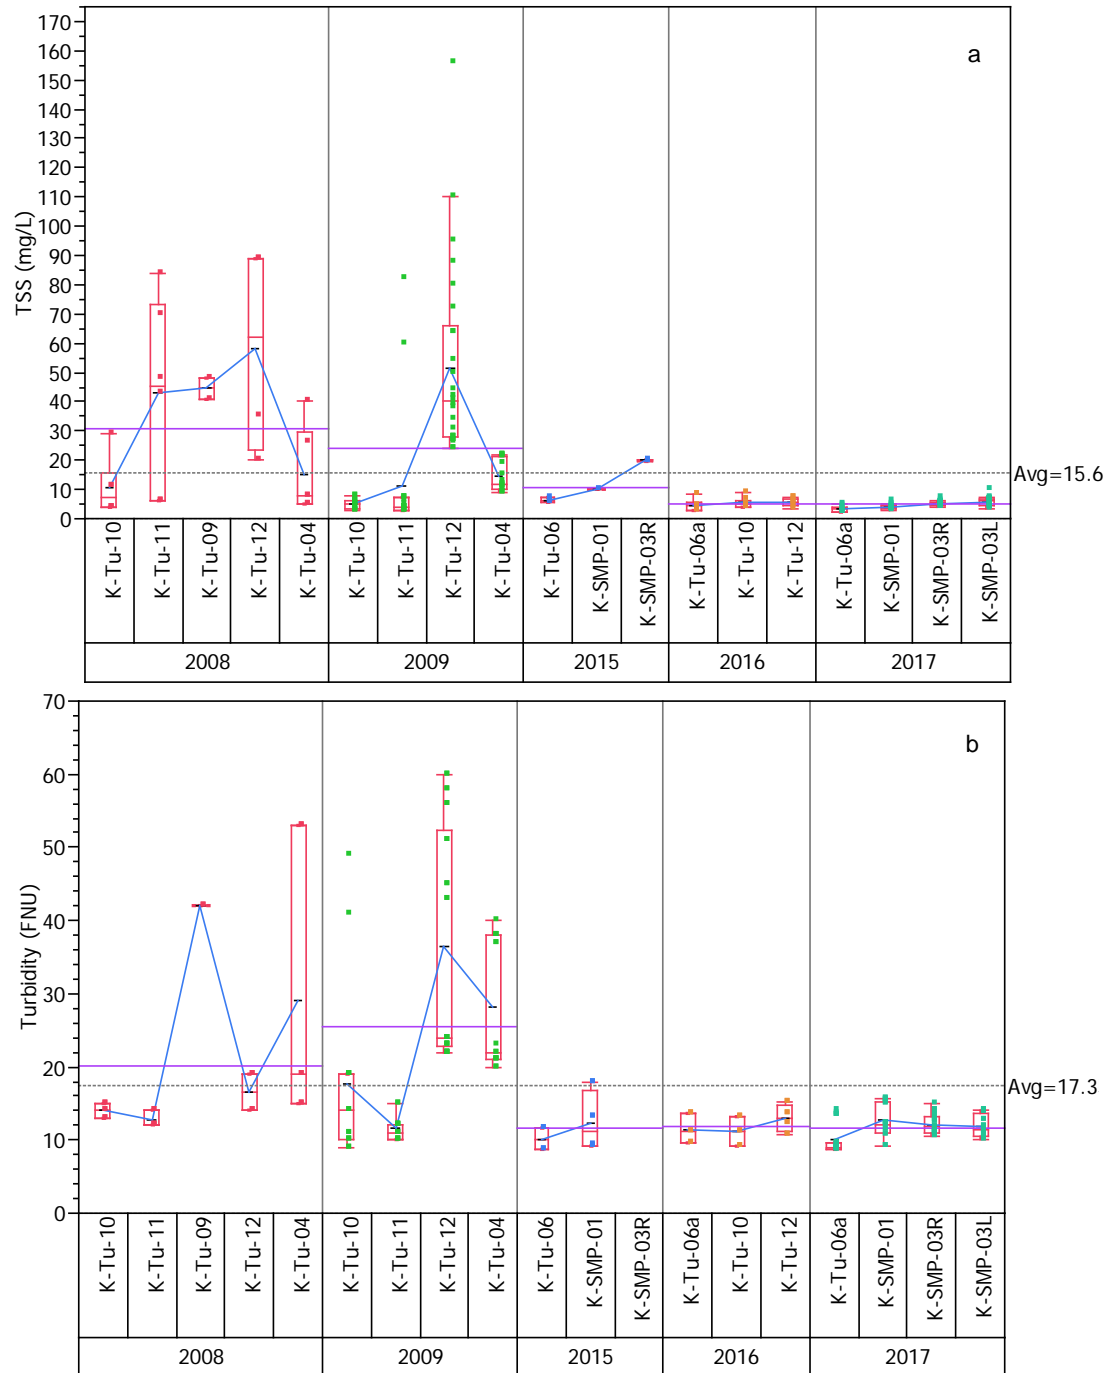
Figure 11: Summary of Winter Discrete TSS (a) and Turbidity (b)

Discrete TSS and Turbidity (Figure 11) data show consistent results with the continuous data. With the ice boom working to produce a stable ice cover upstream of the Project the downstream TSS and turbidity has dropped.

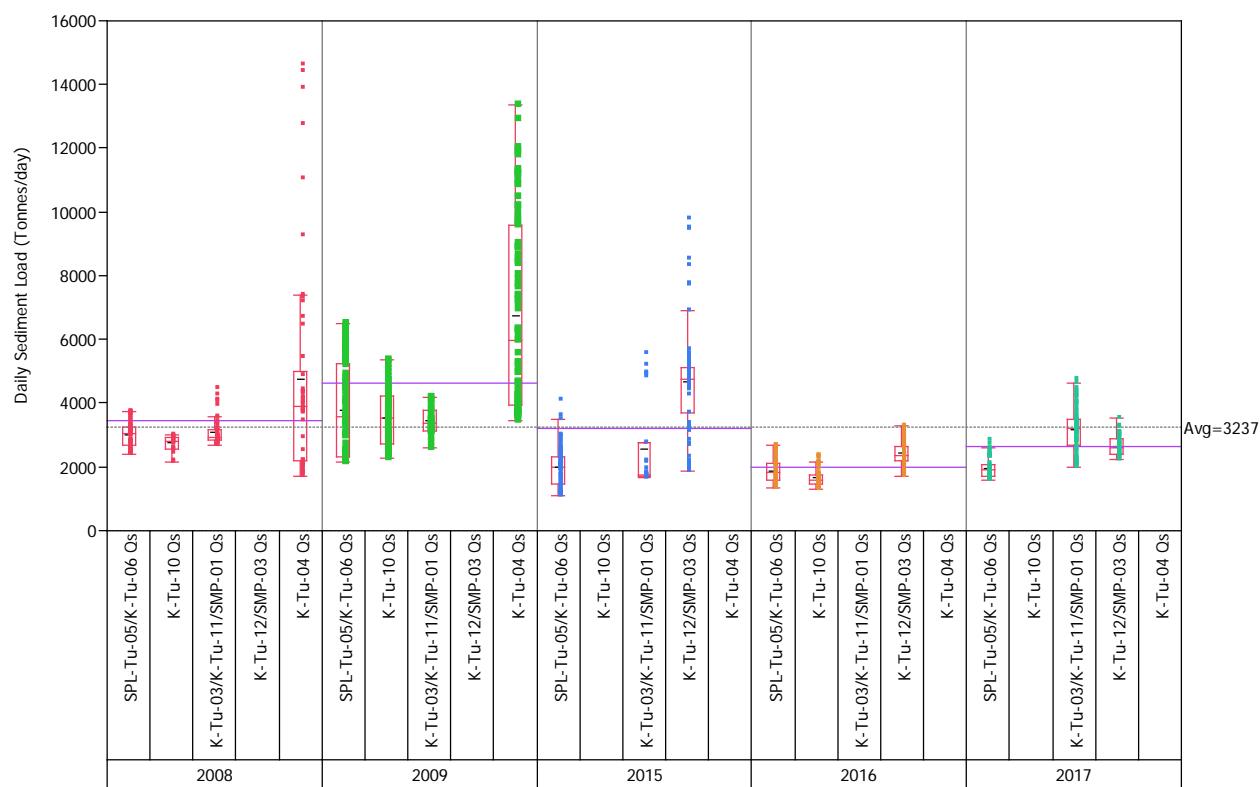
Figure 12: Summary of Winter Daily Suspended Sediment Load

The estimated sediment load at the upstream end of the study area (measured at SPL-Tu-05 on Split Lake and K-Tu-06 Clark Lake) indicates that the winter average was higher during the two pre-construction years (3010 and 3760 Tonnes/day respectively) than the three winters monitored since construction started (1980, 1880 and 1960 Tonnes/day).

As noted above, during the 2015-16 and 2016-17 winters a downstream reduction in turbidity has resulted in a reduced sediment load entering Stephens Lake from the pre-construction period and in 2014-15 when the ice boom failed. It is estimated that approximately 80,000 Tonnes were eroded between the Gull Lake site (K-Tu-03) and Stephens Lake site (K-Tu-04) over a 2 ½ week period in 2007-2008 when the higher turbidity was observed.

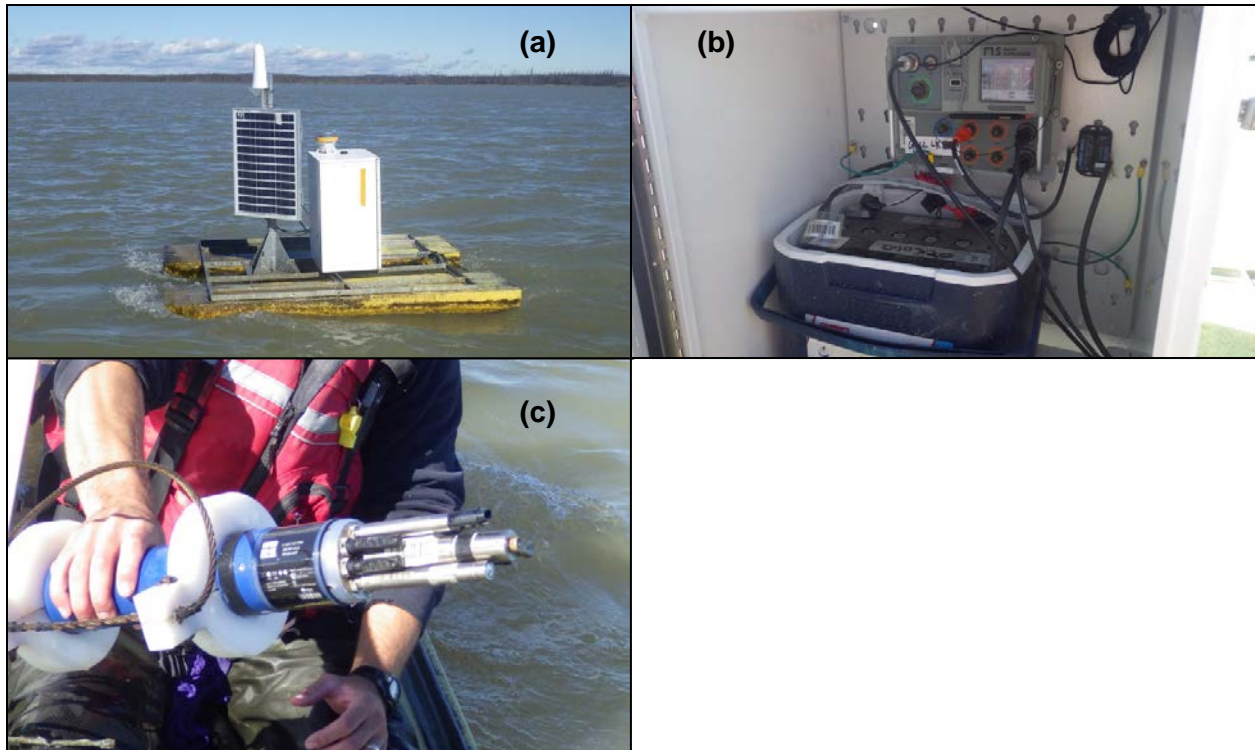
Photo 5: Continuous turbidity monitoring site: (a) catamaran with solar panel, transmitter and electronics cabinet, (b) electronics in cabinet, (c) probe with turbidity sensor installed
