Keeyask Generation Project Physical Environment Monitoring Plan

Physical Environment Monitoring Report

PEMP-2018-01

2017-2018 PHYSICAL ENVIRONMENT MONITORING REPORT: YEAR 4 CONSTRUCTION

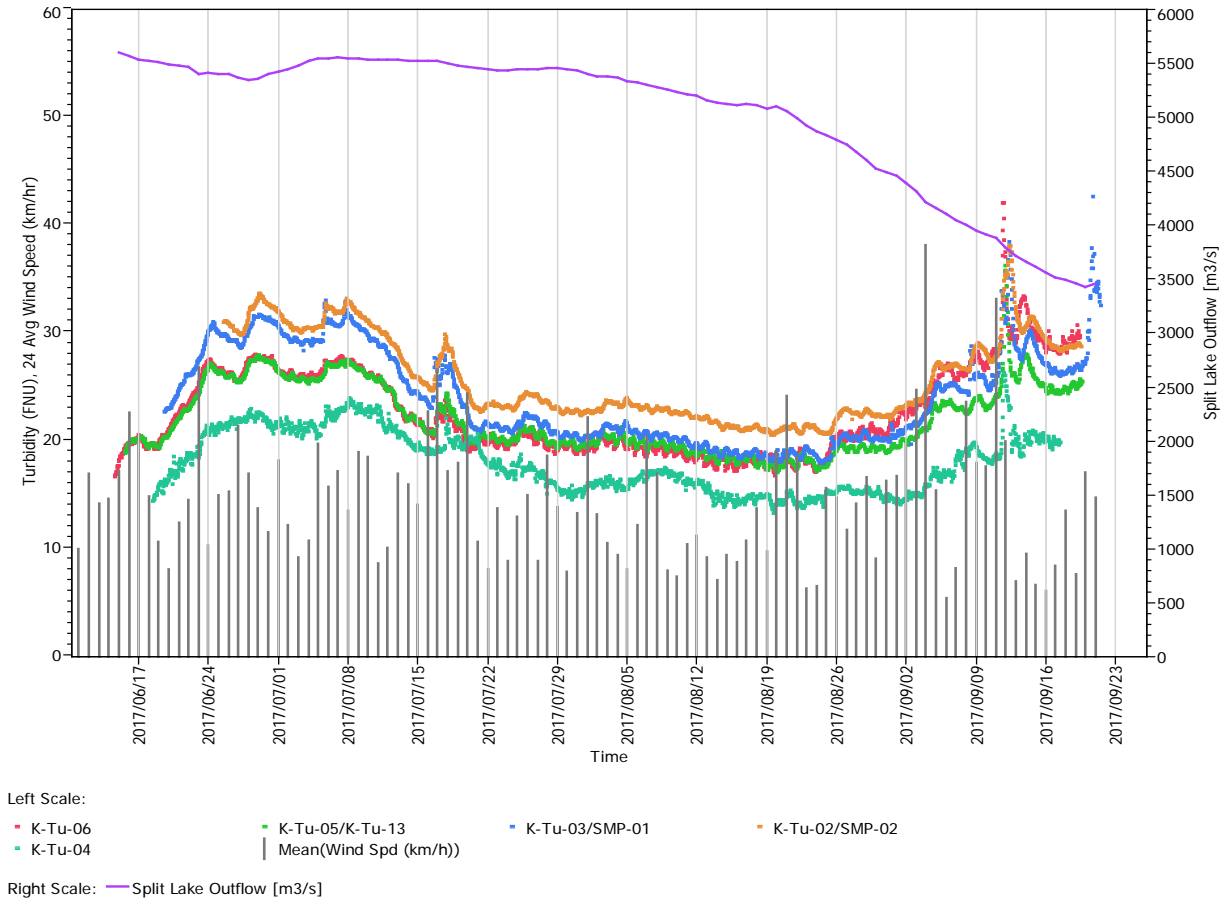
Figure 13: 2017 Summer Continuous Turbidity, Daily Discharge and 24-hr Wind Speed

The turbidity at each of the sites follows a similar pattern (Figure 13) throughout the monitoring period, with an increase observed in late June dropping in late July before increasing again early September. The Nelson River discharge is highest early in the season and drops throughout the monitoring period, the turbidity levels do not follow the discharge pattern through the summer season. The observed spikes are observed at the site located upstream of any changes in water levels due to the Project (K-Tu-06) and are not caused by the Project. As observed in other years, the increases in turbidity are typically occurring during/after high wind/storm events either upstream or over the monitoring area. The wind speed shown in Figure 13 is taken from the Environment Canada Station at Gillam.

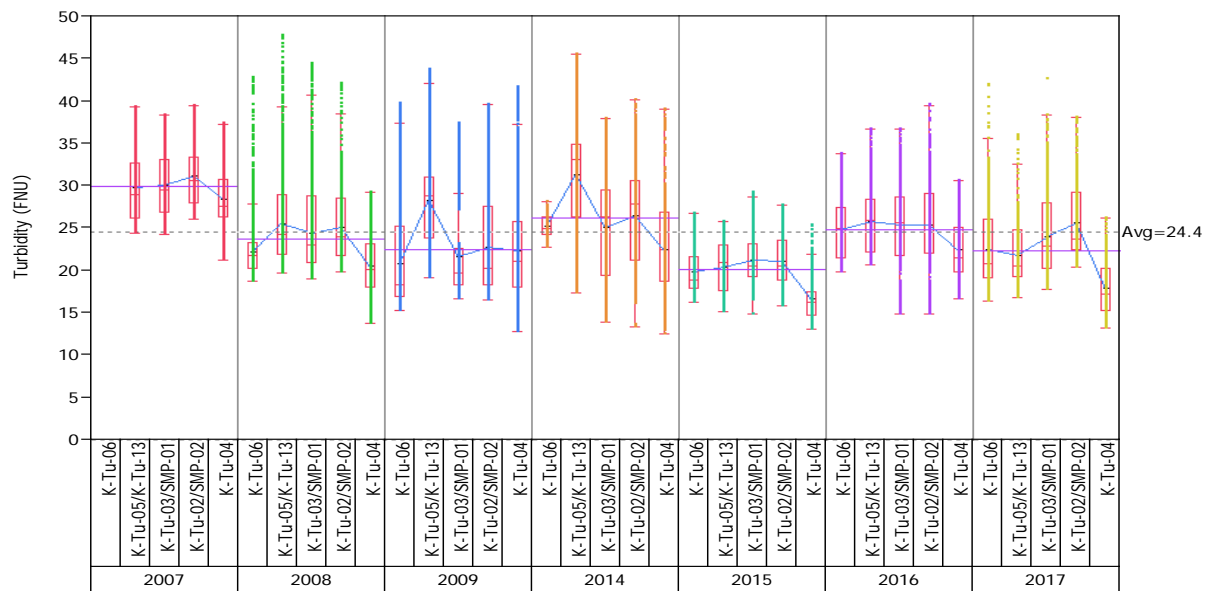
Figure 14: Summary of Summer Continuous Turbidity

The average summer turbidity (Figure 14) was lower in 2017 than in 2016 and below the overall recorded summer average (24.4 FNU) that includes three pre-construction years and four construction years. The highest summer average to date was in 2008 before construction started. Differences between the sites are similar to observations seen in other years and no discernable changes resulting from the Project are evident.

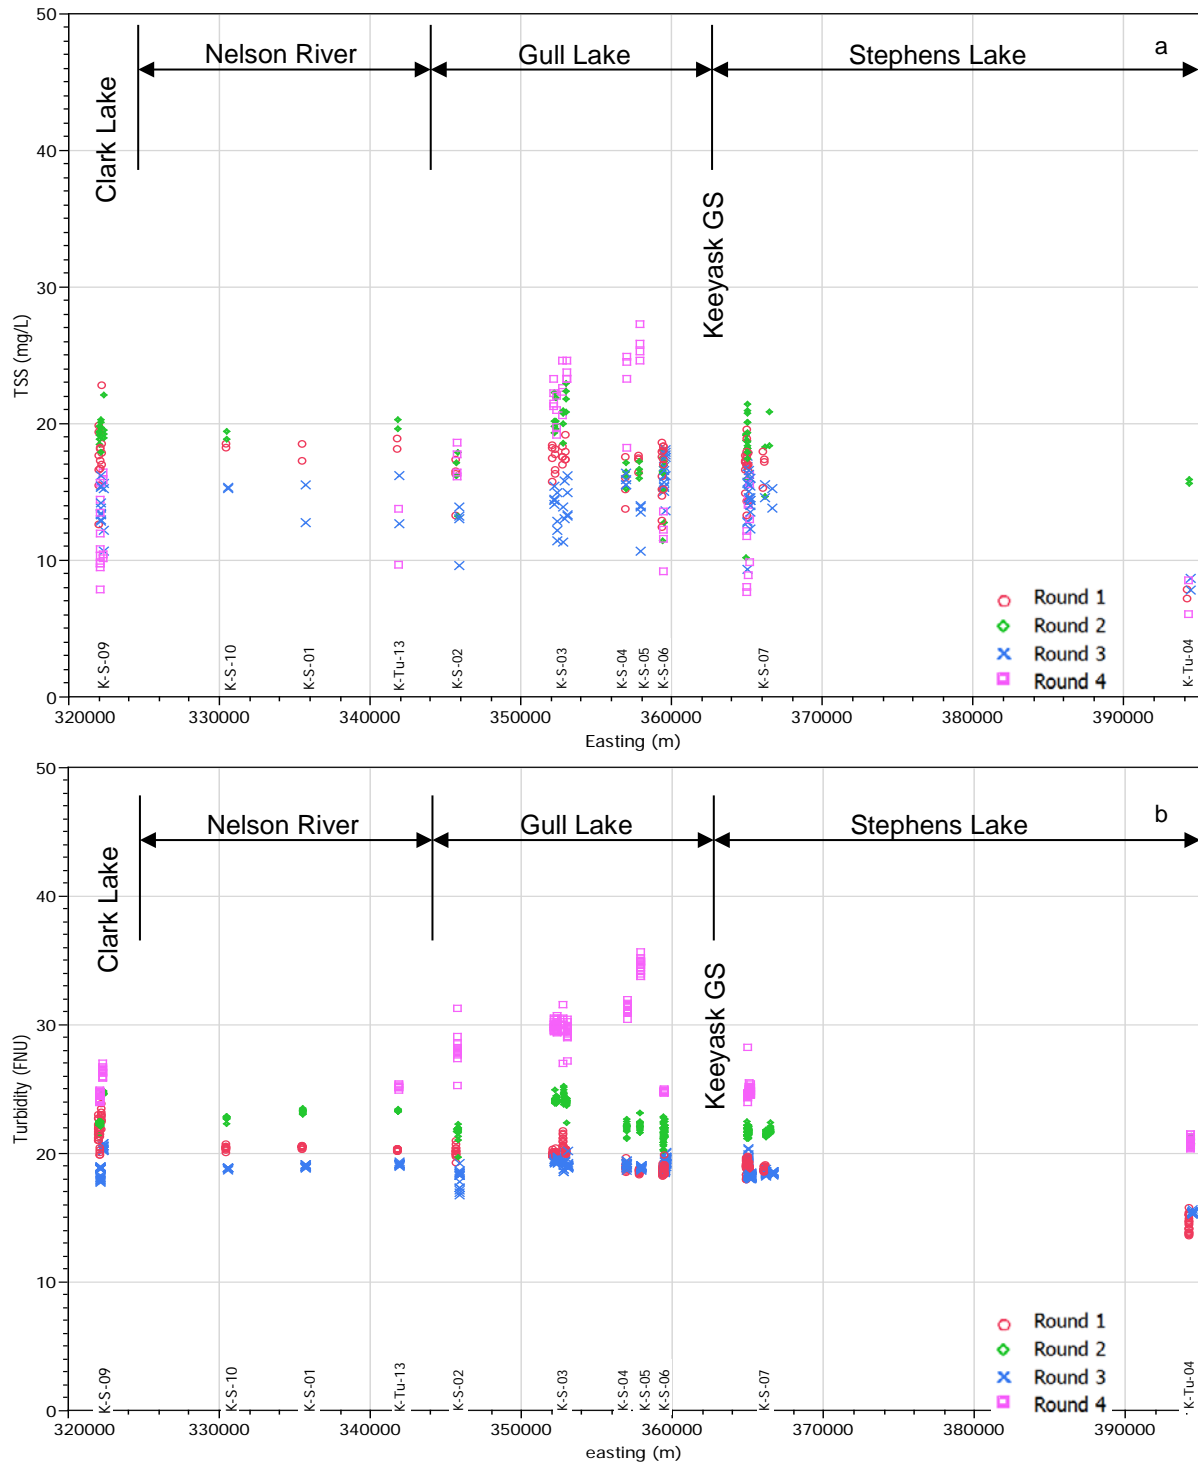
Figure 15: 2017 Summer Discrete TSS (a) and Turbidity (b)

The TSS results (Figure 15) range between 6 and 28 mg/L with round 4 in late September having the highest TSS. The fourth round of sampling occurred from 09/17/2017 to 09/21/2017 which coincided with a period of higher turbidity (Figure 13).

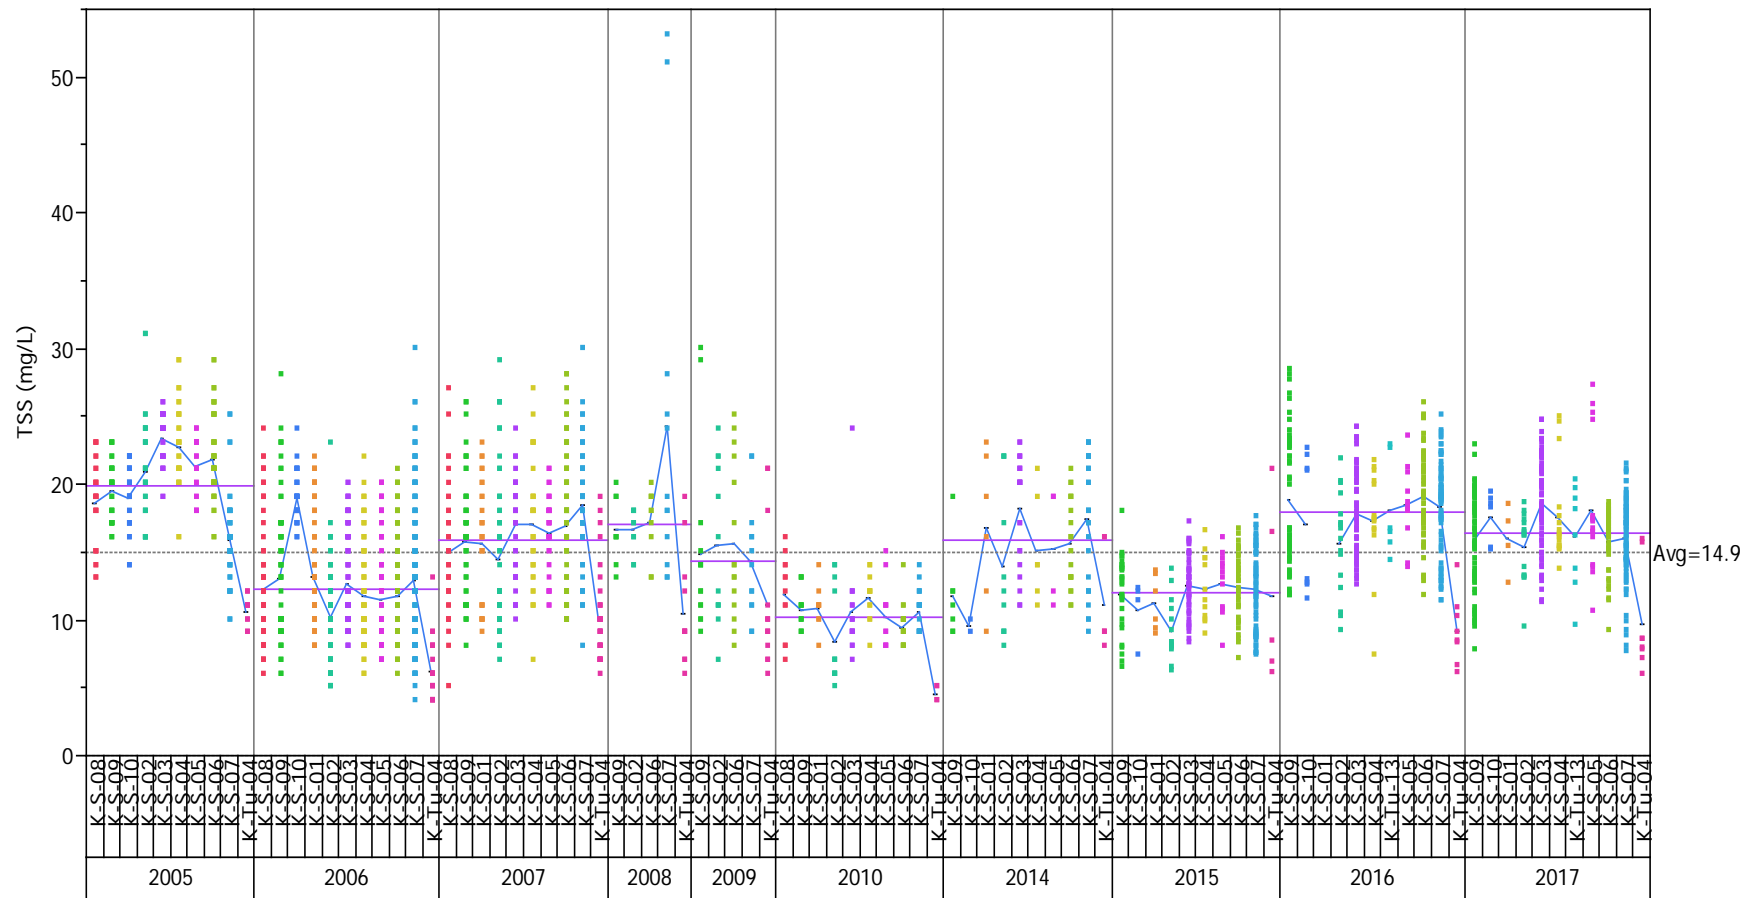
Figure 16: Summary of Summer Discrete TSS

Figure 16 and Figure 17 shows the site, year and overall average of summer turbidity and TSS data collected during the pre-construction and construction periods to date under the sedimentation monitoring program. In 2017, the average TSS across the monitoring area was 1.5 mg/L above and the average turbidity was 3.5 FNU below the long term averages. The average inflow (site K-S-09, Clark Lake) TSS was 0.3 mg/L higher and the average inflow turbidity 2.9 FNU lower than the long term average at that site. Comparing pre-construction and during construction data shows there has been little change in summer averages between the inflow site (K-S-09) and the site just downstream of the Project (K-S-07). At K-S-09 the pre-construction average TSS was 15.0 mg/L and turbidity was 25.8 FNU and during construction the average TSS has been 15.9 mg/L and turbidity has been 24.2 FNU. At the site immediately downstream of the Project site (K-S-07) the pre-construction average TSS was 14.8 mg/L and turbidity was 25.6 FNU and during construction the average TSS has been 15.9 mg/L and turbidity has been 23.8 FNU.

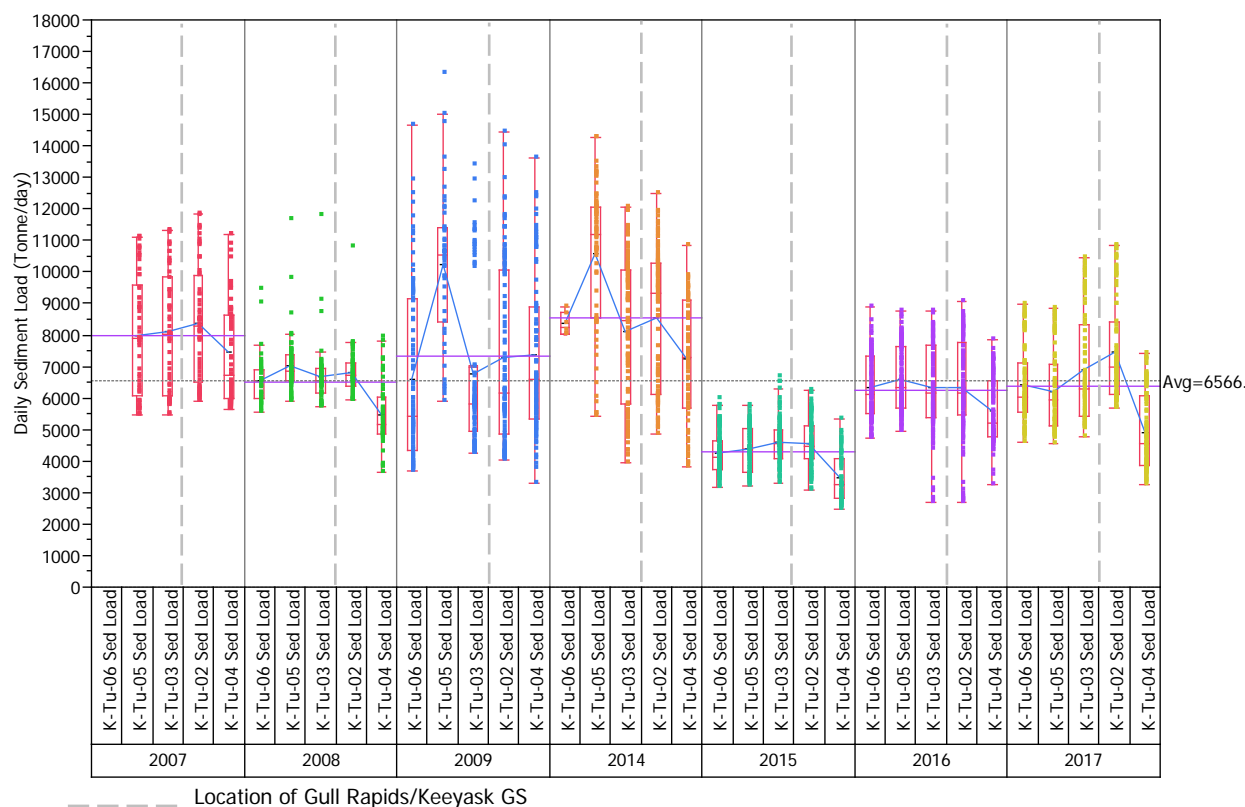
Figure 18: Summary of Summer Daily Sediment Load

The summer suspended sediment loads (Figure 18) are estimated based on the average daily turbidity and Keeyask inflow discharge. Turbidity is converted to TSS concentrations using a Turbidity-TSS relationship developed for the SMP.

The 2017 average summer suspended sediment load was close to the long term average (6,566 Tonnes/day), with the last three years all being near or below the long term average. As seen pre-construction in 2007 and 2009 there was an increase in sediment load through Gull Rapids/Keeyask GS construction area (K-Tu-03) to Stephens Lake (K-Tu-02) with a drop in suspended sediment load through Stephens Lake (K-Tu-02 to K-Tu-04).

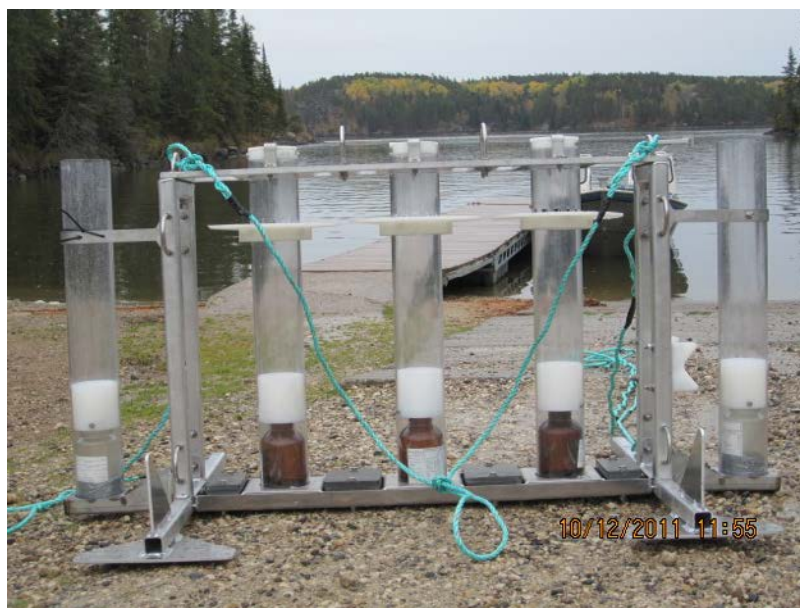
Photo 6: 5-Tube sediment trap used at site K-ST-02

A 5-tube sediment trap (Photo 7) was installed in Stephens Lake to monitor the sediment accumulation rate over the 2016/17 winter and 2017 summer periods. Due to a technical problem no sediment sample was retrieved during the 2017 summer period. Results from the 2016/17 winter monitoring are shown in Table 5.

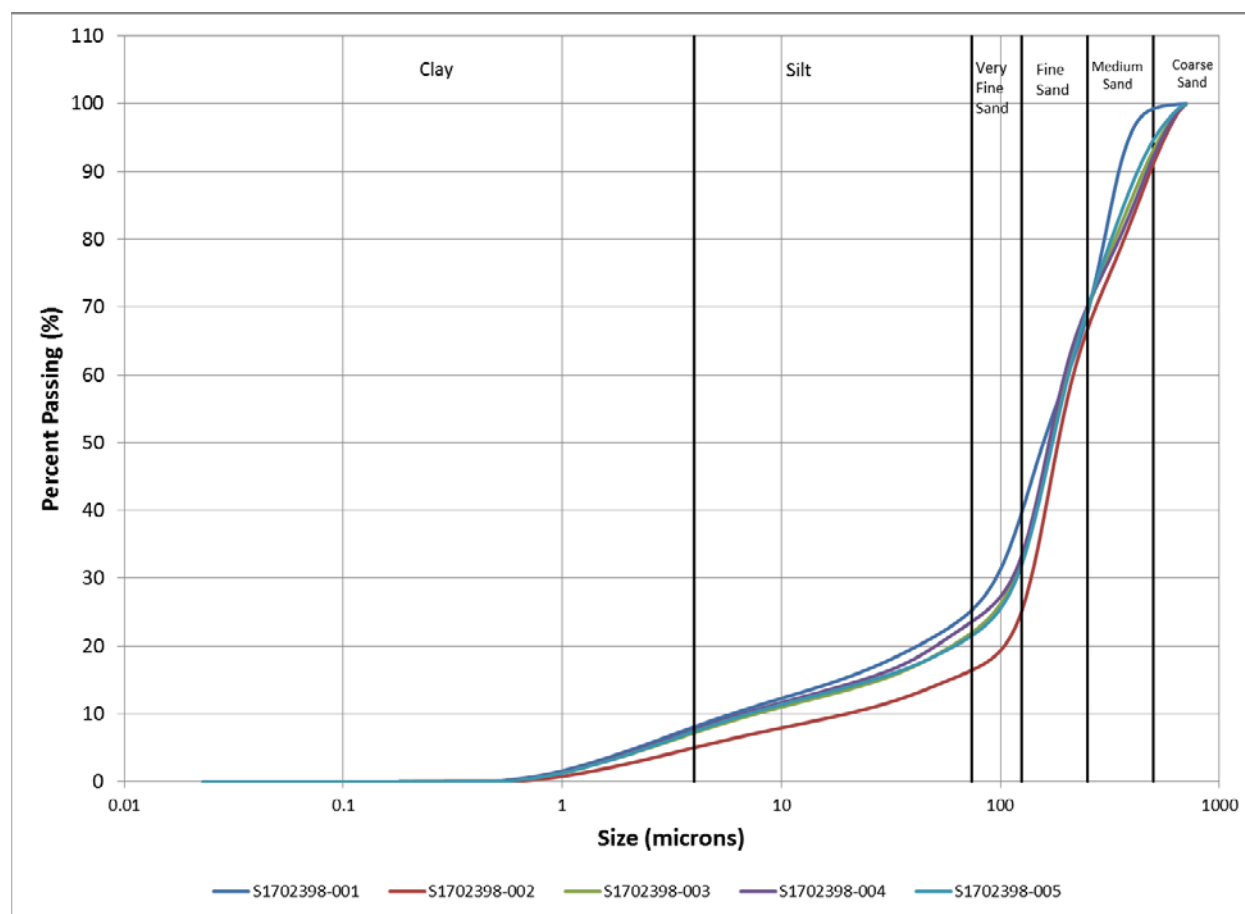
**Figure 19: Sediment Trap Grain Size Distributions**

The 2016/17 winter period had the highest accumulation rate to date (Table 6) during construction; 1.4 to 2.2 times higher than recorded the previous two winters. Note that this monitoring was not done during pre-construction monitoring periods. The accumulation rates do not correlate to the Winter Suspended Sediment Loading (Figure 12); however, the sediment loading does not cover entire period including the period of freeze up and break up. The winter/spring of 2016/17 saw very high flows in spring which likely explains the higher accumulation rates seen that winter. The sediment collected was primarily comprised of material in the fine sand and smaller grain size ranges with some medium sand (Figure 19).

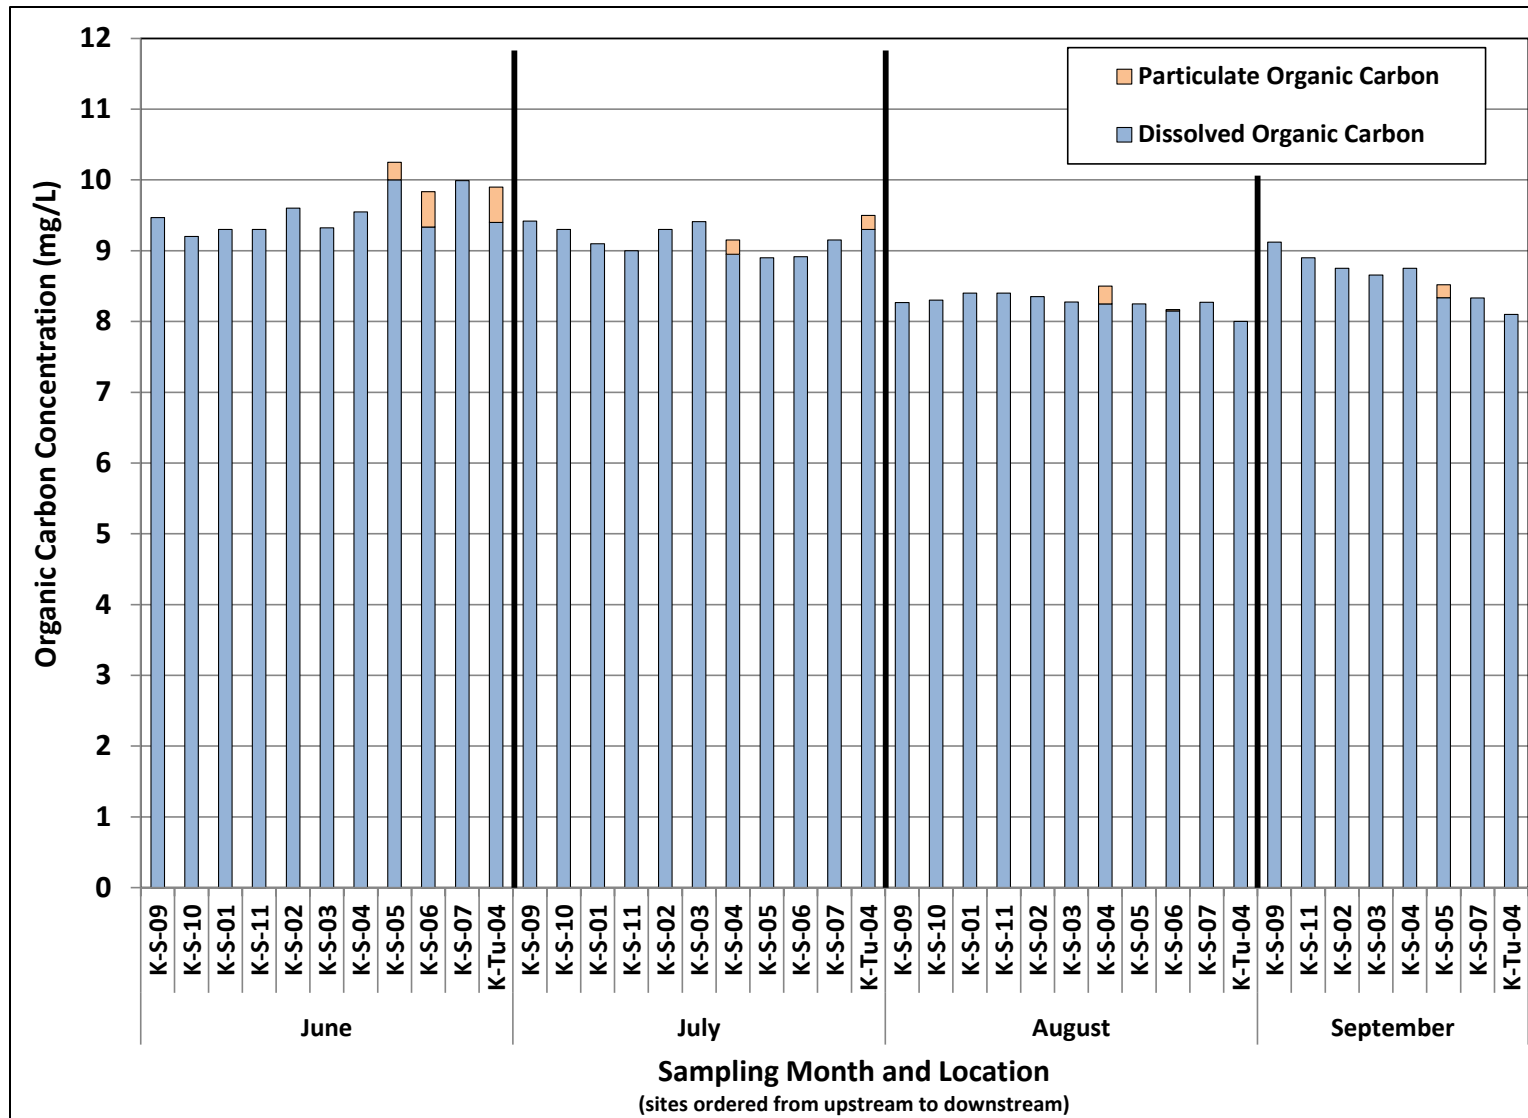
Figure 20: Summary of particulate, dissolved and total organic carbon

From all the results, the site averaged TOC ranged from about 8-10 mg/L and was predominantly comprised of DOC as site averaged POC was typically 0.5 mg/l or less in those cases where TOC was greater than DOC (Figure 20). In each month the site average TOC concentrations vary by 1 mg/L or less across the sites and over the season it only varies over a range of about 2 mg/l. The total organic carbon concentrations measured in summer 2017 are of a similar magnitude and overall range as in 2016. Observations in 2017 are consistent with those reported in the Keeyask EIS for the pre-construction period (KHLP 2012c, Appendix 2H) and, as before, show organic carbon is present primarily in dissolved form.

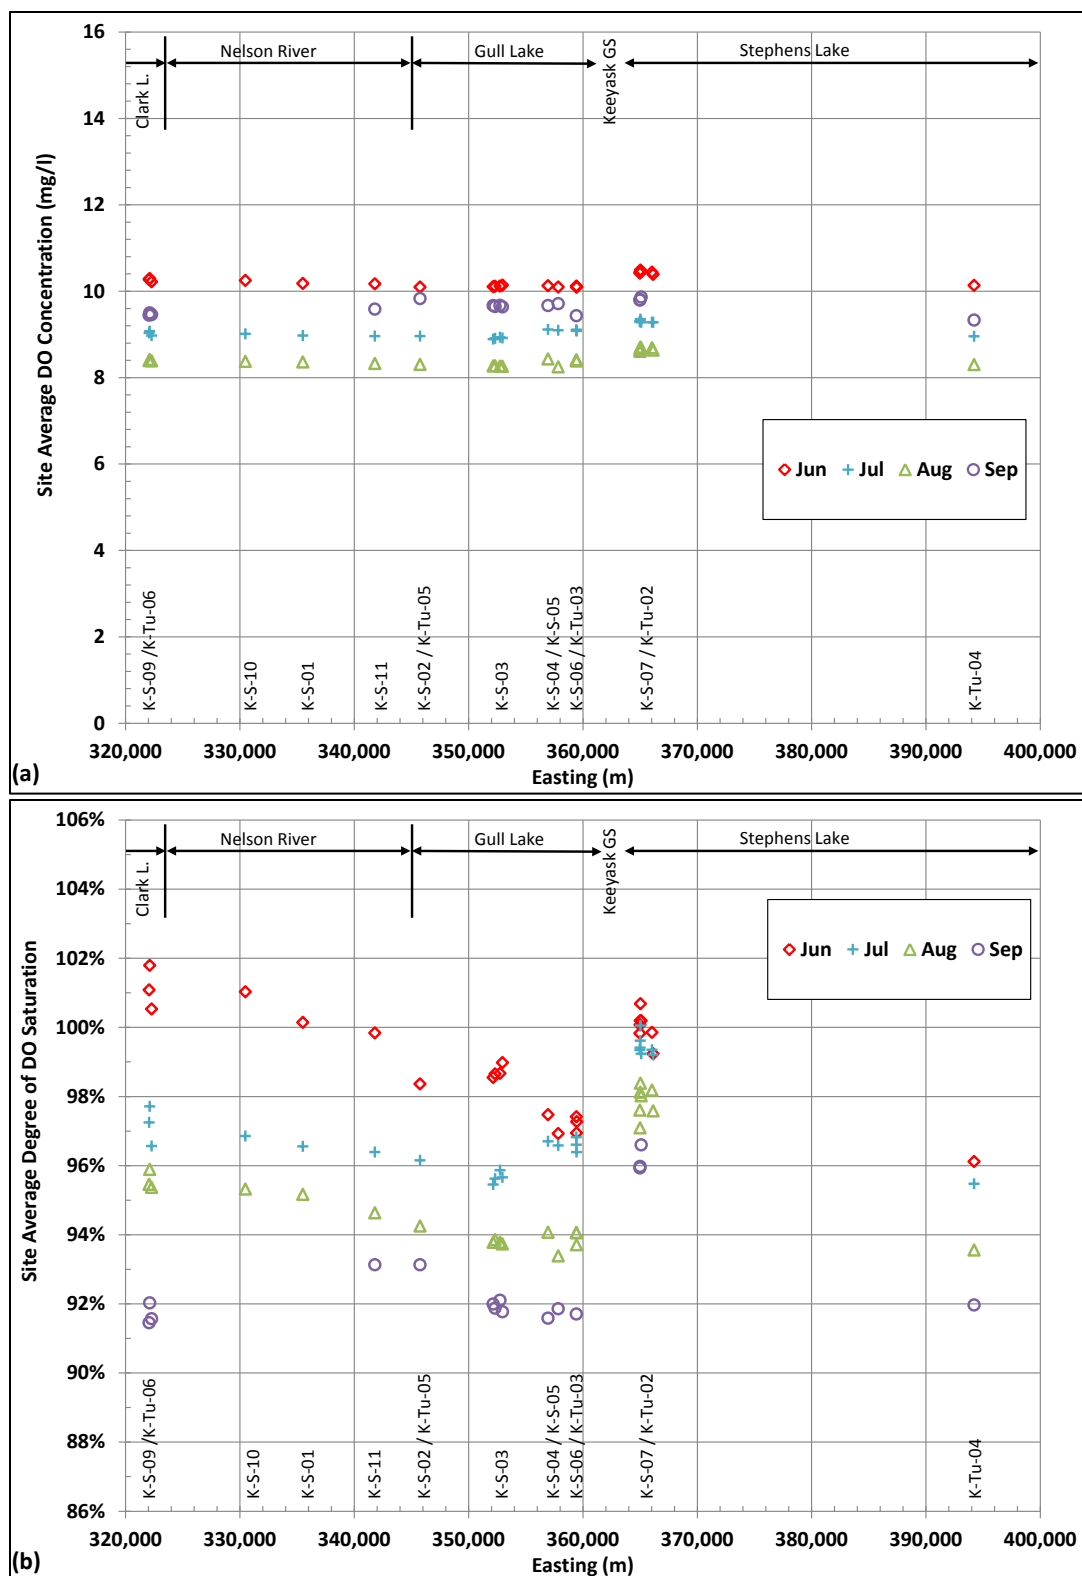
Figure 21: Summer 2017 discrete monitoring results: (a) dissolved oxygen concentration (b) degree of saturation

Overall, the saturation levels varied from a low of about 92% to a super saturated high of 102% (Figure 21), the same as observed in 2016. The average saturation level at the monitoring sites over the entire summer varied from about 93% to 97%. The lowest levels of saturation occurred in September for most sites while June was generally the highest. In each month, the highest levels of saturation typically occur at site K-S-07 just below Gull Rapids (Figure 21). While DO concentrations showed little variation across sites, the degree of saturation tended to decline downstream (except through Gull Rapids) because temperatures tended to cool slightly, about 0.5-1.5 °C, moving downstream from Split Lake (Figure 22).
