Keeyask Generation Project

Sediment Management Plan for In-stream Construction

REPORT #SMP-2018-01

ANNUAL REPORT

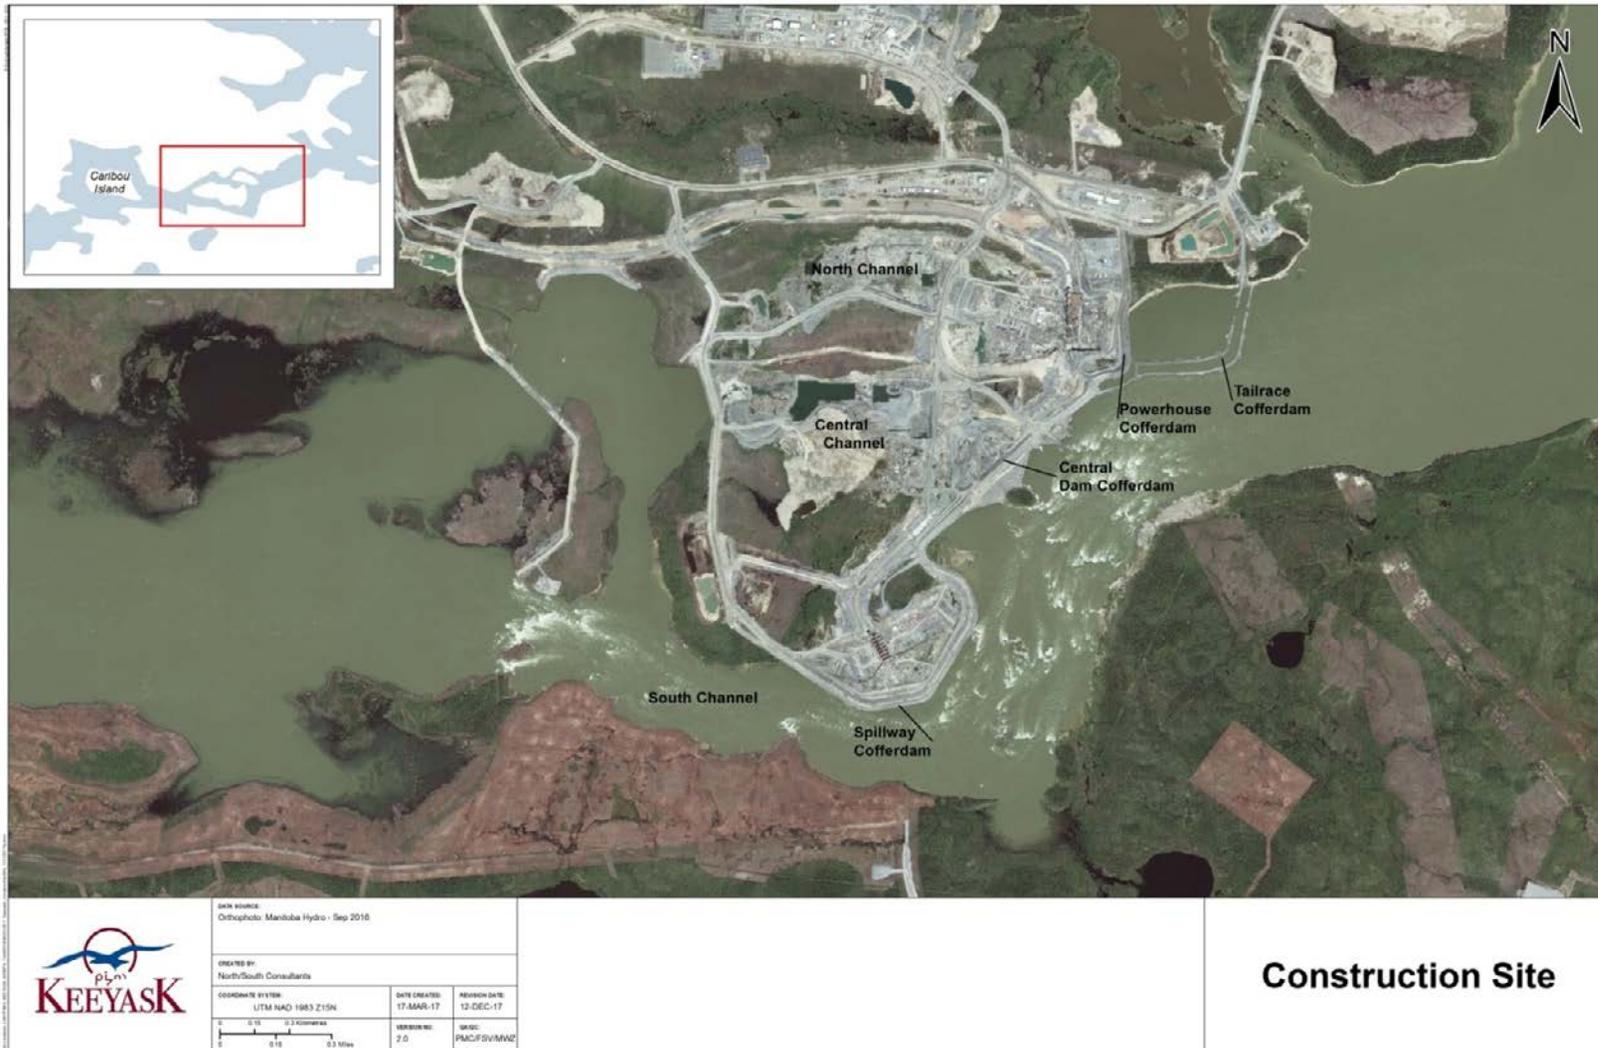
Figure 1: Map of the Keeyask Generating Station site, September 2017

(Note: The North Channel Rock Groin Extension is not shown)

Construction of the Keeyask GS began in mid-July 2014 with the construction of cofferdams in the north and central channels of Gull Rapids (Figure 1). These cofferdams resulted in the dewatering of the north and central channels and the diversion of all flow to the south channel. Construction of the spillway cofferdam, which extends into the south channel of Gull Rapids, was completed in 2015. During 2016 there was little instream construction until placement of rock for the Tailrace Cofferdam began in late fall and continued into 2017. Large rocks were placed in the Nelson River to form the inner and outer groins of the Tailrace Cofferdam. An opening was left in the rock groins to allow fish to move into and out of the cofferdam. Placement of fine material between the two sections of the cofferdam began and was completed in late 2017. An opening was created to allow fish to move freely over the winter of 2017/18.

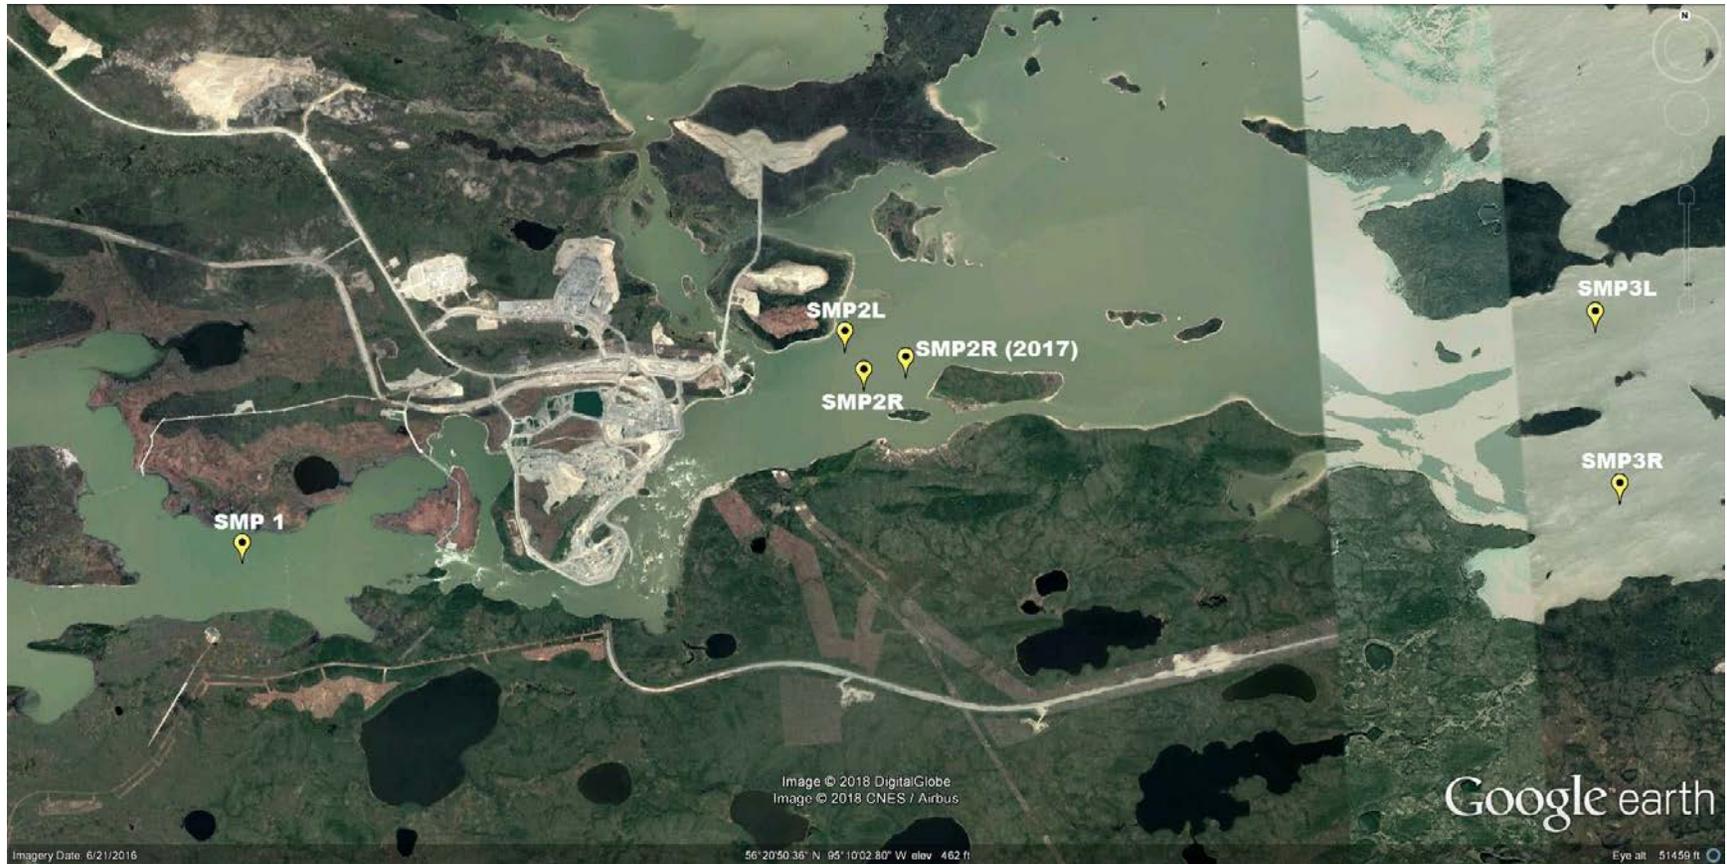
Figure 2: Open water monitoring stations for the Keyeyask Sediment Management Plan

- SMP-1 is located upstream of all construction activities in the Nelson River and monitors ongoing background conditions.
- SMP-2 is located approximately 1.5 km downstream of the future Powerhouse. Data loggers are installed on the left and right sides of the channel (SMP-2L and SMP-2R). This location was chosen, as it is a near-field location within the mixing zone prior to fully mixed conditions.
- SMP-3 is located approximately 9 km downstream from the construction site in the fully mixed zone of the primary flow channel, along the deepest part of the river. This location was chosen because the majority of the flow passes through this south channel and it is

where increases in TSS will mostly occur. Data loggers are installed on both the left and right sides of the channel (SMP-3L & SMP-3R).

During the month of June 2017, the open water monitoring stations were installed on the Nelson River. Five monitoring stations (SMP-1, SMP-2L & SMP-2R, SMP-3L & SMP-3R) were deployed as outlined in the SMP to collect turbidity data for the Project. A backup station (SMP-1A) was installed near SMP-1 as a precaution, so background data would be continuously available in the event that SMP-1, which is the sole upstream monitoring station, failed or became damaged. At each station, sensors were installed two meters below the water's surface (designated TSSS) and two meters above the bottom of the channel (designated TSSB). Figure 2 shows the location of each of the SMP open water monitoring stations. The stations are described in more detail below:

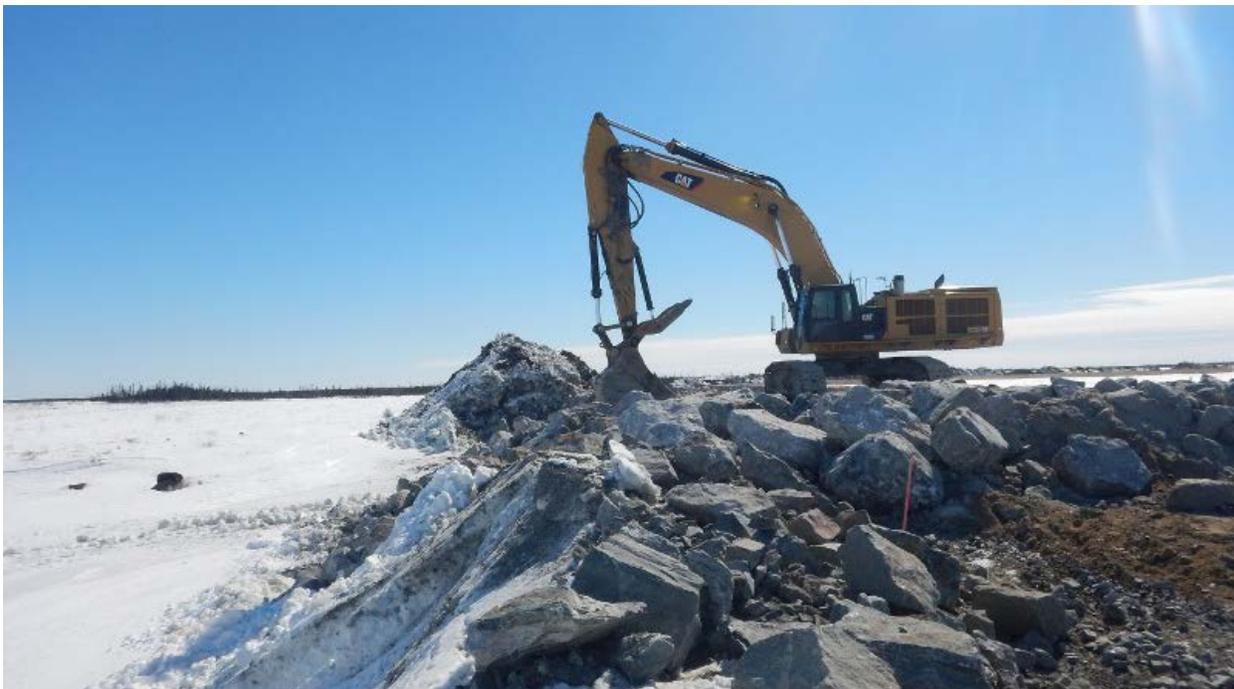
Figure 4: A Cat 390D excavator placing Class C4 rock material at the North Channel Rock Groin on April 12, 2017

Extremely high flows forecasted for the spring melt of 2017 posed a threat to the integrity of the North Channel Rock Groin (NCRG), as over-topping could cause the structure to erode or breach. In-stream construction to expand the footprint of the NCRG by approximately 1000 m² began on April 8, 2017 and was completed on April 13, 2017. As part of the construction, rock material was placed at a section at the northern end of the NCRG (Figure 4) to increase the elevation of that section, as well as widening it by approximately four meters.

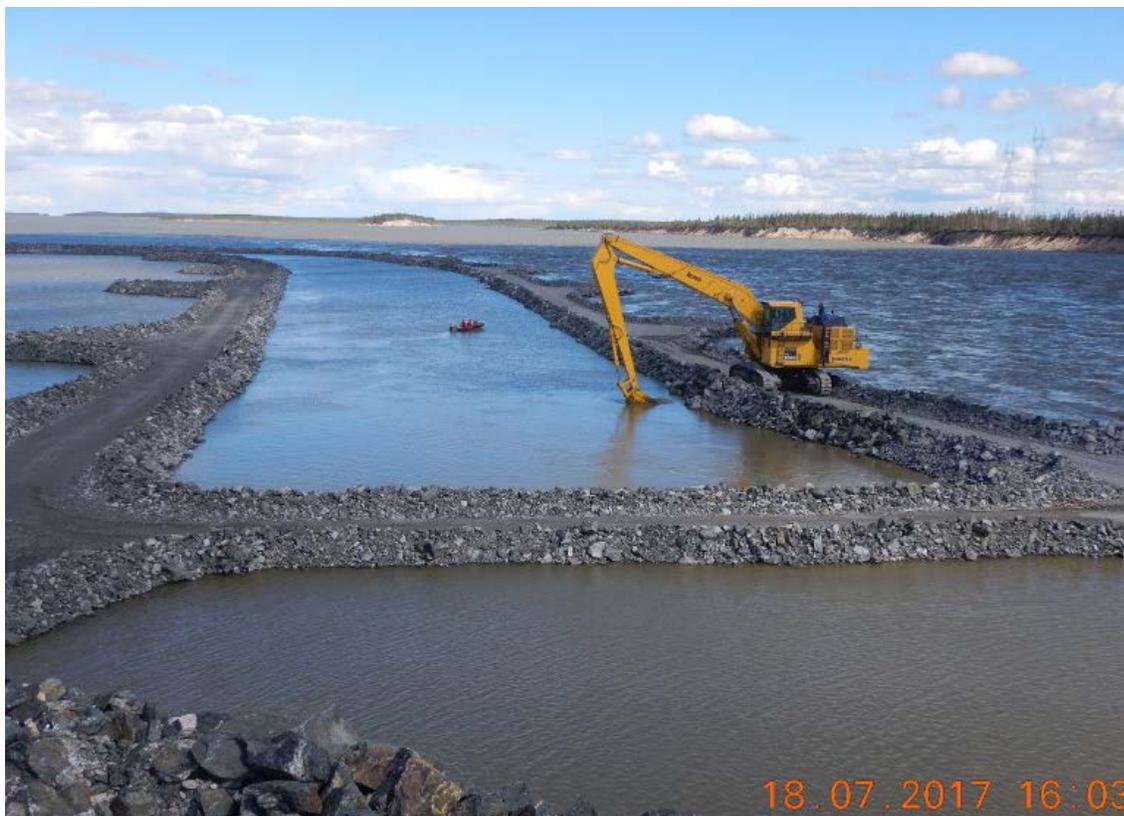
Figure 8: A Komatsu PC2000 excavator being used to carry out bedrock scraping tests to determine the extent of dredging required to remove sediment and rocks from between the groins of the Tailrace Cofferdam. Photo taken July 18, 2017

In-stream work to construct the Tailrace Cofferdam resumed in July 2017. It was expected that sediment between the rock groins would need to be removed before the sandy-silt (“impervious material”) core of the cofferdam could be placed; however, bedrock scraping tests conducted on July 18 and 22, 2017 (Figure 8) indicated that minimal dredging would be required. Dredging and other in-stream preparation for placing the cofferdam’s impervious core were completed between August 12-13, 2017. On August 20 and 21, 2017, the opening in the outer groin was closed with rockfill to create a continuous road/working surface for haul trucks delivering loads of material for its construction (Figure 9). Placement of impervious material between the inner and outer groins, which was required to seal the cofferdam, occurred from August 21-24 (Figure 10).

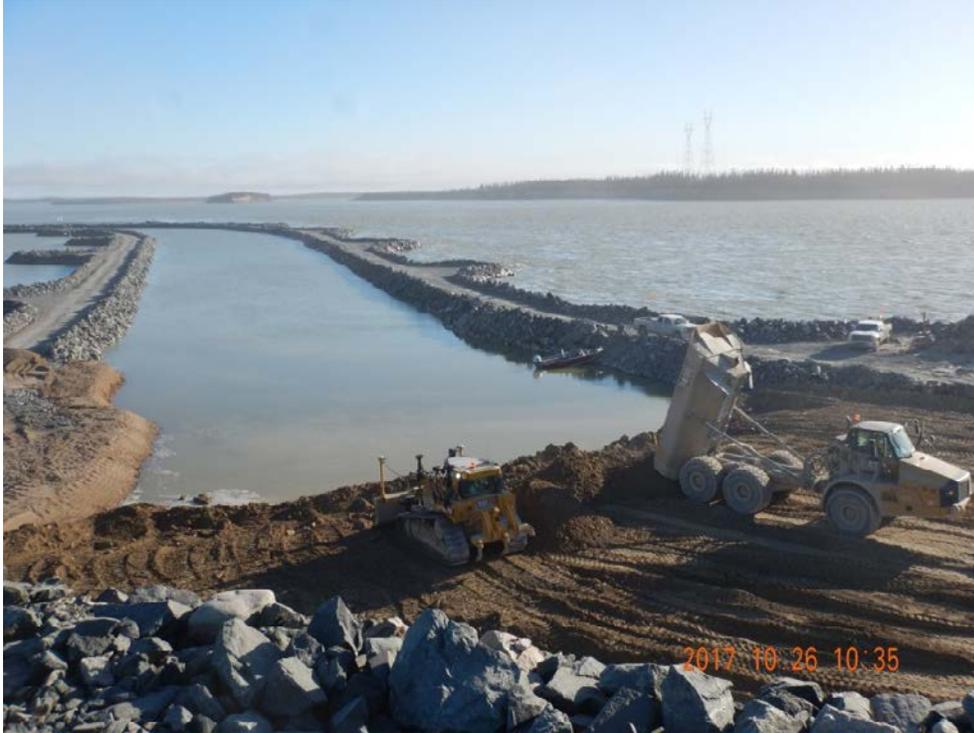
Figure 13: Rock truck delivering sandy-silt “impervious” material to the Tailrace Cofferdam for placement by a Cat D6T dozer to construct the core of the cofferdam

Note: A localized sediment plume can be seen in the immediate vicinity of the area where the material is being placed. Photo taken October 26, 2017.

During in-stream work, as expected there was increased turbidity and some instances of localized sediment plumes in the immediate vicinity of impervious material being placed between the inner and outer groins of the Tailrace Cofferdam (Figure 13; Table 5 and Table 6); however, the plumes quickly dissipated downstream from the work. The range of calculated TSS values determined in proximity to the Tailrace Cofferdam construction was 18.6 to 85.6 mg/L (Table 5 and Table 6). These increases in TSS and localized sediment plumes are not expected to have had measurable aquatic impacts.

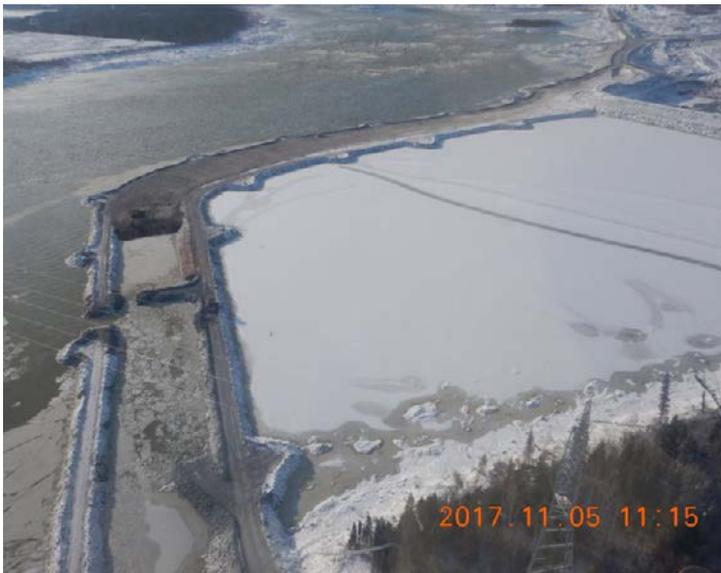
Figure 14: Aerial photo (looking south) of the Tailrace Cofferdam in-stream construction in progress, taken November 5, 2017

In-stream work resumed on October 19, 2017 on the Tailrace Cofferdam. In-stream work included placing rock to close the inner groin of the cofferdam on October 19-20, 2017. During the period between October 20 and November 9, 2017, impervious material was placed between the inner and outer groins to create the watertight core of the cofferdam (Figure 13 and Figure 14). On November 9 and 10, 2017, material was removed from the completed impervious core to create a channel between the bay inside the cofferdam and the Nelson River, so that fish could move through freely throughout the winter (Figure 15). The edges of the opening were capped with large rock to prevent erosion of the impervious core material while this channel remains open. Construction ceased after November 10, 2017.

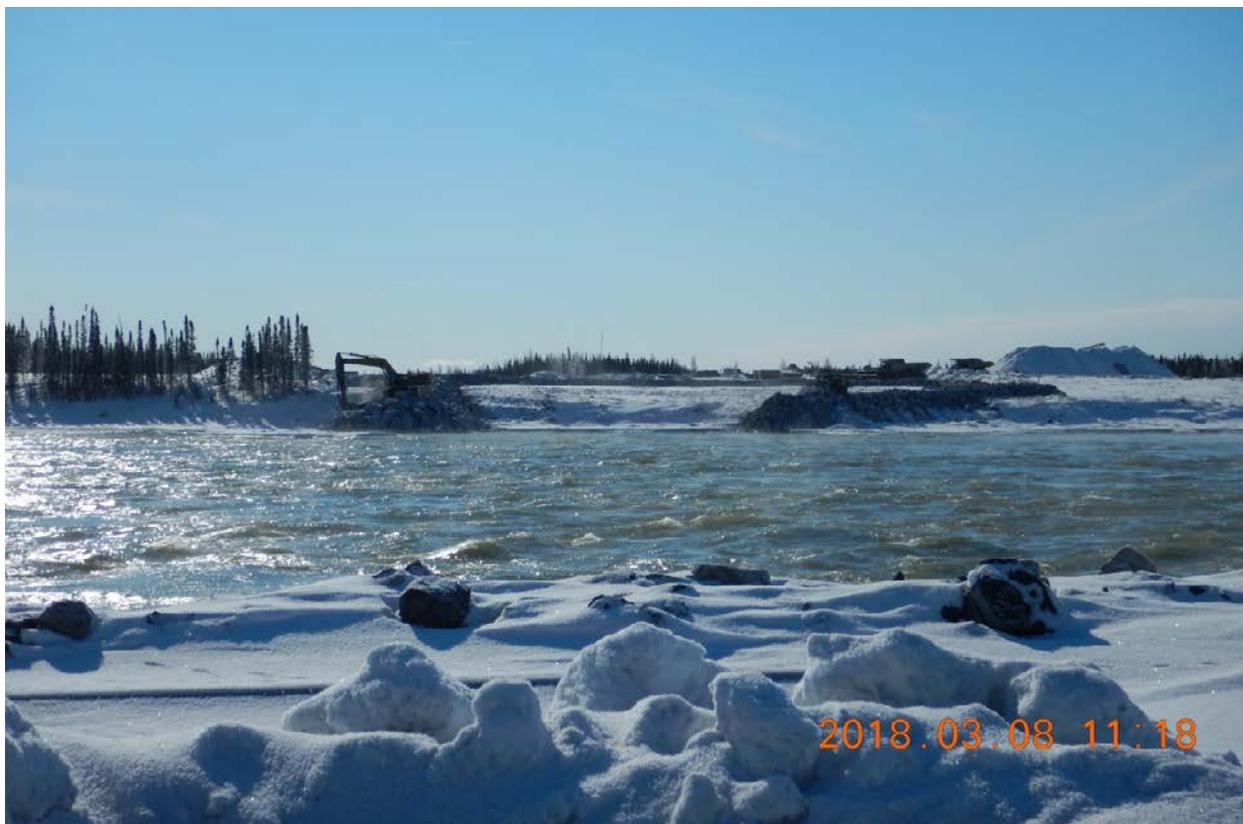
Figure 16: Construction of the Upstream and Downstream South Dam Cofferdams. A dozer places rockfill material on the upstream portion (right), while an excavator breaks ice along the shoreline and moves rockfill material into place on the downstream portion (left)

In-stream work involved breaking up shoreline ice and placing large rock to create two short rock groins on the south shore of the Nelson River (Figure 16). Winter SMP monitoring equipment was in place during this in-stream work and there were no exceedences of the action levels at SMP-3 observed during the time that this in-stream work was occurring (Figure 17).
