Keeyask Generation Project
Terrestrial Effects Monitoring Plan

Wetland Loss and Disturbance Monitoring Report

TEMP-2018-03

Prepared for
Manitoba Hydro

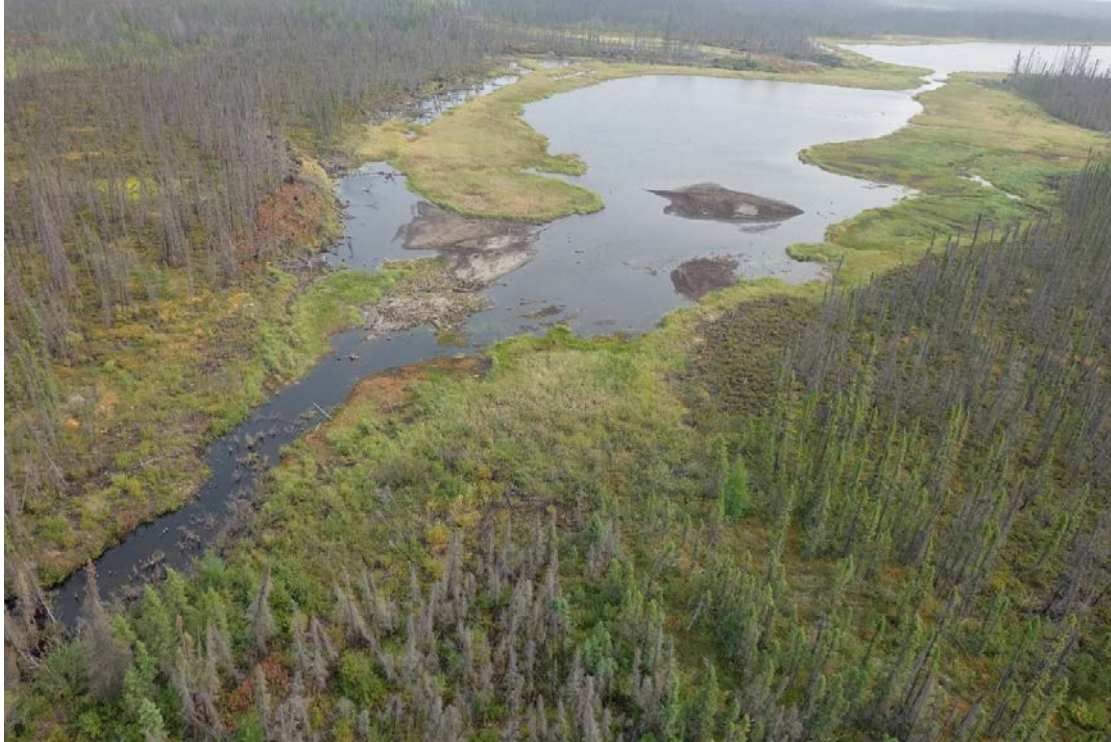
Wetland 3 (August 31)

Figure 3-1: Aerial views of Wetlands 3 and 17 in 2017

Wetland 3 (Figure 3-1) is 5.0 ha in size (Table 3-1), and located about 1 km from the Nelson River, approximately 21 km west of the generating station site (Map 2-1). This wetland has a direct surface water connection to the Nelson River through a lake and then a short stream. Marsh habitat comprised 1.1 ha of the wetland's total area. A 2013 wildfire burned approximately 90% of the marsh habitat buffer (*i.e.*, a 100 m buffer of the marsh habitat; see Section 2.0) included in Wetland 3.

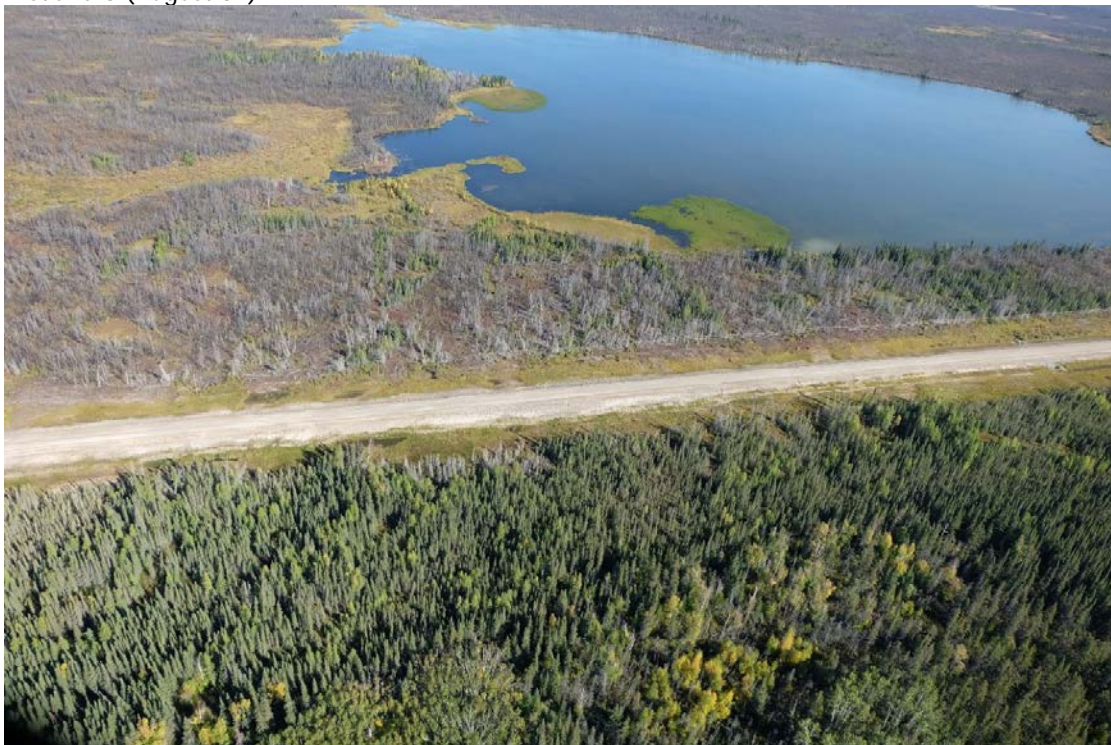
Wetland 17 (September 19)

Wetland 17 (Figure 3-1) is 135.1 ha in size and located on the southwest shore of a small lake located at approximately kilometre 6 along the north access road (NAR). Marsh habitat comprised 97.5 ha of the wetland's total area. Approximately 85% of the marsh habitat buffer burned in the 2013 wildfire.

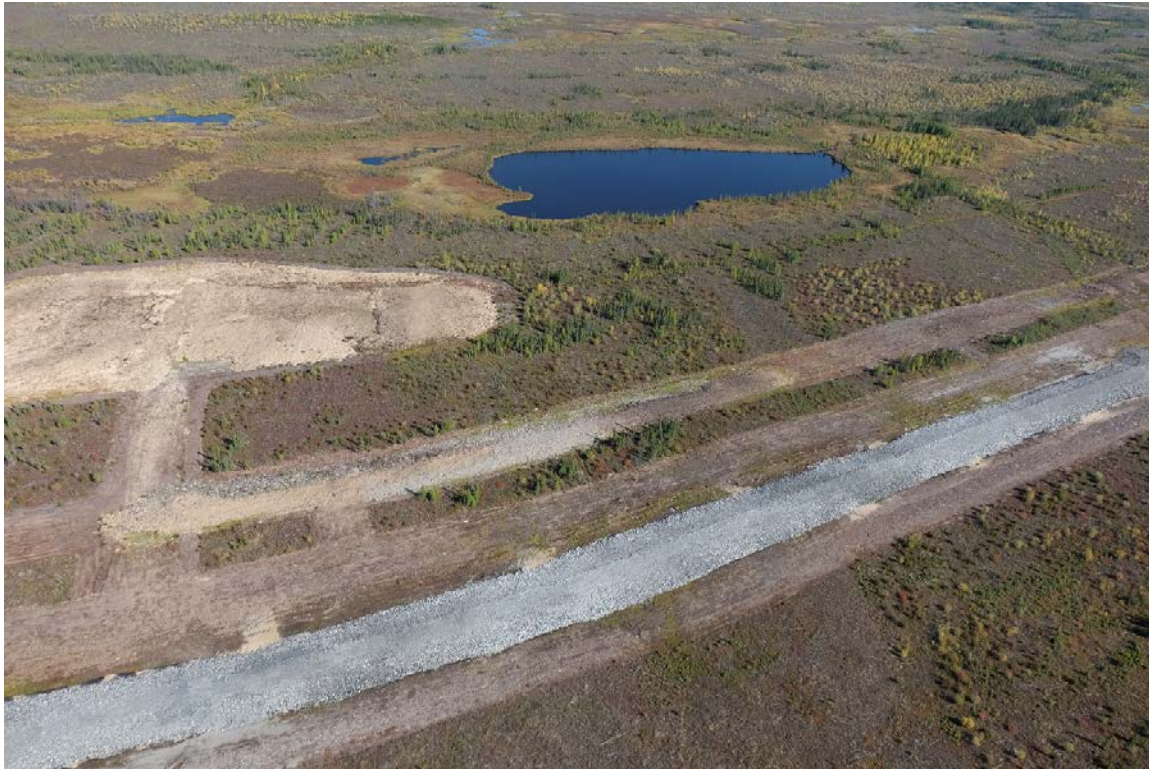
Figure 3-2: Aerial views of Wetlands 37 and 40 on September 19, 2017

Wetland 37 (Figure 3-2) is 17.0 ha in size, and located near the north dyke, adjacent to EMPA D3-E (Map 3-1). Marsh habitat comprised 4.1 ha of the wetland's total area. Approximately 5% of the marsh habitat buffer burned in the 2013 wildfire.

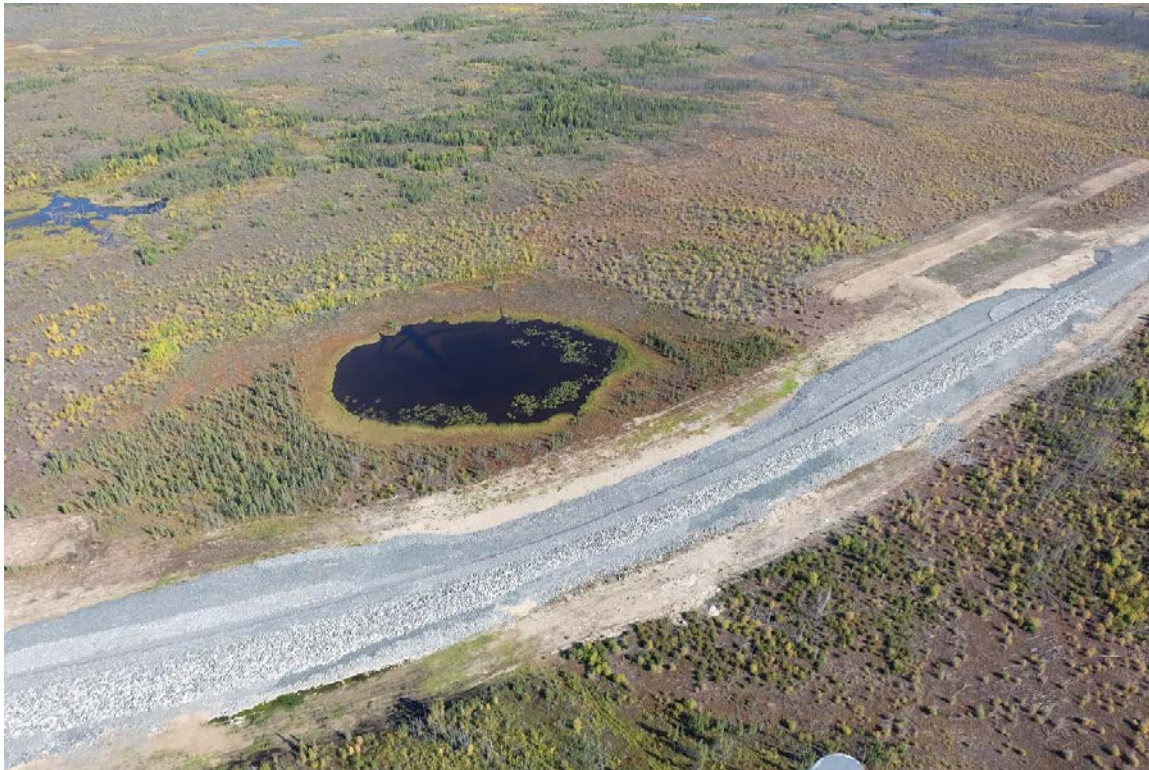
Wetland 40 (Figure 3-2) is 7.9 ha in size, and located along the north dyke, approximately 750 m east of Wetland 37 (Map 2-1). Marsh habitat comprised 1.2 ha of the wetland's total area. Approximately 10% of the marsh habitat buffer burned in the 2013 wildfire.

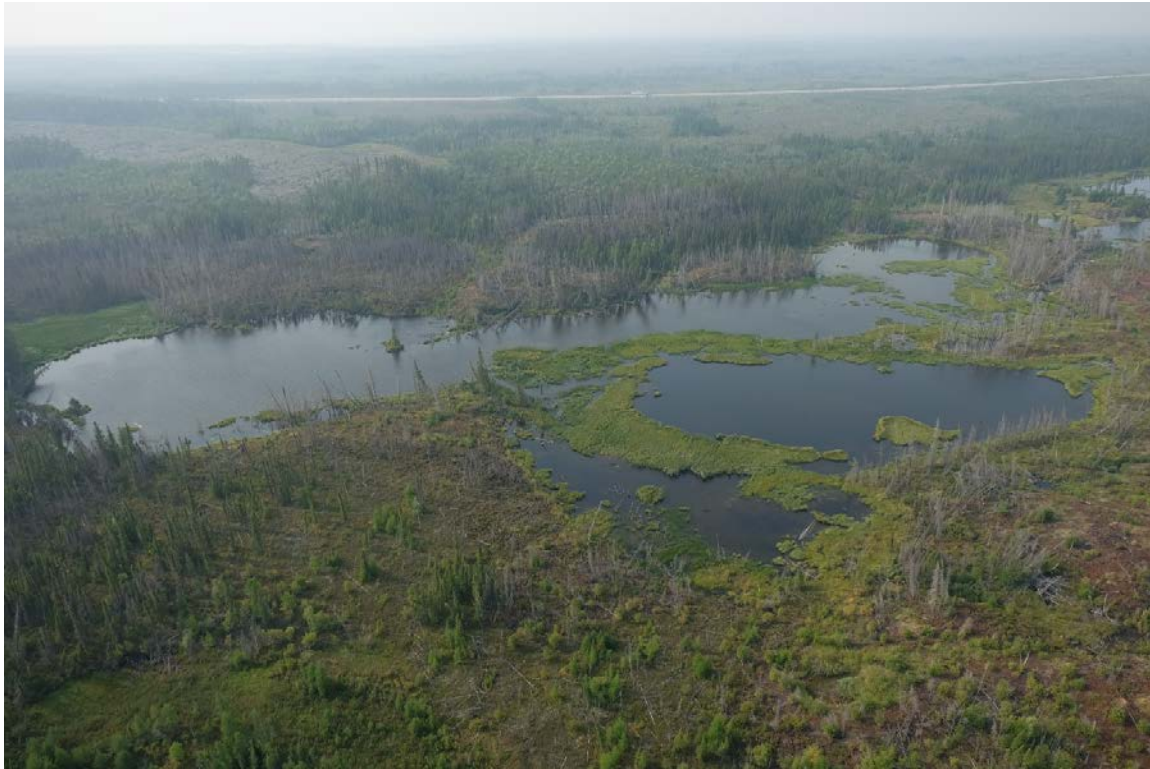
Figure 3-3: Aerial views of Wetlands 42 and 45 on August 31, 2017

Wetland 42 (Figure 3-3) is 15.5 ha in size, and located approximately 750 m north of the NAR at kilometer 14, at the northwestern end of Borrow Area KM15 (Map 2-1). Marsh habitat comprised 2.9 ha of the wetland's total area. Approximately 50% of the marsh habitat buffer burned in the 2013 wildfire.

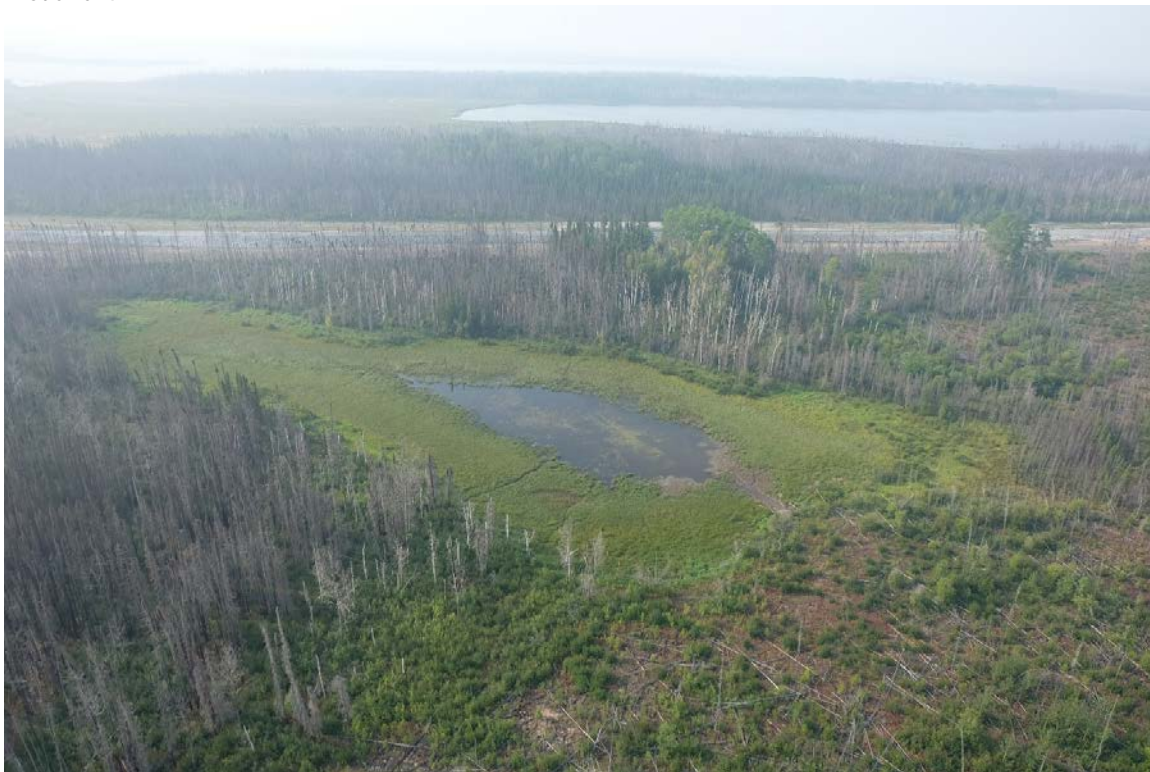
Wetland 45 (Figure 3-3) is 7.3 ha in size, and located along the north dyke, approximately 1.5 km east of Wetland 40 (Map 2-1). Marsh habitat comprised 0.8 ha of the wetland's total area. Approximately 50% of the marsh habitat buffer burned in the 2013 wildfire. Some of the burned area was between the planned north dyke and the marsh habitat, and some sites within this area had either a thin layer of organic matter or exposed mineral substrate.

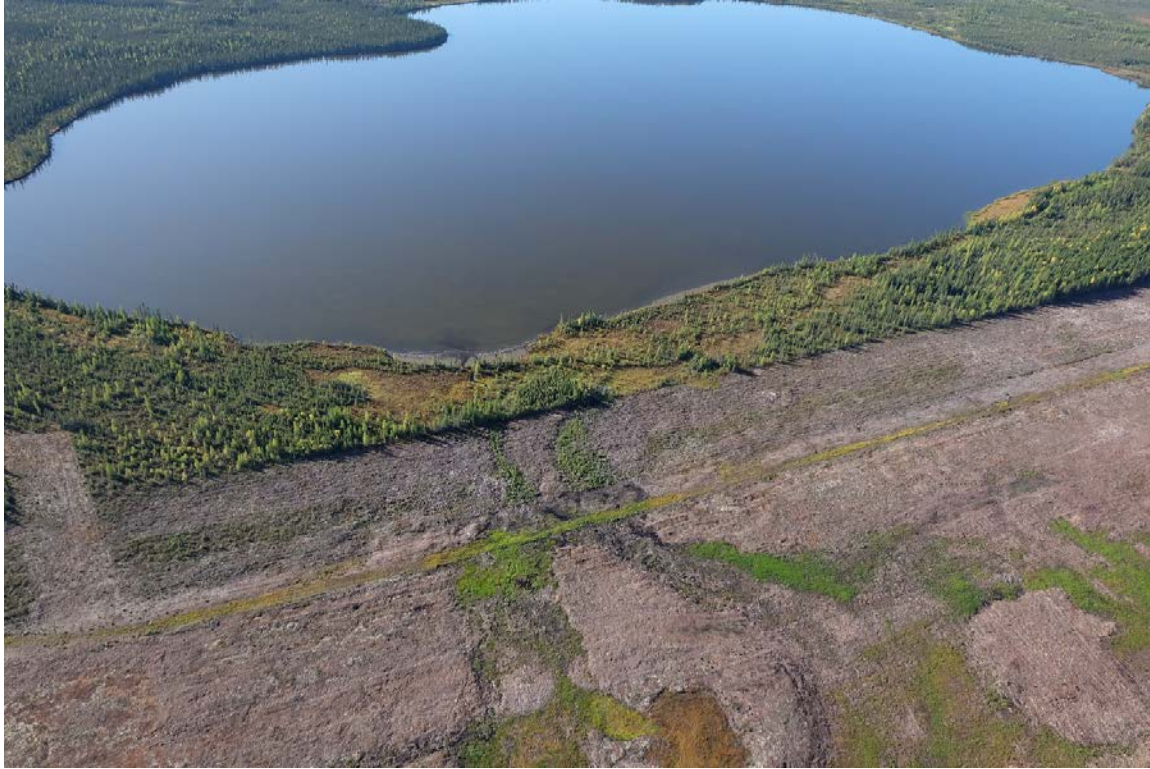
Wetland 47 (September 19)

Figure 3-4: Aerial views of Wetlands 47 and 51 in 2017

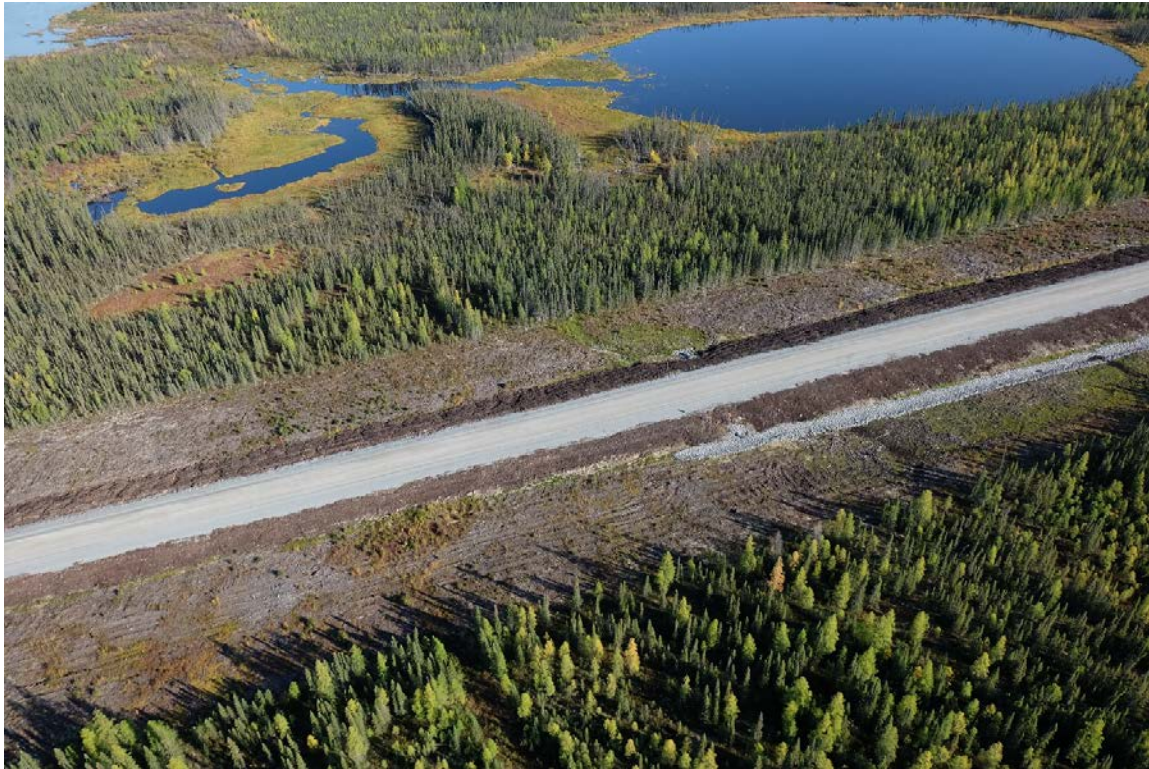
Wetland 52

Figure 3-5: Aerial views of buffers in Wetlands 52 and 53 on September 19, 2017

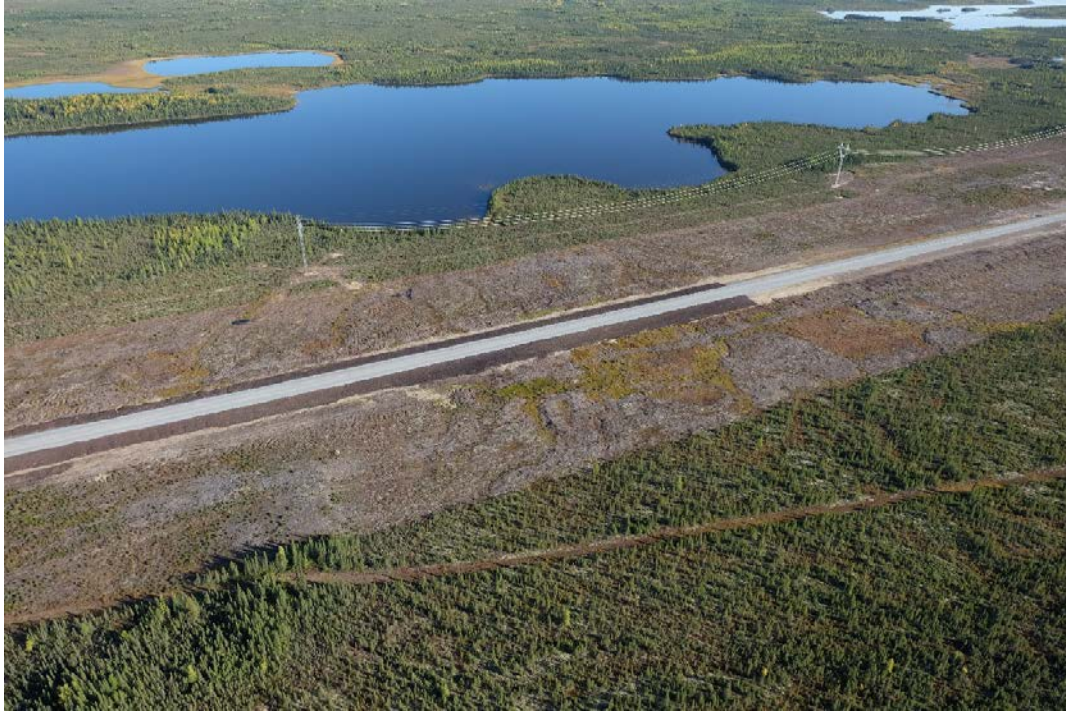
Figure 3-6: Aerial views of Wetlands 54 and 57 on September 19, 2017

Wetland 54 (Figure 3-6) is 113.1 ha in size, and located along the north side of the SAR, north of Borrow Area S-2b (Map 2-1). Marsh habitat comprised 70.1 ha of the wetland's total area. None of the marsh habitat buffer burned in the 2013 wildfire.

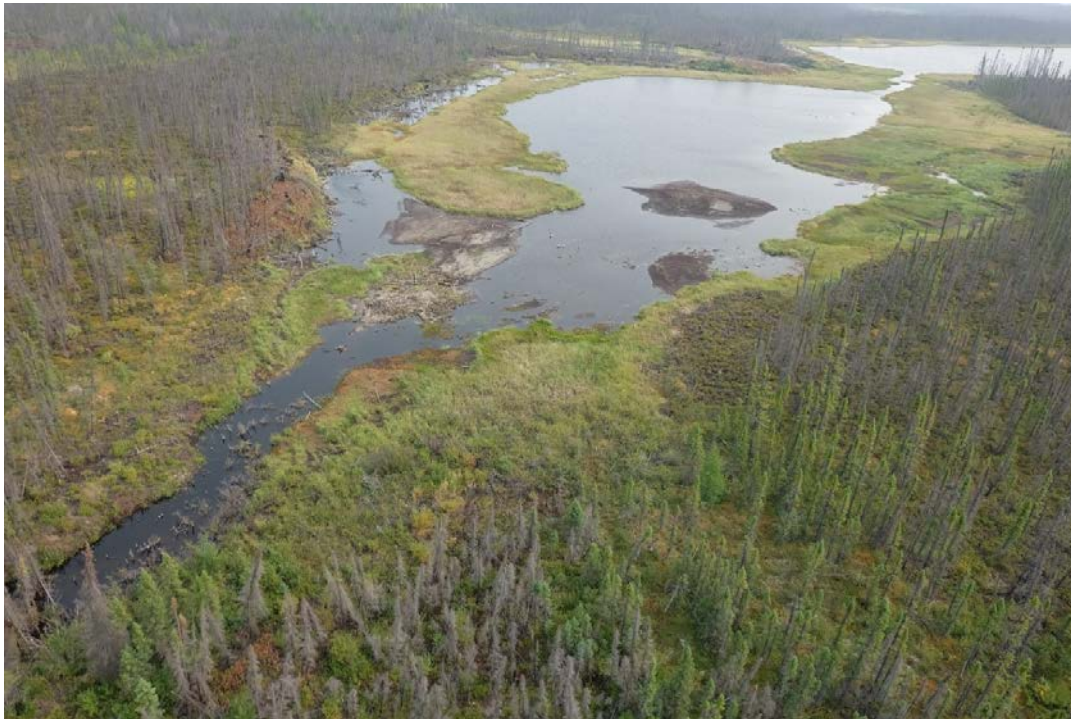
Figure 3-7: Aerial view of cleared trees in the marsh habitat of Wetland 3 on August 31, 2017

Approximately 0.26 ha of the cleared area was in the marsh habitat buffer and 0.10 ha was in the marsh habitat (Table 3-1). Cleared trees were visible where collapsed or collapsing peatlands had become part of the marsh habitat (Figure 3-8).

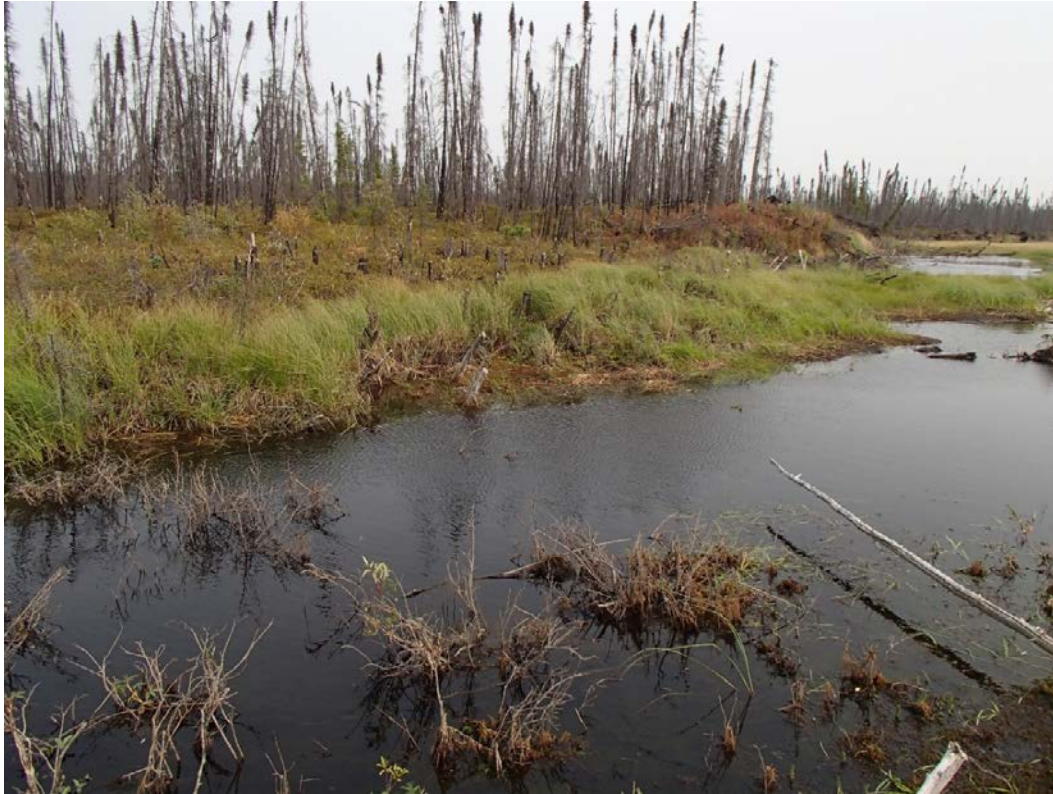
Figure 3-8: Cleared trees along the Nelson River shoreline in the marsh habitat of Wetland 3 on August 31, 2017

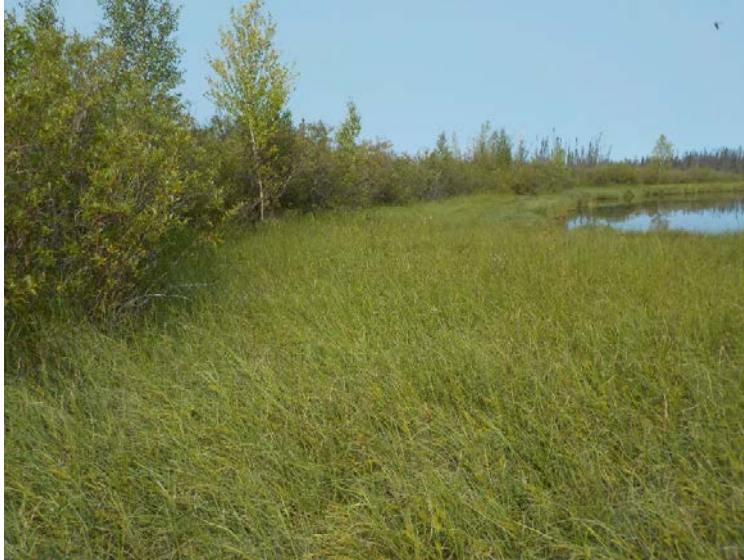
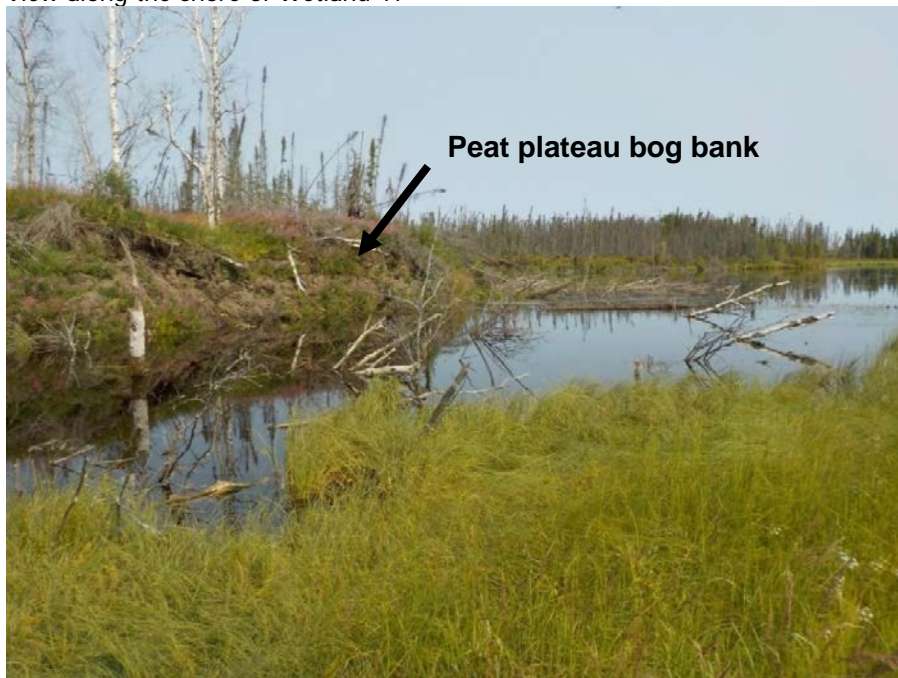
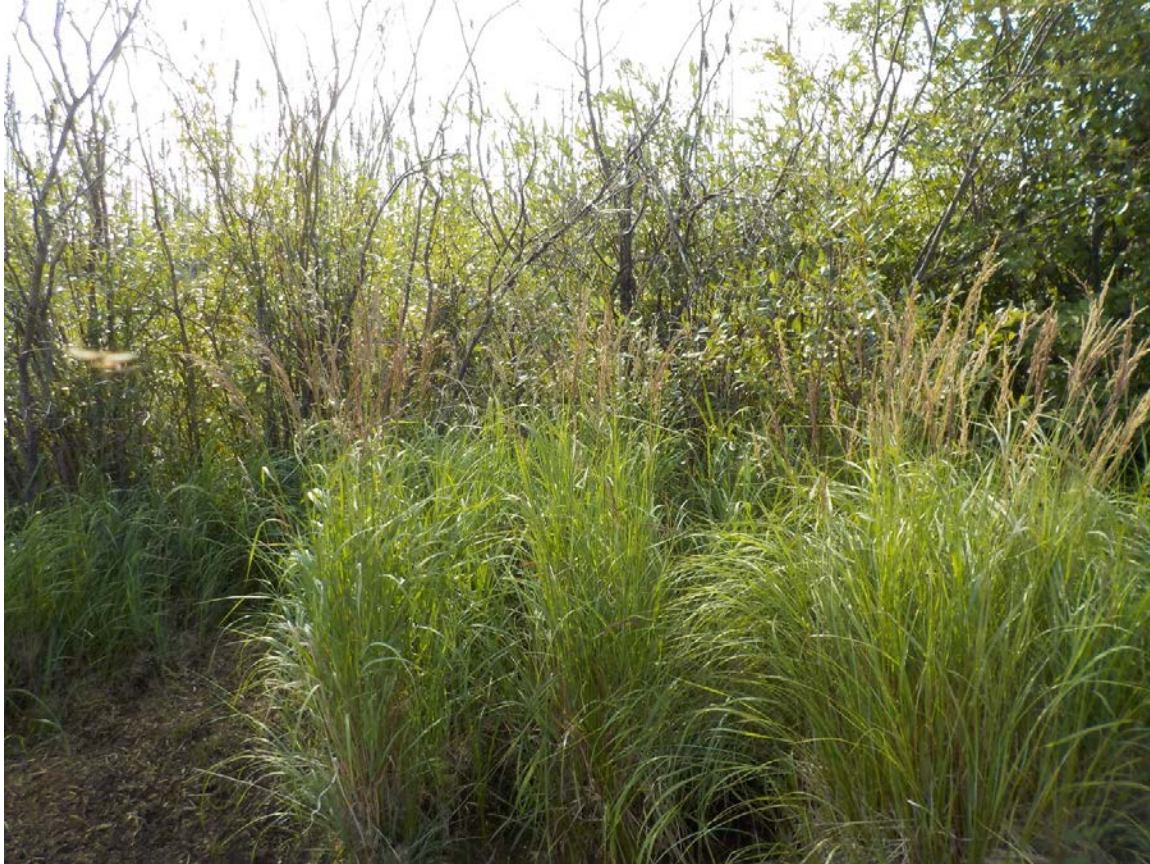
Figure 3-9: Ground photos of Wetland 17 on August 23, 2017

Some shrub and white birch mortality were observed in 2015 along the south side of this marsh at the shoreline (Figure 3-9), with some of the dead stems emerging from the water. The cause of this vegetation mortality was unclear. Some possibilities include the 2013 wildfire, depth to groundwater changes after the wildfire, ground slumping after massive ground ice below the peat had melted (see next paragraph), or indirect hydrological effects of nearby construction. No incremental changes were observed in these locations in 2016 or 2017.

Shoreline slumping around the southwestern edge of the marsh in Wetland 17 (Figure 3-9) was observed in 2015. Given its distance from the NAR, this slumping was likely caused by melting massive ground ice in peat (which the EIS showed was naturally occurring in the region). Ground ice melting was likely accelerated in locations burned during the 2013 wildfire. No incremental changes were observed in these locations in 2016 or 2017.

View along the shore of Wetland 17

Ground slump along the southwestern edge of Wetland 17 (likely due to melting ground ice in peat plateau bog)

Shrub mortality at Wetland 17

Future surveys will continue to monitor these locations.

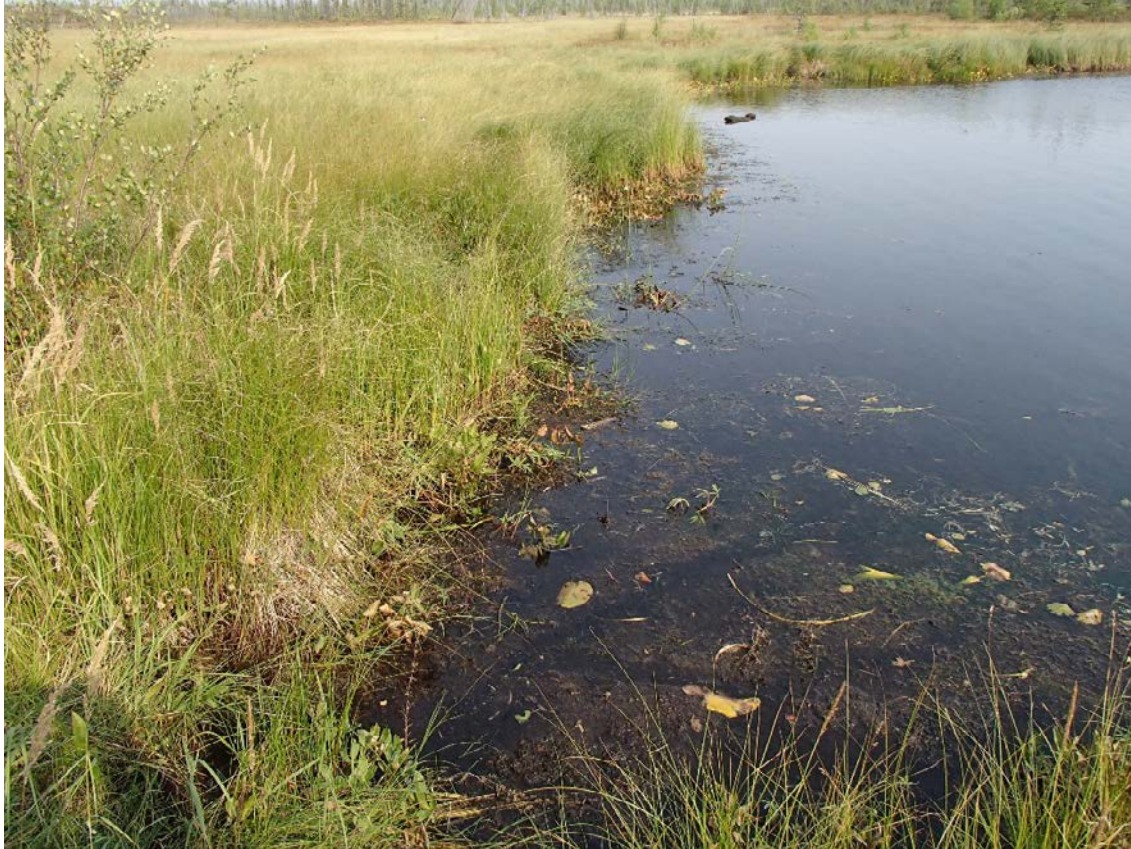
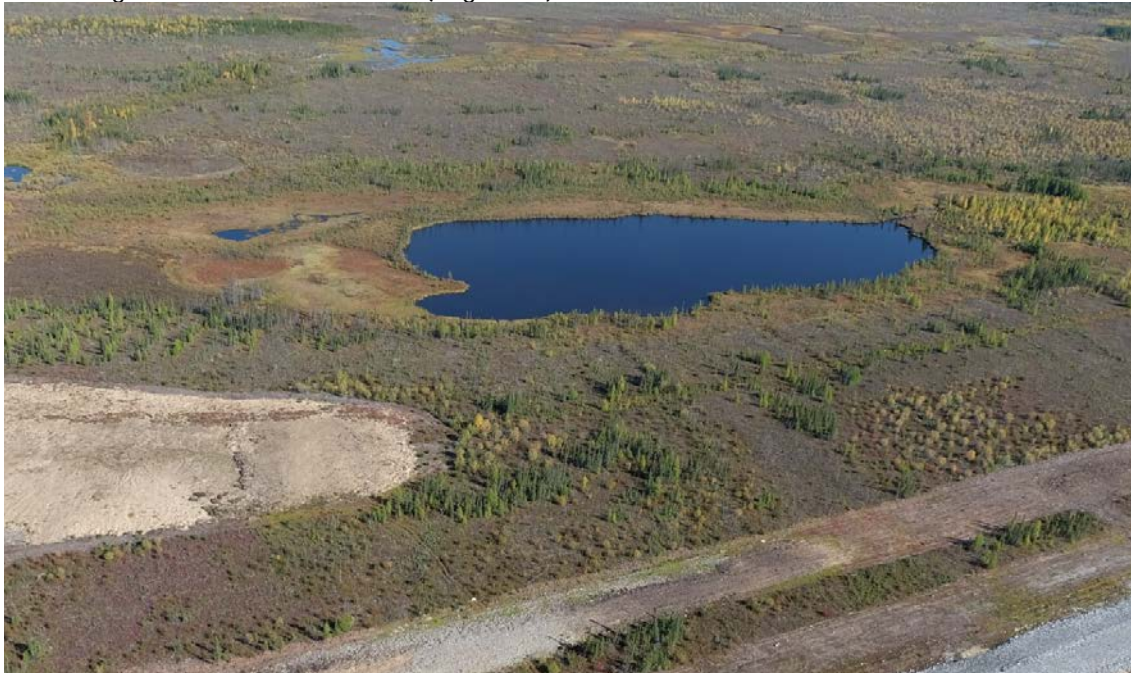
Figure 3-10: Ground and aerial photos of Wetland 37 in 2017

The 2016 ground survey found that a very small amount of EMPA clearing in the possibly disturbed Project footprint (< 0.01 ha; Table 3-1) extended into the buffer portion of the wetland. Ground surveys in 2017 found no further changes to the EMPA since the previous survey, and no new impacts on the wetland were observed.

View along the shores of Wetland 37 (August 31)

Aerial view of Wetland 37 looking northeast (September 19)

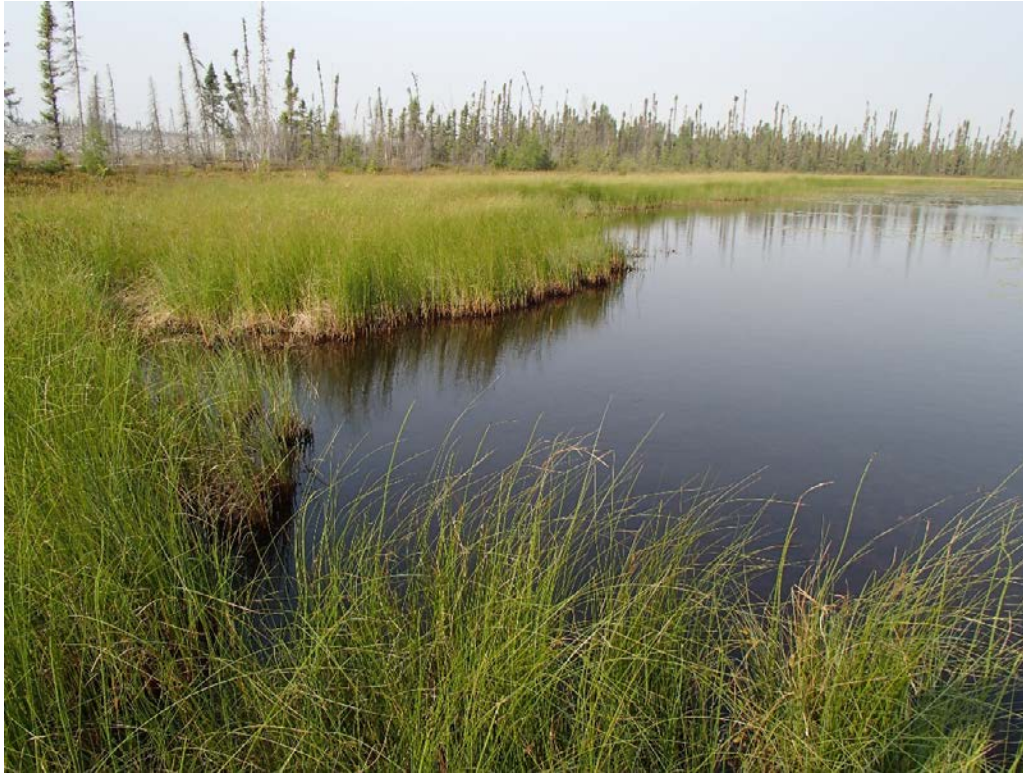
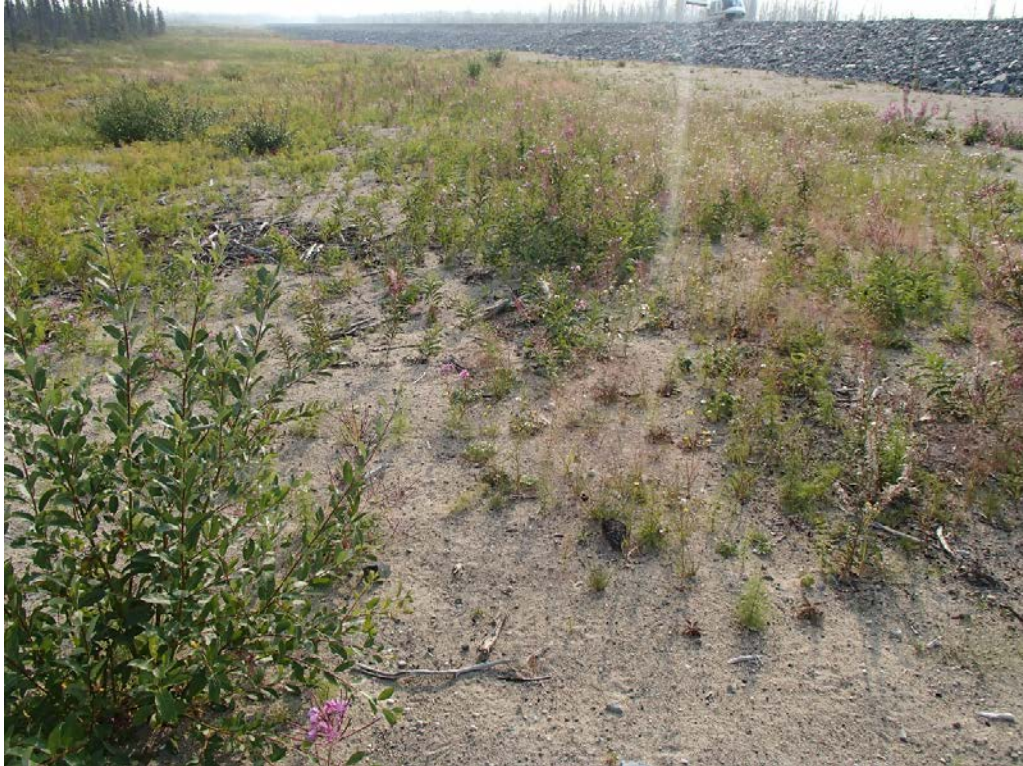
Figure 3-11: Ground photos of Wetland 40 on August 31, 2017

No sedimentation or runoff from the dyke was observed as of the 2017 surveys. The mineral slope facing the marsh remained shallow (Figure 3-11), and it appeared that risk of sedimentation due to runoff was low under current conditions. At the time of the surveys, no sediment control measures (e.g., silt fences) had been implemented. These areas will be monitored for any future effects from runoff.

View along the shores of Wetland 40

Exposed mineral slope adjacent to Wetland 40

It was also noted in 2016 that a shallow slope leading from the dyke clearing to the water's edge should be monitored for the potential to transport sediment from the exposed mineral of the dyke into the marsh.

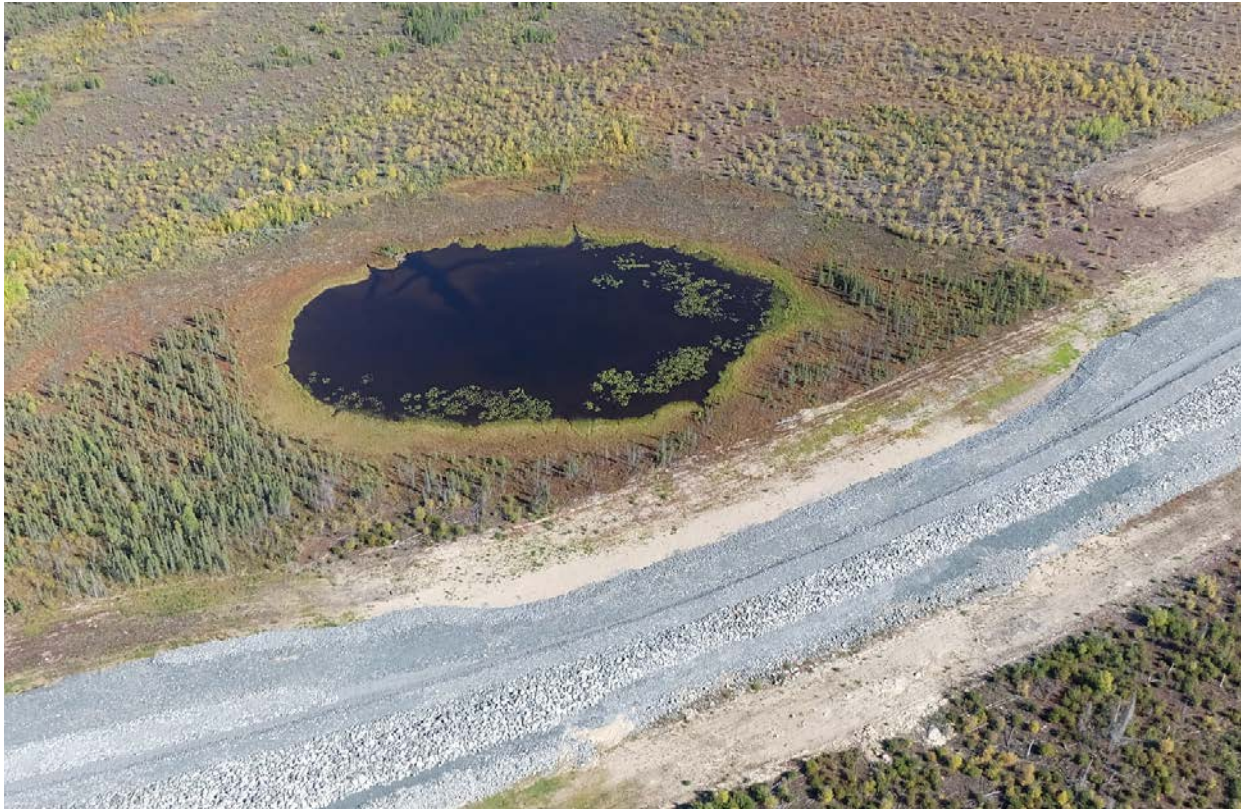
By the time of the 2016 survey, planned Project clearing for the dyke (Figure 3-11; Map 3-1) had extended through the buffer to approximately 3 m away from the southern portion of the marsh habitat (Figure 3-12). All of this 1.75 ha of clearing was within the planned Project footprint (Table 3-2). By the end of August, 2017, development of the north dyke within the cleared area continued, but no impact to the wetland was observed. It was noted that water levels in the marsh habitat at the time of the survey appeared to be lower than typical for reasons discussed in Section 4.0.

Figure 3-12: Aerial view of dyke clearing (all within the planned Project footprint) at Wetland 40 on September 19, 2017

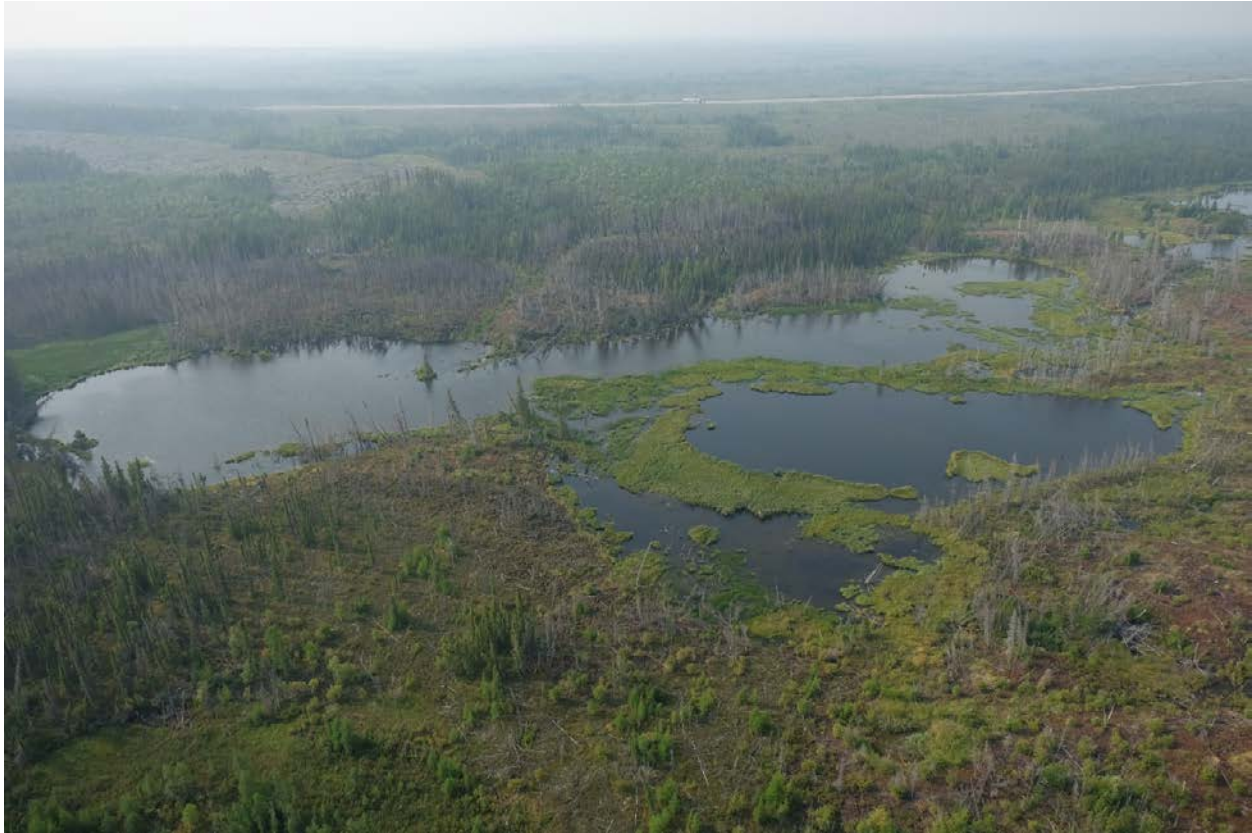
During the 2016 aerial survey, it was noted that there was a significant slope extending downwards from Borrow Area KM15 clearing to the southern edge of the wetland (Figure 3-13).

Up to the time of the 2017 surveys, there were no signs of erosion along the slope to the wetland. Also, there were no apparent changes in the undisturbed vegetation between the wetland and the cleared area in G-1, and no new clearing or excavation in the nearby portion of G-1. The band of intact vegetation will continue to be monitored in order to determine if there is any erosion or surface runoff from the slope into the marsh.

Figure 3-13: Aerial view of Wetland 42 from the north on August 31, 2017

A sediment control recommendation was not made given that the band of undisturbed vegetation between the exposed mineral area and the marsh buffer was approximately 90 m wide.

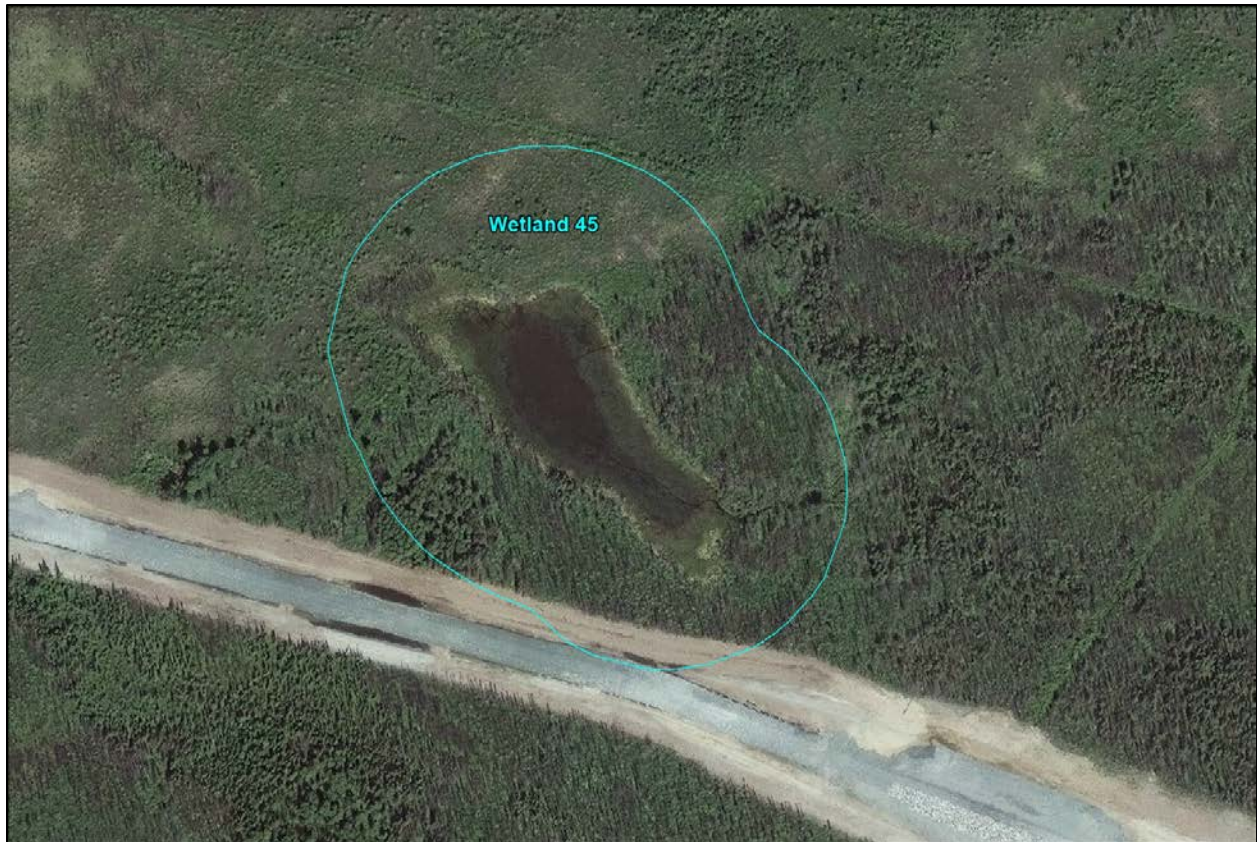
By the time of the 2016 ground survey, north dyke clearing had extended approximately 25 m into the marsh habitat buffer (Figure 3-15 and Figure 3-16; Map 3-1). All of this 0.24 ha of clearing was within the planned Project footprint (Table 3-2) and no other Project impacts were noted at that time. All of the dyke clearing within Wetland 45 was also within the above noted burned area.

Figure 3-15: North dyke clearing (all within the planned Project footprint) at Wetland 45 in July 2017

A 15% slope through the dyke clearing area to the marsh habitat creates the potential for future surface runoff to carry material into the marsh habitat. In addition to the slope containing exposed mineral material in the cleared area (Figure 3-16), the entire slope had been burned with some areas having virtually all vegetation removed. At the time of the 2017 surveys, no runoff or sedimentation was seen entering the marsh habitat. It was noted that there was a small hill between the wetland and the dyke, which may serve as a natural barrier to potential future runoff. These areas will continue to be monitored for potential runoff effects.

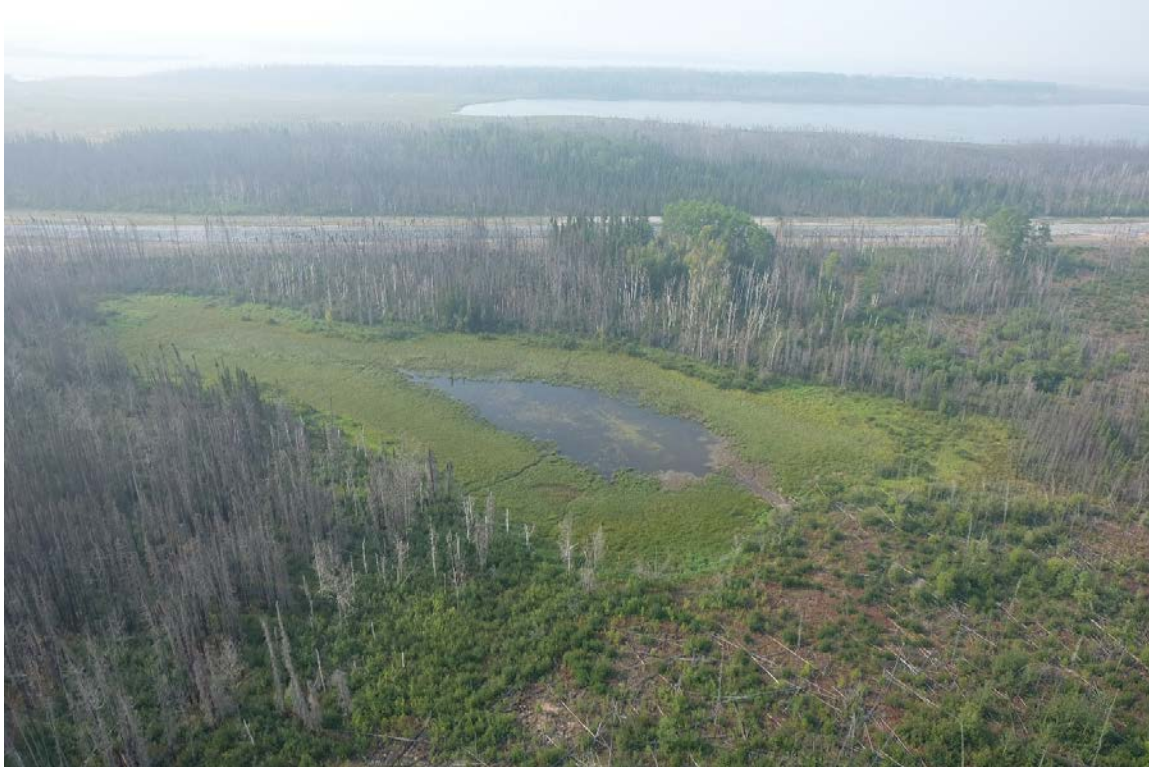
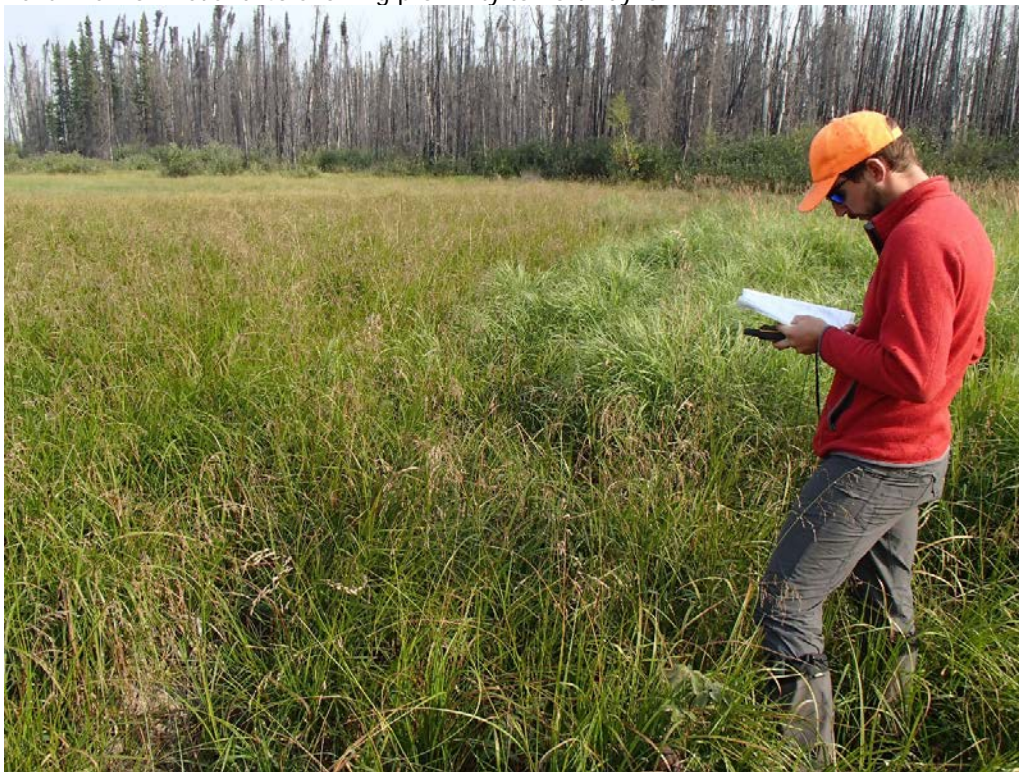
Figure 3-16: Ground and aerial photos of Wetland 45 on August 31, 2017

As of the end of August, 2017, no further clearing had occurred within the marsh habitat buffer, although dyke construction continued within the cleared area.

Aerial view of Wetland 45 showing proximity to north dyke

View along the shore of Wetland 45

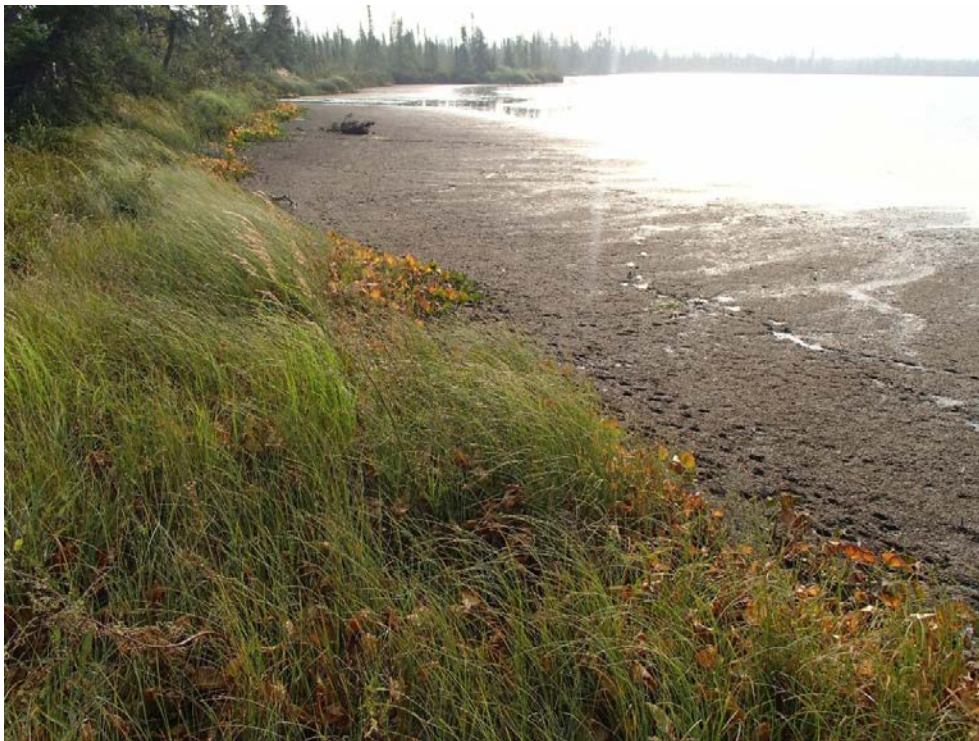
As of August 2017, a total of 1.03 ha of Wetland 47 was cleared, 1.01 of which was in the planned Project footprint (Table 3-2). No further clearing had occurred within the possibly disturbed Project footprint. At the northwestern edge, south dyke clearing occurred within 50 m of the shoreline (Figure 3-18). Part of a runnel, draining water through the wetland into the lake, was cleared where it was within the planned Project footprint, and woody debris had accumulated in the channel, but this did not appear to block water flow into the uncleared wetland. There were no apparent Project-related impacts from the clearing in the marsh habitat buffer. It was noted that water levels appeared relatively low in the marsh habitat (Figure 3-17).

Figure 3-17: View along the Wetland 47 shore in August 31, 2017
