Keeyask Generation Project
Terrestrial Effects Monitoring Plan

Wetland Loss and Disturbance Monitoring Report

TEMP-2018-03

Prepared for
Manitoba Hydro

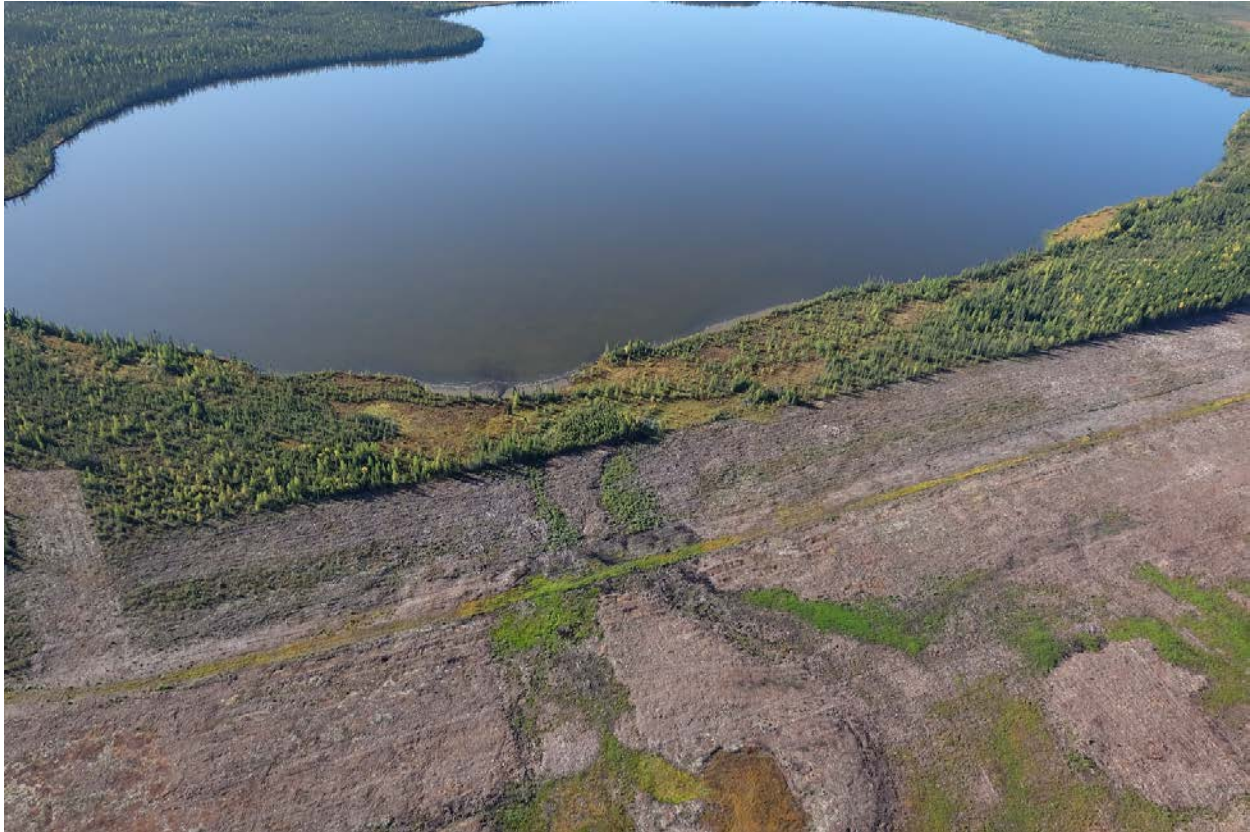
Figure 3-18: Aerial view showing the proximity of south dyke clearing to Wetland 47, September 19, 2017

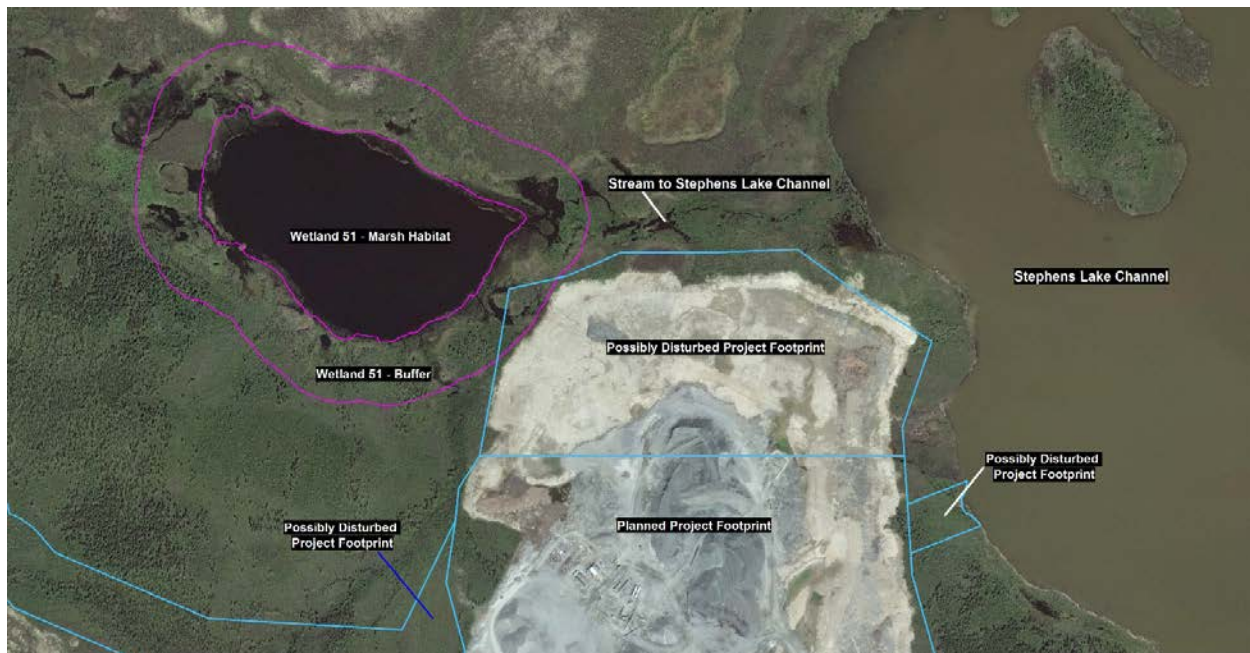
Figure 3-19: Wetland 51 in 2017 satellite imagery showing adjacent EMPA, stream to Stephens Lake channel and boundaries of licensed Project footprint

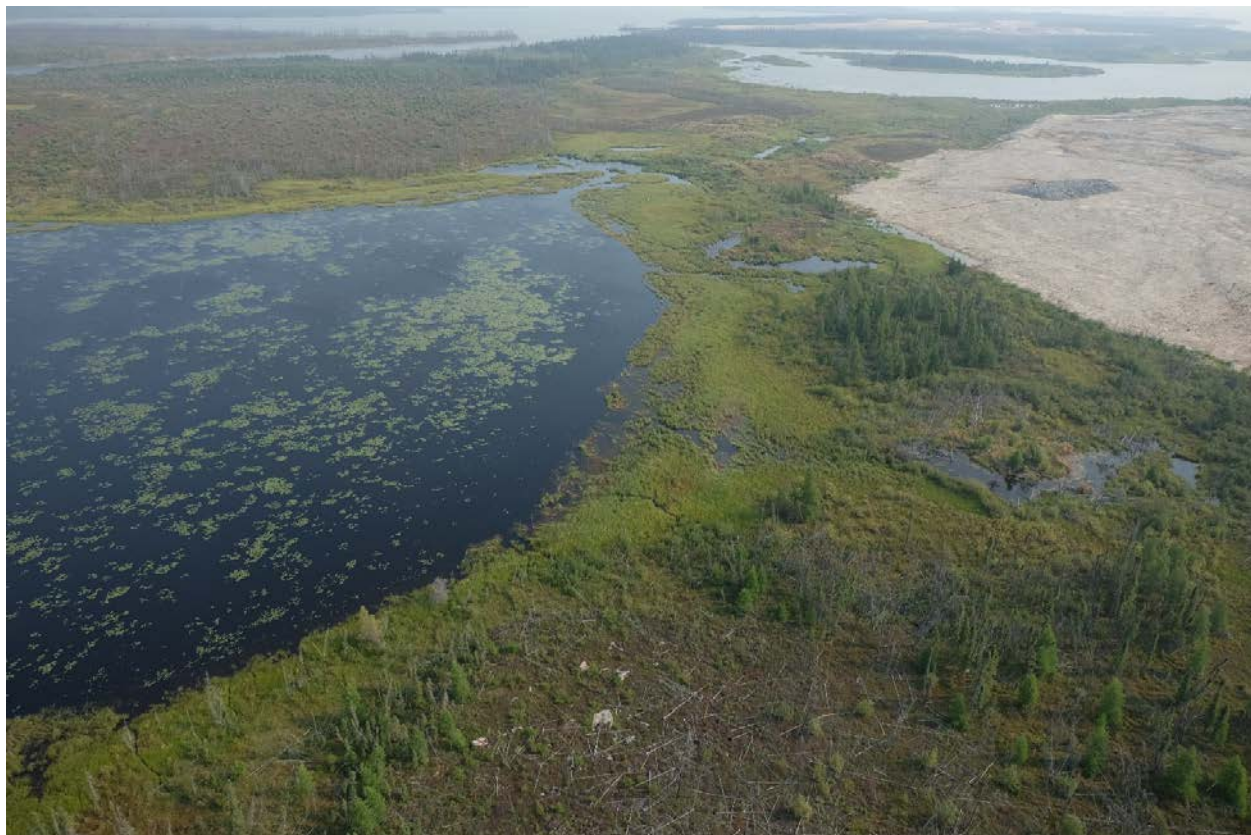
As of late summer 2017, the only additional Project impact within Wetland 51 was sediment deposition into the buffer portion of the wetland. While the EMPA D16 slopes adjacent to the buffer in Wetland 51 had not been altered since the 2016 surveys (Figure 3-20), two larger erosion channels had developed in the slope. These channels were now depositing sediment into the water adjacent to the wetland (Figure 3-21), although none of the wetland vegetation within the marsh buffer had been covered. While sediment may have entered the buffer under water, mapping of submerged sediment was not attempted (an arbitrary area of 0.005 ha was used to record the impact). There was no apparent vegetation mortality within Wetland 51 between the EMPA slope and shoreline.

Figure 3-20: Aerial photo of Wetland 51 and adjacent EMPA on August 31, 2017

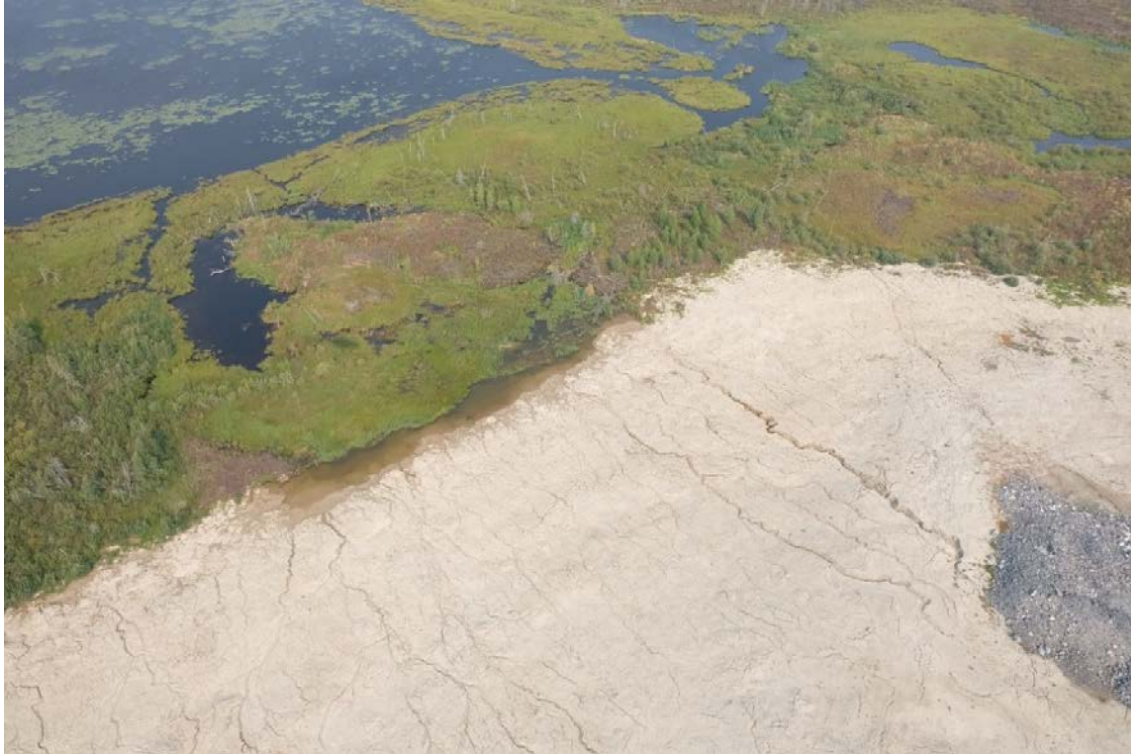
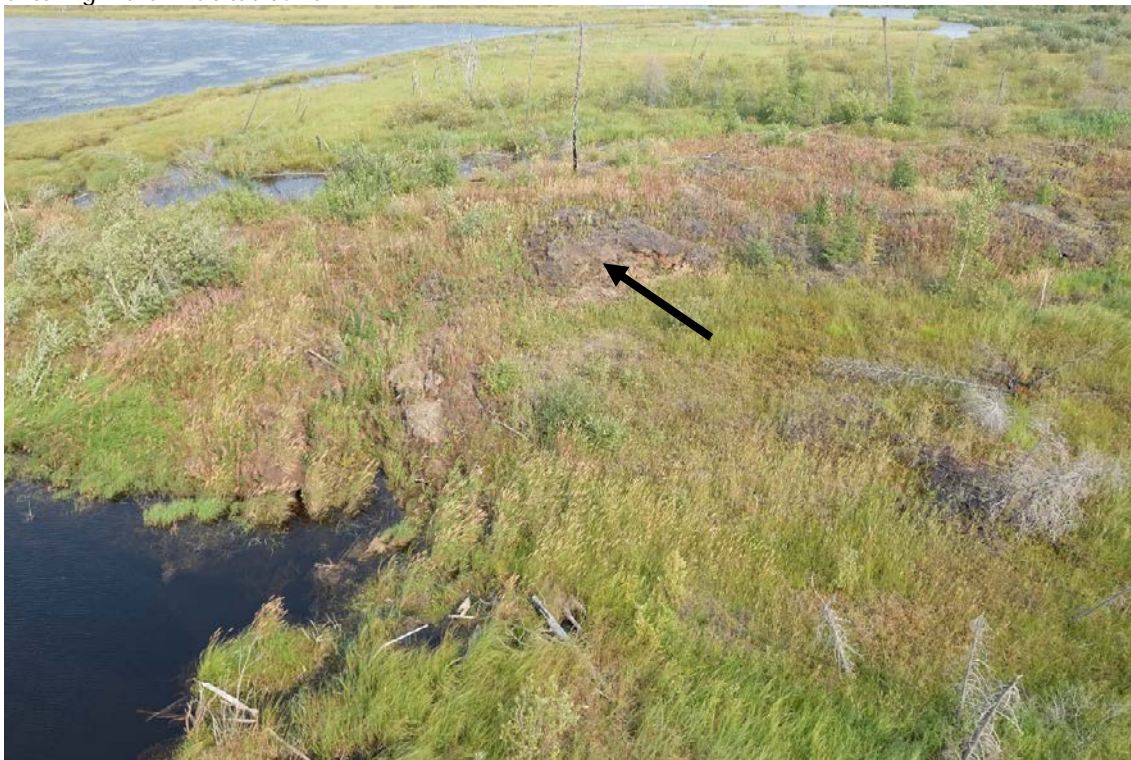
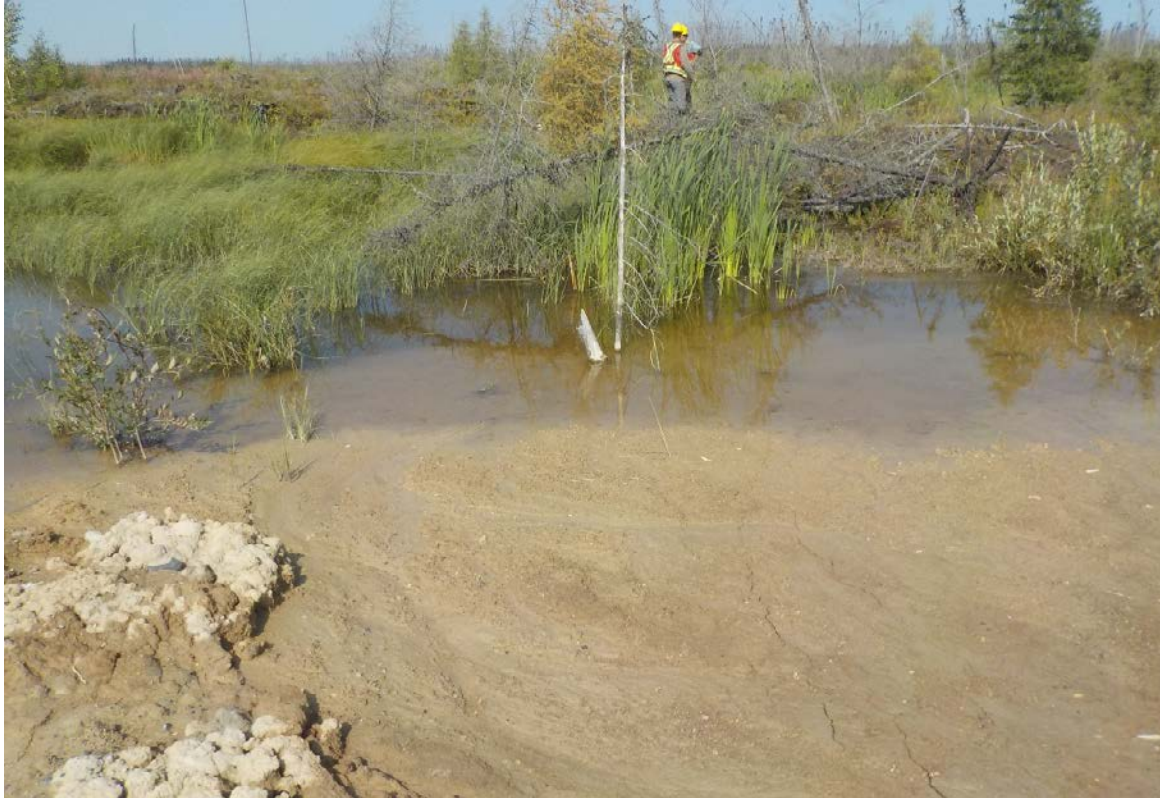
Figure 3-21: Aerial and ground photos of Wetland 51 in August 2017

Recent slumping of peat banks was observed around a small peat plateau bog between the wetland and EMPA slope (Figure 3-21). It was unclear if potential water regime changes due to the EMPA caused or accelerated this slumping, or if the slumping was due to massive ground ice melting that is occurring throughout the Keeyask region as a delayed response to past climate warming (ECOSTEM 2011).

Aerial view of EMPA slope near the east shore of Wetland 51, showing erosion channels and sediment entering marsh habitat buffer

Slumping peat bank within Wetland 51 buffer

Sediment from EMPA entering the buffer of Wetland 51

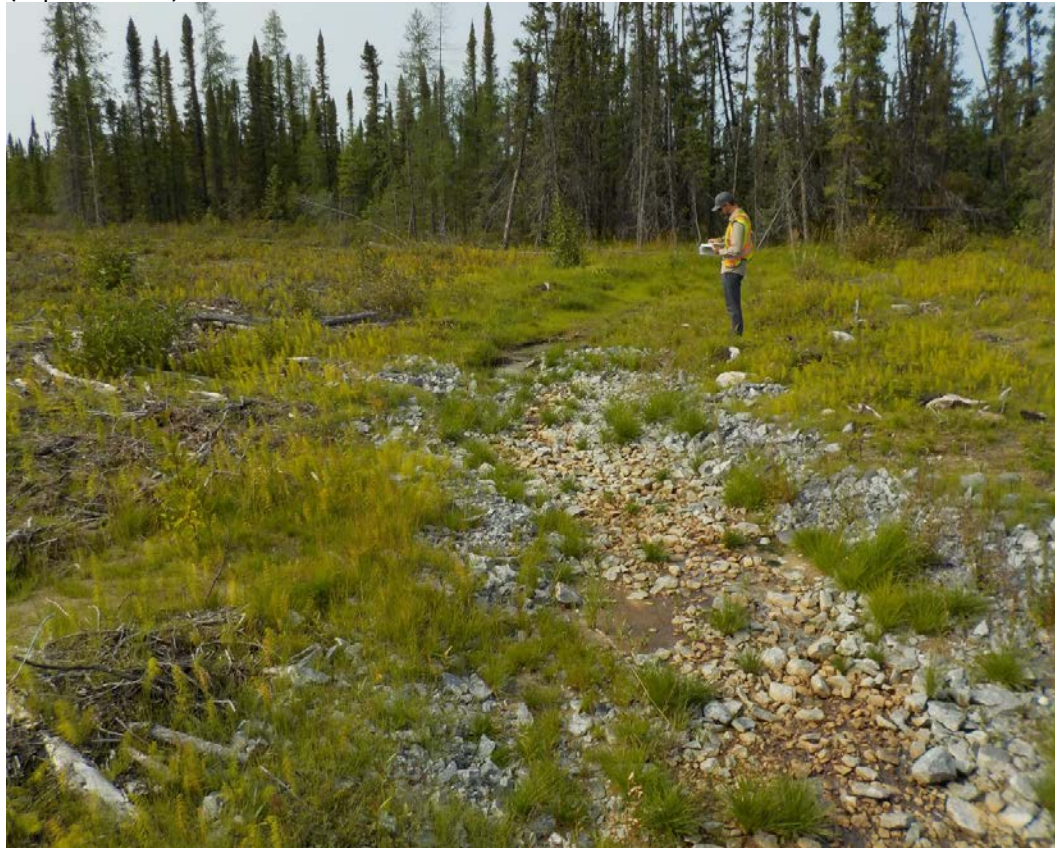
Figure 3-22: Aerial and ground photos of Wetland 52 in 2017

Ground surveys in 2017 did not find any evidence of sediment runoff from the SAR extending beyond the cleared ROW. Aerial surveys observed that the vegetation appeared to be healthy, there was no noticeable evidence of Project-related disturbance, and there were no obvious signs that water levels were being affected by the access road.

Aerial view of Wetland 52 showing peat plateau bog between the SAR and the wetland (September 19)

Drainage channel between SAR and treeline of peat plateau bog (August 23)

Monitoring of water levels and the condition of the marsh's drainage outlet for Project effects will continue.

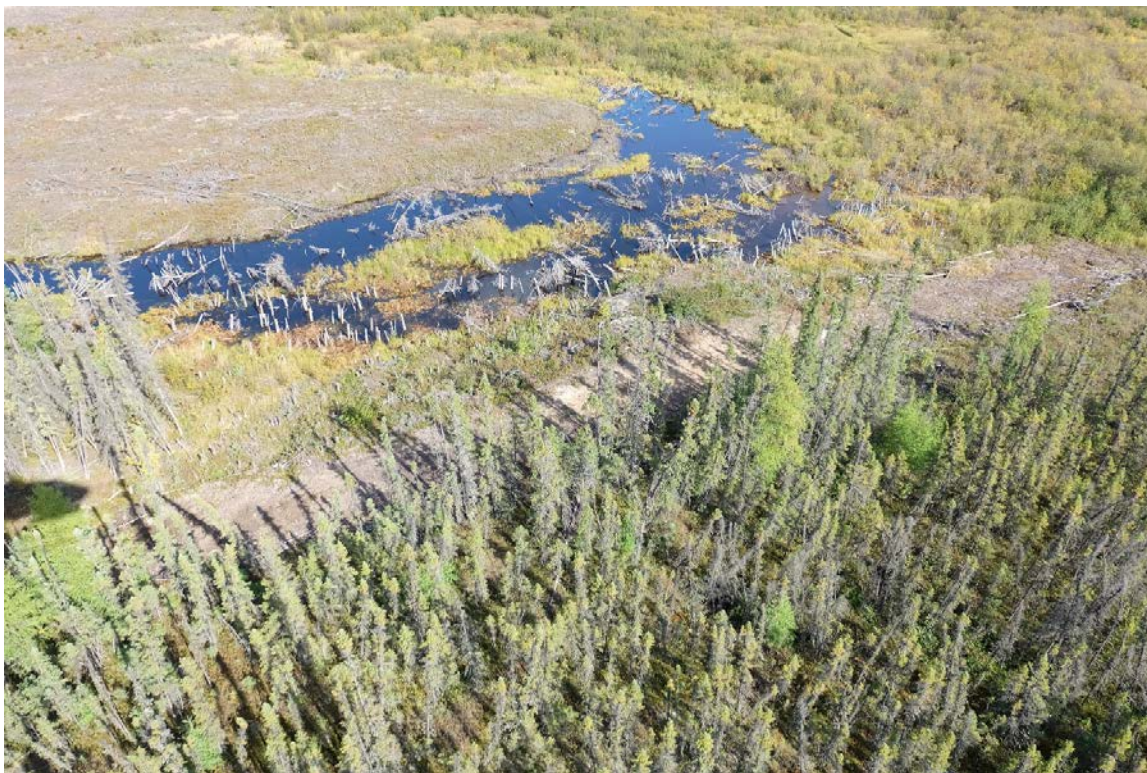
View of trail cut through the Wetland 53 buffer (wetland is off bottom of photo)

Figure 3-23: Aerial photo of Wetland 53 on September 19, 2017

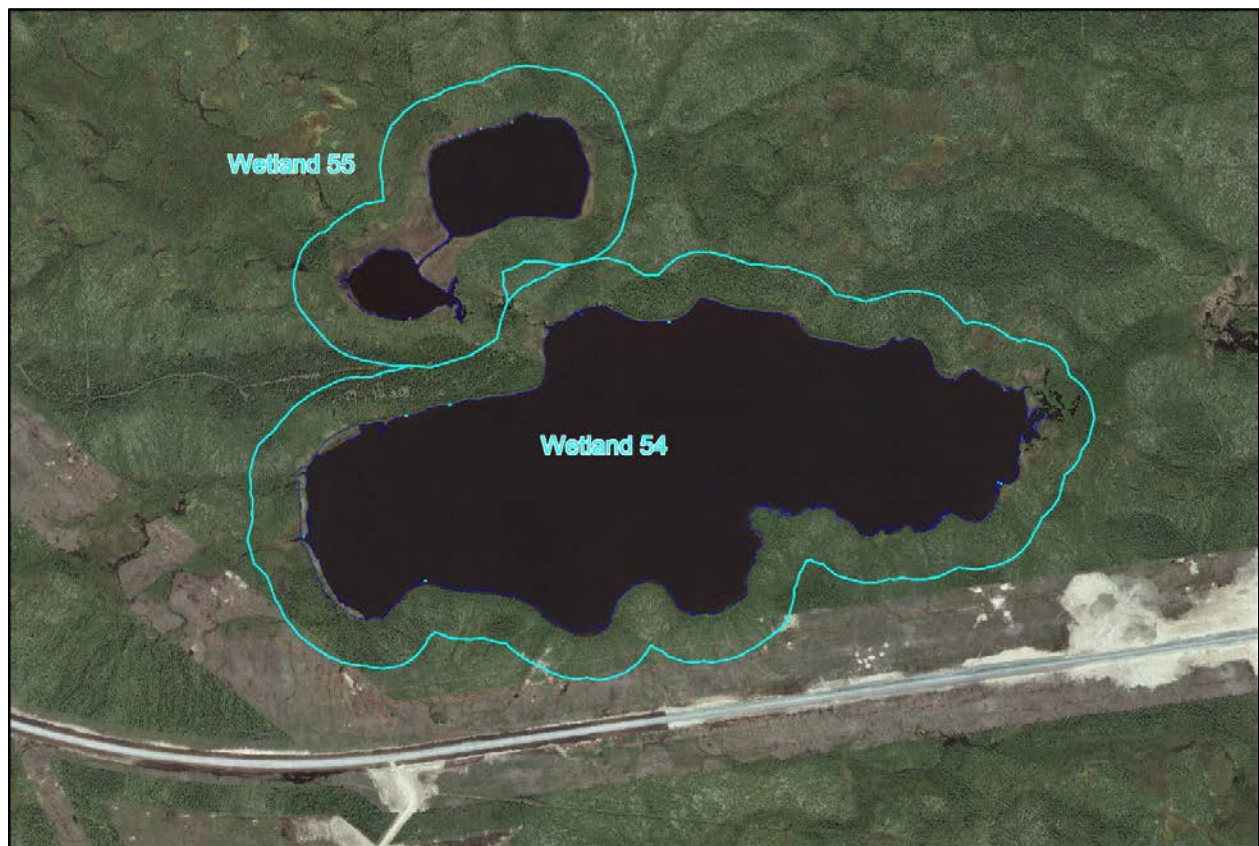
The clearing visible in the 2015 DOIs and aerial survey photos was for the Keeyask Transmission Project ROW. This clearing, which only impacted the marsh habitat buffer, had come as close as 20 m to the marsh habitat in some locations (Figure 3-24). No evidence of erosion or sedimentation into the marsh habitat was observed during the 2015 ground survey.

Figure 3-24: View of Wetland 54 in July, 2017 satellite imagery

The relatively dense existing low vegetation in the cleared areas within 100 m of the marsh should be adequate to stabilize soils and facilitate revegetation.

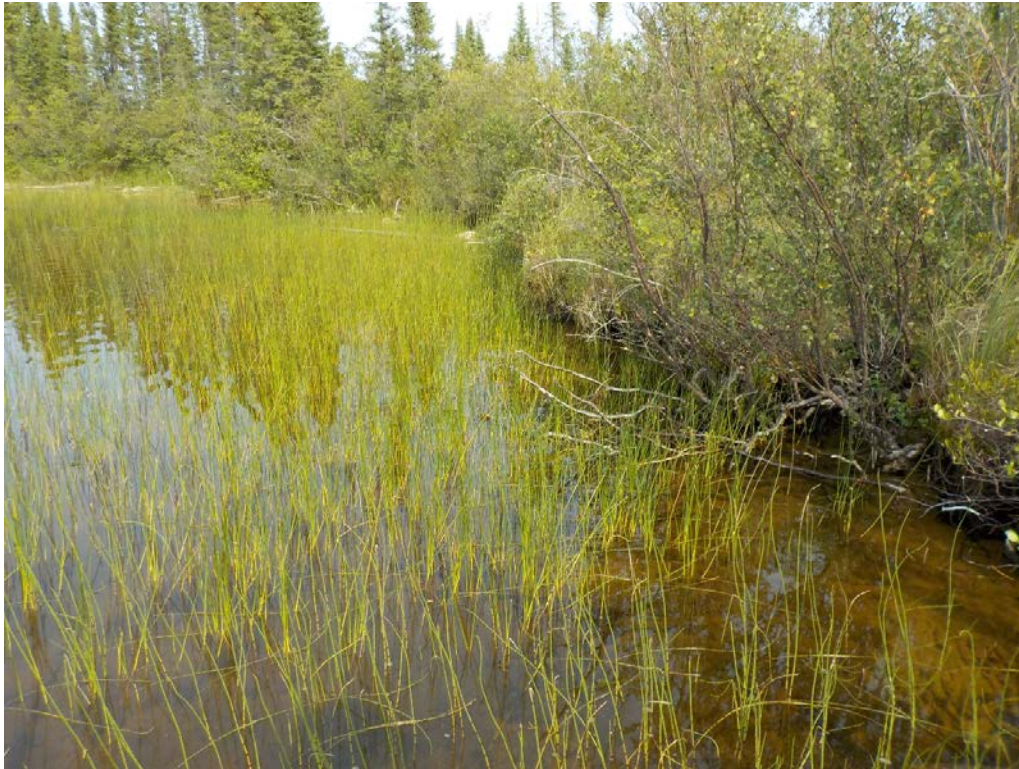
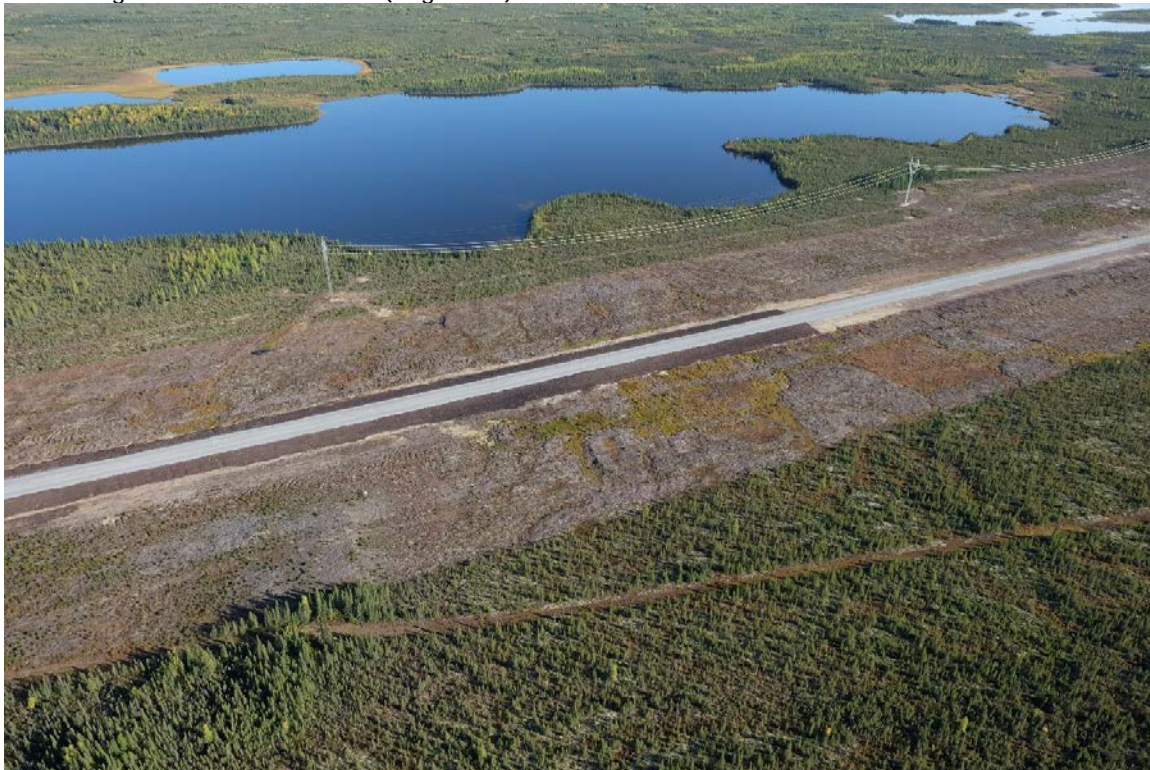
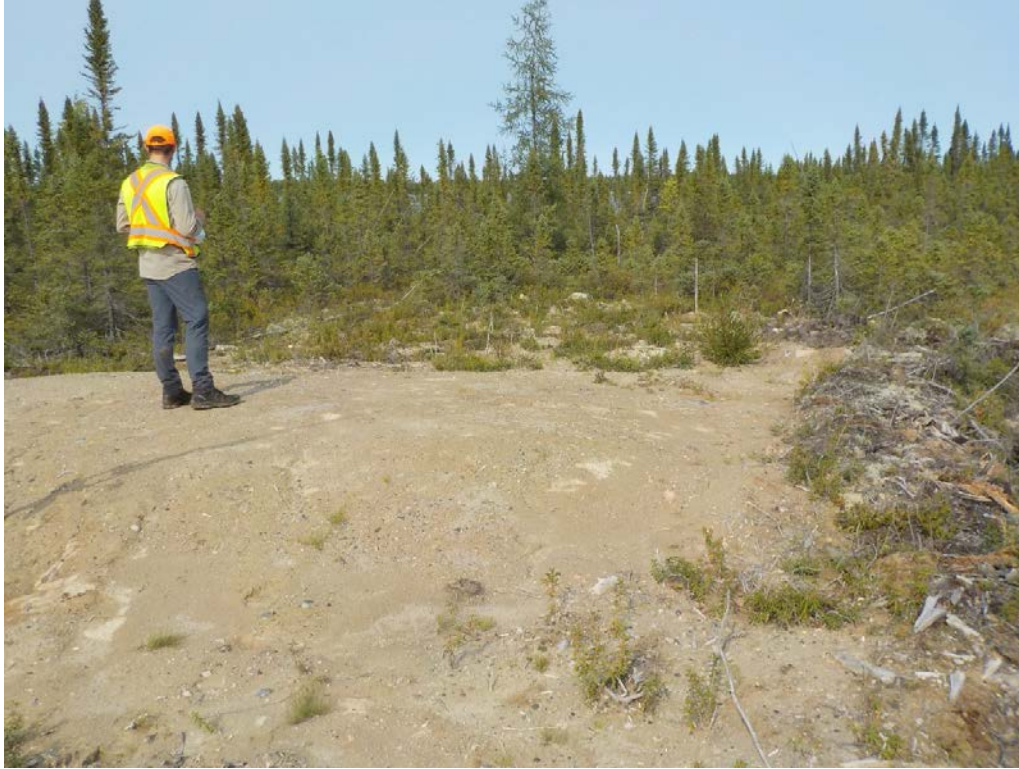
Figure 3-25: Ground and aerial photos of Wetland 54 in 2017

Ground surveys in 2016 found no expansion of the impacts recorded in 2015. New impacts were limited to clearing and disturbance for two Keeyask Transmission Project towers south of the marsh, which came right up to the marsh habitat buffer boundary (Figure 3-25). No new Project clearing or disturbance to Wetland 54 or its buffer was found during 2017 surveys.

View along the Wetland 54 shore (August 23)

Transmission towers adjacent to Wetland 54 buffer (September 19)

Ground view of transmission tower clearing and disturbance adjacent to Wetland 54 buffer (August 23)

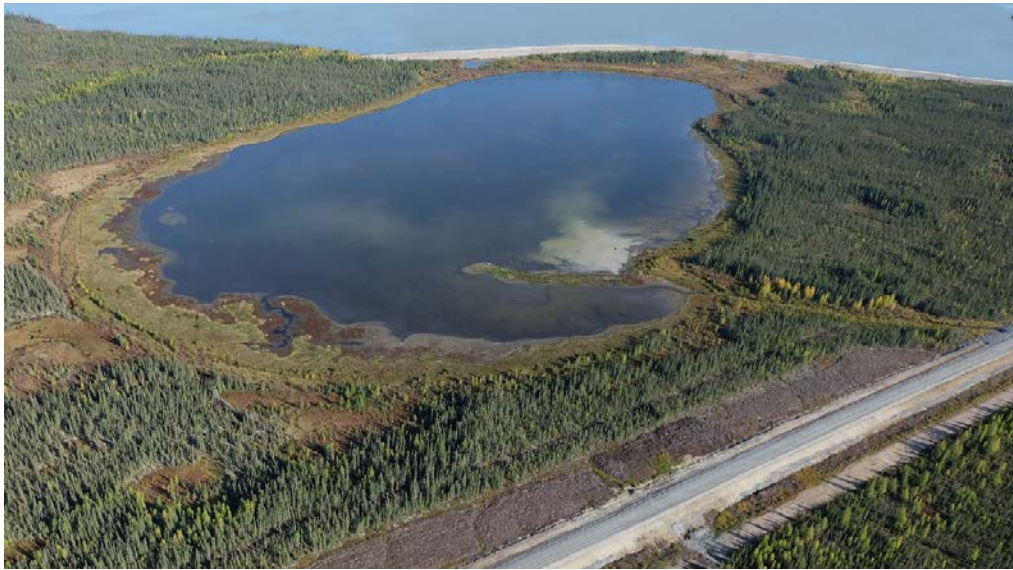
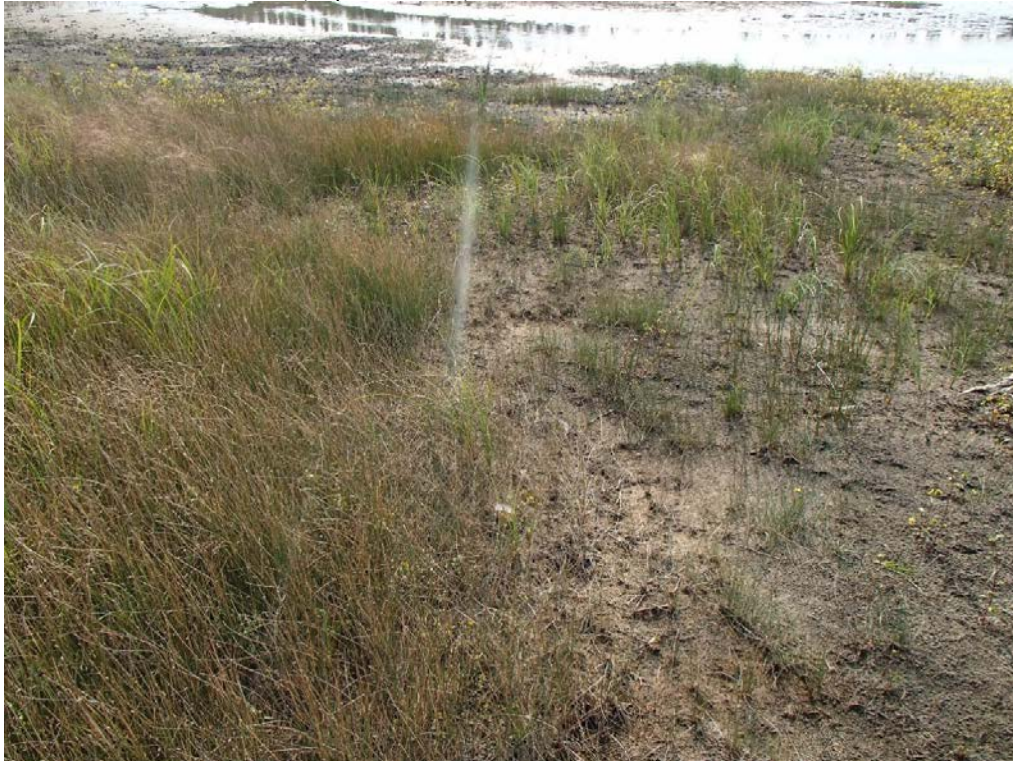
Figure 3-26: Aerial and ground photos of Wetland 57 in 2017

In terms of other potential Project impacts, a ditch from the SAR drains into the marsh habitat. The observed water levels in the waterbody in 2016 and 2017 were very low compared to those observed in 2015. For 2016, some of the possible causes were lower water levels on Stephens

Lake (marsh habitat is within 75 m of Stephens Lake; see Section 4.1) or altered hydrology due to road construction. Surveys of the drainage ditch from the SAR and the surrounding area did not find an obvious Project-related cause for the low water levels observed in 2016 and 2017.

Aerial view of Wetland 57 (September 19)

Low water levels in marsh habitat (August 31)

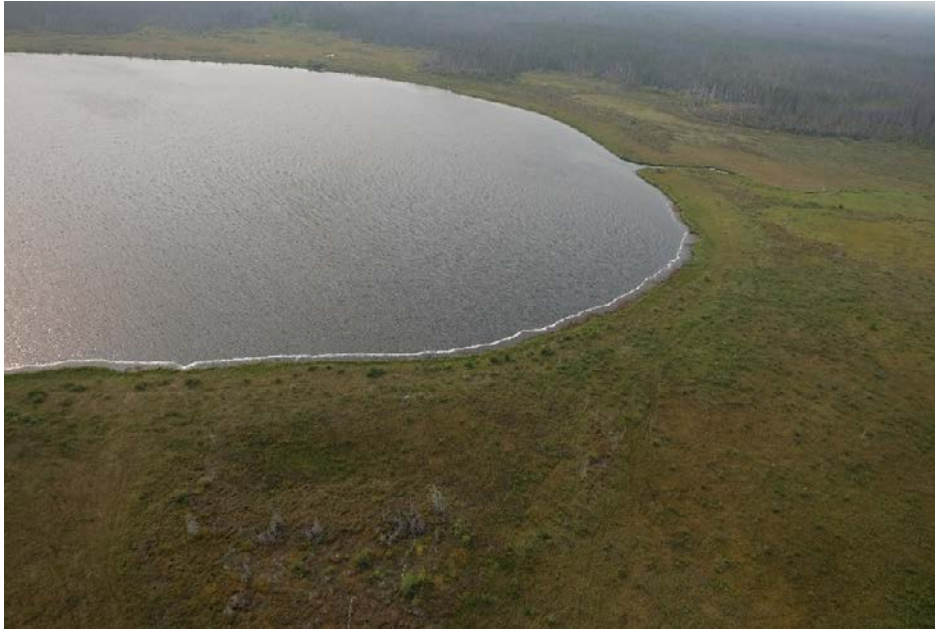
Wetland 7

Figure 3-27 shows the state of two of the remaining 30 wetlands visited during the aerial surveys. They were not closely surveyed because there were more than 100 m from existing Project clearing or disturbance. Monitoring in 2018 will determine if any of these or any of the other 30 wetlands have been impacted by the Project since the 2017 surveys.

Figure 3-27: Aerial photos of Wetlands 7 and 36 on August 31, 2017

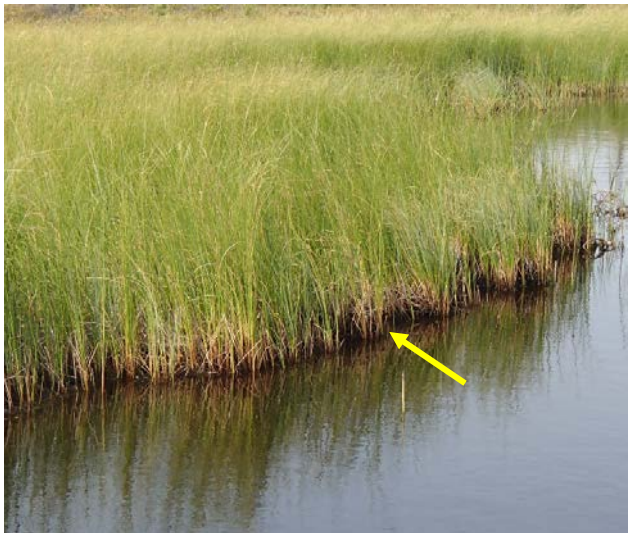
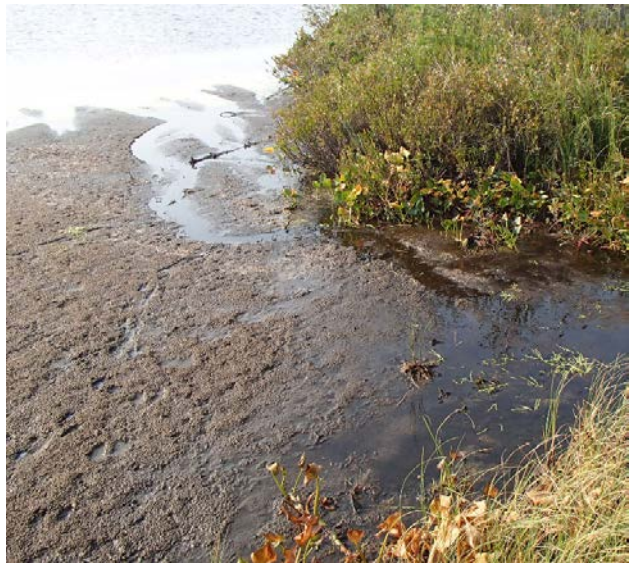
Figure 4-1: Photos illustrating evidence of lower than typical water levels in summer 2017

Natural variations in water levels in off-system waterbodies (which are unrelated to Project) were of interest for the wetland monitoring because they can lead to changes to marshes and their habitat. During the aerial surveys conducted in 2016 and 2017, it was noted that water levels in off-system waterbodies appeared to be lower than typical throughout Study Zone 3 (Map 2-1) at the time of the survey. This observation was based on exposed lake bottom areas, where different plant species were appearing relative to water levels, visible water lines on banks and vegetation, and on DOIs from various years.

Typically submerged portions of vegetation exposed in Wetland 40

Exposed lake bottom at Wetland 47
